CAPE LOOKOUT NATIONAL SEASHORE
Cape Lookout Lighthouse
Keeper's Dwelling (1907)
**HISTORIC STRUCTURE
REPORT**

**Historical Architecture, Cultural Resources Division
Southeast Regional Office
National Park Service**

2002
Historic Structure Report
Cape Lookout Lighthouse Keeper's Dwelling
(1907)
Cape Lookout National Seashore
LCS#: 091838

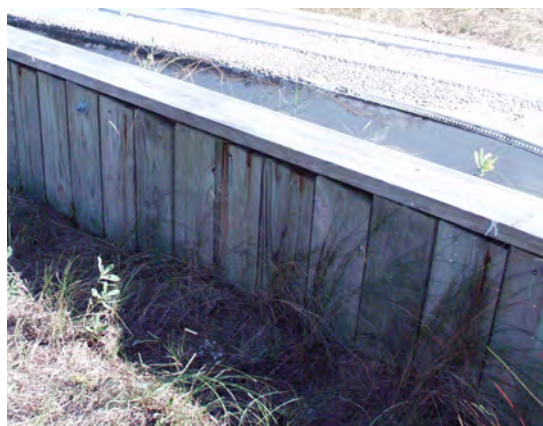
Figure 2 View of flood wall surrounding house. (NPS-SERO-CR, 2002)

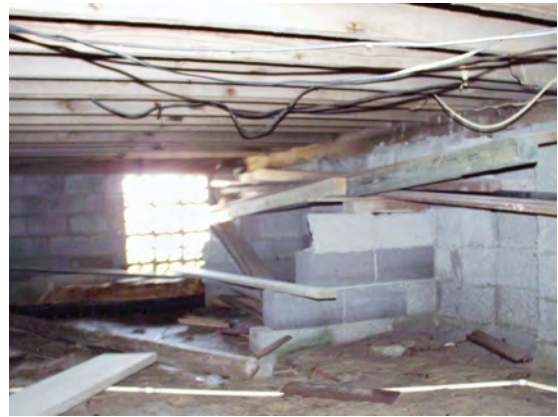
Figure 3 View north in crawl space, showing lattice block used to allow floodwater to pass through the building. (NPS-SERO-CR, 2002)

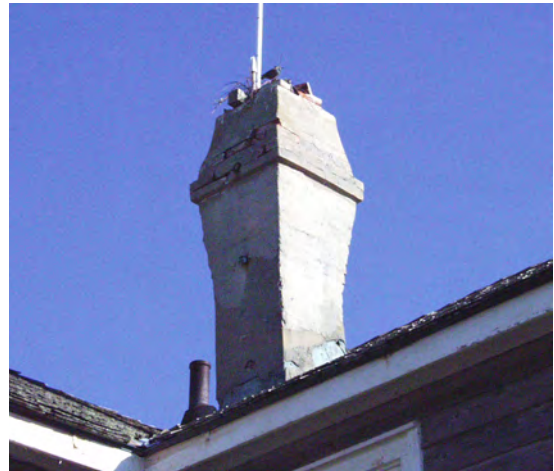
Chimney: The house was constructed with a single brick chimney stack that originally served a fireplace in the sitting room (Room 101) and a cook stove in the kitchen. When the house was moved, the foundation of the chimney was lost, but the original fireplace and chimney stack were moved intact and reset on a concrete block foundation. The chimney is

Figure 4 View of chimney. (NPS-SERO-CR, 2002)

- Match original foundation brick, if located, or, if not, match brick on existing historic chimney.
- Remove stucco from chimney, repair chimney as necessary.

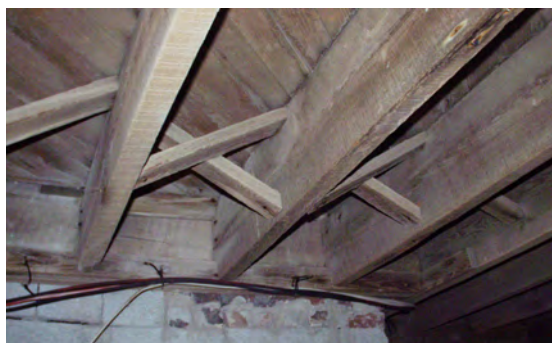
Figure 6 View of typical floor framing. (NPS-SERO-CR, 2002)

- Inspect framing of kitchen floor and perimeter sills for possible damage; repair as necessary.
- Reconstruct floor framing for front porch.

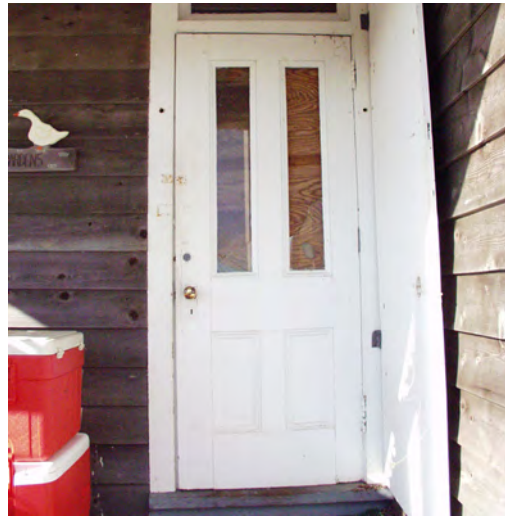
Figure 8 View of back door. Original front door was of a similar design. (NPS-SERO-CR, 2002)

may simply be the result of old damage and repairs to the door, which closely resembles the door indicated on the original architectural drawings for the house. Vandals recently broke one of the back door's beveled-glass lights.

- Repair and preserve all existing window sash.
- Repair and preserve all wood- framed window screens; where missing, install new wood- framed screens.
- Repair and preserve back door.
- Replace modern front door with replica of original.
- Remove plywood shutters on porches if the added security is unnecessary.

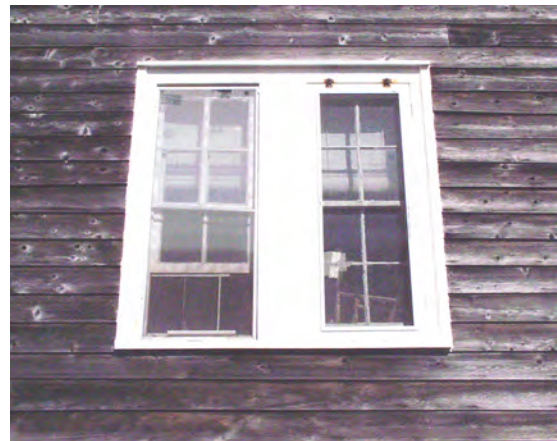
Figure 9 View of typical double windows. (NPS-SERO-CR, 2002)

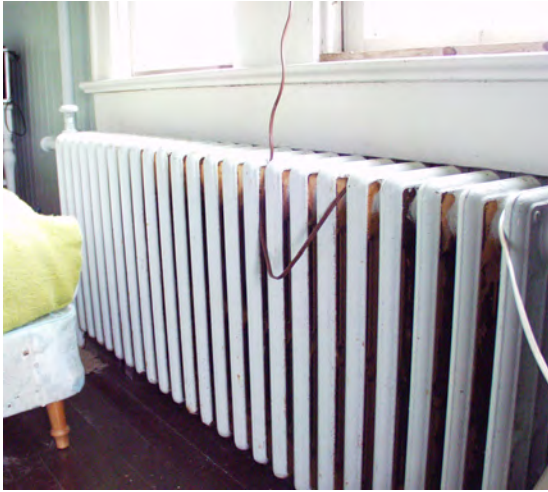
Figure 35 View of radiator in Room 203, which was typical of those installed in the 1930s. (NPS-SERO-CR, 2002)

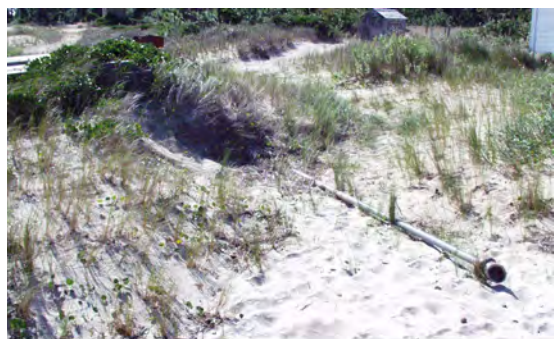
Figure 38 Waste line from kitchen at original site. (NPS-SERO-CR, 2002)

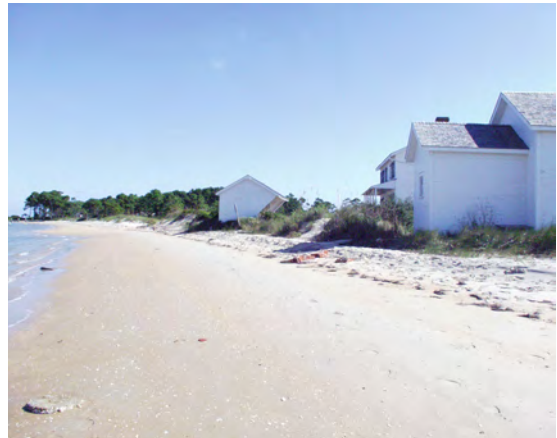
Storms exposed the foundation of the Coal House in 1999, and comparison of the site today with historic photographs makes clear the threat that exists to the entire complex. Over two thousand square feet of the historic light station compound is now below the high water mark, and there are no signs that the erosion is abating. Only periodic beach replenishment by the Army Corps has kept the remainder of the light station complex intact.

Figure 39 View to northeast showing present shoreline of Cape Lookout Bight at lighthouse station. Summer kitchen is at right and coal and wood shed is at center. (NPS-SERO-CR, 2002)
