CAPE LOOKOUT NATIONAL SEASHORE
Coast Guard Station Boat House
**HISTORIC STRUCTURE
REPORT**

2004
Historic Structure Report
Coast Guard Station Boat House
Cape Lookout National Seashore
Cape Lookout Village
LCS#: 09t830

Historic Structure Report

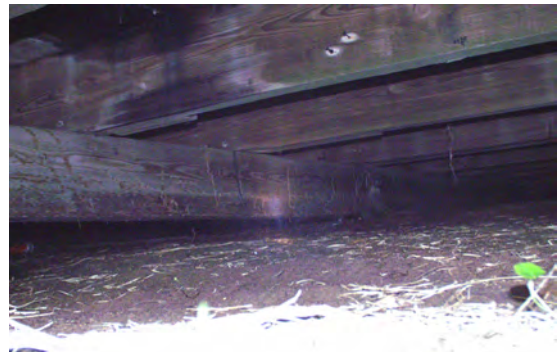
Figure 25 View of floor framing near rear of house. (NPS-SERO-CR, 2003)

There is evidence that termites have attacked the floor framing, but the damage may not be widespread. Walls are generally plumb, floors are level, and the roof shows no visible signs of structural deficiencies.

- Inspect and repair sills and joists when building is relocated.

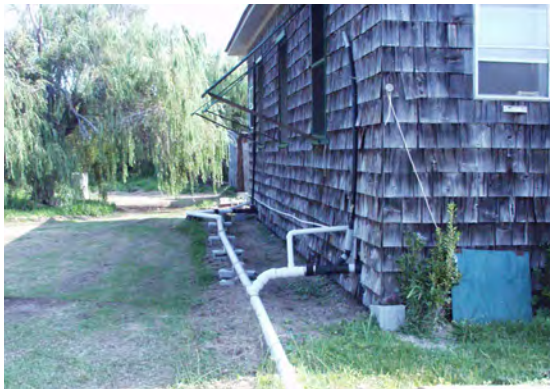
Figure 39 View of waste lines at rear of house. (NPS-SERO-CR, 2003)

The condition of the wiring could not be examined. Water and sewer lines are relatively new but are run in an *ad hoc* fashion across the rear of the house. There is no central heating.

- Install new water supply and waste lines if new rest rooms are installed.
- Design electrical system with simple lighting to serve exhibits.
- Install smoke/fire detector system.
- If necessary, install electrical baseboard heaters.
