Cape Lookout National Seashore  
Portsmouth  
**GEORGE DIXON HOUSE**  
**HISTORIC STRUCTURE**  
**REPORT**

2004  
Historic Structure Report  
George Dixon House  
Cape Lookout National Seashore (CALO)  
Portsmouth, NC  
LCS#: 12519

## Historic Structure Report

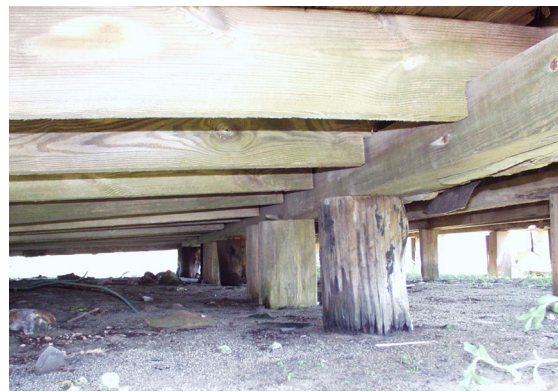
*Sills and Plates:* Perimeter sills have undergone extensive repairs and modifications, especially on the southeast side of the house where the original sill has been replaced by a stacked trio of boards, 2" by 6- 1/2". The 6" by 8" sill at the front wall of the house appears to be typical of the original sills. A beam, 6' by 7", runs through the house from end to end and supports the walls above that separate front from rear rooms. Support piers near the middle of this beam (under the central hall) appear to have been undermined and/or otherwise been displaced. As a result, the beam has broken and partially collapsed, causing nearby joists to split and allowing the center of the house to drop several inches.

**Figure 11** View northeast of front sill, showing typical joist/sill connections and wooden piers. (NPS-SERO-CRS, 2002)

condition; but at least one joist has split as a result of the collapsing beam.

- Replace sill at southeast end of house and collapsing sill running through center of the house; repair other sills as necessary; raise and level building structure.
- "Sister" new floor joists to broken joists.
- Inspect stud connections to sills and plates and repair as needed.

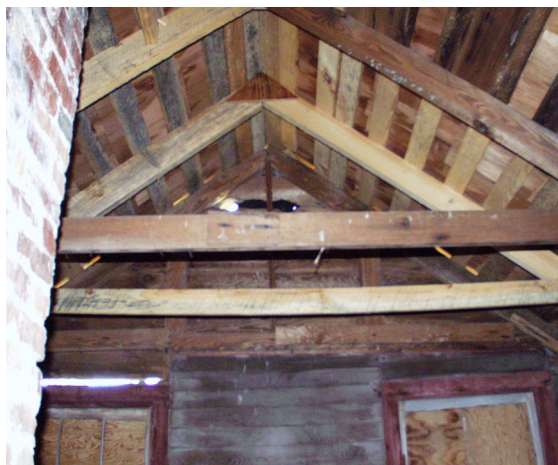
**Figure 12** View to northwest Room 202. Historic ceiling has been removed. (NPS-SERO-CRS, 2002)

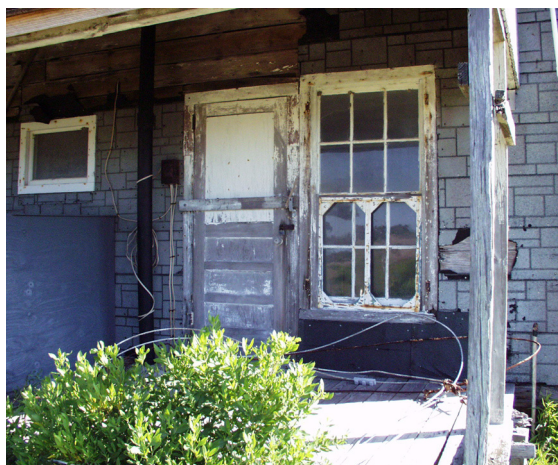
**Figure 13** View of original, 6/6 window with typical wood frame for screening. Original location for back door opening was at window at extreme left in this image. (NPS-SERO-CRS, 2002)

- Replace front door with four- panel door similar to those that remain on the interior.
- Replace window on northwest side of Room 102 with a four- panel door, similar to the other exterior doors.
- Remove and close existing back door.
- Restore original back door opening, using typical four- panel door.

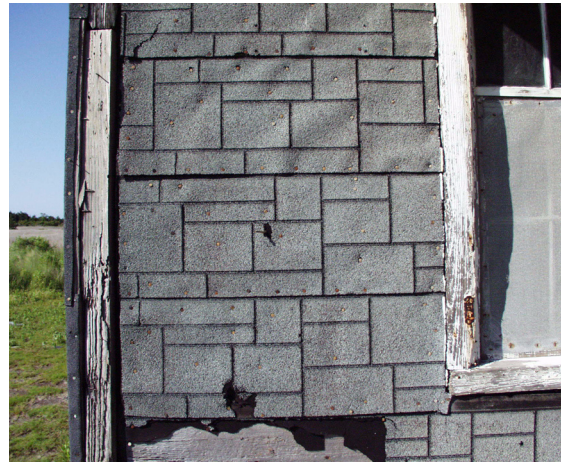
The exterior of the house was also stripped of its original siding. Old siding and material removed from the interior appears to have been used to resheath the house with flush- laid boards that were then covered with the present asphalt composition panels. The old wood- shingled roof covering remained in place but within a few years had been replaced by green, asphalt- composition, “hurricane” shingles.<sup>29</sup>

**Figure 14** View of added asphalt siding. Note part of shutter hinge on adjacent window casing, which is original. (NPS-SERO-CRS, 2002)

- Remove existing asphalt siding, preserving at least one complete panel in the park's permanent collection.
- Identify original 1" by 8" siding material, and re- install all sound material as lapped siding, replacing missing material as necessary.
- Paint siding and trim as dictated by careful analysis of surviving finishes.

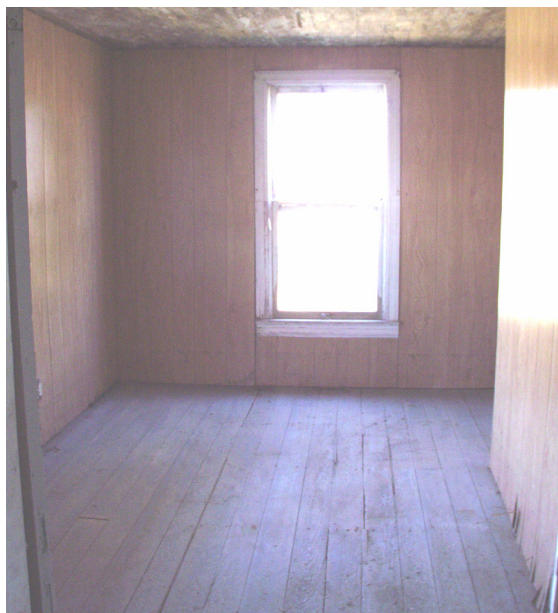
**Figure 20** View north in Room 101, showing window that infills earlier door to now-missing kitchen wing. (NPS-SERO-CRS, 2002)
