CAPE LOOKOUT NATIONAL SEASHORE
GUTHRIE- OGILVIE HOUSE
**HISTORIC STRUCTURE
REPORT**

**Historical Architecture, Cultural Resources Division
Southeast Regional Office
National Park Service**

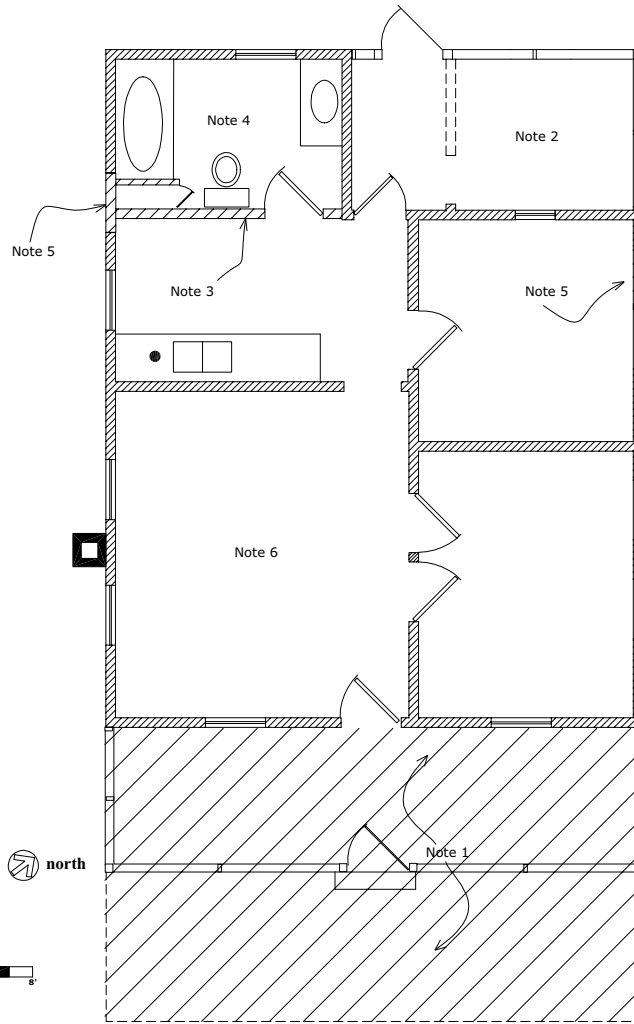
1. Remove modern porch (hatched area) and reconstruct historic porch.
2. Remove existing bathroom and restore back porch.
3. Reconstruct wall and rehabilitate kitchen.
4. Install new bathroom.
5. Close modern window opening.
6. Remove modern sheet paneling and restore tongue-and-groove paneling.

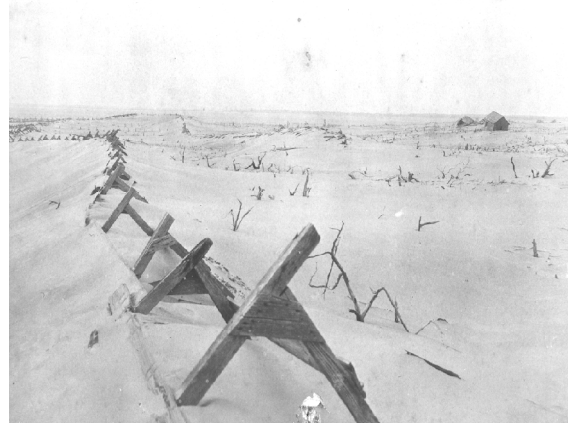
Figure 4 View of Shackleford Banks after 1899 hurricane. Note the partially-submerged structures at upper right. (CALO Coll., F-184)

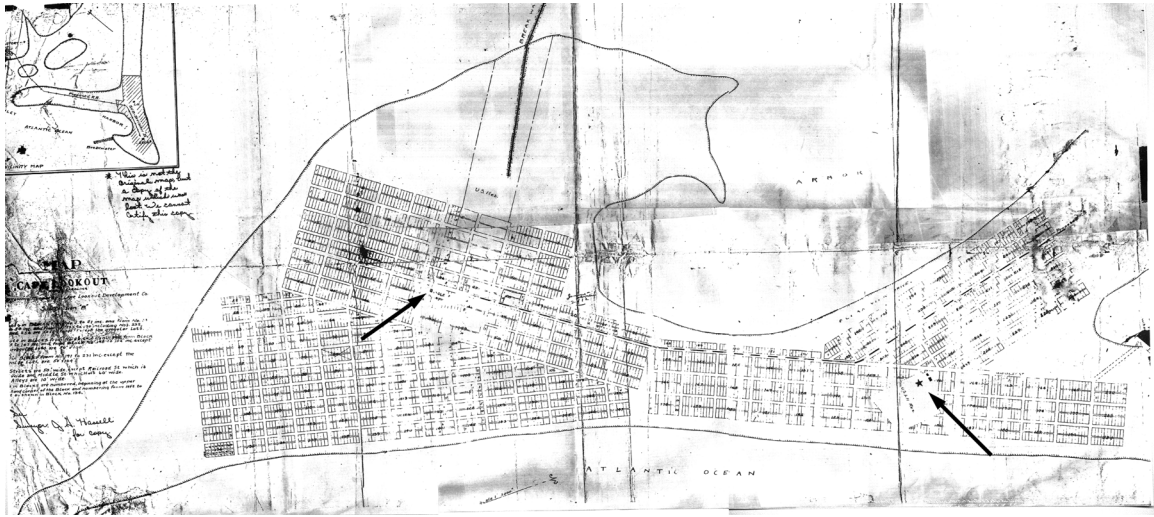
Figure 6 Plat of proposed development of Cape Lookout in 1915. Arrows have been added to indicate Coast Guard Station, at left, and Lighthouse at right.

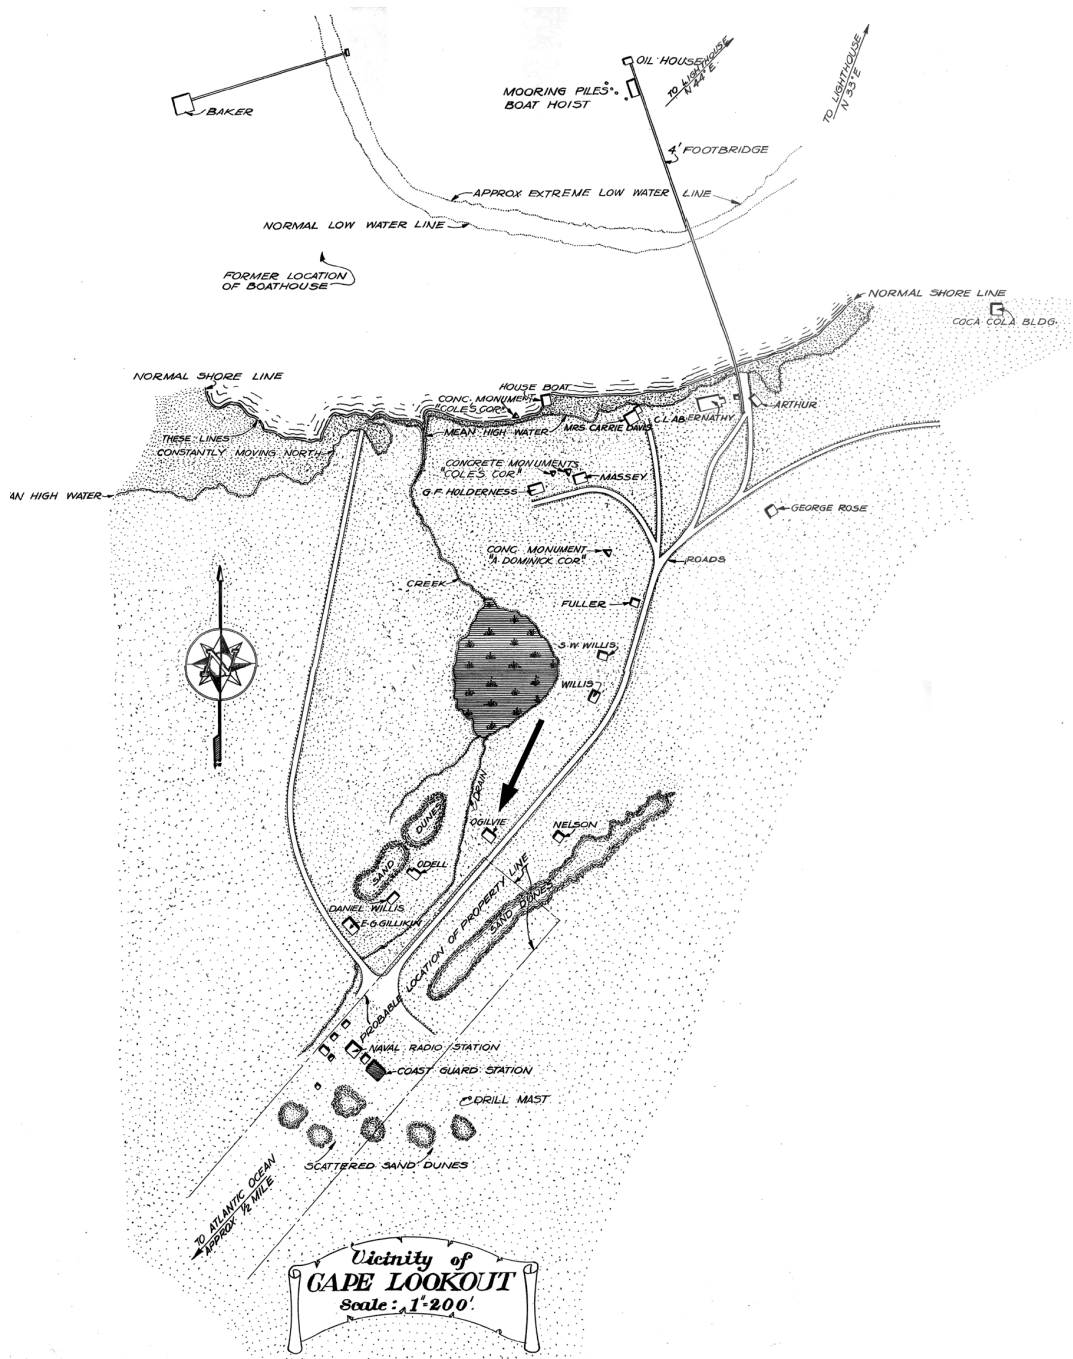
Figure 7 Map of Cape Lookout, August 1934, with arrow showing location of Guthrie-Ogilvie House. (U.S. Coast Guard Coll., copy in park files)

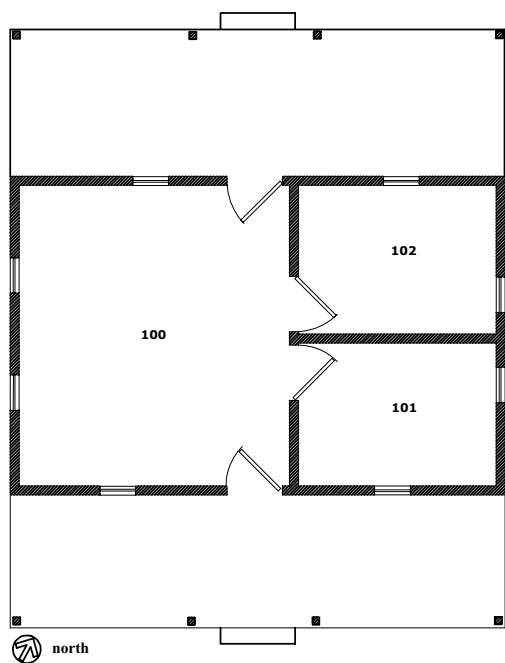
Figure 9 Probable plan of Guthrie-Ogilvie House as originally constructed. (T. Jones, NPS-SERO-CR, 2003)

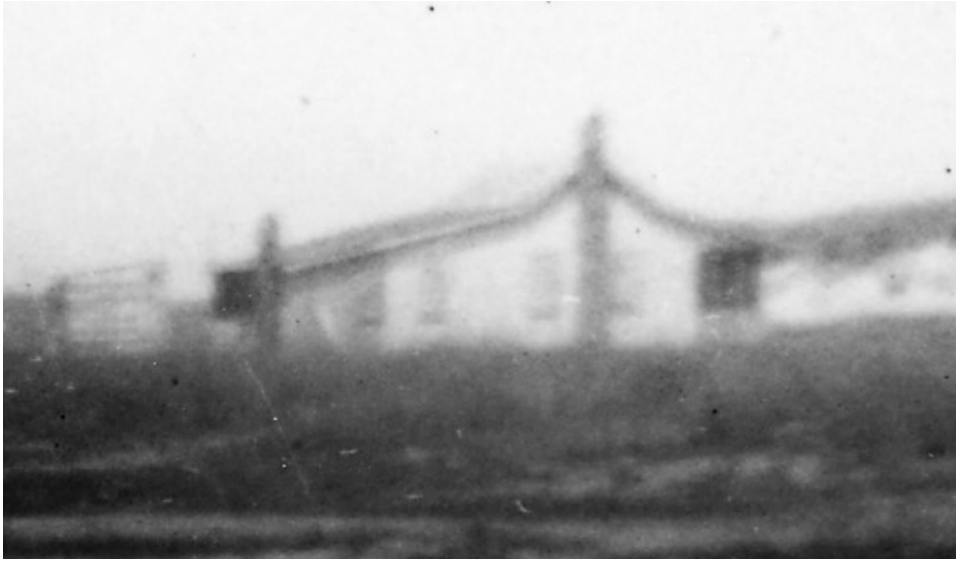
Figure 11 Detail of c. 1943 photograph showing Guthrie-Ogilvie House. (CALO Coll., Royer Coll.)

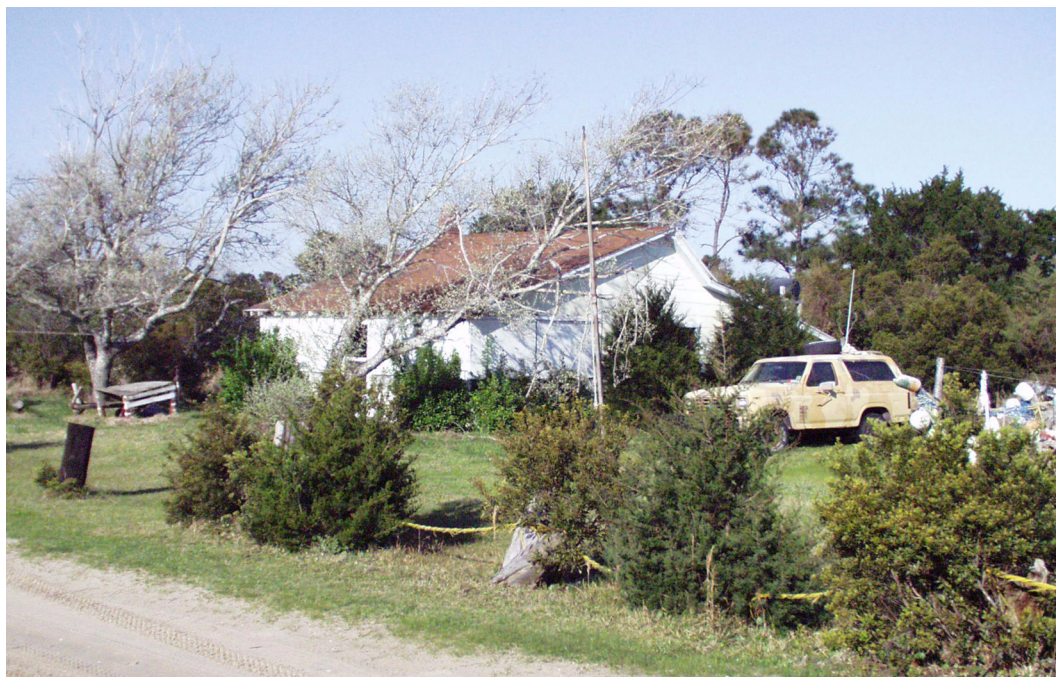
Figure 15 View to west of Guthrie-Ogilvie House. (NPS-SERO-CR, 2003)

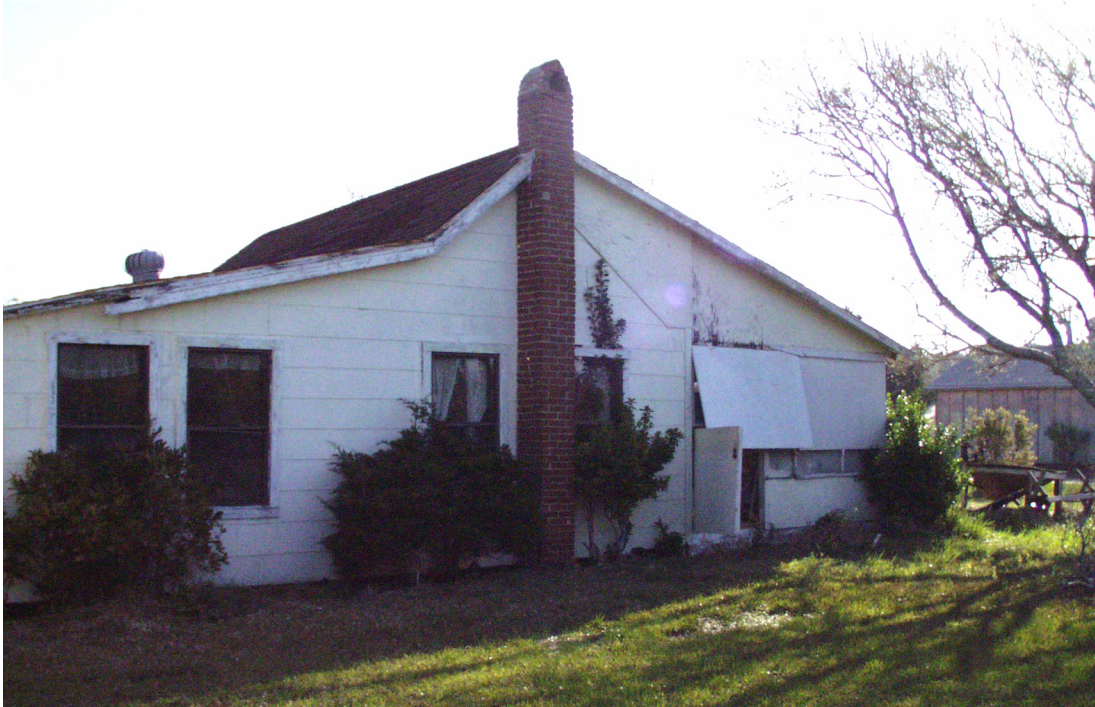
Figure 17 View east of house. (NPS-SERO-CR, 2003)

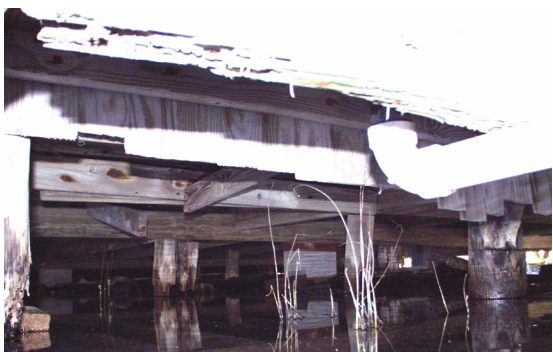
Figure 21 View south under old porch, now a bathroom. Note original siding. (NPS-SERO-CR, 2003)

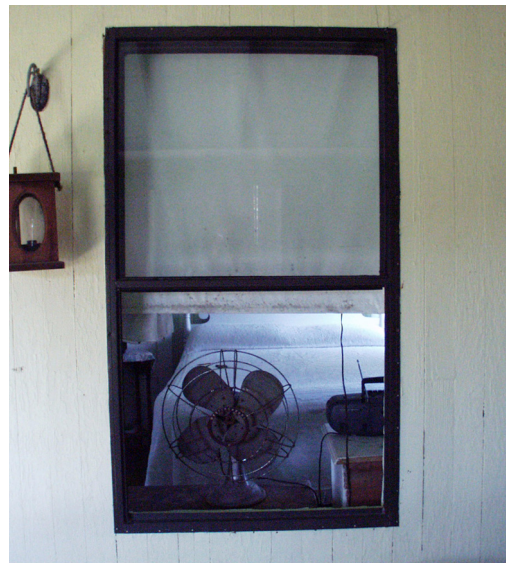
Figure 23 View of typical modern storm window that replaced all of the historic wooden sash. (NPS-SERO-CR, 2003)

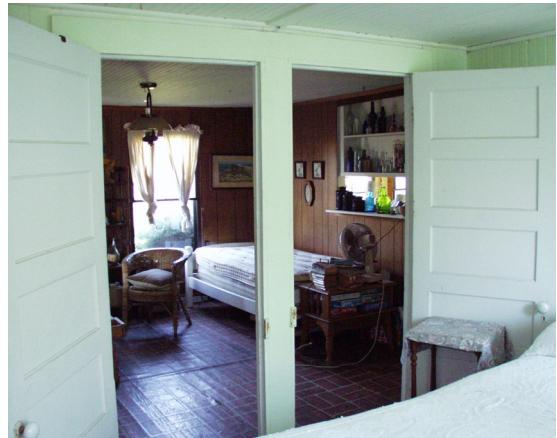
Figure 31 View to west into Room 100, showing double doors opening into Room 101. (NPS-SERO-CR, 2003)

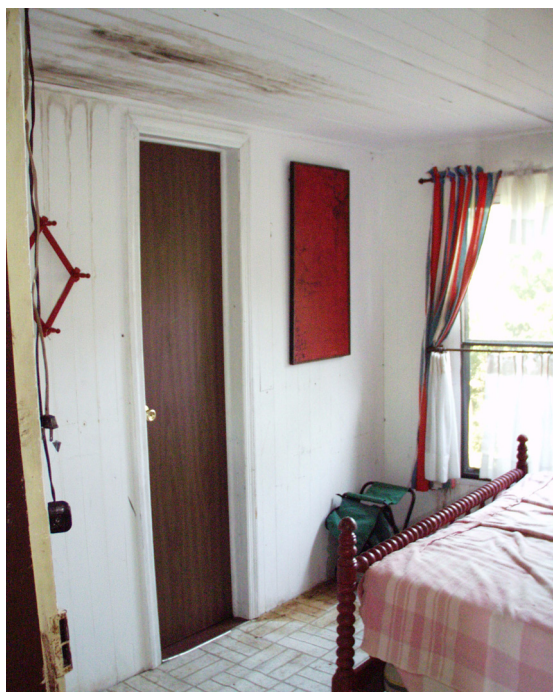
Figure 34 View north of Room 102, showing door added for bathroom. Note water damage to ceiling. (NPS-SERO-CR, 2003)

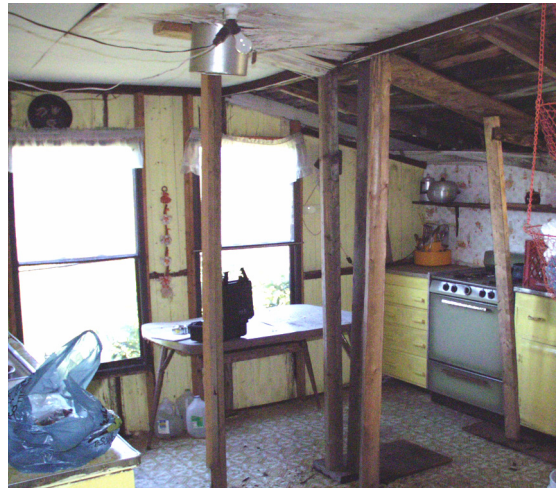
Figure 35 View west in Room 103, showing deteriorated shed-roofed addition that was combined with this room after World War II. (NPS-SERO-CR, 2003)

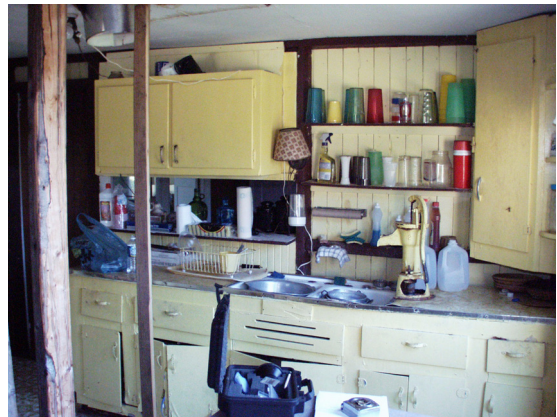
Figure 36 View of kitchen counter and cabinets in Room 103. (NPS-SERO-CR, 2003)

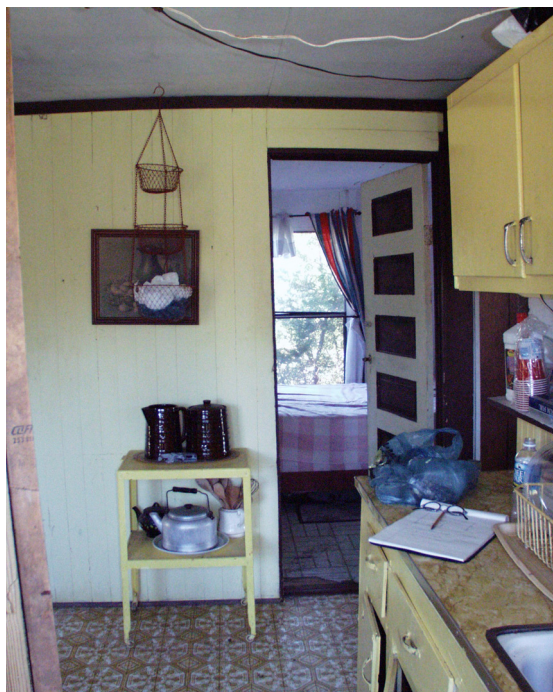
Figure 37 View northeast in Room 103. (NPS-SERO-CR, 2003)

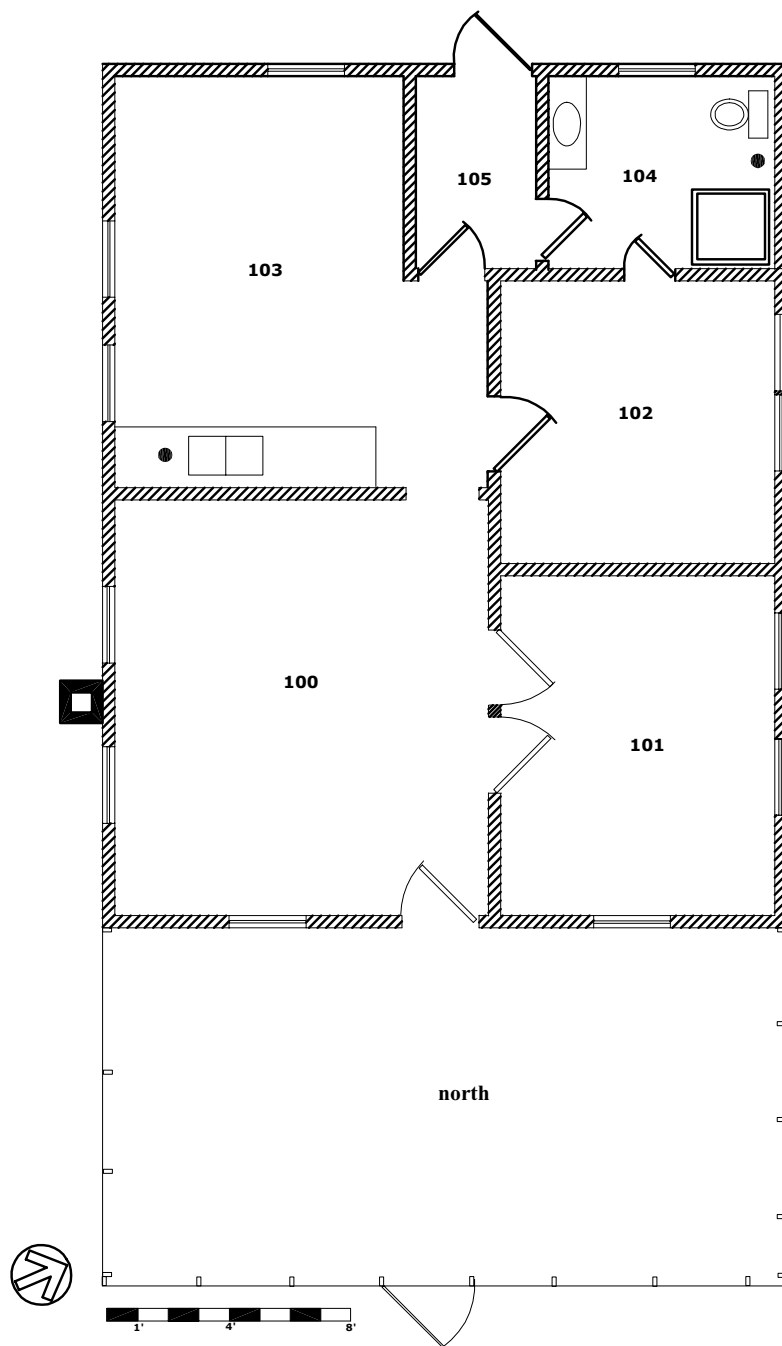
Figure 41 Floor plan of existing house. (T. Jones, NPS-SERO-CR, 2003)

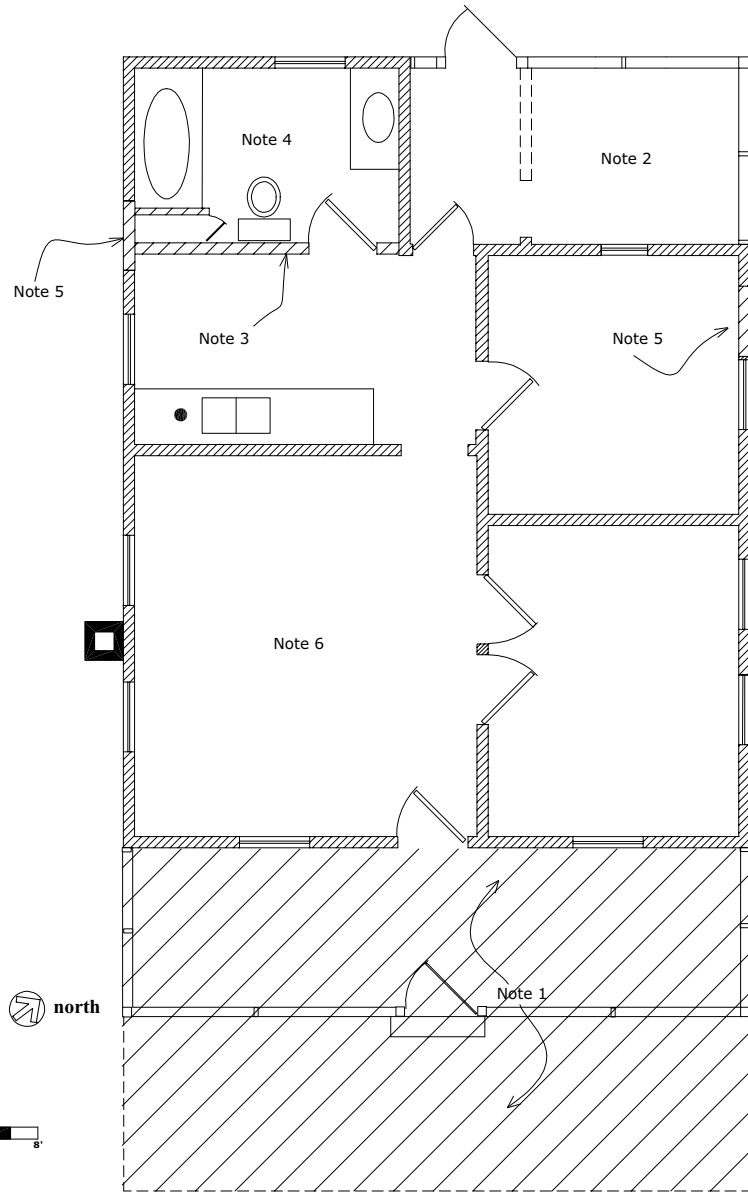
Recommendations for Treatment & Use
