Cape Lookout National Seashore
LEWIS - DAVIS HOUSE

HISTORIC STRUCTURE REPORT

**Historical Architecture, Cultural Resources Division
Southeast Regional Office
National Park Service**

2004

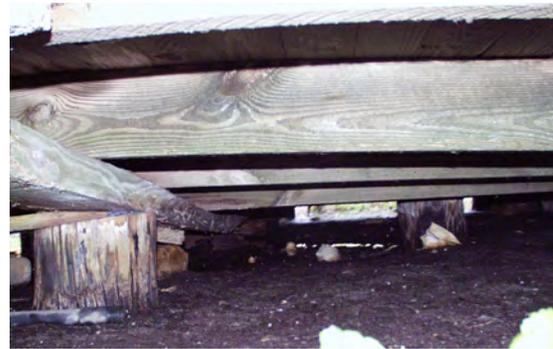
The wood frame of the main body of the house is set on a series of wooden piers, 8" - 12" in diameter, sunk to some indeterminate depth into the ground. Piers are so low that the house's frame is only a few inches above grade. Most are, at best, in fair condition, and concrete block have been inserted at some locations to provide additional support. Water is standing under large areas of the house, contributing to its ongoing deterioration.

Figure 23 View of crawl space and piers. (NPS-SERO-CR, 2002)

- Raise house and replace all wood piles, replicating the existing size and placement of piles.
- Design and install storm-resistant mechanism to tie the house's wood frame to the foundation piles.

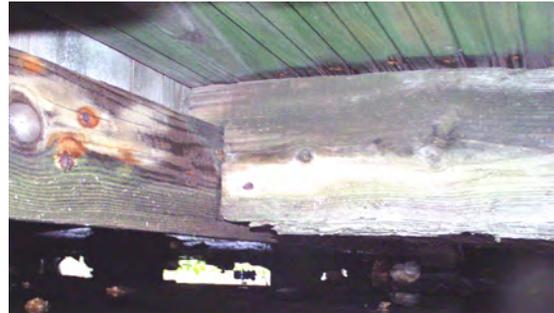
Floor: Floor joists appear to be a mix of 2" by 4" and 2" by 6" (actual dimensions could not be ascertained), set on 30" - 36" centers. Deterioration is widespread. Sills appear to be mostly single 2" by 8". Along the northwest side of Room 104, floor joists and sill have collapsed and there is major structural damage in Room

Figure 24 View of typical joist sill connection. (NPS-SERO-CR, 2002)

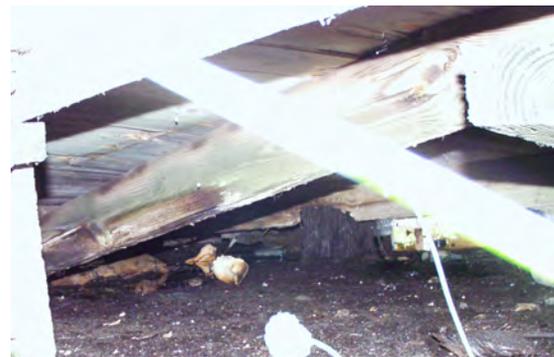
The structure has suffered major damage from termites and a leaking roof. Floors are collapsing in Rooms 101, 104 and 105, and there appears to have been major damage to the sills throughout the house. The roof, too, is in extremely poor condition, with large areas of rotten and termite-ridden rafters and decking. Although most of the historic finishes remain in place, the house as a whole is in very poor condition.

Figure 25 View of collapsing floor under Room 104. (NPS-SERO-CR, 2002)

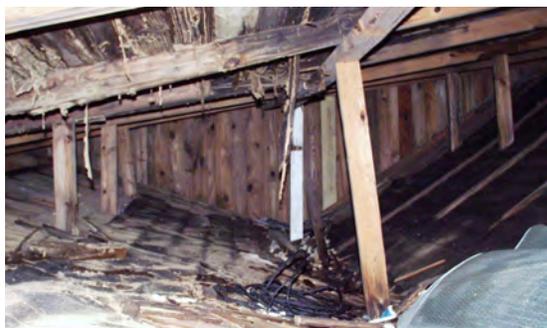
Figure 26 View of junction of roofs of two original structures; note severe termite damage in rafters and decking at left. (NPS-SERO-CR, 2002)

- Stabilize structure before repairs proceed.
- Remove 1950s roof structure and restore original roofs.
- Repair floor, wall, and ceiling framing as necessary and make improvements in connections of framing members to reduce the possibility of significant damage from high winds.
- Remove porch additions and restore porches to their appearance in the 1940s photographs.
- If entire house cannot be salvaged, repair and preserve original structure encompassing Rooms 100 and 101.

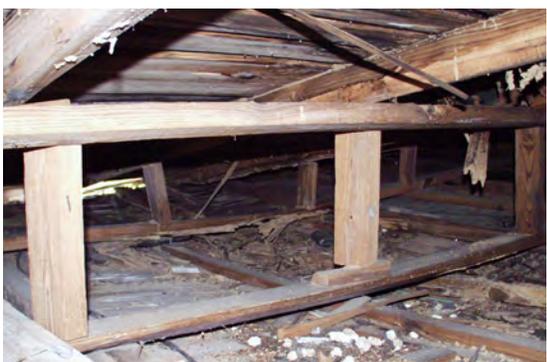
Figure 28 View of heavily-damaged roof and ceiling structure over Room 104. (NPS-SERO-CR, 2002)

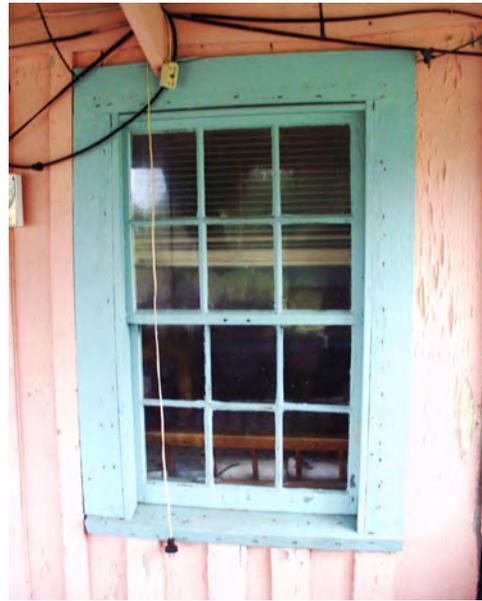
Figure 29 View of window W-2 on southeast (front) side of house, with exterior siding and trim typical of the original building. (NPS-SERO-CR, 2002)

batten siding was left exposed. There are numerous broken shingles, and all of the siding, which is now painted pink, is stained and mildewed.

- Remove cement-asbestos siding.
- Repair underlying boards and install new battens to match the original.
- Repair and preserve historic board-and-batten siding and trim on front and side porches.
- Repair and preserve other exterior woodwork.

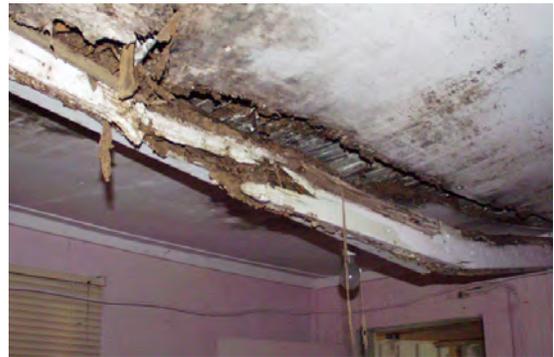
Ceiling: The ceiling, like the floor, is on the verge of total collapse due to severe termite and water damage. It was originally finished with double- V- joint, tongue- and- groove boards, 3- 1/2" wide.

Figure 41 View to east of ceiling in Room 104. (NPS-SERO-CR, 2002)
