Cape Lookout National Seashore

Portsmouth Life- Saving Station

# Historic Structure Report

2006

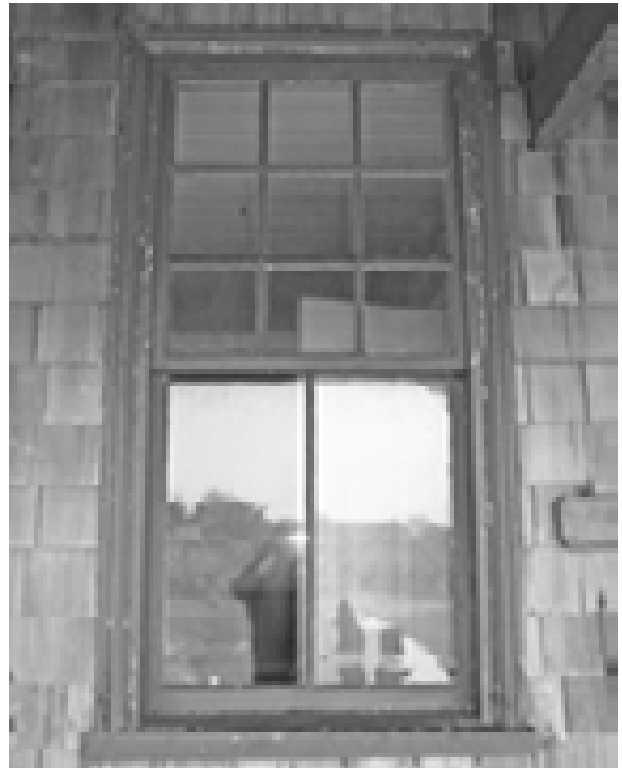
*Condition:* Some of the sash may have been replaced, and most are in good condition, although many of the counterweight ropes are broken and there are several panes of broken glass. The sash in the attic window, which are almost certainly original, are badly weathered, primarily because the interior side of the sash has not been maintained. At the northeast end of the boat room (Room 107), recent storms badly damaged both windows (w- 6 &

FIGURE 76. View of W-2, a typical nine-over-two window. (T. Jones, NPS, 2005)

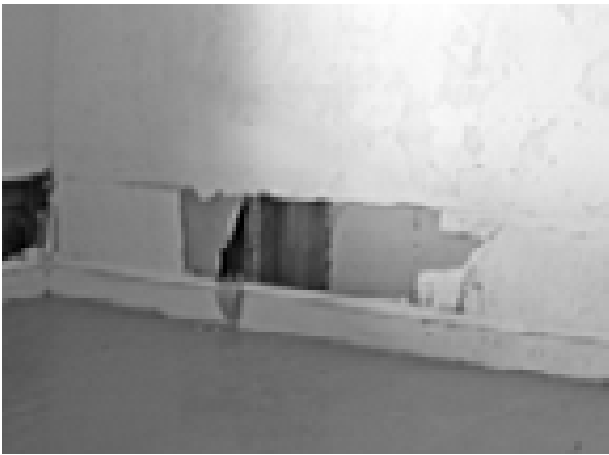
FIGURE 89. View of water-damaged plaster on rock lath in Room 106. (T. Jones, NPS, 2005)

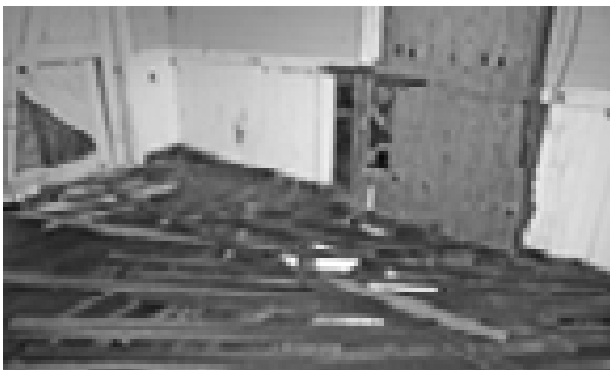
FIGURE 121. View of flooring damaged by storm surge in 1993. (T. Jones, NPS, 2005)

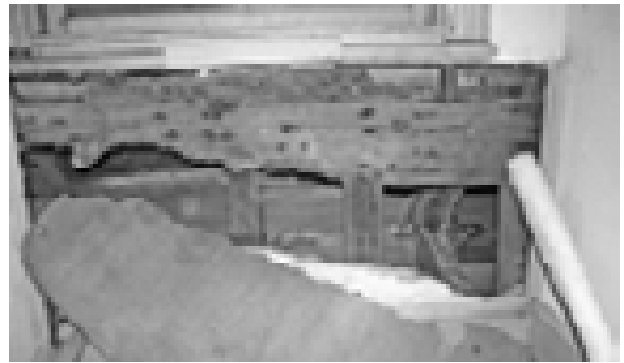
FIGURE 142. View damaged wall below window in Room 202. (T. Jones, NPS, 2005)
