## Cape Lookout Village Cultural Landscape Report

Cape Lookout National Seashore  
Carteret County, North Carolina

9 May 2005

## **Cultural Landscape Report**

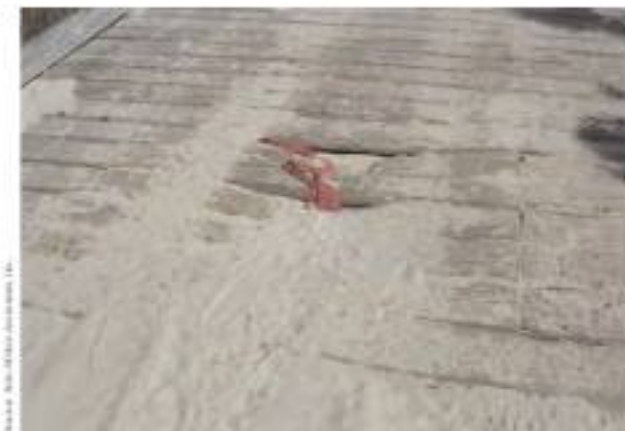
Figure 3-55. A wooden bridge crosses an intermittent driveway as part of a road leading between Back Road and the village precinct. As seen in this photograph, the bridge is in need of repair.

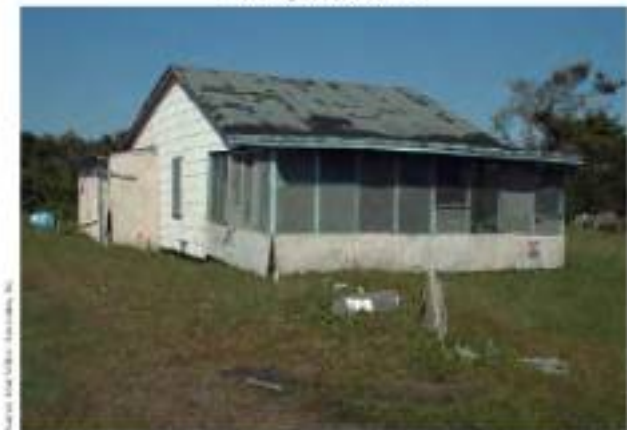
Figure 1-05. The Carrie Annandall Davis (Lawie-Davis) House is significantly deteriorated.

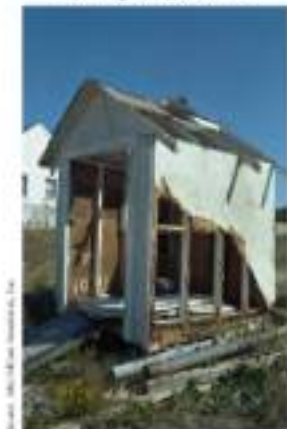
Figure 3-101. This small wood storage shed at the Coast Guard station is very deteriorated.

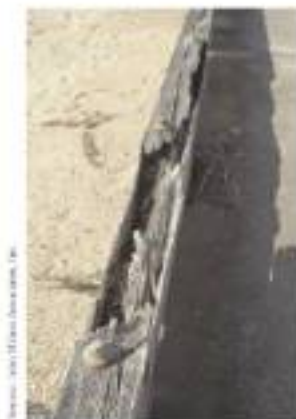
Figure 3-137. Wood has bolted to the edge of the concrete foundation to prevent visitors and vehicles from falling off the edge.

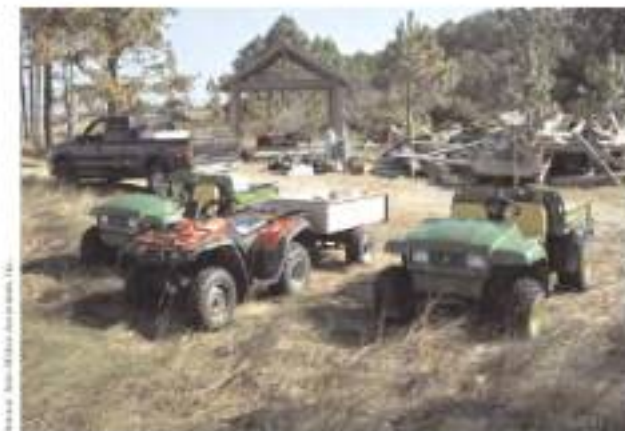
Figure 3-157. Numerous piles of debris are found in the lighthouse area. Some damage caused by Hurricane Isabel.

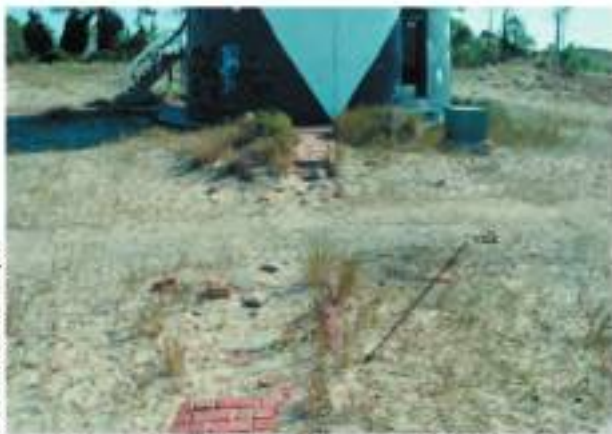
Figure 5-27. The existing historic walk between the lighthouse and the oil shed is in poor condition and is broken by a non-contributing road alignment running through walk. The historic walk should be restored and the non-contributing road removed.

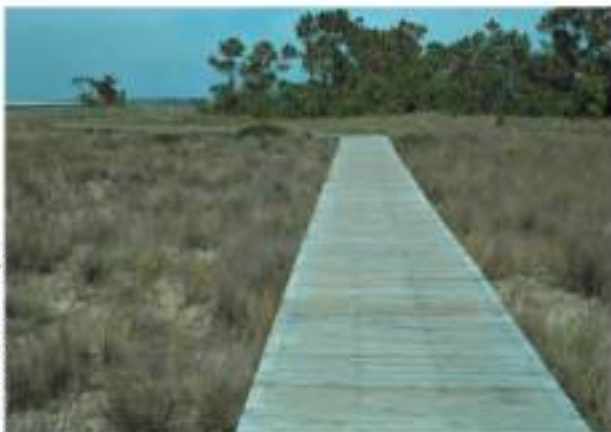
Figure 3-26. A wooden boardwalk leads from the boat landing to the rear of the USCG cutter's dwelling. The route should be altered to provide access to the historic stone entrance of the dwelling.

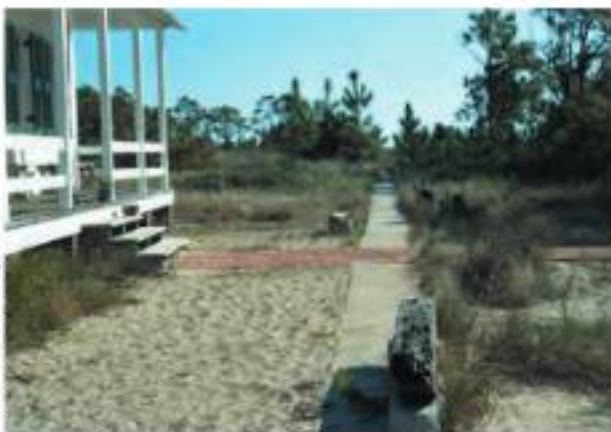
Figure 3-28. The boardwalk should meet the existing, historic concrete sidewalk.

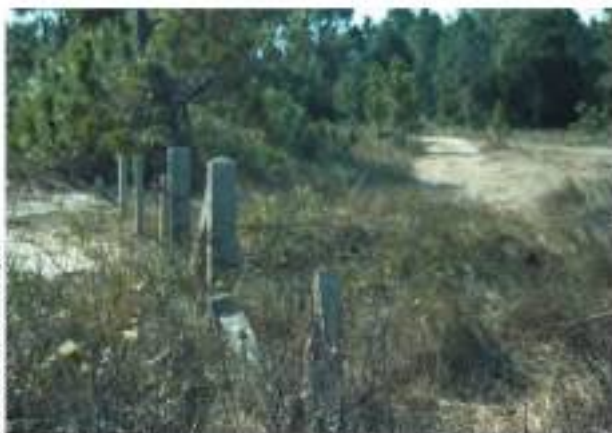
Figure 3-33. Additional concrete fence posts survive behind the summer kitchen. These may be useful when reconstructing or interpreting the missing fence line around the lighthouse precinct.

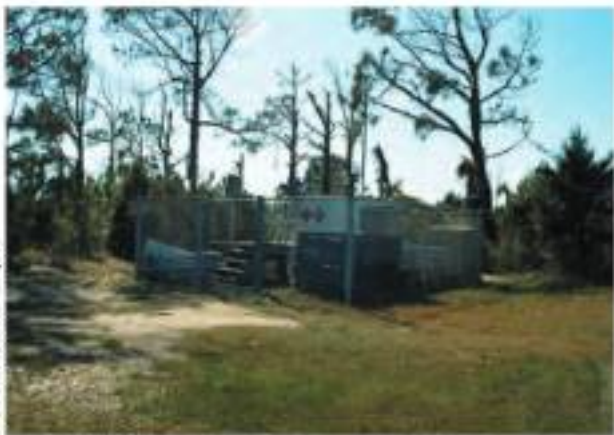
Figure 3-35. Existing condition of chain-link fence surrounding material storage.

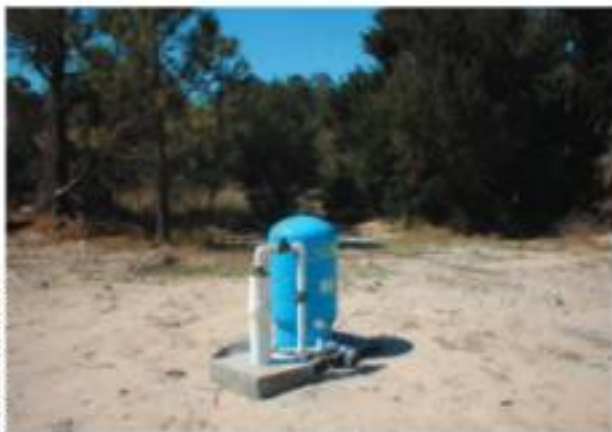
Figure 5-37. New well at lighthouse requiring pumping.
