# Portsmouth Village Cultural Landscape Report

Cape Lookout National Seashore  
Carteret County, North Carolina

## Cultural Landscape Report

December 2007

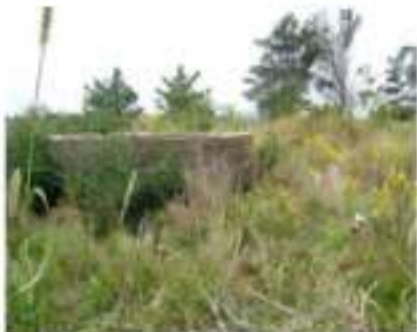
FIGURE 99. The concrete cistern near the Keller Seyron Cemetery.

**Keller cistern.** In close proximity to the Keller Seyron Cemetery there are two round cisterns once associated with the Ed Keller House, now in ruins. The concrete cistern is approximately three feet high and ten feet in diameter (Fig. 99). The brick cistern is slightly smaller. They are currently open to the air. These cisterns are exhibiting some signs of deterioration and are in fair condition.

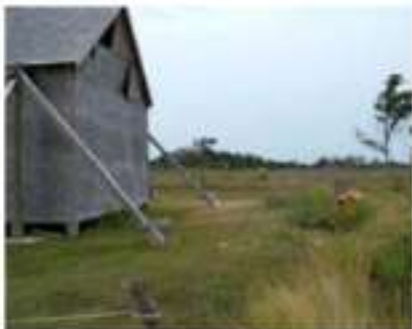
FIGURE 121. Temporary barriers limit access to the northwalled George Dixon House.

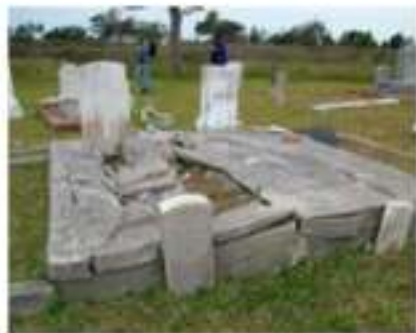
FIGURE 131. The condition of some of the concrete vault covers in the Community Cemetery is poor.

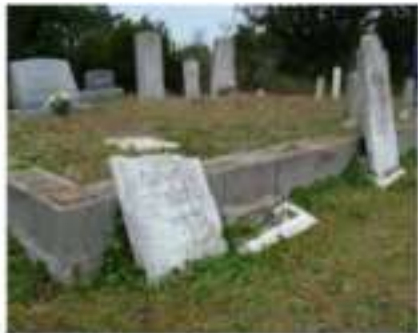
FIGURE 134. There are condition problems with many of the headstones in the Portsmouth Cemetery.

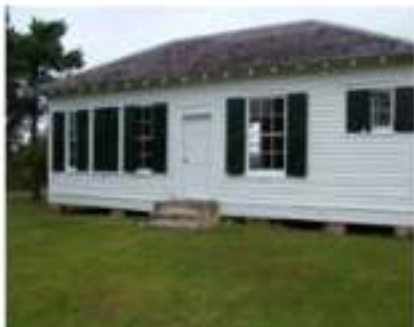
FIGURE 168B. The same view in 2006. Note the loss of the brick landing and walk, changes in paint color on the door and shutters, the reconfiguring and reshingling of the roof, and the loss of foundation plantings since 1963.

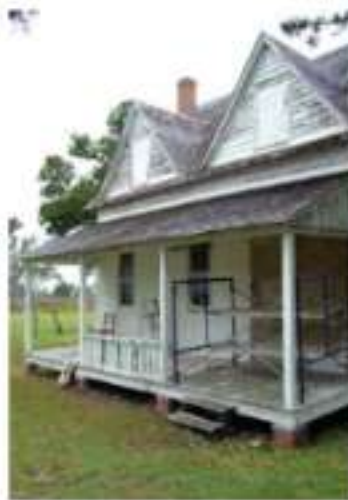
FIGURE 178B. The same view in 2006. Note the replacement of the central dormer with two dormers and alteration of the porch posts and railing. Woodwork beneath the porch is no longer present.

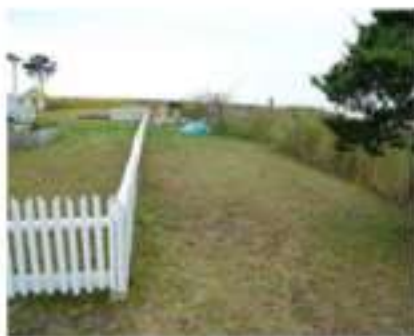
**FIGURE 183B.** The Henry Pigott House yard is relatively similar in 2006, with the primary exception of the loss of vegetation to the exterior of the fence. Segments of the picket fence are missing in the rear.

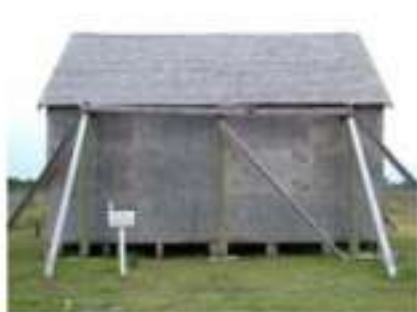
FIGURE 186B. The George Dixon House in 2006 is meshballed following severe hurricane damage.

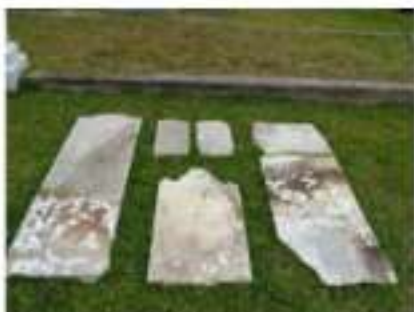
FIGURE 204. Biological growth and sugaring have affected these grave markers.

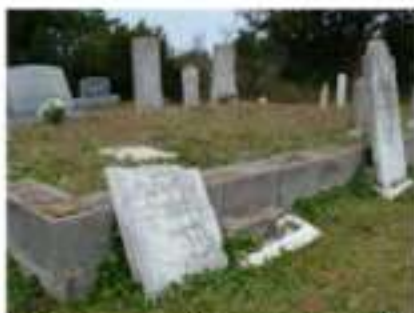
FIGURE 205. Some grave markers have cracked into multiple pieces.

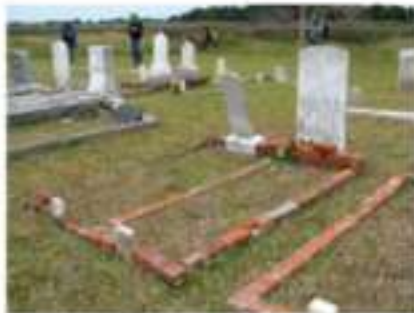
FIGURE 206. Some grave markers are displaced from their original position, such as the marker at left in the foreground.

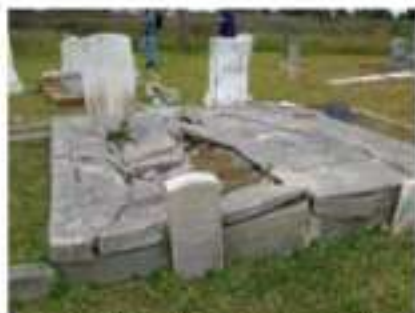
**FIGURE 208.** Cracking and displacement of concrete vaults can allow water to percolate, accelerating deterioration of the features.

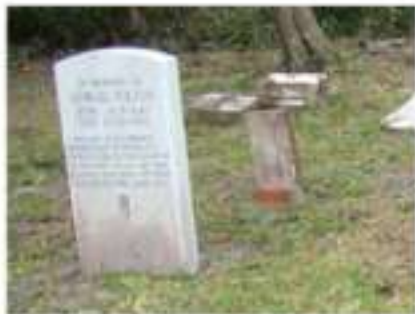
**FIGURE 209.** Rising damp has discolored the Samuel Tolson marker.
