# **Cape Lookout National Seashore**

# **Washington Roberts House**

## **Historic Structure Report**

### **Developmental History**

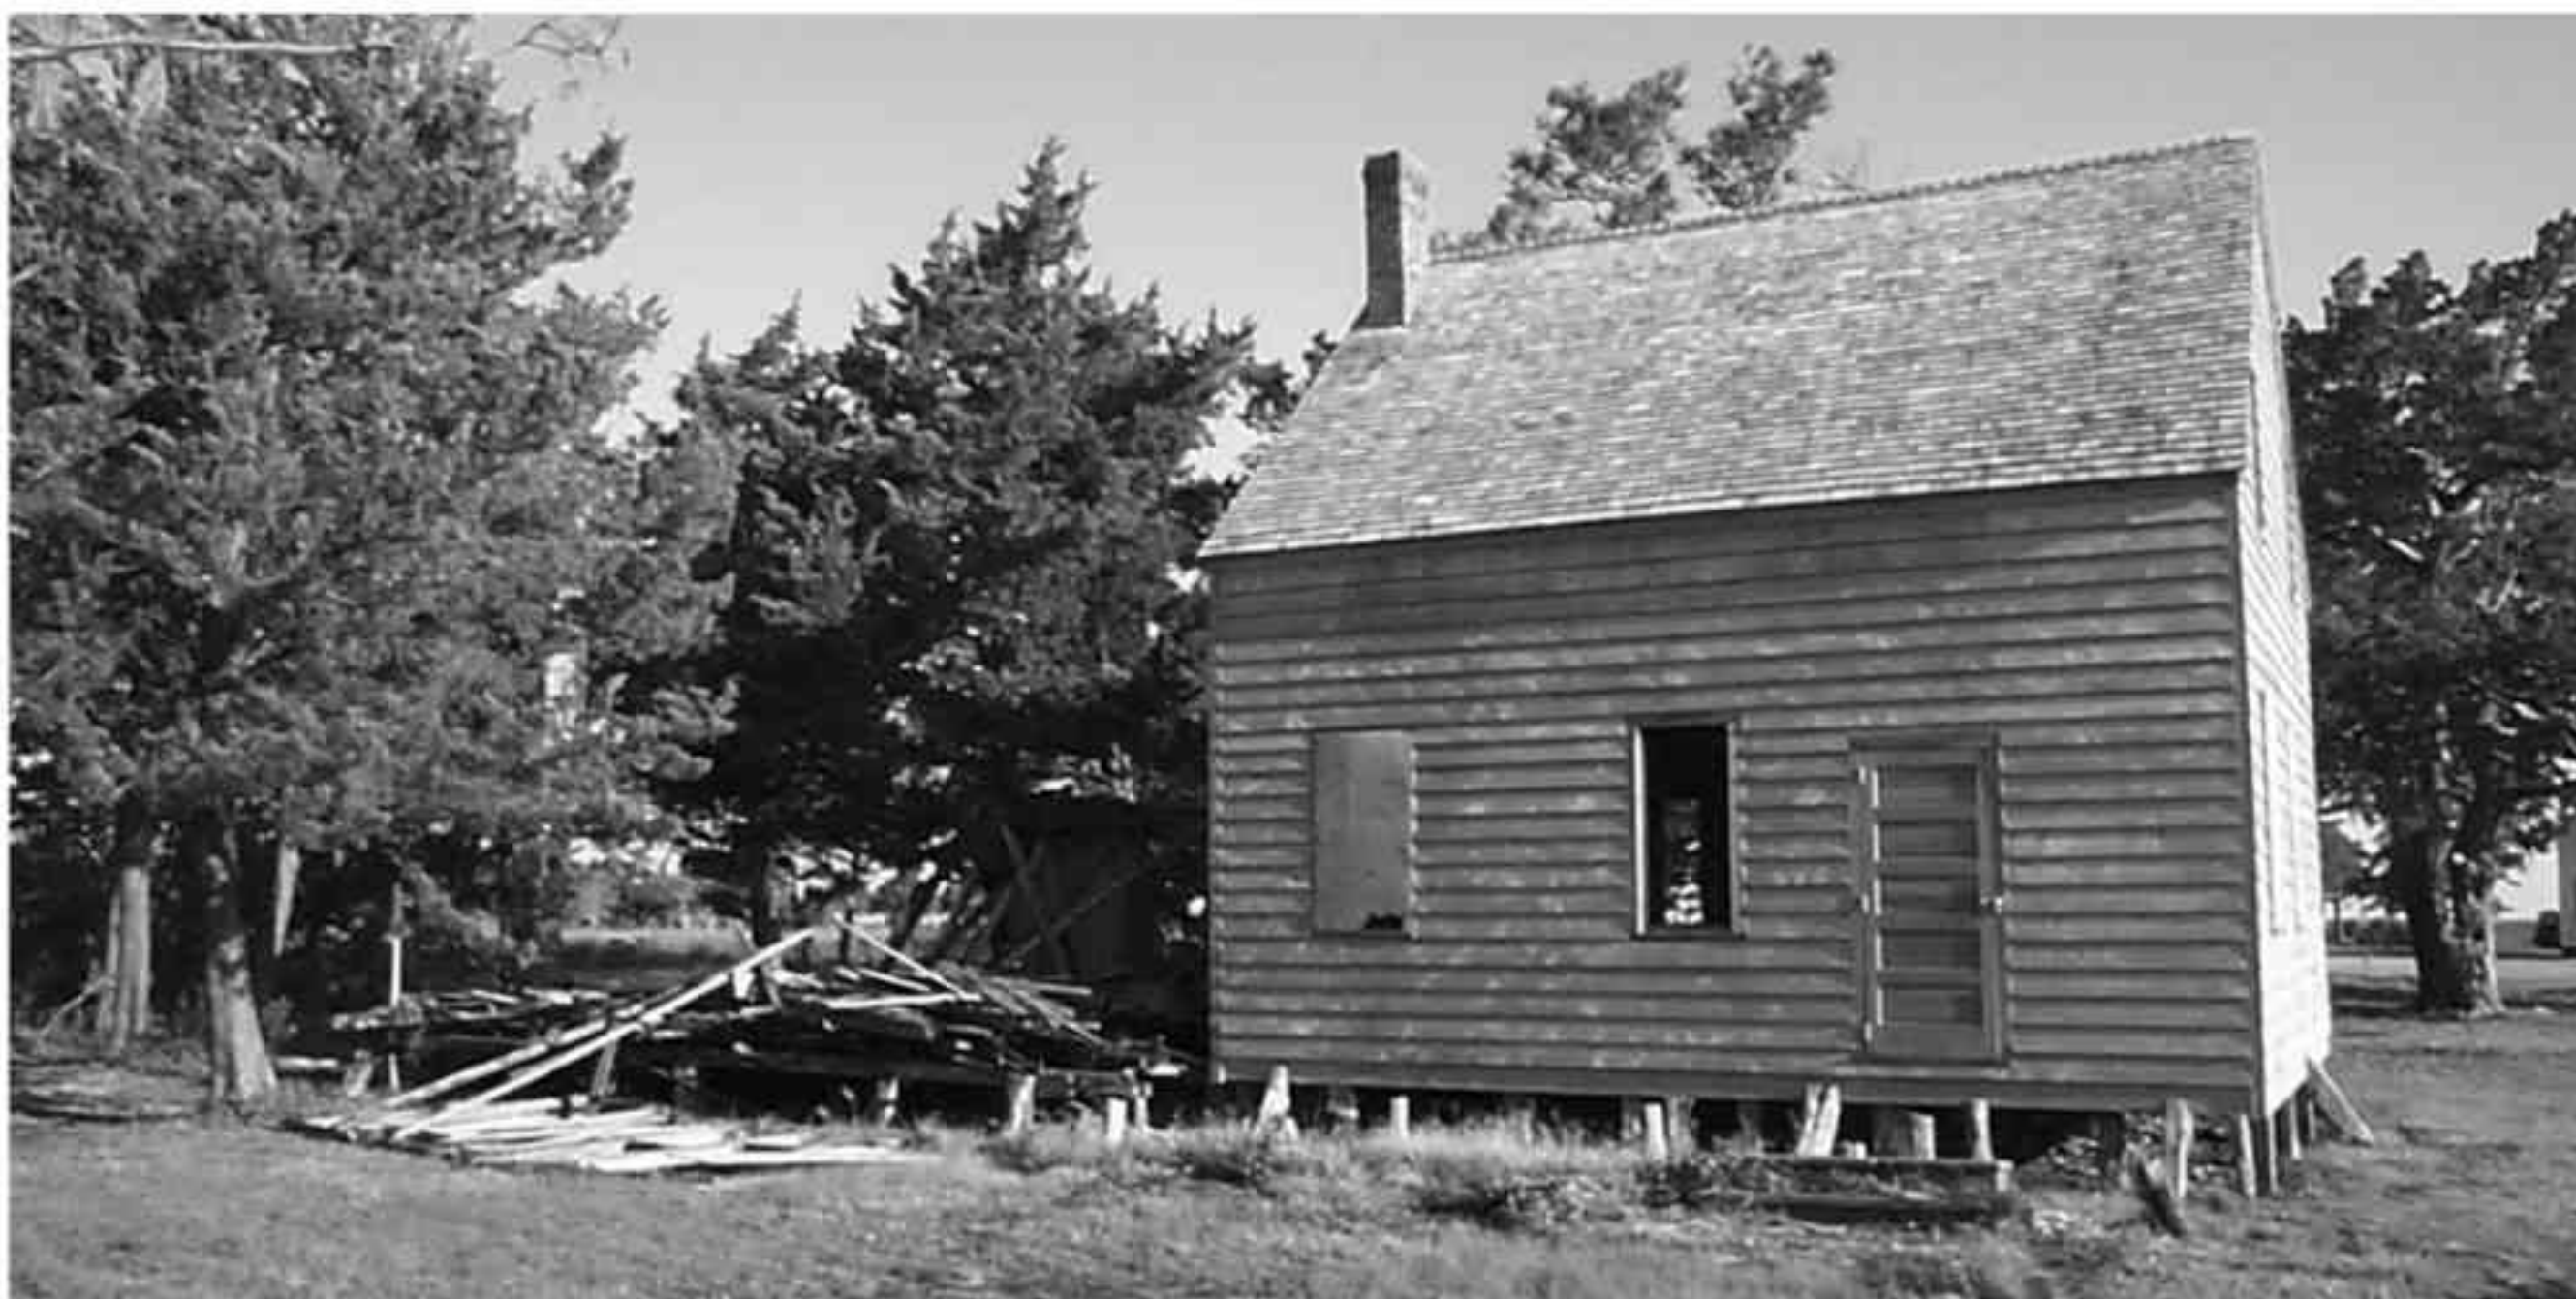
In September 2003, as this report was being completed, Hurricane Isabel swept the Outer Banks with the eye coming ashore around Drum Inlet a few miles south of Portsmouth. Although only a Category 2 hurricane, the storm's surge inundated the entire island and a number of structures sustained significant damage. The nearby George Dixon House was severely damaged, but little, if any, damage was sustained by the main block of the Roberts House. Unfortunately, wind and water completed destruction of the house's ruined kitchen wing. It was partially reconstructed in 2006.

FIGURE 29. View of Roberts House after exterior rehabilitation and after destruction of kitchen by Hurricane Isabel. (NPS-SERO-CR, 2003)

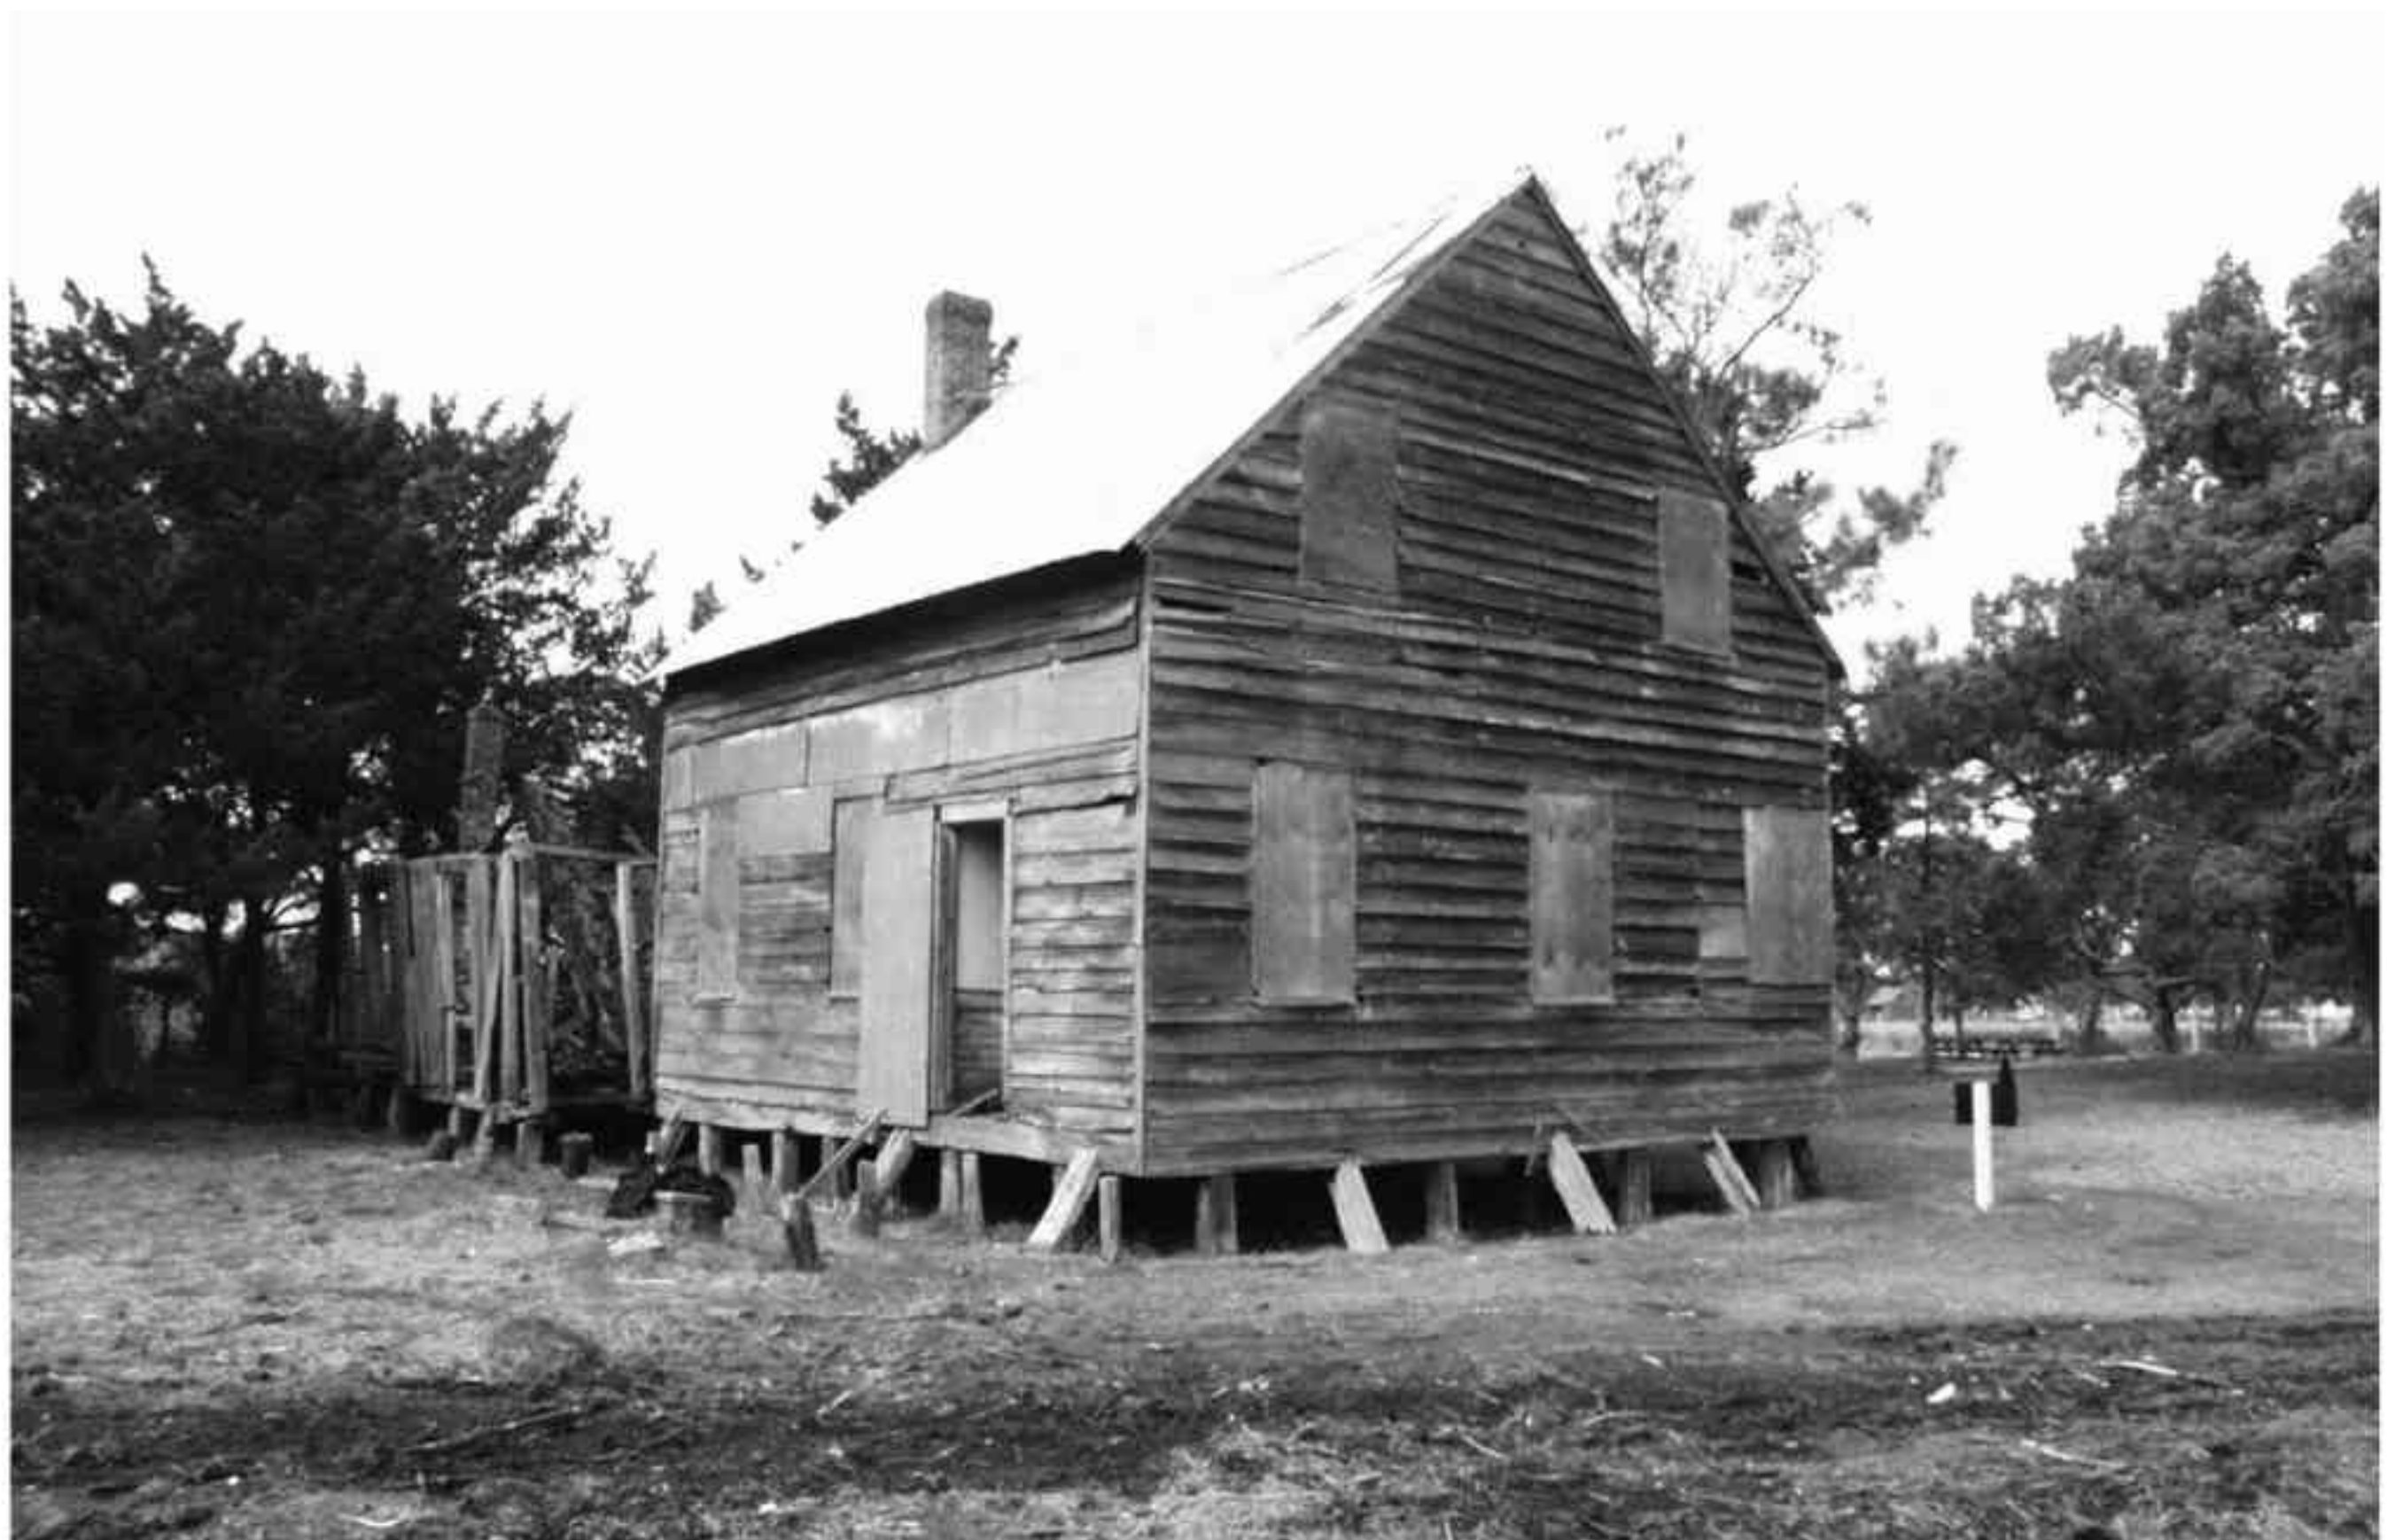
The house is badly deteriorated, with the kitchen wing in ruinous condition.<sup>42</sup> The front porch was removed before the 1960s, all of the historic doors

FIGURE 30. View northwest of Roberts House. (NPS-SERO-CR, 2002)

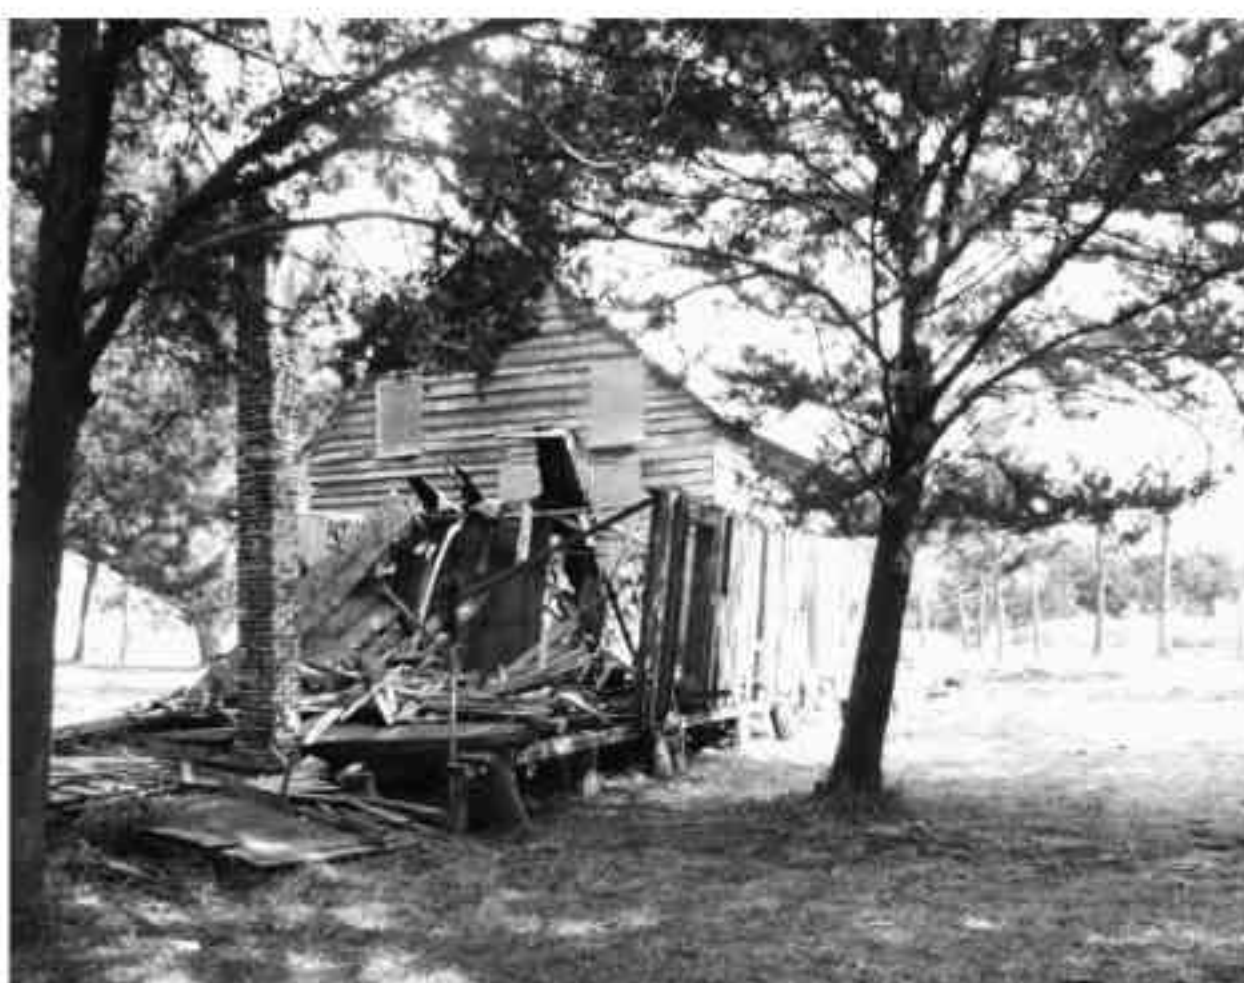
FIGURE 33. View to east, showing ruined kitchen wing in foreground. (NPS-SERO-CR, 2002)

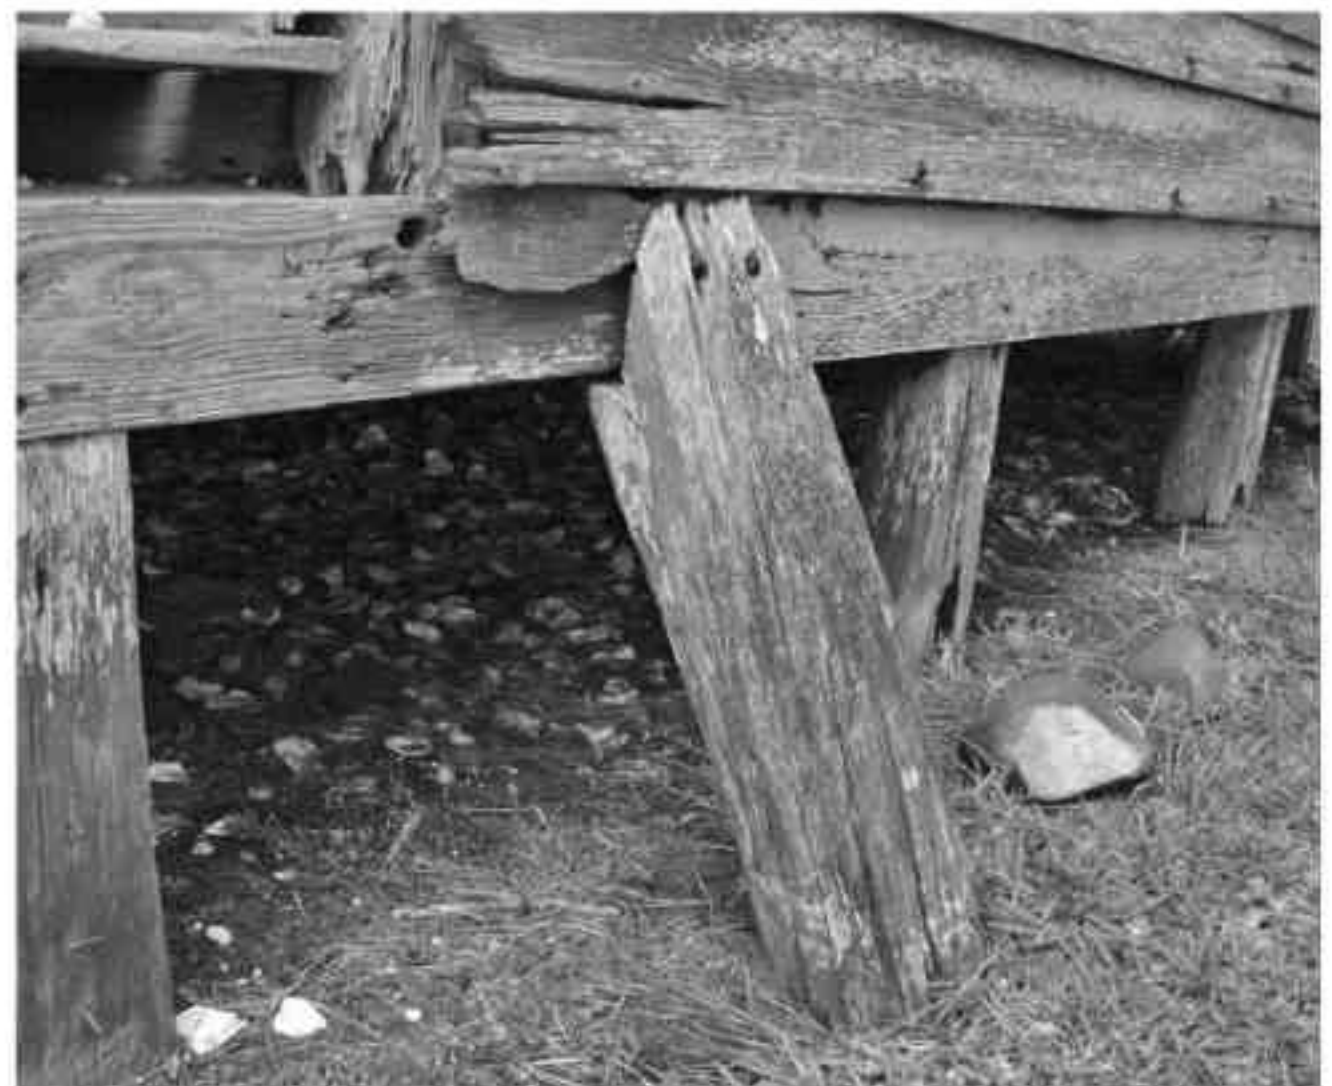
There are three braces each on the south, east, and north sides of the main block of the house, but there is only one brace on the west side. A 90-degree notch has been cut into the sloping face of that brace, probably to support the framing of the wooden, "coffin-like" cistern that once stood in that area. Part of the sill on the west side is covered by the kitchen wing and could not be examined, but with the original chimney in that location, additional bracing may have been unnecessary. Some of the original braces may have been replaced over the years, with the ones on the north and west

FIGURE 35. View of a typical "bird's-mouth" hurricane brace on north side of house. (NPS-SERO-CR, 2002)

sides of the house most likely to be original. Condition varies, however, and a number are badly deteriorated.

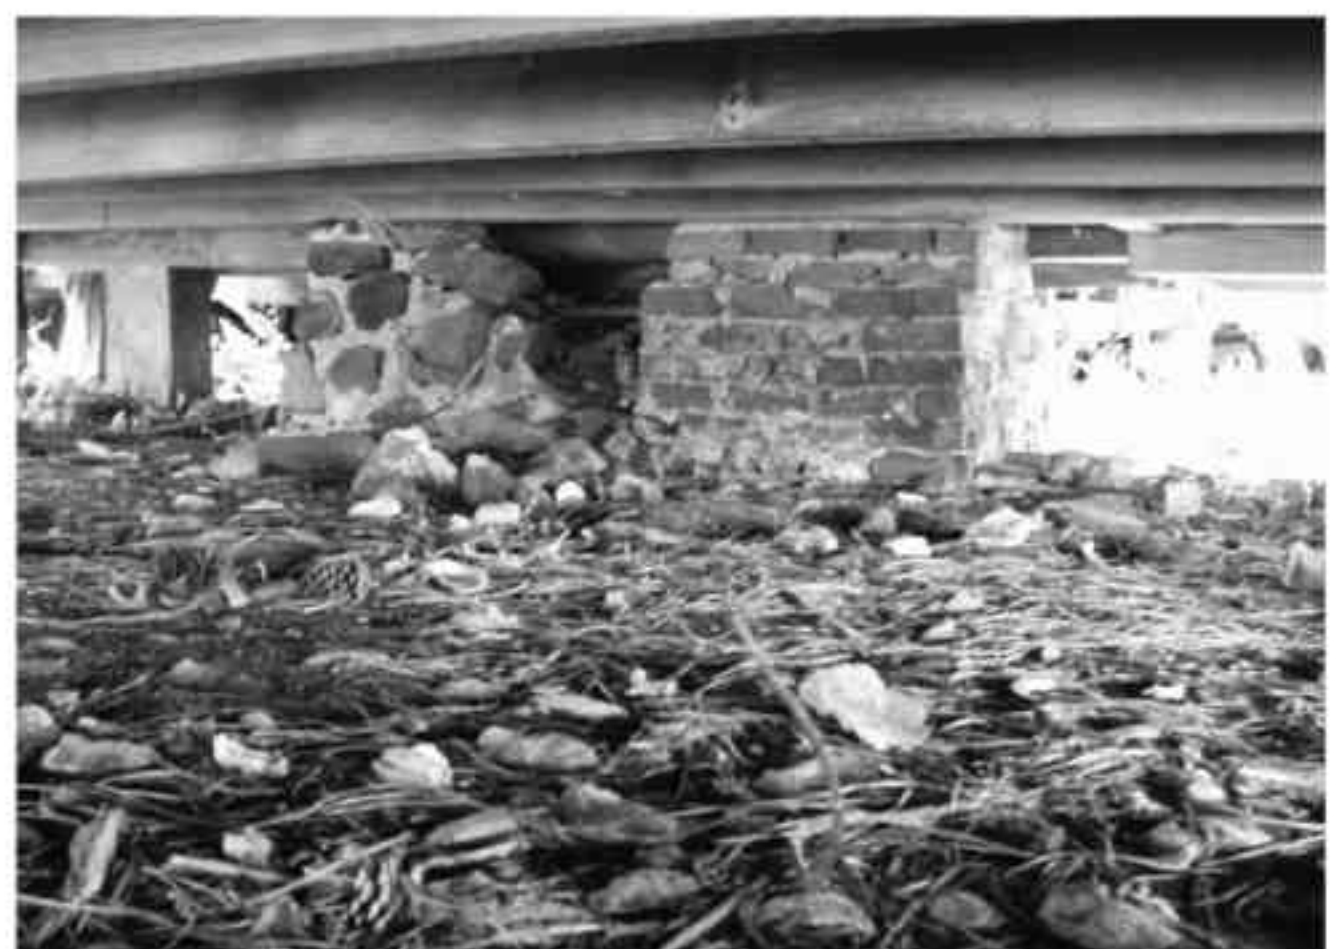
FIGURE 36. View of chimney foundation, with brick at right marking existing chimney base and stone at left marking larger extent of original chimney. (NPS-SERO-CR, 2002)

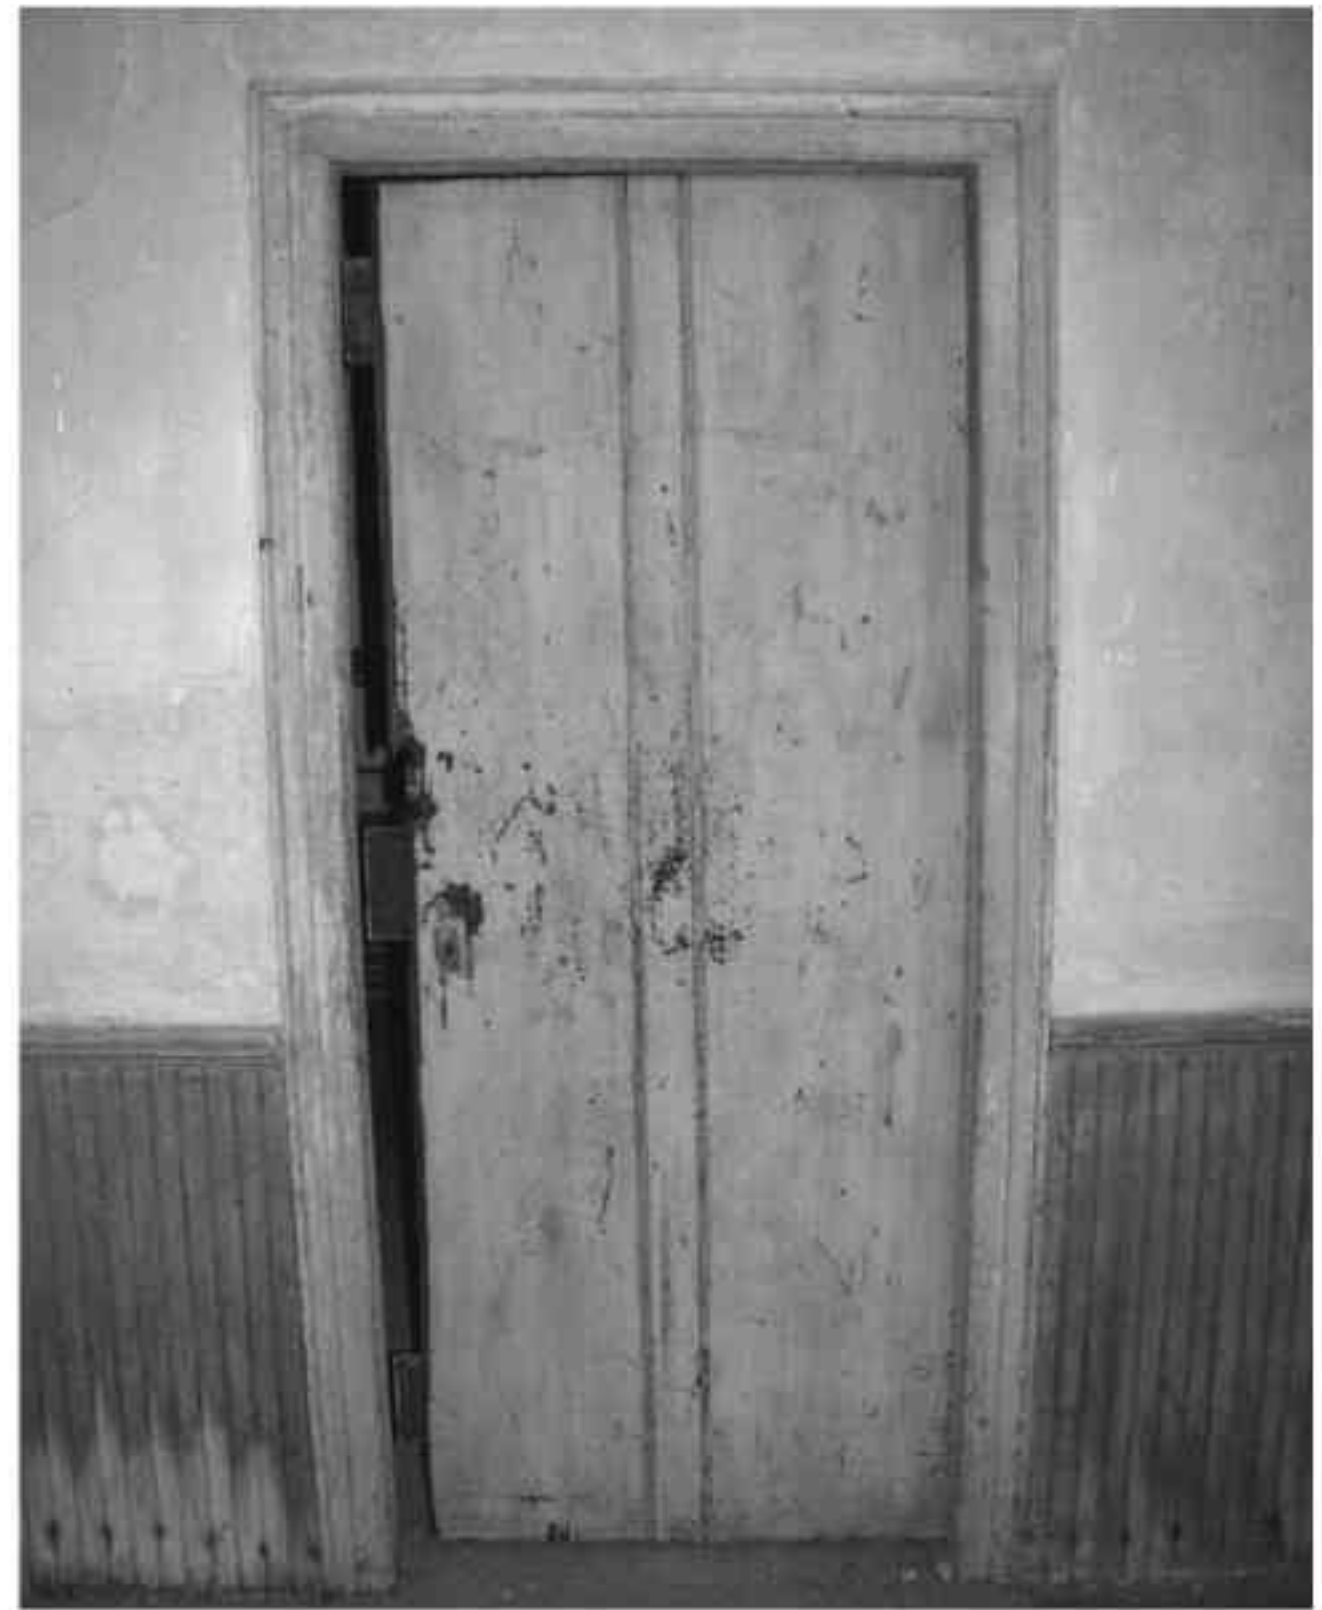
Neither of the interior doors in the kitchen addition could be identified, although evidence may survive under the collapsed roof. Except for the door between Rooms 102 and 103, all of the interior doors in the main block of the house are also missing, most of them torn from their frames. The surviving door is historic and is probably typical of the original interior doors. Measuring 6'-6" by 2'-9", it is constructed with three beaded boards, two around 12" wide, and a center board about 5" wide, held together by three chamfered ledger boards. The door is hung on 4-1/2" butt hinges and originally was fitted with a large rim lock. Only the lock catch remains in place on the jamb, the lock having been ripped off by thieves, splintering the door in the process.

FIGURE 47. View of outside face of door D-9 to Room 102. (NPS-SERO-CR, 2002)

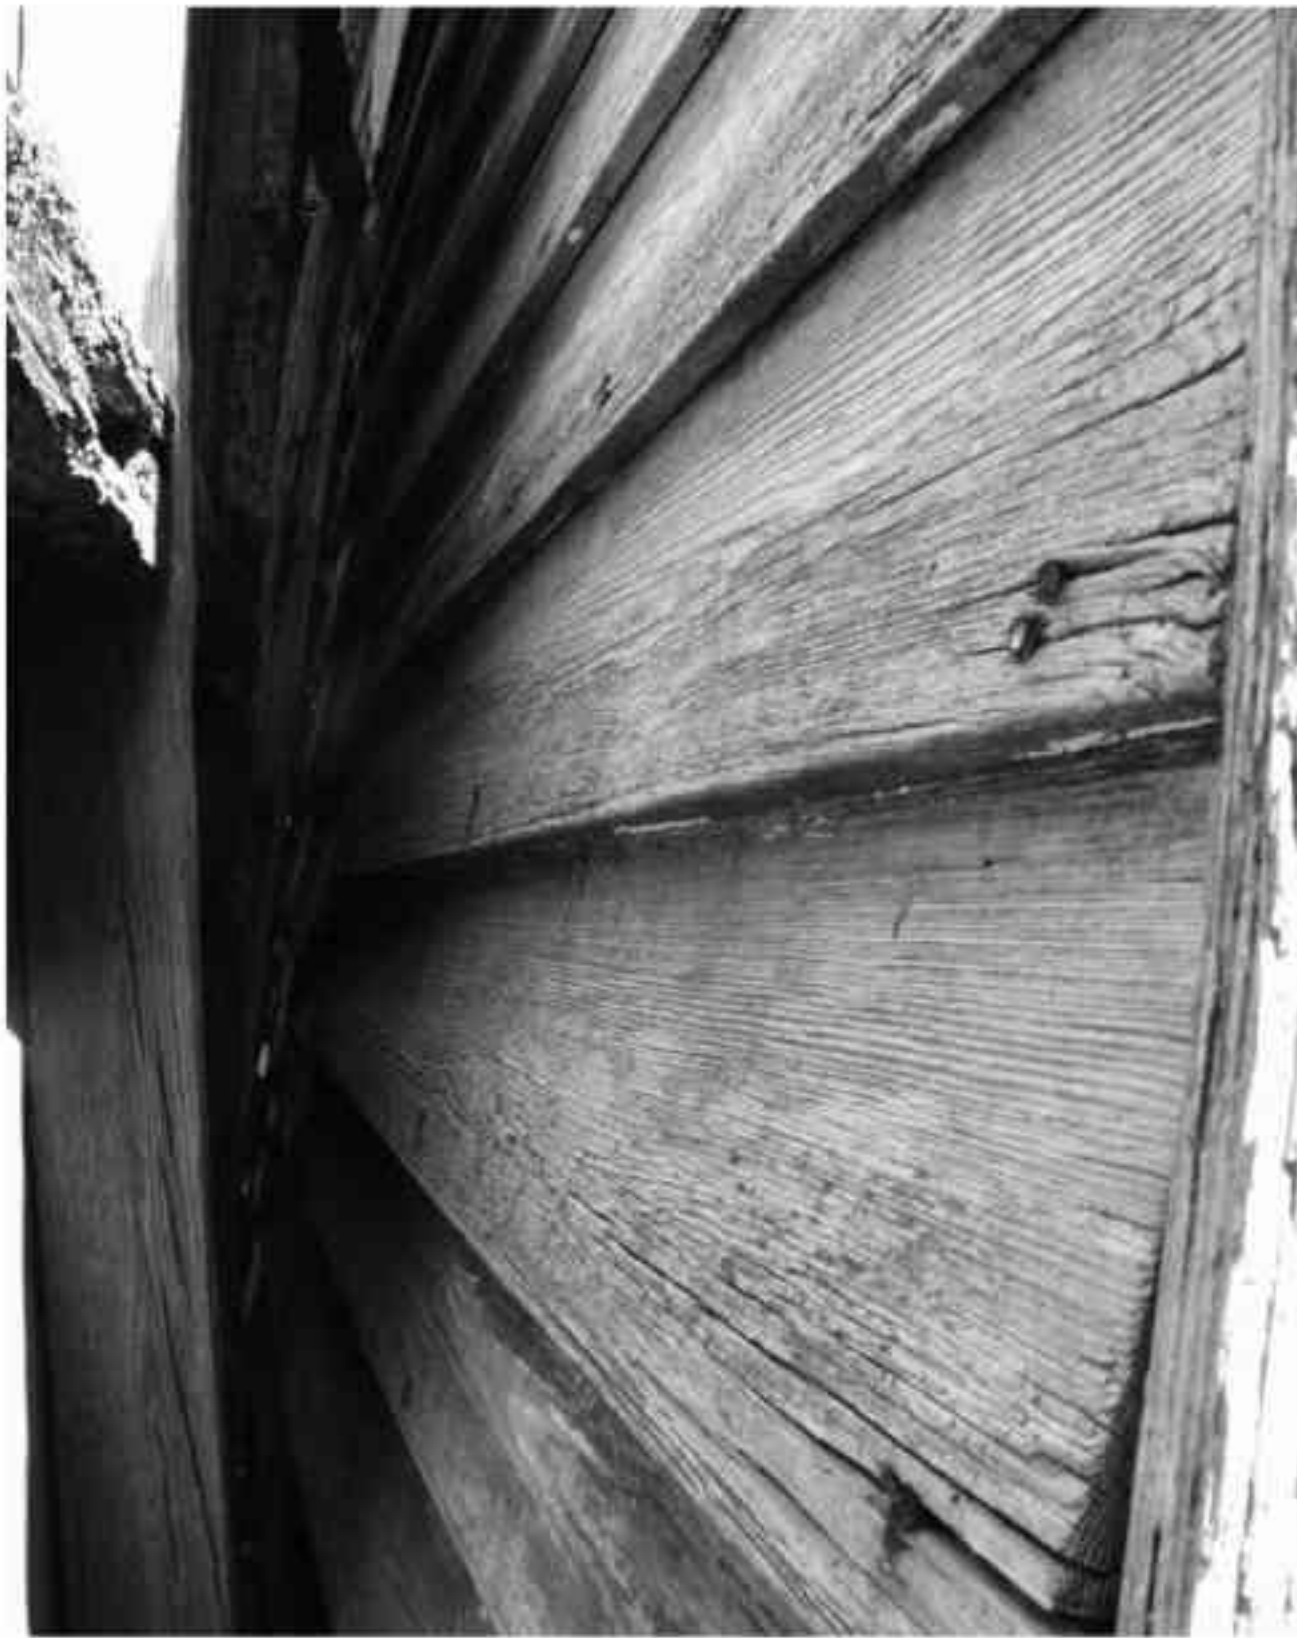
All of the siding is badly eroded, and the beading of the siding on the main block of the house has disappeared from all but a few of the boards that were protected by the kitchen addition. Nearly all of the siding on the north, east, and west sides of the

FIGURE 52. View of original beaded siding remaining on north west side of main block at kitchen addition. All of this siding was replaced in 2003. (NPS-SERO-CR, 2002)

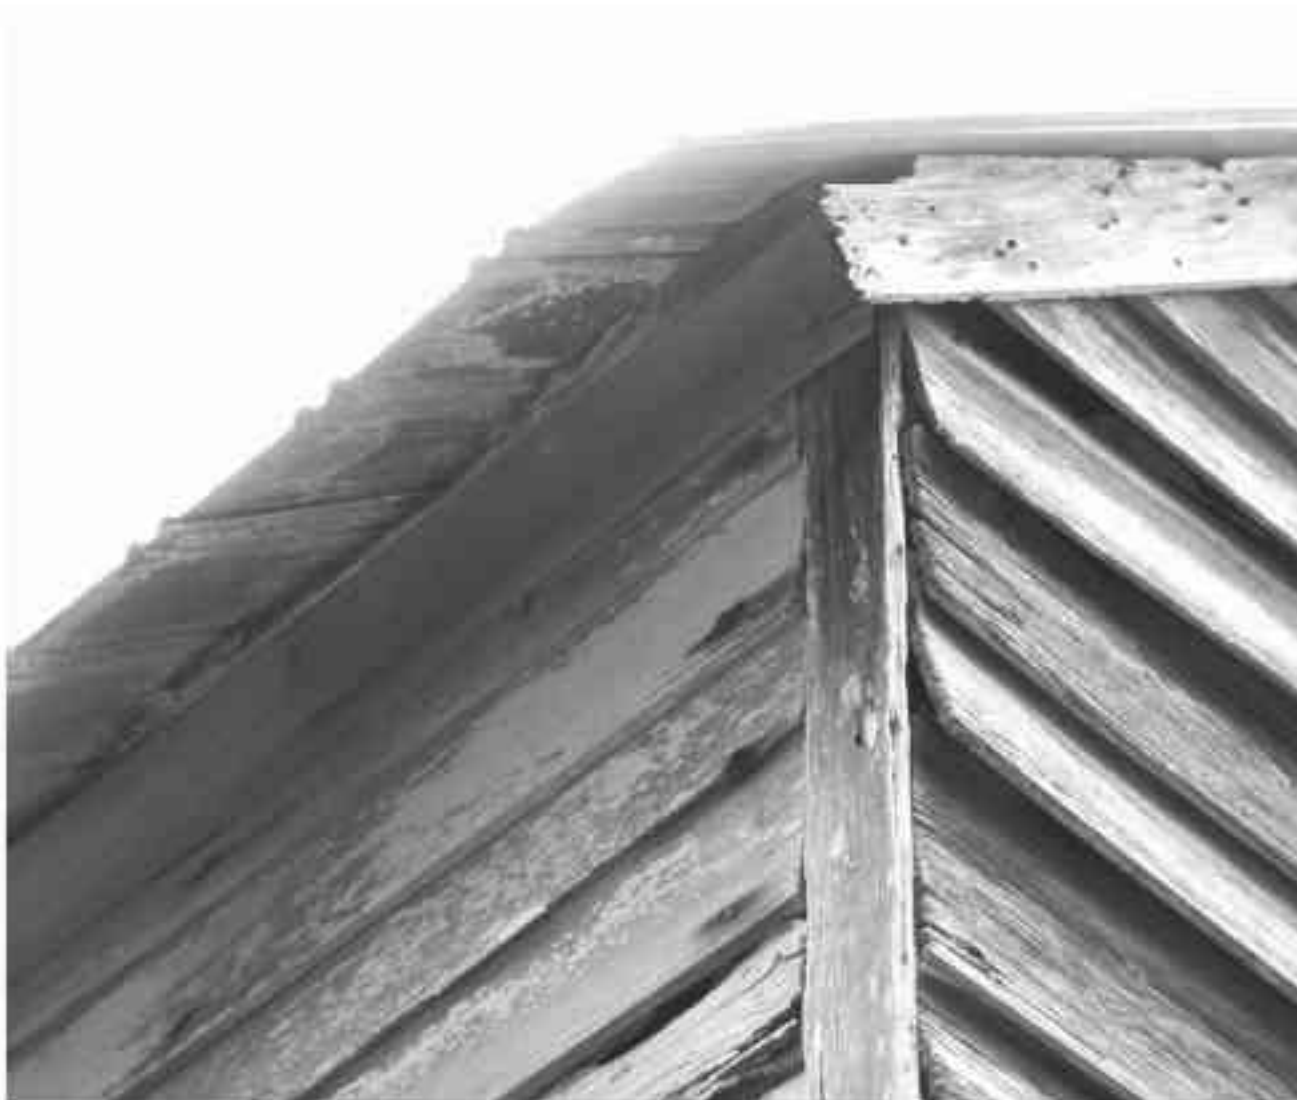
FIGURE 53. View of north corner of house, showing typical treatment of eaves and corners. Light areas appear to be paint but may actually be due to the presence of lichen or other natural discoloration. (NPS-SERO-CR, 2002)

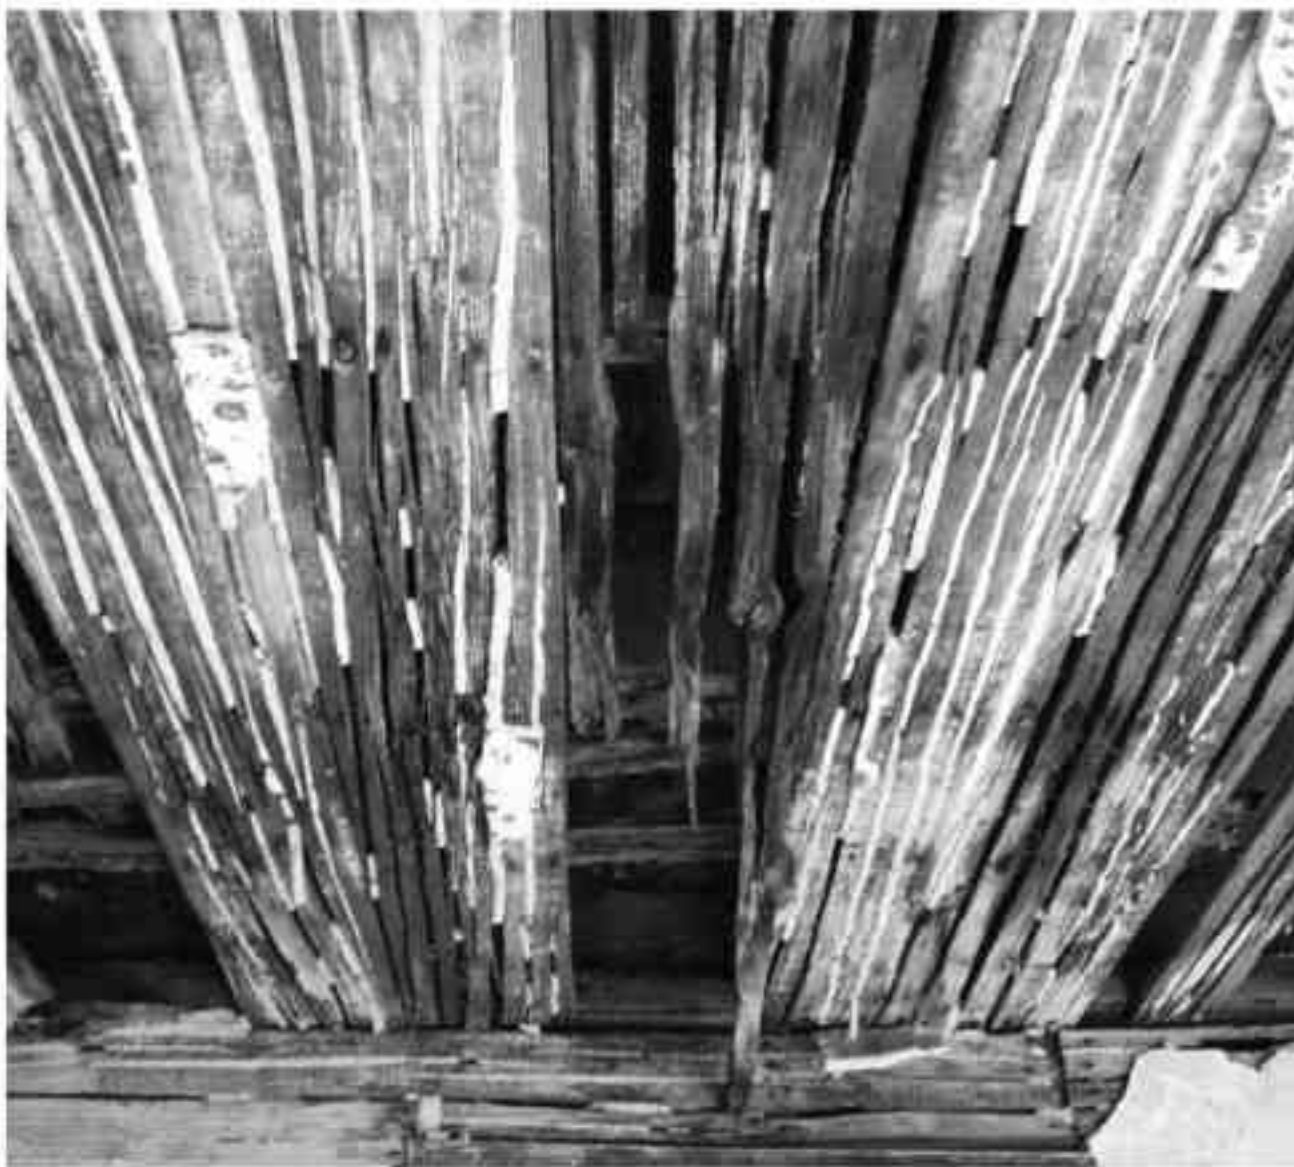
Most ceilings and walls are plastered on an unusual lath which was created out of sawn boards that were split longitudinally to create keys for the plaster. Much of this material remains intact along with plaster on sawn lath from later alterations. Walls are paneled, which may have been typical of finishes

FIGURE 56. View of ceiling in Room 101, showing typical split-board plaster lath. (NPS-SERO-CR, 2002)

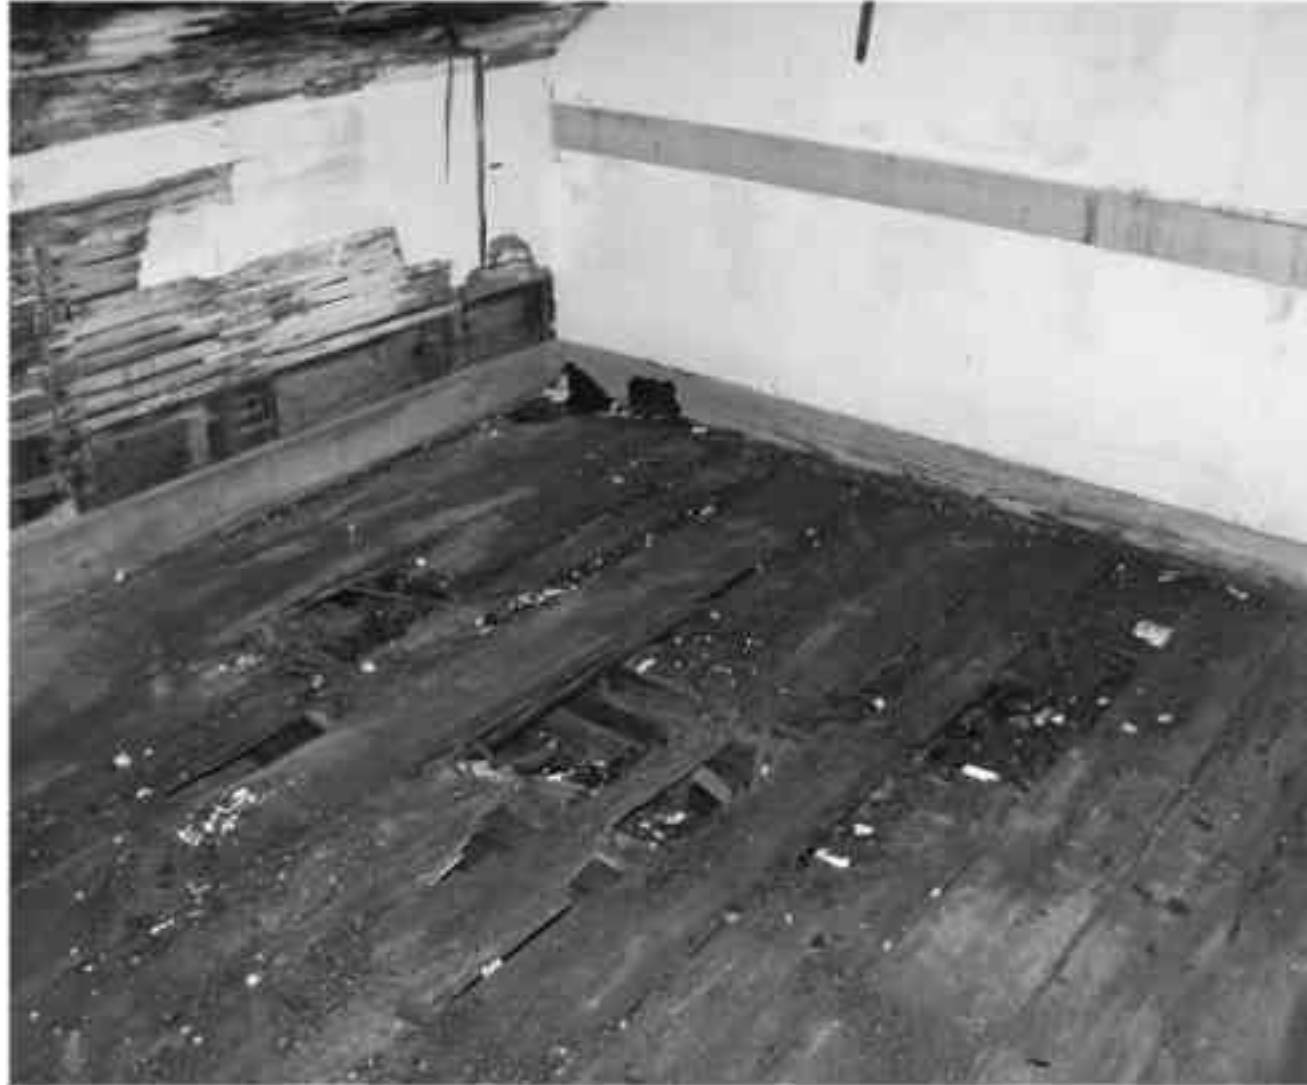
FIGURE 73. View of damaged floor in Room 203. (NPS-SERO-CR, 2002)
