# **Cape Lookout National Seashore**

# **Washington Roberts House**

## **Historic Structure Report**

### **Developmental History**

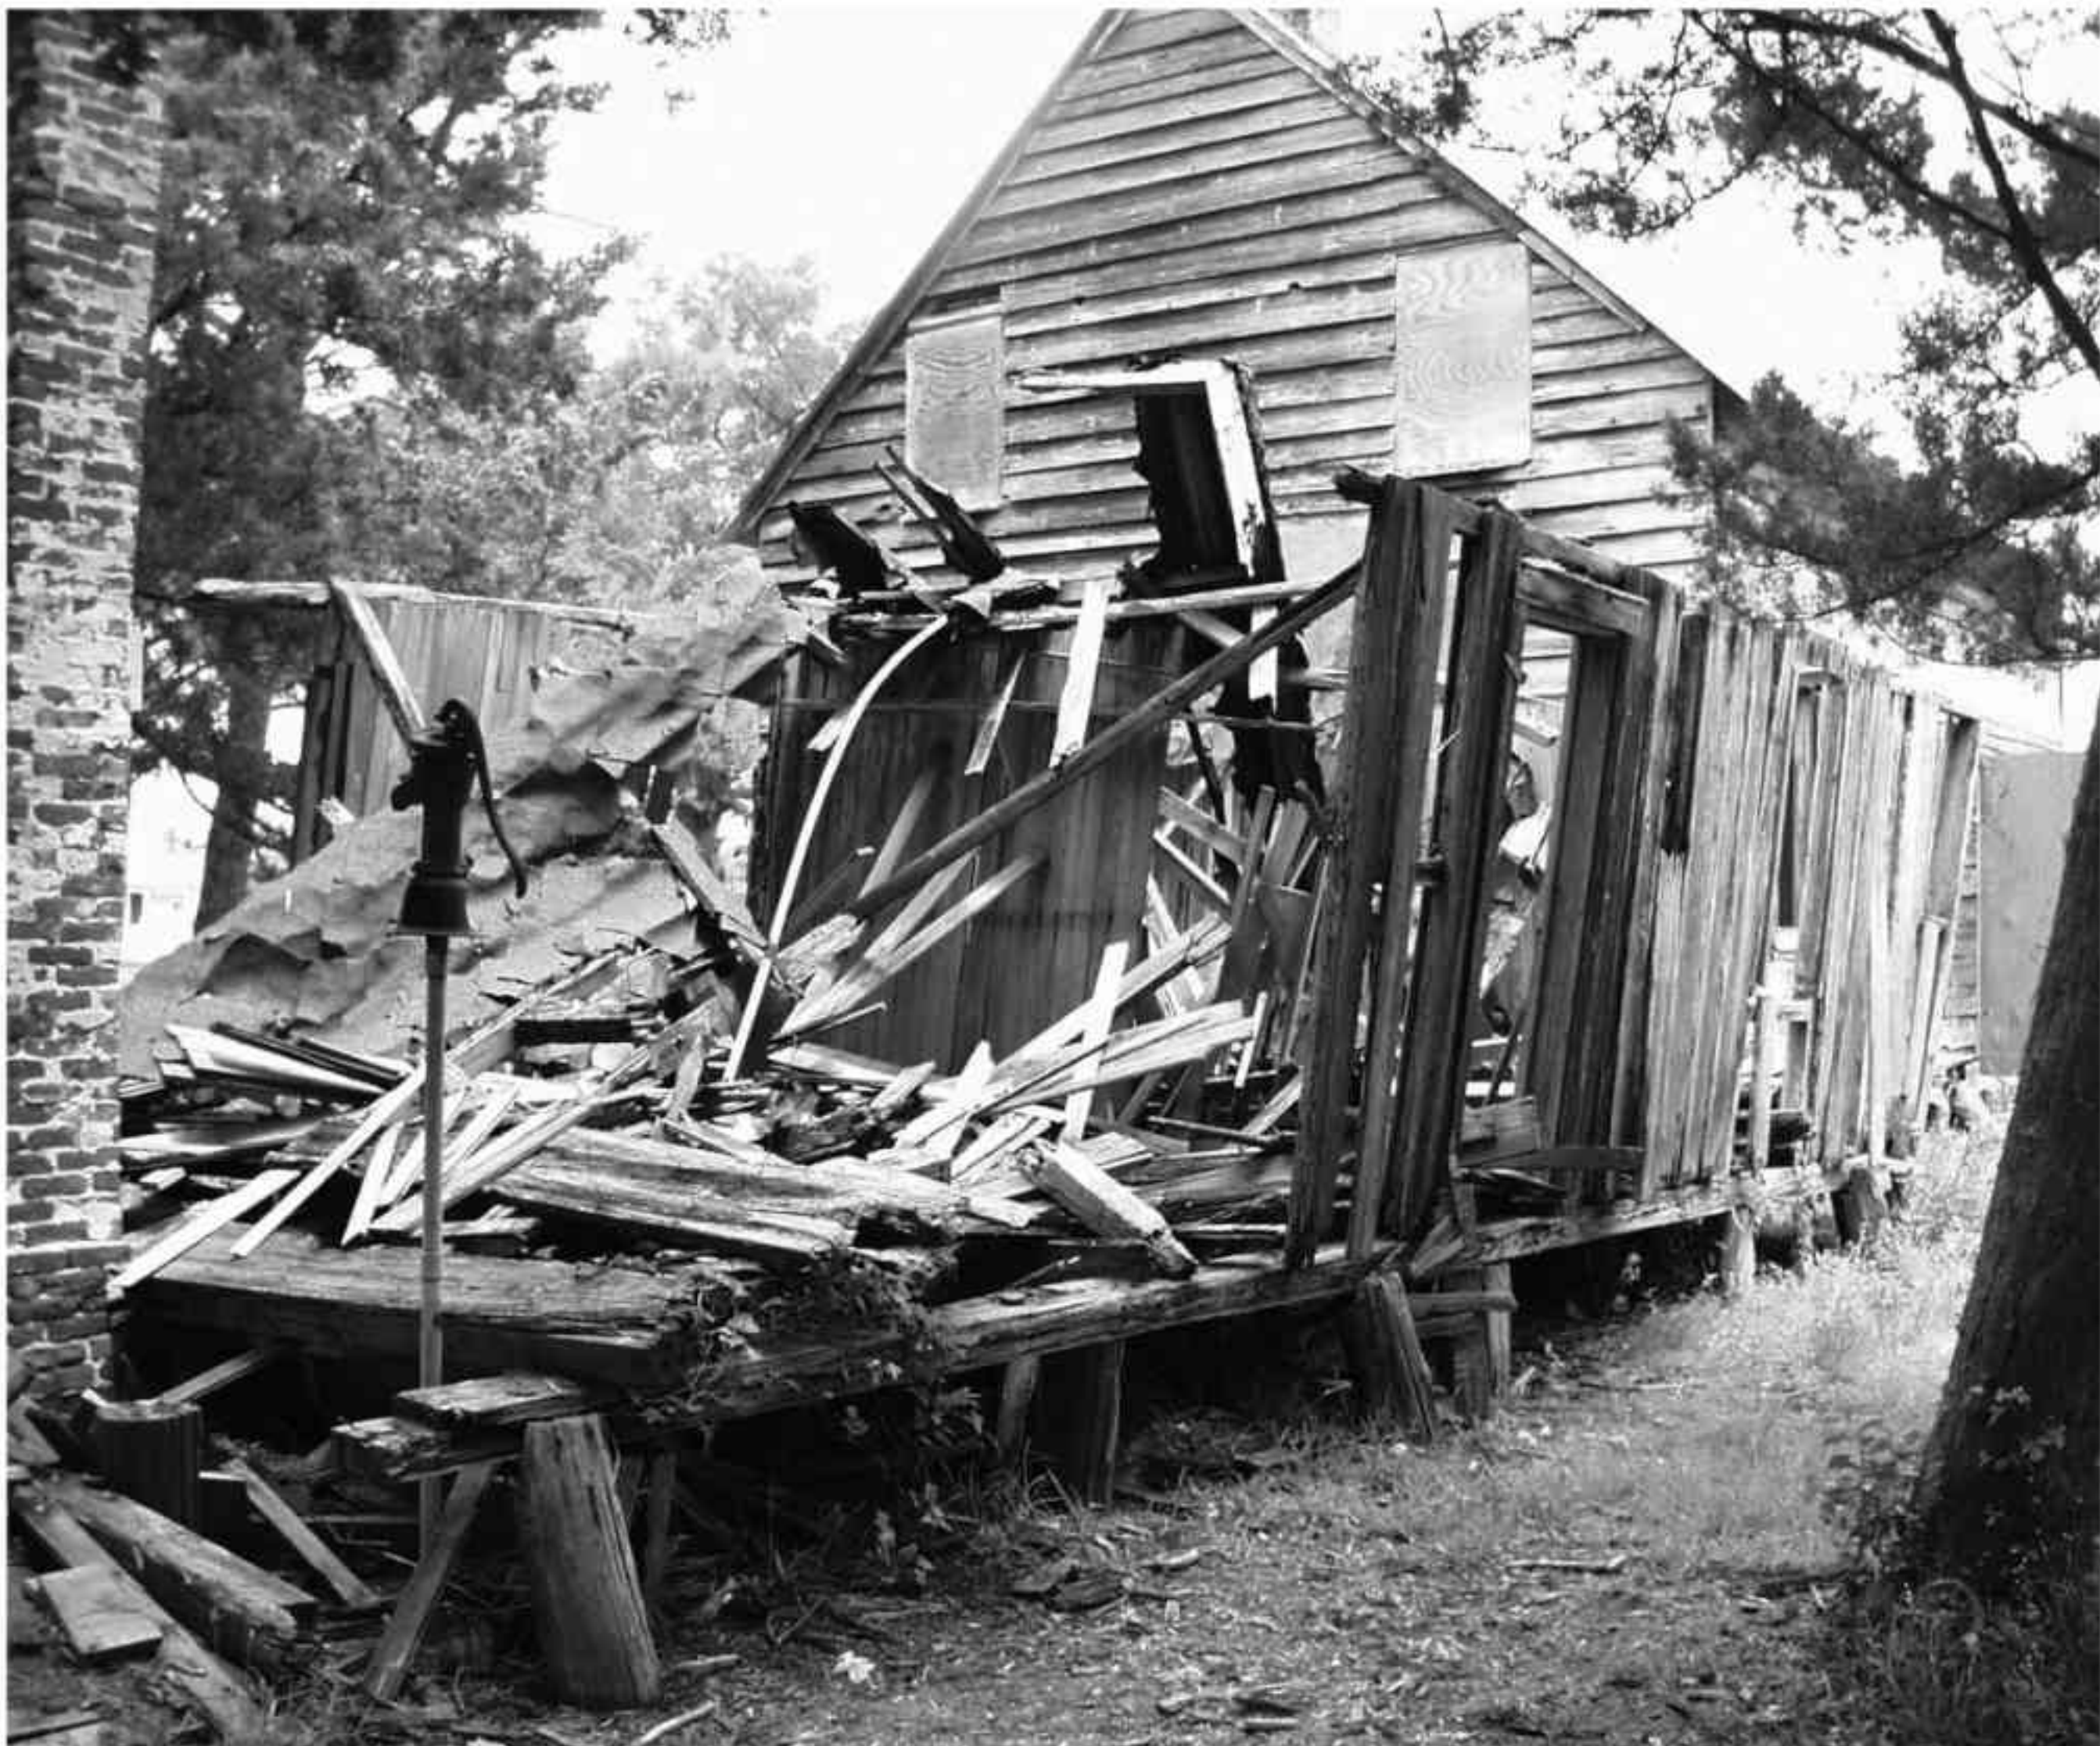
FIGURE 75. View east of kitchen wing, showing remains of Rooms 105 and 106. (NPS-SERO-CR, 2002)
