4 LAZY F RANCH

Historic Structures Report

September, 2008

Grand Teton National Park
National Park Service
P.O. Box 170
Moose, Wyoming 83012

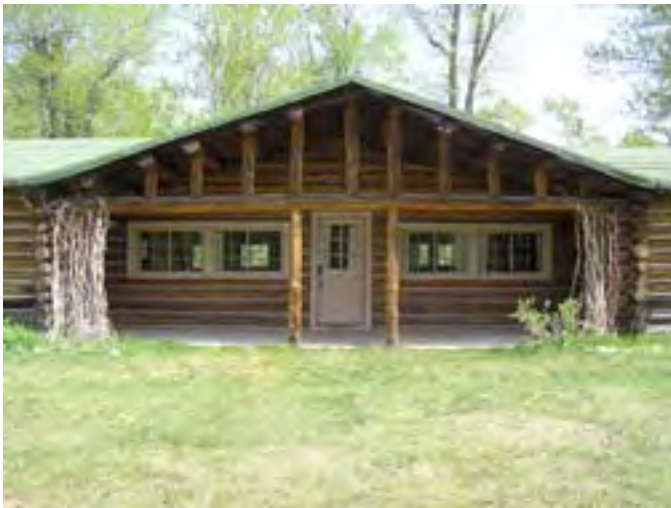
Figure 24. Looking east at the main entrance to the Lodge and the gable roof with the log structure.

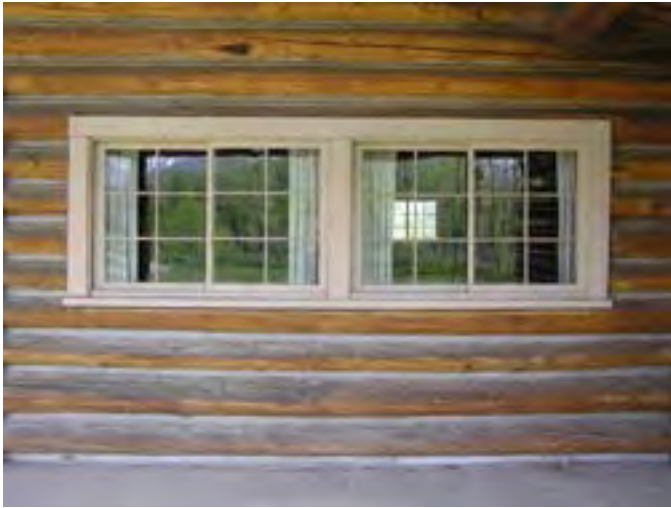
Figure 26. Looking east at a typical set of wood sliding windows in the entrance porch area.

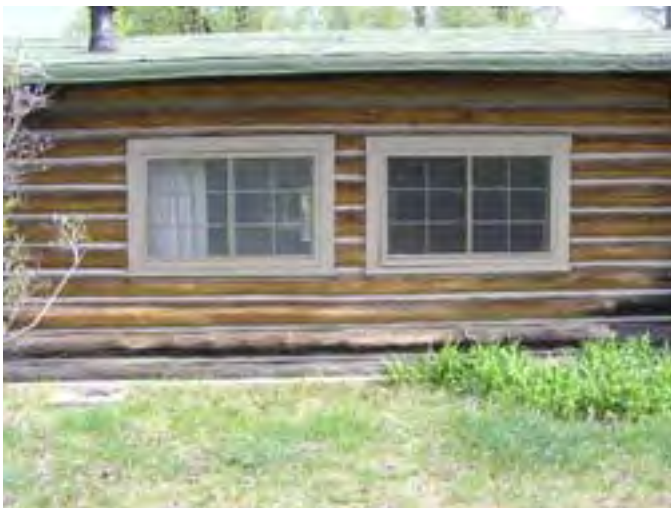
Figure 28 – Looking east at a typical log wall on the west side of the Lodge. The logs are very dry and there is some surface rot on the bottom logs and under the valley areas where water drains onto the logs. The concrete foundation appears to be in good condition. The grade around does not slope away from the building so there is no positive drainage.

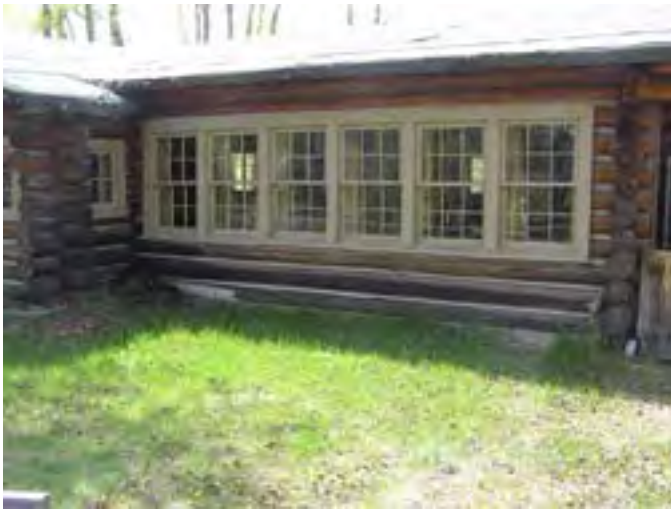
Figure 32 – Looking southwest at the dining room wall and typical wood double-hung windows. The windows are in good condition. The log walls are dry but the daubing is good.

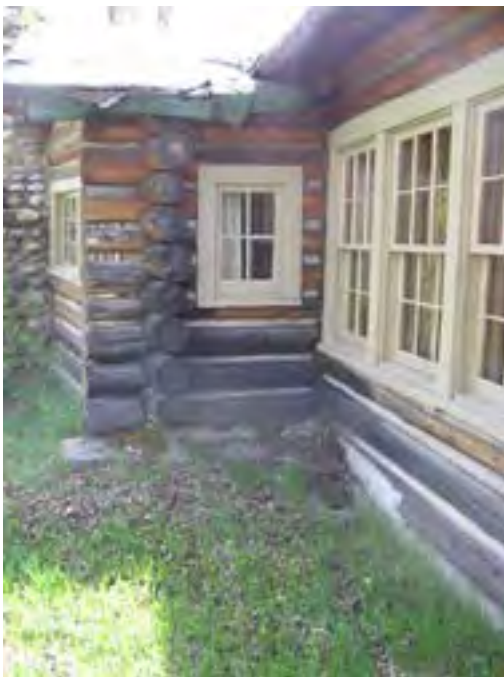
Figure 33 – Looking south at the intersection of the dining room and great room walls. Note the soil that has accumulated on this side of the building and the rotted base logs. Also, note the damaged sheet asphalt roof.

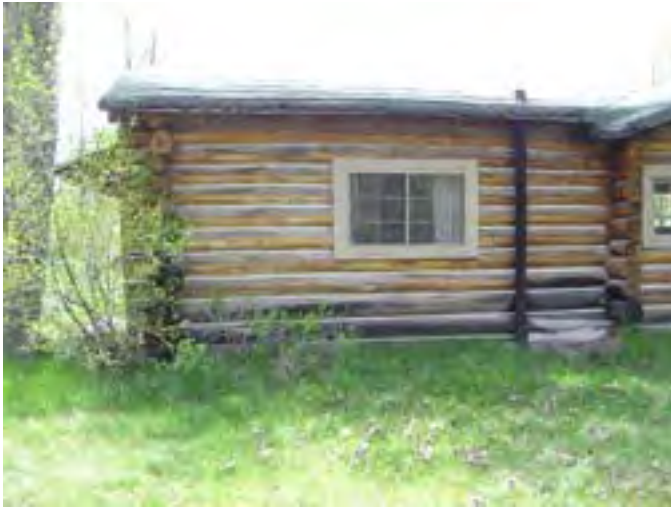
Figure 35 – Looking west at the bedroom wall. Note the rot in the lower base logs and soil around the base of the building in this area.

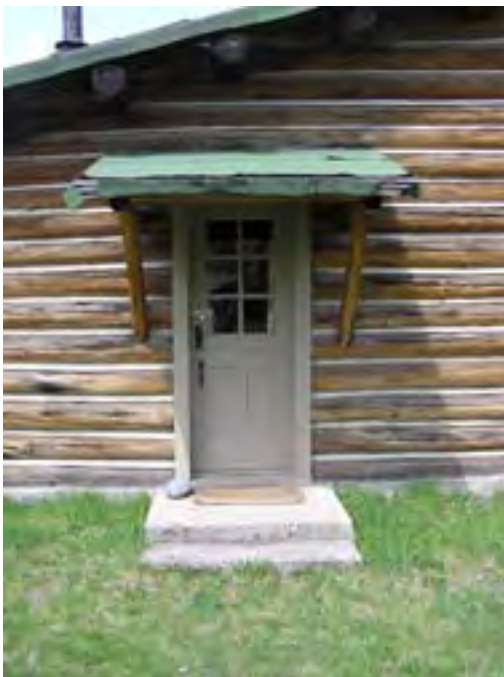
Figure 36 – Looking north at one of the typical shed roofs over the exterior doors in the bedrooms. Note the damaged sheet asphalt roof.

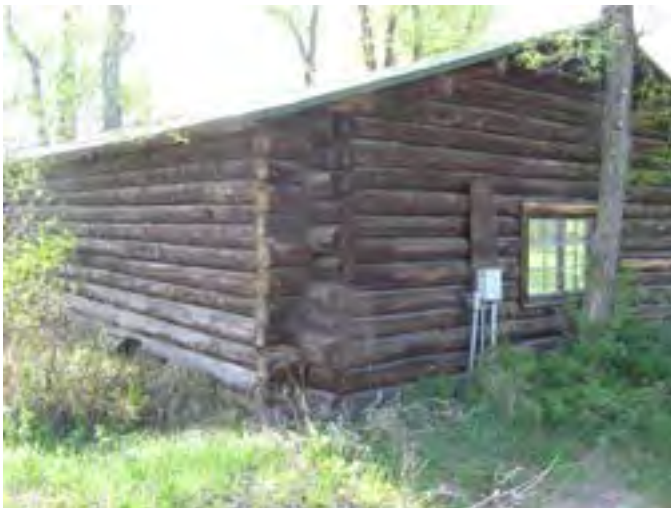
Figure 52 – Looking southeast at the garage. Note the soil accumulation around the building, which is causing some rotted sill logs.

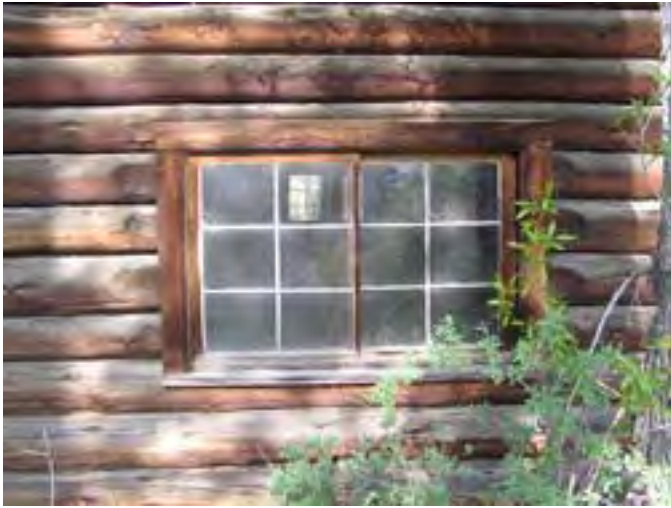
Figure 53 – Looking west at the wood window sash on the east side of the garage. The glazing is deteriorated and the wood is dry. The sill has some rot.

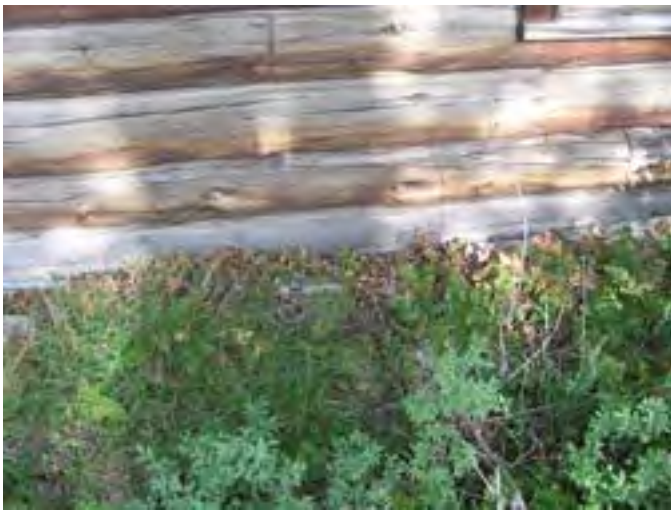
Figure 54 - Looking west at the base of the east wall. Note the soil accumulation and the rot in the sill log. The daubing is poor.

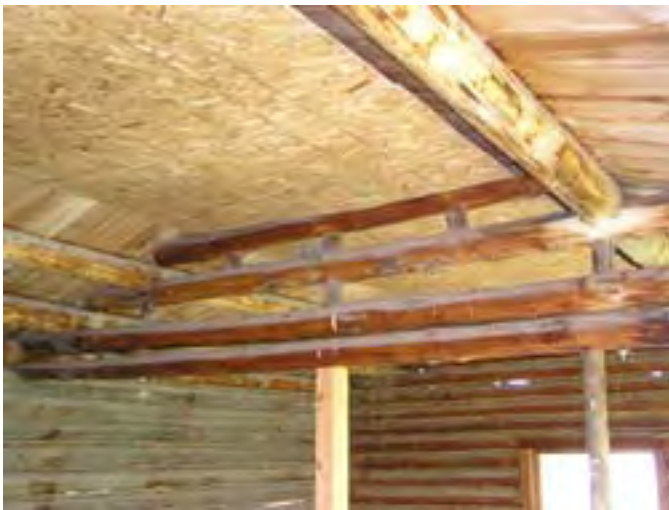
Figure 56 – Looking east at the roof structure and the supports in the middle section of the roof. Note the sag in the roof logs.

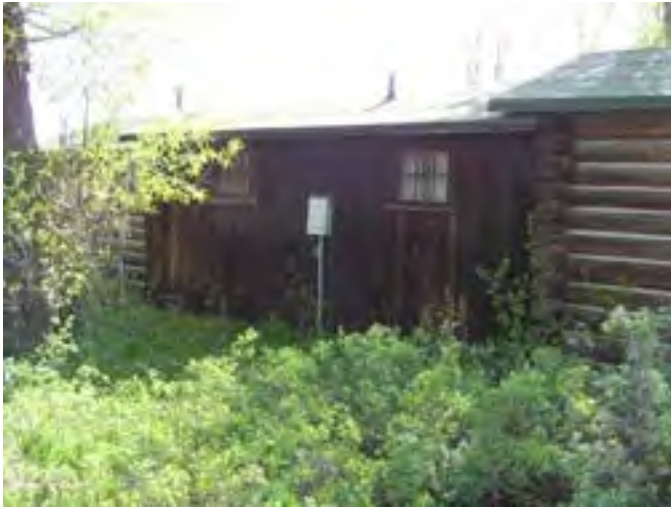
Figure 73– Looking at the center wood frame structure that connected the two log cabins. The wood is very dry and the base is rotted due to soil build-up around the building.

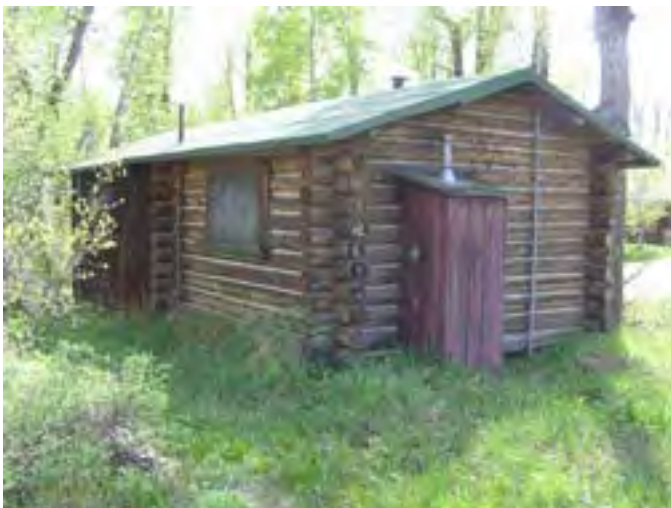
Figure 85 – Looking southwest at the log cabin portion of the building. Note the soil build-up around this end of the building which is causing the sill logs to rot.

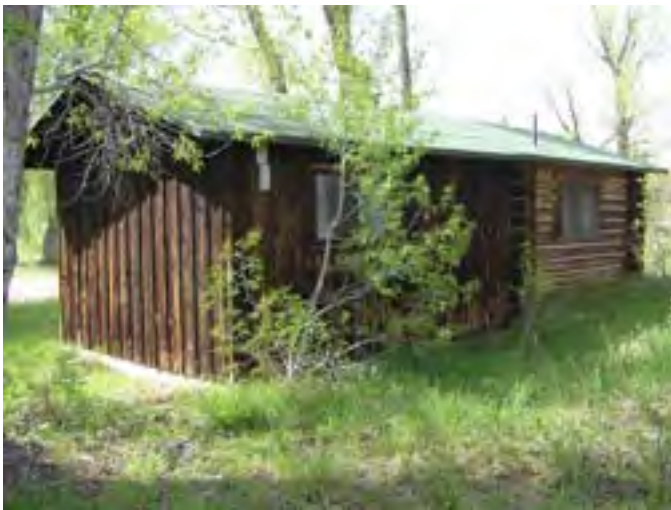
Figure 87 – Looking northwest at the frame addition to the building. Most of the addition sits up on the concrete foundation but the grade is poor on the east side.

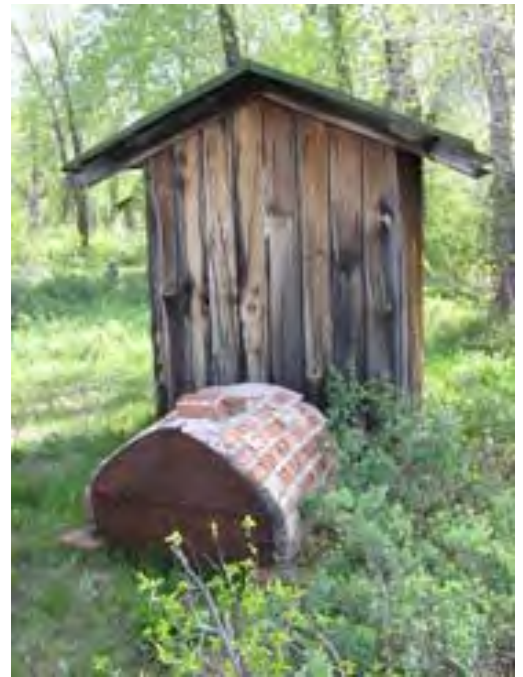
Figure 93 – Looking south at the smokehouse. The brick firebox is starting to break apart on the end closest to the building. Some mortar is missing. Note the weathered boards on the back of the building.

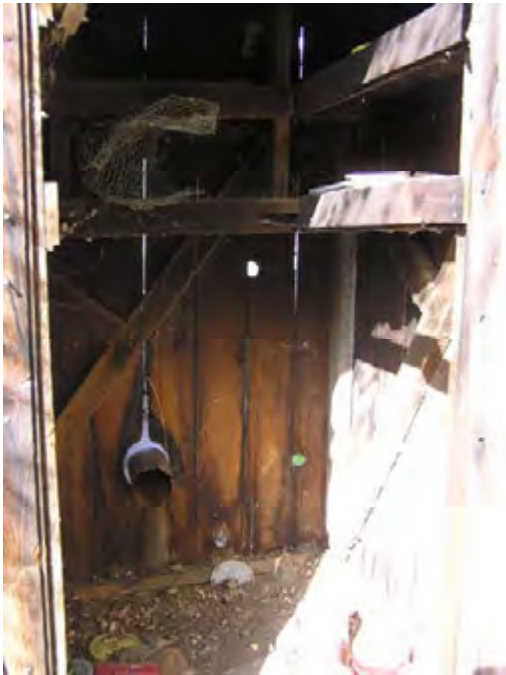
Figure 94 – Looking north at the interior of the smokehouse. The wood interior is also deteriorating.

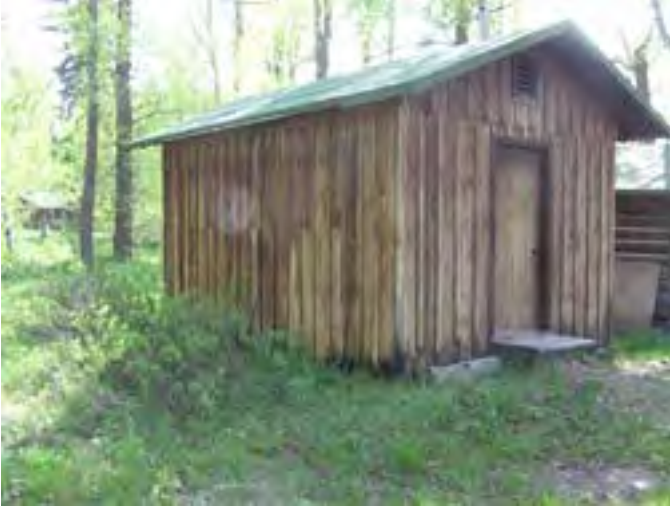
Figure 101 – Looking southwest at the board and batten Mouse House. The wood materials are very dry and there is some rot along the base of the wood siding.

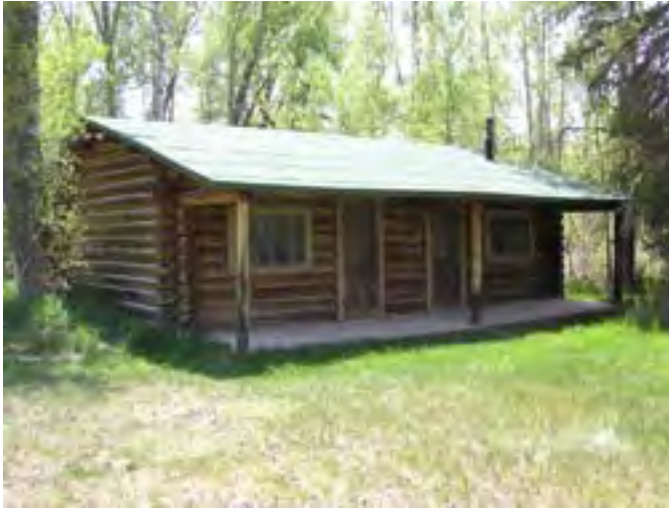
Figure 106 – Looking southwest at the cabin and the front porch and entrance. The roof is in good condition. The doors are in good condition but the screen doors are weathered and the wood is dry.

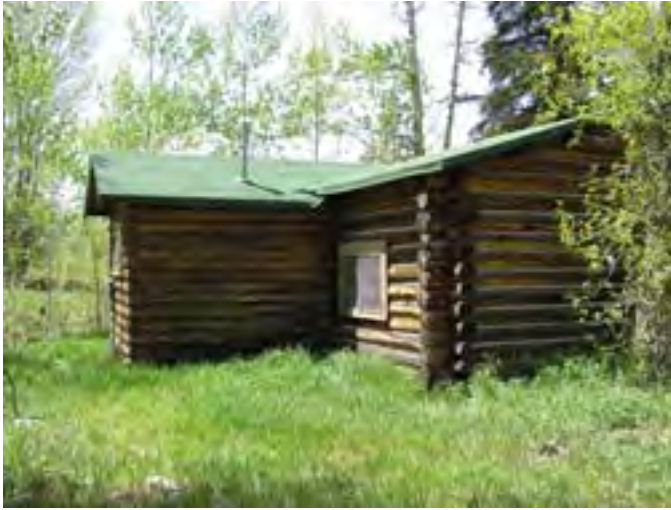
Figure 109 – Looking west at the back of the building with the bathroom addition. Most of the logs and the roof are in good condition. The sill logs and some of the wall logs are weathered and rotted.

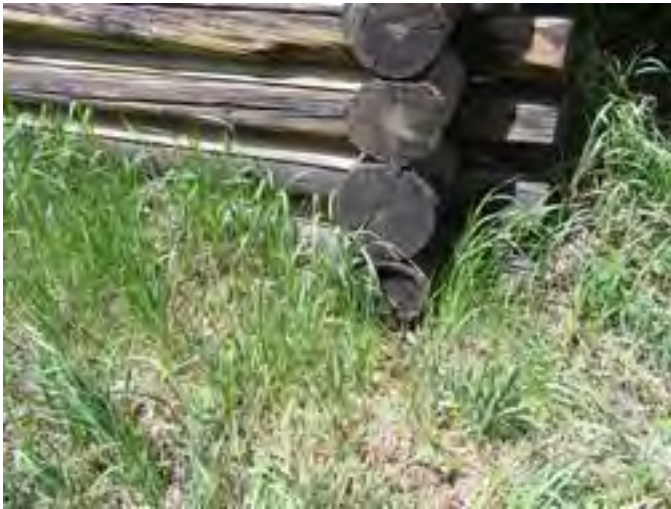
Figure 110 – Looking north at a corner of the back wall of the cabin. Note the soil built up around the sill logs and weathered and rotted wall logs.

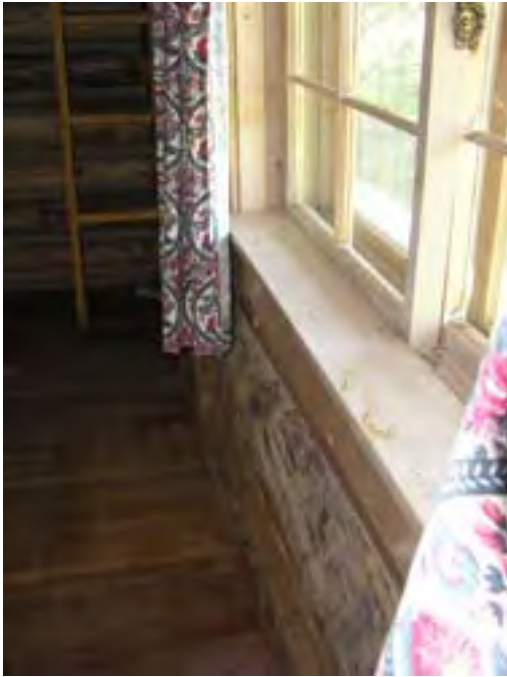
Figure 115 – Looking west along the window sill. Note the water stains on the sill and the dry wood.

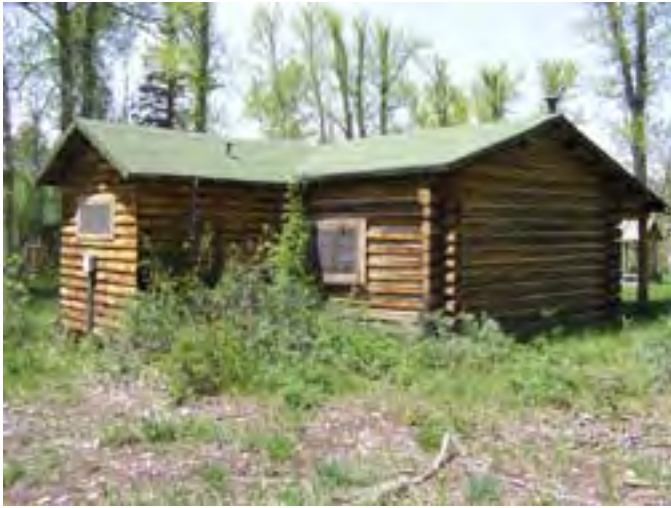
Figure 121 – Looking northwest at the cabin. Note the vegetation and soil build-up around the base, which is causing rot in the sill log and base logs of the wall. The wall logs are dry but the daubing is generally good.

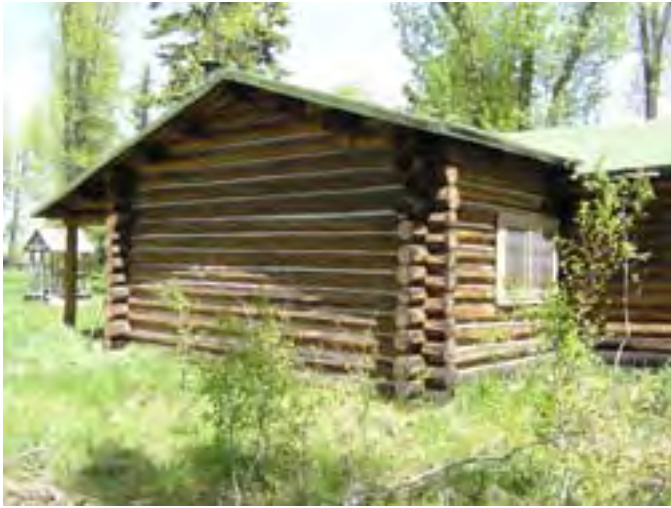
Figure 124 – Looking northeast at the cabin. Note the soil build-up around the base.

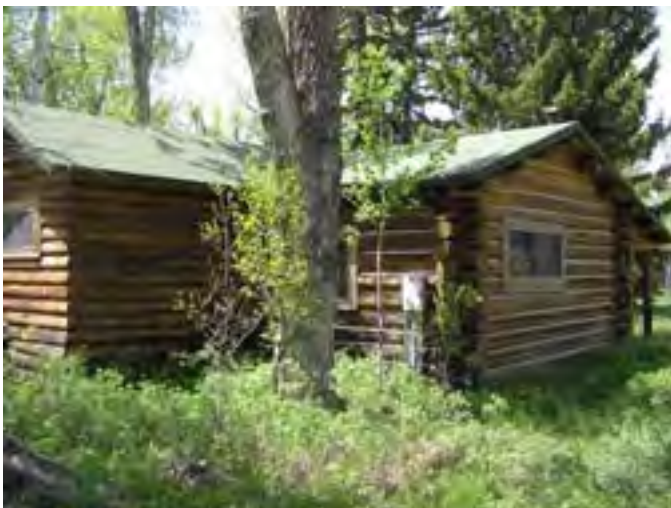
Figure 131 – Looking northwest at the cabin. The wall logs are dry and there is some rot in the sill logs due to the vegetation and soil build-up around the base. The daubing is generally good.

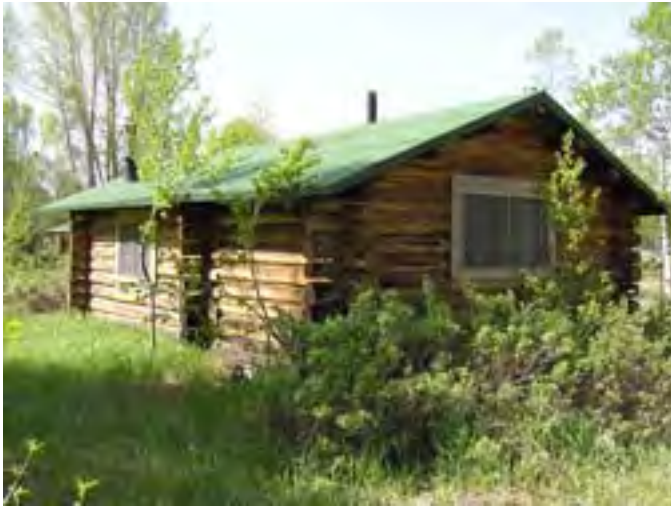
Figure 143 – Looking southwest at the cabin. Note the shrubbery and soil build-up around the building.

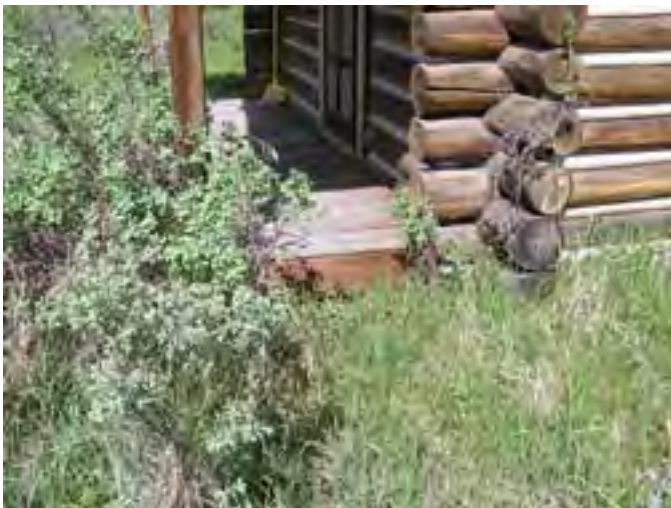
Figure 145 – Looking west at the edge of the porch which is weathered and has some rot. The columns supporting the roof rest outside the porch on concrete and stone piers.

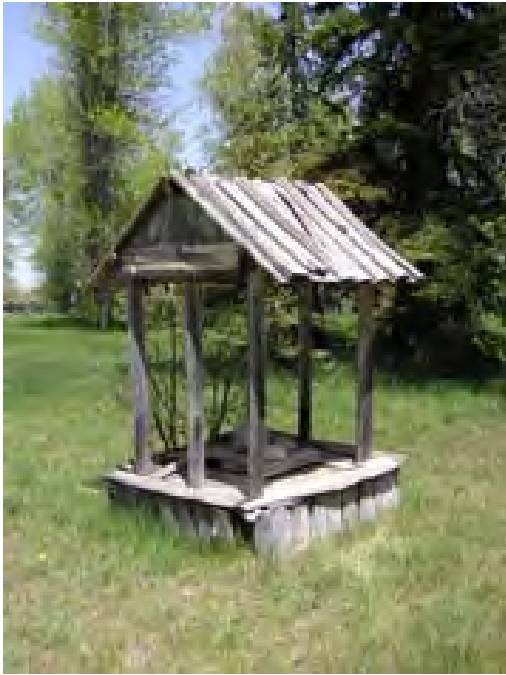
Figure 159 – Looking southeast at the well housing. The structure is weathered and there is rot along the base. The board and batten roof is in poor condition.

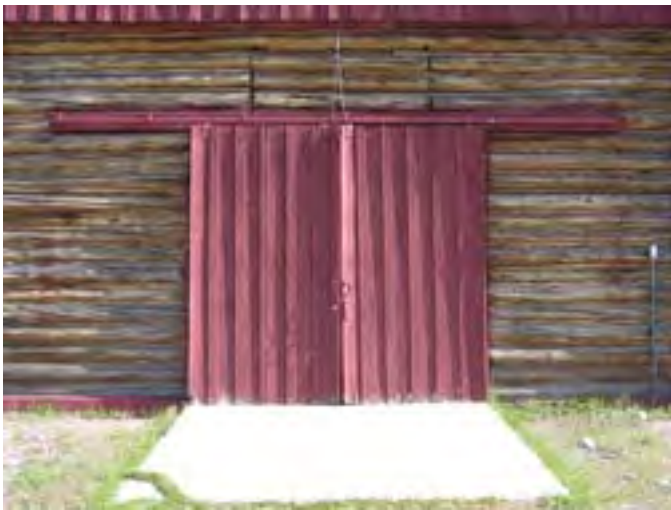
Figure 191 – Looking north at the wood sliding doors. They are warped and in fair condition.

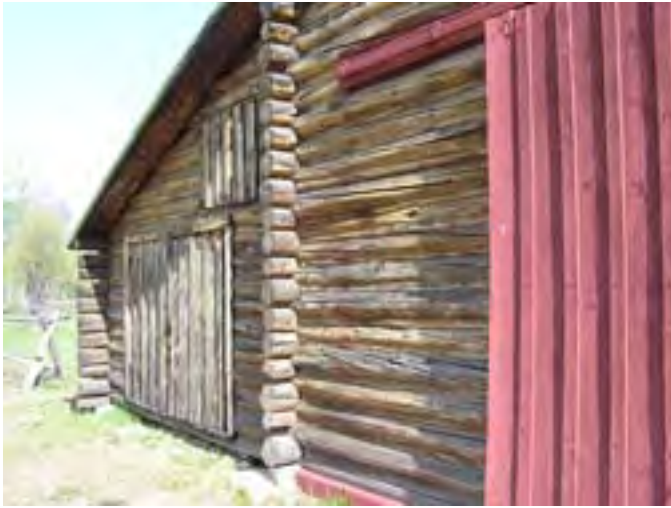
Figure 193 – Looking northwest along the front of the building showing the log work. The center section has a concrete foundation that helps to support the front wall and is in good condition. The shed roof structure has some settlement under the doors that are in poor condition.

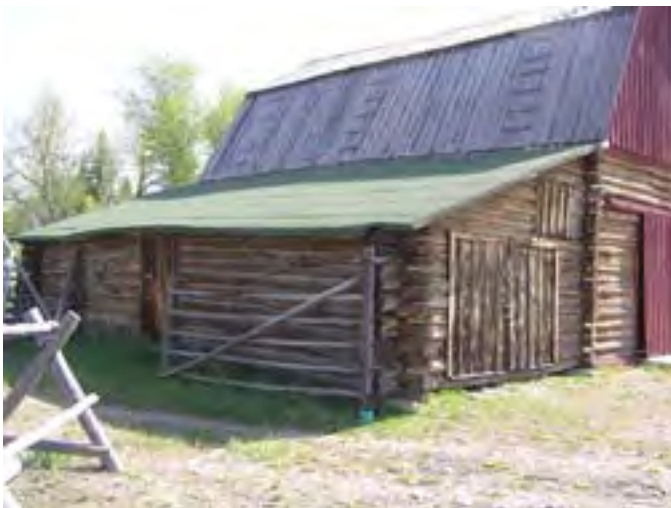
Figure 194 – Looking northeast at the Barn. There is some settlement in the log walls which show up in the eave of the roof. The sheet asphalt is in good condition but the board and batten roof of the central section is in poor condition.

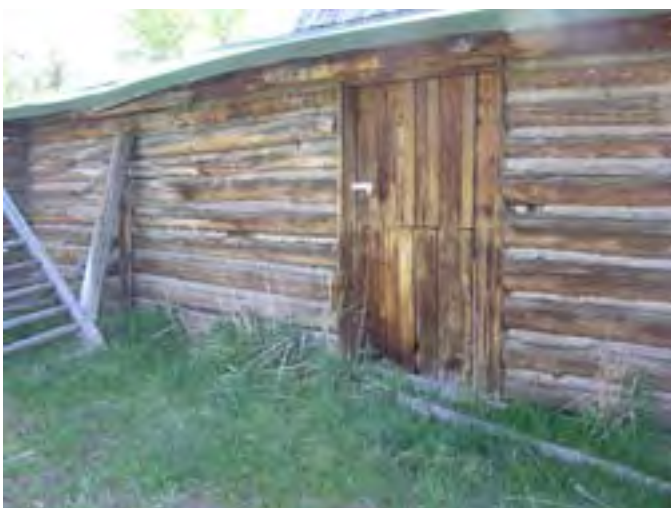
Figure 195 – Looking east at a door in the west wall. The door is in poor condition and there is rot in the sill logs because of the soil build-up around the base on this side of the building.

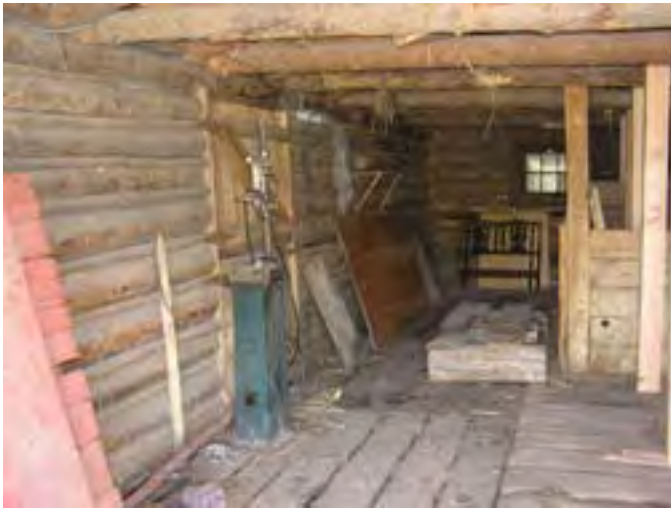
Figure 200 – Looking north at the interior of the west wing. There is some rot in the floor and the structure for the roof needs to have additional supports to take care of the snow loads on the building.

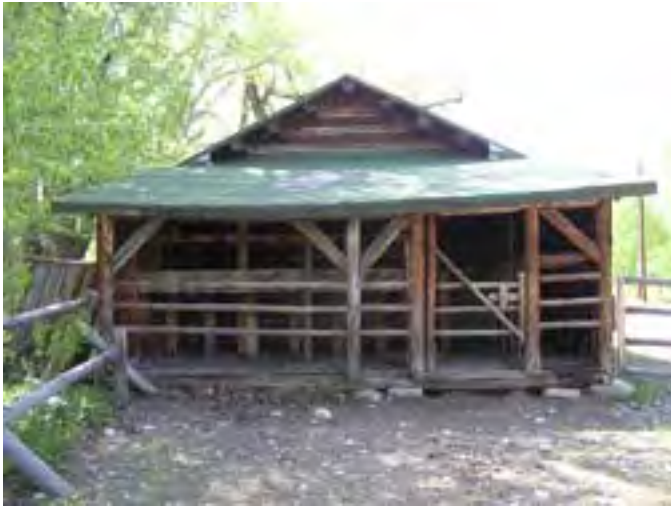
Figure 210 – Looking south at the open end of the shed-roof addition. A pole fence closes off the shed where tack was kept. There is some rot in the base of the floor and the posts of the fence. Most of the wood is very dry.

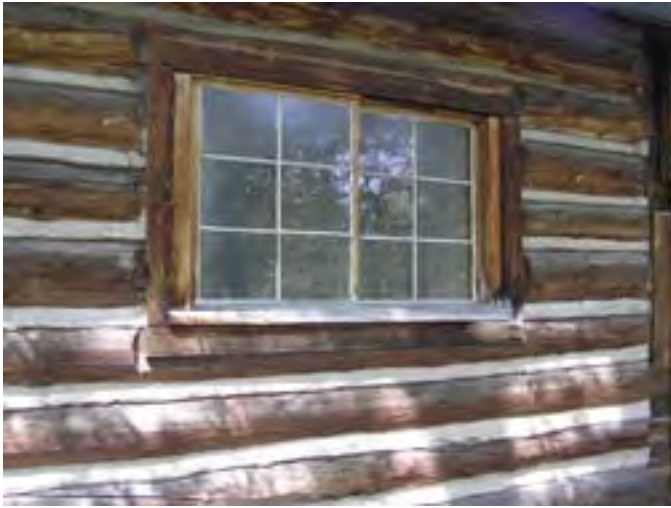
Figure 213 – Looking west at a typical wood sliding window on the Tack Room. The window is in poor condition. The log walls are dry but the daubing appears to be generally in good condition.

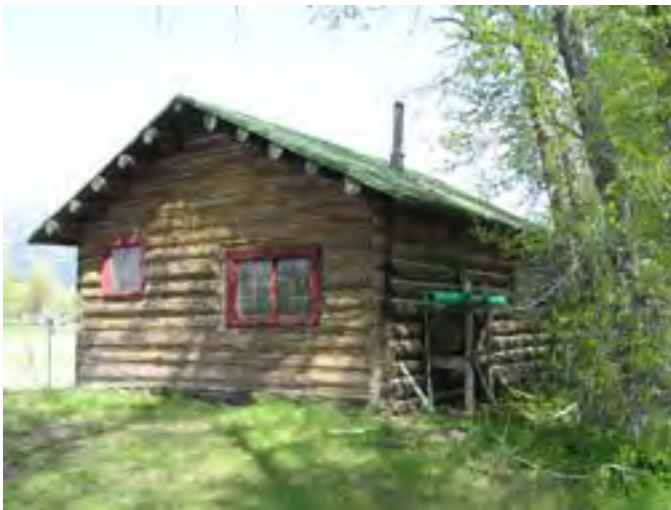
Figure 214 – Looking northwest at the Tack Room. Note the soil accumulation around the south and east sides of the building. The sill logs and some wall logs are rotted in this area.

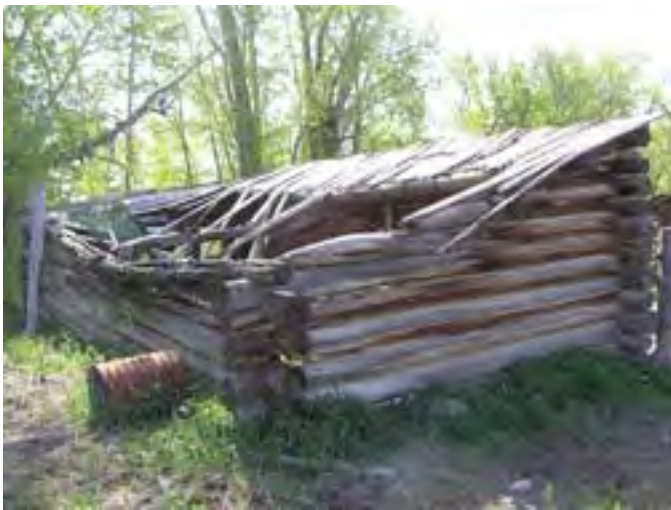
Figure 220 – Looking east at the end of the Chicken Coop. Note the collapsed roof causing the walls to fail also.

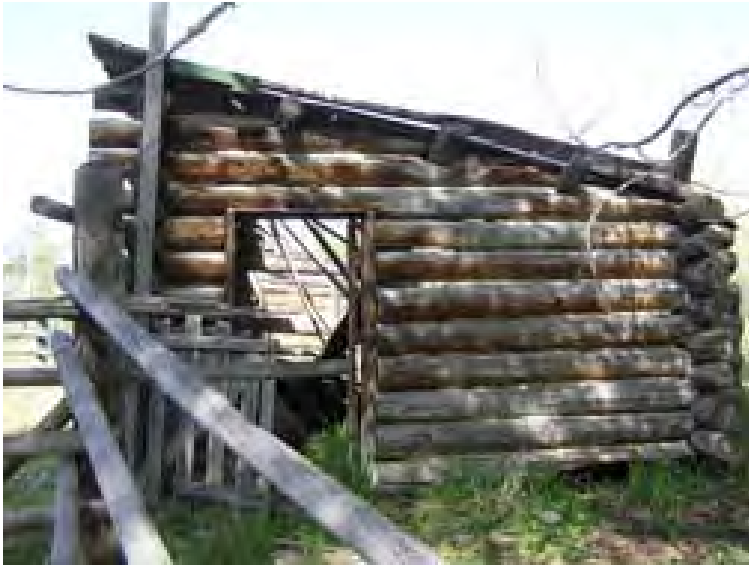
Figure 222 – Looking west at the wall of the Chicken Coop. There appears to be rot in all of the sill logs and upper parts of the walls which did support the roof.
