Snake River Land Company

Grand Teton National Park

Historic Structure Report

Prepared by
Colorado State University
Architectural Preservation Institute
Christopher Koziol, Principal Investigator

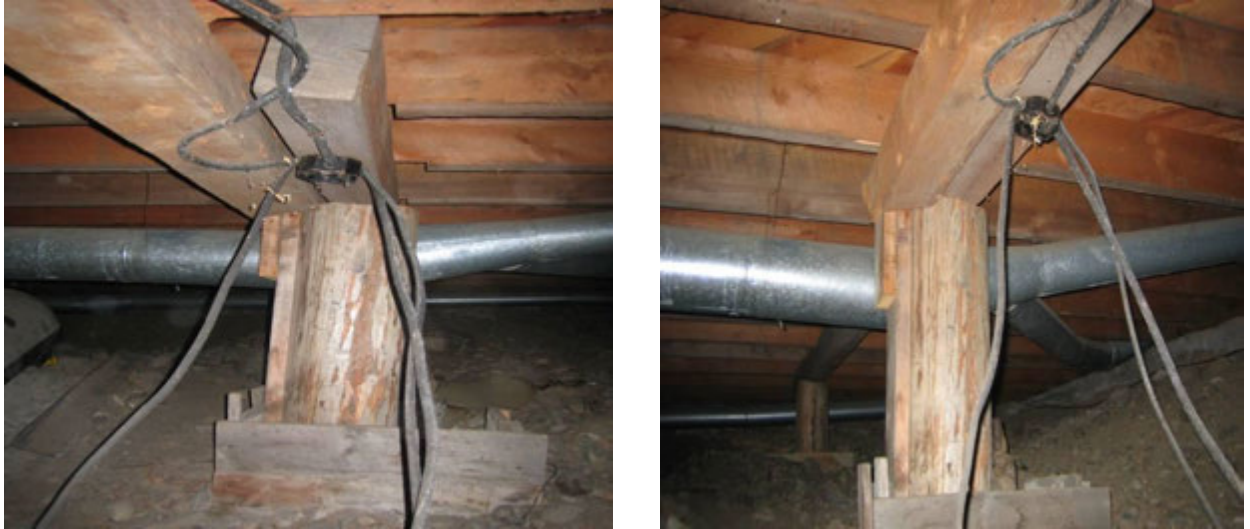
Figure 27 Improperly bearing beam

The original structure sits on a perimeter concrete poured foundation with pier and beam infill structure. The wood joists are 2x8s, spanning from the concrete foundation wall to 6x6 beams resting on piers (see 1st floor framing plan). Identified here is one concern in which a 6x6 beam is not full bearing on the timber pier.

Overall the foundation can be considered to be in **fair** condition, however certain areas (identified below) are **poor**.

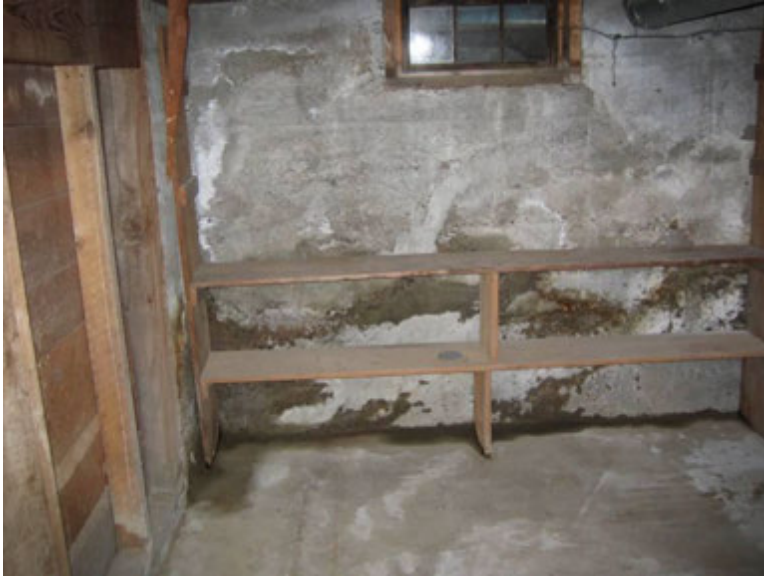
One concern in the basement and around the foundation is the evidence of damp and efflorescence on the foundation wall both in the cellar and the crawl space. There are a several reasons for this.

Figure 28 Evidence of damp

- Improve drainage
 - Grade away from structure. Typical practice requires a minimum of 2%, which is $\frac{1}{4}$ inch per foot.
 - Consider the use of a swale around the structure or the use of French drains that drain away from the structure and into a lower lying area.

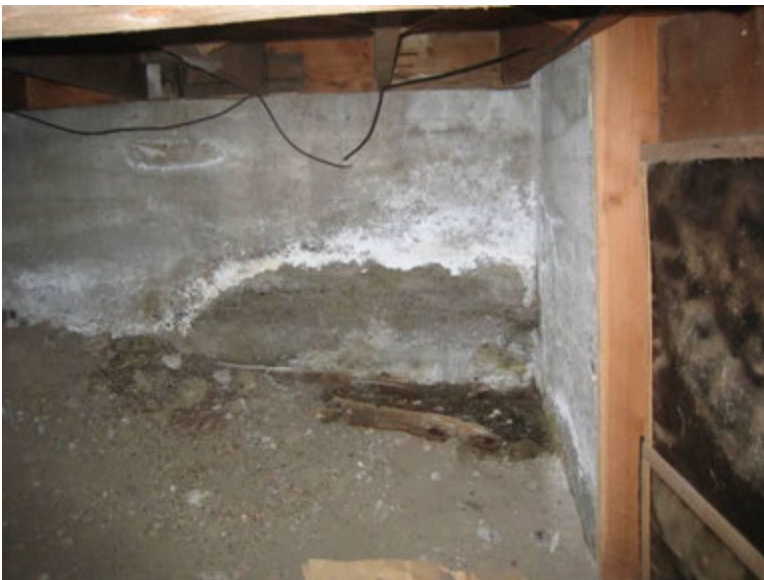
Figure 29 Evidence of Efflorescence

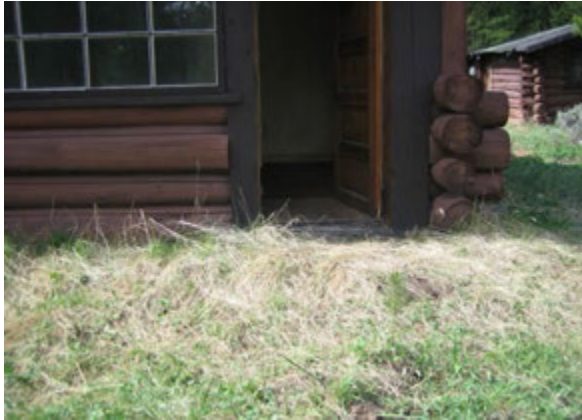
While moisture is of some concern in the basement areas, it is in those parts of the building which are without proper foundations that are the most problematic. This is particularly true in the northwest corner of the building under bedroom #3 and the adjacent bedroom #2 addition. Bedroom #3 may have originally been an enclosed entry porch and bedroom #2 appears to be an early addition. Neither bedrooms #2 and #3 have the same crawl space foundation

Figure 30 Negative drainage at bedroom 3 (Northwest Corner)

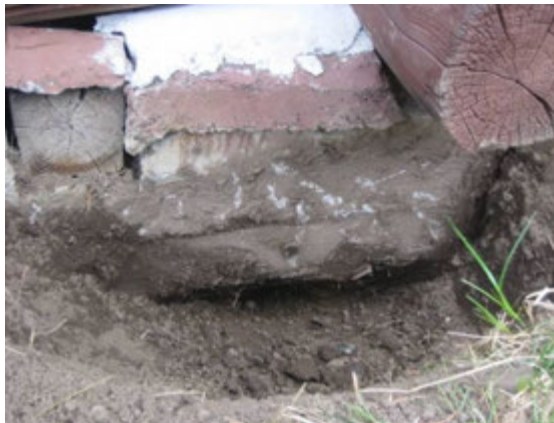
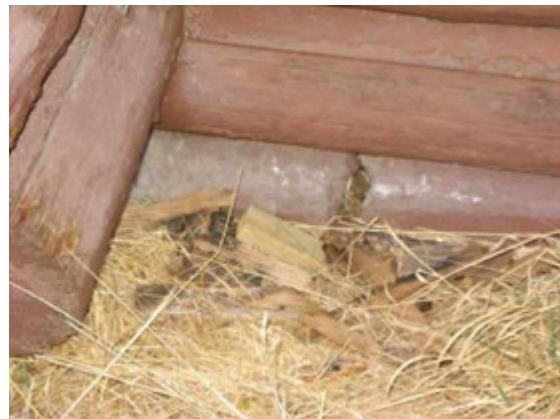
system as the original structure. There is an eighteen-inch concrete wall around the perimeter of this part of the structure supporting the log walls. The southwest corner of the concrete foundation has experienced significant freeze and thaw action causing the foundation to crack and settle in this corner. One can see the settling of the structure and roof system here as well. This part of the foundation is in **poor** condition. Corrective measure should be taken:

Figure 31 Bedroom 2 foundation freeze and thaw action and cracks

- Underpin the foundation extending it to a depth below frost line to prevent further freeze and thaw action.

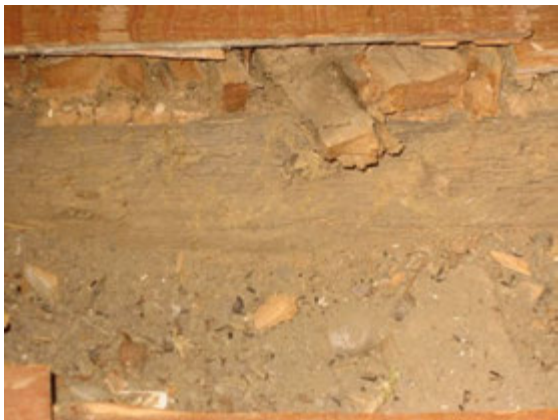
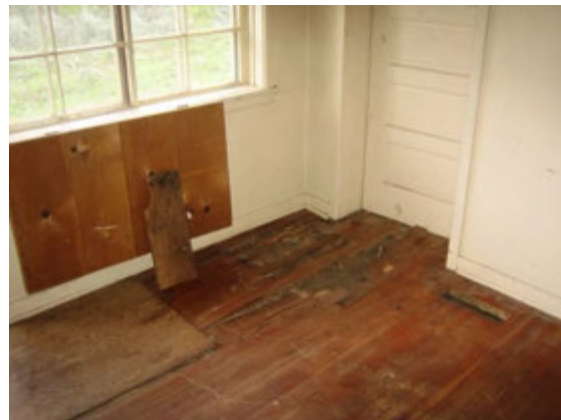
The drainage problems cited above have also caused rot in the sill logs of the structure in a few areas. The principal area of concern is the west bedrooms, #2 and #3 (northwest corner). The floor system here is comprised of log sleepers that sit on the ground with the sub floor nailed perpendicular to the logs. The floor covering is then nailed parallel to the log sleepers. On the exterior north side there is a small earthen berm that naturally over time has developed and is not allowing water and snow to drain away from the structure but is actually draining water under the sill log and into the floor system of the bedroom. Due to this there is significant rot in the log sleepers of this floor system. The sill log of the north exterior log is also deteriorated to the point of needing replacement. Again here the drainage needs corrected to allow water to drain away from the foundation and structure.

Figure 32 Rotting log sleepers and sub floor in Bedroom #3

- Create a crawl space foundation with the floor joists elevated off the dirt.
- The crawl space should then be properly ventilated to allow any moisture that does get under the floor system to dry out.

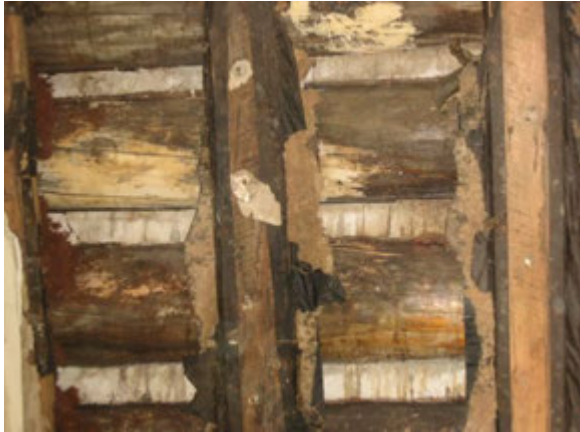
The upper three logs on the west wall of bedroom #3 have sustained considerable rot. There is evidence from a roof leak that has been corrected but

Figure 34 Bedroom #3 west wall – resistance drilling sample locations #2-6

the rot has deteriorated the logs to the point requiring replacement. Ron Anthony of Anthony and Associates completed several resistance drillings of the top three logs on the west elevation and determined that more than 50% of these logs were rotted with void inside. Maybe the most critical area here is the significant rot in the saddle notches as well. These logs should be replaced in kind. Ron Anthony has identified these logs as lodgepole pine.

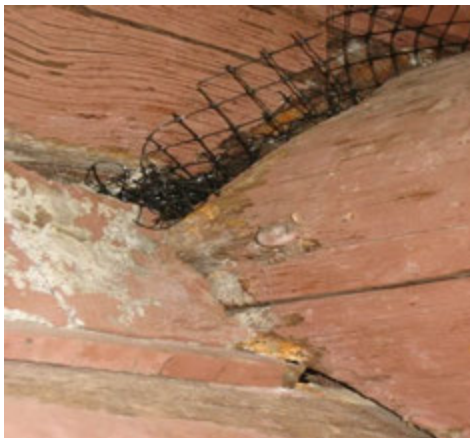
The log wall-separating bedroom two and three has experienced significant rot on the top three logs as well from a previous roof leak. The main area of concern here are the saddle notches. Ron Anthony again did resistance

Figure 35 Bedroom 3 saddle notch rot – Resistance drilling #15

drilling on the top three logs in both the saddle notch and the logs extending east inside the building. Resistance drilling number seven indicates a mostly void area in the log inside the building and drilling number fifteen indicates the third log from the top is mostly voids but the log immediately under (fourth from the top) resistance drilling number fourteen indicates only a 1/2" void.

- These logs need to be replaced.

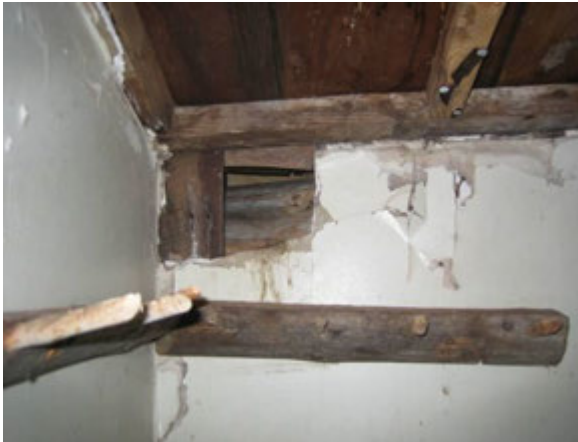
On another note we observed the ceiling in this room has been dropped and originally the ceiling was vaulted with exposed purlins. The walls as well have been furred out with sheetrock covering the walls and dropped ceiling.

Figure 36 Log walls furred and sheetrock covering

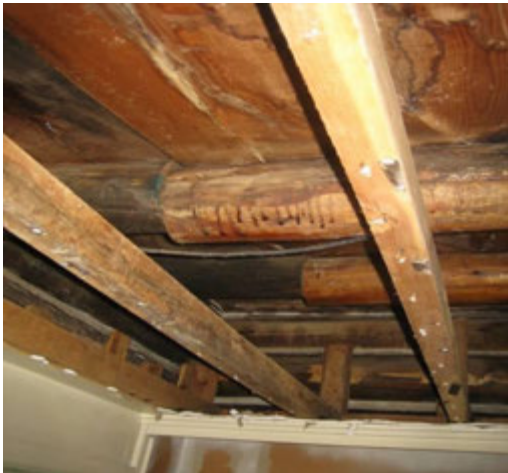
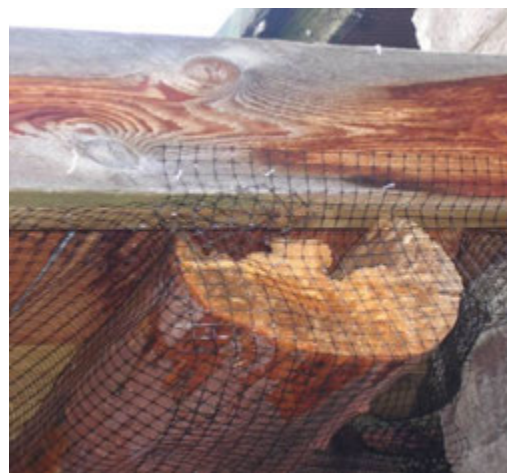
Figure 37

The second area of concern in this roof system is again with the purlins. The bearing point on the outside south wall has

Bedroom #2-purlin butt connection Bedroom #2 purlin rot – Resistance Drill #1

significant rot. Ron Anthony identified a 50% void in the bearing point with the use of resistance drilling here as well. On the outside of these purlins we can see where the overhang has been cut back due to rot on the ends of the purlin at a previous date.

- Replacement of these purlins is critical to maintain the integrity of the roof system.

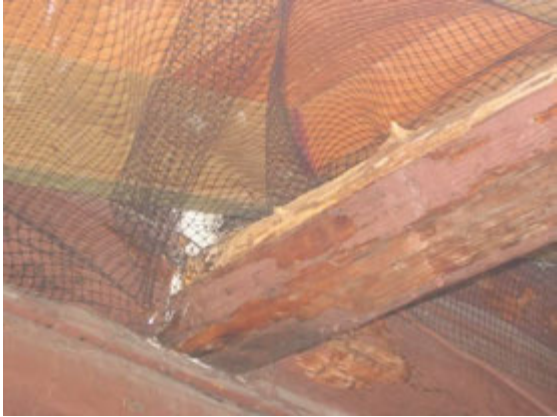
Figure 38 Bedroom #2 purlin rot at bearing point

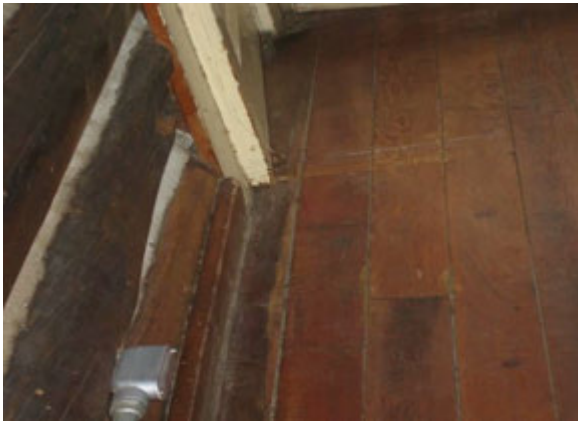
Wood elements associated with **bedroom #1** are in **good** condition. The only concern here is the west wall has either subsided or the floor structure has heaved. It is roughly one inch out of plumb. This is causing the door between Bedrooms #1 and #3 to not open. Further investigation is required to determine the ultimate cause.

Figure 39 Bedroom #1 floor heaving

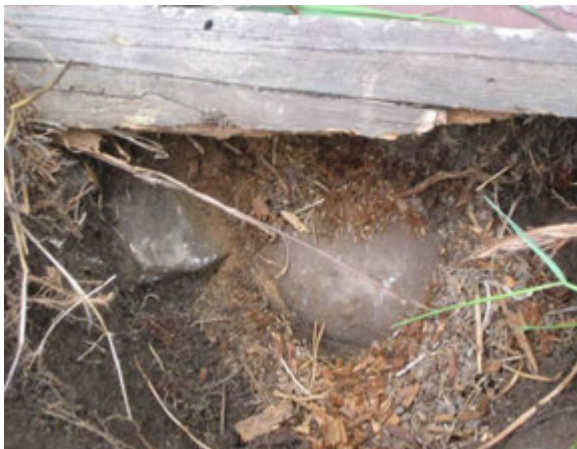
Figure 40

most point of the building. The spandrel logs bear on the sill log only. The foundation seems to be in stable condition although it is recommended to provide a foundation below frost depth at this area. Because of overgrowth of vegetation and poor drainage the sill log has deteriorated to the point of needing complete

The **east porch** is in **fair** condition.

East porch dry-stacked rock foundation,
Deteriorated sill log

- Drainage in this area needs to be corrected as well to fix any current and future rot and water intrusion problems.
- The floor system here seems to match bedrooms two and three with wood sleepers in direct contact with dirt with a sub floor over it. Again this should be corrected to ensure a long lasting rot free floor system.

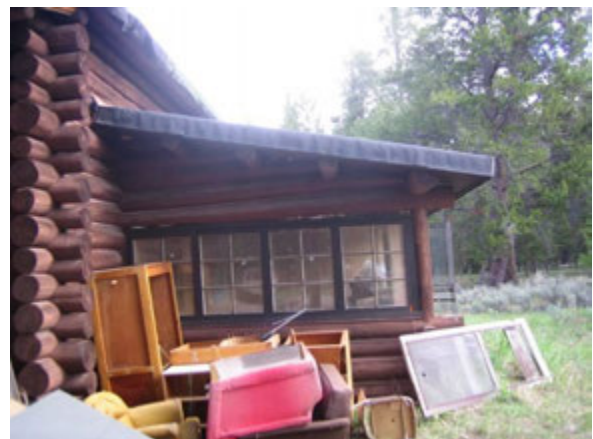
Furniture impeding proper drainage

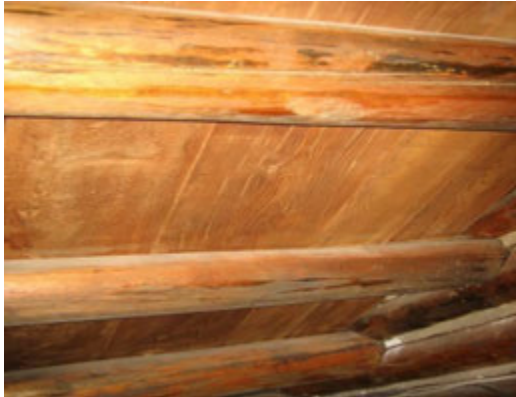
Figure 41

the office. The ceiling appears to have been dropped and walls furred and sheet rocked as well.

Original vaulted ceiling above office

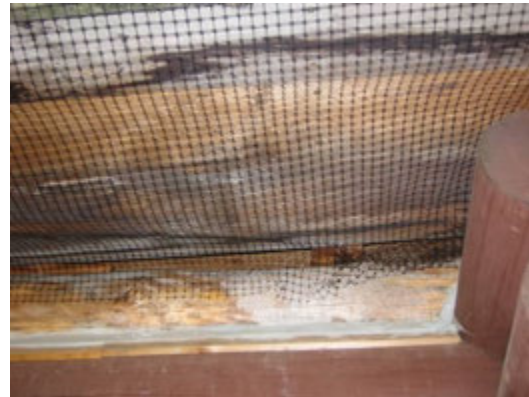
The floor system as well as the log walls are in **good** condition. However, we have observed a replacement log has been installed on the south elevation, eastern most upper log. The log is not of matching quality and it is recommended to be replaced with a log of equal quality, looks, and species. We did observe that the **office** addition seems to have originally had a vaulted ceiling with exposed purlins, as does the rest of the structure. It currently has a dropped ceiling with vermiculite insulation in the attic space. The utility addition lies between the kitchen and office addition and is under the same roof structure as

Replacement log at office

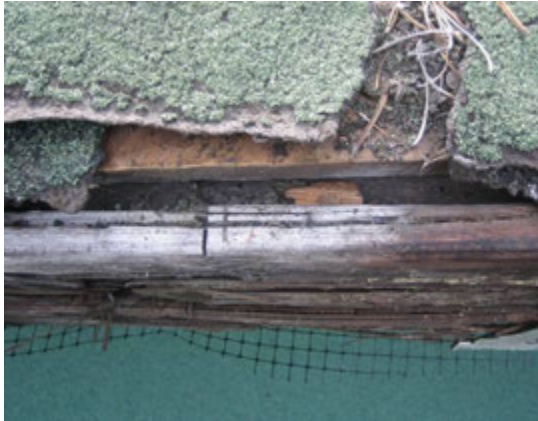
Some recent work has been done to the roof on bedrooms #2 and #3 and the kitchen, utility, and office additions. The roofing material in this area is a standard rolled roofing material and is in **fair** condition. The flashing in these areas seems to be in stable condition. The area of immediate concern here is that another fascia board has been nailed on over the rolled roofing helping hold the rolled roofing over the fascia. While it helps hold the roofing over the fascia it is causing rot on this fascia as well as not allowing the water to drip off the roof as intended.

Figure 43
Fascia rotting and roofing not covering

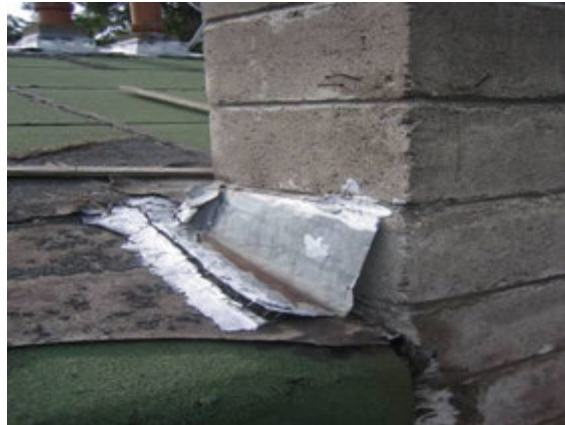
This part of the structure has four layers of roofing materials and they are in **poor** condition. The major point of deterioration here is the flashing around roof penetrations and especially the fireplace.

Flashing deteriorating at cinder block flue

- All layers of roofing should be removed and the roof decking and 2x4 rafters inspected for rot and replaced as needed. Each penetration shall then be flashed properly including the fireplace. This will ensure no water leaking into the structure.

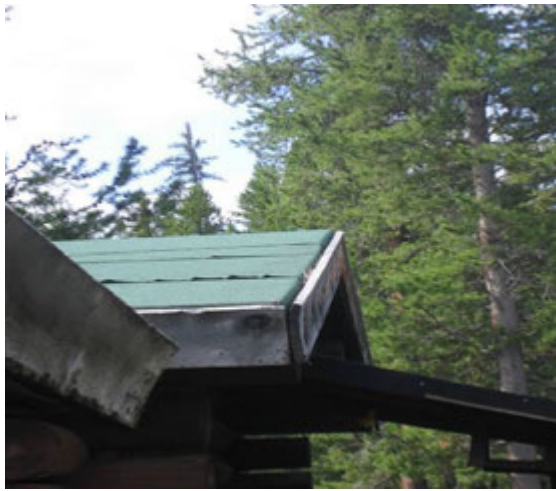
Figure 44
Rolled roofing w/ fascia covering flue

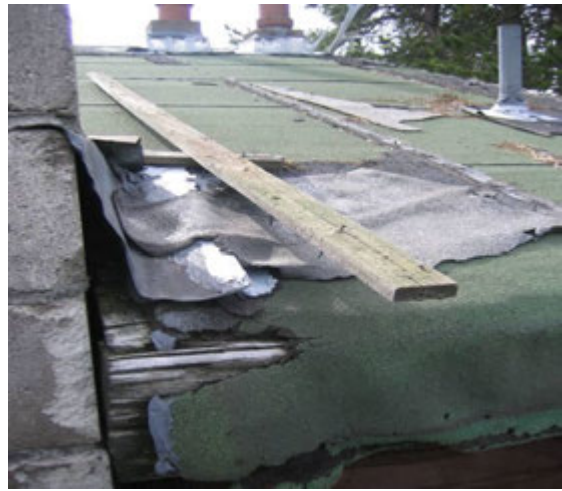
Flashing deteriorating at cinder block

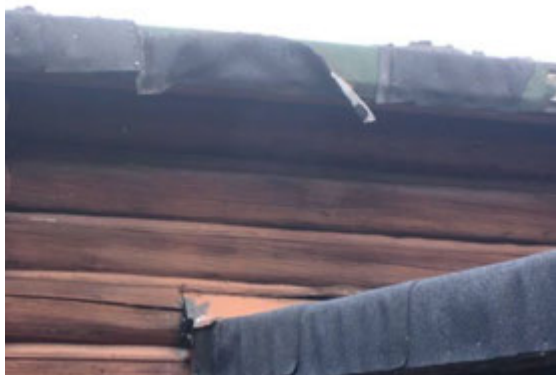
Figure 45
Rolled roofing covering fascia

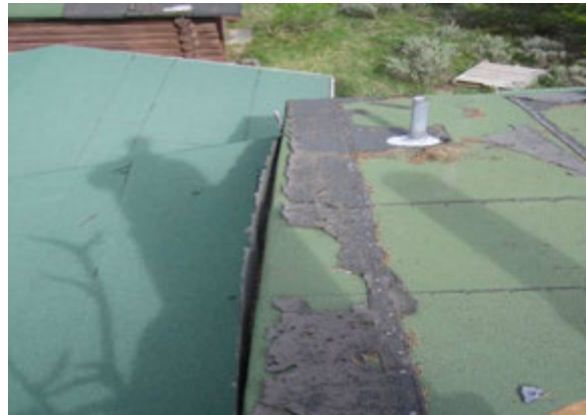
Layers of rolled roofing deteriorating

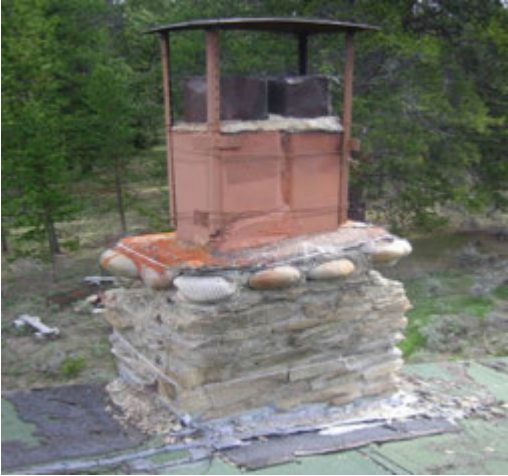
Figure 46
Flashing deterioration at fireplace

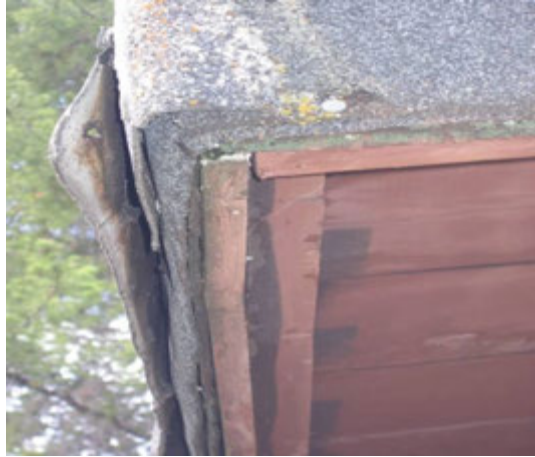
Rolled roofing covering fascia

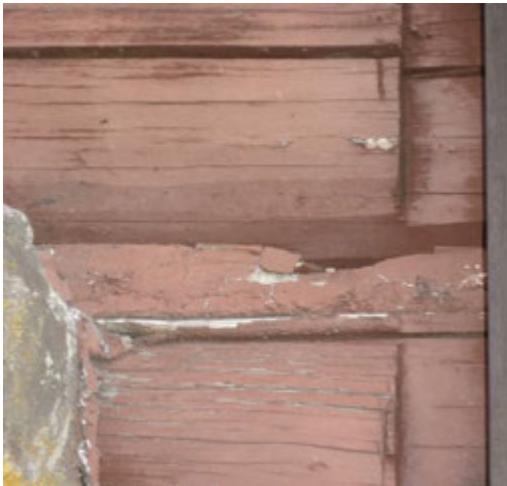
The next main area that needs to be addressed is the daubing of the exterior logs. The original material was a masonry type material with a willow stop. Much of the daubing is deteriorating. Hence, it is considered in **poor** condition. Daubing is often considered a mid-range maintenance issue.

Figure 48
Daubing Deterioration

- Loose daubing should be identified throughout the entire structure,
- removed, and those areas re-daubed.

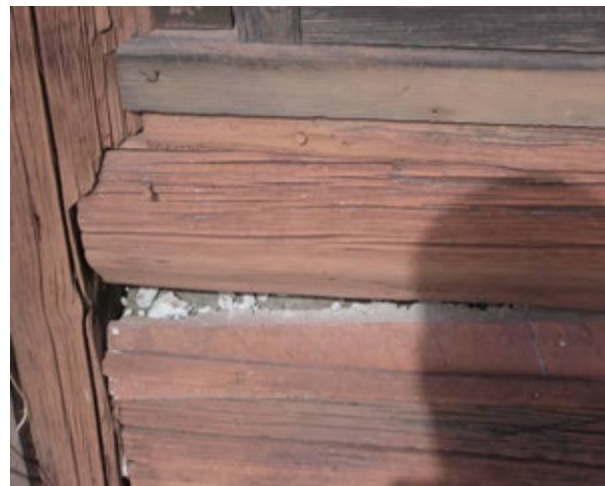
Daubing Deterioration 2

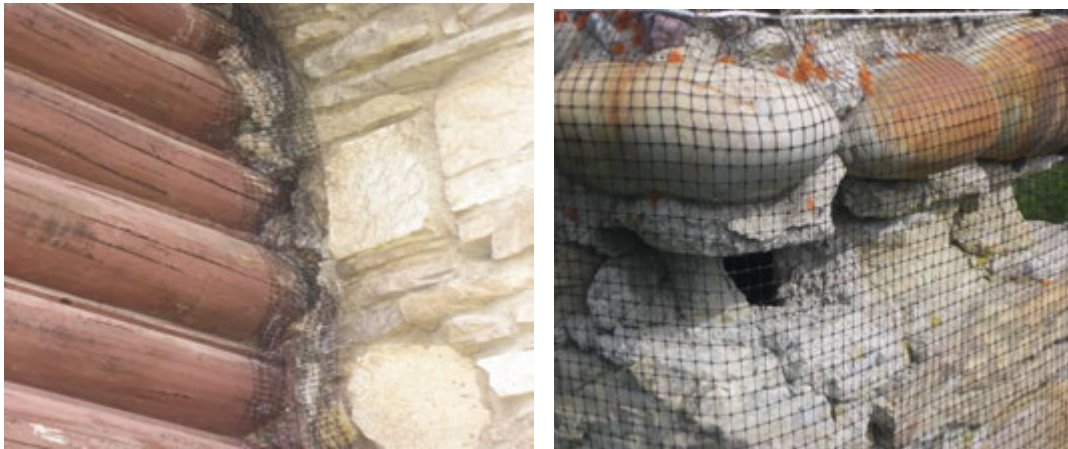
Figure 49

Another feature of note is the fireplace. It appears as though the foundation under the fireplace is settling on the north edge of the foundation, thus causing the fireplace to pull away from the log structure. There are large identifiable gaps between the masonry and log structure, which will also lead to

water infiltration. This feature is in **fair** condition, as it is in need of attention, but is not damaged to an extreme.

Fireplace pulling away from log structure Fireplace mortar deterioration

- The foundation of the fireplace should be stabilized and the gaps filled with an appropriate product. The fireplace is also seeing deterioration in the mortar at the top. There are noticeable amounts of mortar falling out.
- Repointing is recommended.

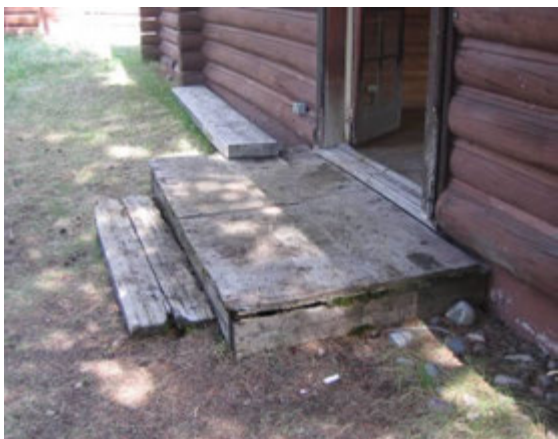
Figure 50

South porch deterioration

- The entire exterior needs to be refinished to help seal the logs and wood against further deterioration.

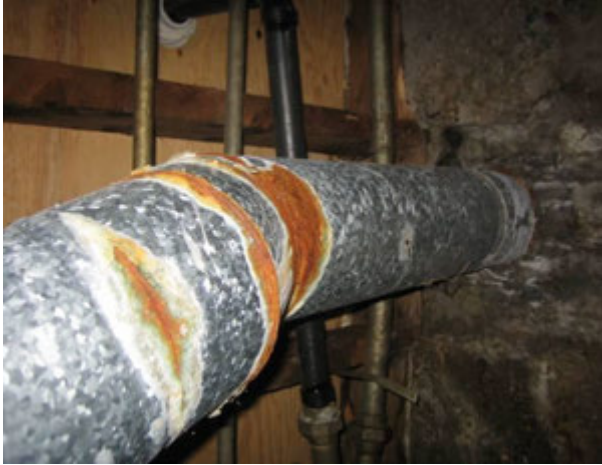
Figure 51
HVAC duct rusting

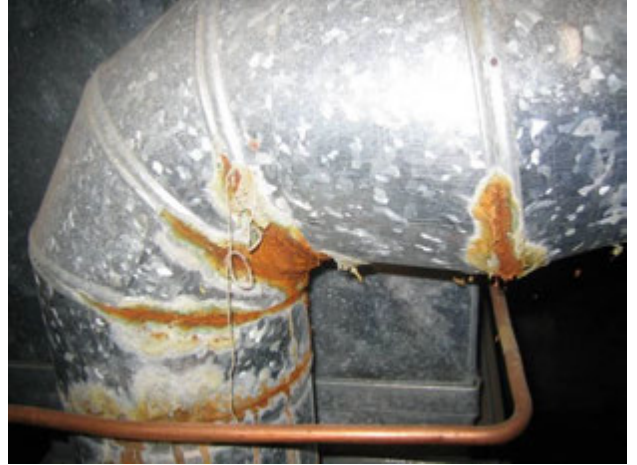
HVAC duct rusting 2

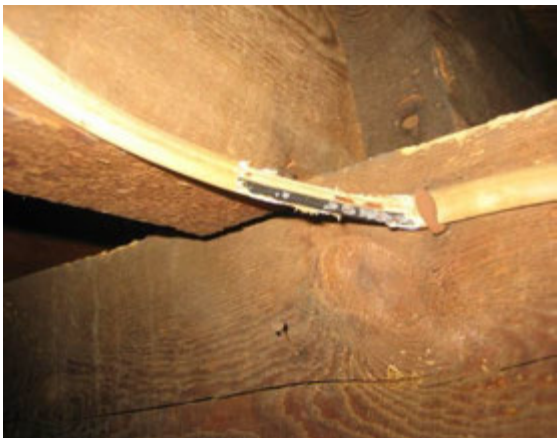
Figure 56
Bare wiring chewed by rodents
