## Hilina Pali 2005

The Civilian Conservation Corps  
An Archeological Inventory Survey of the Hilina Pali  
Erosion Control Project of 1940

Pacific Island Network  
National Park Service  
U.S. Department of the Interior

Publications in Anthropology 12  
2008

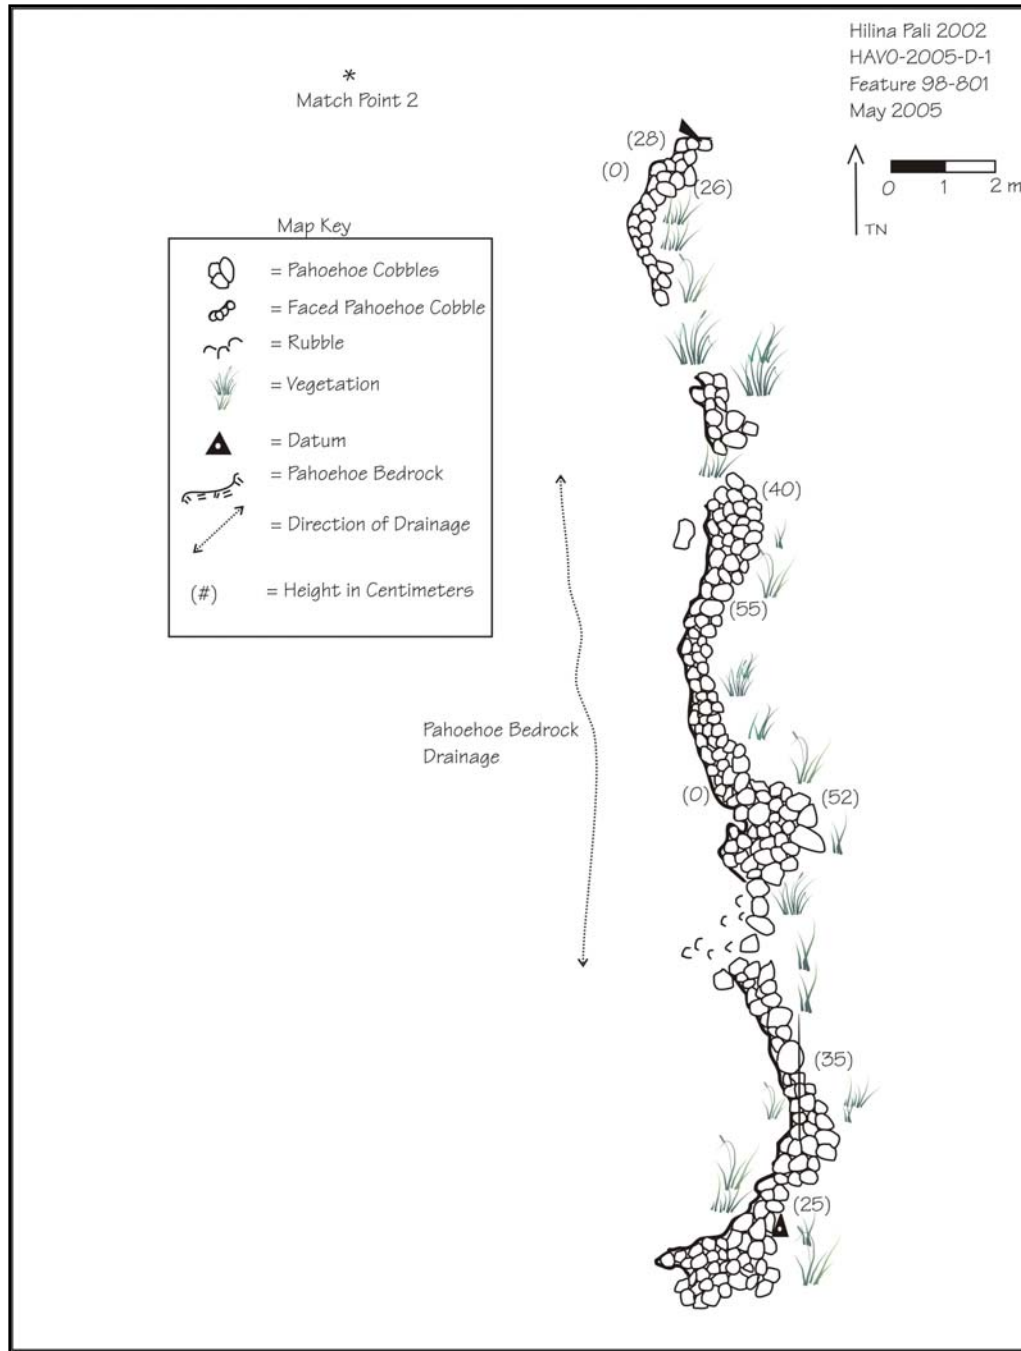
**Figure 27. Feature HAVO-2005-D-1, Rock Wall**

period. The technique applied: some areas are of well fitted stones where a flat surface meets flat surface and jagged surfaces interlocks with facing stones jagged surface. The wall exhibits areas of disturbance where the wall height is shorter and rubble is adjacent or downslope to the west or southwest. The sandy sediments have built up on the northeast or east side and the vegetation is growing over the wall. A bullet artifact was found that has the dimension 5.2 cm X 1.3 cm in diameter. The vegetation includes grasses, *pūkiawe*, *a'ali'i*, ferns, and partridge pea. The impacts on the feature include vegetation, weathering, erosion, deposition of sediment, and wind. The feature is in good condition.

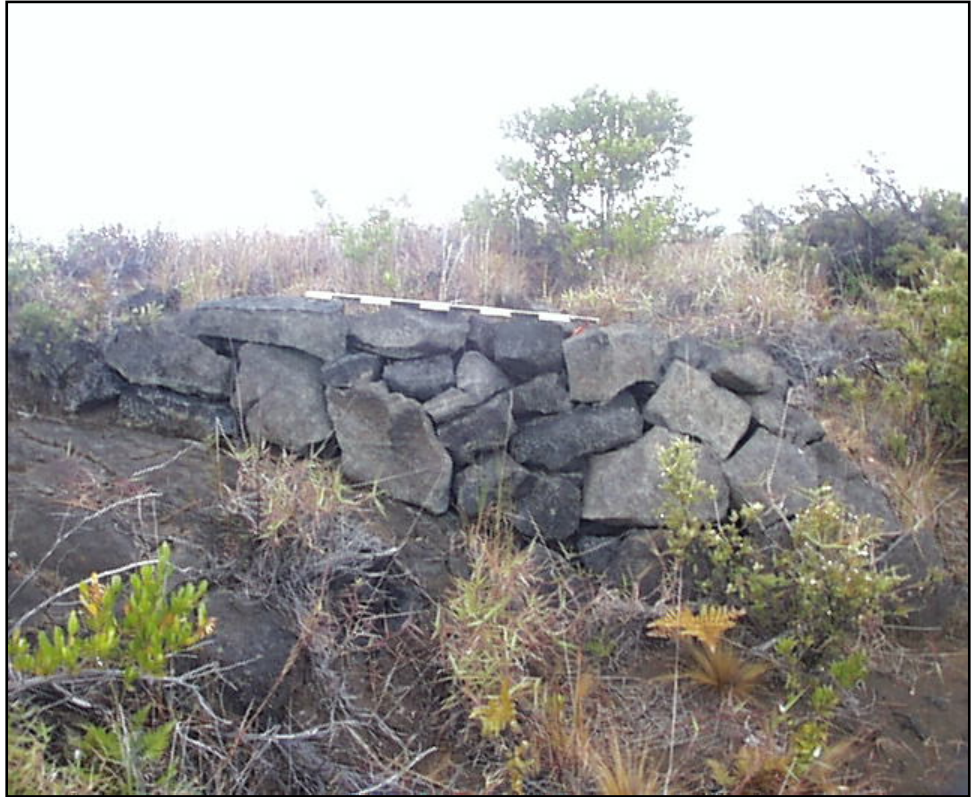
**Figure 28. HAVO-D-2005-5, Rock Wall**

**HAVO-2005-D-5** (Feature 98-805) is a 3.5 m x 1 m x 97 cm high wall. It is constructed with basalt slabs stacked to a height of 2 to 4 rocks high. It is located on a moderate slope in the west direction abutting a pāhoehoe outcrop on the northeast side and embedded in a matrix of ashy soil. The wall utilizes the outcrop height. The slabs are lying flat in places and upright in others. 98-805b is a 15 m x 80 cm x 55 cm high wall. It is constructed of tabular pāhoehoe cobbles and boulders. The top has flat lying rocks with some base stones upright. The southeast edge has sediment build up. The impacts are seismic activity and weathering. The

vegetation is sparse to moderate with *a'ali'i*, ferns, molasses grass, and *pūkiawe*. This feature is in excellent to good condition.

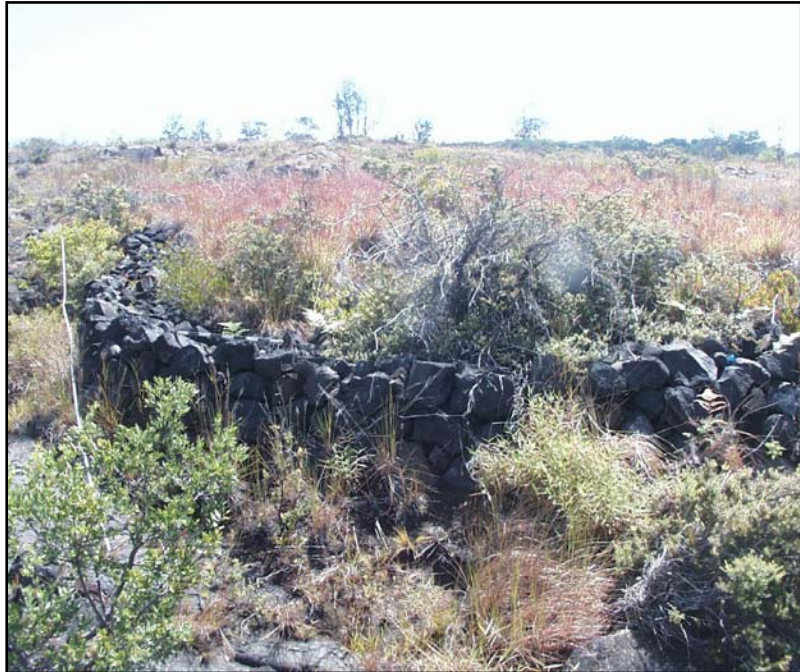
**Figure 29. HAVO-2005-D-11 Rock Wall**  
Photo Courtesy of the National Park Service

**HAVO-2005-D-11** (Feature 98-812 a, b) is a 16.8 m x 1.25 m x 1.04 m high C-shaped wall. The wall opens to the northeast. It is constructed with slabs along the base placed upright. The stacking occurs to the height of 3 to 4 rocks high. The vegetation is dense. 98-812b is a 6.4 m x 1 m x 67 cm high wall. It is constructed with upright and flat lying slabs. The stacking is from 2 to 4 rocks high. The vegetation is dense. Types of impacts are weathering, seismic activity, and vegetation. The vegetation includes *a'ali'i*, bracken fern, grasses, and *pūkiawe*. The feature is in good condition.

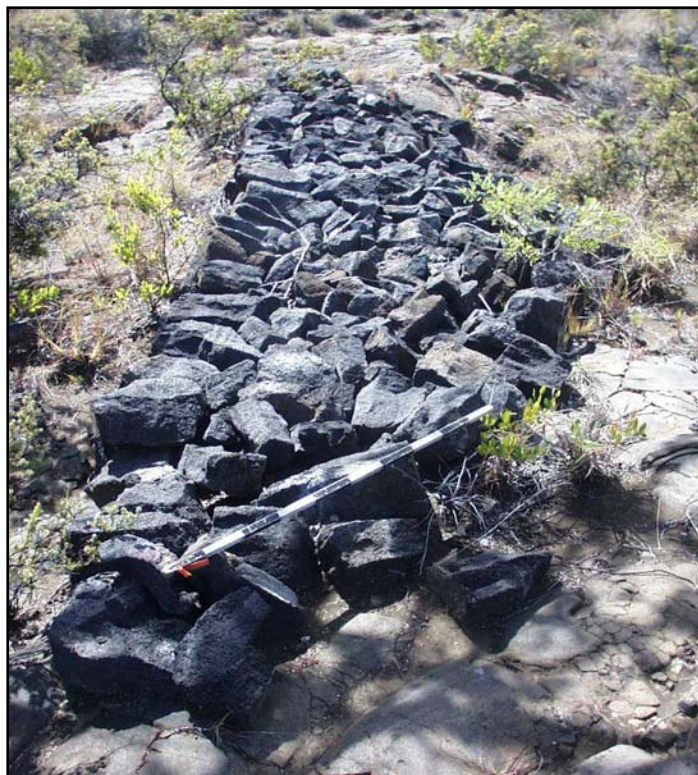
**Figure 31. HAVO-2005-D-15, Retaining Wall**

include vegetation, weathering, and soil accumulation. The feature is in good condition.

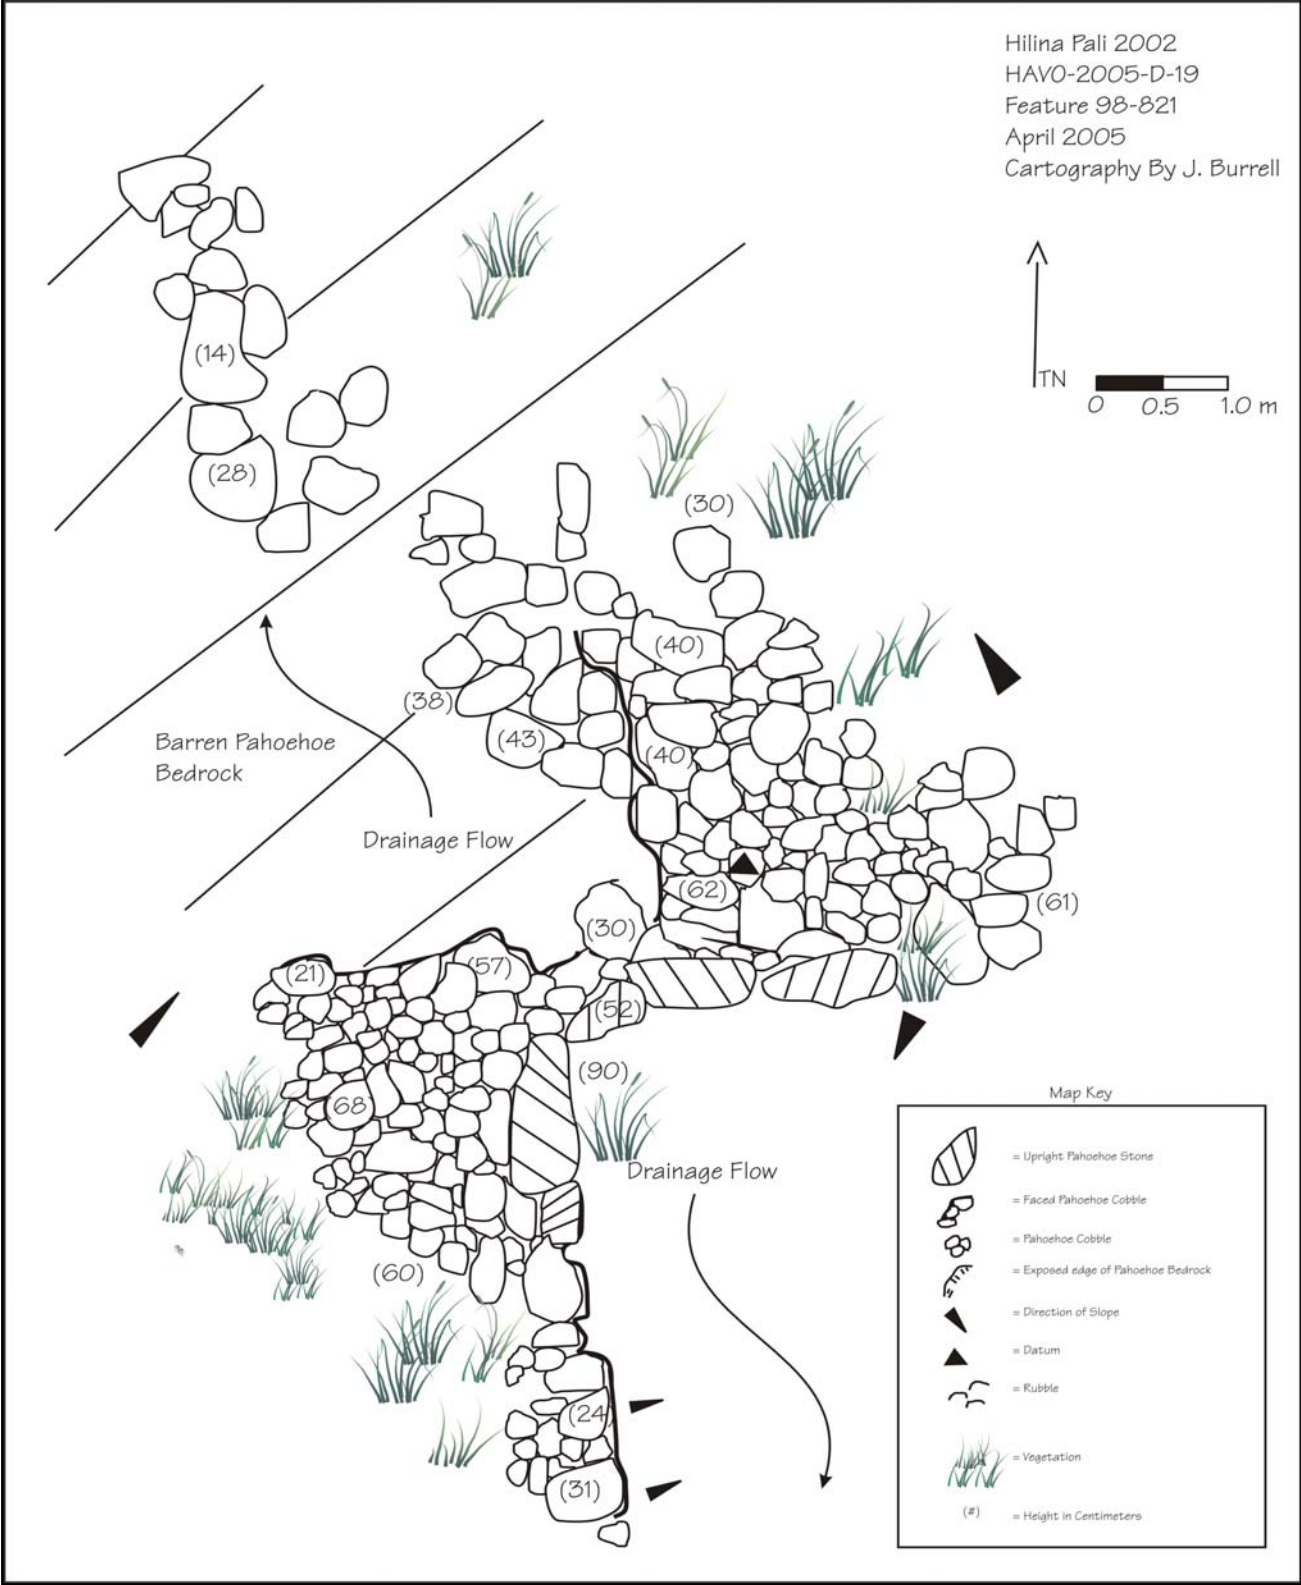
**Figure 34. Feature HAVO-2005-D-19, Dam**

**HAVO-2005-D-19** (Feature 98-821) is a 8.5 m x 7 m x 77 cm high wall. It is constructed across the width of a drainage with boulders on the exterior and cobbles on the interior stacked to a height of 1 to 3 rocks high. The impacts include weathering and vegetation. The vegetation consists of *pūkiawe*, *a'ali'i*, grasses, bracken fern, and 'ākia. This feature is in good condition.
