Hilina Pali 2002  
HAVO-2005-D-33  
Feature 98-838, wall  
April 2005  
Cartography By J. Burrell

Hilina Pali 2002  
 HAVO-2005-D-35  
 Feature 98-840, enclosure  
 April 2005  
 Cartography By J. Burrell

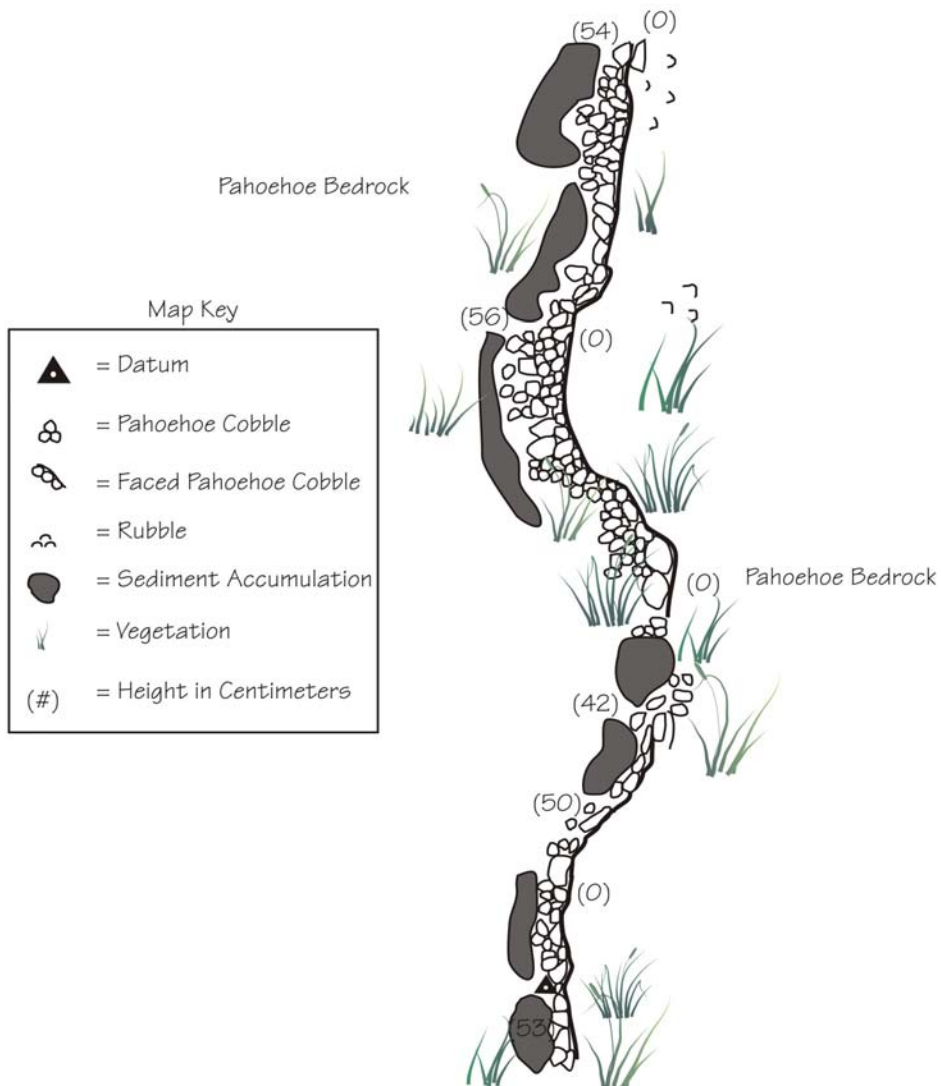
Figure 36. Feature HAVO-2005-D-33, Rock Wall

**HAVO-2005-D-33** (Feature 98-838) is a 17.1 m X 1 m X .59 m high wall constructed of stacked blocky pāhoehoe boulders built on top of pāhoehoe bedrock. The feature is along a NW/SE axis. The feature is not strictly linear or curvy, and wraps along the west side of a N/S running drainage. The east facing is constructed from large blocky pāhoehoe boulders that are stacked 2-4 rocks high to create a wall of uniform height. The feature surface consists of piled blocky pāhoehoe boulders creating an uneven choppy surface. The west side of the feature is not visible due to the vegetation and soil that has accumulated to the height of the wall. The vegetation of the area consists of *pūkiawe*, *a'ali'i*, ferns, grasses and the feature has been impacted by seismic, vegetation, weathering, and soil accumulation.

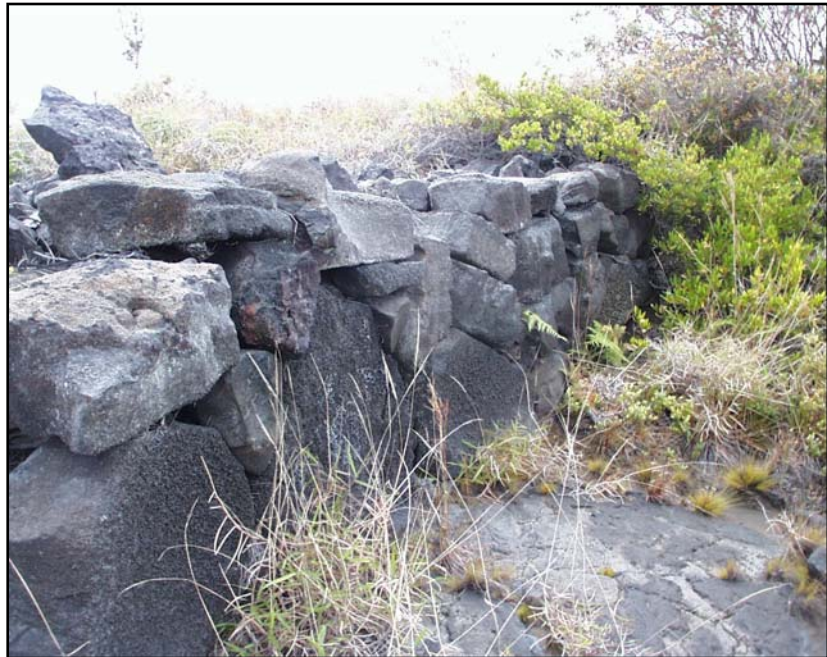
**Figure 37. HAVO-2005-D-43 Rock Wall**

**HAVO-2005-D-43** (Feature 98-855) is a 6.7 m X 3.1 m X 1.1 m high wall constructed of large pāhoehoe

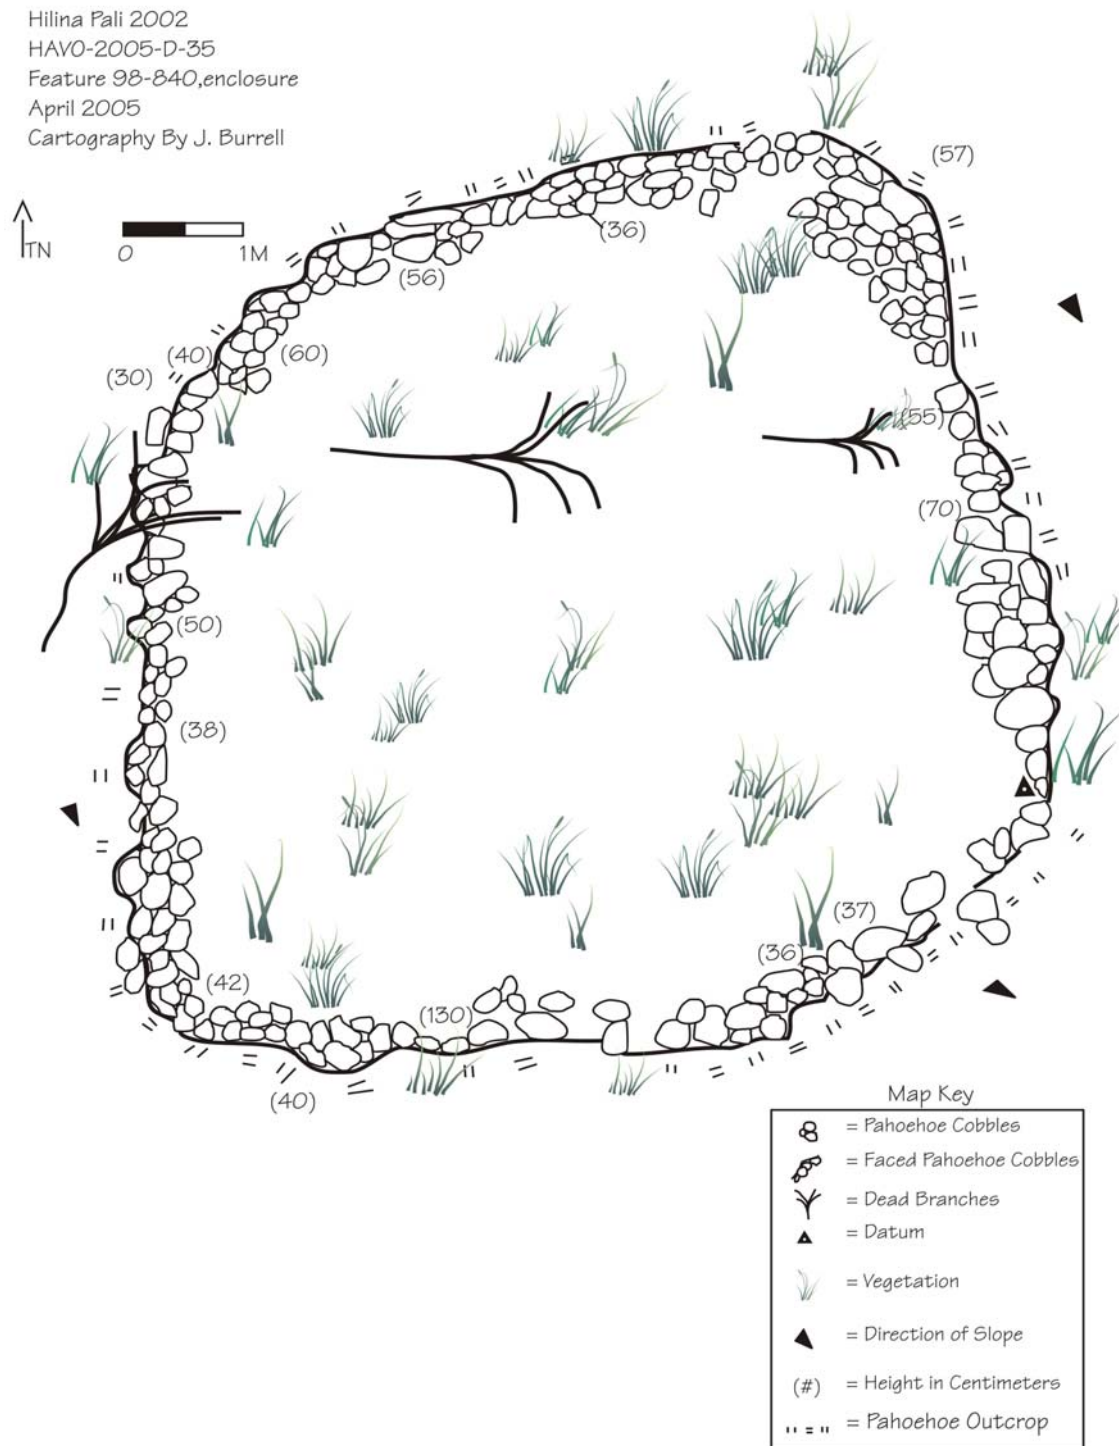
Figure 38. Feature HAVO-2005-D-35, Enclosure

**HAVO-2005-D-35** (Feature 98-840) is a 8 m X 7.5 m X 70 cm high enclosure constructed of porous basalt slabs located in the medial portion of drainage exterior. The feature is surrounded by a pāhoehoe outcrop and the interior is an ashy soil matrix. The feature is built around this natural contour and the slabs are laid upright along the exterior for height with the top having

both upright and flat lying slabs. The exterior and the interior portions are filled with mainly grasses with a few small shrubs, a few medium shrubs, and a couple of large trees. The wall to the south is lower with the drainage wall at a higher elevation. The stacking height is one to two rocks high and the vegetation consists of *a'ali'i*, grasses, and *pūkiawe*. The impacts on the site include weathering, seismic, and vegetation and it is in fair condition.

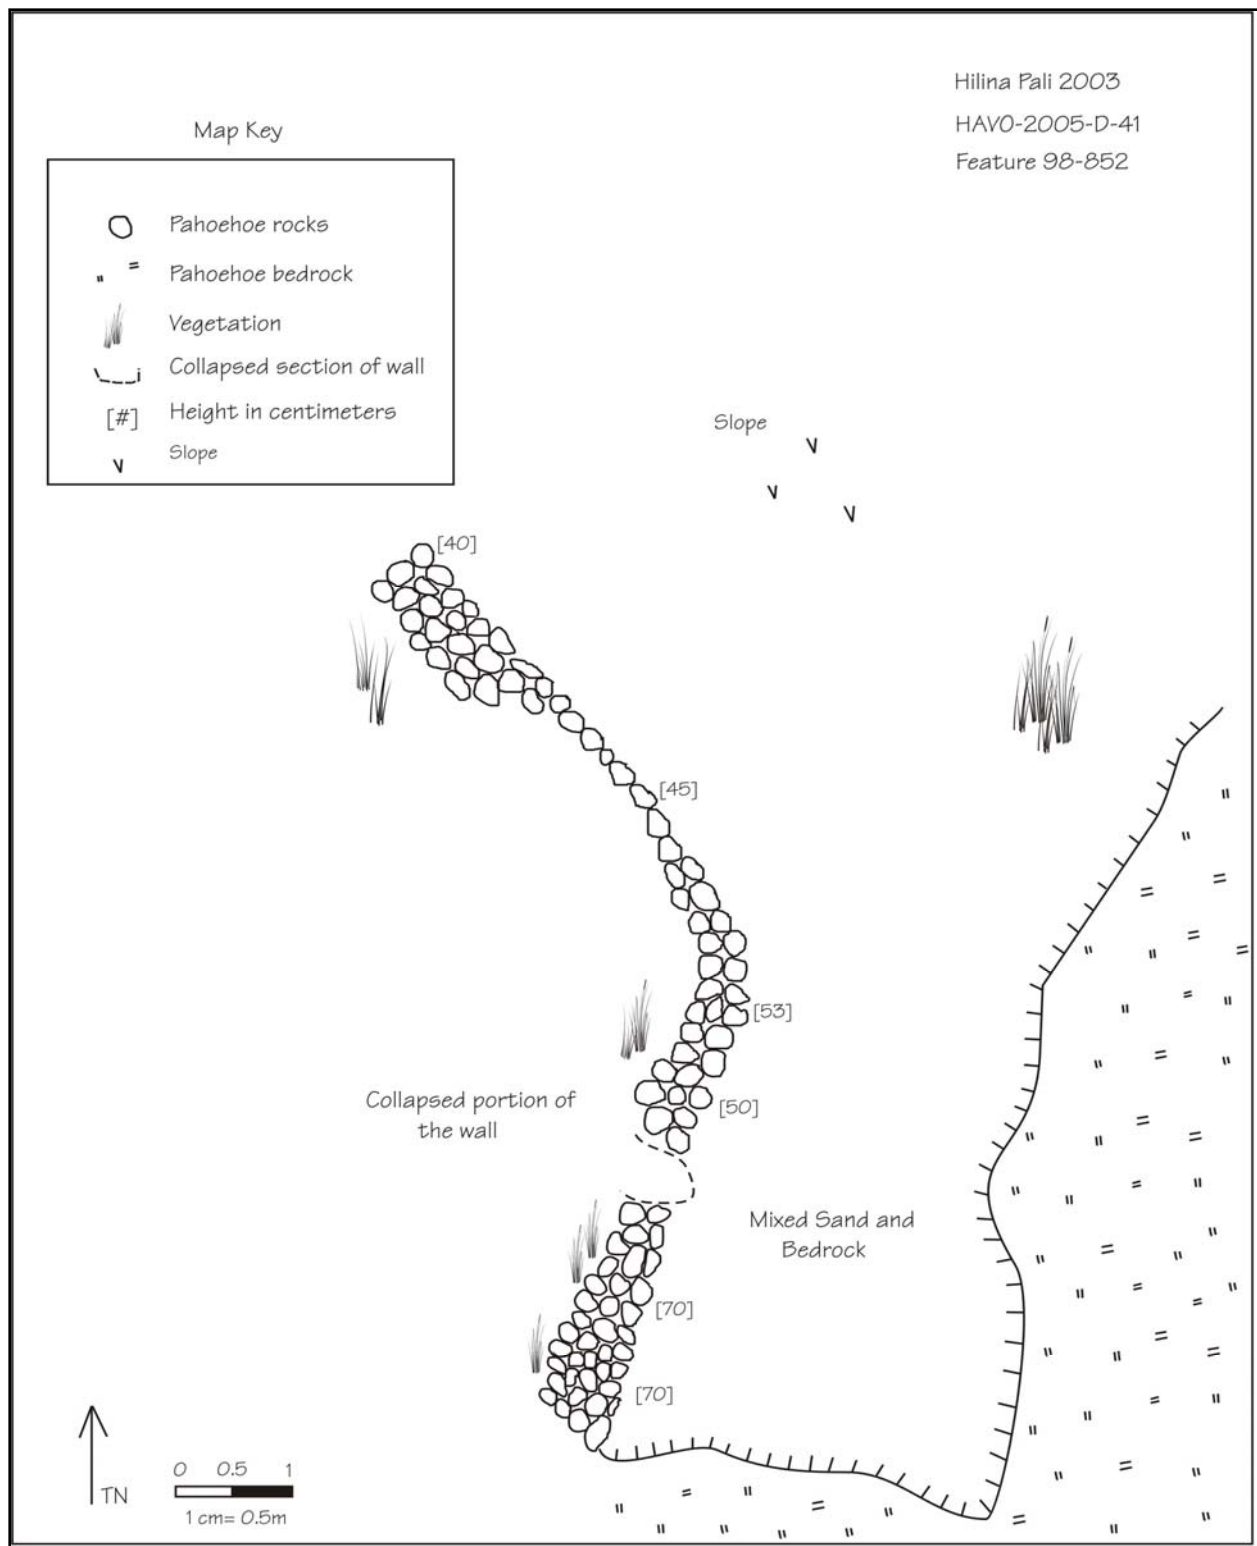
**Figure 39. Feature HAVO-2005-D-41, Rock Wall**

**HAVO-2005-D-41** (Feature 98-852) is a 15 m X 1 m X .8 m high wall constructed of pāhoehoe cobbles and boulders and dry stacked two to four courses high. The wall begins along the south side of a small tumulus and trends northeast to southwest and then curves to the south-southeast. This feature is vertically faced and in excellent condition. There is a fine soil/sand deposition all along the west side of the wall, which could indicate less

water flowing through this area. The feature could potentially be impacted by flooding and vegetation and is surrounded by *a'ali'i*, *pūkiawe*, broomsedge, molasses grass, as well as other grasses. The feature is in excellent condition.

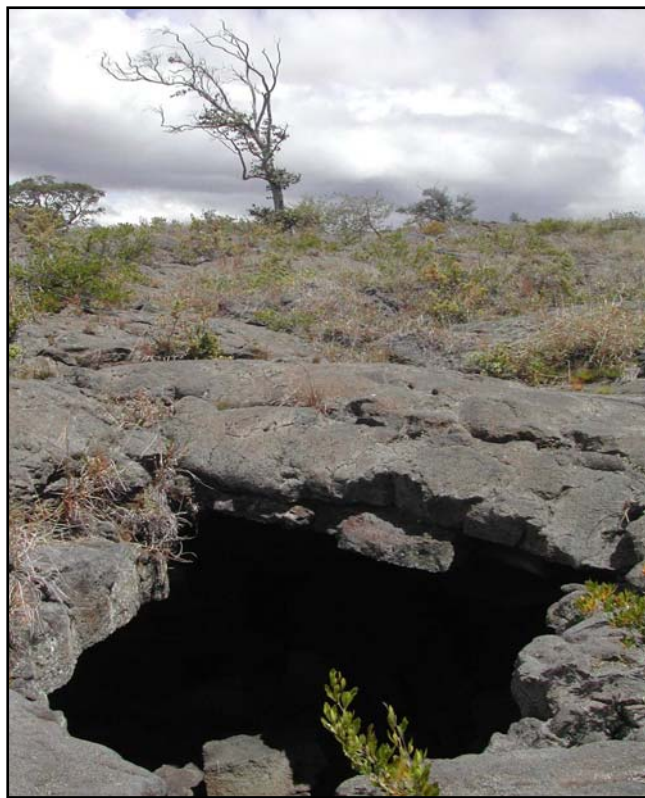
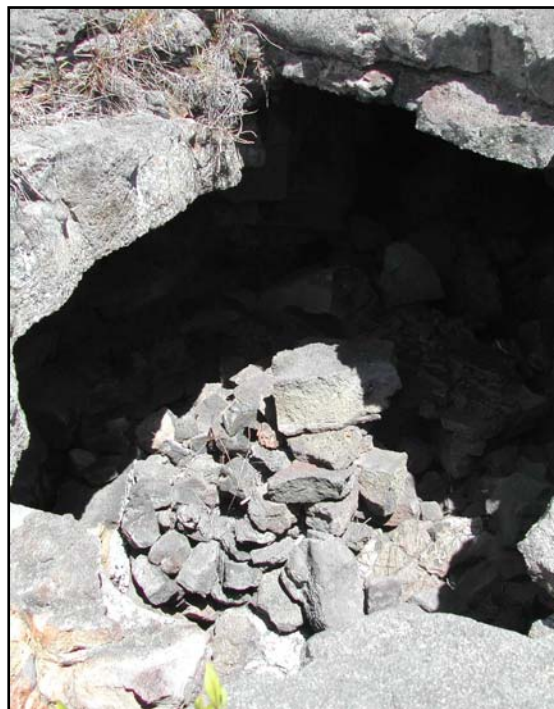
**Figure 44. HAVO-2005-D-53, Cave Entrance**

Other than the stacked rocks at the entrance the cave does not appear to have any cultural material inside. There is a large amount of soil deposited into the cave as well as mud and debris. The vegetation of the area consists of *pūkiawe* and the feature is in good condition.

**Figure 45. HAVO-2005-D-53,  
Stacked Rocks at Cave Entrance**  
Photo Courtesy of the National Park Service

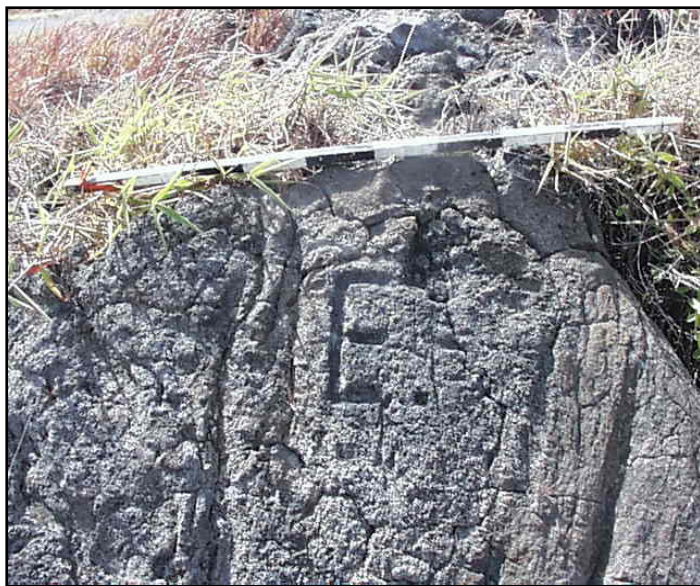
**Figure 46. HAVO-2005-D-54 Pecked  
Petroglyph**

**HAVO-2005-D-54** (Feature 98-877) is a 20 cm X 14 cm X 1-1.75 cm deep pecked petroglyph. The petroglyph was pecked into the W/NW face of a shallow tumulus. The tumulus face is weathered, cracked, and light brown in color. The pecked image looks like a letter "E" followed by a period. The petroglyph is deeply pecked with nice straight geometric lines and sharp corners. The area where the petroglyph is carved has some shallow natural cracks surrounding the feature, plus a small hole in the bedrock that is probably

natural. The petroglyph is located less than 10 m from the west of Hilina Pali Road. A shotgun shell was found at the south corner of tumulus, which is 1.2 cm in diameter.

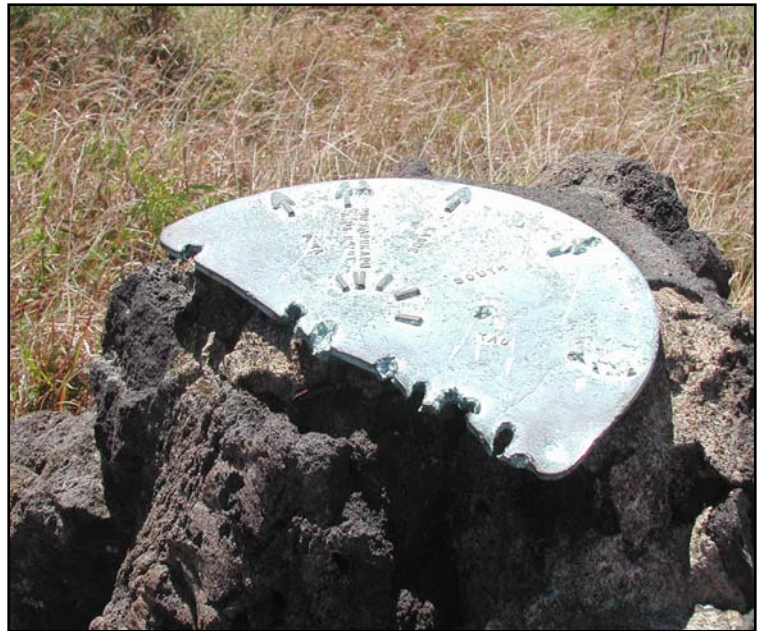
**Figure 47. HAVO-2005-D-57 Hilina Pali Pointer**

**HAVO-2005-D-57** (Feature 98-881) is a 1.2 m X 50 cm X 1.2 m in height Hilina Pali Information Pointer. This feature is made of mortared pāhoehoe boulders and some cobbles. The pointer is located off the end of Hilina Pali road approximately 50 m south of the shelter at the start of the trailheads. On the top of the information pointer there is a metal plate with arrows and names pointing towards Ka‘u, South, Kalue, Puu Pukapu, Apua Point and Puna. This feature is located on top of the pali overlooking the ocean. Seismic activity and fire are potentially impacting this feature. Vegetation surrounding this feature includes grasses, *koa*, *‘ōhi‘a* and guava. This feature is in excellent condition.

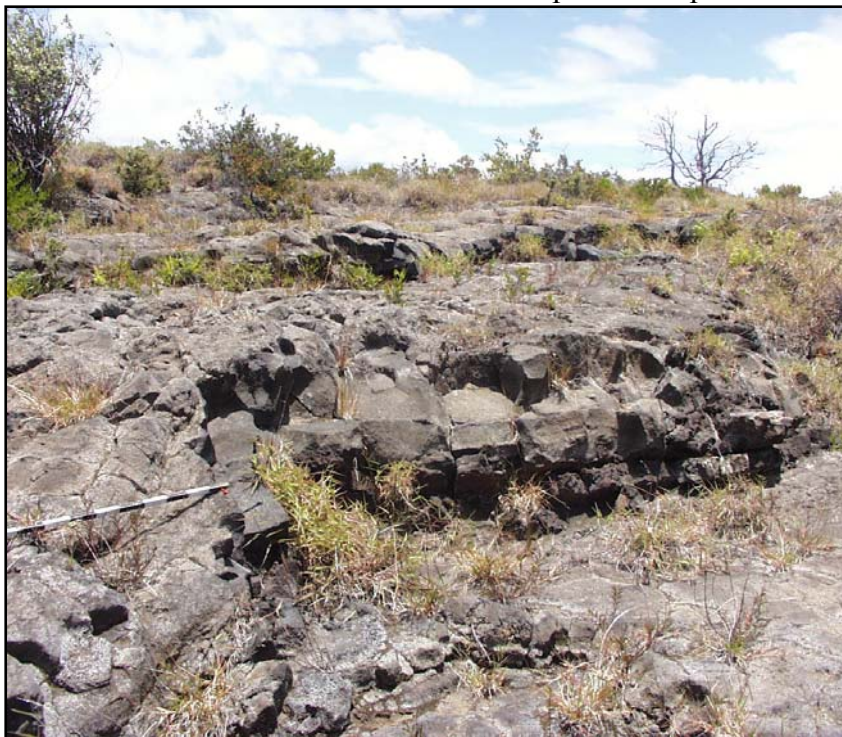
**Figure 50. Feature HAVO-2005-D-64 Rock Quarry**

**HAVO-2005-D-64** (Feature 02-13 a, b) is a 8 m x 1.02 cm deep quarried edge. The edge faces E-SE with 1 shelf (6.7 m x 1.2 cm x 37 cm deep quarried shelf). 02-13b is a 8.4 m x 3.2 m deep quarried edge with a shelf 2.1 m x 70 cm x 16 cm deep. This quarry is SW of 02-13a. 02-13c is a 10.5 m x 1.3 m deep quarried edge. Located along the east bank of the drainage. 02-13d is a 21 m quarried edge. Sub-feature is located on the west bank of the drainage . The south section measures 8 m x 68 cm deep and the north section is 10.5 m x 62 cm deep. The impacts to this feature include floodwater, weathering, and vegetation. The vegetation consists of molasses grass, *a'ali'i*, *pūkiawe*, partridge pea, other grasses, and bracken fern. This feature is in good condition.

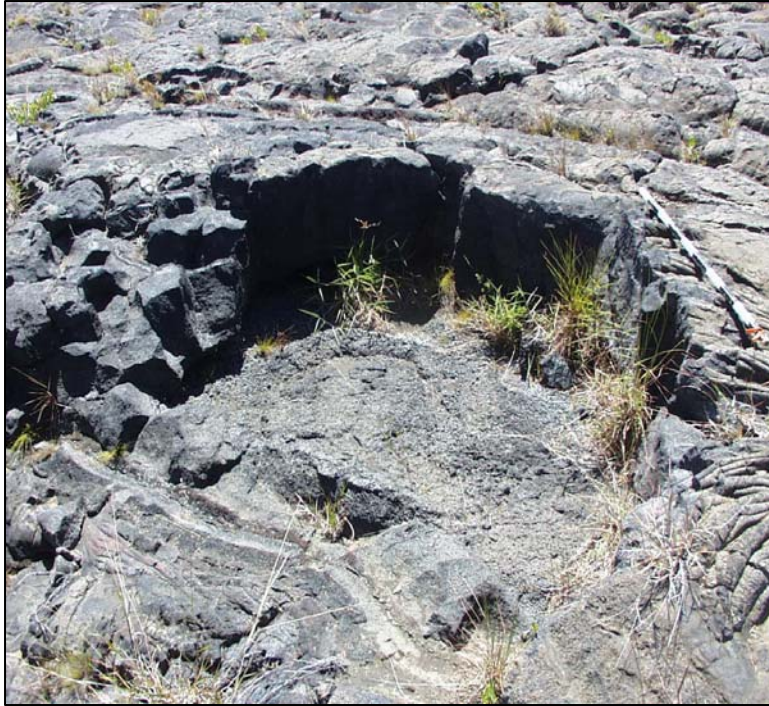
**Figure 51. HAVO-2005-D-72 Rock Quarry**

**HAVO-2005-D-72** (Feature 02-21) is a 3.1 m x 1.9 m x 81 cm deep quarry. Feature is located 3 m west of feature 98-807 within the drainage. The edge is C-shaped and the SE section is quarried into a shelf. Impacts are floodwater, weathering, and vegetation. The vegetation includes molasses grass and *pūkiawe*. This feature is in excellent condition.

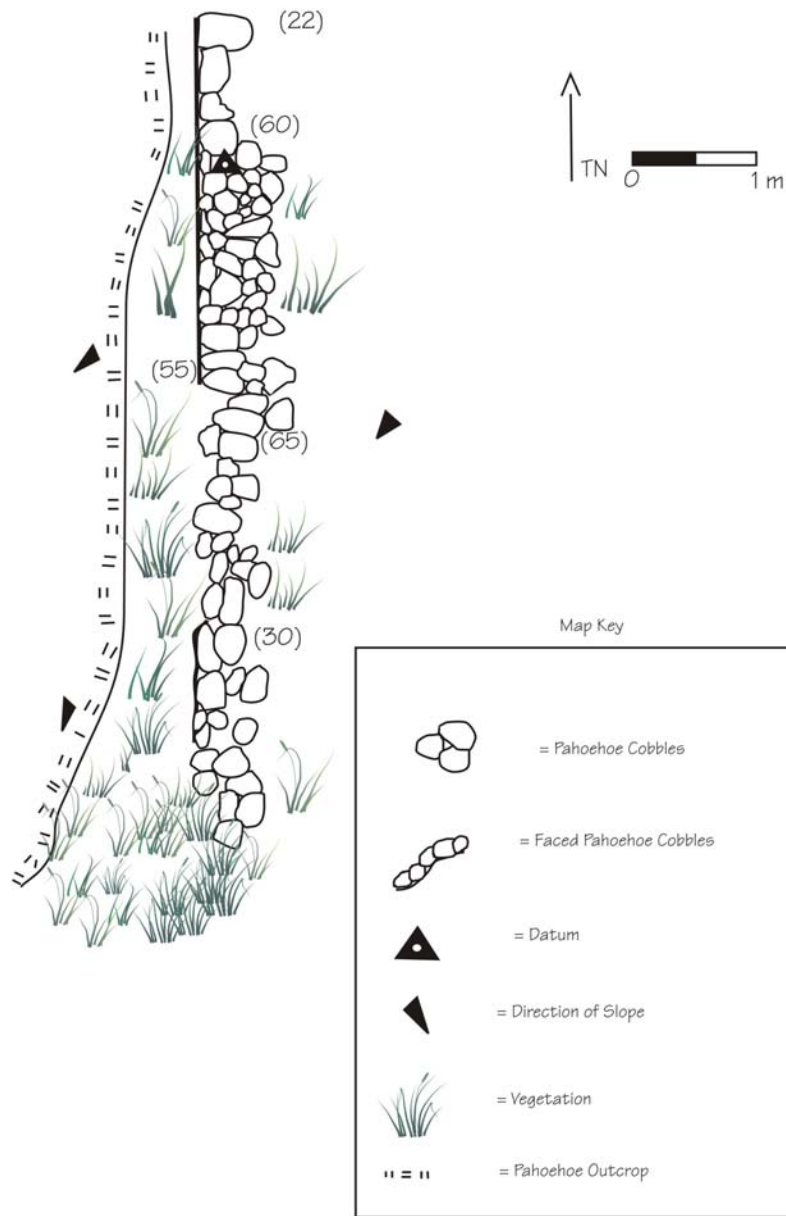
Figure 55. Feature HAVO-2005-D-34, Rock Wall

**HAVO-2005-D-34** (Feature 98-839) is 6.75 m X 75 cm X 85 cm high wall constructed of porous basalt slabs and located on the natural contour on the east side of the drainage. The northwest end abuts a pāhoehoe outcrop. Slabs are placed upright to maximize the height. The rocks are stacked to a height of 2-4 rocks high. The medial to the south end is at a minimum stacking in a matrix of ashy soil and moderate to dense vegetation. The feature probably continues south but the vegetation is too dense to see. The vegetation includes *a'ali'i*, bracken fern, grasses, partridge pea, and *pūkiawe*. Impacts on the feature include weathering, seismic, and vegetation.

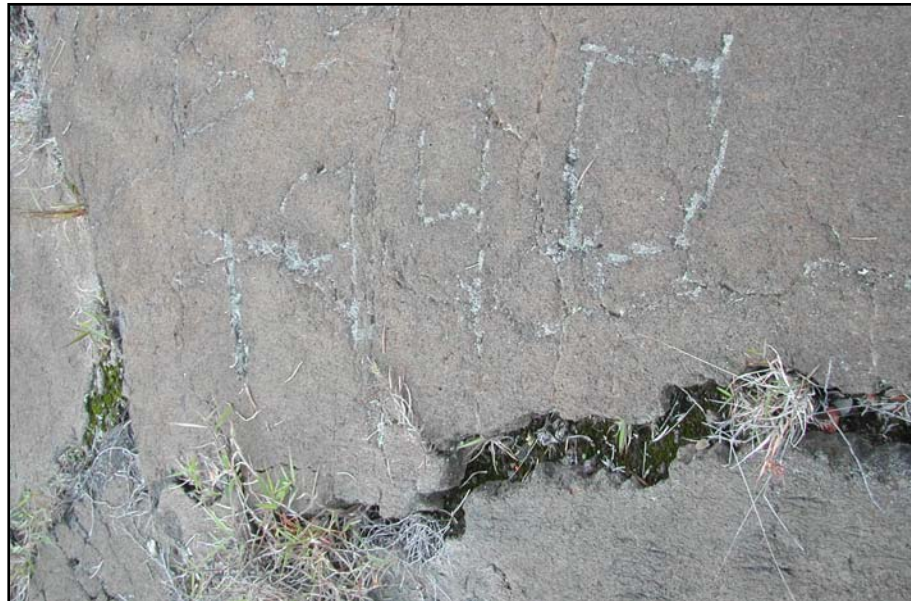
**Figure 60. Site Number 50-10-62-24525, HAVO-2005-D-112, "1940" Petroglyph**

**HAVO-2005-D-112** (Feature 03-17) is a 1.65 m X 1.3 m pecked petroglyph pecked on an open slab of pāhoehoe bedrock. The petroglyph is comprised of the letters "R.E.D. DENISON, CCC 1940". This petroglyph is found near another CCC petroglyph recorded in 03-12 and a lava tube recorded in 03-14. The feature is in an area vegetated by *pūkiawe*, *a‘ali‘i*, *‘ōhi‘a*, and grasses. It is in excellent condition.

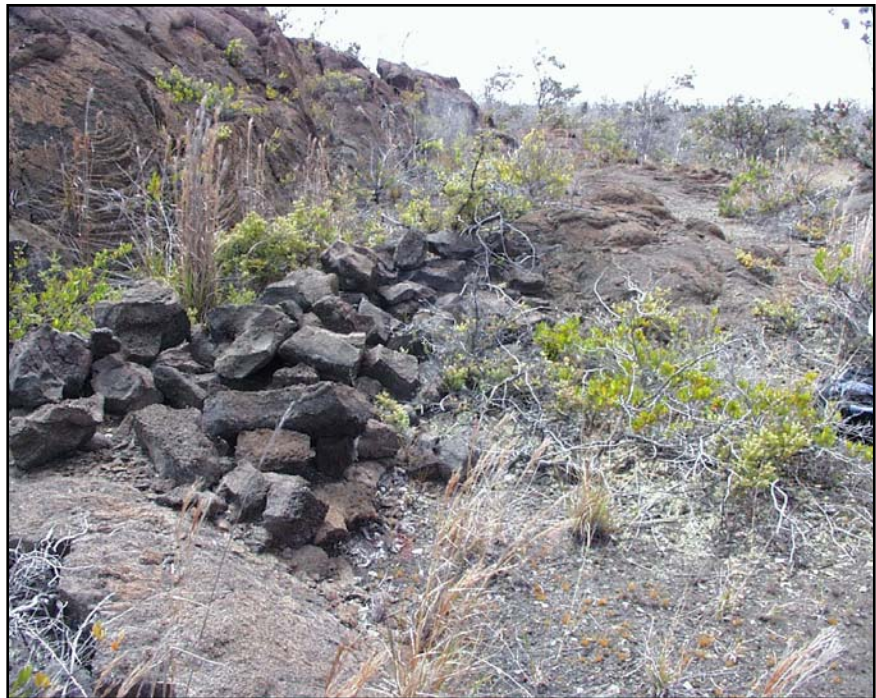
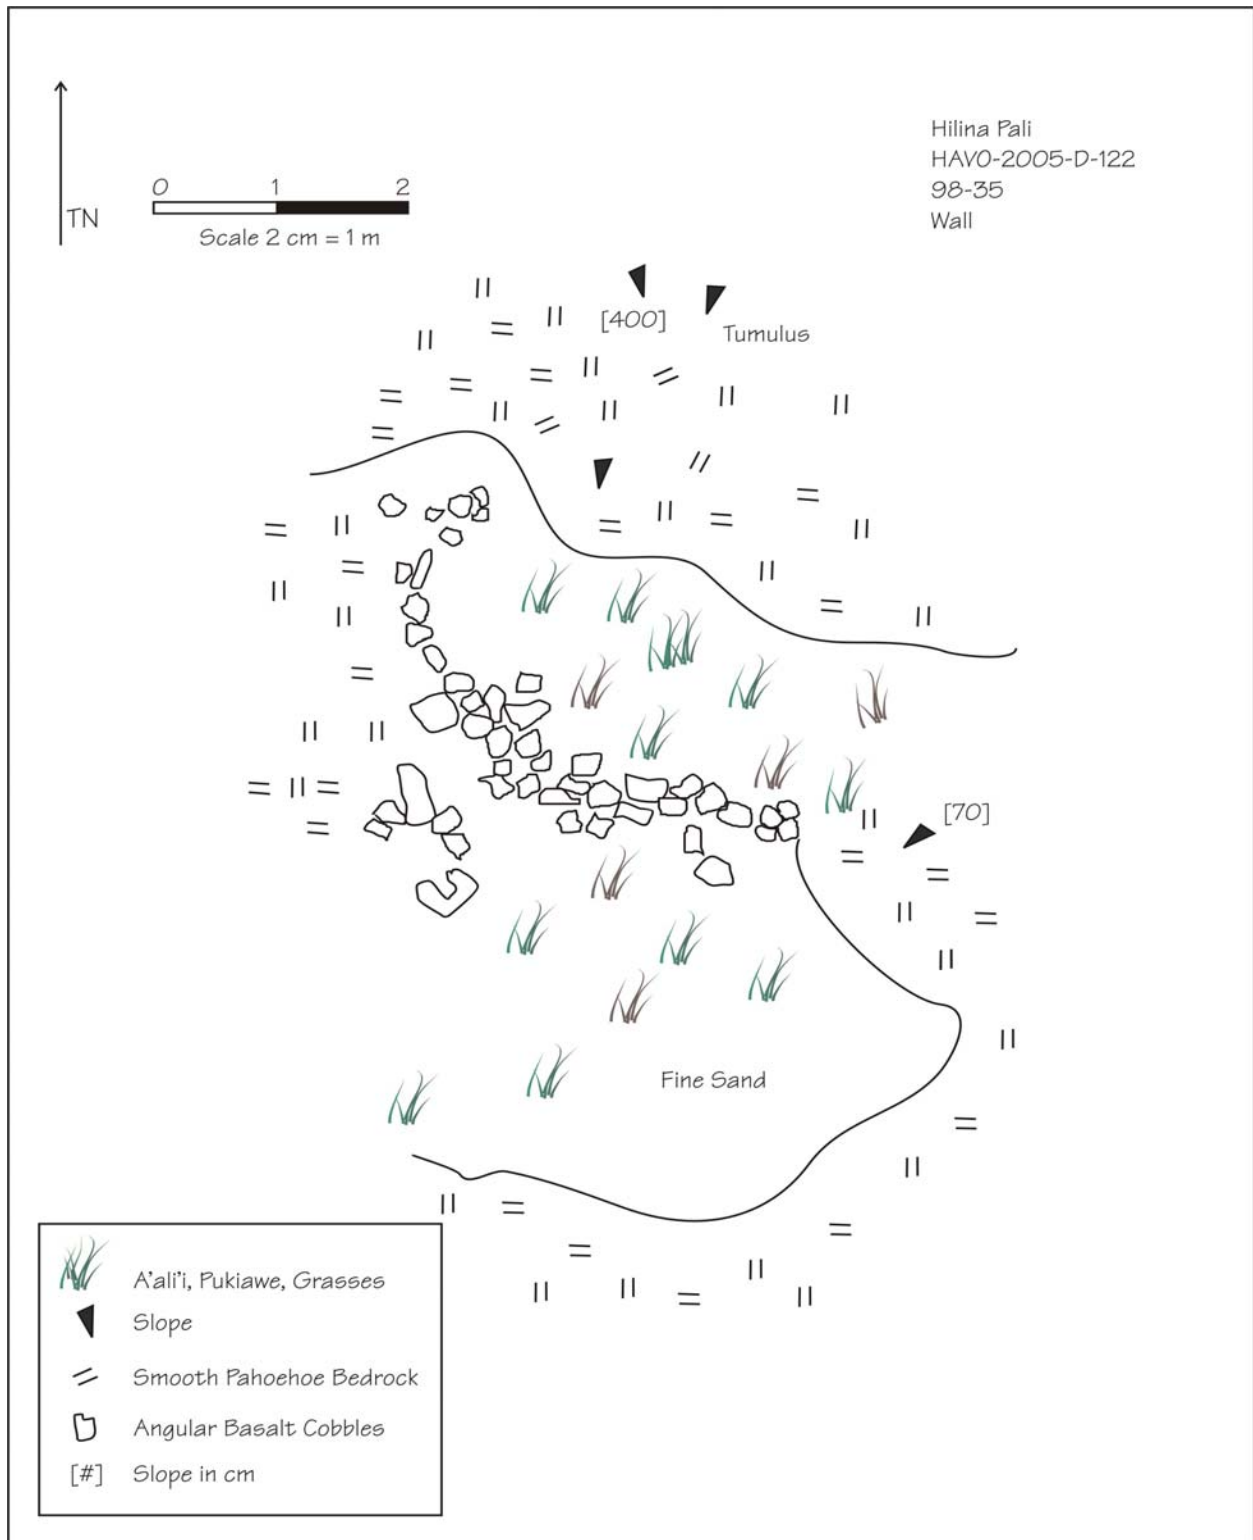
(Feature 98-35) is a 3.3 m X 1.05 cm X 0.50 m in height rock wall constructed with pāhoehoe cobbles and boulders very loosely stacked 1-2 courses high. The wall is located southeast of a pāhoehoe tumulus and may have served as a temporary shelter. To the northwest of the feature it appears that there is some possible excavation. Seismic activity and vegetation are potentially impacting this feature. Vegetation surrounding this feature includes *pūkiawe*, *ōhi'a*, grasses and *a'ali'i*. This feature is in fair condition.

**Figure 64. HAVO-2005-D-122. Rock Wall**  
Photo courtesy of the National Park Service

**Figure 67. HAVO-2005-D-122, Rock Wall**

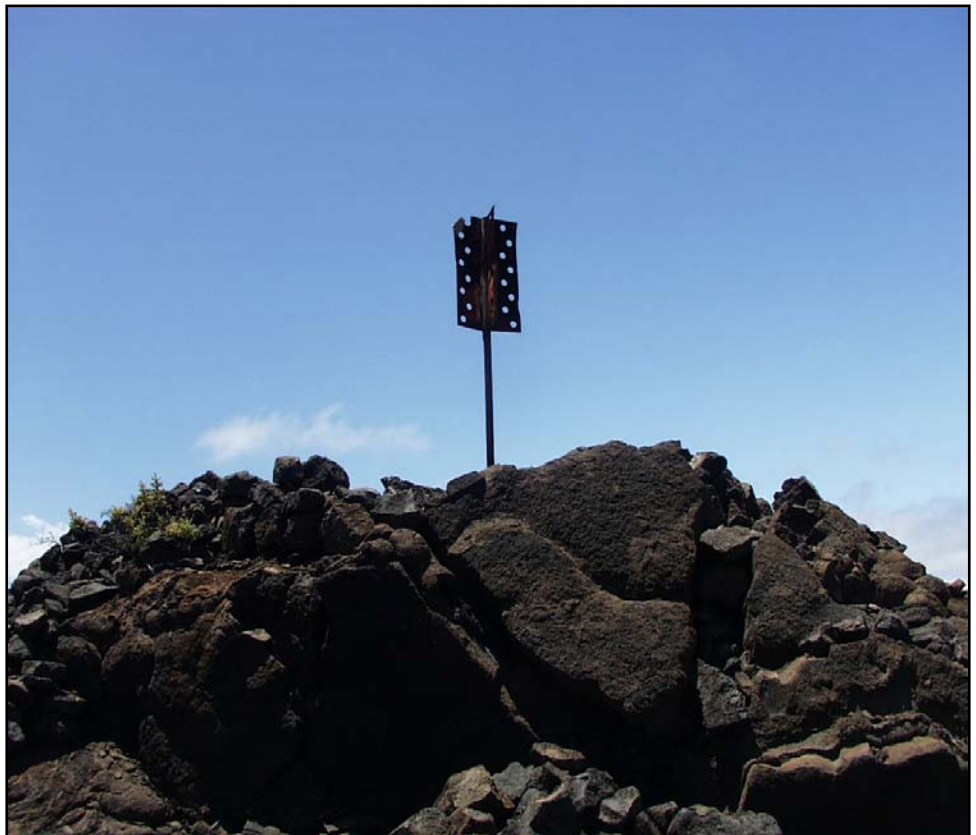
**Figure 65. HAVO-2005-D-125. Pu‘u Ohale.**

(Feature 98-40) is a 1.5 m wide X 4 m tall metal post and sign placed on top of a high pāhoehoe tumulus with 4 metal sheets sticking out of the top uniformly pointing in each direction. The marker, or flag is cemented into the top of the tumulus and surrounded by walls. In each metal sheet there is approximately 8 uniform holes. The metal is corroded and rusted. This site is named Pu‘u Ohale and, according to Don Swanson, was placed there by the Hawaiian Territorial Survey that took place in the early part of the 20<sup>th</sup> century. These surveys took place to mark boundaries as well as make topographic

maps. In the cement there are the words “Pu‘u Ohale” and “HTS 1938.” Around this feature there are many broken bottles and old rusted aluminum cans. There is a temporary shelter built around the tumulus which is described in feature HAVO-2005-D-128. Potential impacts to this feature include seismic activity, corrosion and human. Vegetation surrounding this feature include *pūkiawe*, ‘ōhi‘a and a‘ali‘i. This feature is in good condition.

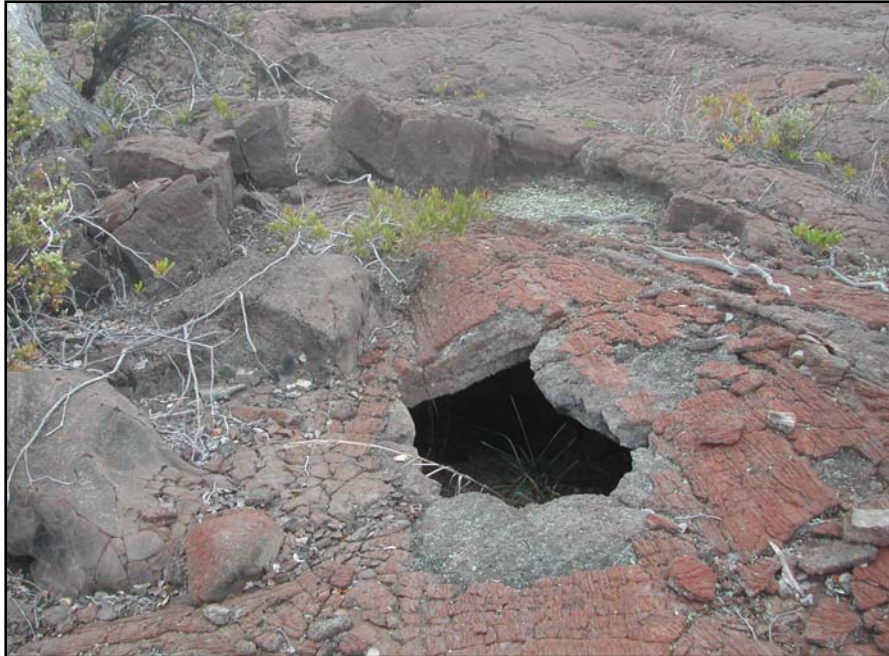
**Figure 68. HAVO-2005-D-126. Lava blister and possible temporary shelter**

**HAVO-2005-D-126** (Feature 98-66) is a 0.8 m long X 0.4 m wide X 0.4 m deep blister that formed from pāhoehoe lava flow. The opening in the flow is small and could have possibly been opened up more by human activity. It is a small blister but possibly big enough to fit someone inside that is lying down. Therefore it could function as a sleeping shelter. There are goat bones inside the blister and 15 m from blister there is a rock pile/ahu that is described in feature 98-54. Feature 98-66 could potentially be impacted by goats and erosion and is surrounded by *pūkiawe*, *‘ōhi‘a*, and *a‘ali‘i*. It is in good condition.
