Tech Notes

WINDOWS

Installing Insulating Glass in Existing Steel Windows

MERGENTHALER LINOTYPE BUILDING

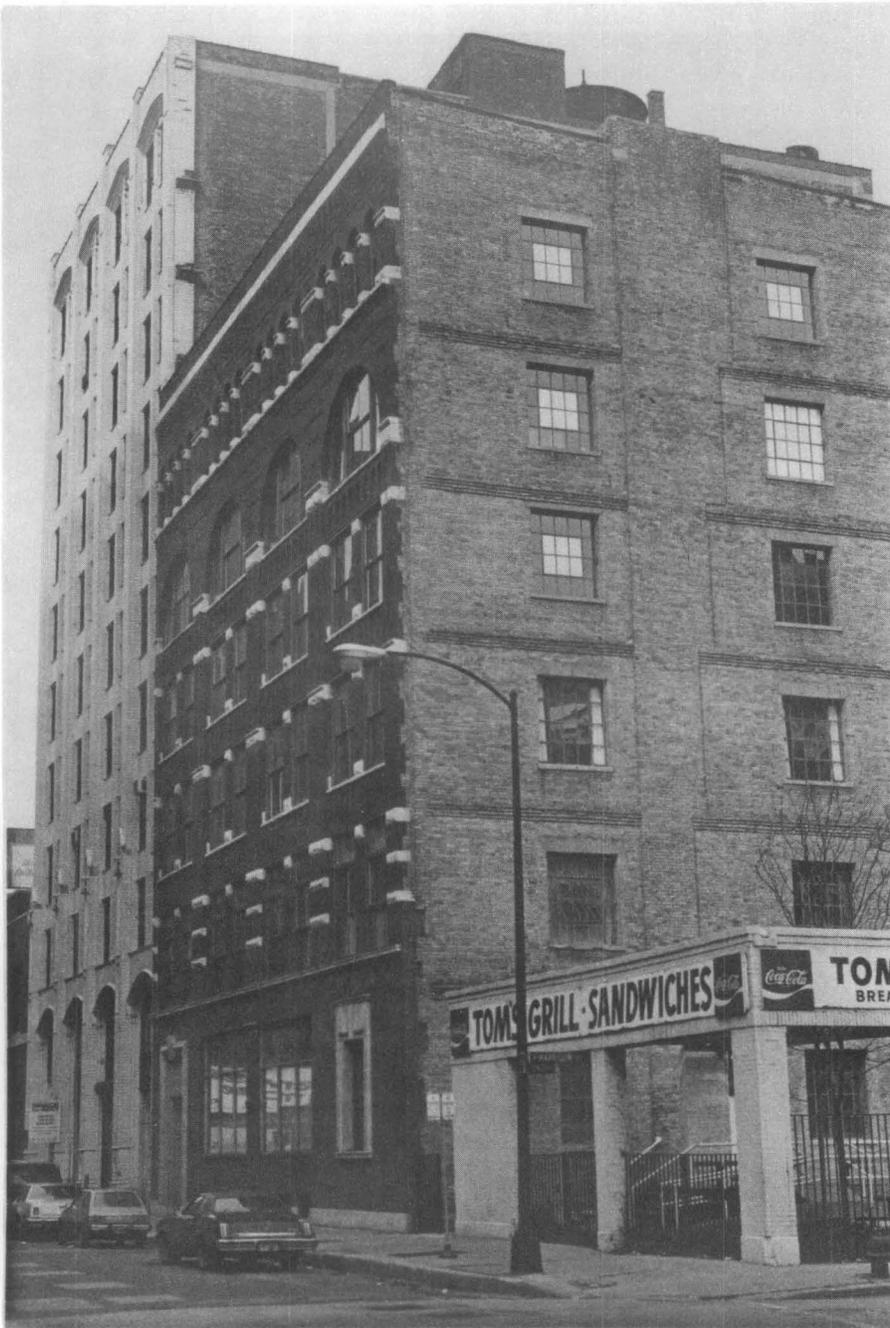
Figure 1. Insulating glass was installed without changing the appearance or operation of the steel window. Drawings: Martha L. Werenfels

Only about half of the glazing cost was directly attributable to the use of insulating glass since from the outset, the residential use of the building tended to dictate from a marketing perspective that the existing wire glass be replaced. Thus it was decided that in lieu of only repairing and reglazing with clear 1/4" glass, which would have been the cheapest of the four identified window options, sufficient benefits could be derived by using double glazing to improve the window's energy performance (see figure 1).

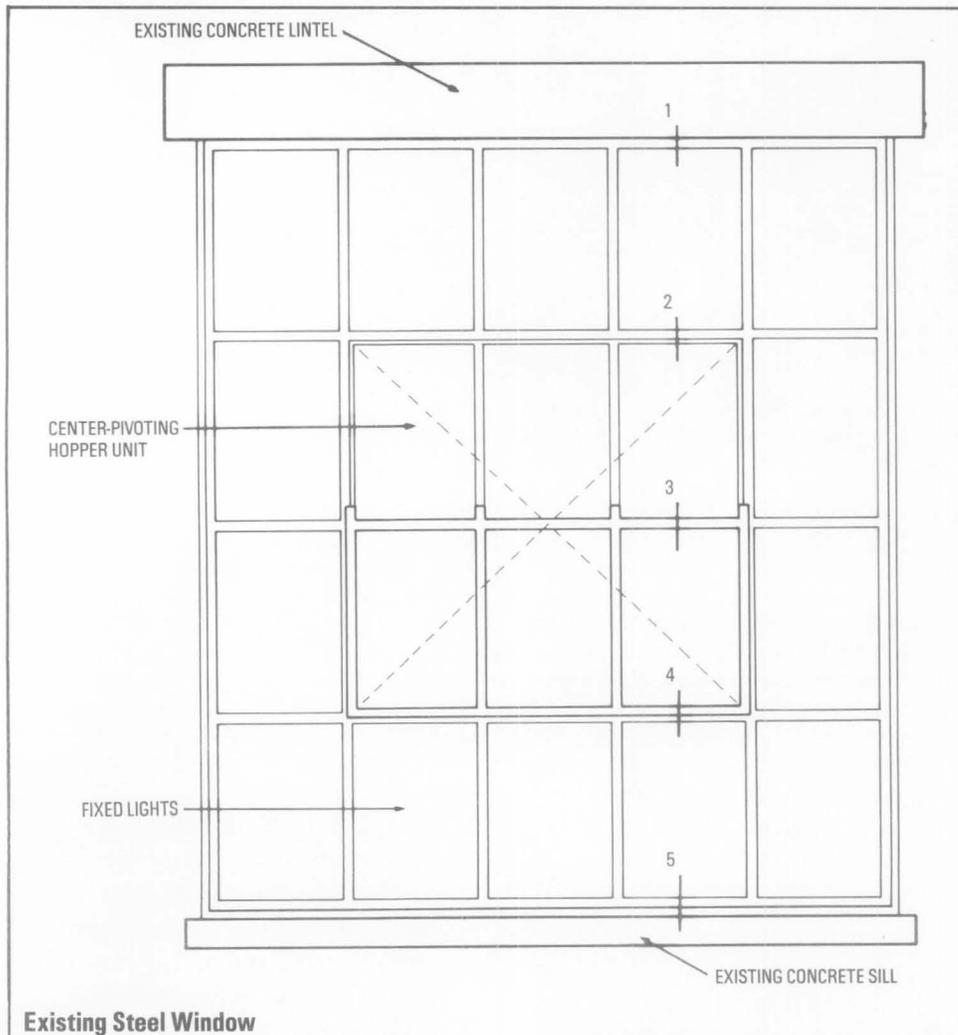
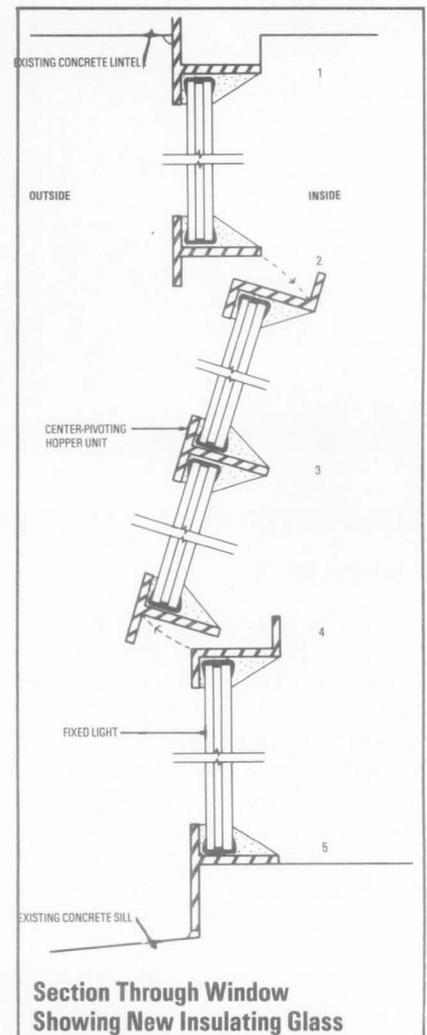
Figure 2. Spring glazing clips and face putty were used instead of the original metal glazing angles in installing the new glass. Drawings: Martha L. Werenfels

The original wire glass had been held in place by glazing angles bolted to the muntin bars. In removing the glass it was decided, due to deterioration of the glazing angles and the labor-intensiveness of reinstallation, that new spring glazing clips and steel sash glazing compound would be used instead (*see figure 2*).

The insulating glass had been delivered to the site, vacuum sealed and with a continuous glazing edge. After the bed putty was applied to the sash, the insulating glass was installed with glazing clips and face putty.

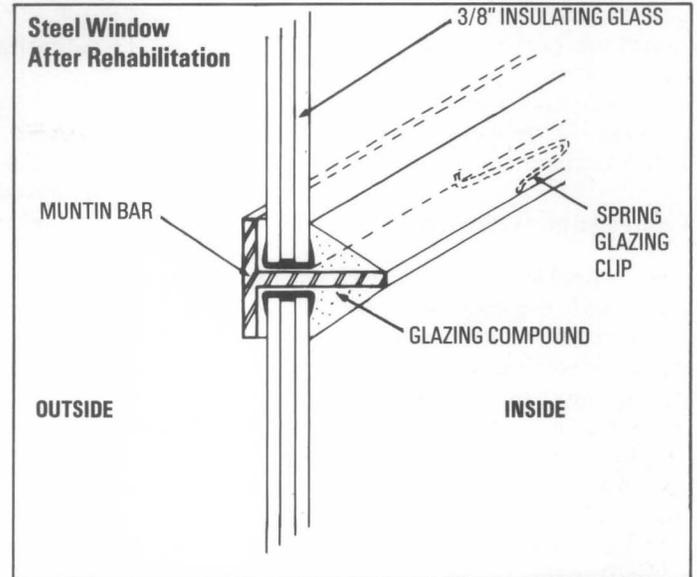
Figure 3. The historic steel windows were repaired and then upgraded through the addition of insulating glass. Photo: Charles E. Fisher

On the whole, the reconditioned windows are performing well and are providing the desired improvements in personal comfort (*see figure 3*). There was no real problem in marketing the condominiums and residents have capitalized on the interior design opportunities provided by the large windows and the loft space.
