Cape Lookout National Seashore

**Cape Lookout  
Life-Saving Station**

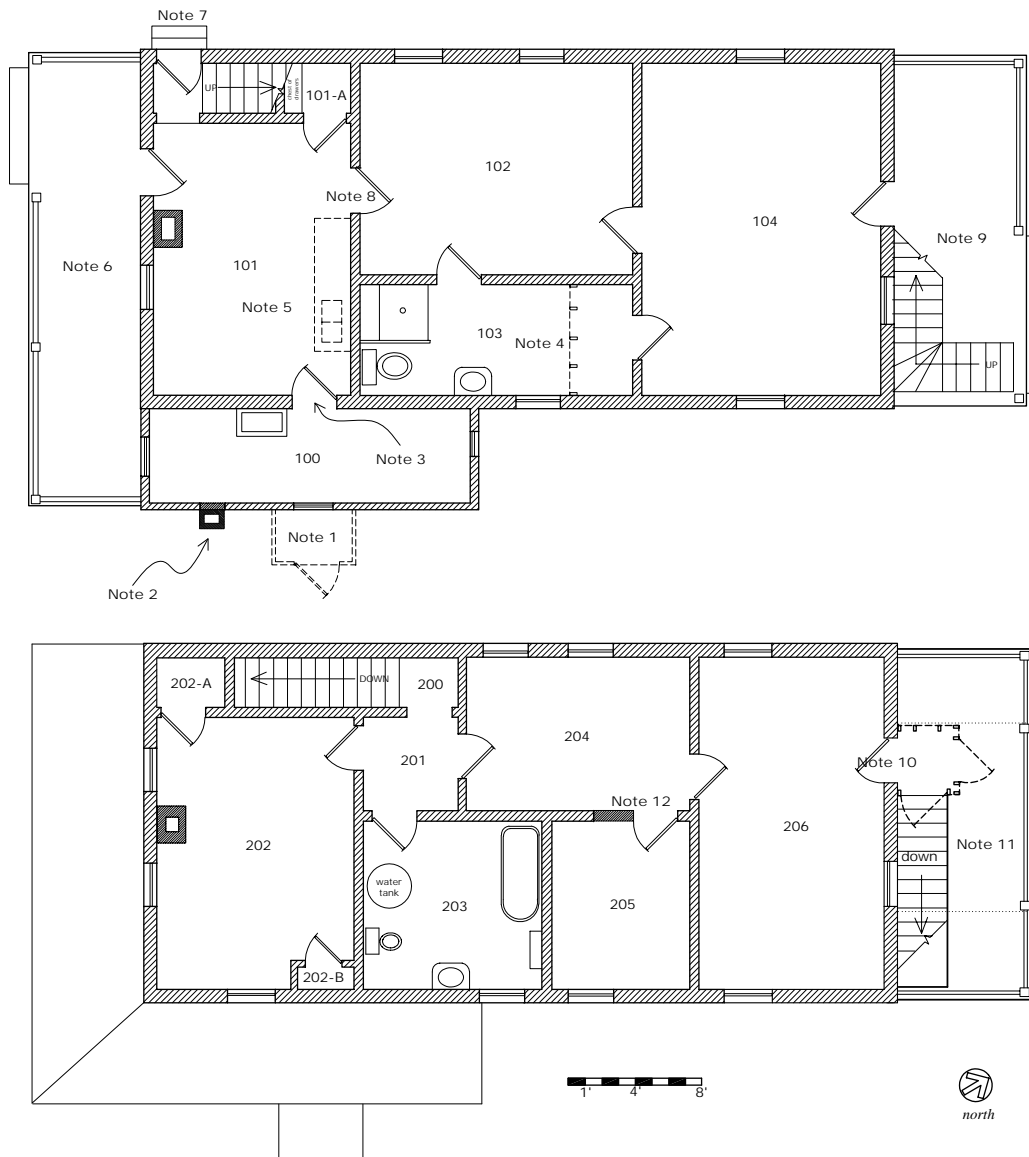
1. Remove existing vestibule and replace existing door with four-over-four window to match original.
2. Remove window and reconstruct chimney.
3. Install door currently leading to vestibule in this opening.

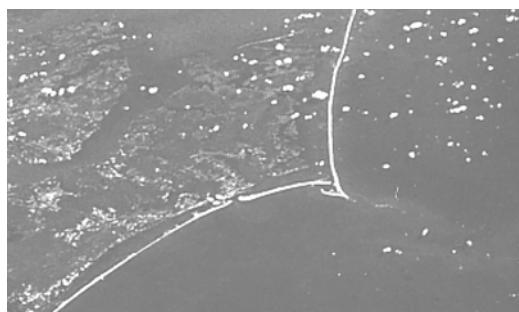
**Figure 1** Cape Lookout as viewed from earth orbit, 1969. Breakers and shallows around its dangerous shoals can be distinguished stretching away from the cape. (CALO Coll. #F-184)

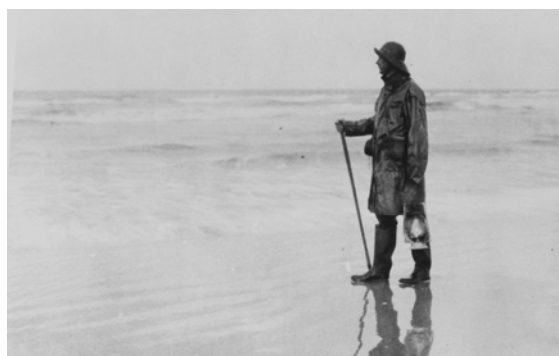
**Figure 6** Surfman on patrol in foul-weather gear. (CALO Coll. #G-08)

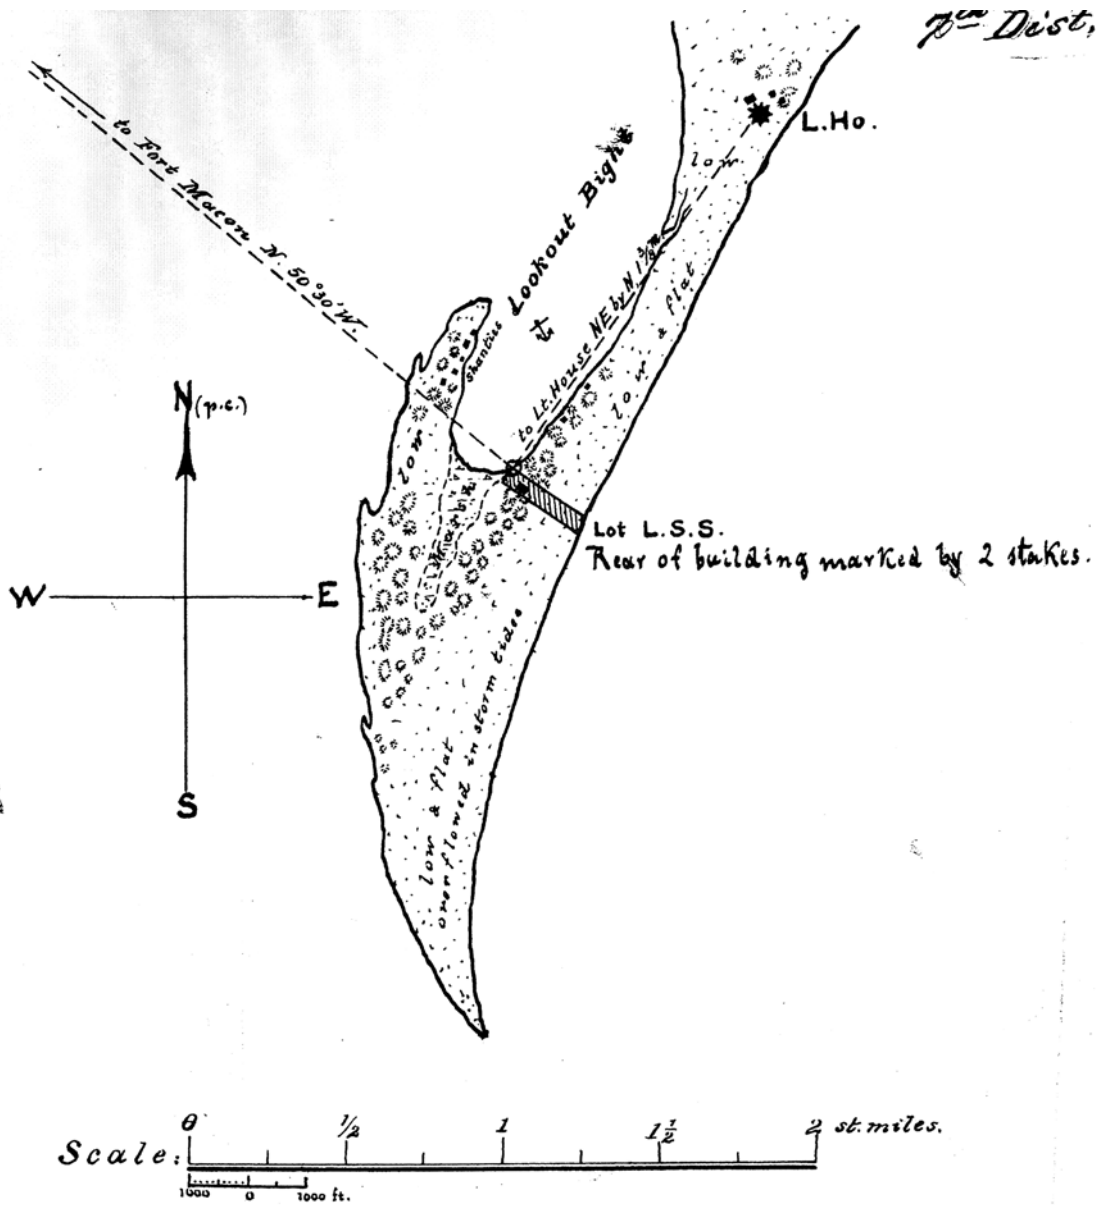
Sketch showing site of Life-Saving Station on Cape Lookout, N.C.

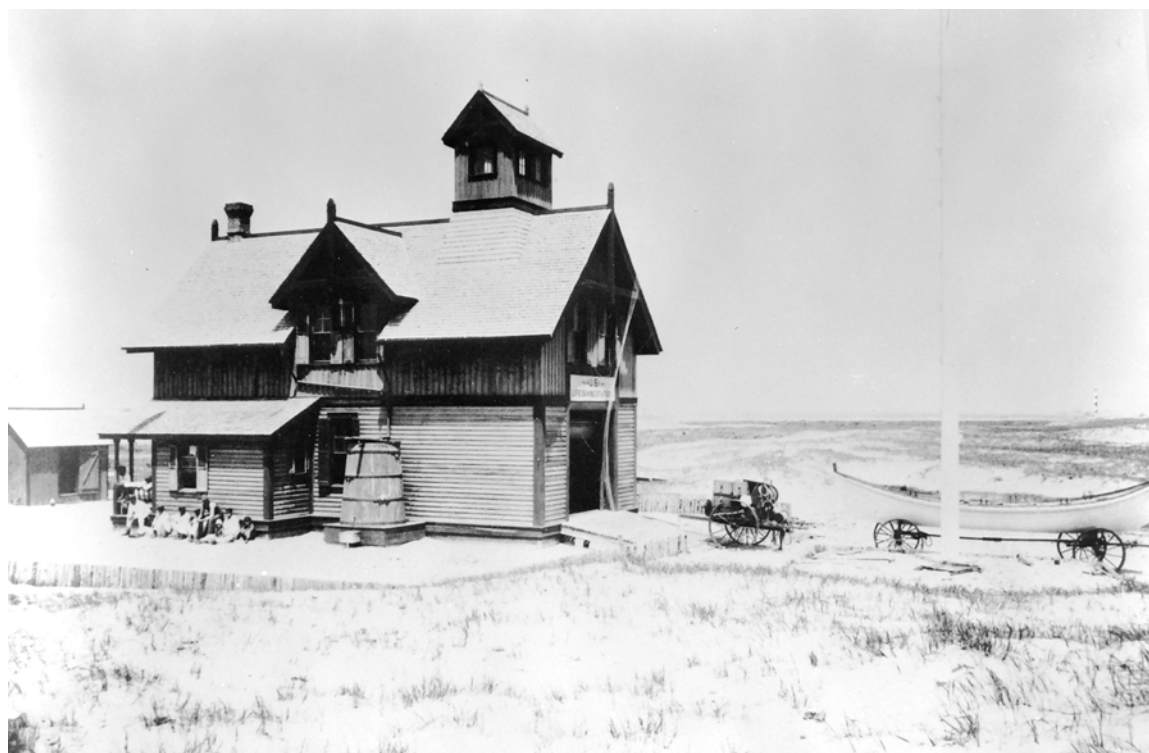
**Figure 8** View to north of Cape Lookout Life-Saving Station, 1893. Lighthouse is barely visible on the horizon at extreme right. (CALO Coll. G-09)

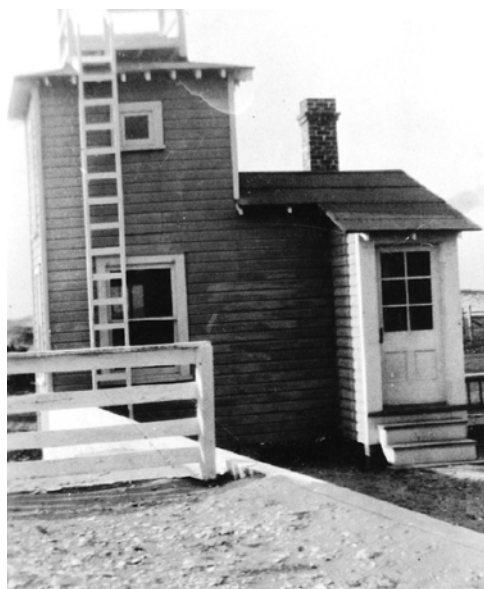
**Figure 14** The Navy's "radio shack" at Cape Lookout Coast Guard Station. (CALO Coll, D20)

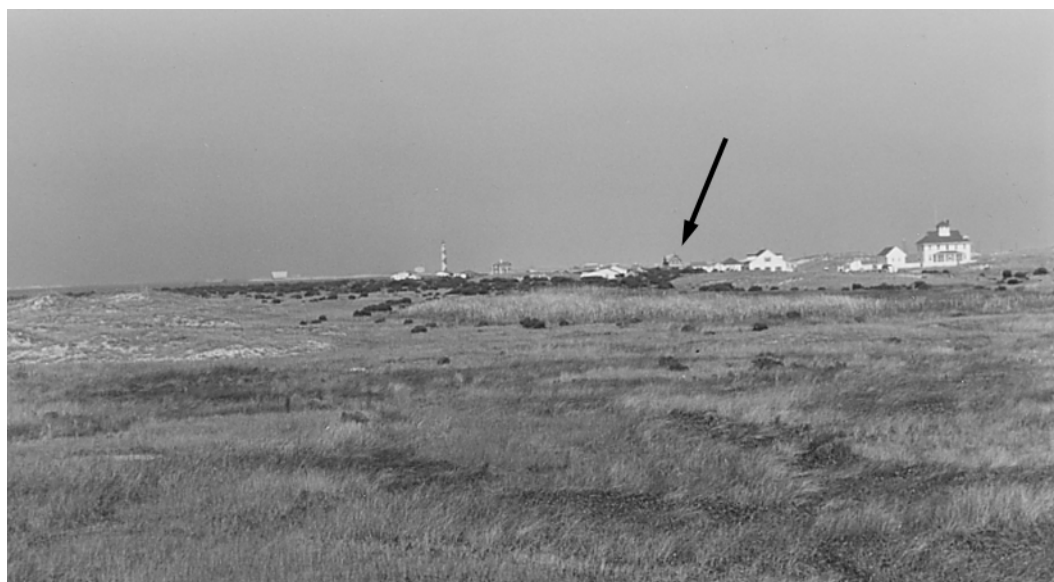
**Figure 17** View northeast at Cape Lookout, c. 1969. Arrow indicates location of old life-saving station. (CALO Coll. G-37)

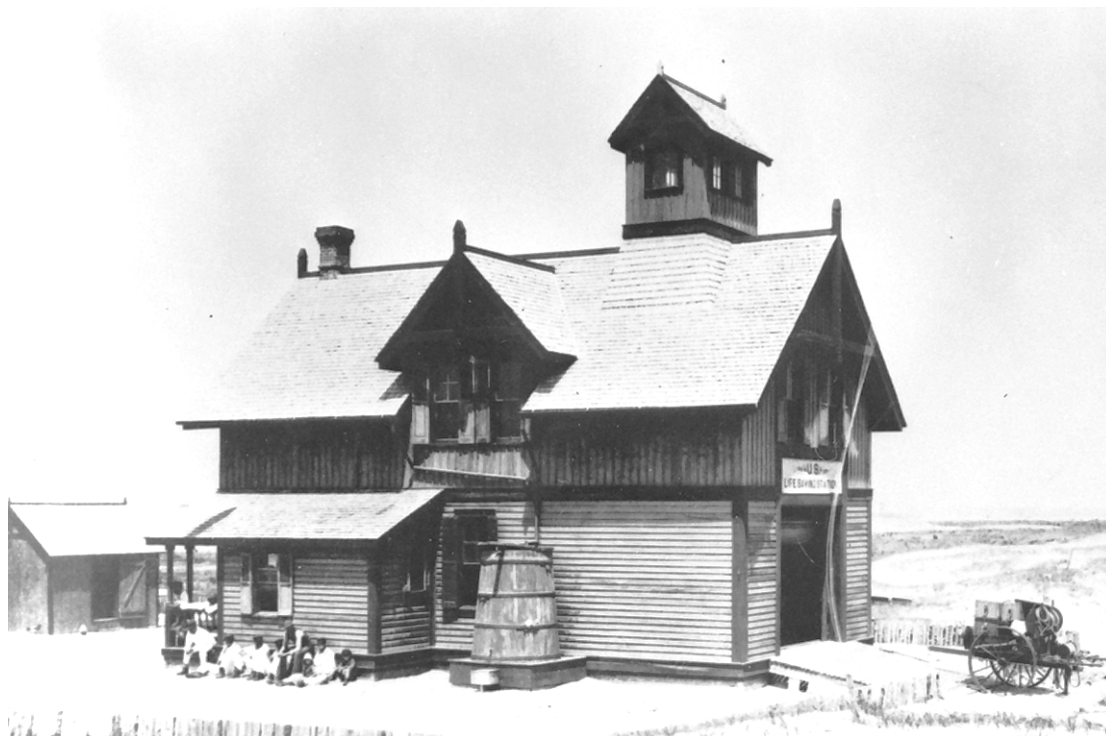
**Figure 19** View of Cape Lookout Station, c. 1893, with oil house visible at left. (CALO Coll. G-09)

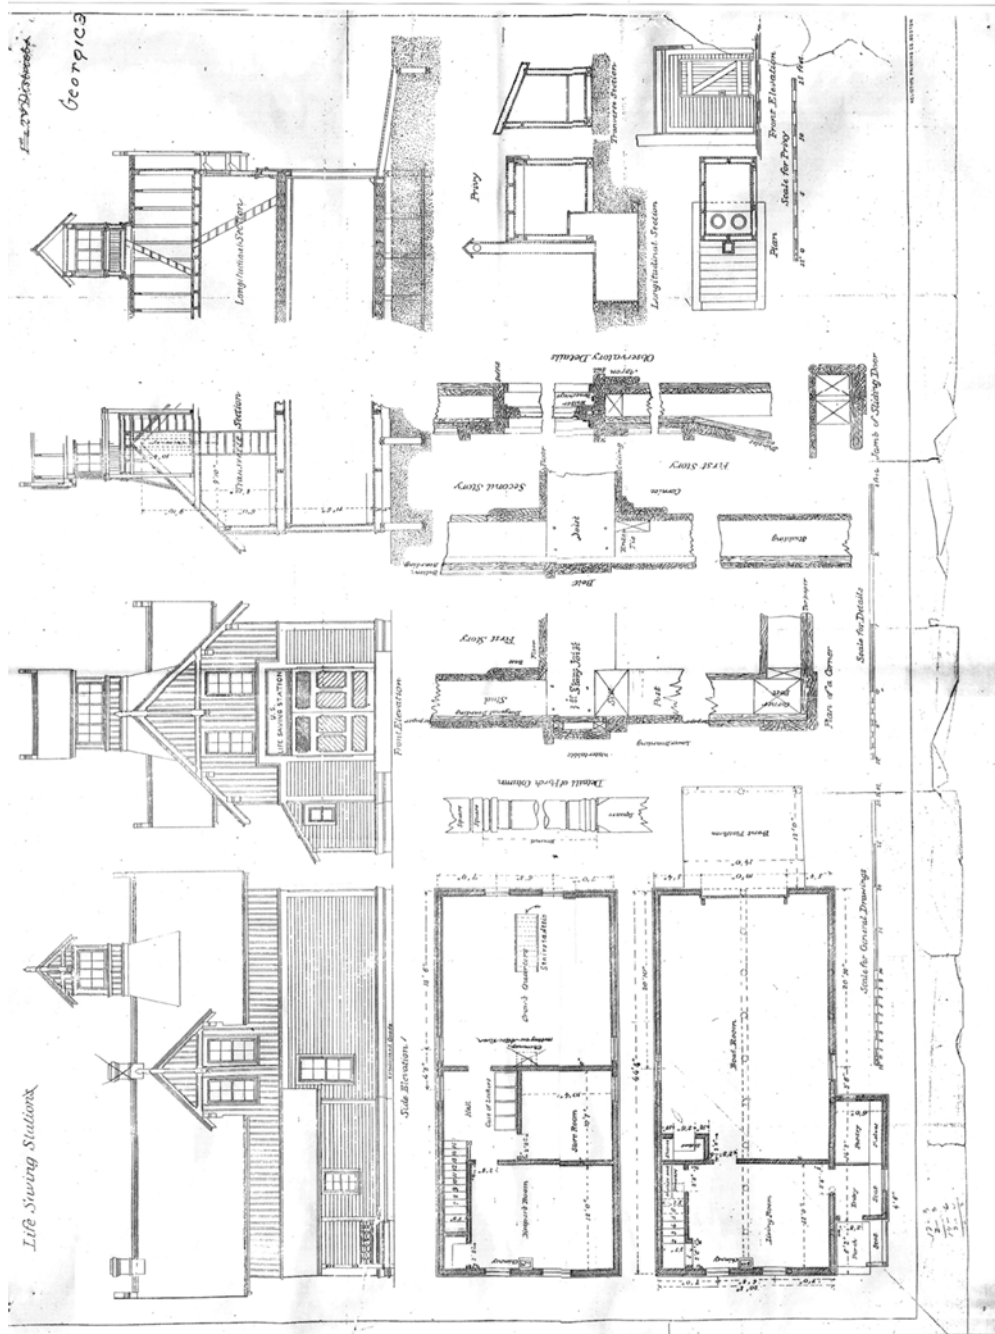
**Figure 20** Plans for Georgica Life-Saving Station (c. 1886) on Long Island. Plans for Cape Lookout Station were almost identical. (United States Coast Guard Coll.)

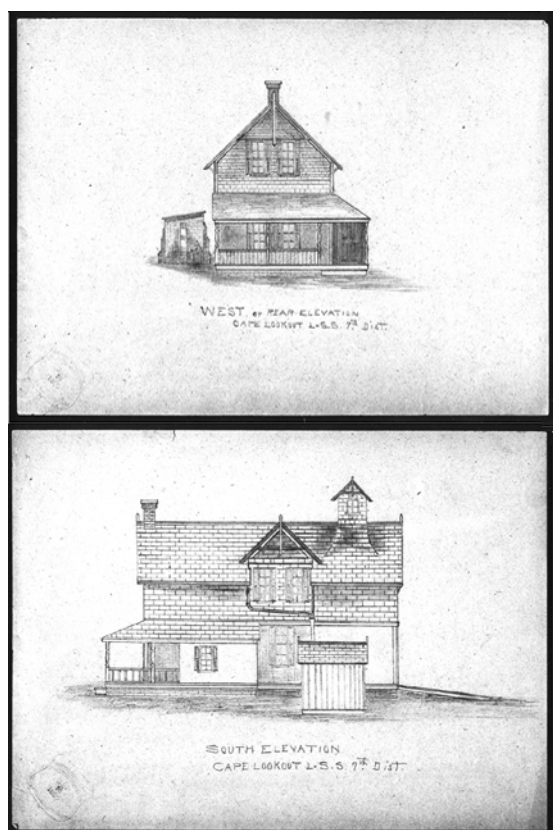
**Figure 23** Elevations of Life-Saving Station, 1905, showing back porch added around 1897. (U.S. Coast Guard)

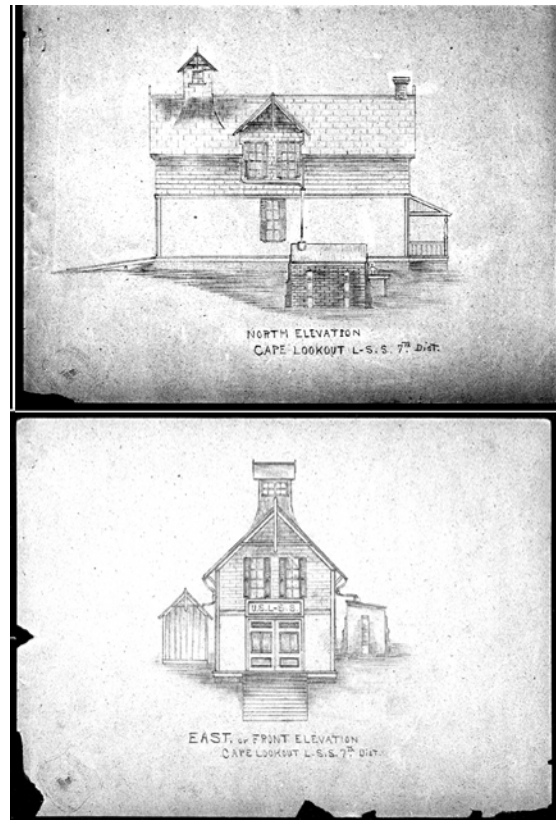
**Figure 24** Elevations of Life-Saving Station, 1905. (U.S. Coast Guard)

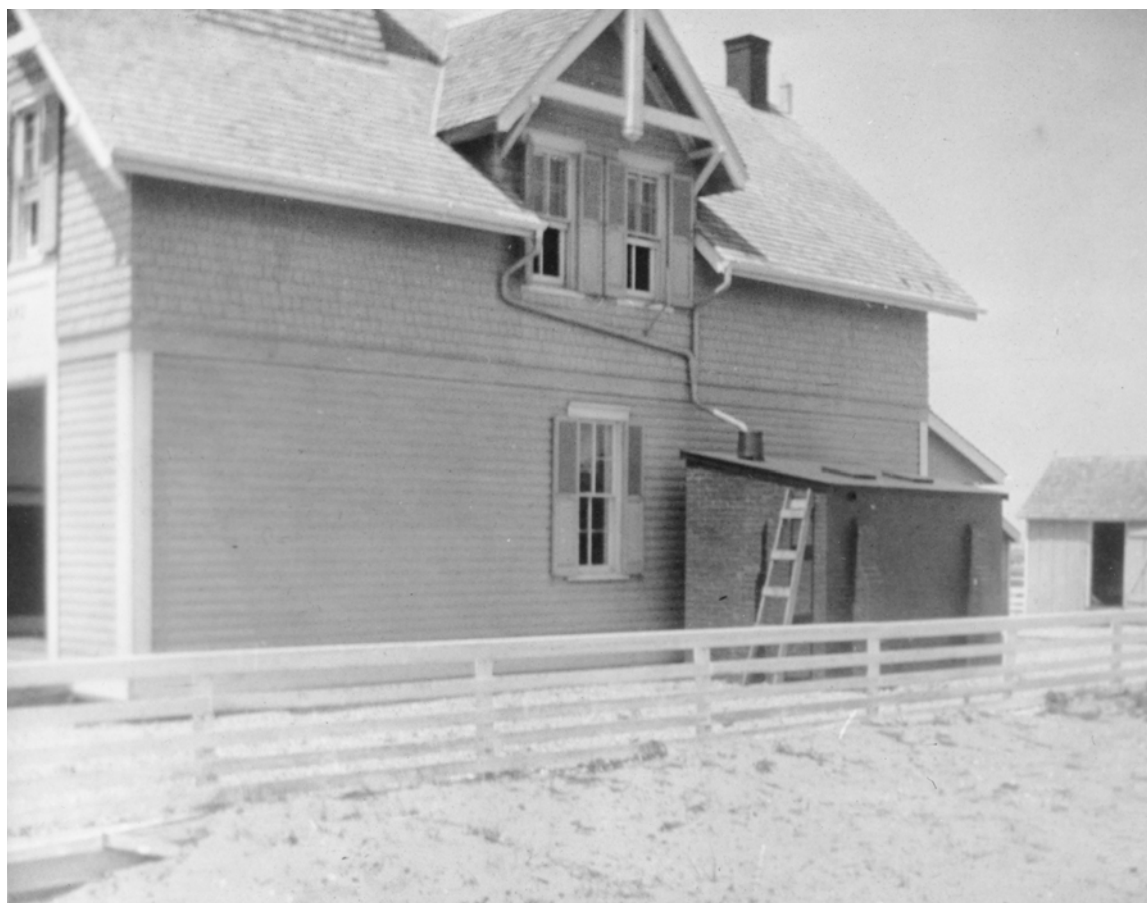
**Figure 25** View of live-saving station c. 1915, showing one of two cisterns that served the building.<sup>38</sup> (CALO Coll, USLSS#2)

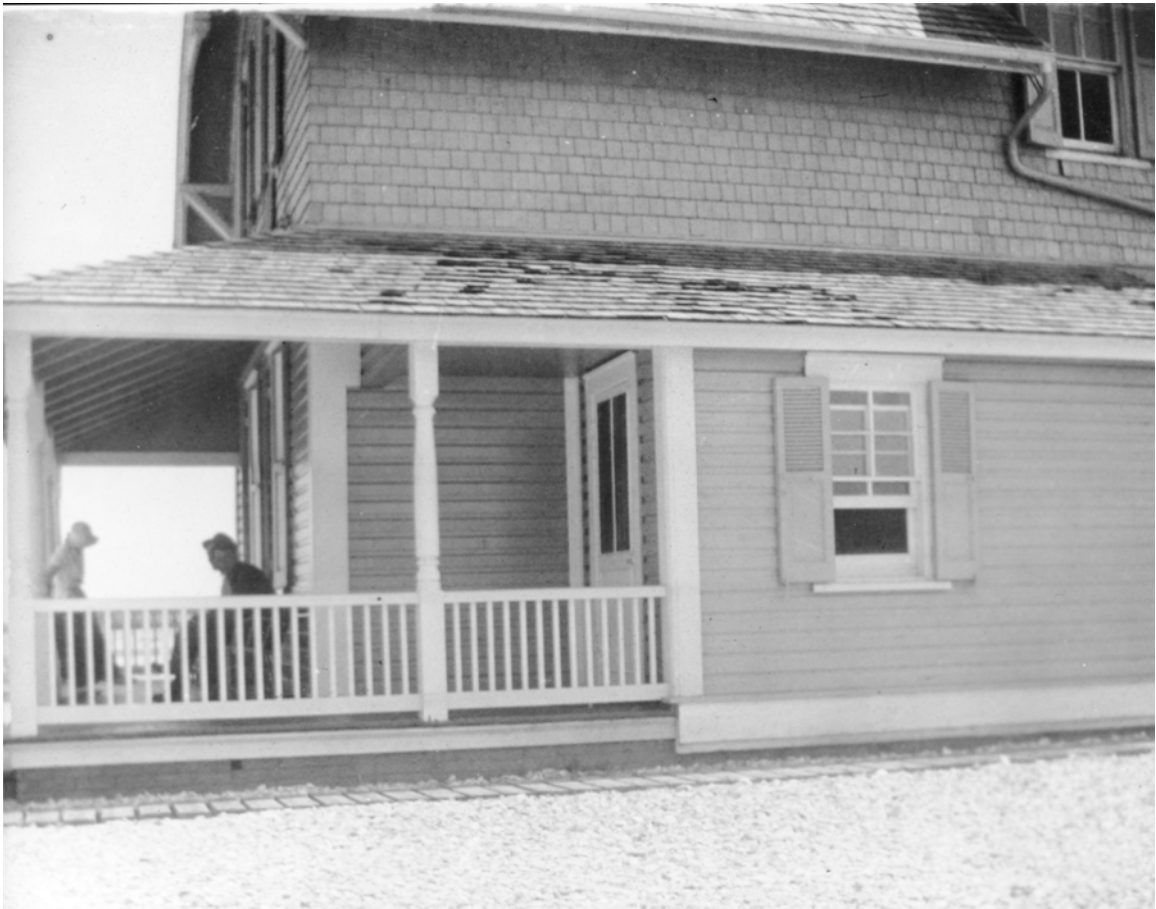
**Figure 26** View of back porch of life-saving station, c. 1915. (CALO Coll.)

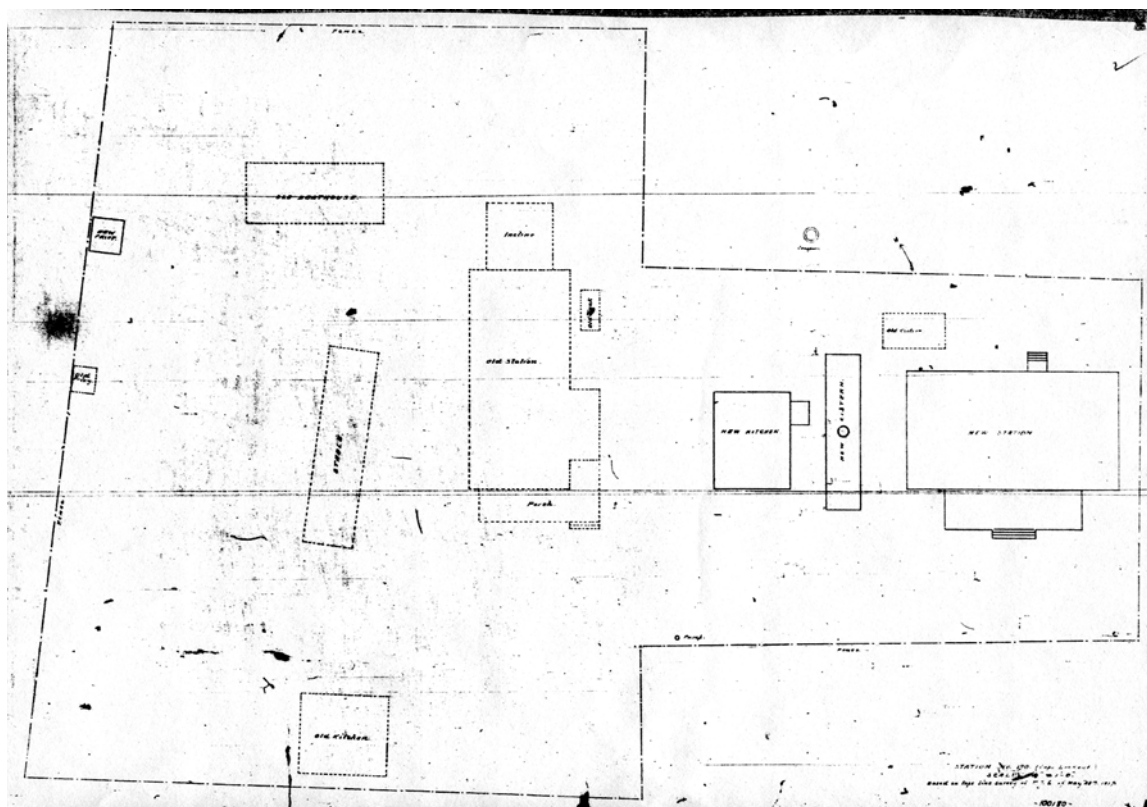
**Figure 27** Plan of Cape Lookout Coast Guard Station, May 1917, with new building at right on site of old life-saving station, which is shown on its new site at center. (U. S. Coast Guard)

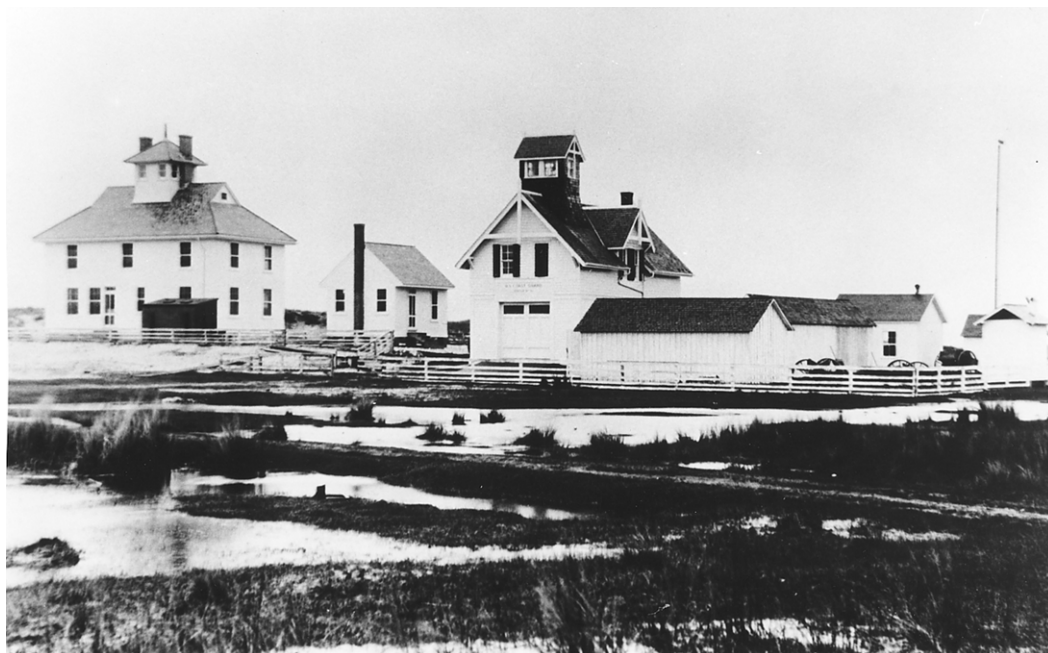
**Figure 28** View to south of Cape Lookout Coast Guard Station #190, shortly after the new station was completed in 1917. (CALO Coll. D-57)

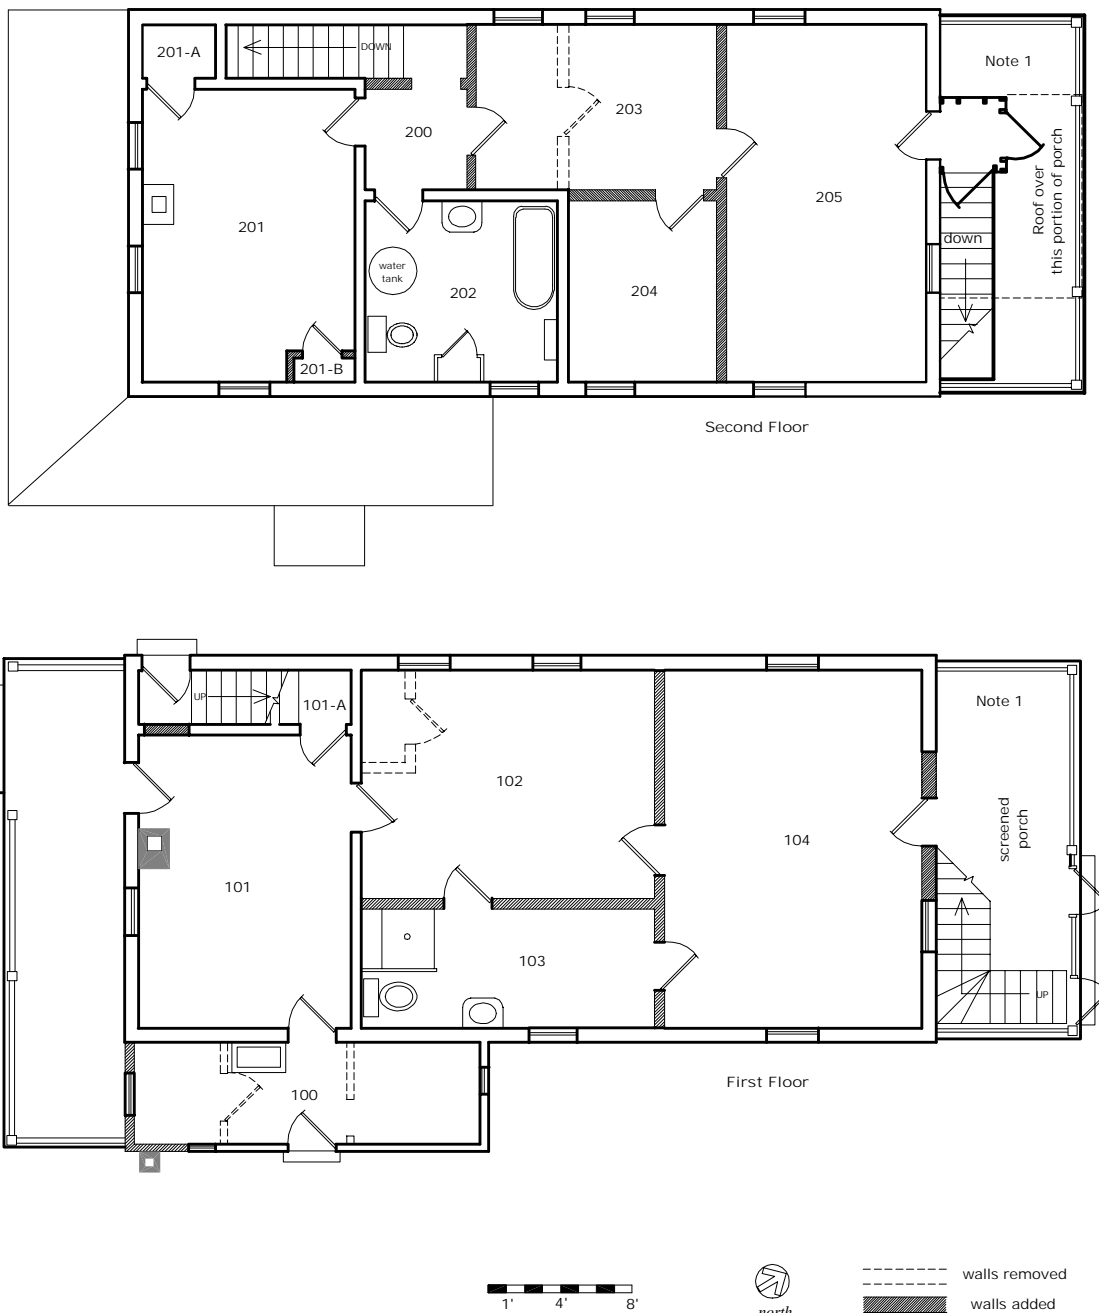
**Figure 30** Plan of old life-saving station, depicting changes that occurred between the world wars, most of them in the early 1920s. Room 103 may not have been converted into a bathroom until the late 1930s. (T. Jones, NPS-SERO-CR, 2003)

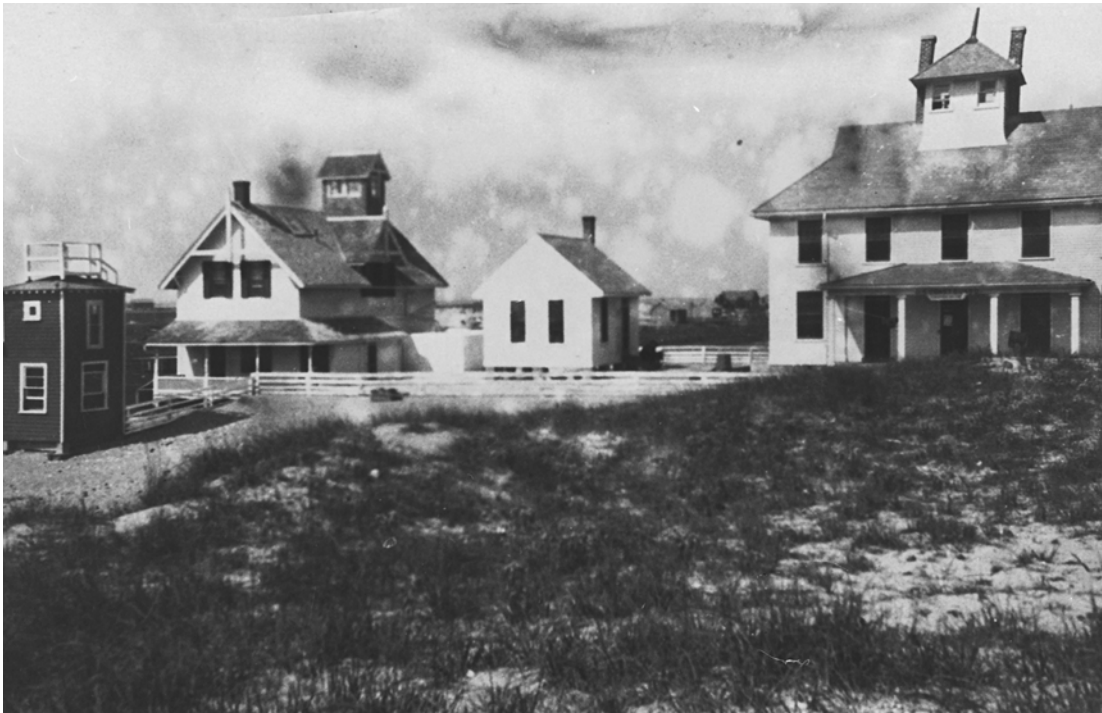
**Figure 31** View north of Cape Lookout Coast Guard Station, 1920. The new compass station, or “radio shack,” is at left, and the new concrete cistern is visible between the kitchen at center and the old life-saving station. (CALO Coll. D-52)

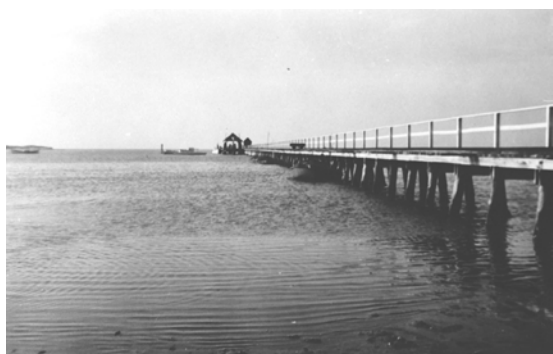
**Figure 32** View of the “dock in the hook” in 1943, and the boat house that replaced the original boat house that was torn down in 1916. (CALO-Coll.)

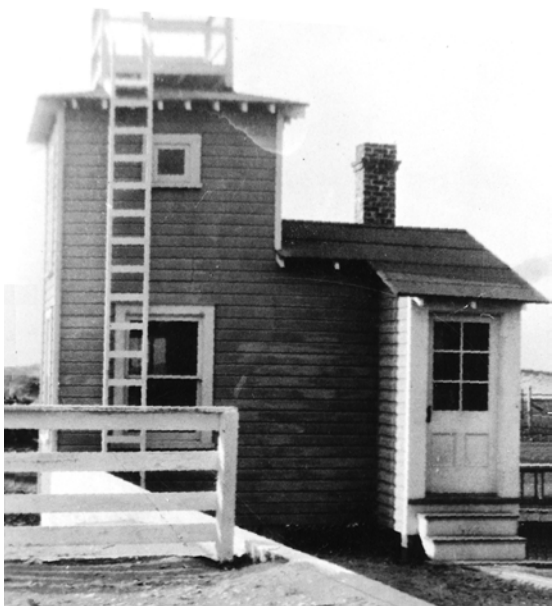
**Figure 33** View of 1919 “Radio Shack” during World War II. The concrete retaining wall seen here remains on the site. (CALO Coll. D-20)

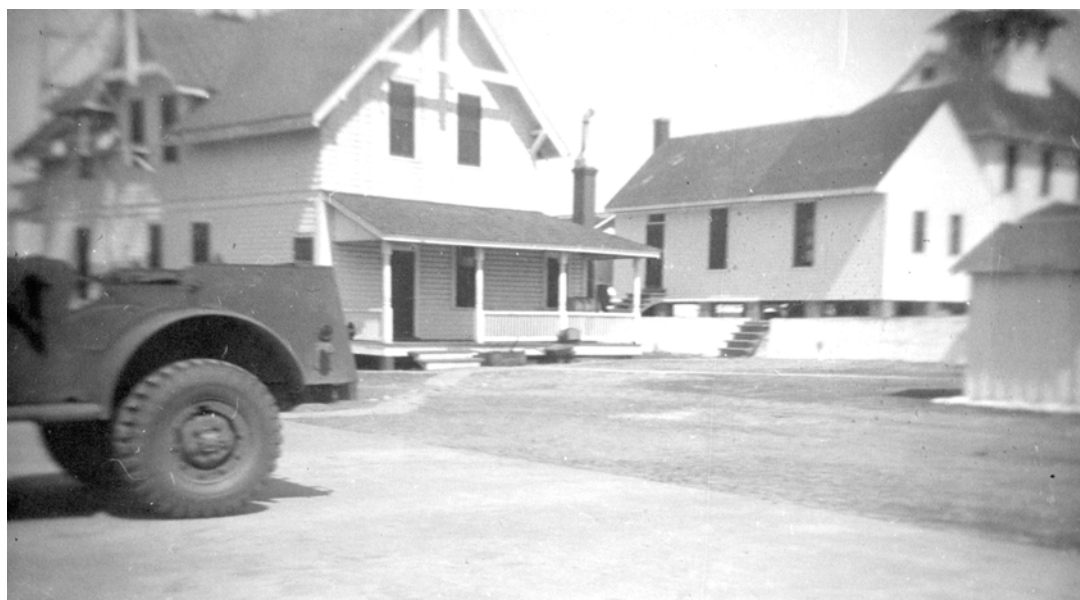
**Figure 35** View of Coast Guard Station and old life-saving station, 1943. (CALO Coll. Siff-02)

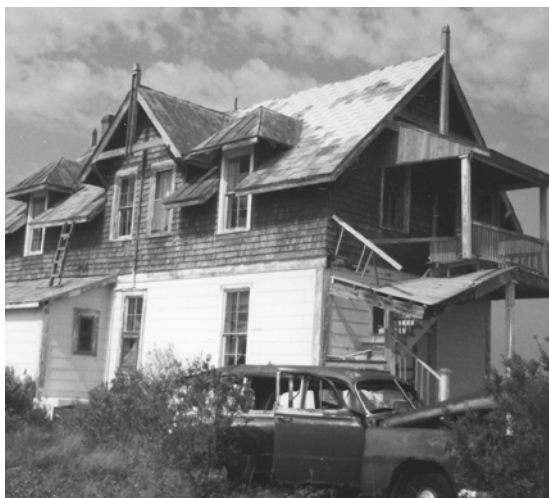
**Figure 40** View of old life-saving station, c. 1969. (CALO Coll.)

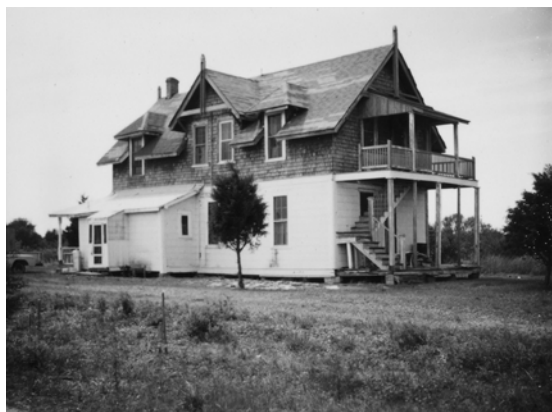
**Figure 41** View of old life-saving station in 1978. (CALO Coll.)

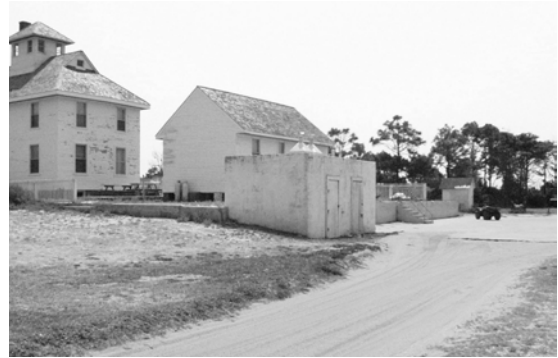
**Figure 45** View south at Coast Guard Station complex. The flat-roofed building at center is the cistern (c. 1920) for the Life-Saving Station, which stood just to the right in the path of the present roadway. (NPS-SERO-CRS, 2002)

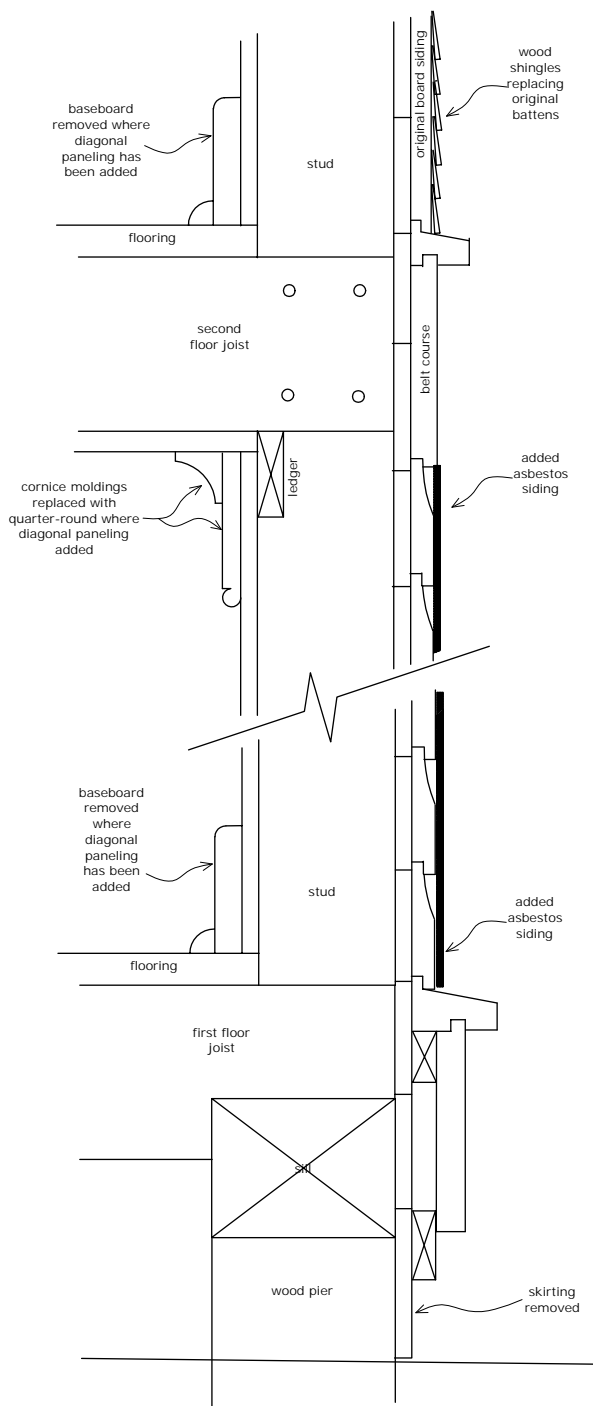
**Figure 47** Typical wall section showing framing details and finishes, adapted from original plans and from field observations. (T. Jones, NPS-SERO-CR, 2003)

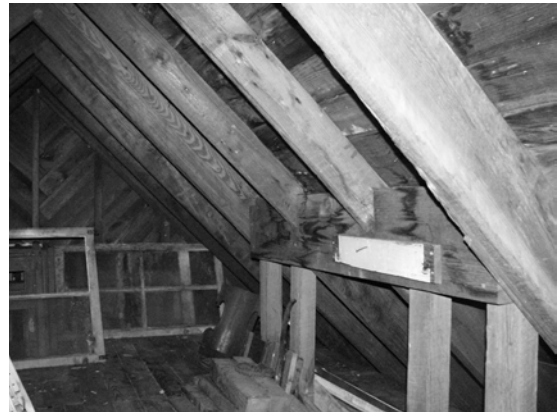
**Figure 48** View of roof framing at northeastern end of the building. Rafter at upper right is original; the next two, which are smaller, infill the original opening for the lookout. (NPS-SERO-CRS, 2002)

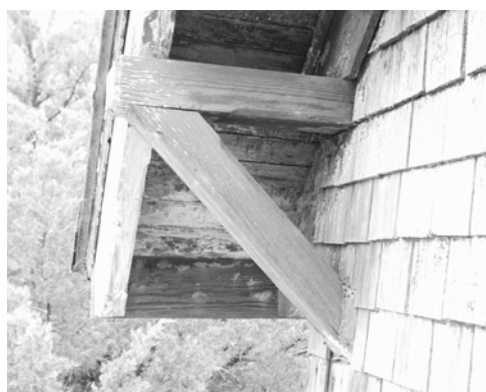
**Figure 55** View of typical gable eave bracket. (NPS-SERO-CRS, 2002)

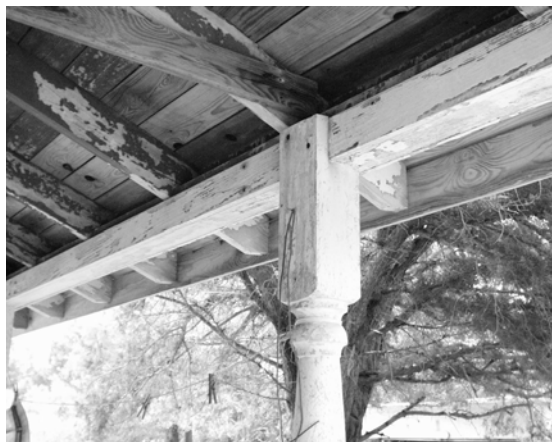
**Figure 58** View of typical post, header and roof framing on rear porch. (NPS-SERO-CRS, 2002)

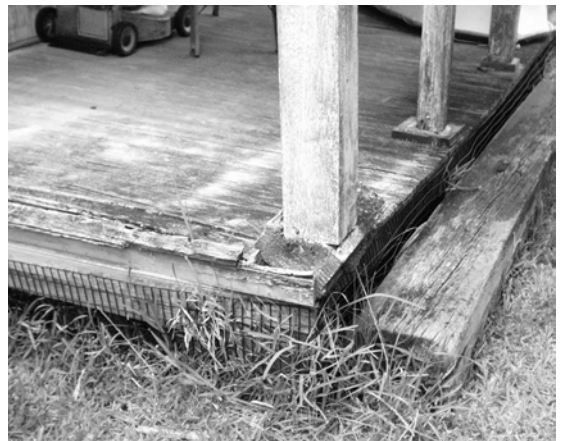
**Figure 60** View of northeast corner of front porch, showing corner post seriously destabilized by deterioration of the sills at that location. (NPS-SERO-CRS, 2002)

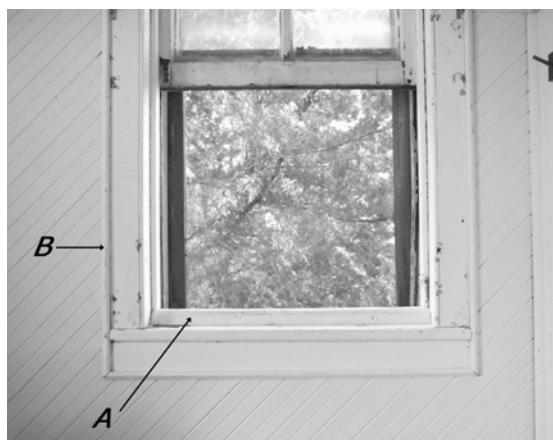
**Figure 61** Detail of typical window trim on walls where diagonal paneling has been added. "A" denotes the oversize stop added on top of the window stool. "B" denotes the 1" back band added along with the diagonal paneling. (NPS-SERO-CRS, 2002)

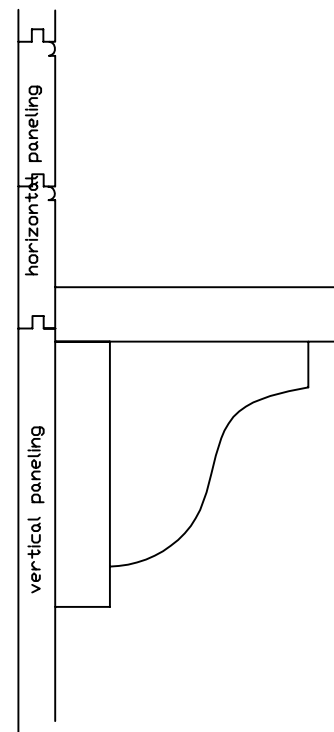
**Figure 62** Section depicting original wall finishes and rail which was removed where diagonal paneling was installed. (T. Jones, NPS-SERO-CRS, 2002)

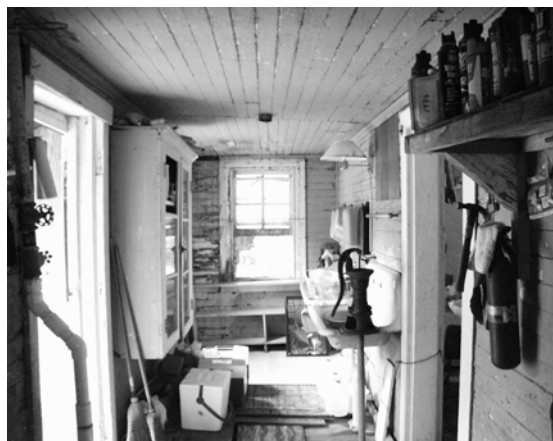
**Figure 64** View south in Room 100, showing location of original entry porch. Door opening at left replaced a window in the original configuration of the space. (NPS-SERO-CRS, 2002)

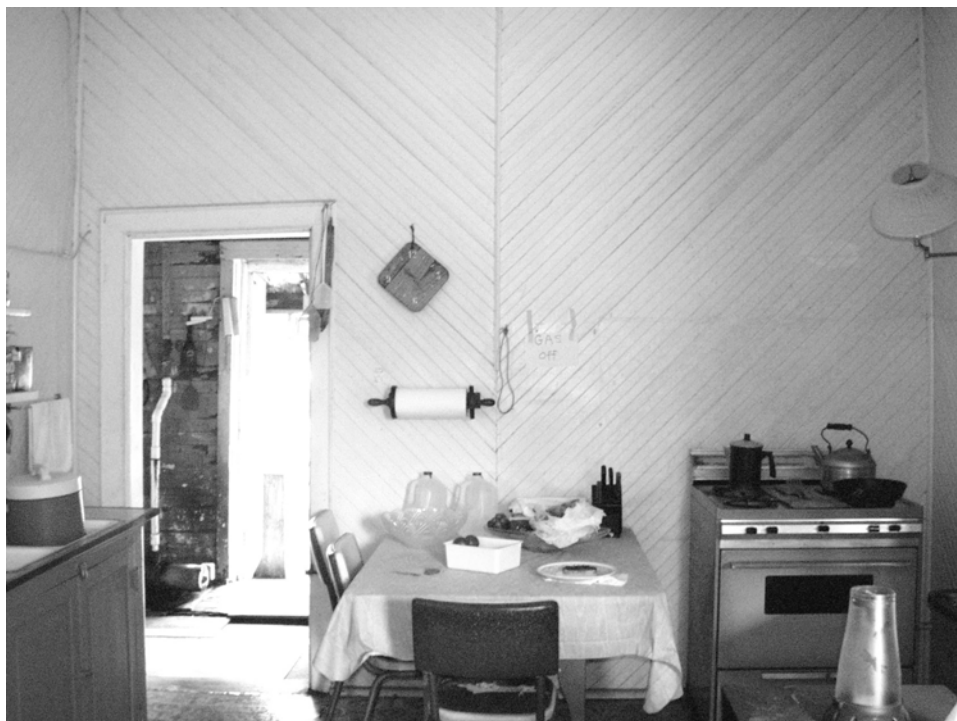
**Figure 66** View to east in Room 101, showing original door opening to Room 106 and typical diagonally-laid paneling added in the early twentieth century. (NPS-SERO-CR, 2002)

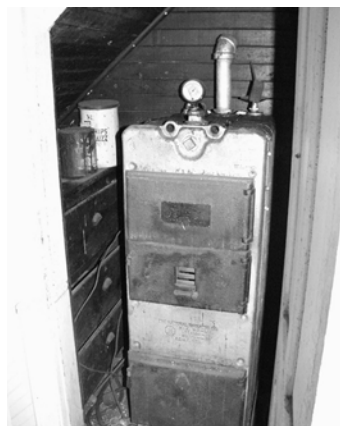
**Figure 67** View of original closet on west side of kitchen and defunct boiler now stored in the space. (NPS-SERO-CRS, 2002)

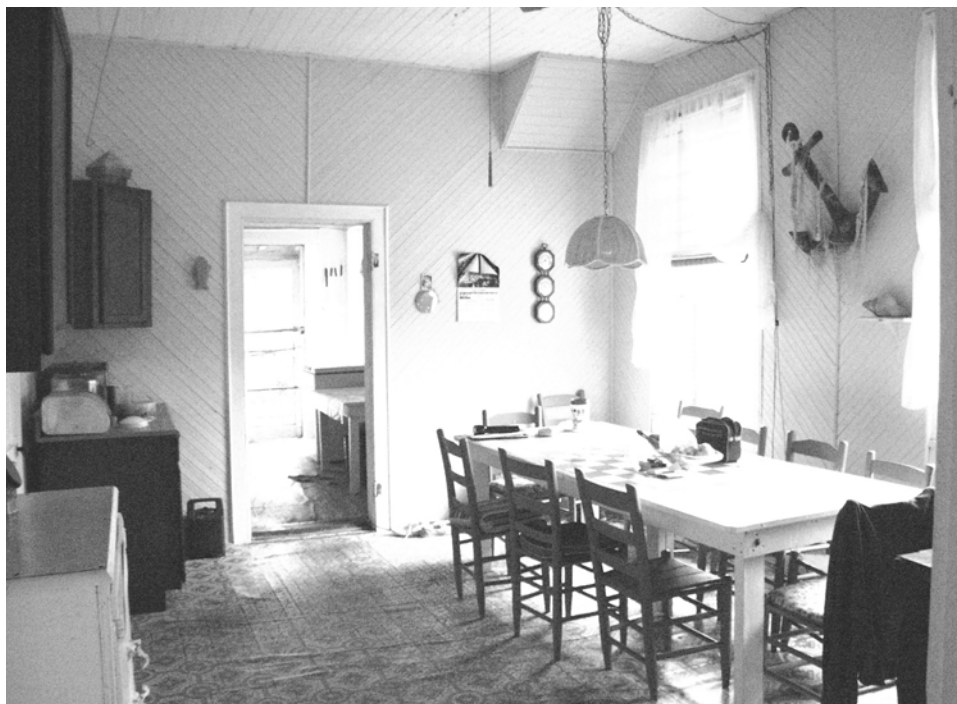
**Figure 69** View to southwest in dining room. (NPS-SERO-CRS, 2002)

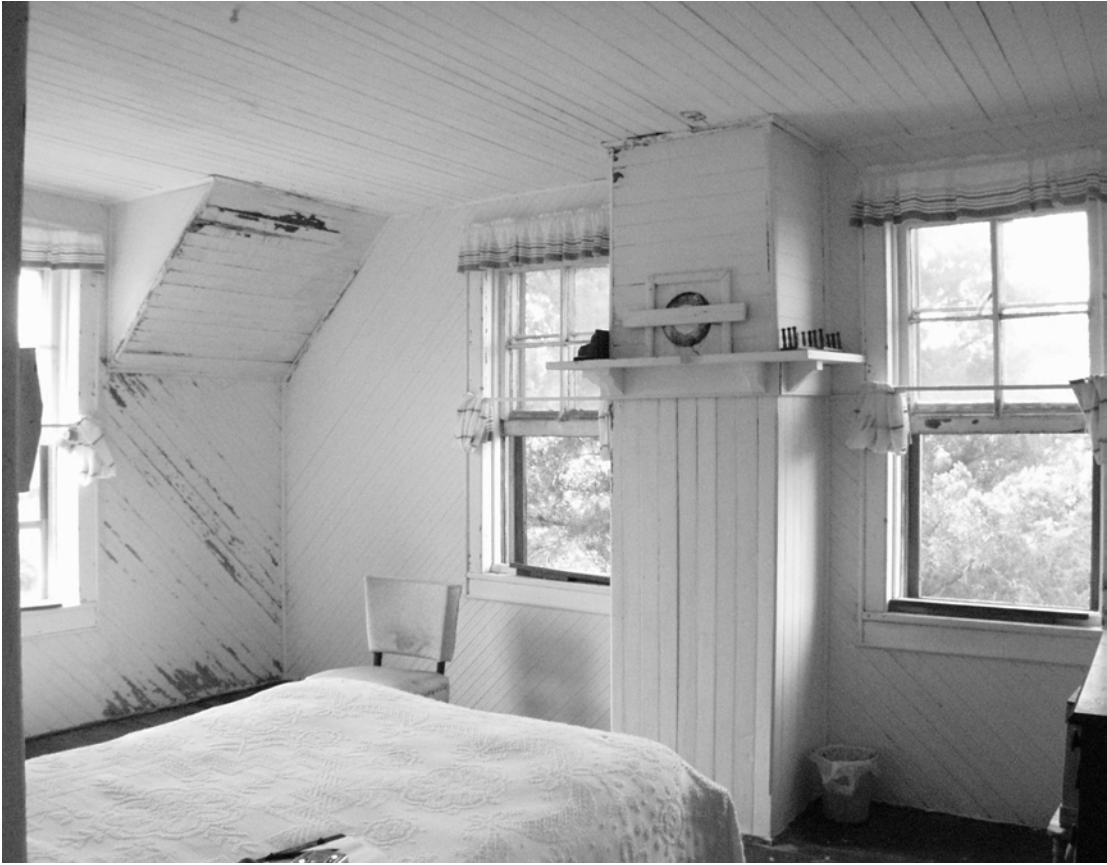
**Figure 76** View to south in old keeper's room (Room 202). Note original paneling and plate rail around chimney rising between the two windows on the south wall. (NPS-SERO-CRS, 2002)

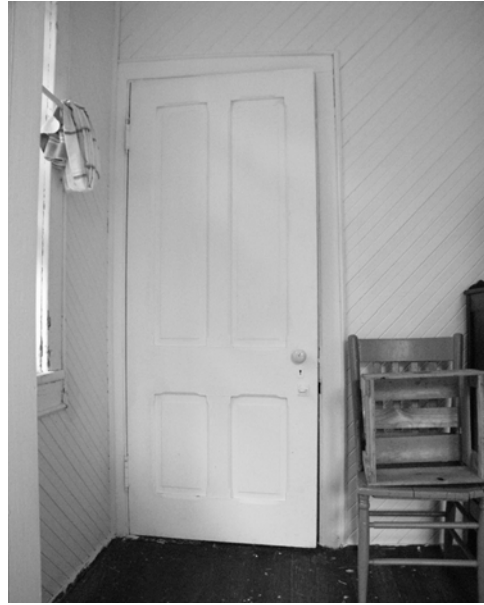
**Figure 78** View of original door in Room 202, complete with original mortise lock and porcelain knob. (NPS-SERO-CRS, 2002)

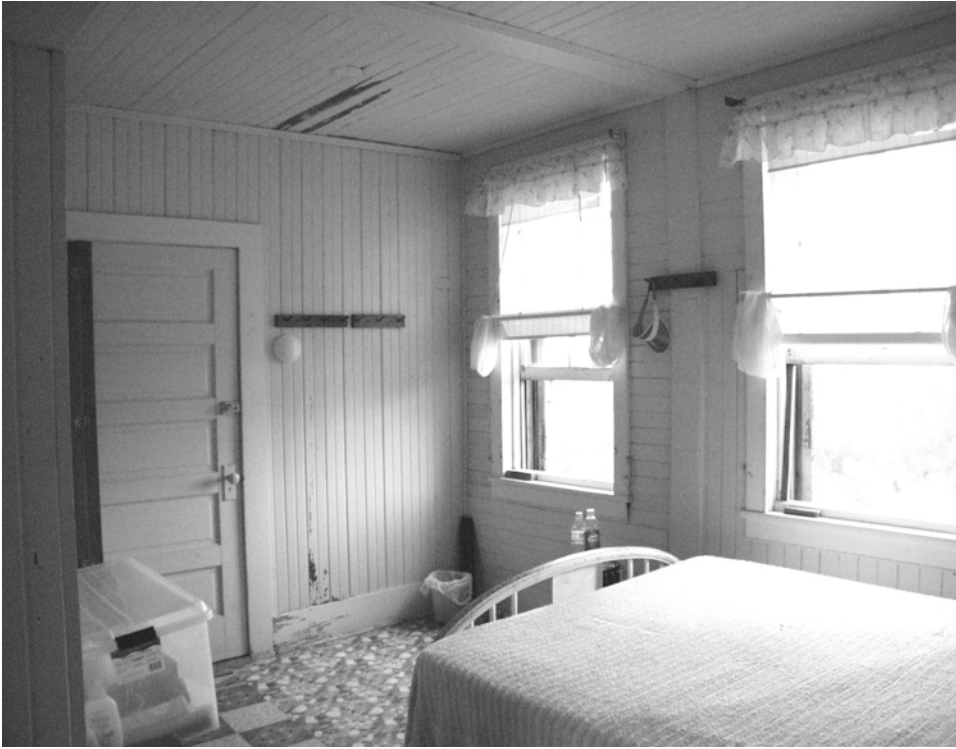
**Figure 82** View to west in Room 204. The wall that separated the original hall from the crews' quarters was located between the two windows. (NPS-SERO-CRS< 2002)
