Cape Lookout National Seashore

**Cape Lookout  
Life-Saving Station**

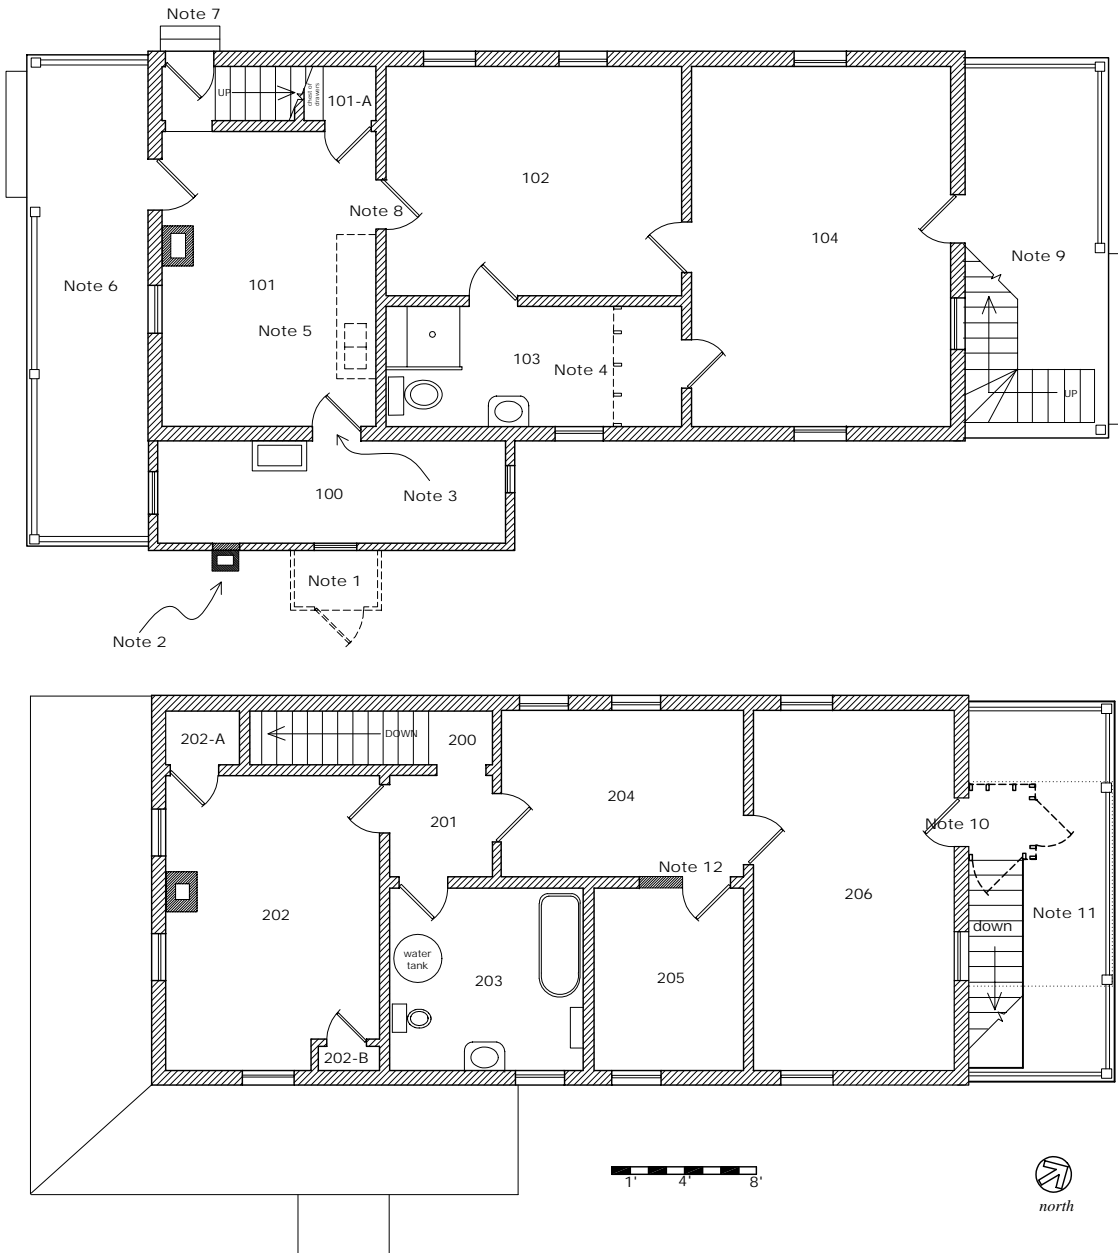
1. Remove existing vestibule and replace existing door with four-over-four window to match original.
2. Remove window and reconstruct chimney.
3. Install door currently leading to vestibule in this opening.
