I 29.86/4.5 A 5

Clemson University

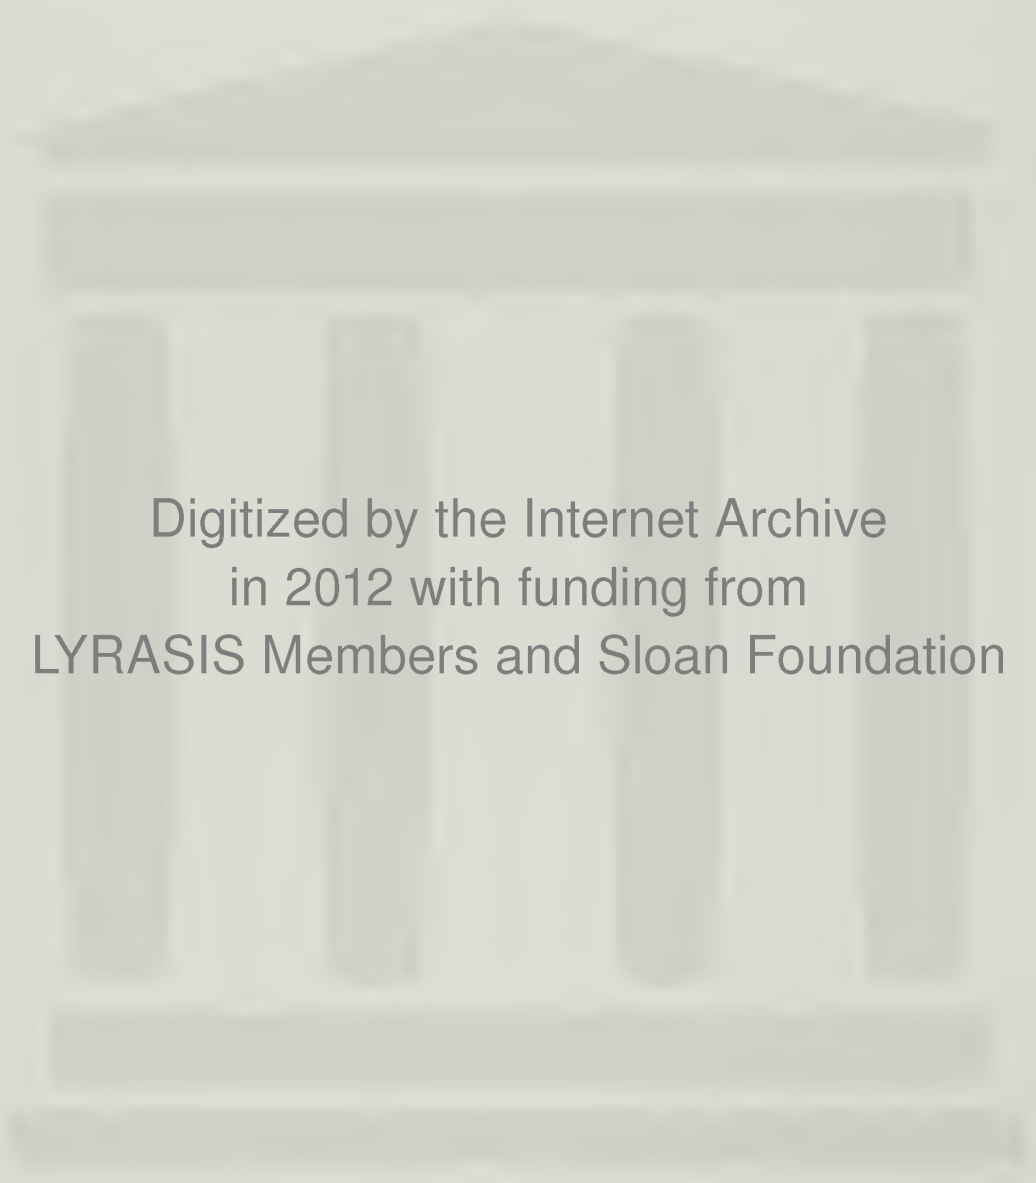
Digitized by the Internet Archive
in 2012 with funding from
LYRASIS Members and Sloan Foundation

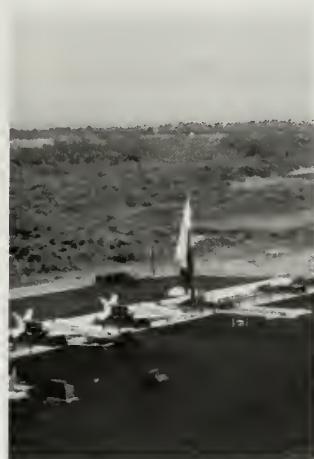
CULTURAL LANDSCAPE REPORT FOR THE SANDY HOOK COASTAL DEFENSE BATTERIES

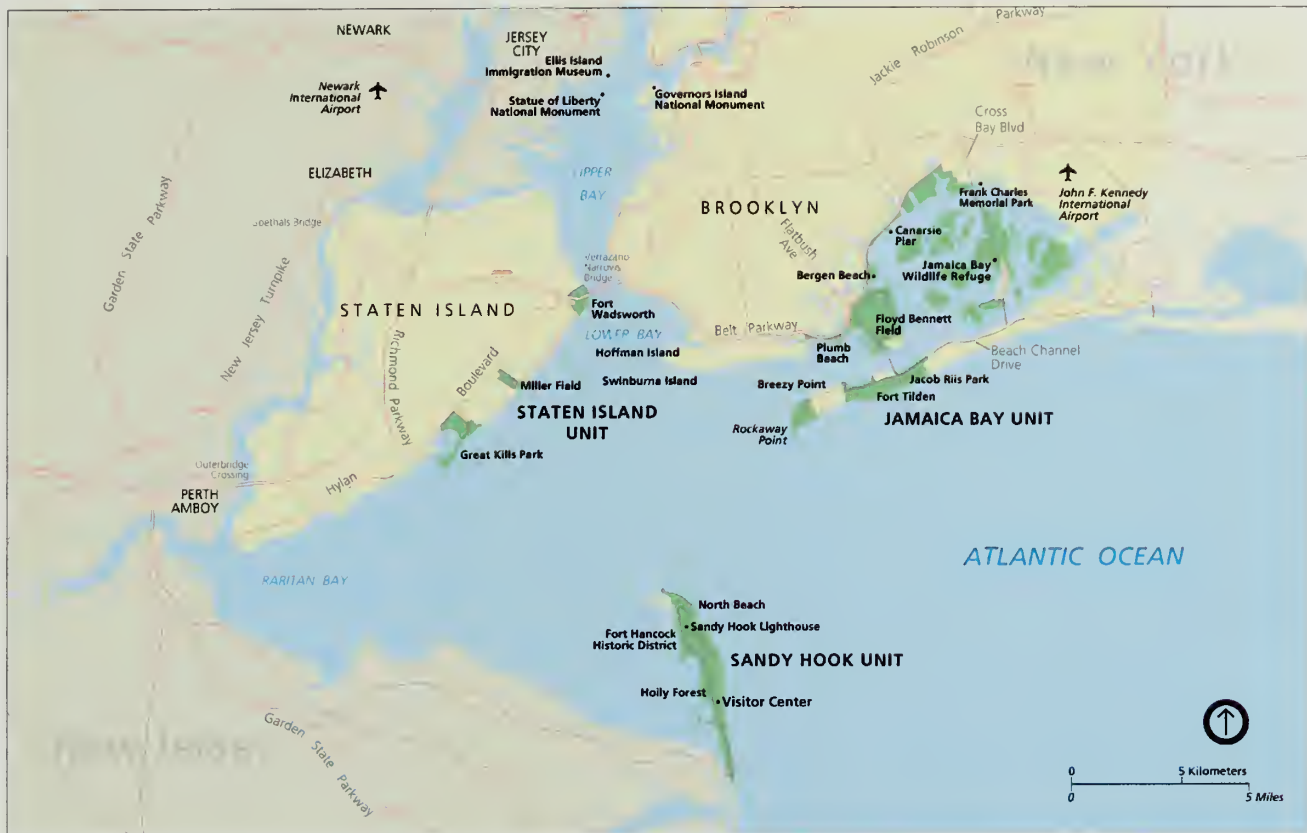
Figure 1.1. Gateway National Recreation Area Location Map. Sandy Hook is one of three units of the Gateway National Recreation Area (Harpers Ferry Center, National Park Service Maps, <http://data2.itc.nps.gov/hafe/hfc/carto-detail.cfm?Alpha=GATE#>).

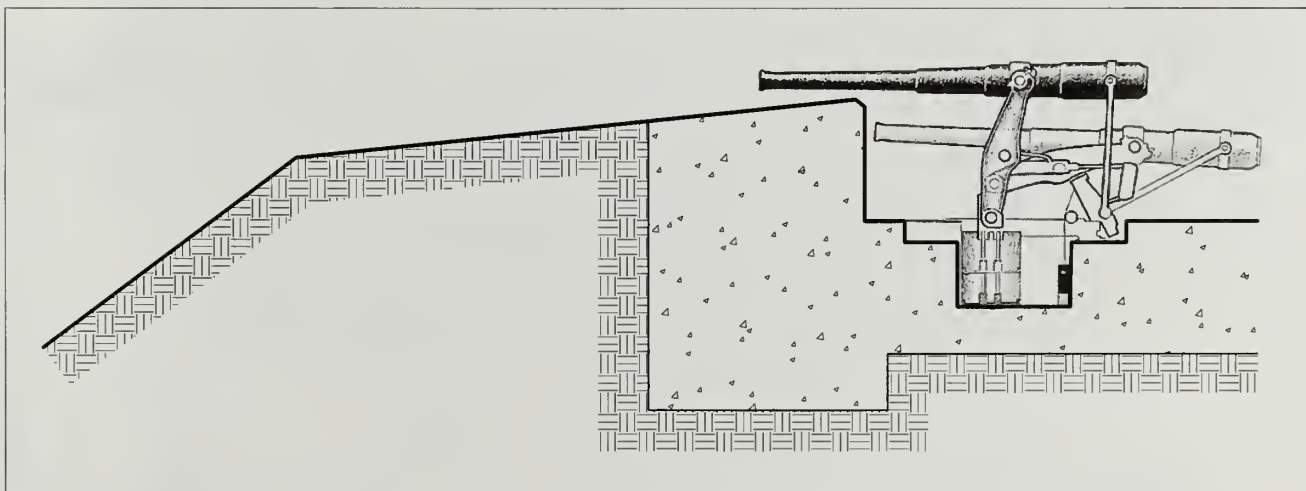
Figure 2.12. Section of disappearing gun in concrete and earth-shielded battery. Following the Endicott Board's recommendations, new coastal defenses utilized rifled artillery emplaced in concrete platforms that were shielded by concrete and earth for impact absorption and concealment into the surrounding landscape (Hugh Brown, Harpers Ferry Center Commissioned Art Collection, Exhibit 12/Graphic # 12-7 and Olmsted Center).

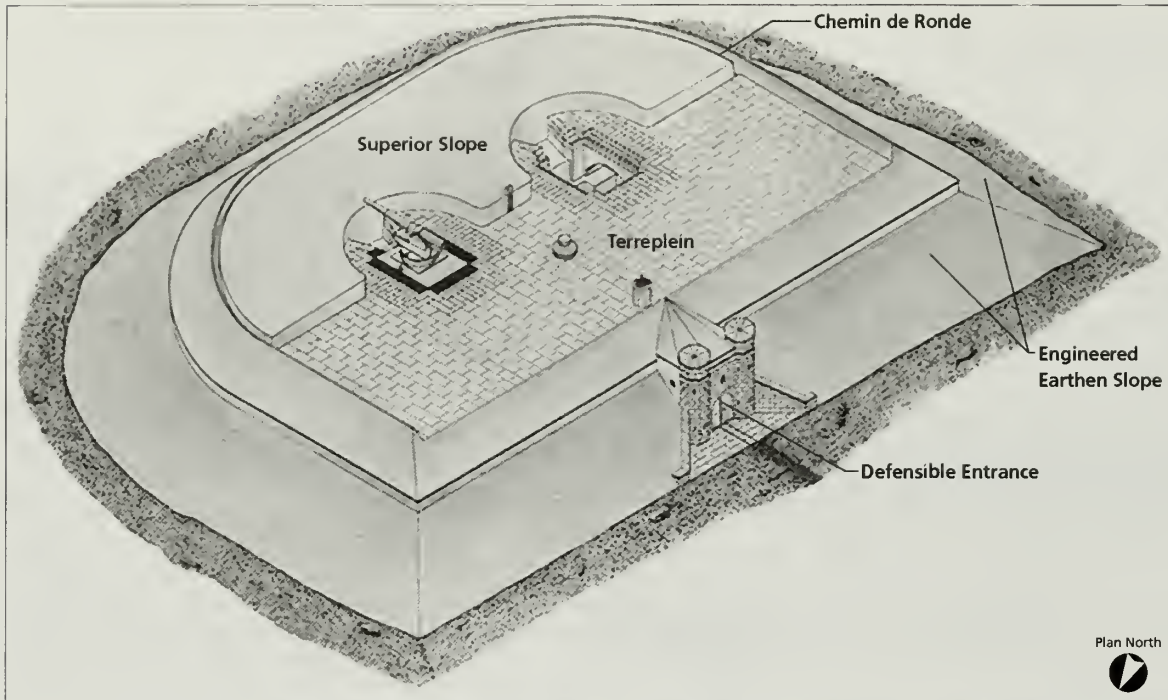
Figure 2.13. Annotated isometric view of Battery Potter. Battery Potter’s west facade featured a defensible entrance that resembled a castle. At the top of the battery, two openings were constructed in the terreplein for raising and lowering the guns. East of the guns, a concrete superior slope gently descended to a sentry route known as a *chemin de ronde* that was fronted by a parapet wall. A concrete slope angled away from the parapet and met an engineered earthen slope that blended the massive concrete structure in with the surrounding land (GATE 10312 and Olmsted Center).

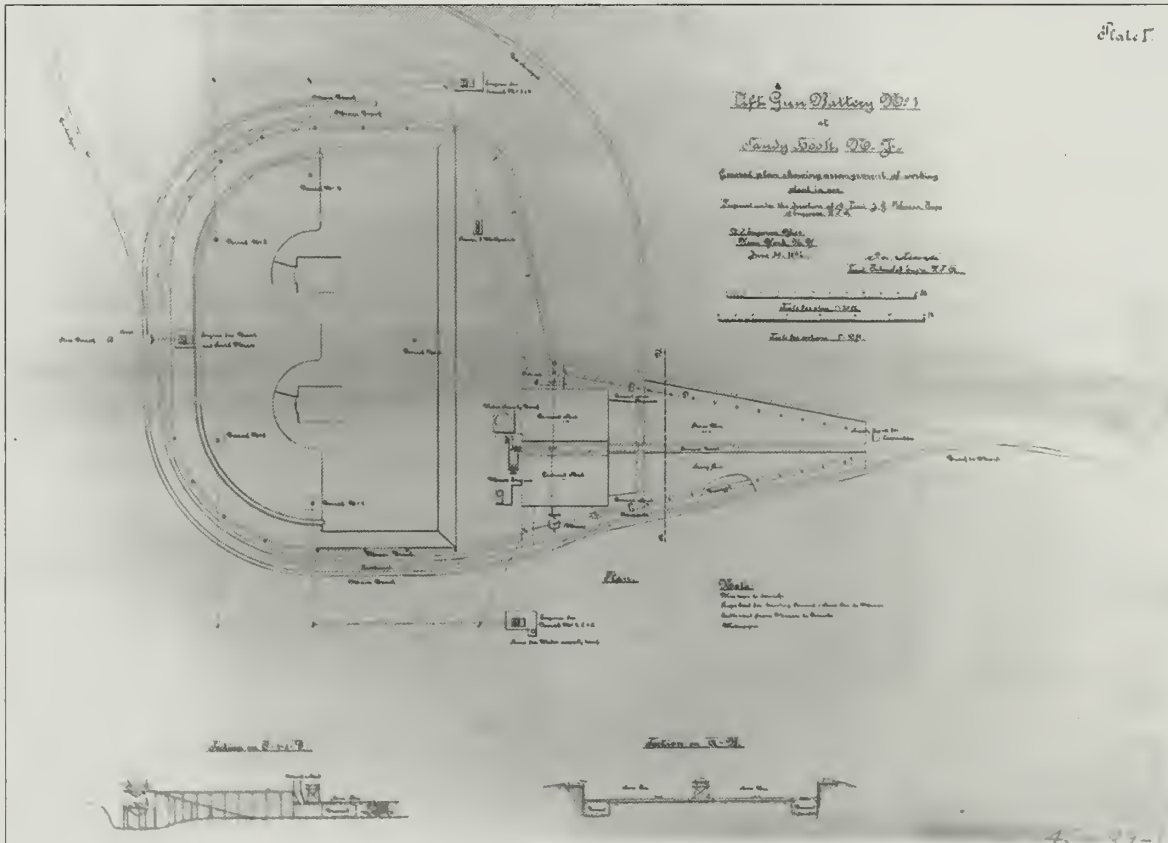
Figure 2.14. Lift Gun Battery No. 1 at Sandy Hook, N.J., June 30, 1892. Prior to excavation starting for Battery Potter, temporary storage facilities were constructed and mixing equipment installed for concrete production. Cement and broken stone were transported by railroad to the production site west of the battery (Lee and Laham, *Historic Structure Report*).

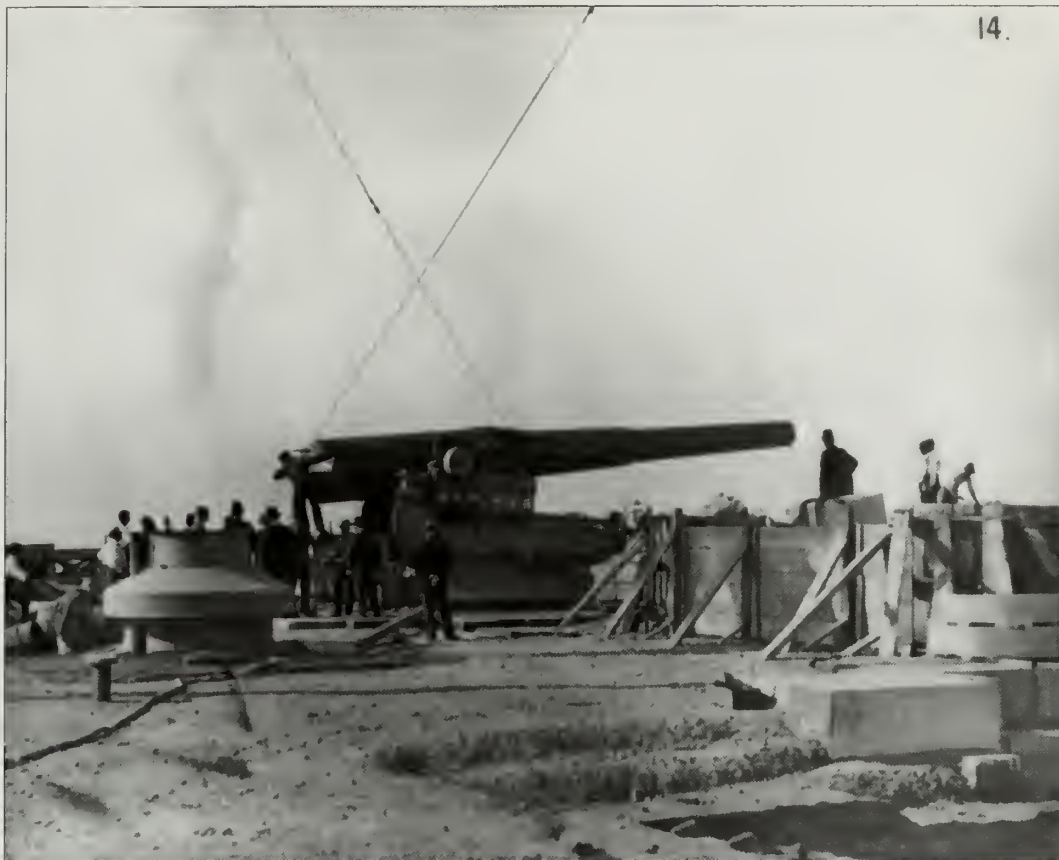
Figure 2.15. Battery Potter's north emplacement, September 12, 1892. The first of Battery Potter's two 12-inch guns was mounted at the north emplacement in August 1892. A month later, two rounds were test fired inaugurating a new era of coastal defense for metropolitan New York (GATE 7804).

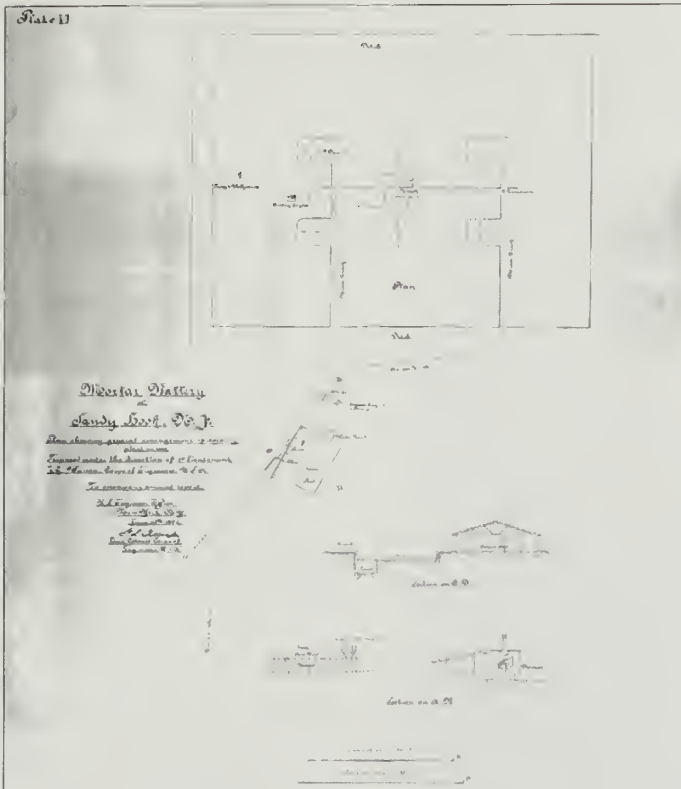
Figure 2.22. Plan for concrete plant at the Mortar Battery, 1892. Similar to the work undertaken at Battery Potter, concrete for the Mortar Battery was produced at a dedicated, constructed facility that stored and mixed broken stone, cement, sand, and water. Broken stone and cement arrived at the site by a railroad that originating at the government wharf (GATE 10676).

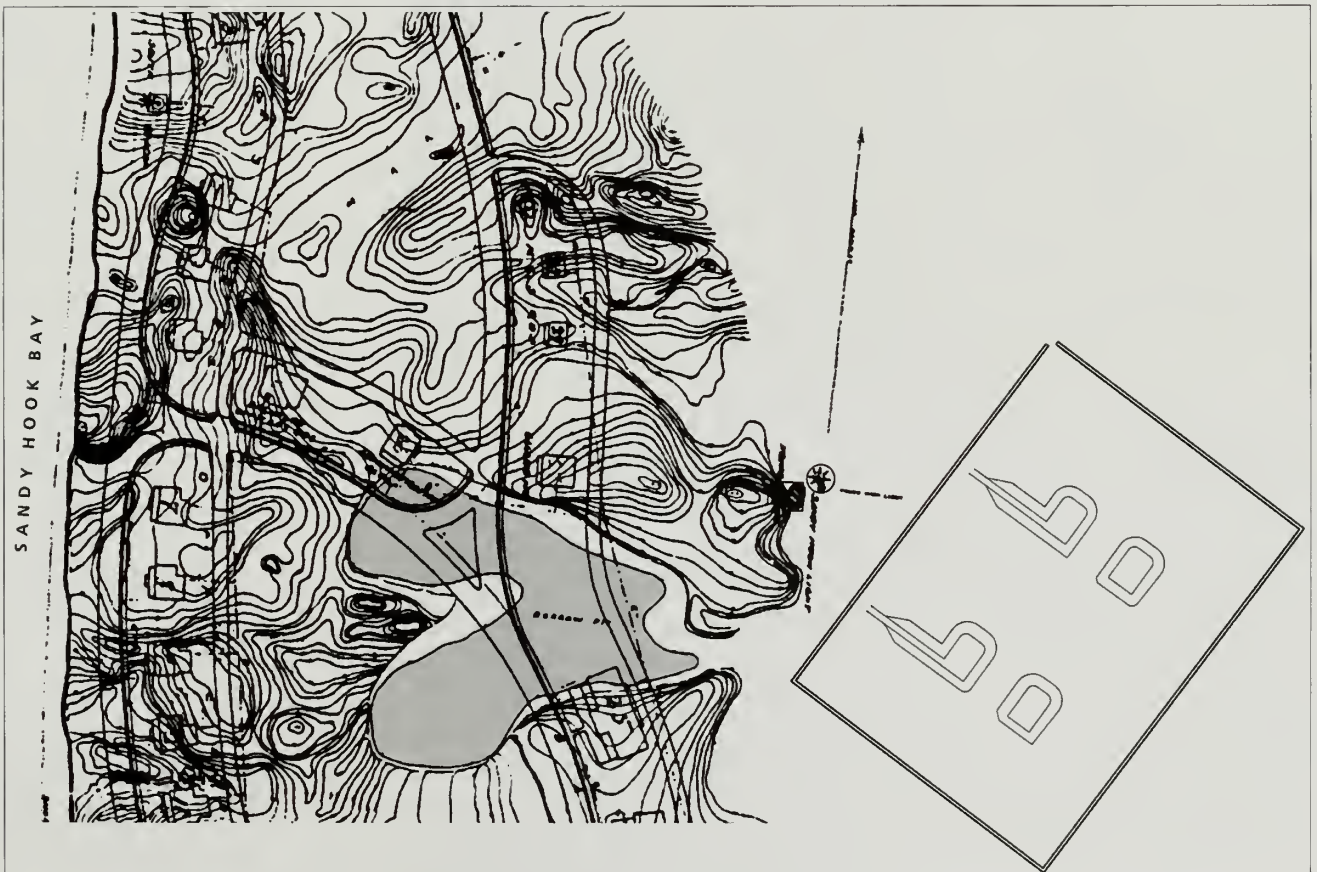
Figure 2.23. Plan of sand borrow pit and relationship to the Mortar Battery. Sand for concrete production and to create the Mortar Battery's engineered earthwork was excavated from nearby deposits known as borrow pits (highlighted by gray tone) and brought to the site by rail lines (Olmsted Center, 2009).

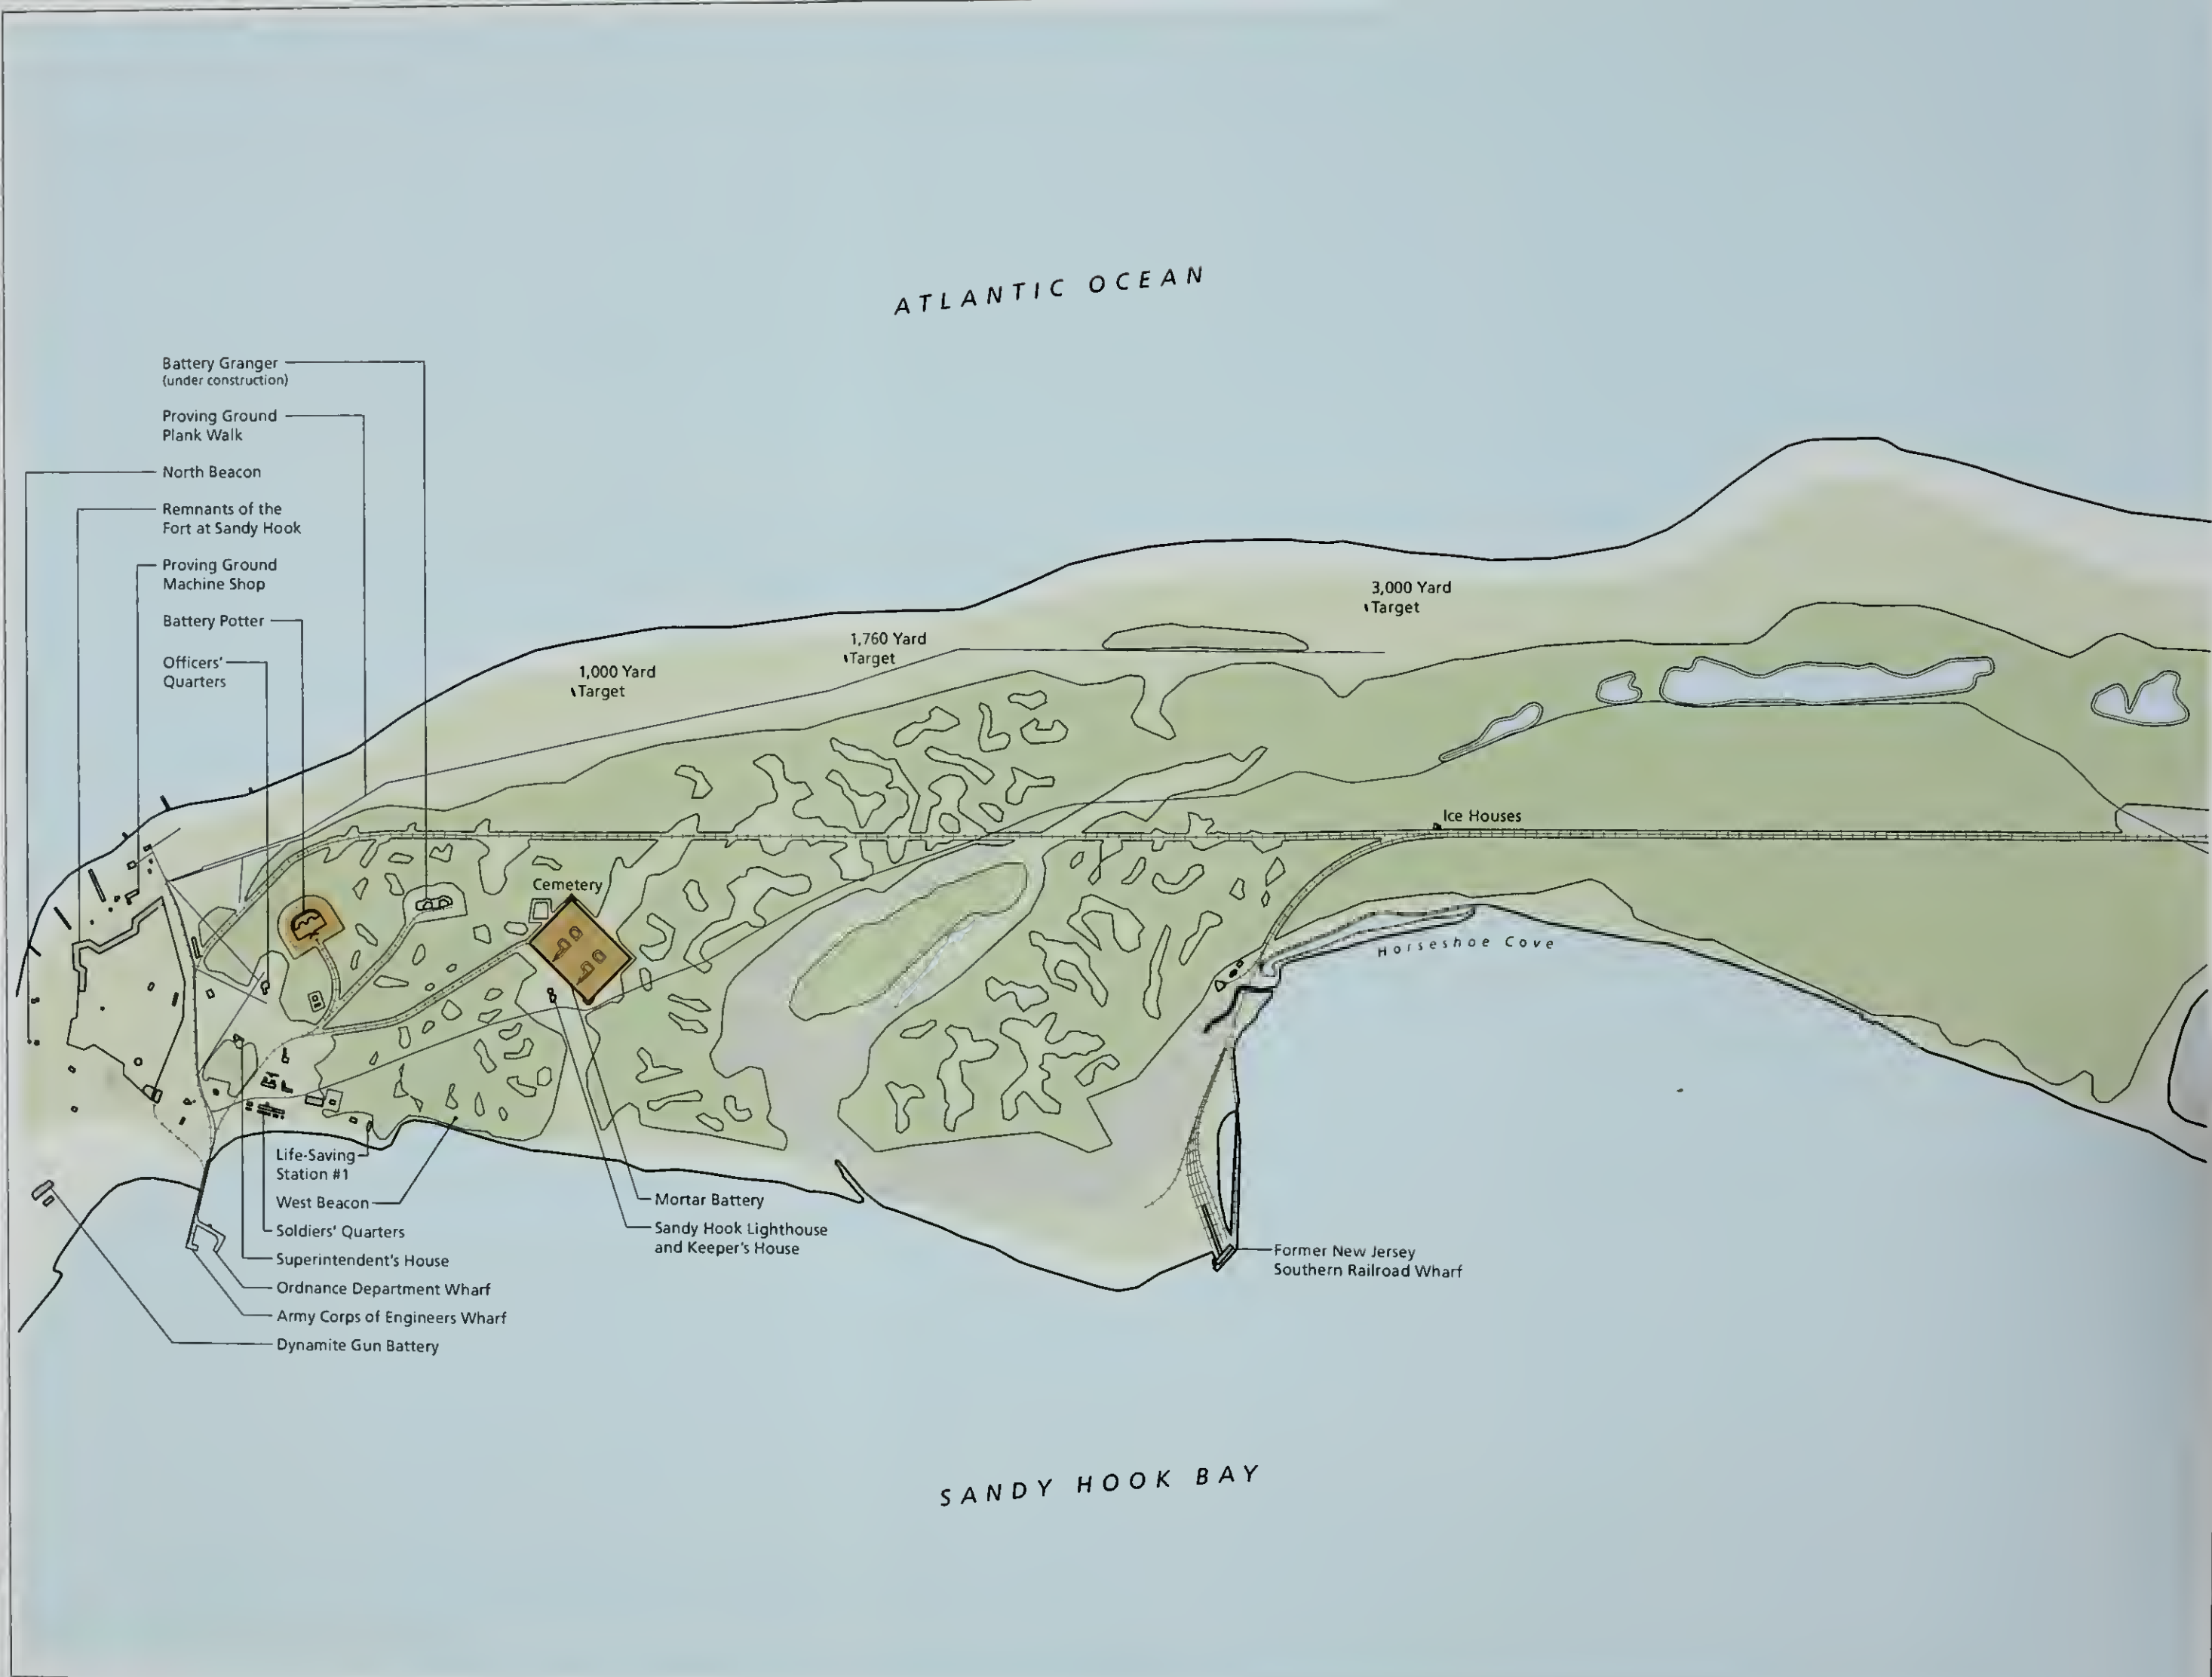
EXPANSION OF COASTAL DEFENSES 1895–1919

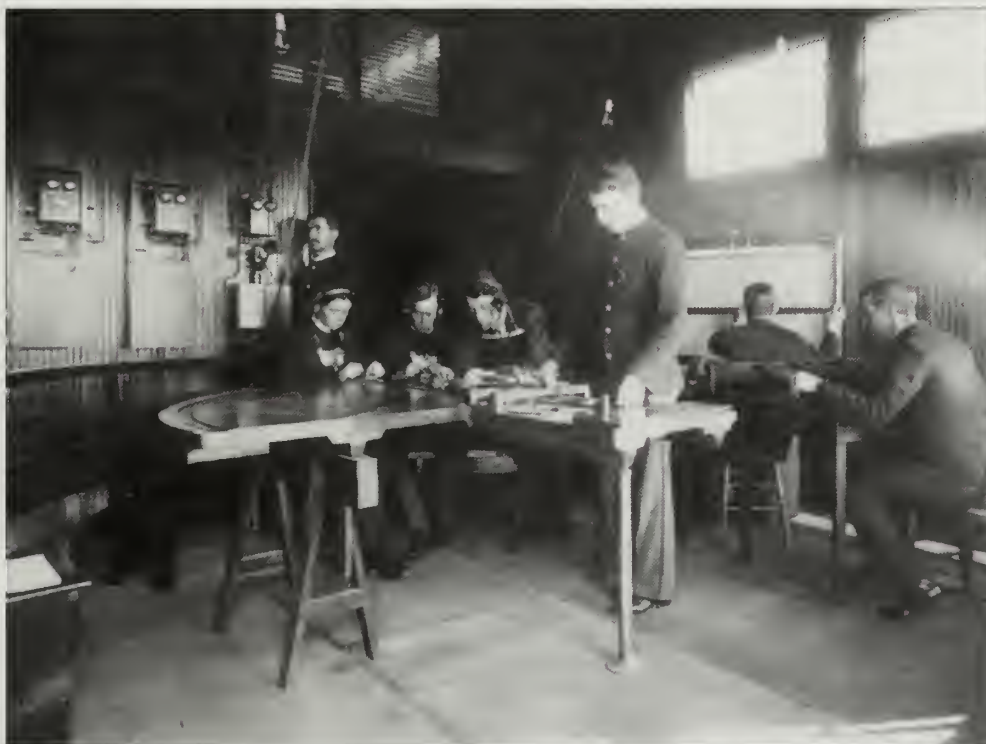
Figure 2.25. Interior of Battery Potter plotting room, circa 1907. Part of the Taft Board's recommendations to incorporate the latest technology resulted in improvements to fire control—the process of acquiring and firing on enemy ships. The communications between observation, calculating, and firing were increasingly handled by telephone, seen mounted on the wall in this image (GATE 7819).

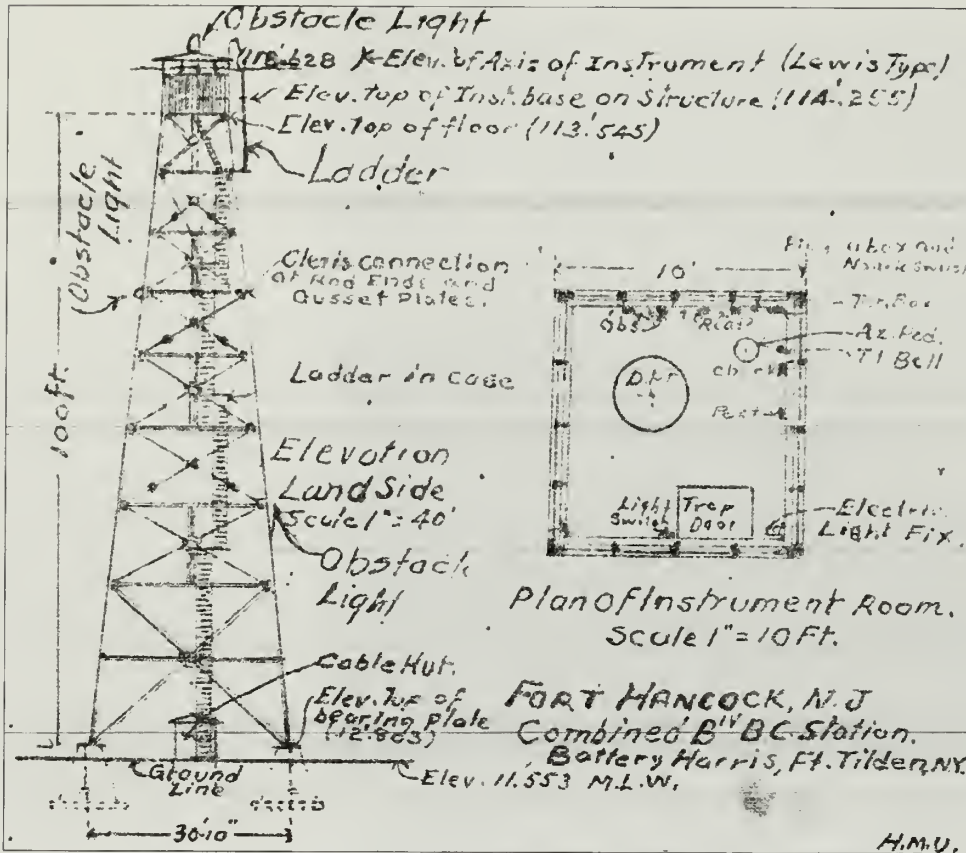
Figure 2.26. Battery commander's station for Fort Tilden's Battery Harris, 1927. The accuracy of triangulating an enemy ship's position improved with greater distance between two observation points. The Army erected a tower at Sandy Hook to support the aiming accuracy of the guns at Fort Tilden, located on the Rockaway peninsula in New York (Report of Completed Works, CDSG ePress).

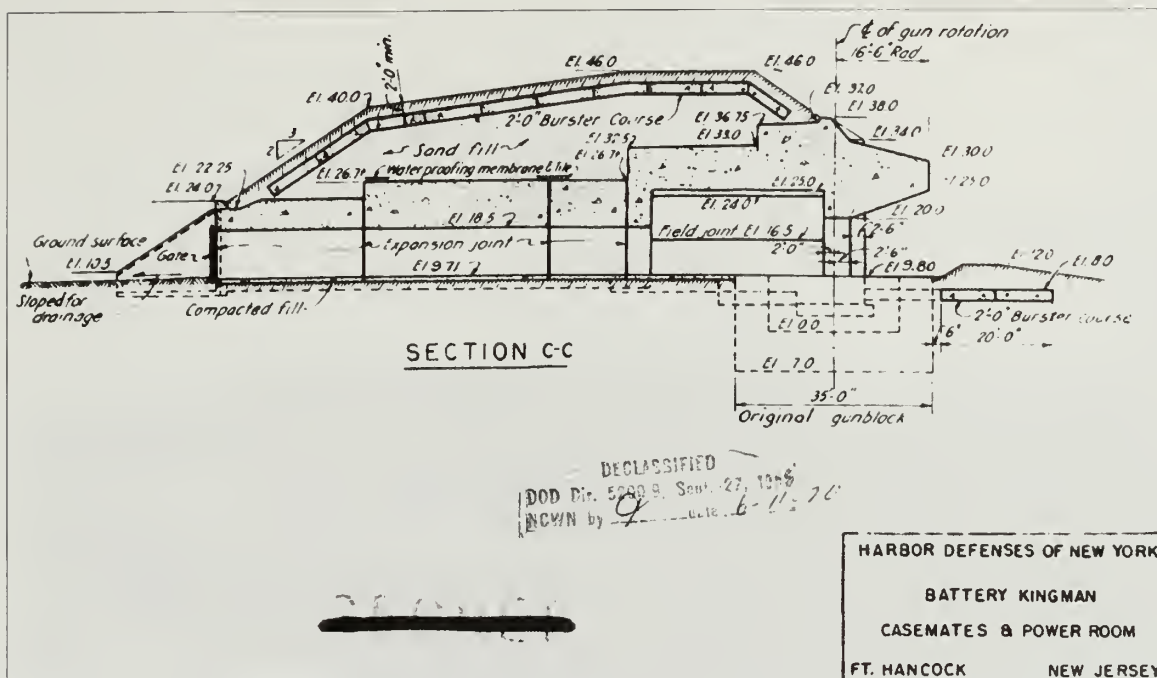
Figure 2.78. Section through Battery Kingman's emplacement #2, 1944. Two of the protective measures added to Batteries Kingman and Mills were concrete canopies that extended over the gun platforms and a concrete burster course intended to denote a bomb near the surface of the casemate before it could penetrate deeper into the earthwork and cause more damage (Report of Completed Works, CDSG ePress).

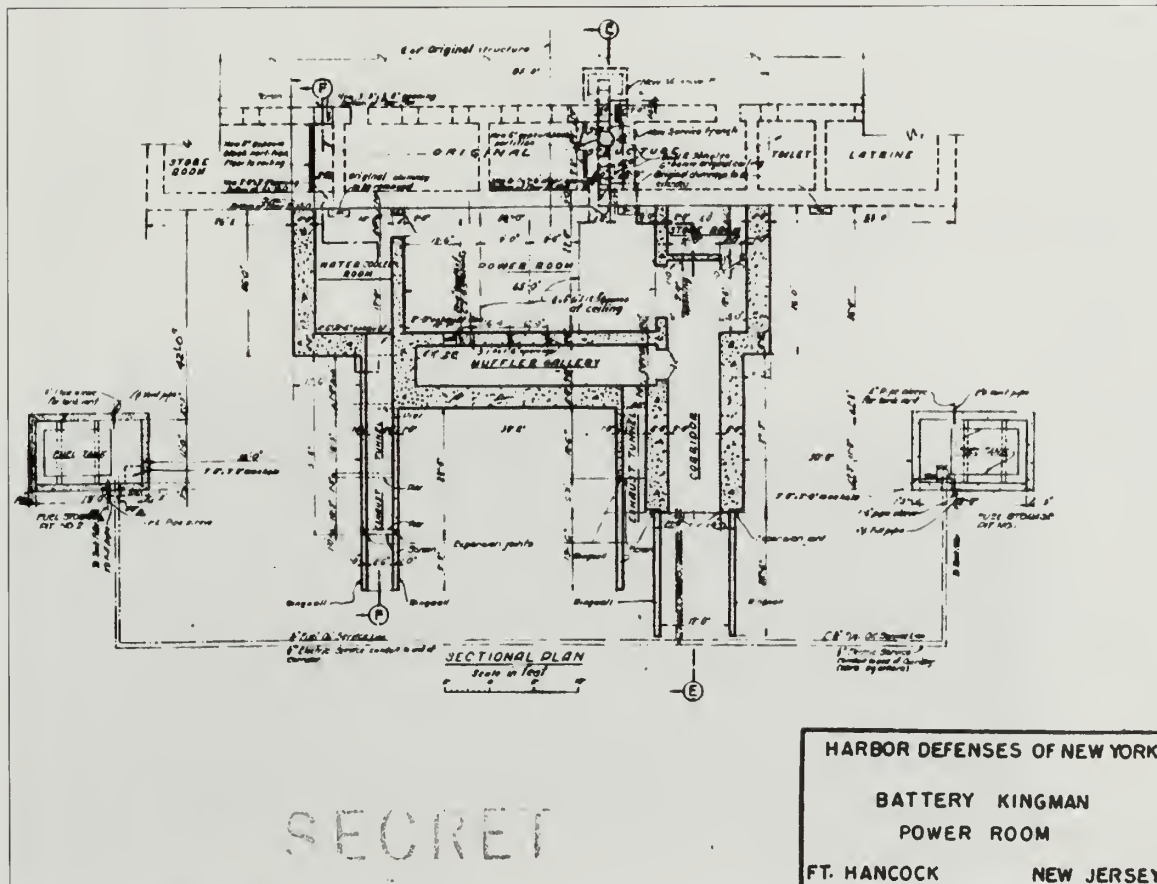
Figure 2.79. Plan of power room at Battery Kingman, 1944. Preparing Batteries Kingman and Mills for World War II also included adding a power room to the west of the quarters and store room. The existing railroad tracks that had traveled under a covered passageway were moved to the west of this addition (Report of Completed Works, CDSG ePress).

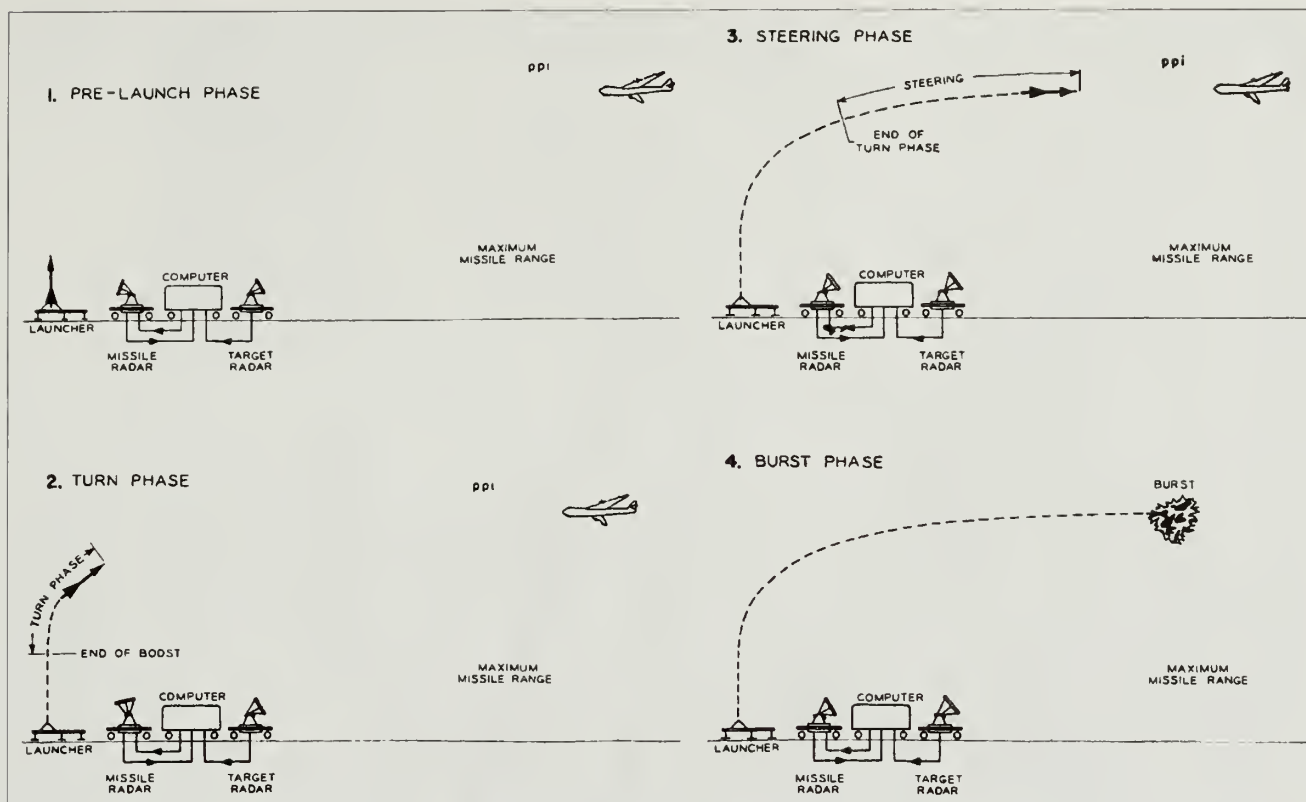
Figure 2.89. NIKE Ajax missile flight diagram. Ajax missiles were guided by a series of three radars. Incoming enemy aircraft were identified by acquisition radar and then transferred to Target Tracking Radar (TTR) to determine the aircraft's elevation and range. Based on tracking information, missile guidance was calculated and sent to Missile Tracking Radar (MTR) to control the missile's flight. Upon arriving at the predicted intercept point, computers transmitted a burst signal to detonate the missile (Mary T. Cagle, *Historical Monograph: Development, Production, and Deployment of the NIKE Ajax Guided Missile System 1945–1959*, United States Department of Defense, Army Ordnance Missile Command, June 1959).

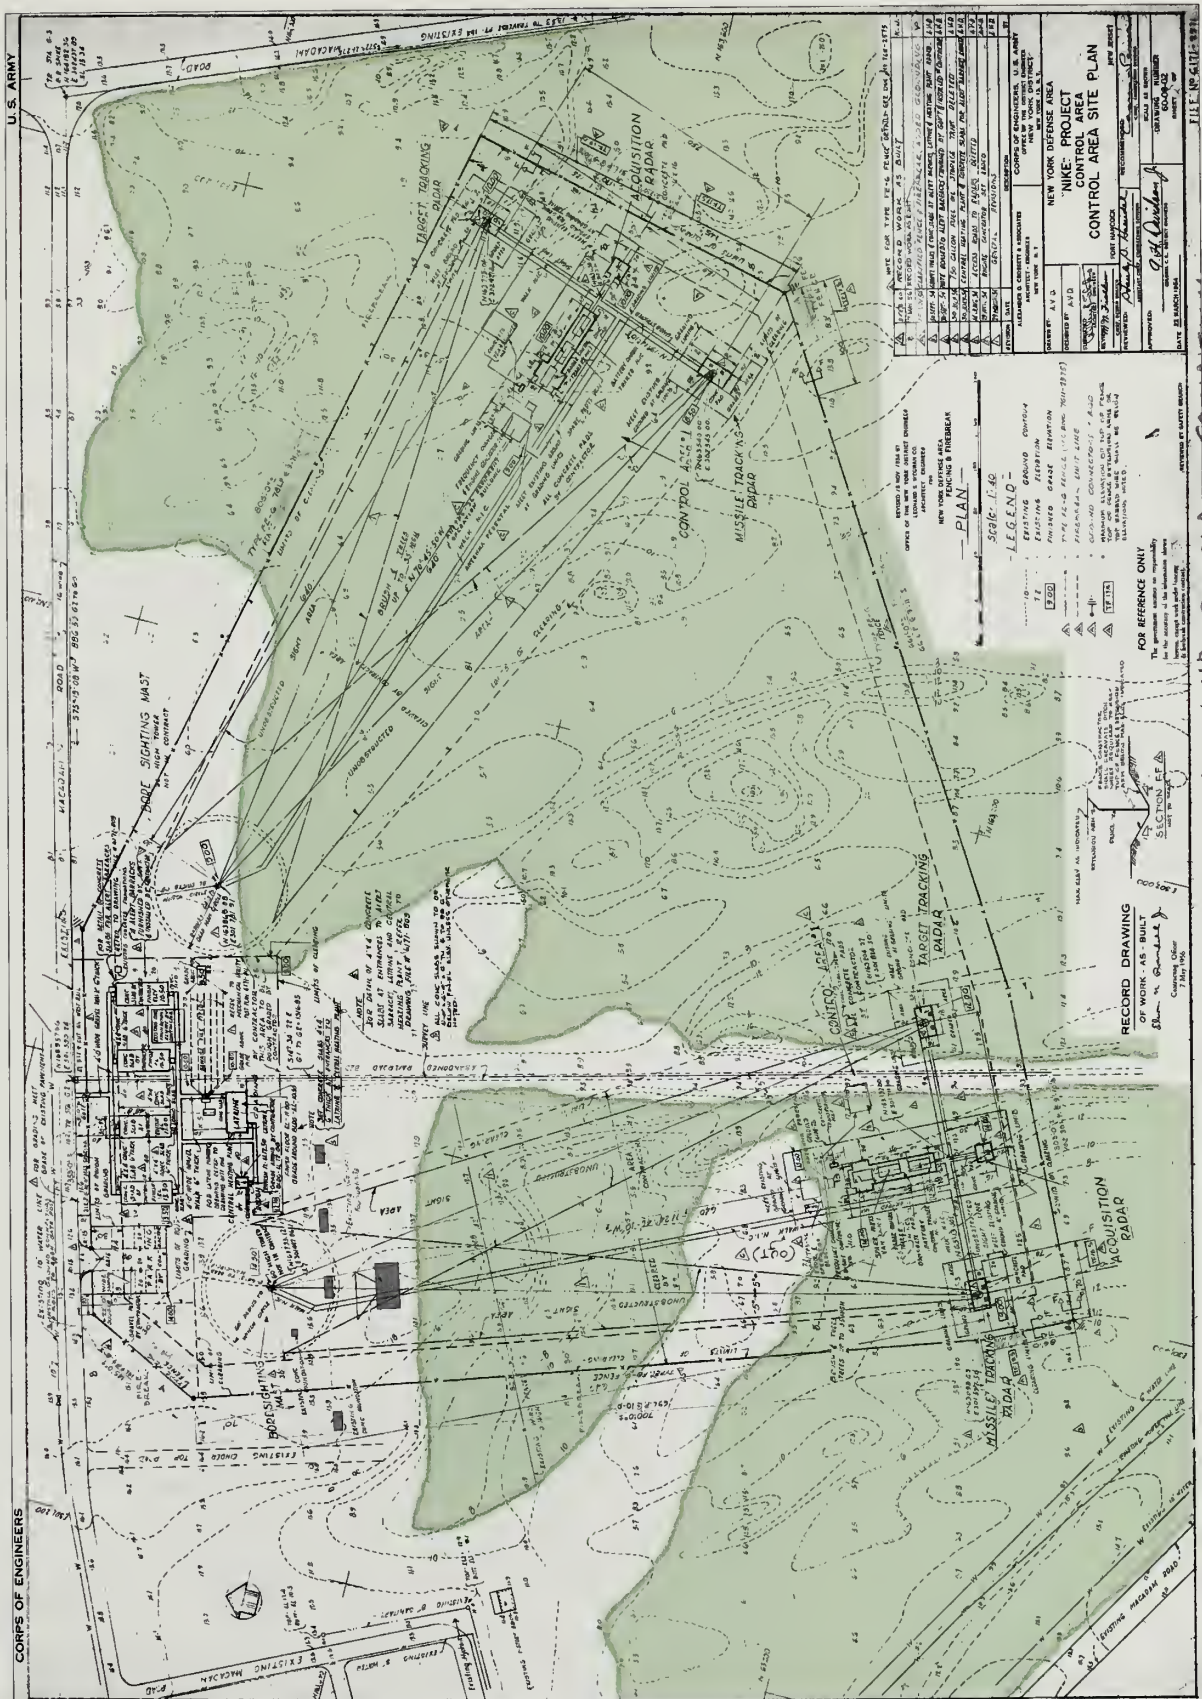
Figure 2.94. "NIKE" Project, Control Area Site Plan, 1954. In the proposed layout of the NIKE radar site, six concrete foundations (shaded gray) lack building descriptions and appear small enough to be outbuildings or auxiliary structures. The plan also shows vegetation cover (shaded green) occupying more than half of the proposed area and labeled "brush and trees up to 35' high" (GATE 11052 and Olmsted Center).

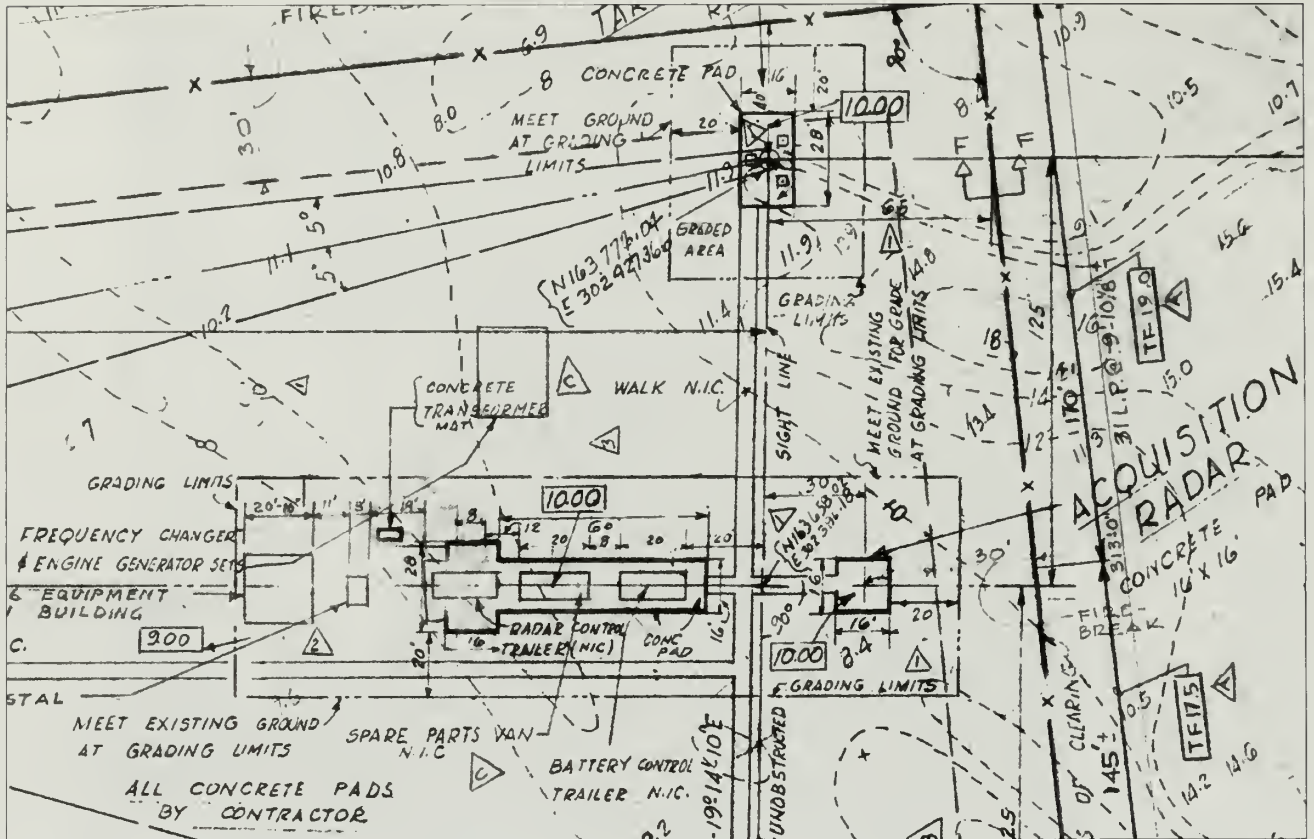
Figure 2.95. Detail of acquisition radar and control trailers, NIKI Project, Control Area Site Plan, 1954. At both control areas, two trailers located north of the acquisition radar contained computers and equipment for radar and missile guidance. In between the two trailers was a third used for maintenance and storing spare parts (GATE 11052).

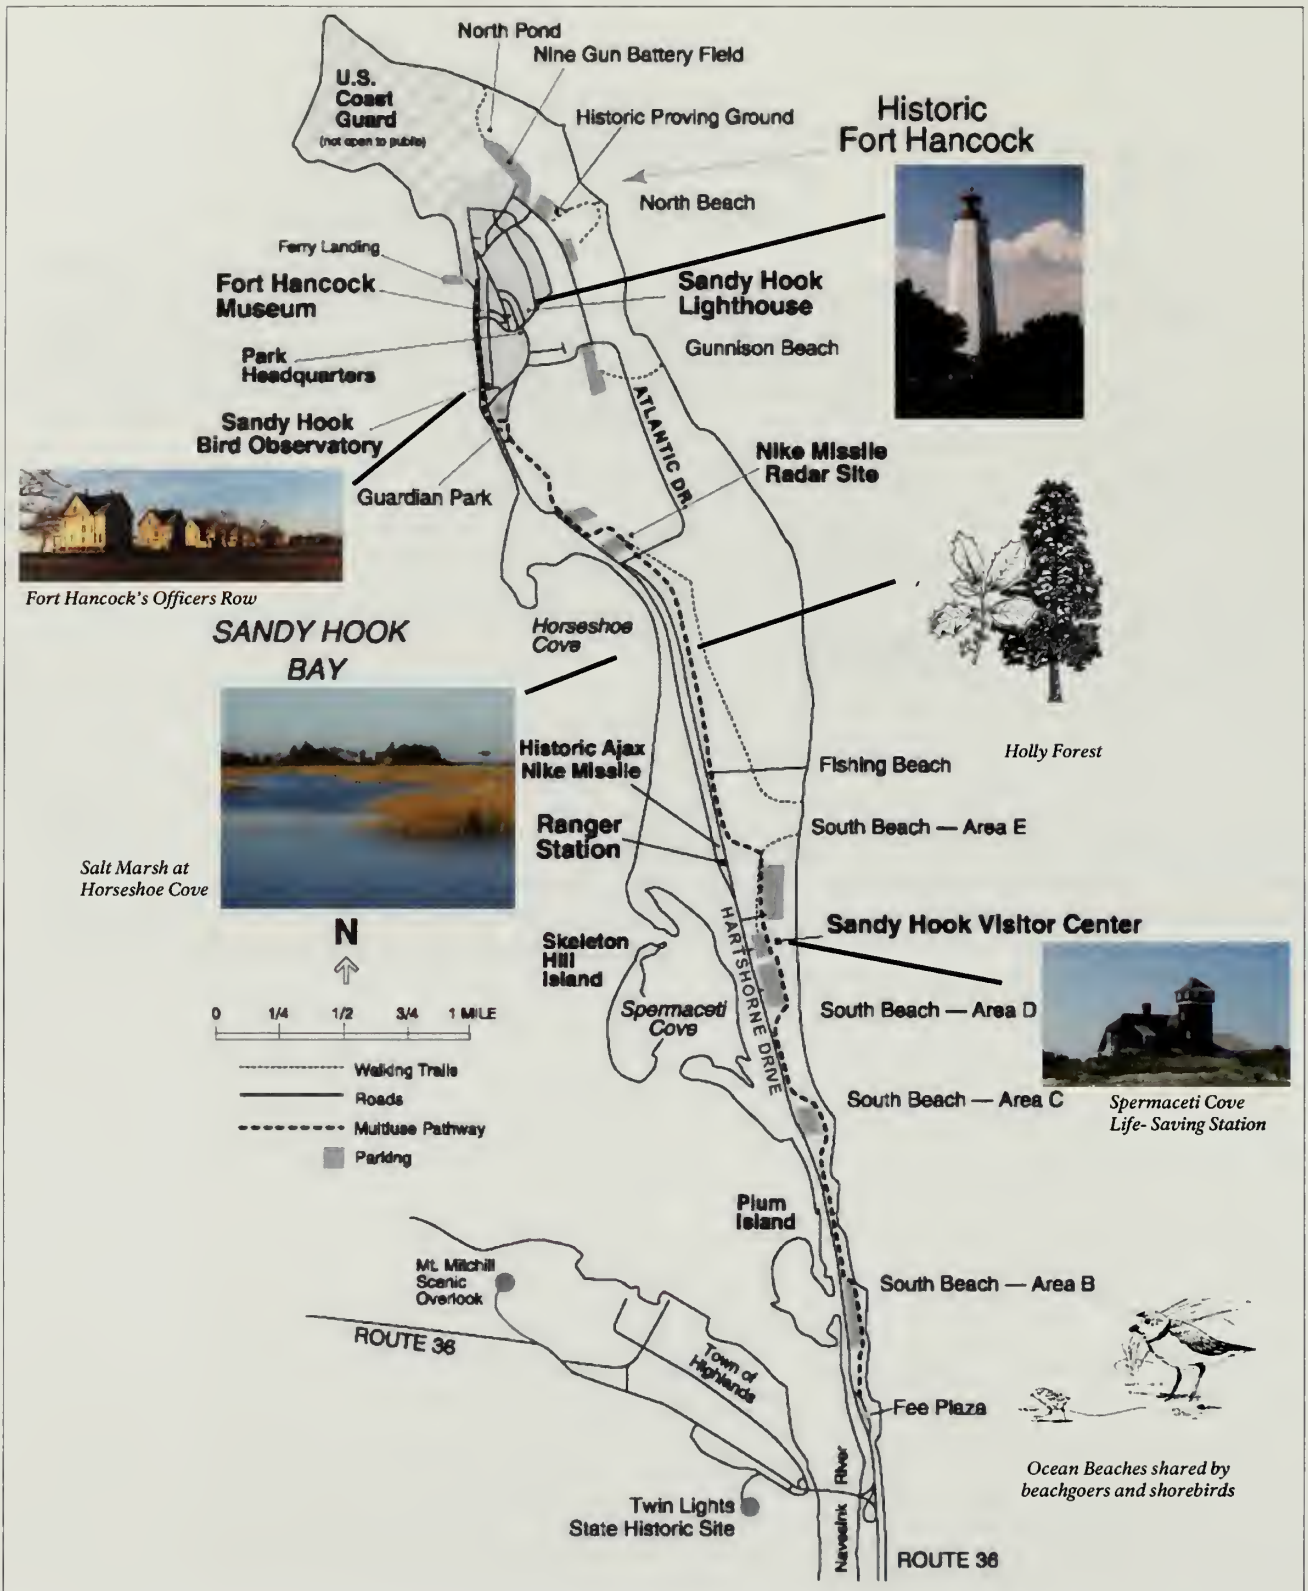
Figure 2.120. Multi-use path map. Recently, the park installed a Multi-Use Path that starts at the south entrance C and continues north to the ferry landing. The path was designed to accommodate bicycle, roller blade, and pedestrian traffic and routes visitors past the perimeters of the NIKE radar and launch sites (<http://www.nps.gov/gate/planyourvisit/upload/mup%20map.pdf>).

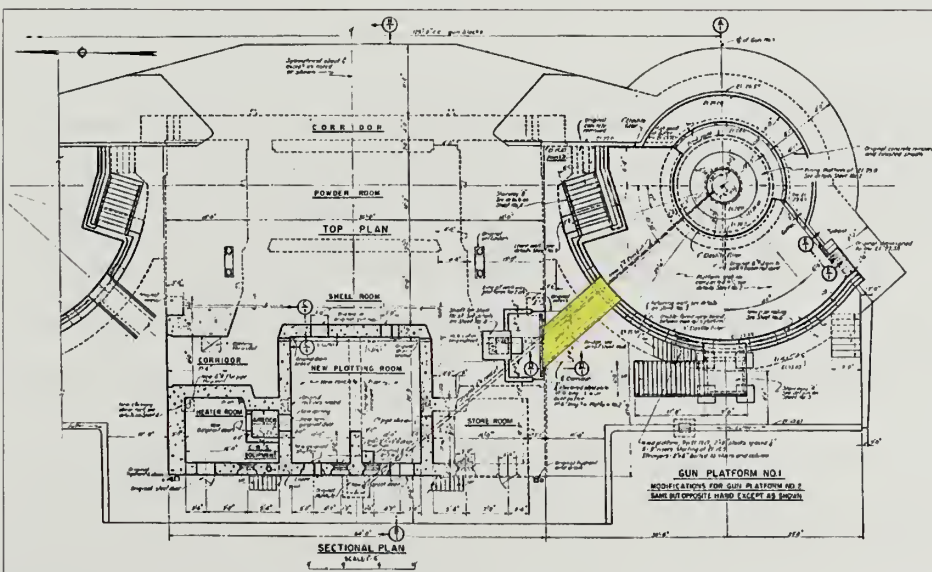
Figure 2.122. Detail of Harbor Defenses of New York, Battery Gunnison, Alterations and Additions, Fort Hancock, New Jersey, 1943. In 2001, the park demolished a concrete bridge (highlighted in yellow) at Battery Gunnison in order to eliminate hazards created by the deteriorating concrete. The bridge spanned between the south gun platform and the shell hoist (GATE 10689).
