I 29.86/4.5 A 5

Clemson University

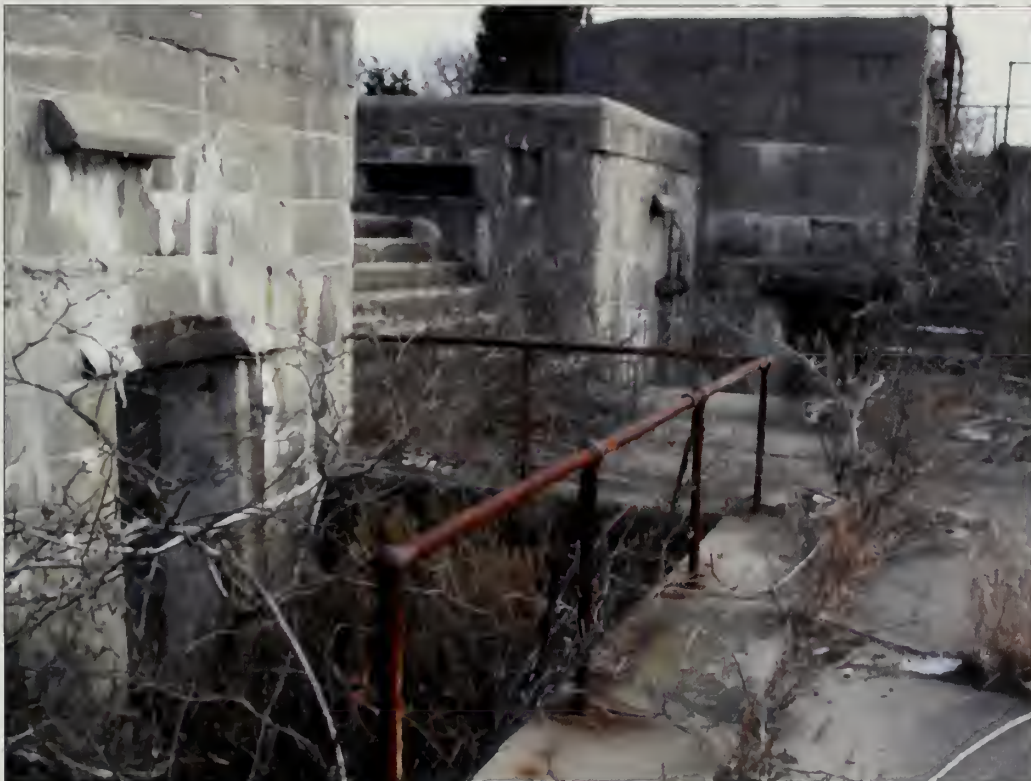
Figure 3.2. View looking northeast at stairwells to magazines, Battery Urmston. Both handrails and guardrails show a heavy degree of corrosion and are staining the concrete below them. Access to existing doors is blocked by vegetation that has grown up in the stairwells (Olmsted Center, January 2009).

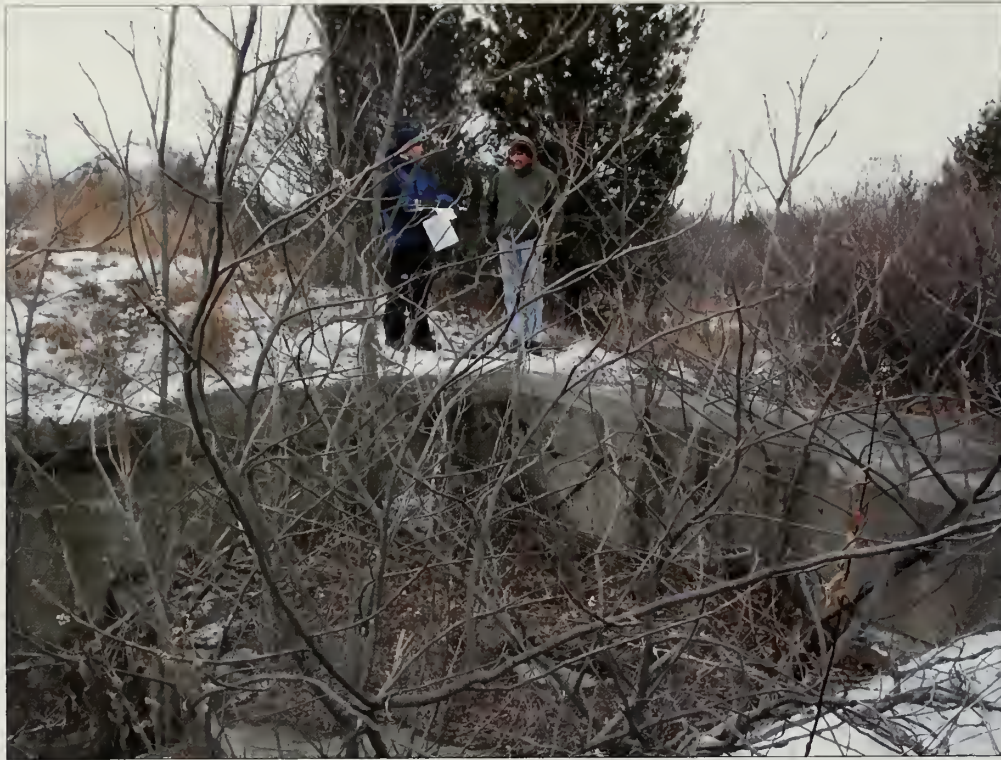
Figure 3.3. View looking northwest at gun platform #3, Battery Urmston. Large woody vegetation primarily consists of eastern red cedar (*Juniperus virginiana*), beach plum (*Prunus maritima*), hackberry (*Celtis occidentalis*), and ailanthus (*Ailanthus altissima*). These species have also found suitable locations to grow in the low-lying areas, flat surfaces, and cracks of the battery (Olmsted Center, January 2009).

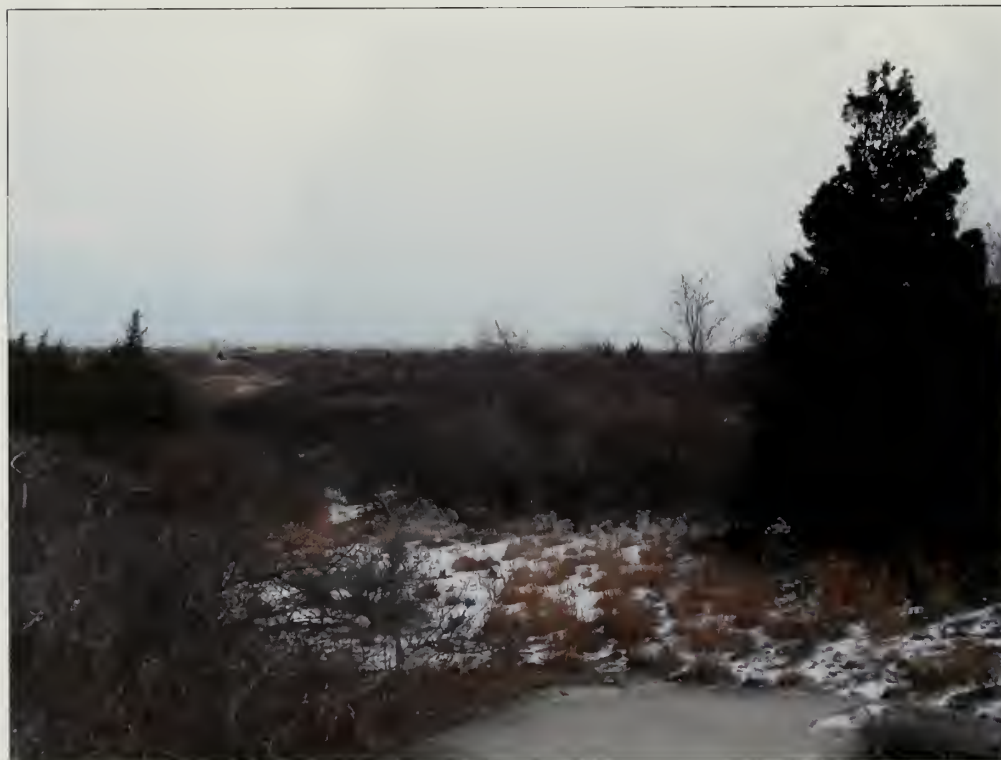
Figure 3.4. View looking northeast from gun platform #4, Battery Urmston. The views from the gun platforms and battery commander's station to the water are primarily impeded by woody vegetation growing at the interface of the engineered slope and concrete battery structure (Olmsted Center, January 2009).

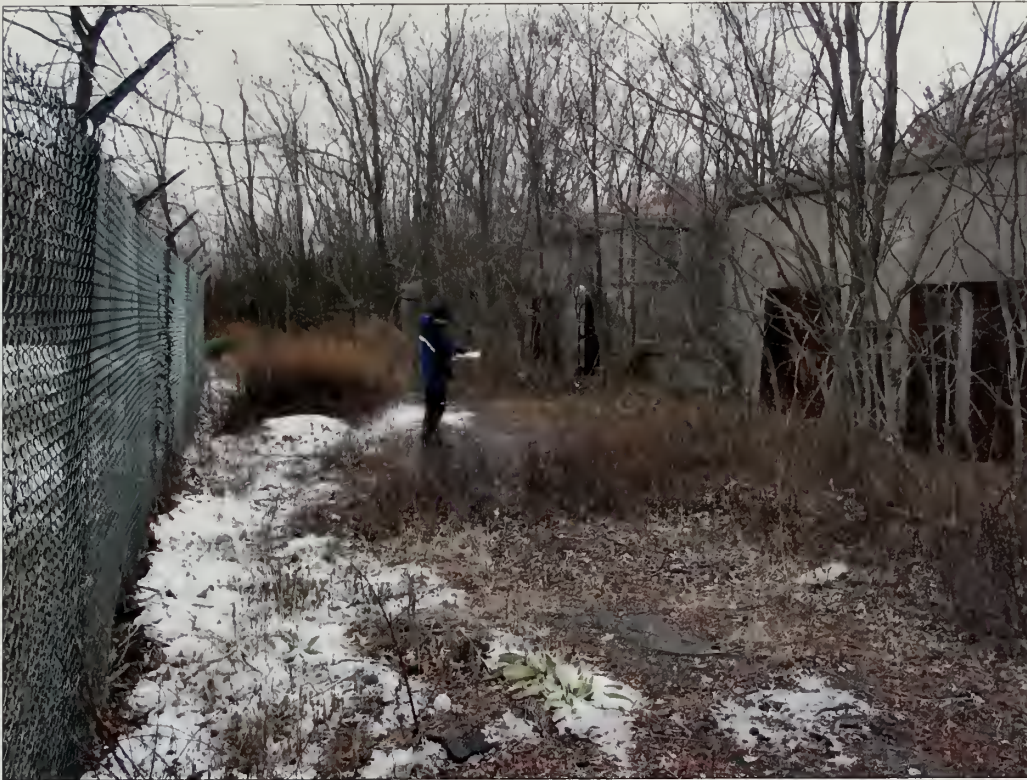
Figure 3.5. View looking west at U.S. Coast Guard perimeter fence and Battery Morris. There is currently no vehicular access to Battery Morris and staff and visitors wishing to see the structure walk on a trail surface comprised of broken asphalt and accumulated leaf litter and debris. Emerging woody vegetation obscures a clear definition of the trail and makes access difficult (Olmsted Center, January 2009).

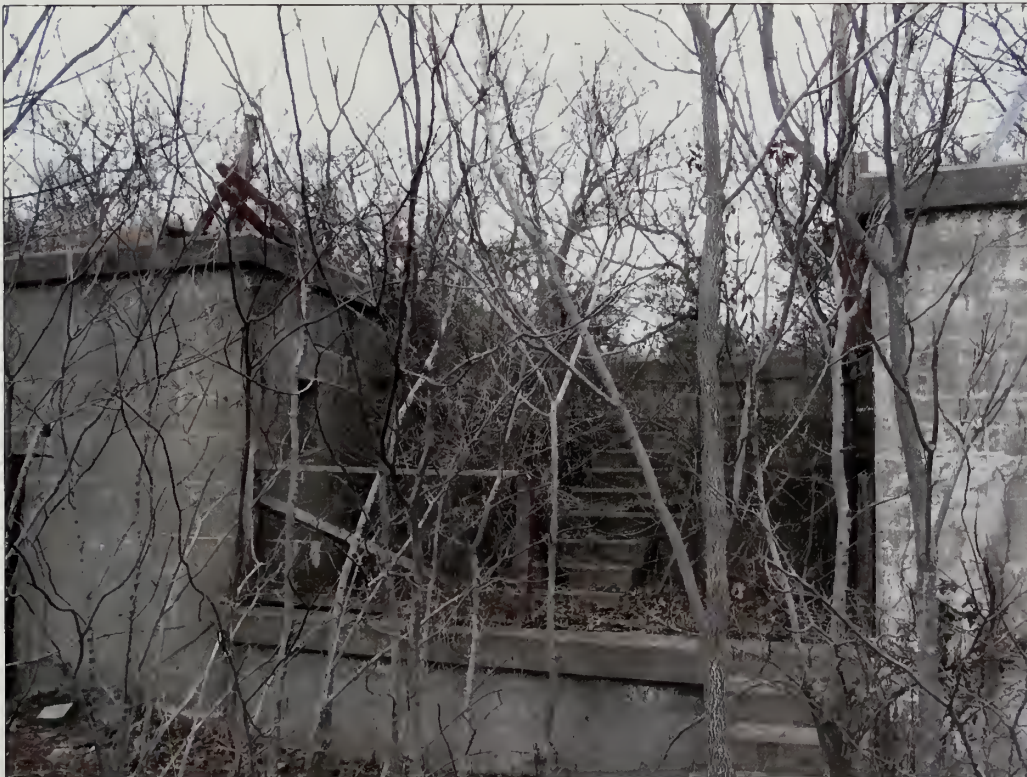
Figure 3.6. View looking north at emplacement #2, Battery Morris. Woody vegetation is growing in and around the stairs to the point where they are difficult to ascend and reach the gun platforms (Olmsted Center, January 2009).

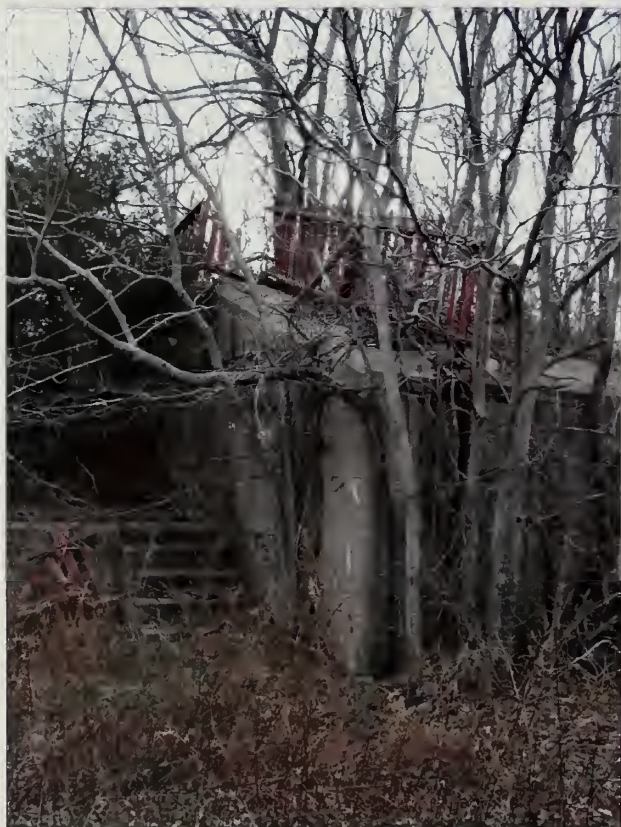
Figure 3.8. View looking northeast at gun platform #1, Battery Morris. A wood picket fence is located to the north and east of the gun platform that is painted maroon red and is in poor condition (Olmsted Center, January 2009).

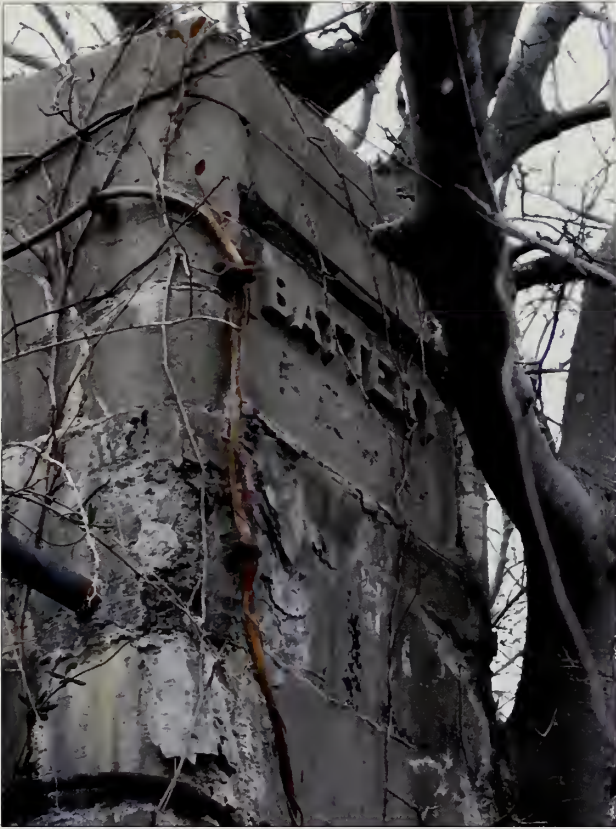
Figure 3.9. View looking northeast at corner of structure, Battery Peck. Efflorescence can be seen on many of the vertical surfaces and spalling is present on both horizontal and vertical surfaces indicating water has penetrated the concrete and is damaging the material (Olmsted Center, January 2009).

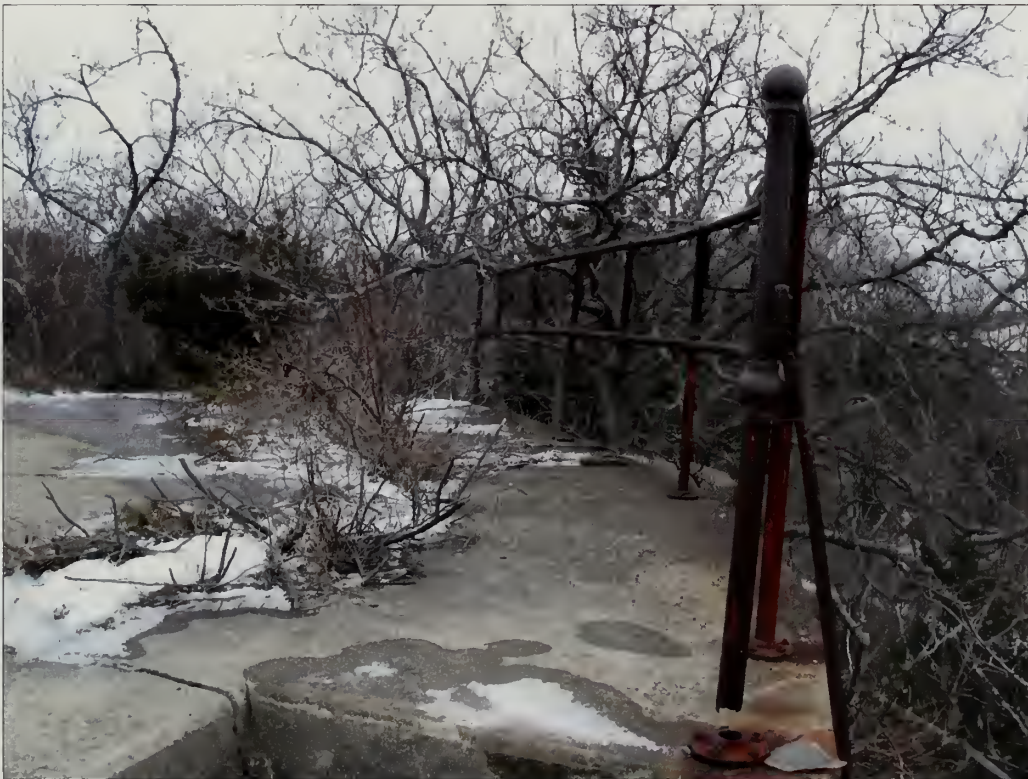
Figure 3.10. View of guardrail south of emplacement #1, Battery Peck. The railings are in fair to poor condition with corrosion covering most pieces. Some assemblies lack any solid material where the vertical members fasten the railing to a solid support (Olmsted Center, January 2009).

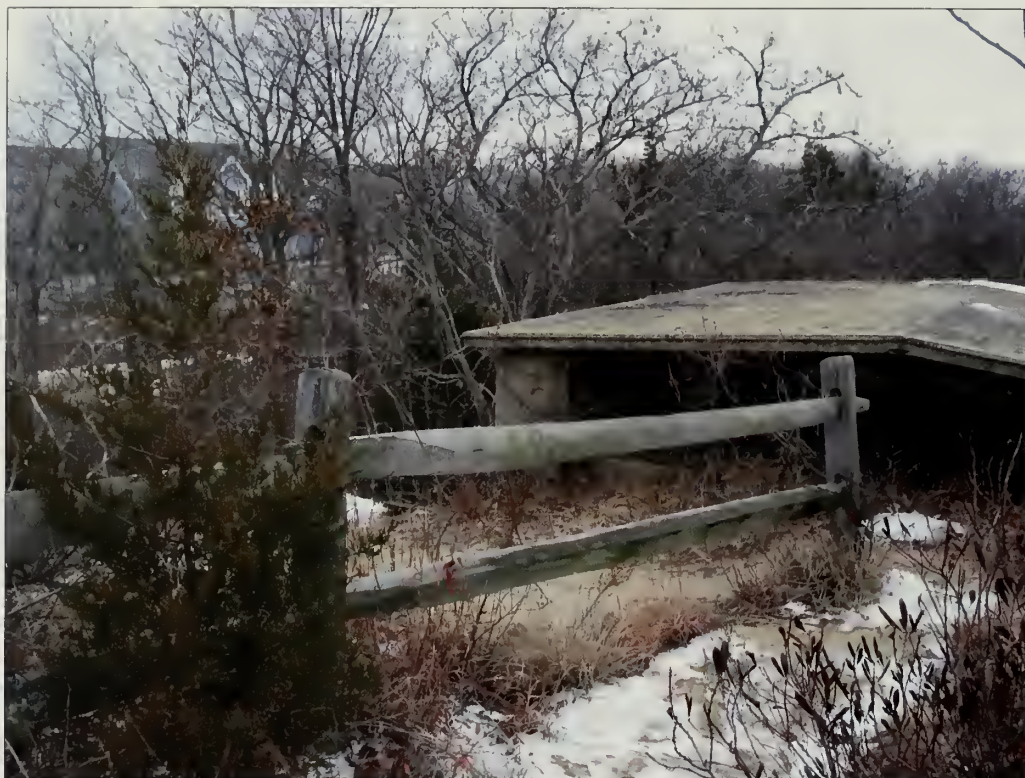
Figure 3.11. View looking northwest at Battery Engle (CRF Station Peck). The concrete coincidence range finder station (CRF) constructed on top of Battery Engle is located west of Battery Peck and features a low-pitched concrete roof. The structure appears in fair condition with some minor efflorescence visible on the roof (Olmsted Center, January 2009).

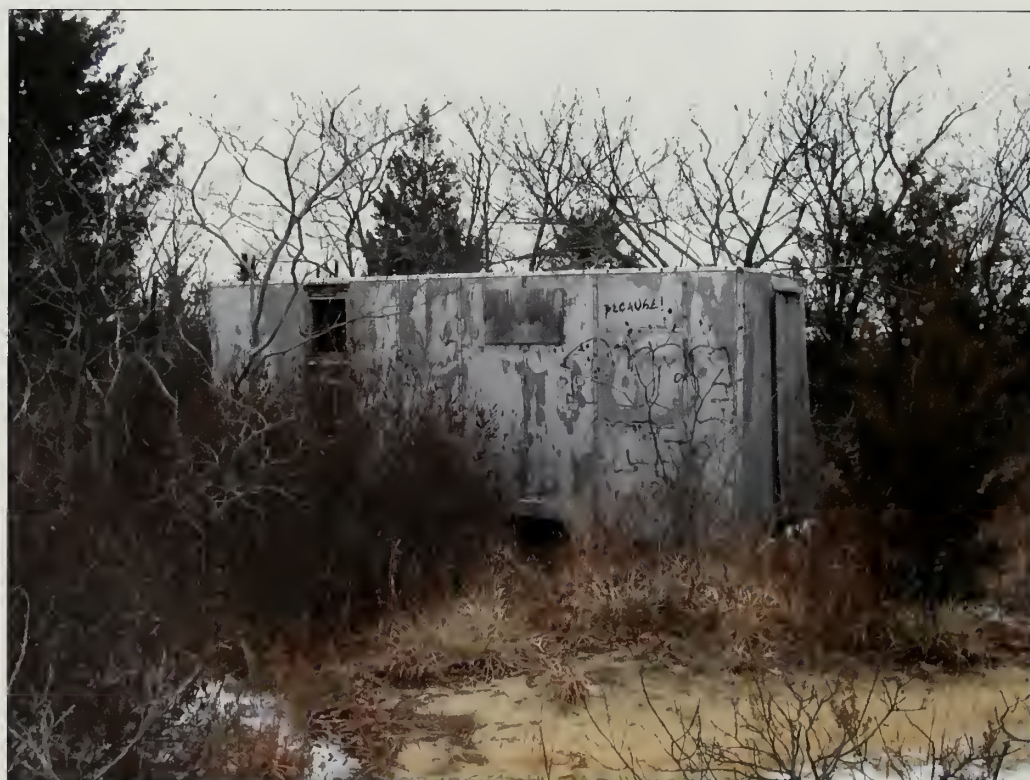
Figure 3.12. View looking north at a post World War II trailer, Batteries Engle and Peck. Northeast of Battery Engle, a communications trailer sits abandoned. The trailer is a frequent target for graffiti (Olmsted Center, January 2009).

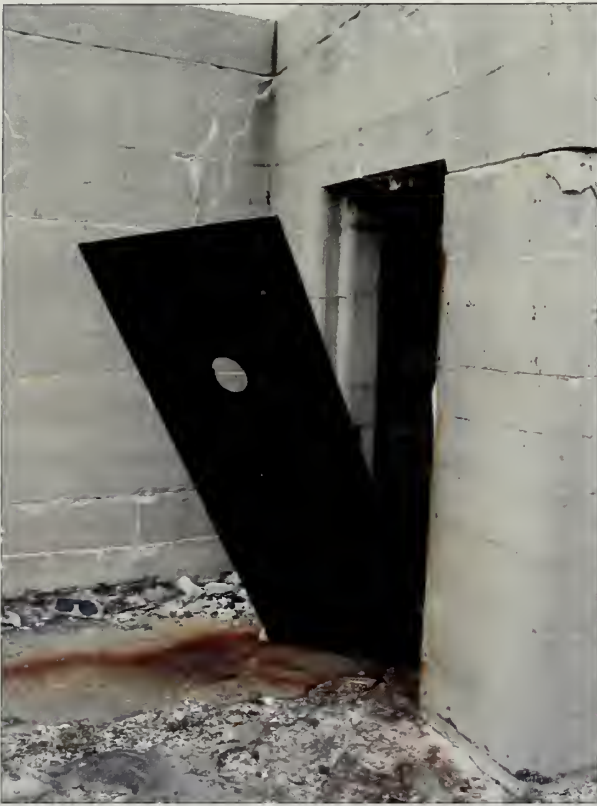
Figure 3.17. View of failing metal door, Nine Gun Battery. Several dozen doors and windows are missing or not properly mounted at the magazines, commander's stations, and other auxiliary rooms at Nine Gun Battery (Olmsted Center, January 2009).

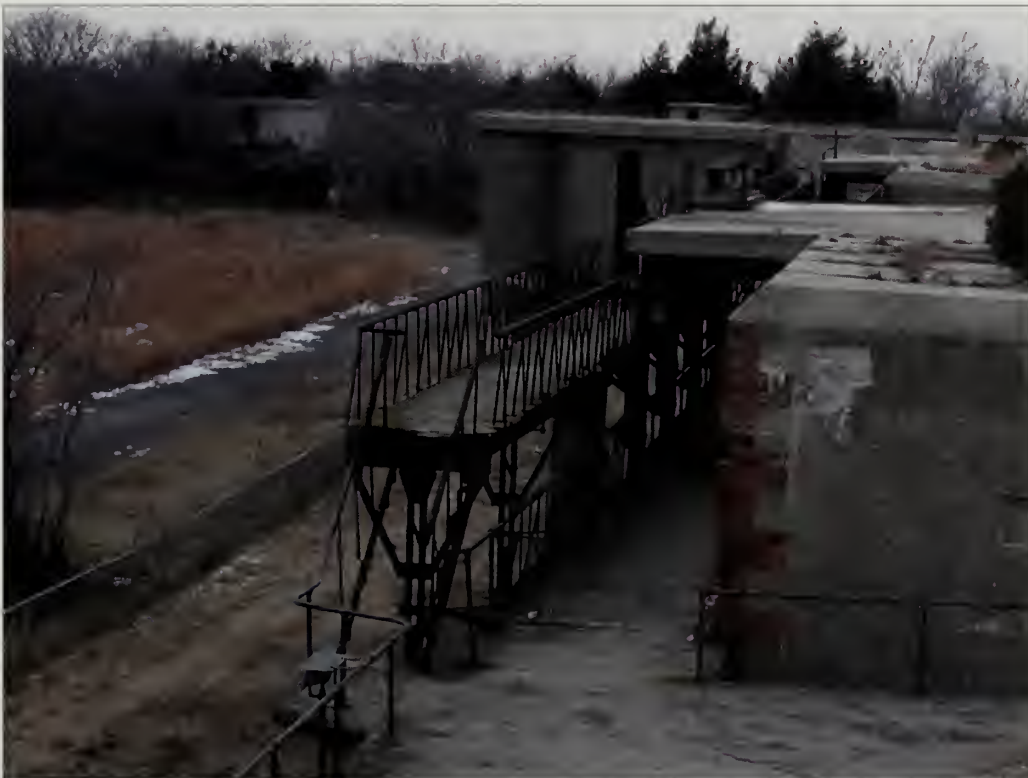
Figure 3.18. View looking west at battery commander's station Halleck, Nine Gun Battery. A cantilevered structure between emplacements #5 and #7, intended to provide access to the commander's station, is in poor condition (Olmsted Center, January 2009).

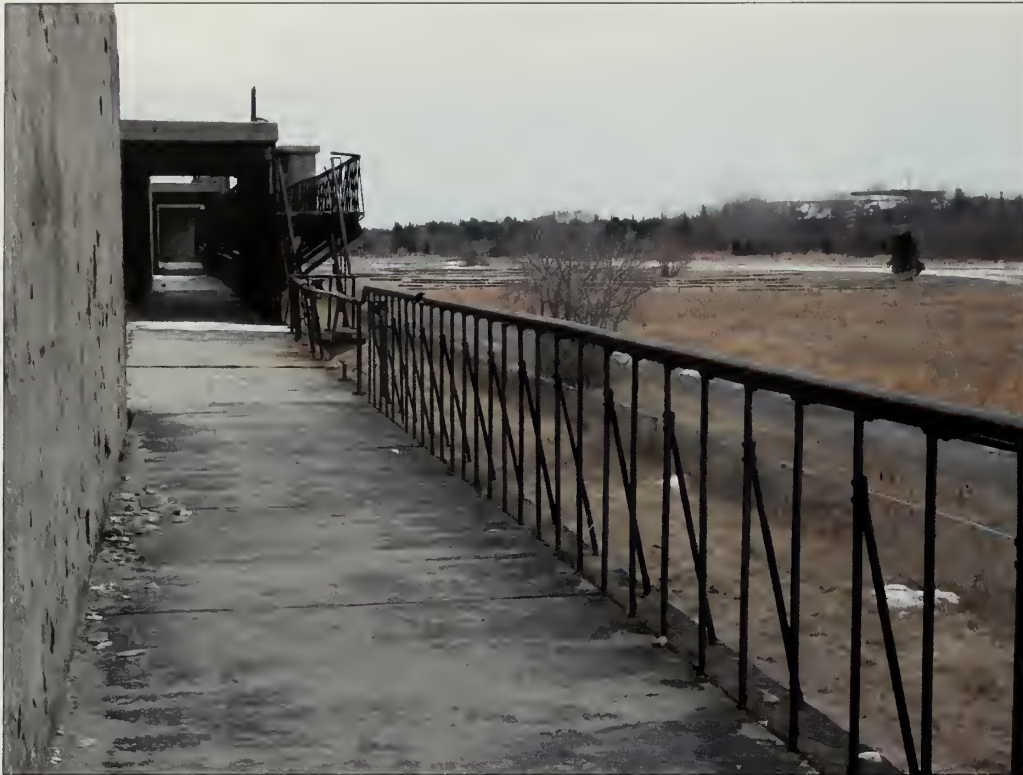
Figure 3.19. View looking south at existing guardrail, Nine Gun Battery. Both handrails and guardrails are present at Nine Gun Battery and are generally in good to fair condition (Olmsted Center, January 2009).

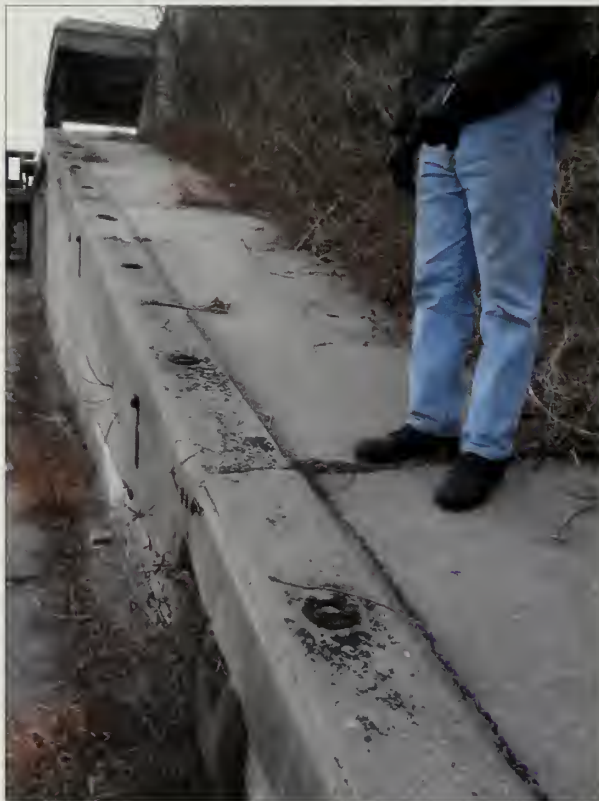
Figure 3.20. View looking northwest at the concrete ramp to gun platform #1, Nine Gun Battery. At transitions between the ground level and gun platforms and also the gun platforms and terreplein, there are stairs and ramps that lack any kind of railing. This ramp has escutcheon plates but lacks a guardrail (Olmsted Center, January 2009).

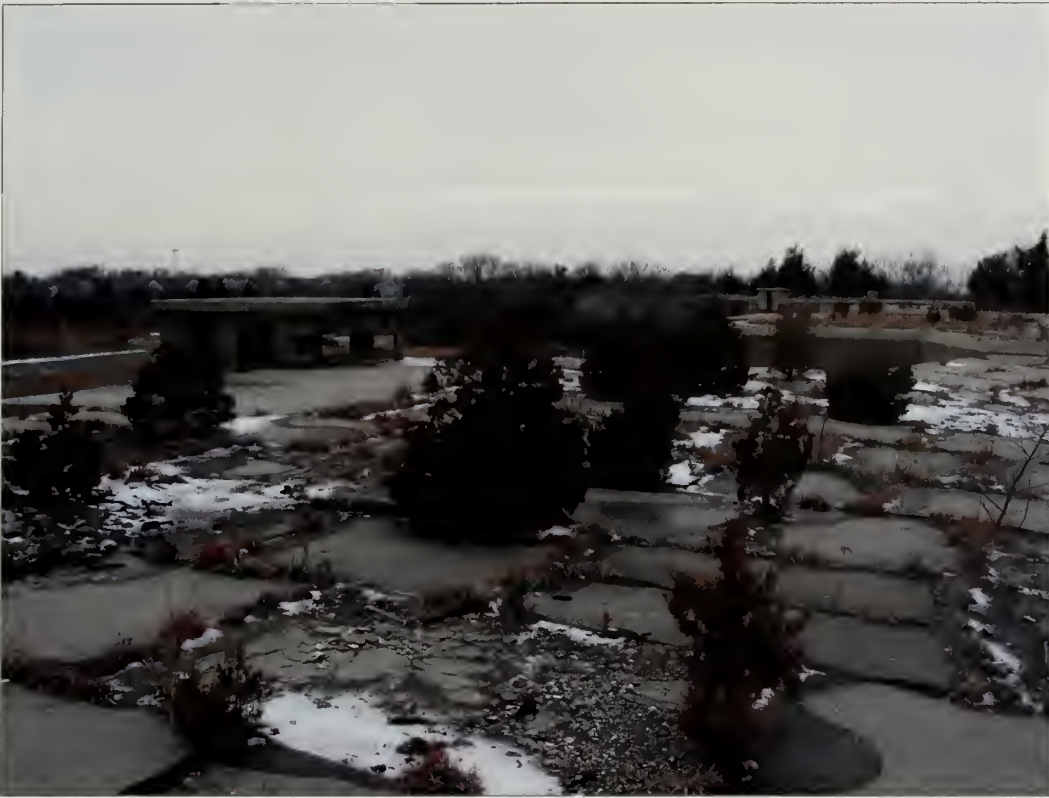
Figure 3.21. View looking west toward battery commander's station Bloomfield, Nine Gun Battery. In addition to growing on the engineered earthwork, eastern red cedars (*Juniperus virginiana*) have emerged in the cracks and cold joints of the battery's horizontal concrete surfaces (Olmsted Center, January 2009).

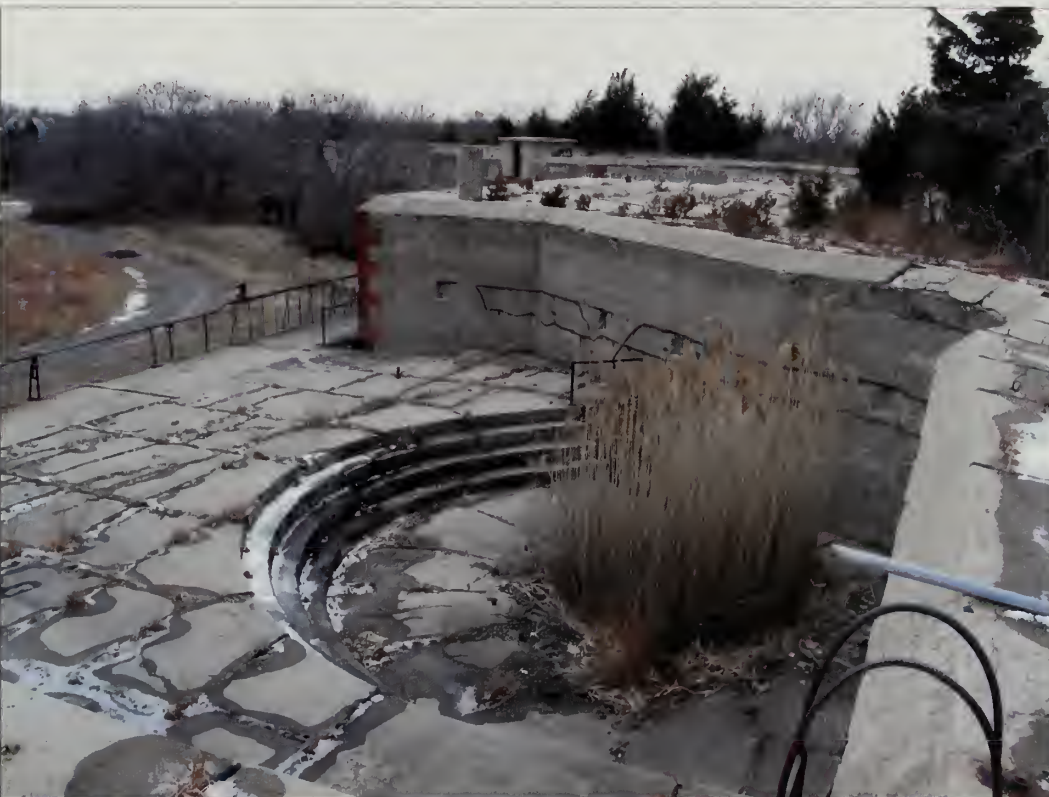
Figure 3.22. View looking west at emplacement #7, Nine Gun Battery. Phragmites (*Phragmites* sp.), also called common reed, is growing in the gun wells at emplacements #6, #7, and #9 (Olmsted Center, January 2009).

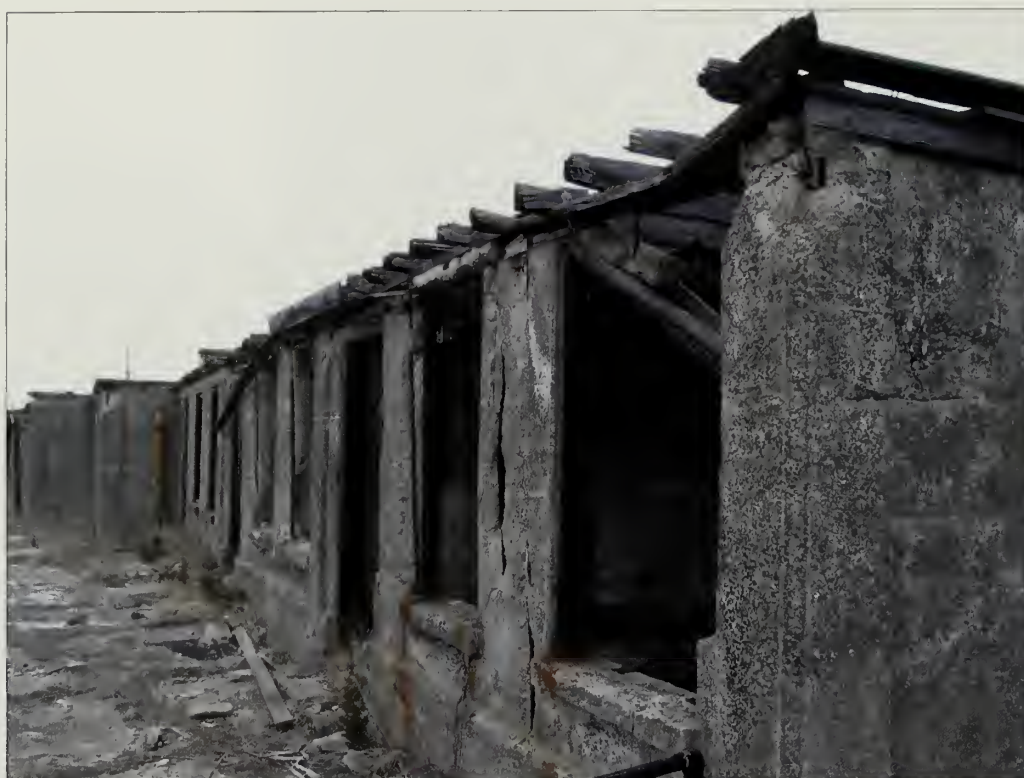
Figure 3.27. Fire control stations, Battery Potter. On the terreplein, two groups of deteriorating concrete structures are located west of the former gun emplacements. The structures served as fire control stations and feature large openings in their east elevations to provide views to the Atlantic Ocean (Olmsted Center, January 2009).

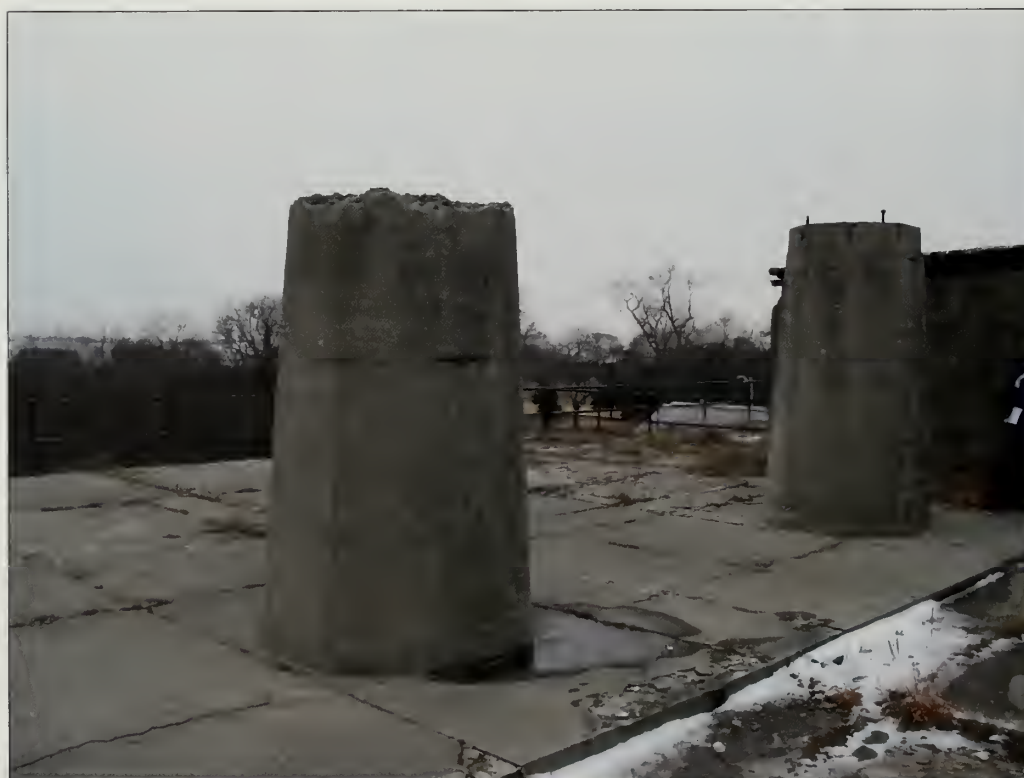
Figure 3.28. View looking northwest at concrete pillars, Battery Potter. South of the two groups of fire control stations, two concrete pillars remain from another structure that served as an additional fire control station (Olmsted Center, January 2009).

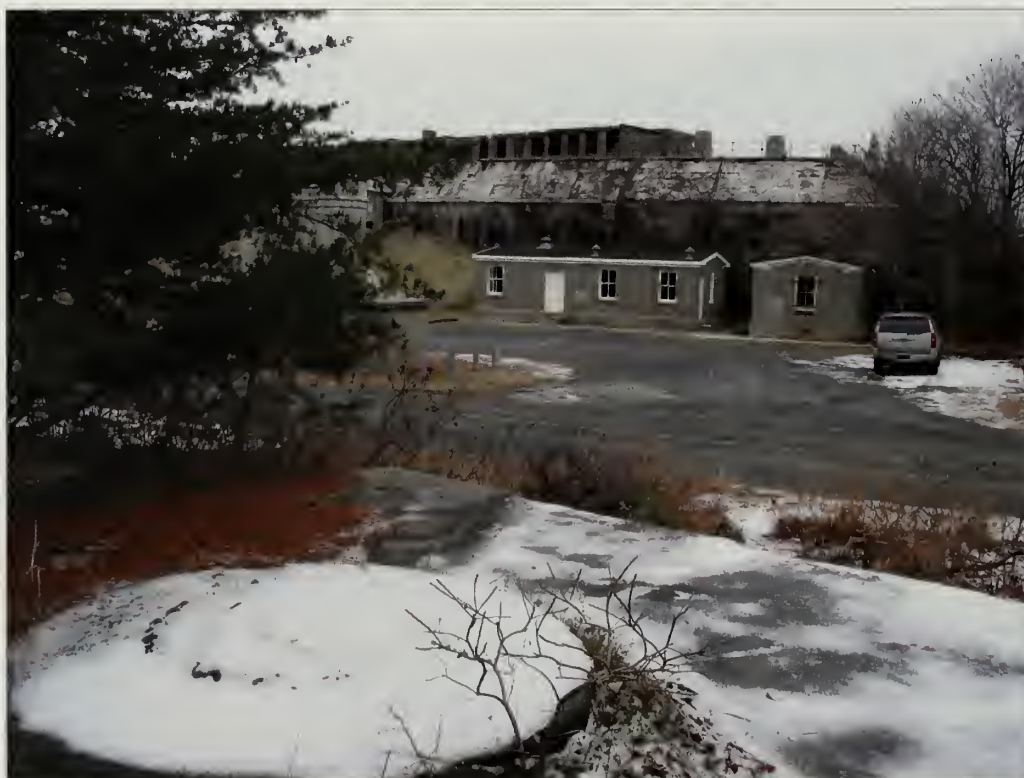
Figure 3.32. View looking northeast at foundation, Hudson Drive, and Battery Potter. Across from the parking area and west of Hudson Drive, a concrete foundation occupies a small opening in a dense stand of woody vegetation. The foundation supported a metal tower used to identify targets and improve fire control (Olmsted Center, January 2009).

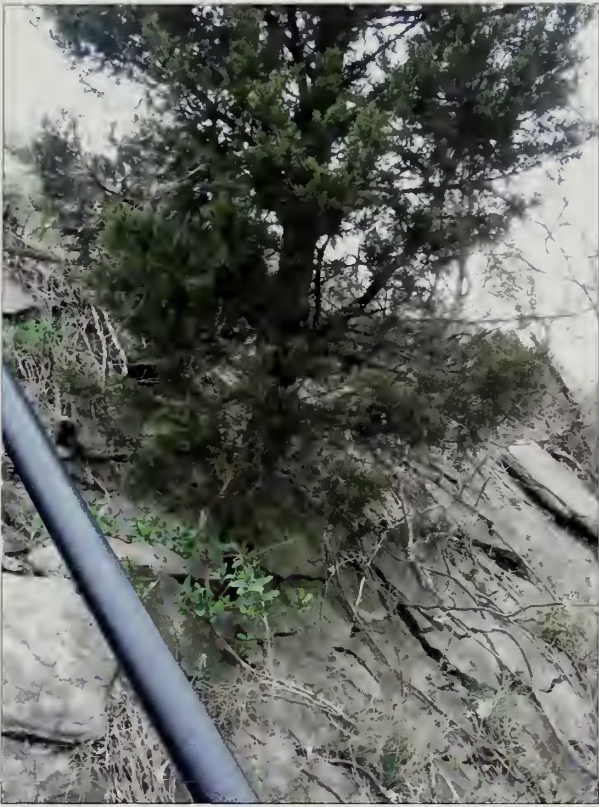
Figure 3.33. View looking east from access stairs, Battery Potter. The sloped portion of the concrete battery, rising approximately ten-feet above the engineered earthwork, has eastern red cedars (*Juniperus virginiana*) growing in cracks and in large spalling areas (Olmsted Center, April 2008).

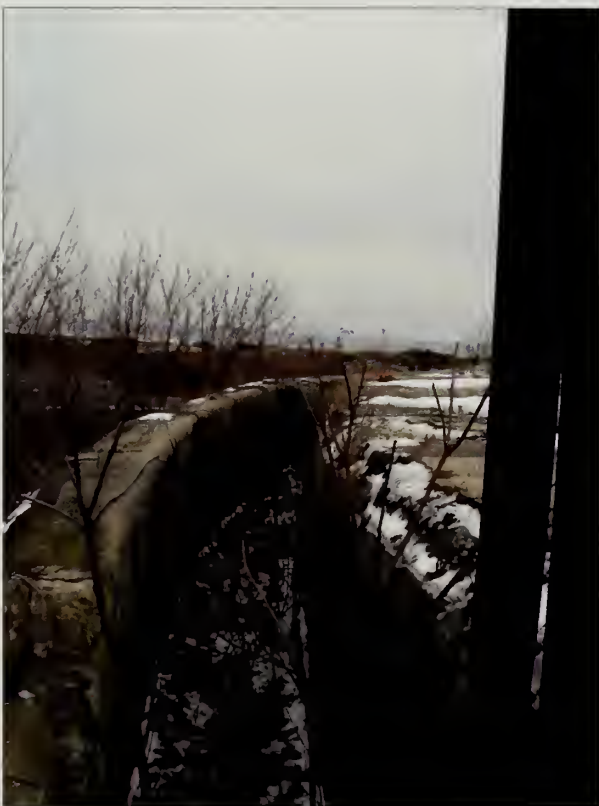
Figure 3.34. View looking east at the *chemin de ronde*, Battery Potter. The *chemin de ronde* is presently a collection area for leaf litter and debris that supports the growth of woody vegetation (Olmsted Center, January 2009).

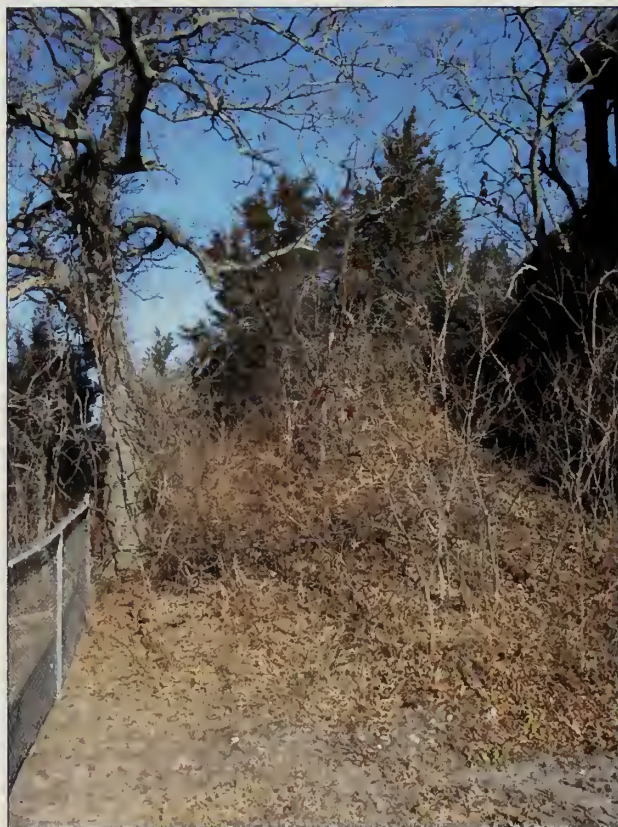
Figure 3.36. View looking northwest at engineered slope to rear of Battery Granger. Between Hudson Drive and the battery, a chain-link fence (left) and signage have been erected to warn visitors of potentially hazardous conditions (Olmsted Center, January 2009).

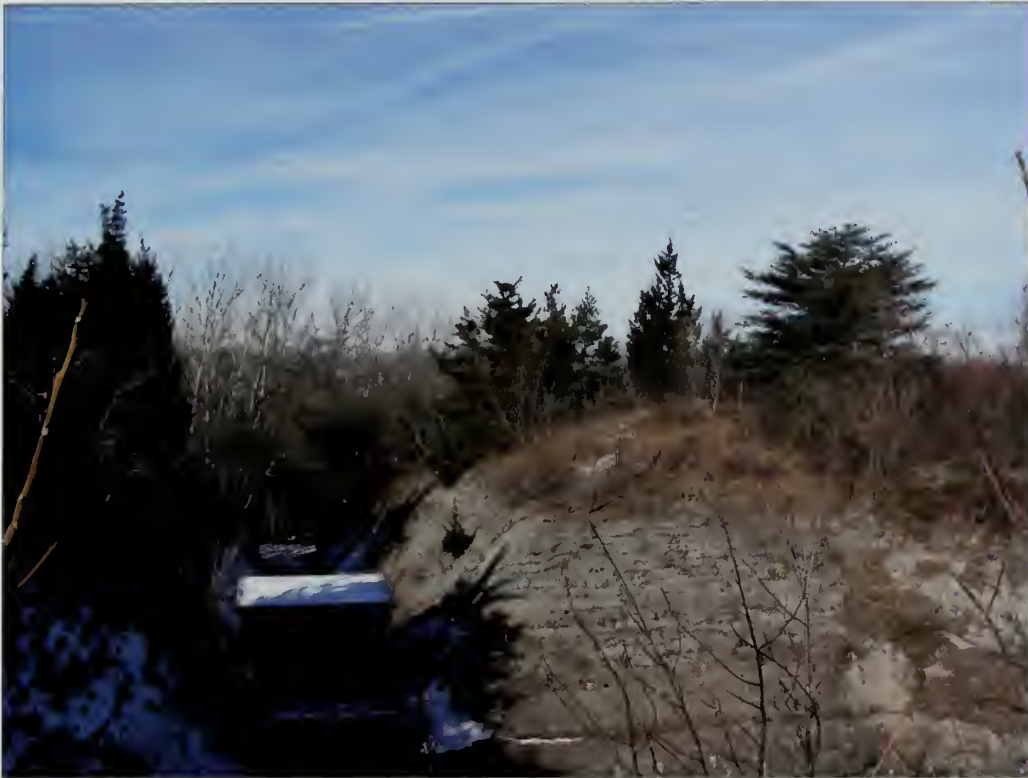
Figure 3.37. View looking west across southwest mortar pit, the Mortar Battery. Efflorescence and spalling are present on the concrete blast slope above the mortar pit. These symptoms of water infiltrating concrete can be seen on additional horizontal and vertical concrete surfaces at the Mortar Battery (Olmsted Center, January 2009).

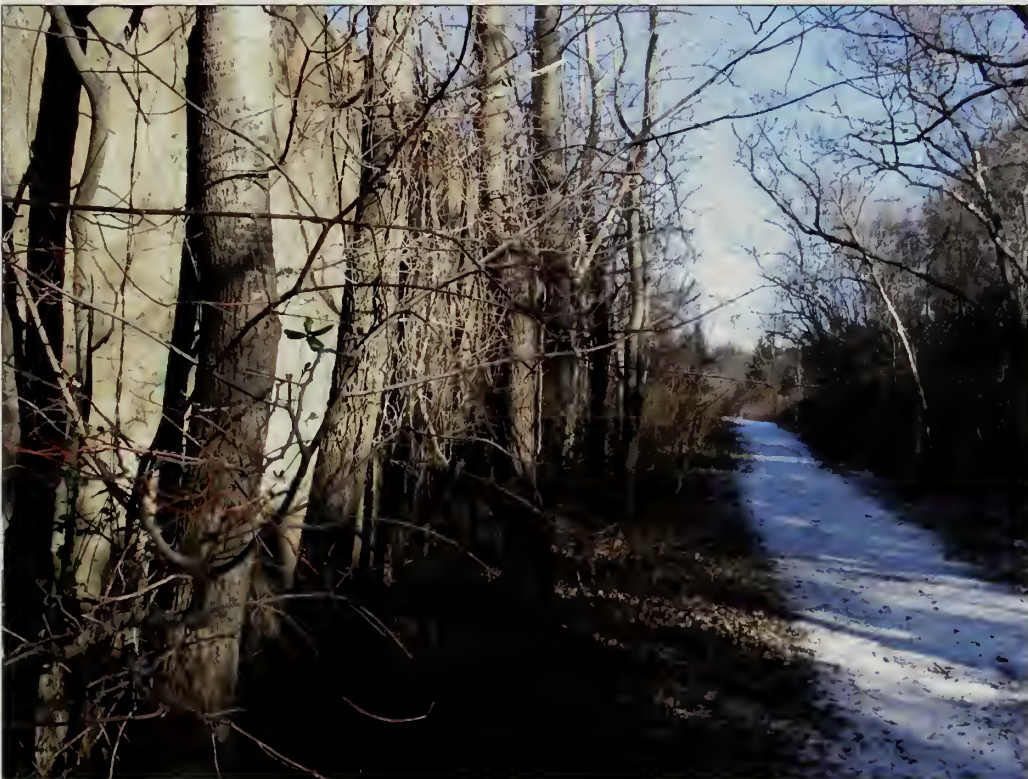
Figure 3.38. View looking north along perimeter wall, the Mortar Battery. Large woody vegetation is growing between the perimeter wall and the trail to the northwest and southwest emplacements. The main species along the perimeter wall is hackberry (*Celtis occidentalis*) (Olmsted Center, January 2009).

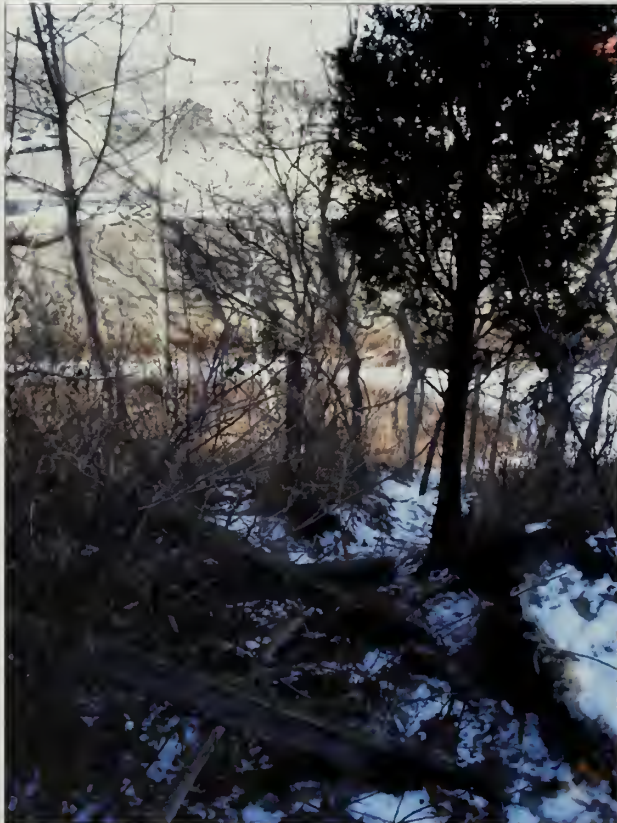
Figure 3.40. View near top of southwest mortar pit, the Mortar Battery. At the top of the Mortar Battery, several wood post and wire cable fences are installed that are in fair to poor condition (Olmsted Center, January 2009).

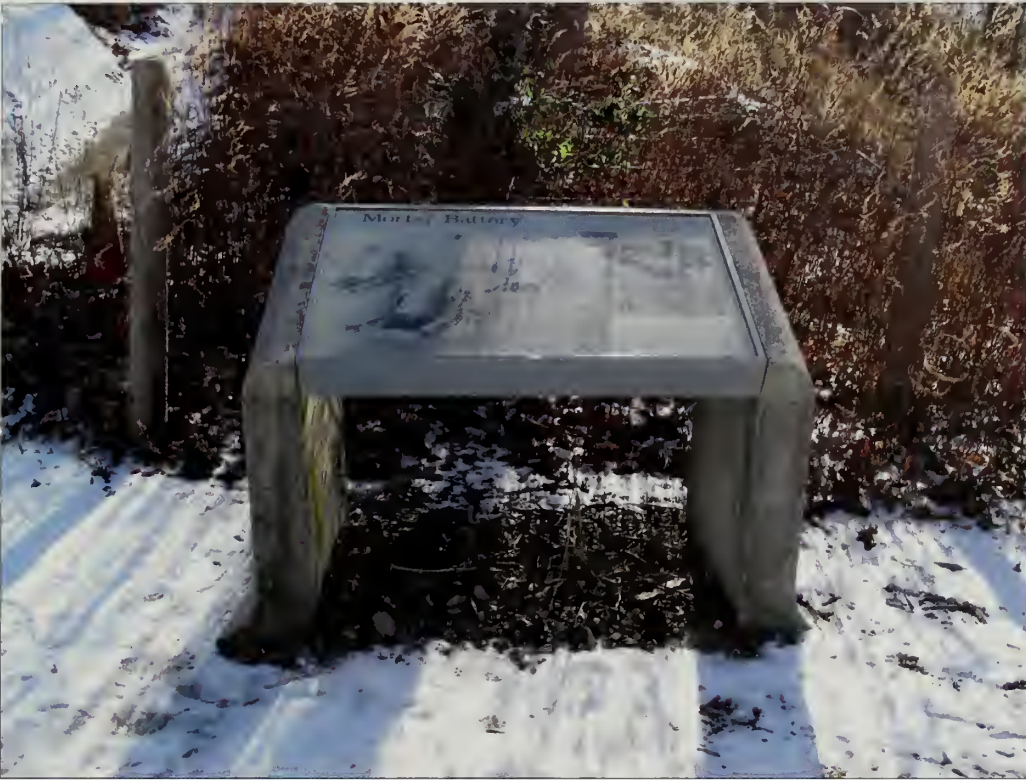
Figure 3.41. View looking east at wayside, the Mortar Battery. Inside the perimeter wall, a wayside is located just south of the gallery to the southwest mortar pit (Olmsted Center, January 2009).

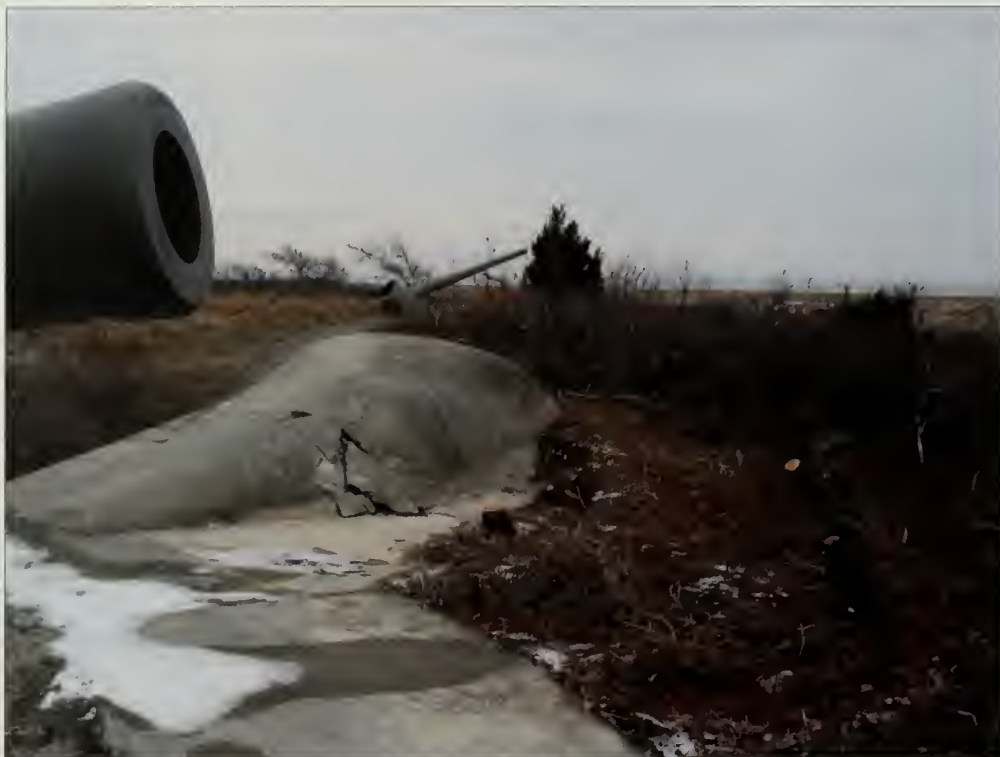
Figure 3.43. View looking north from emplacement #1 to emplacement #2, Battery Gunnison. Spalling is present on a concrete feature due to infiltration of water and freeze-thaw cycles (Olmsted Center, January 2009).

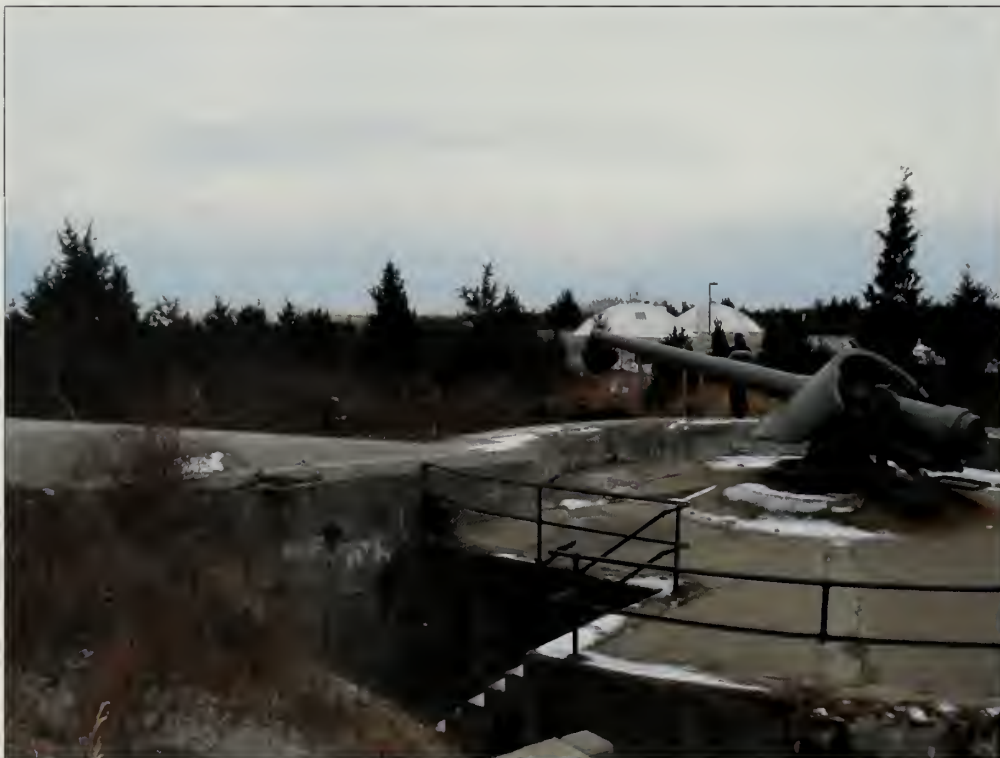
Figure 3.44. View looking southeast at emplacement #2, Battery Gunnison. The vegetation on Battery Gunnison's engineered slopes is primarily eastern red cedar (*Juniperus virginiana*) and beach plum (*Prunus maritima*) (Olmsted Center, January 2009).

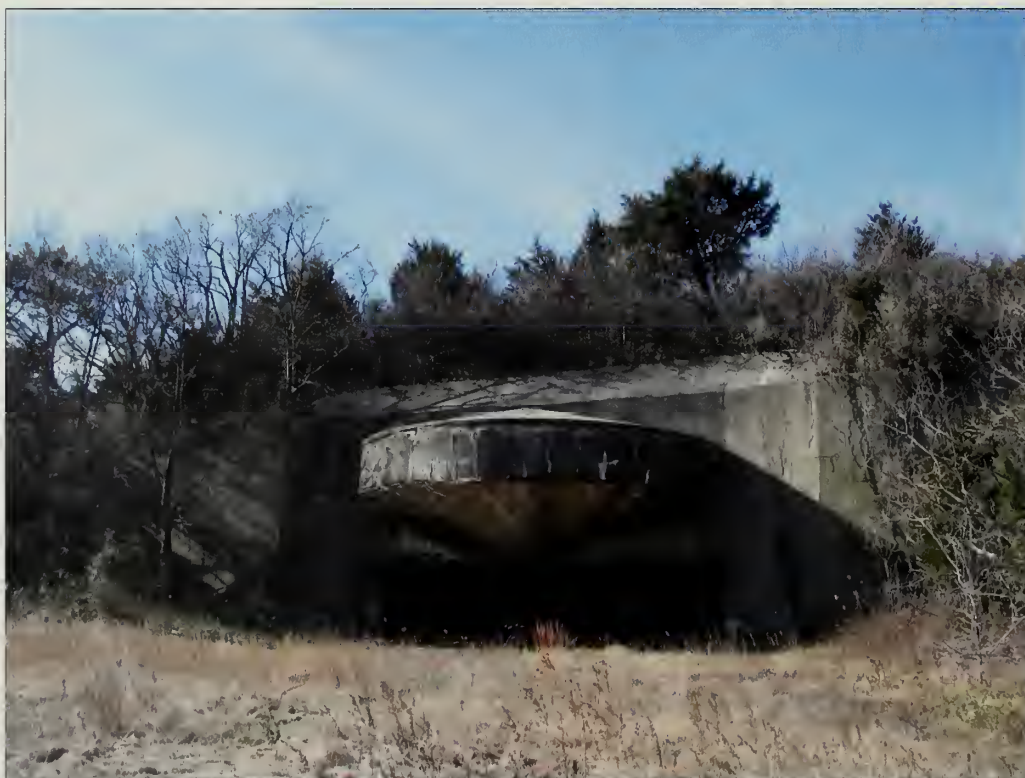
Figure 3.48. View looking southwest at emplacement #2, Battery Kingman. Designed to shield the gun platform from overhead fire, the concrete canopy exhibits efflorescence indicating water is infiltrating the concrete and drawing out impurities to the surface (Olmsted Center, January 2009).
