I 29.86/4.5 A 5

Clemson University

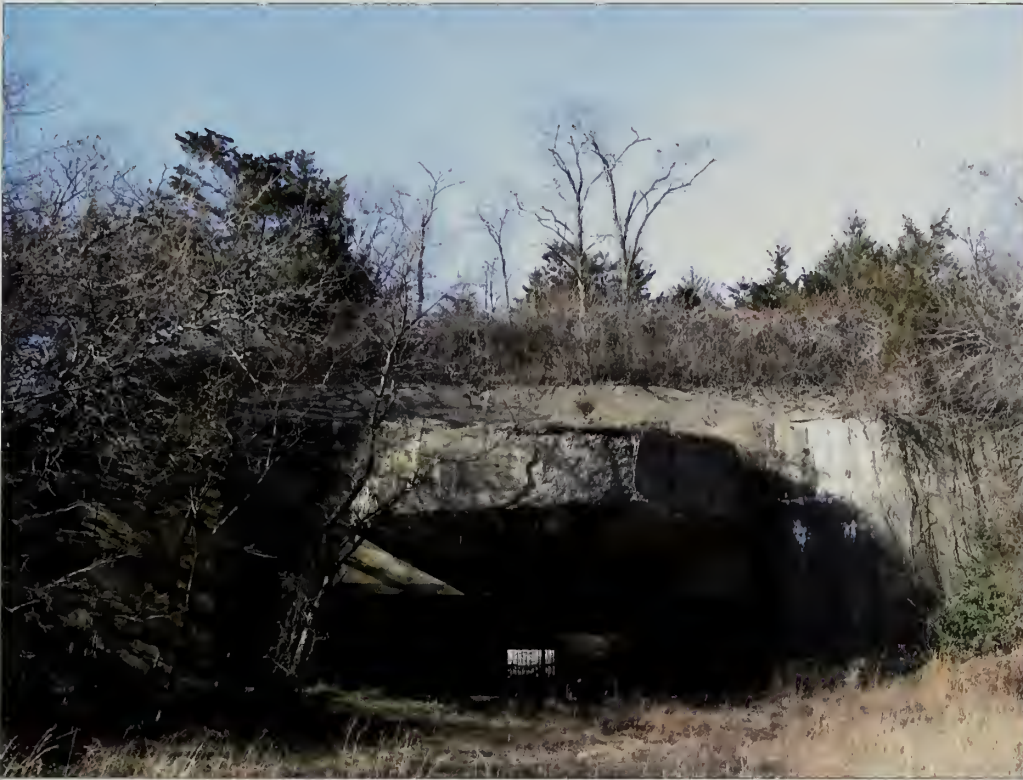
Figure 3.49. View looking west at emplacement #2, Battery Mills. Above the emplacement, large spalling areas on the concrete canopy result from infiltration of water and seasonal freezing and thawing (Olmsted Center, January 2009).

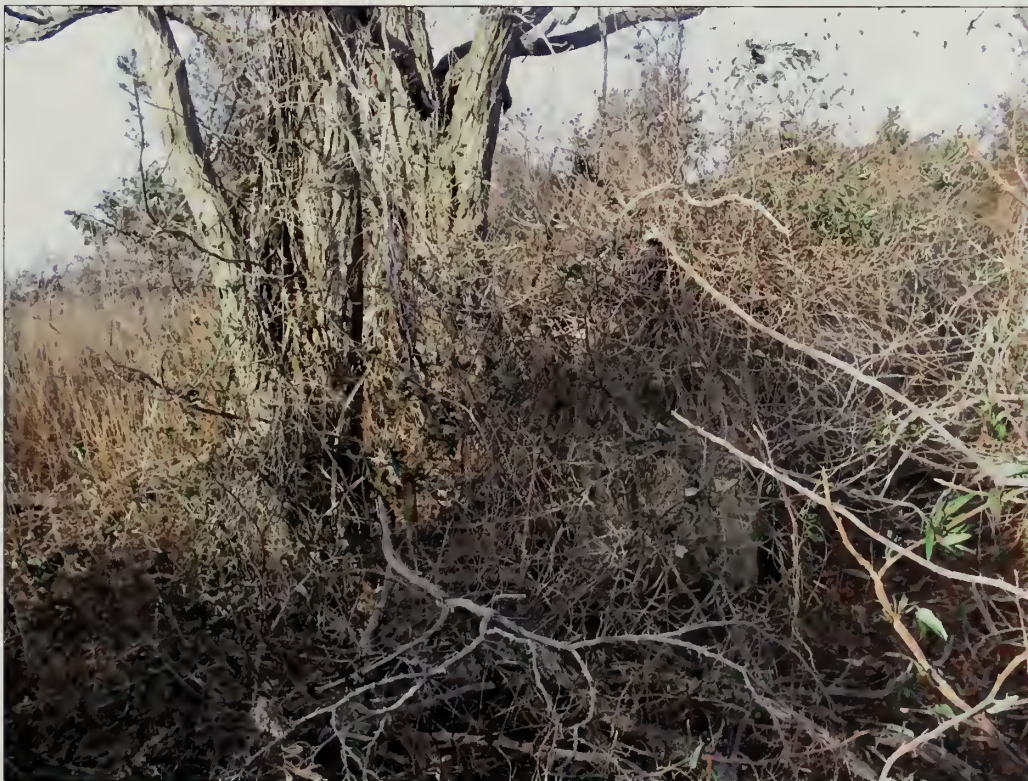
Figure 3.50. View looking north from the top of Battery Kingman. A concrete box, engulfed by Japanese honeysuckle (*Lonicera japonica*), is located south of emplacement #2 on the top of the engineered earthwork (Olmsted Center, January 2009).

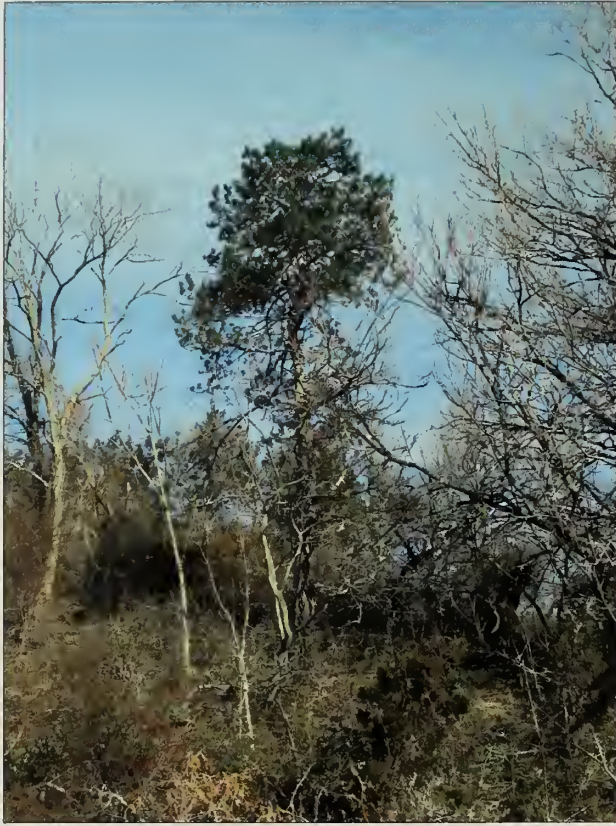
Figure 3.55. Scrub pine south of emplacement #1, Battery Mills. A few scrub pine (*Pinus virginiana*) were observed on the engineered earthwork that primarily contained mature eastern red cedar (*Juniperus virginiana*), hackberry (*Celtis occidentalis*), and ailanthus (*Ailanthus altissima*) (Olmsted Center, January 2009).

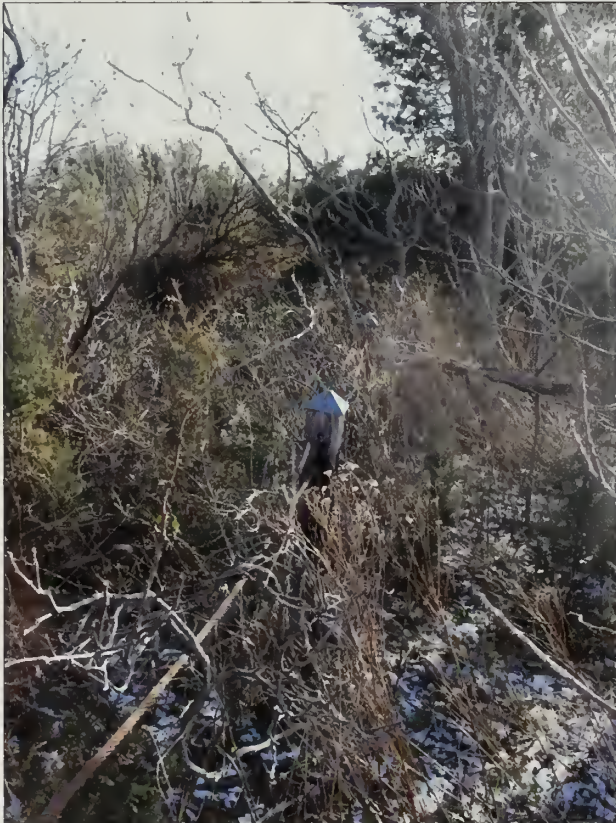
Figure 3.56. Post and wire fence, Battery Kingman. Near the high point above Battery Kingman's emplacement #2, a post and wire fence is installed that is overrun by vines and other vegetation (Olmsted Center, January 2009).

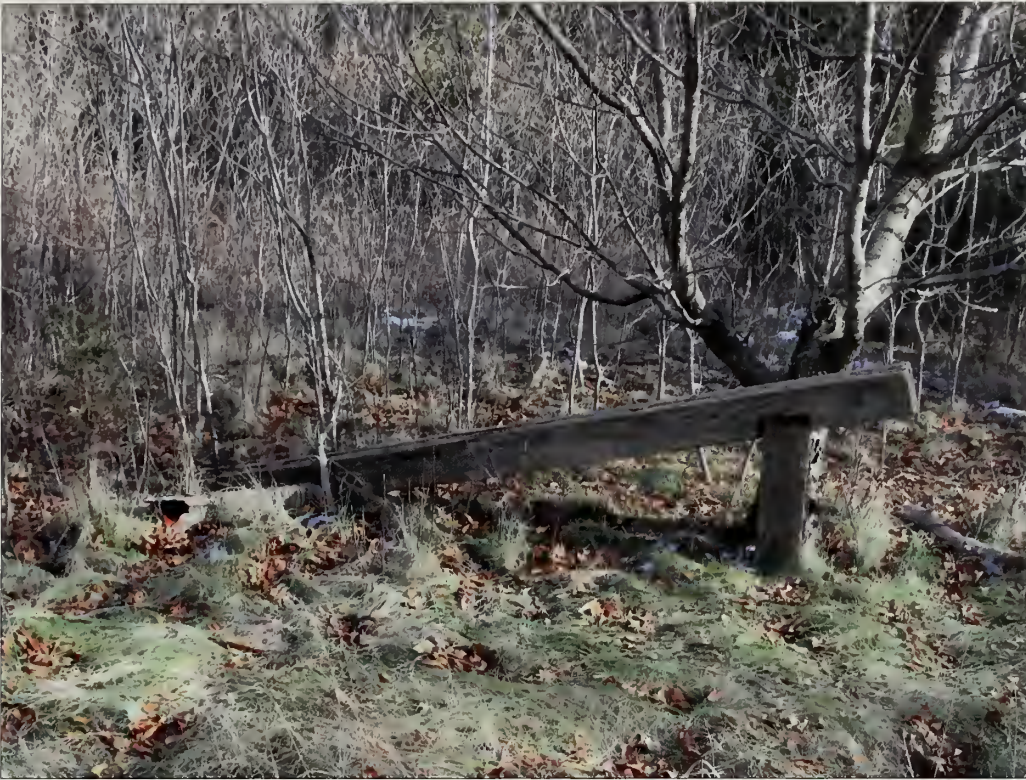
Figure 3.57. View looking east at collapsed wood guardrail, Battery Kingman. Across from both gun emplacements, a series of wood guardrails are installed along the eastern edge of the unpaved road. The guardrails are in fair to poor condition (Olmsted Center, January 2009).

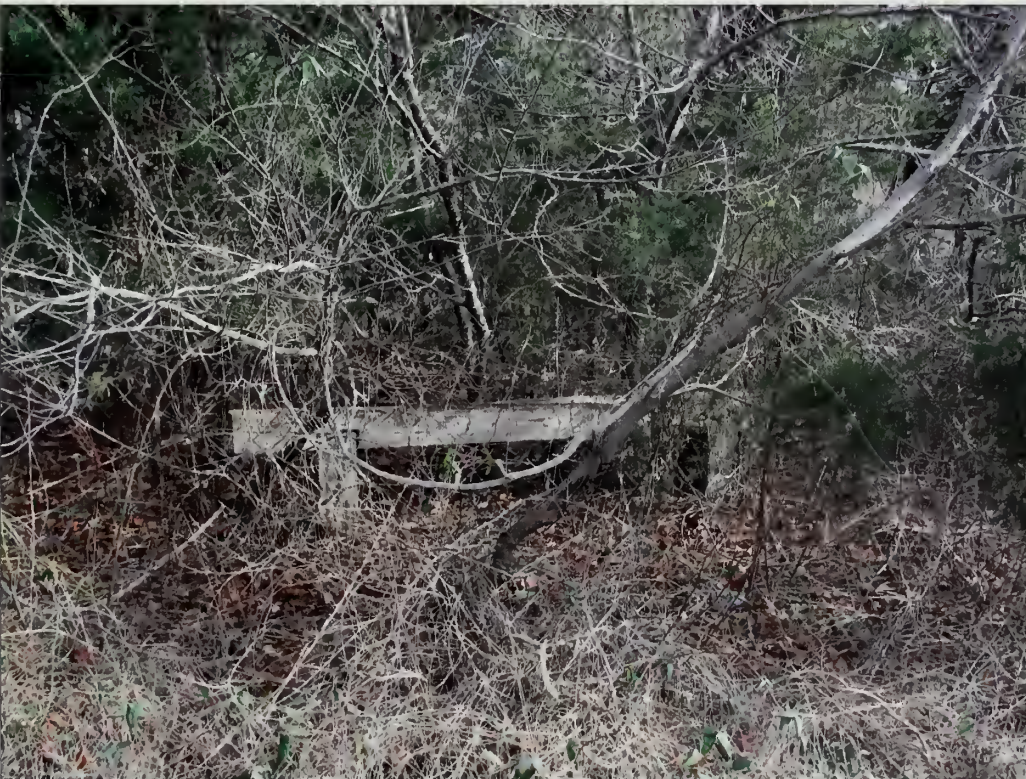
Figure 3.58. View looking east at wood guardrail, Battery Mills. Two series of wood guardrails are installed along the eastern edge of the unpaved road. The guardrails are in fair to poor condition and located across from the gun emplacements (Olmsted Center, January 2009).

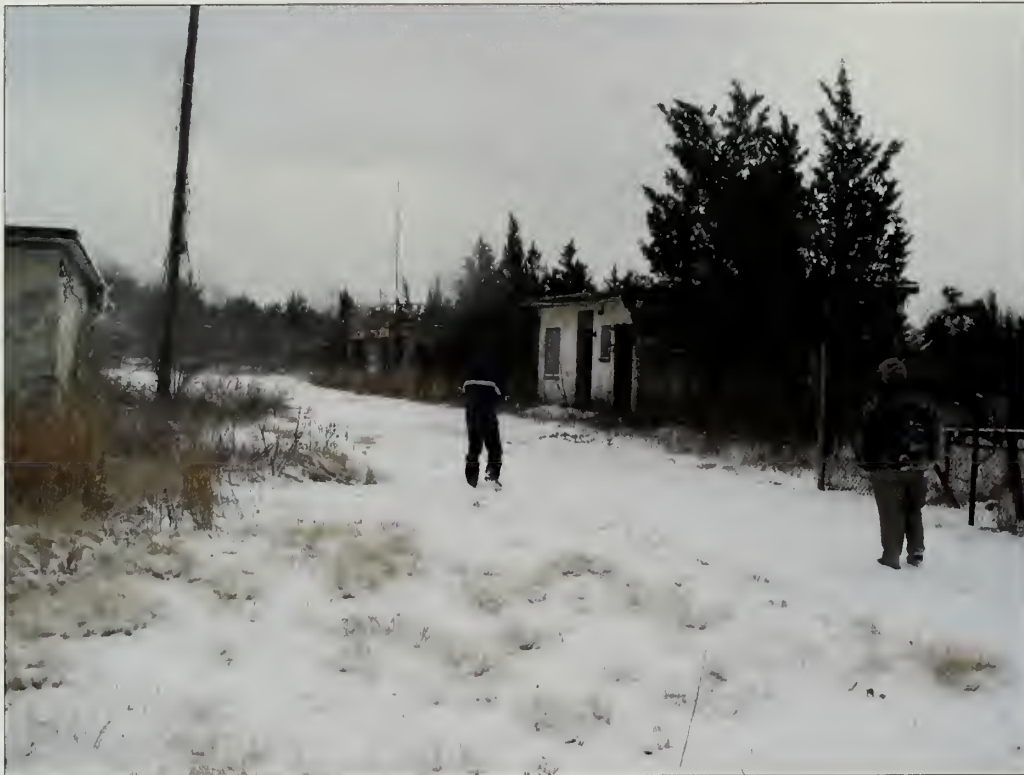
Figure 3.59. View looking southeast from vehicular route to Control Area #1, NIKE radar site. From each control area, a vehicular route leads to the Ready Barracks. From Control Area #1, the route is paved and ends in a hammerhead turnaround south of the Ready Barracks (Olmsted Center, January 2009).

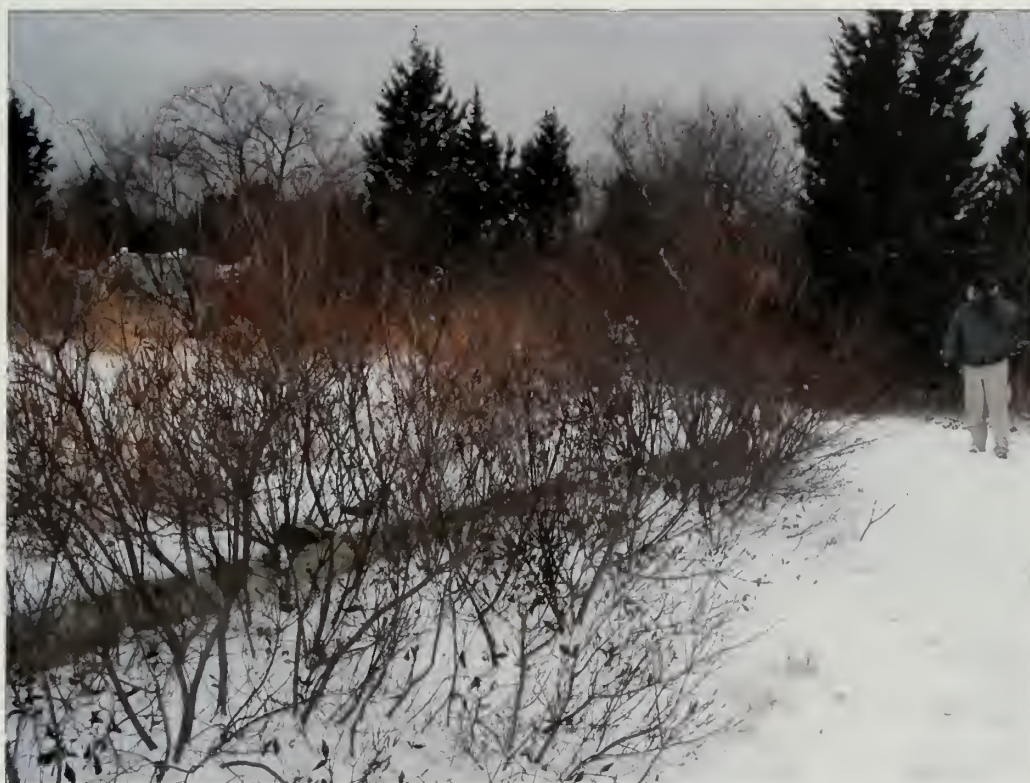
Figure 3.61. View looking north at HIPAR foundation, NIKE radar site. The foundation is obscured by shrub species such as bayberry (*Myrica* sp.) seen in the foreground (Olmsted Center, January 2009).

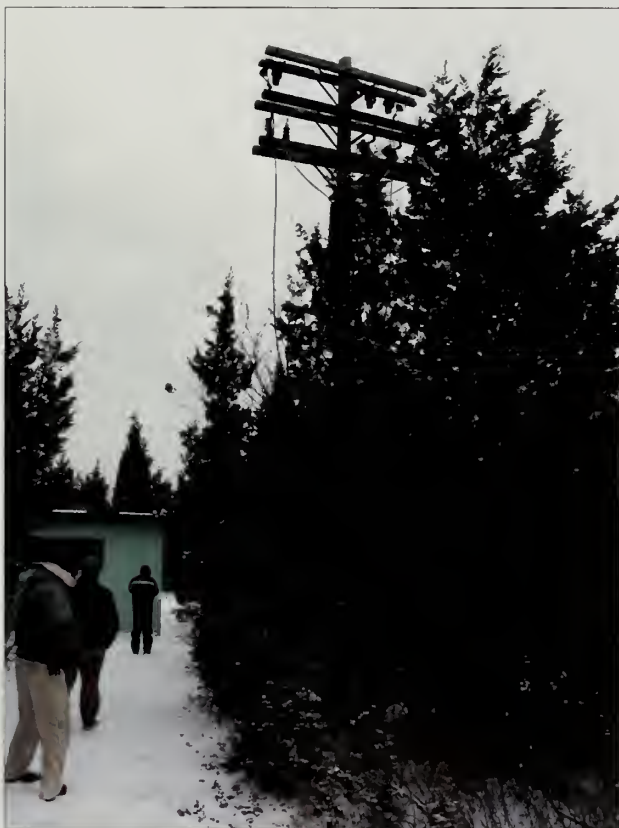
Figure 3.62. View looking north along walkway to Ready Barracks, NIKE radar site. The eastern red cedars (*Juniperus virginiana*) are immediately adjacent to and encroaching on the walkway (Olmsted Center, January 2009).

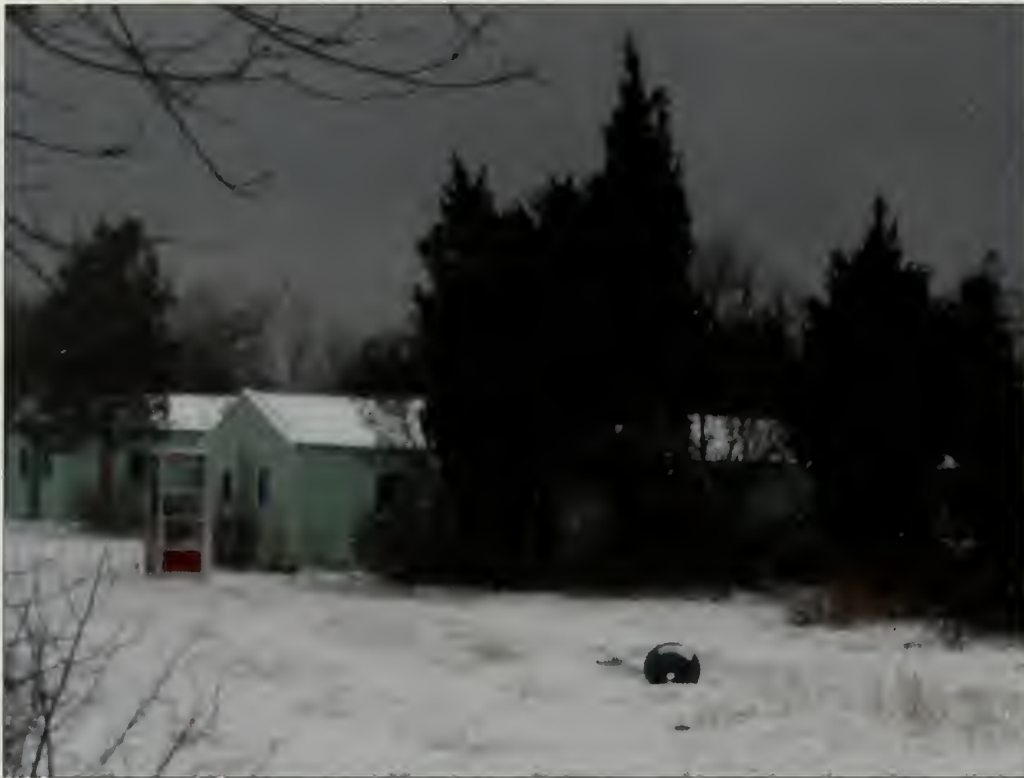
Figure 3.63. View looking northwest at the Ready Barracks, NIKÉ radar site. Pedestrian-scale lights line both walks from the control areas to the Ready Barracks. The lights are in good to fair condition with the exception of one light pole which is knocked over (Olmsted Center, January 2009).

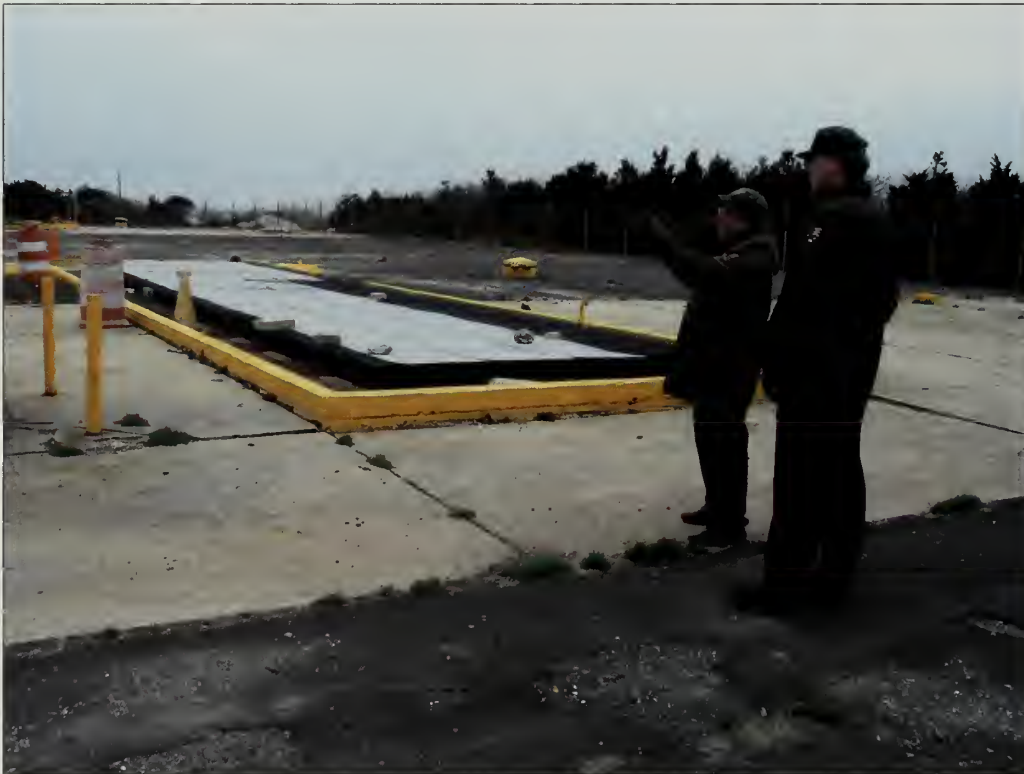
Figure 3.64. View looking west at elevator to missile magazine (425), NIKÉ launch site. The northern section of the launch site contains the underground missile magazines and concrete pads for launching racks. The concrete pads are oriented north to south for firing missiles to the east (Olmsted Center, April 2008).

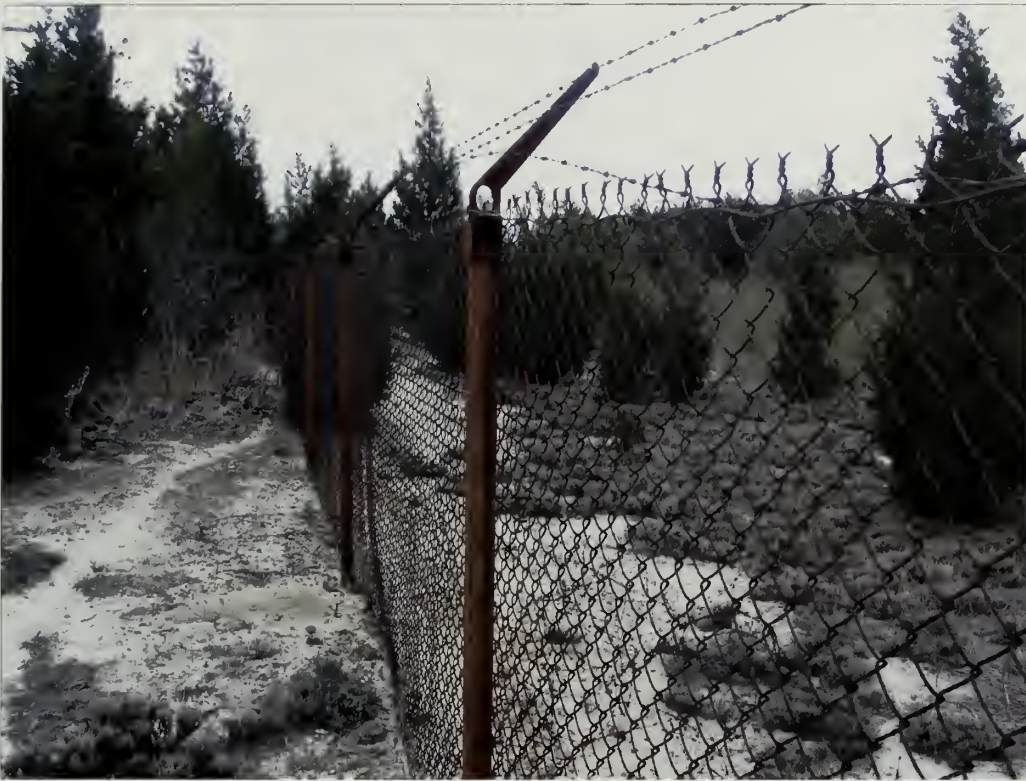
Figure 3.69. Outer fence, NIKE launch site. The launch site features a perimeter fence along its outside boundary and then adds an inner fence that encloses the missile magazines. This section of fence is in fair condition (Olmsted Center, April 2008).

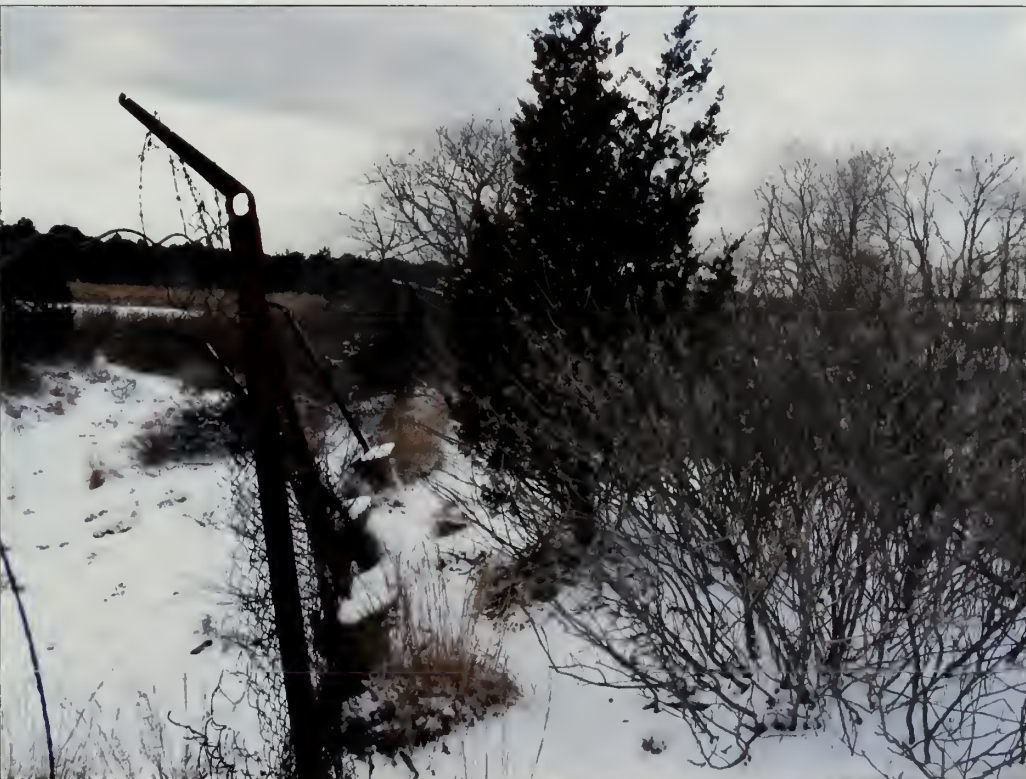
Figure 3.70. Outer fence, NIKE launch site. The inner and outer fences are comprised of chain-link sections secured to H-shaped posts. The top of each post holds a single extension arm that supports strands of barbed wire. This section of fence is in poor condition (Olmsted Center, January 2009).

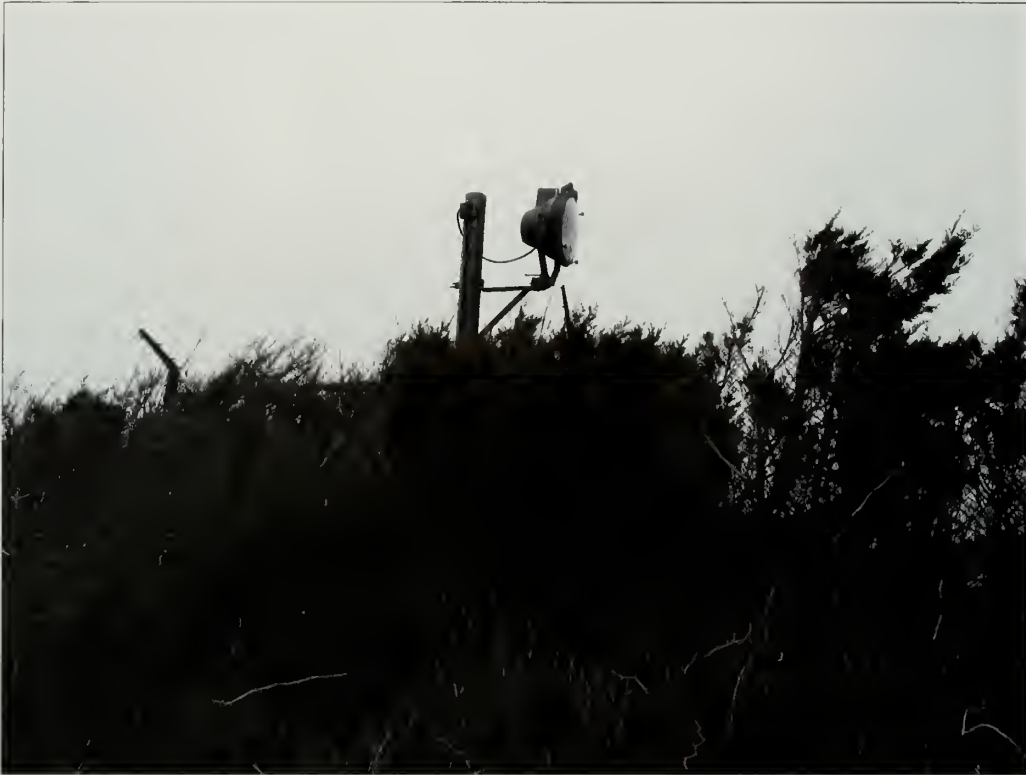
Figure 3.71. Floodlight, NIKE launch site. At the Missile Magazine area, eight floodlights are positioned along the inner fence. Each light features a parabolic fixture mounted with a metal bracket to a wood pole. Six similar lights are located at the Missile Maintenance Area on the engineered earthworks (Olmsted Center, April 2008).

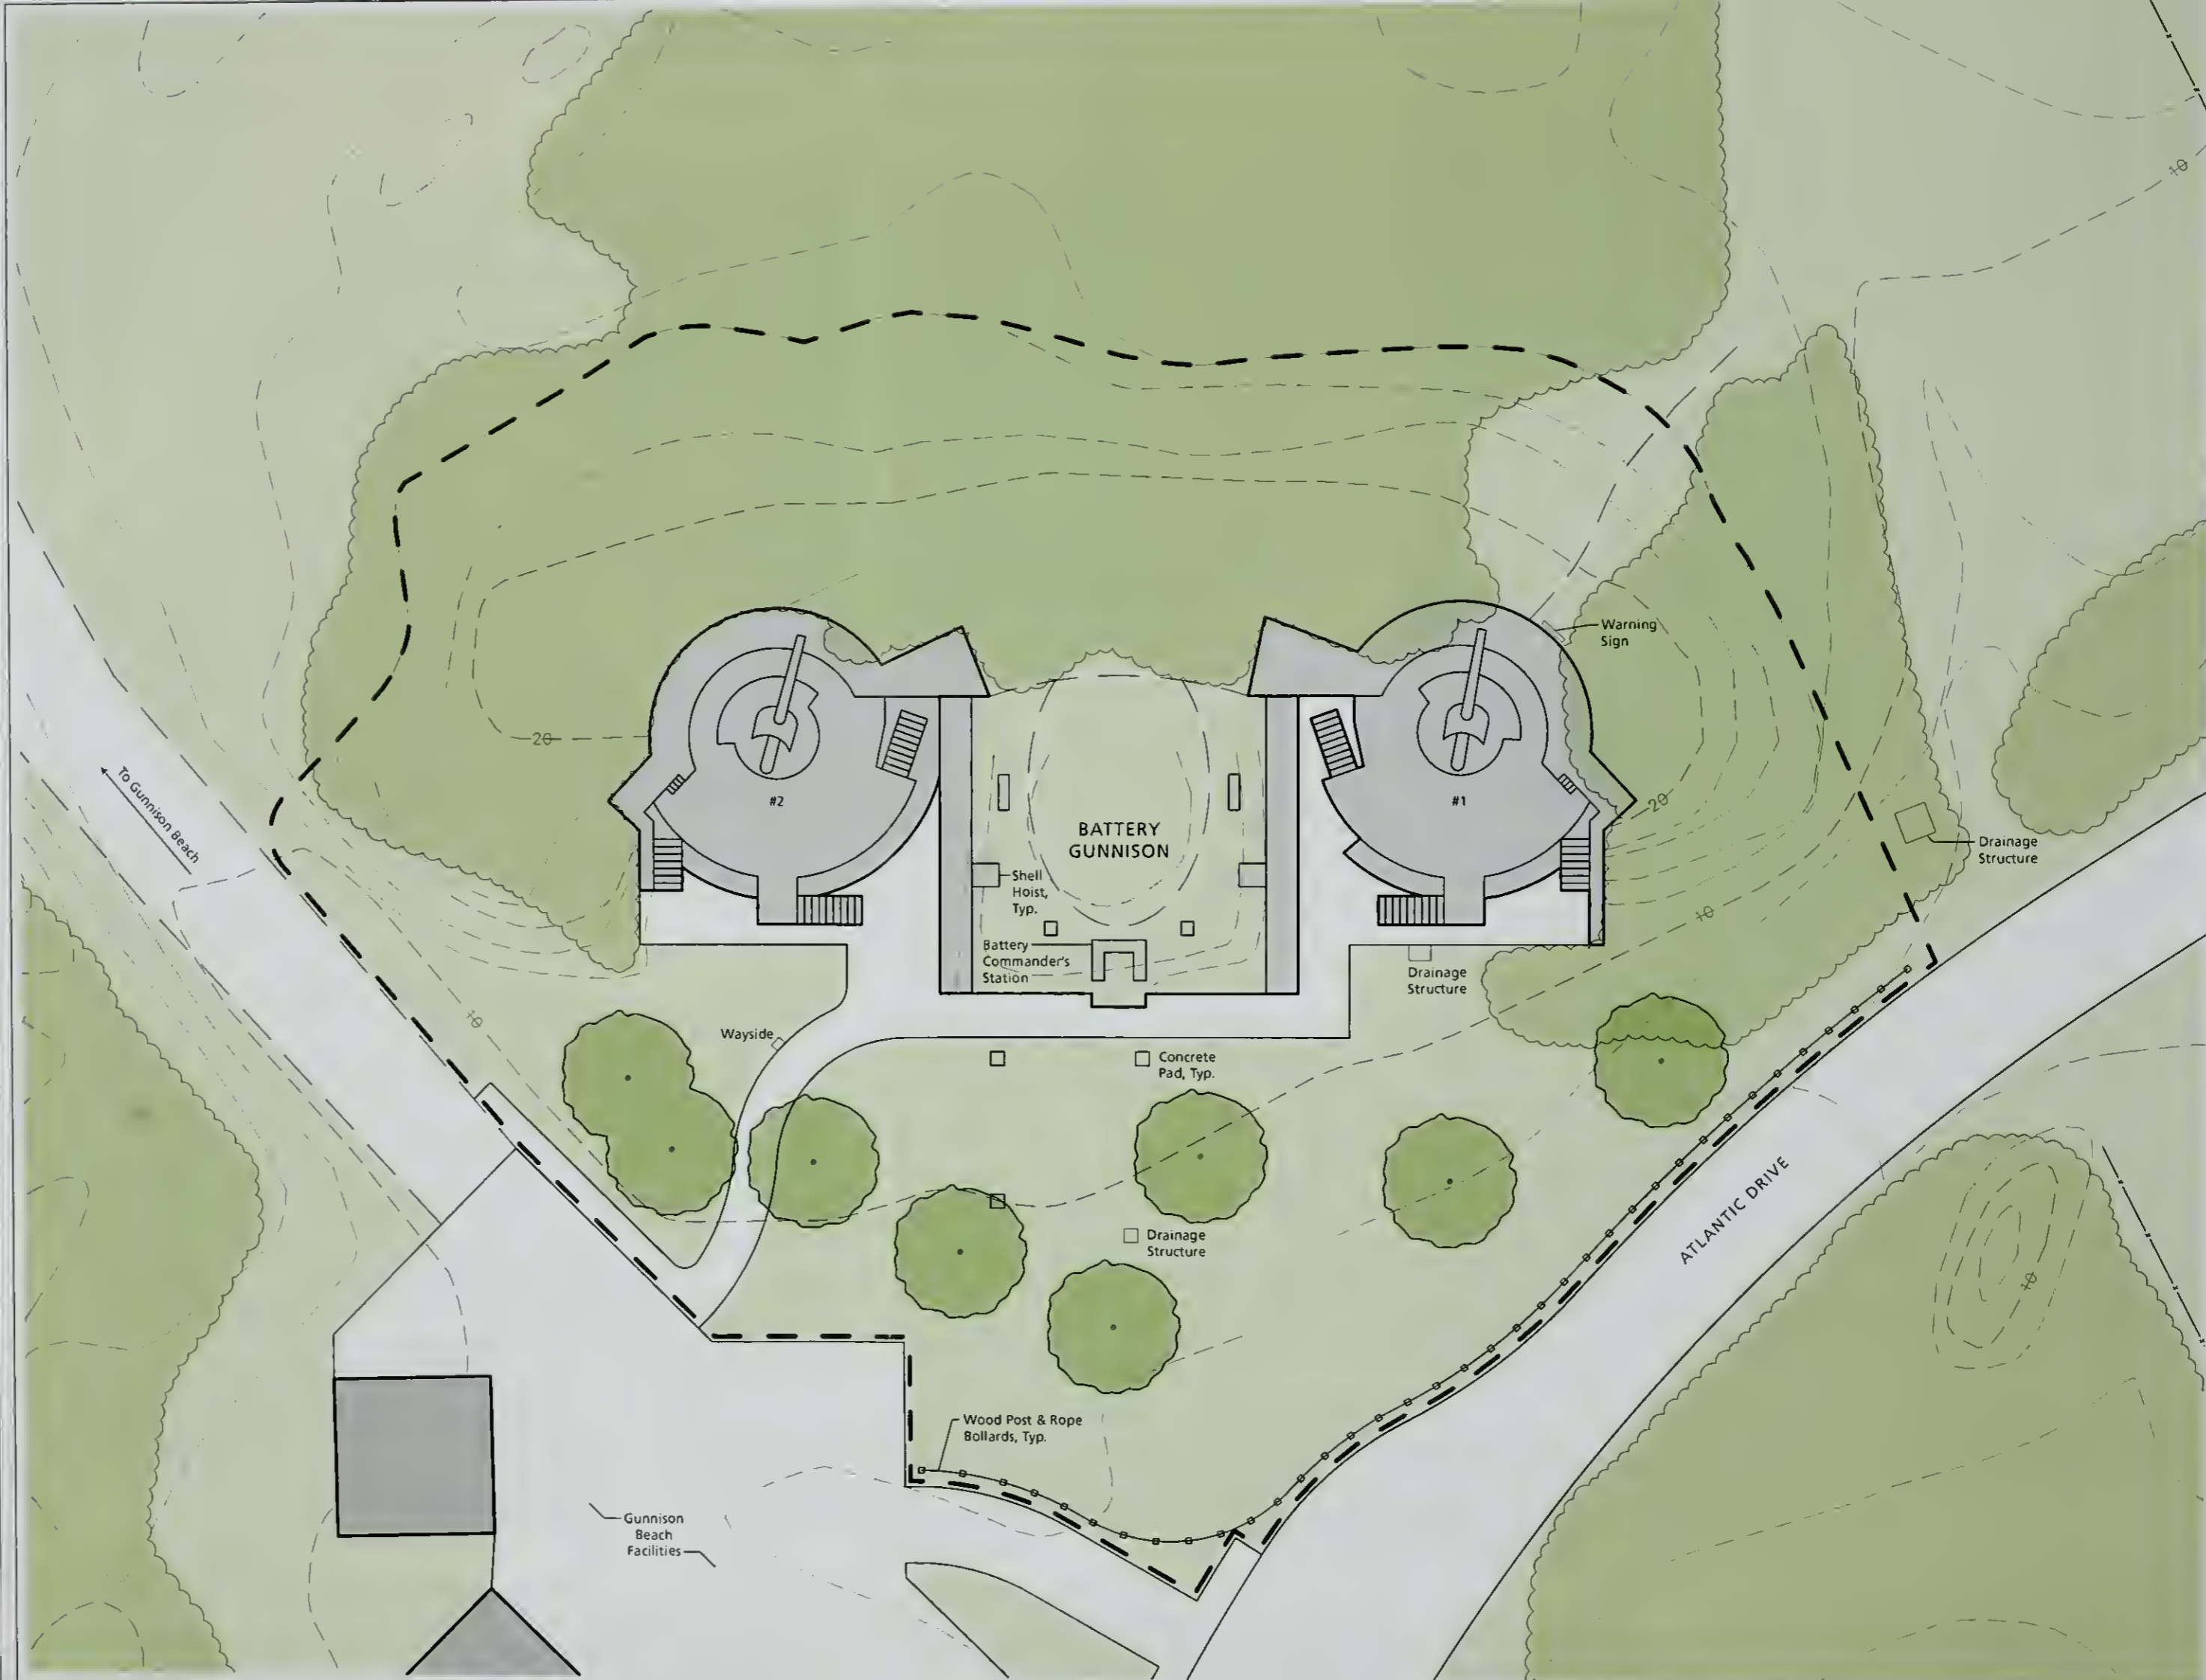
Battery Kingman
Existing Conditions

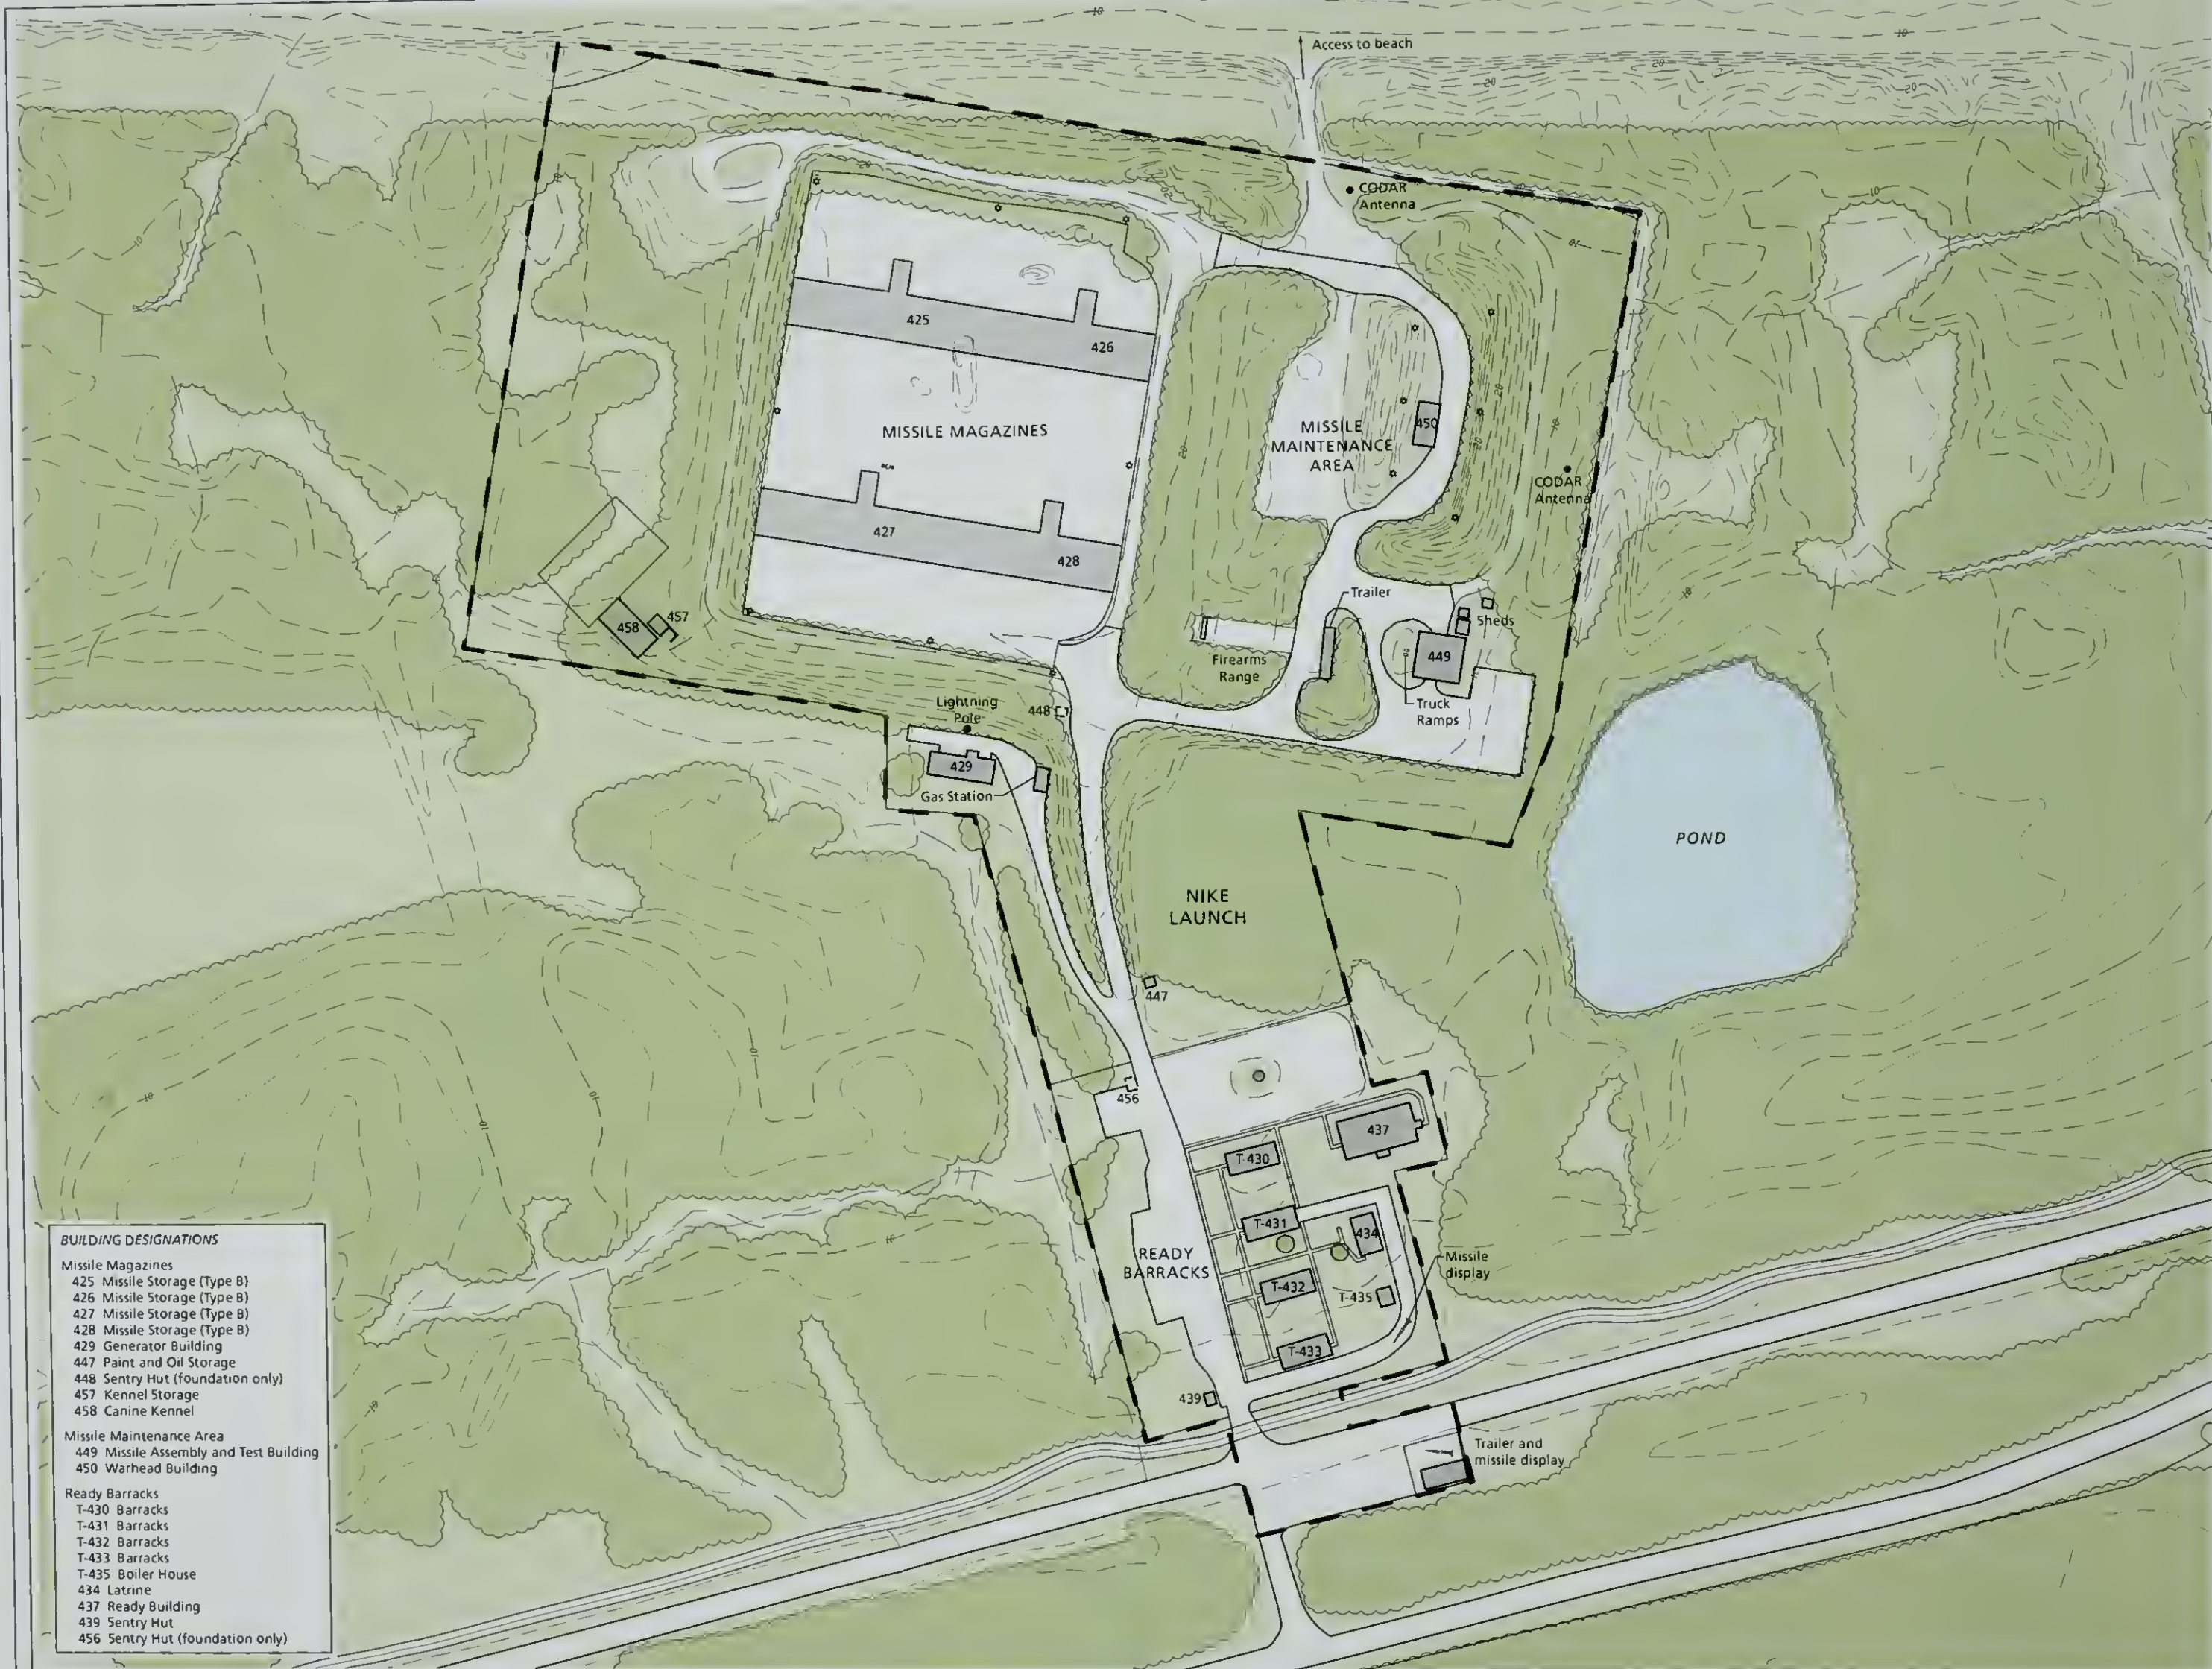
BUILDING DESIGNATIONS

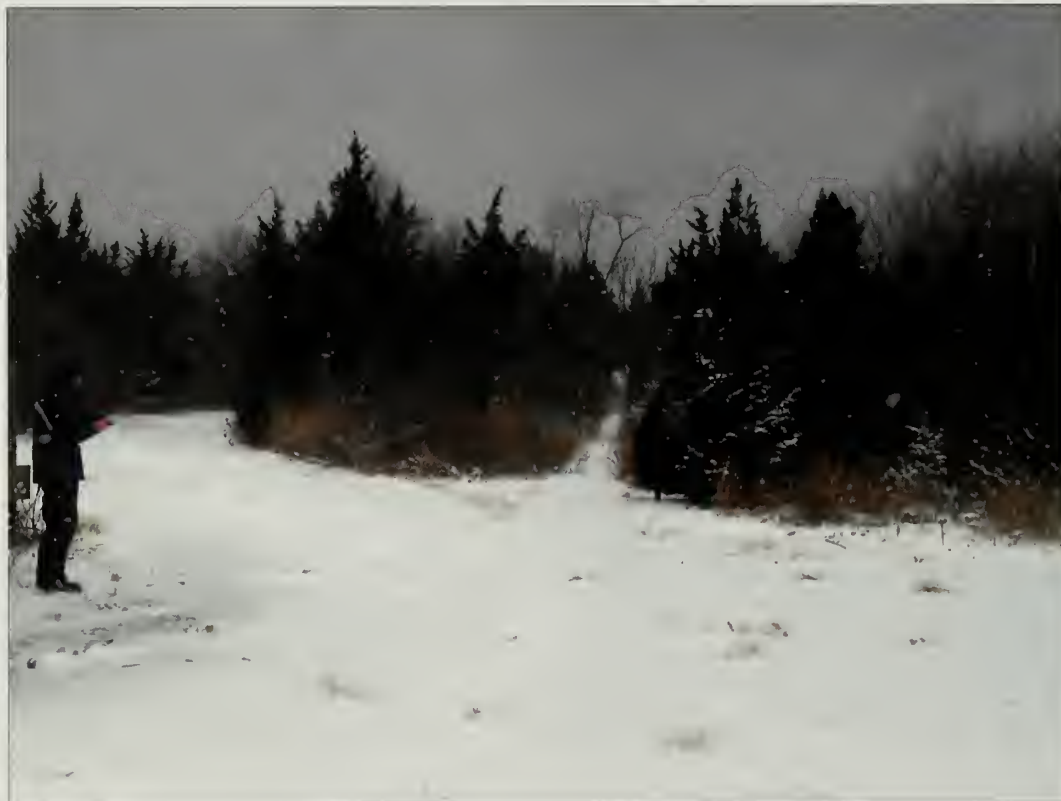
Figure 4.17. View looking northwest at pedestrian walkway, Control Area #1, NIKE radar site. The concrete walkways connecting the control areas and Ready Barracks are presently extant and in fair condition. Some portions of the sidewalks are being covered by encroaching woody vegetation (Olmsted Center, January 2009).

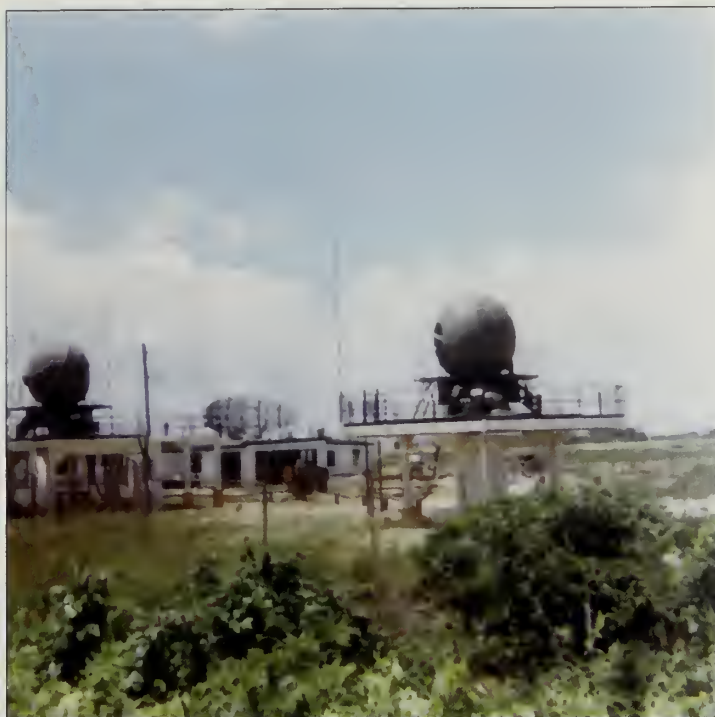
Figure 4.18. View looking west at target tracking radars (417 and 473), Control Area #1, NIKE radar site, circa 1962. A combination of bare sand and grass species was typical around the buildings and structures at the radar site. The vegetation in the foreground is in front of the perimeter fence and therefore outside the radar site (GATE 22043).

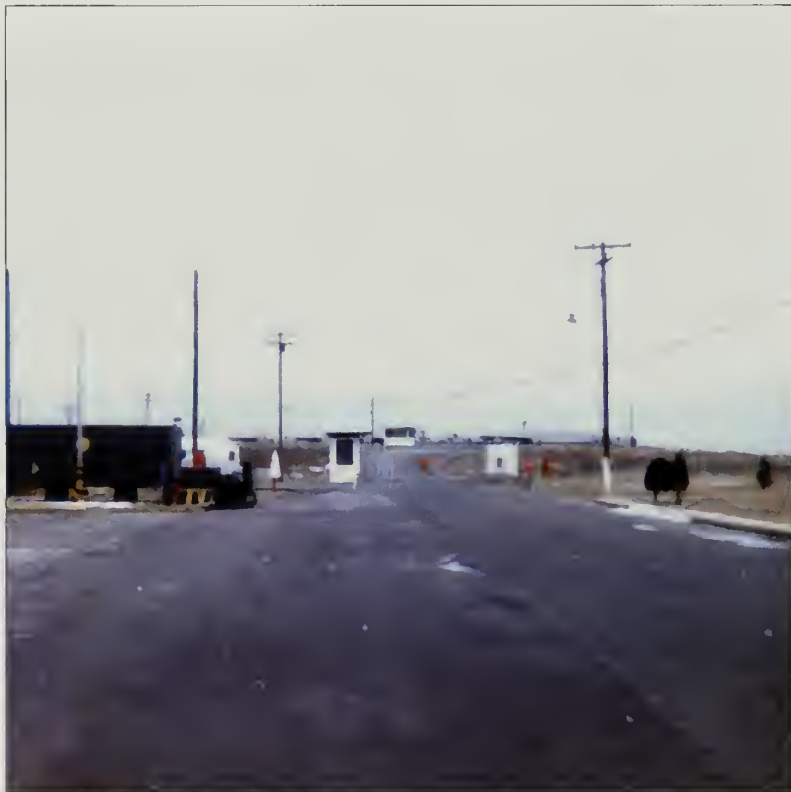
Figure 4.21. View looking east at the Missile Magazines and Missile Maintenance Area, circa 1958. The access road to the Missile Magazines and Missile Maintenance Area was paved with asphalt as part of alterations to the launch site for the Hercules missile. The road is presently extant and in good condition (GATE 22042).

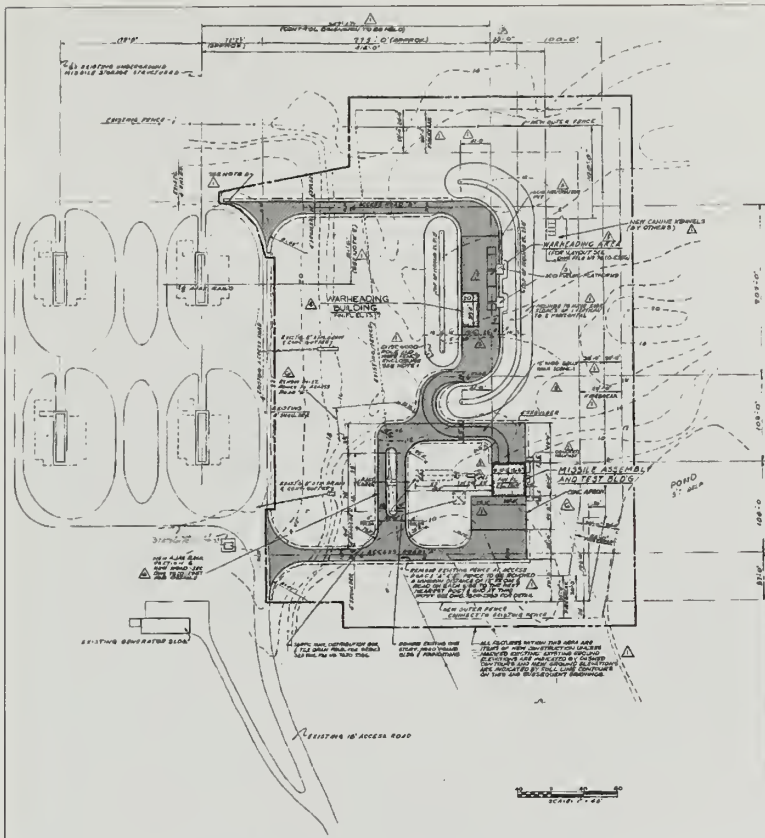
Figure 4.22. Site plan for Missile Maintenance Area, 1958. The gray tone has been added to show vehicular circulation present during the historic period (GATE 7620-2983 and Olmsted Center).

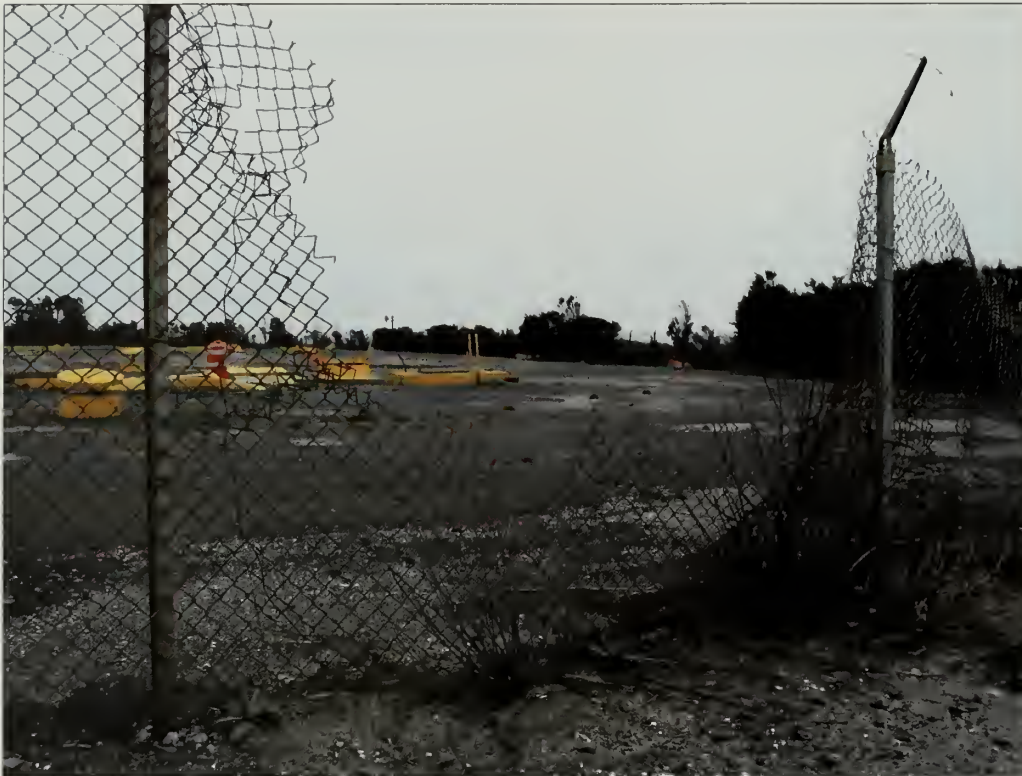
Figure 4.28. View looking southeast across Missile Magazines, NIKE launch site. The Army installed an inner security fence around the Missile Magazines as a component of the launch site's security upgrades to use Hercules missiles fitted with nuclear warheads. The inner fence is presently extant with chain-link sections attached to H-shaped posts and is in fair to poor condition (Olmsted Center, April 2008).
