I 29.86/4.5 A 5

Clemson University

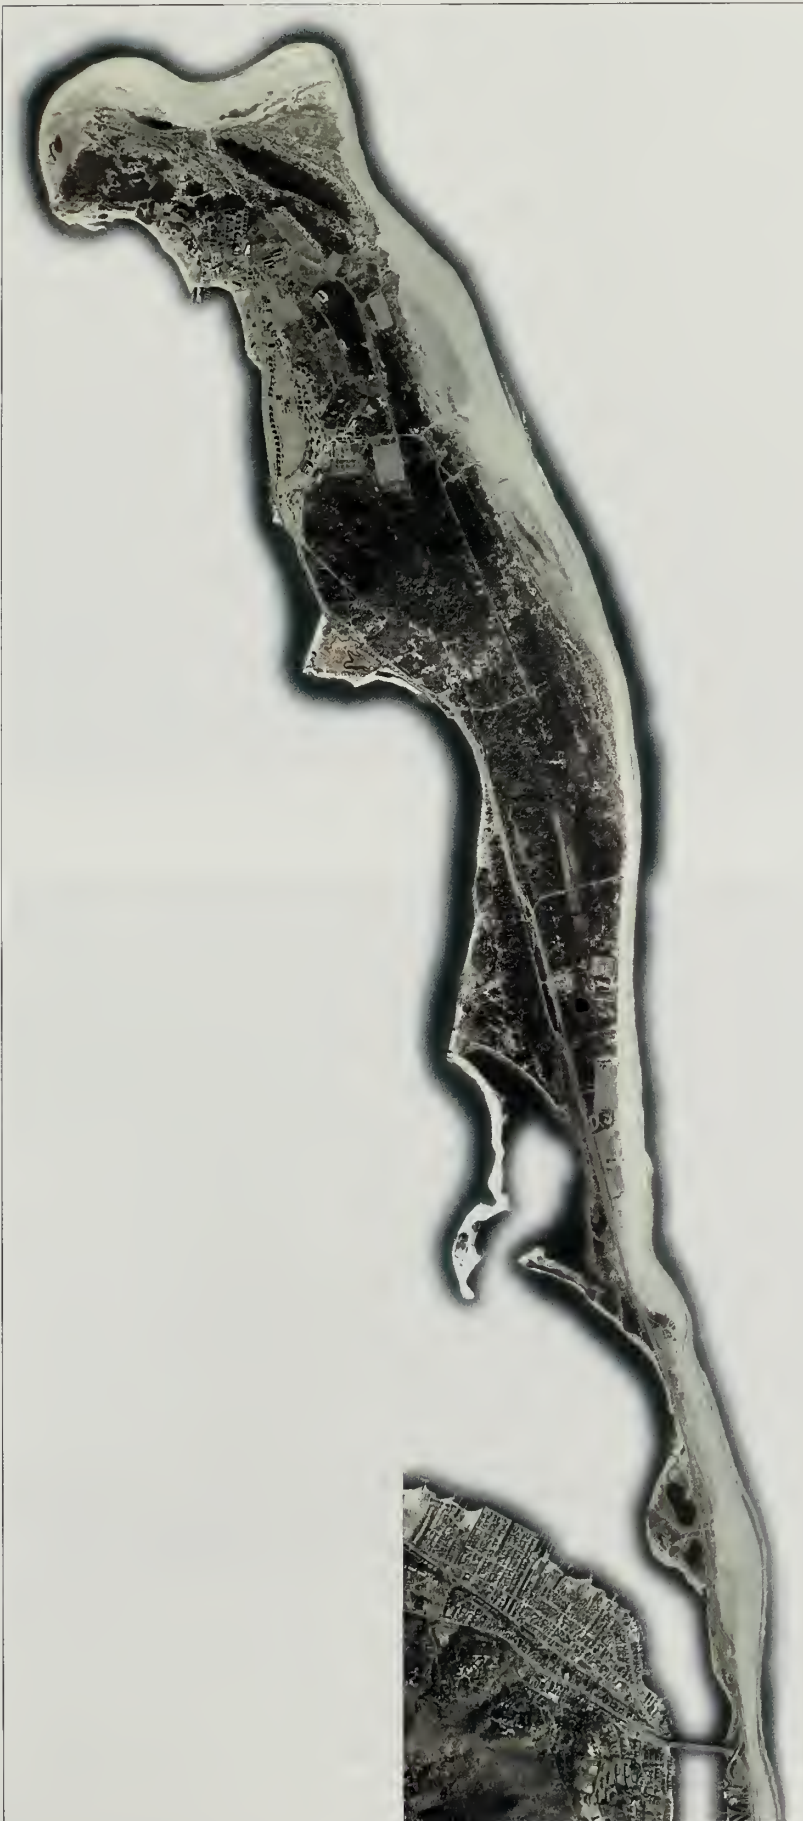
Figure 5.1. Aerial photograph of Sandy Hook landform, 2006. Prior to the National Park Service's administration, Sandy Hook was a highly secured Army reservation that featured successive generations of coastal defenses which guarded the southern approach to New York City (GATE GIS).

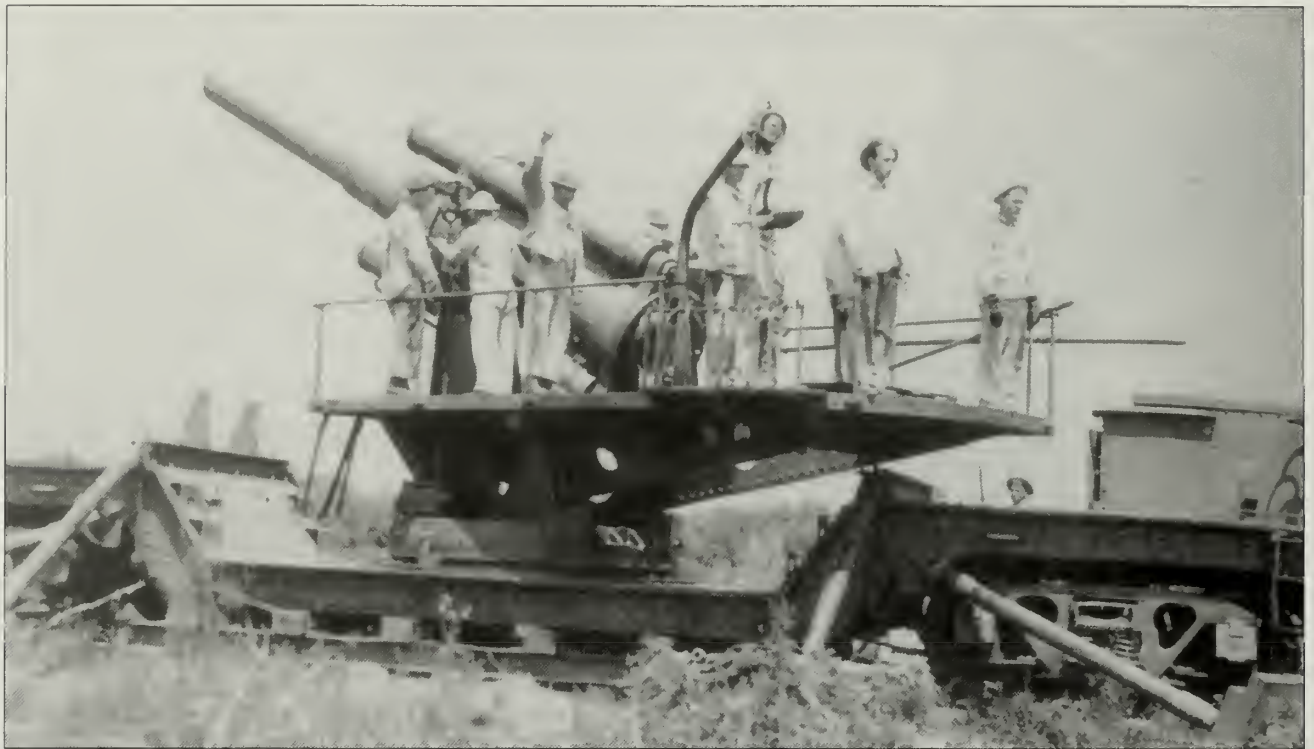
Figure 5.2. Mobile railway gun, circa 1939-1940. Mobile artillery, such as this 8-inch caliber gun, played an important role in coastal defenses at Sandy Hook, however, the treatment recommendations will focus on the concrete gun batteries and NIKE missile installation (Thomas Hoffman, *Fort Hancock*, Charleston, SC: Arcadia Publishing, 2007).

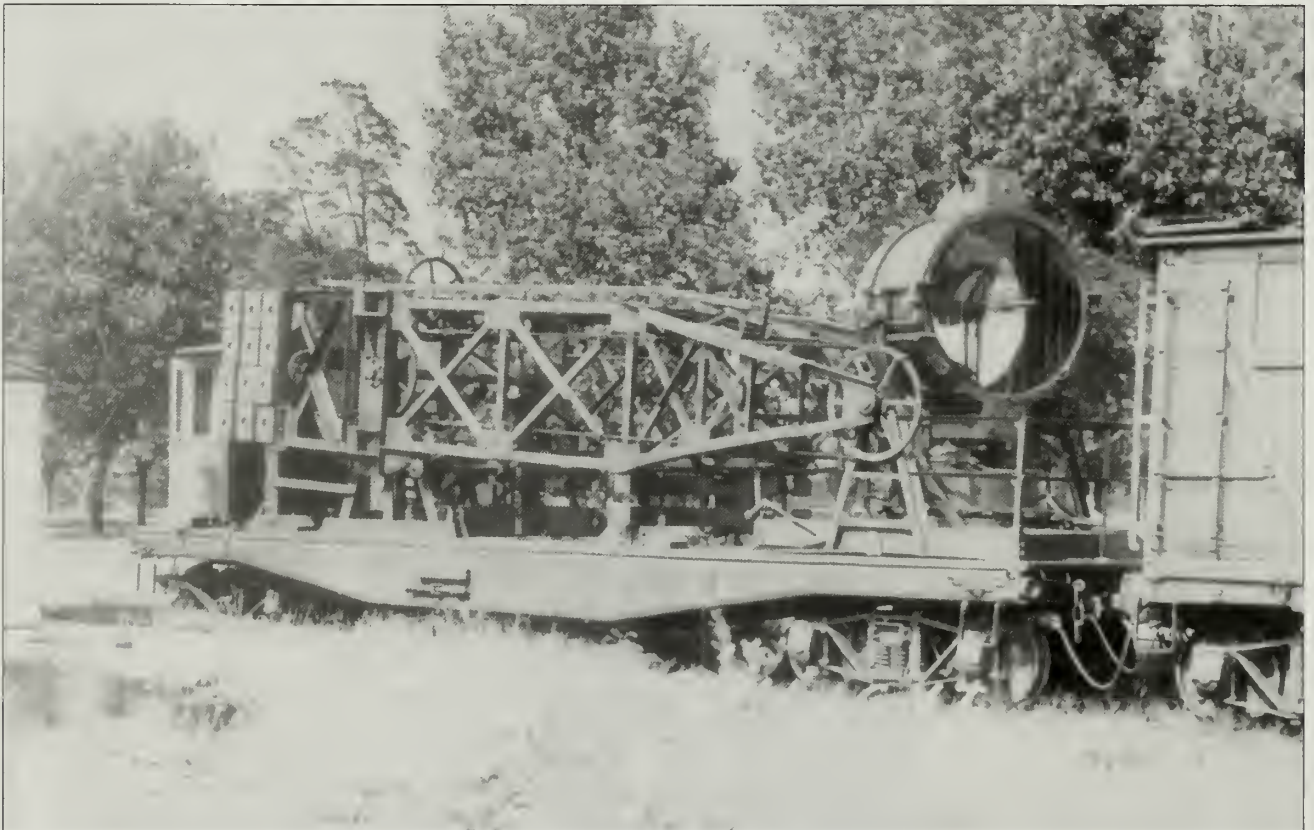
Figure 5.3. Collapsible railway searchlight, no date. Similar to mobile artillery, mobile searchlights as well as small, auxiliary structures were features of Sandy Hook's landscape that played a role in defending the southern approach to New York Harbor. These mobile and sometimes temporary structures will not be addressed in the treatment section (Thomas Hoffman, *Fort Hancock*, Charleston, SC: Arcadia Publishing, 2007).

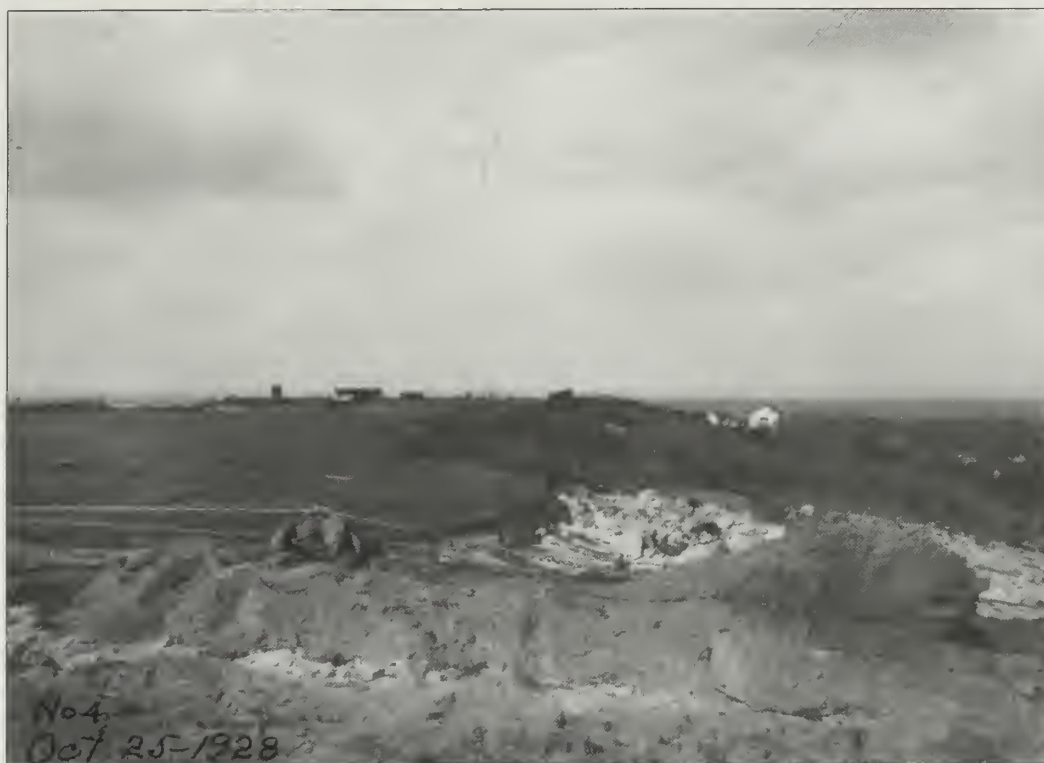
Figure 5.5. Sand being hauled into place in front of the terreplein, Nine Gun Battery, 1928. Engineers covered the concrete structures with sand and earth for concealment and to help absorb the impact of enemy fire (GATE 7009).

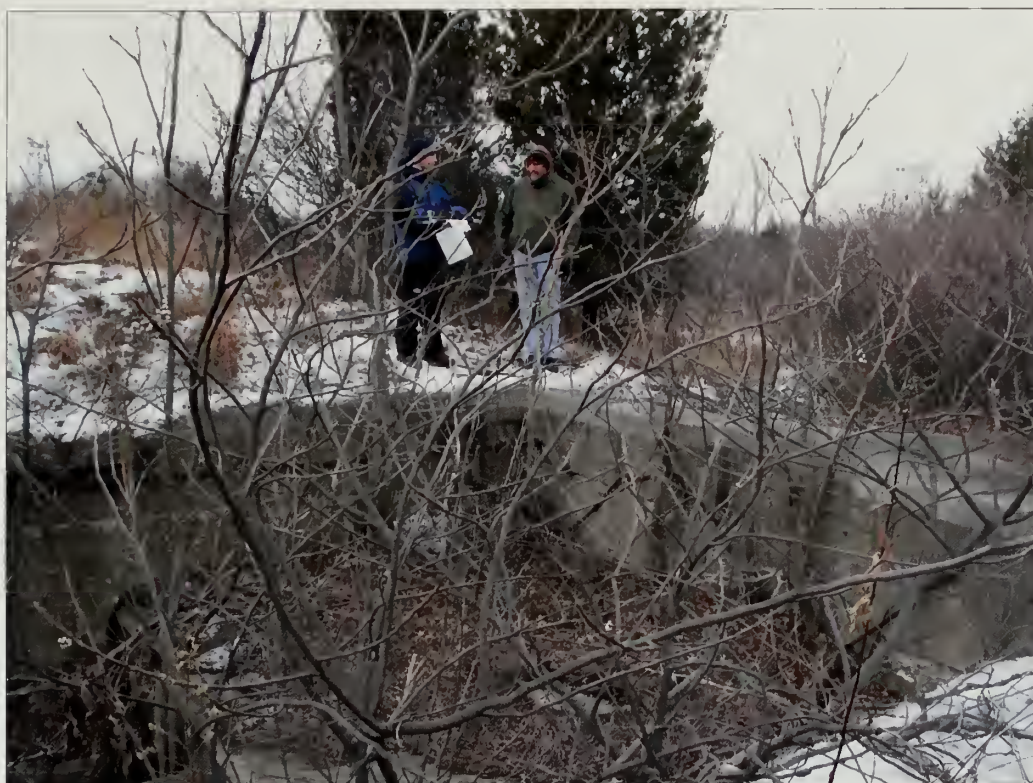
Figure 5.9. View looking northwest across gun platform #4, Battery Urmston. Low and flat areas like this gun platform have accumulated soil, leaf litter, and moisture. These conditions have resulted in the growth of woody vegetation that should be removed from the structure (Olmsted Center, January 2009).

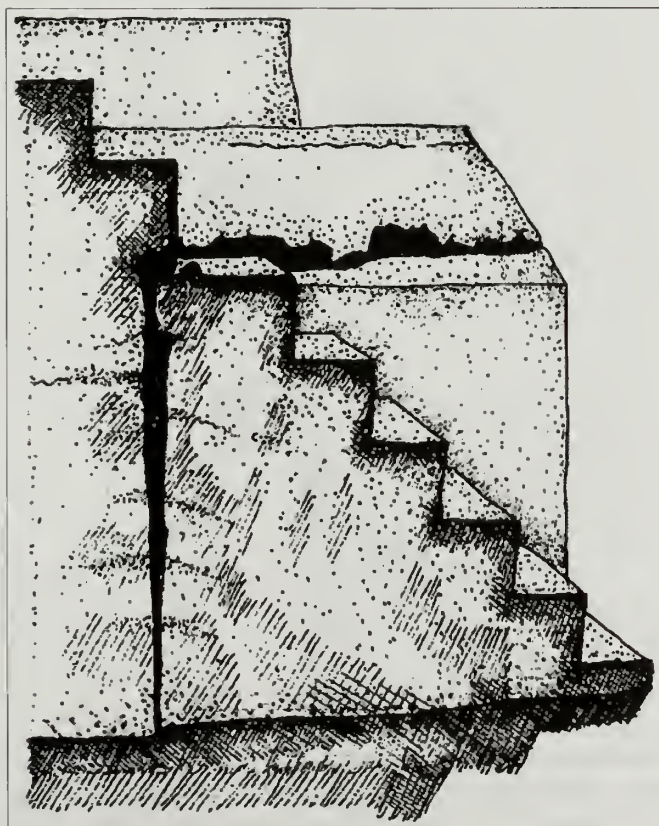
Figure 5.10. Concrete separation at unreinforced steps. Separation between individually cast concrete elements provides another opportunity for woody vegetation to emerge. The voids can also be exacerbated by growing woody material (Joe C. Freeman et al., *Seacoast Fortifications Preservation Manual*, Golden Gate National Recreation Area, San Francisco, California, United States Department of the Interior, National Park Service and KEA Environmental, July 1999, 148).

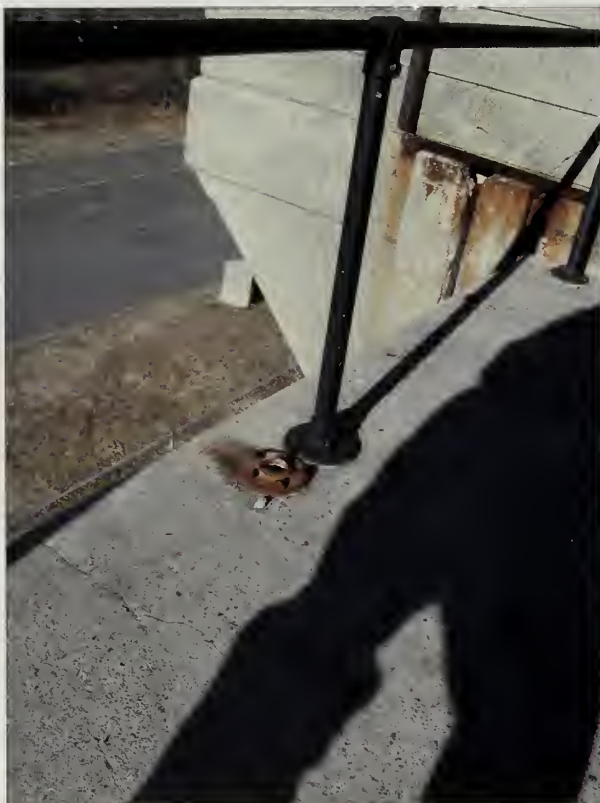
Figure 5.12. View looking west at safety railings, Battery Granger. The existing railing system at Battery Granger displays successive generations of railing components and repairs (Olmsted Center, January 2009).

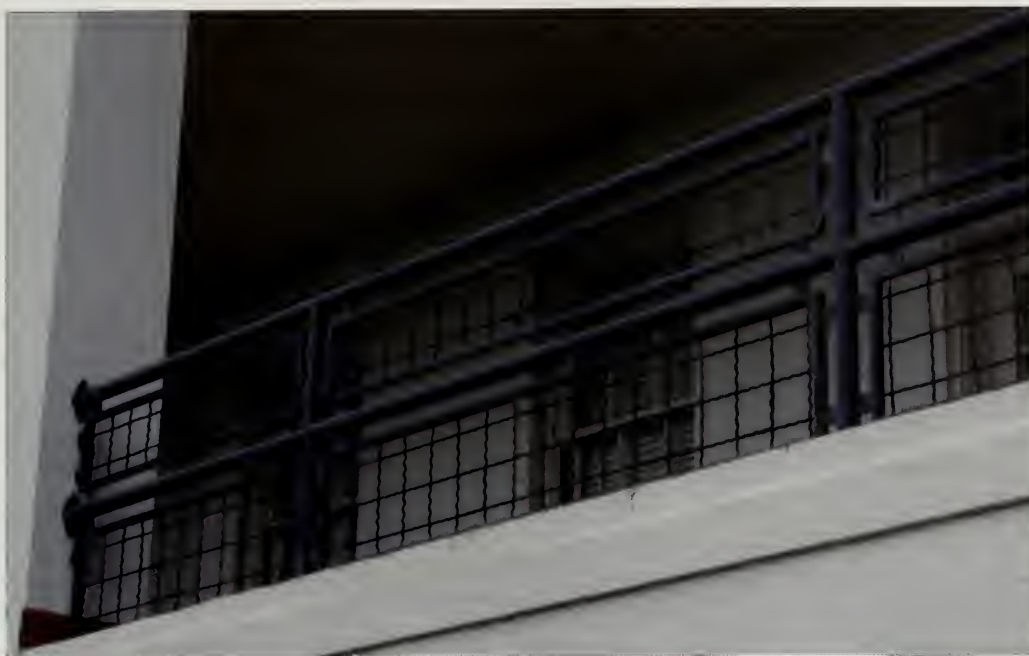
Figure 5.13. Example of the infill approach to retrofitting railing systems for compliance with life-safety codes. In the wide openings between the horizontal pipe rail members, a mesh panel framed by square bar stock has been added. The frame is connected to the existing pipe rails by welding metal tabs between the two (Barbara Judy, Golden Gate National Recreation Area).

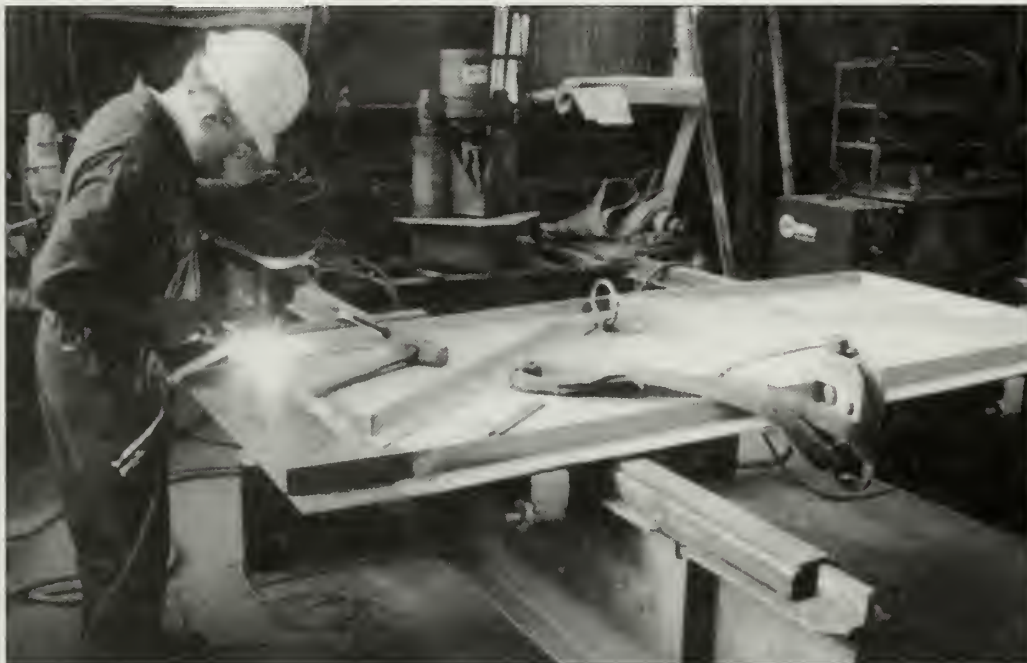
Figure 5.16. Off-site repair of historic metal door for Battery Worth, Fort Casey, Washington. Standing water resulted in the bottom portion of this door being severely deteriorated. The door was removed and is shown being repaired with a new steel plate and angles (From, David M. Hansen, Kimberly Keagle, and Deborah Rehn, *Historic Fortification Preservation Handbook*, Olympia, WA: Washington State Parks and Recreation Commission, 2003, 3.102).

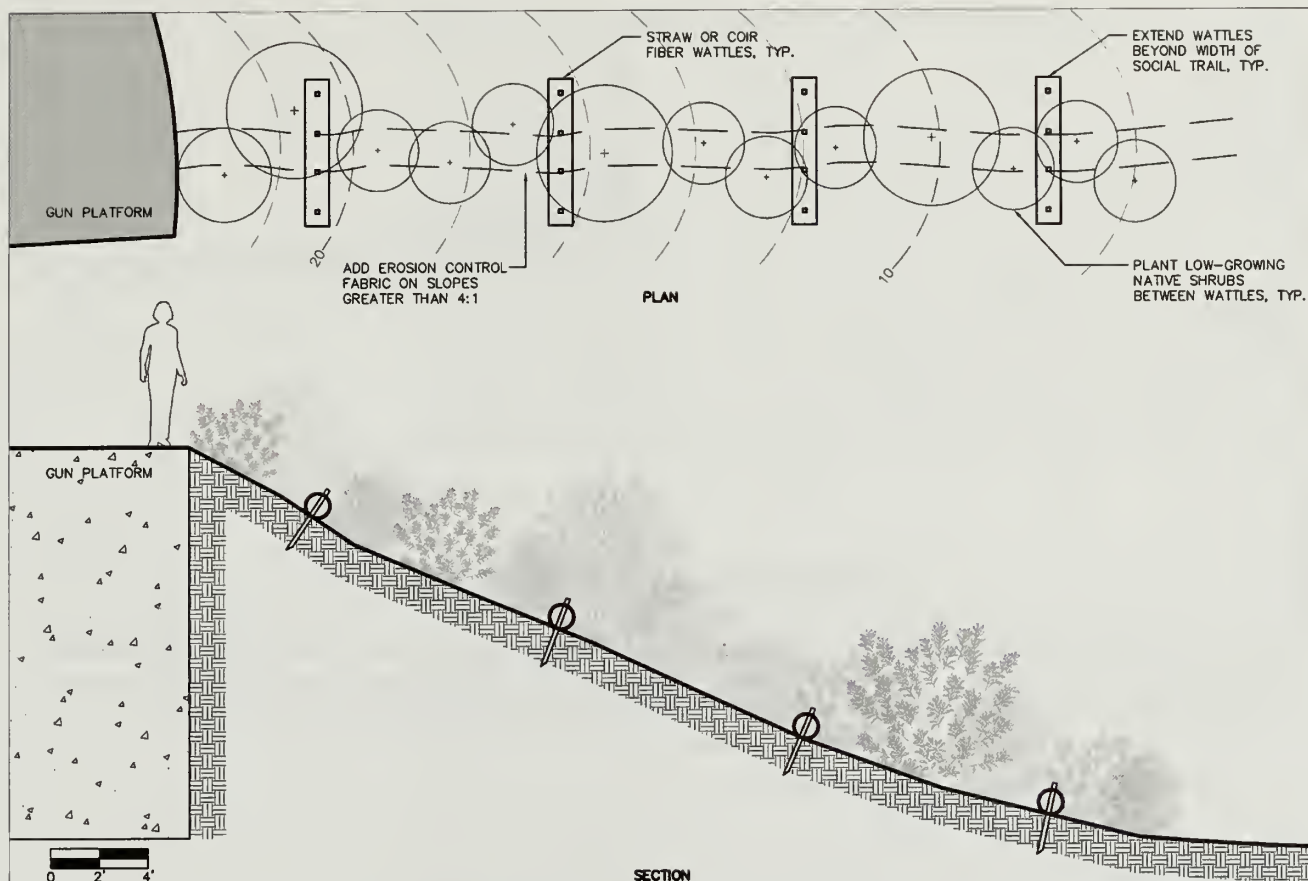
Figure 5.17. Typical revegetation detail to close an existing social trail. To manage erosion on closed social trails, straw or coir fiber wattles should be installed at approximately ten-foot intervals. Low-growing native shrubs should be planted between the wattles to discourage future use (Olmsted Center, 2009).

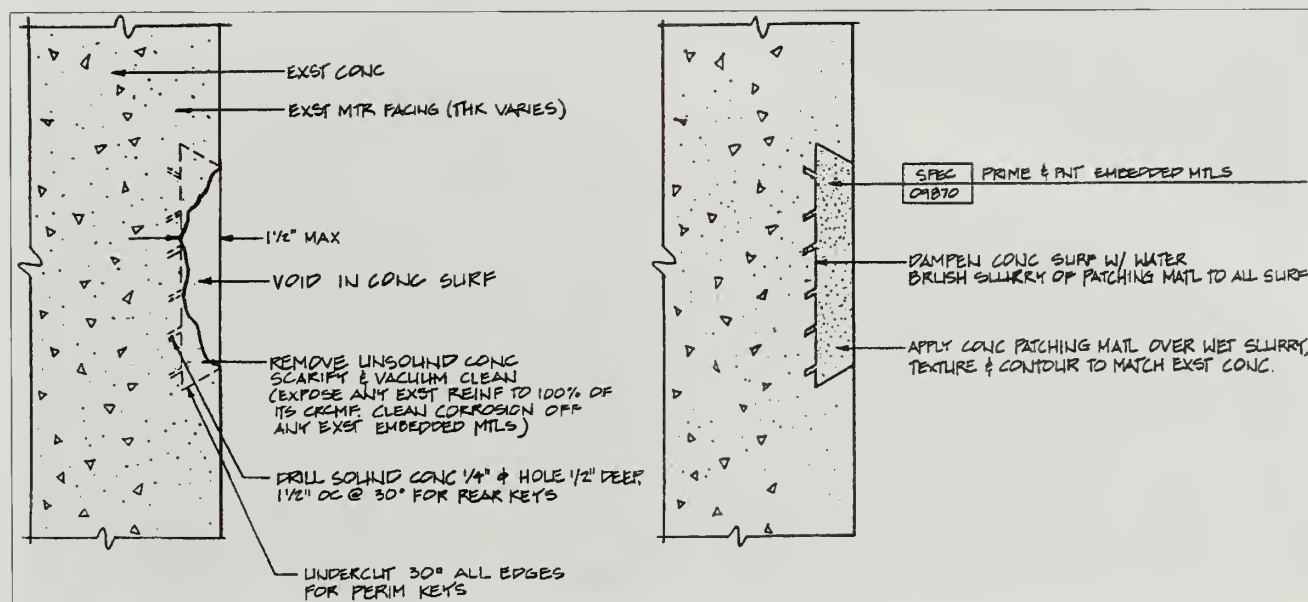
Figure 5.18. Typical repair of spalling concrete surface. The image on the left illustrates the removal of unsound concrete and preparation of the area to receive patching material. On the right, the patch is in place and has been finished to be compatible with the character of the historic concrete. In addition, the prepared area may be lightly coated with an approved bonding agent to promote greater adhesion of the new concrete (Hansen, Keagle, and Rehn, *Historic Fortification Preservation Handbook*, 3.78-3.79).

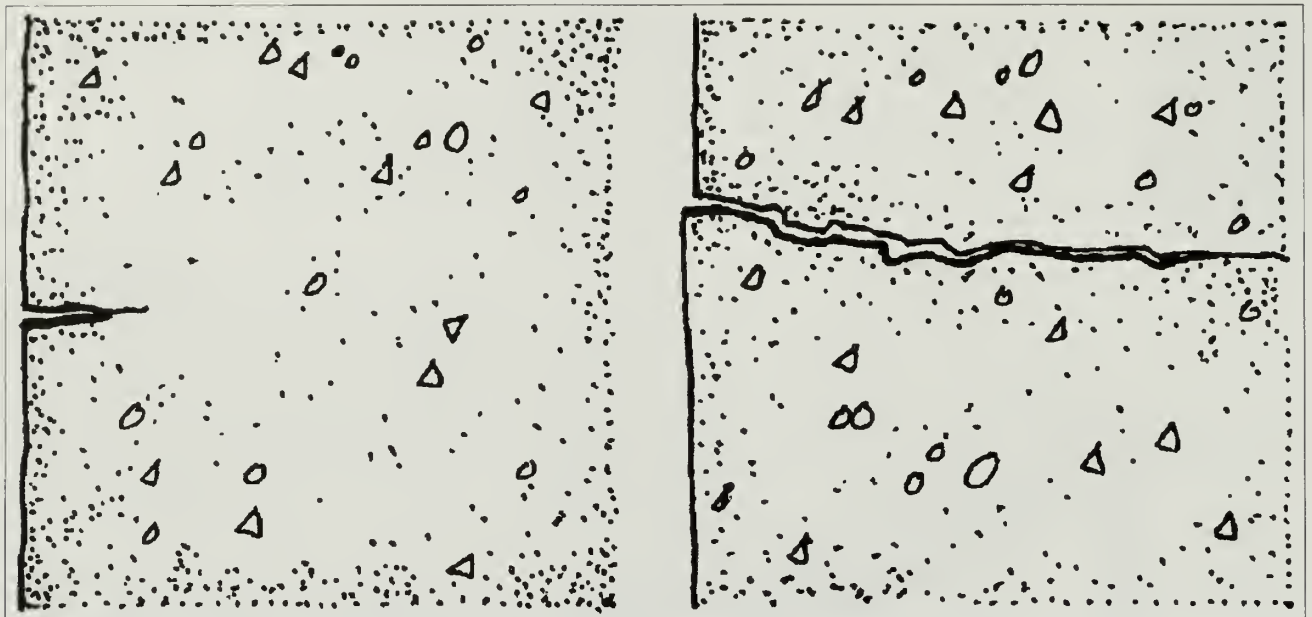
Figure 5.19. Typical concrete cracks. The image on the left illustrates a small, surface crack that can be repaired by grouting and sealing. The image on the right illustrates a large, structural crack that will require extensive repairs. Consultation with a structural engineer is recommended to determine a preferred method of repair (Freeman et al., *Seacoast Fortifications Preservation Manual*, 147).

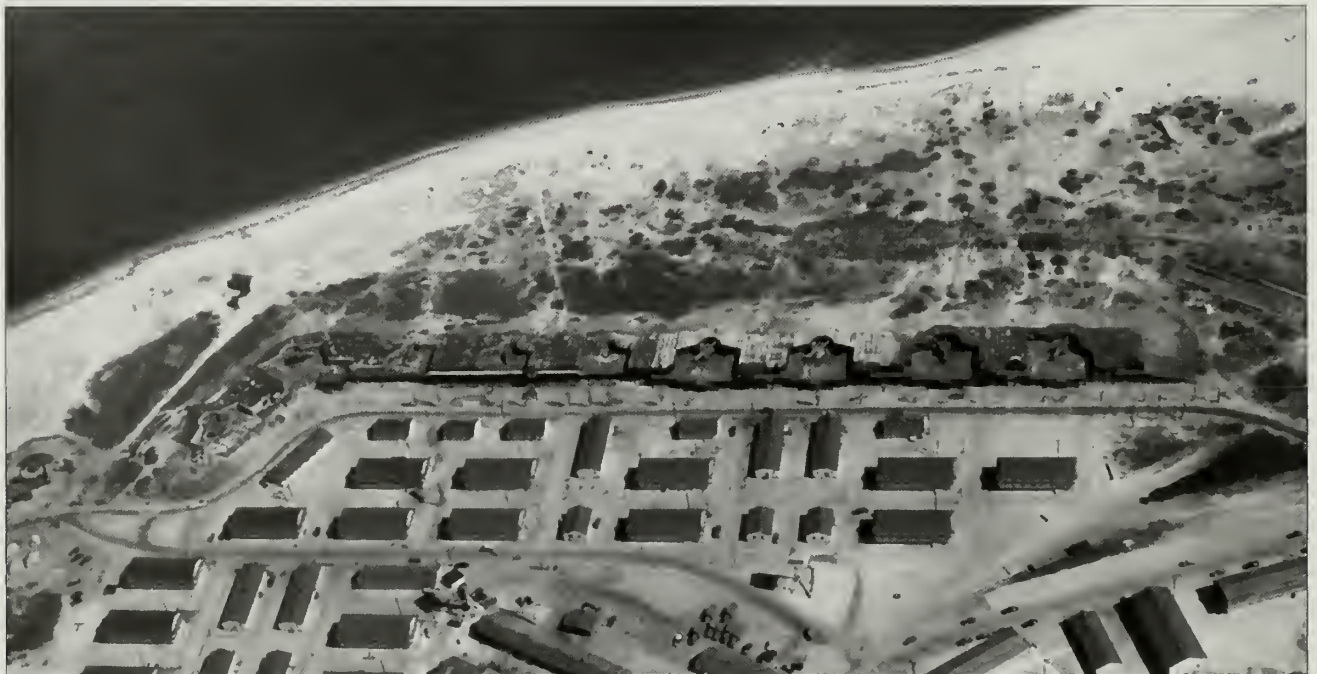
Figure 5.20. Oblique aerial view of Nine Gun Battery, 1942. This World War II-era photograph of Nine Gun Battery, and a portion of Battery Peck (left), indicate they were both finished with an asphalt emulsion paint (also refer to cover photograph). This surface treatment has worn away from gun platforms #3 and #4 (center) and the brighter appearance of the concrete underneath is visible (National Archives, Record Group 661 S, Philip S. Gage Collection, Fort Hancock Folder).

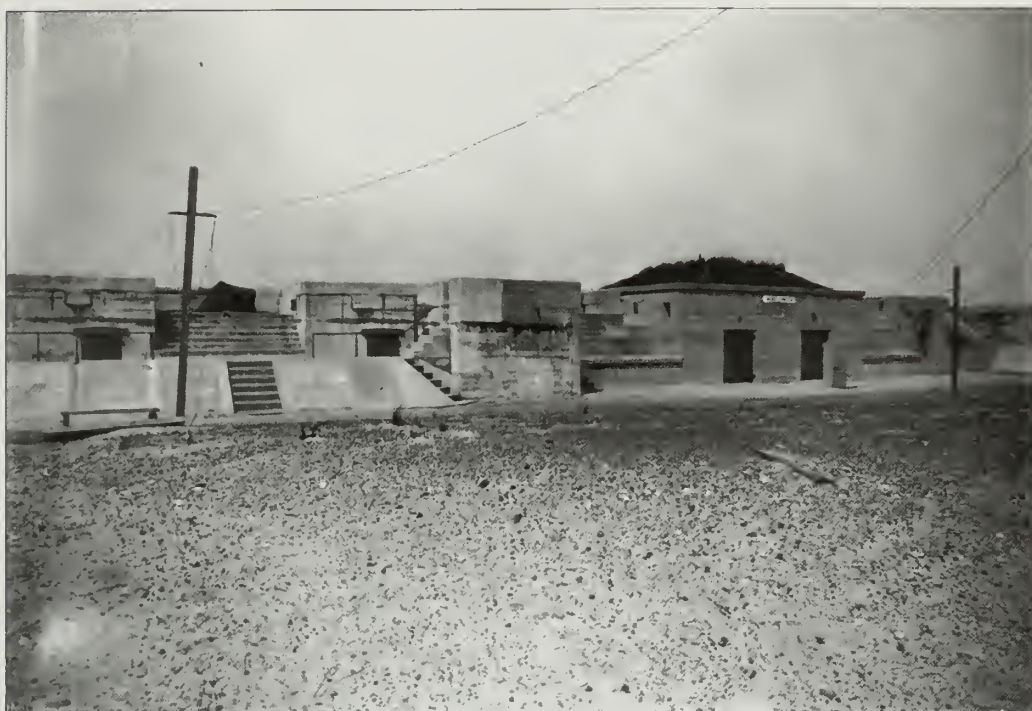
Figure 5.21. View looking northeast at Battery Urmston, circa 1900. In contrast to its appearance today, the south side of Battery Urmston contained no woody vegetation (GATE 7882).

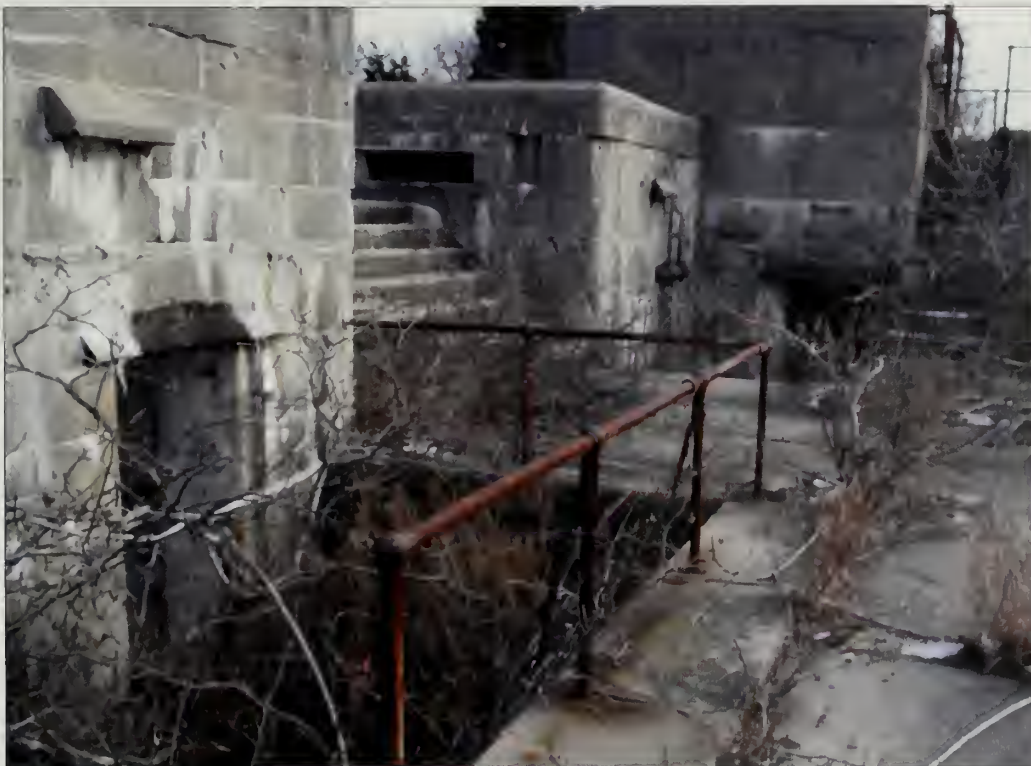
Figure 5.26. Existing historic safety railing at Battery Urmston is fabricated of pipe rail sections and ball joint connectors. After treating corrosion and restoring the historic finish, infill panels should be installed where there is a vertical change equal to or greater than thirty inches in order to provide greater safety at the large openings below the top rails (Olmsted Center, January 2009).

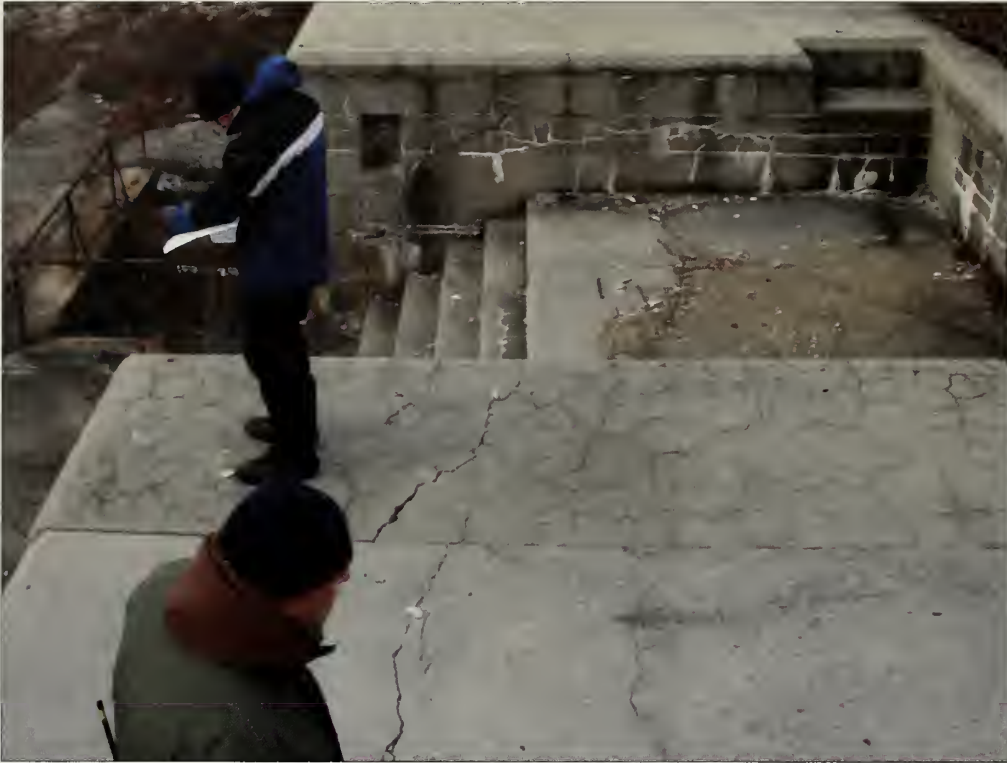
Figure 5.27. View looking down at gun platform #5, Battery Urmston. The tops of the magazines and bomb proofs show less evidence of spalling concrete, yet substantial cracks are present (Olmsted Center, January 2009).

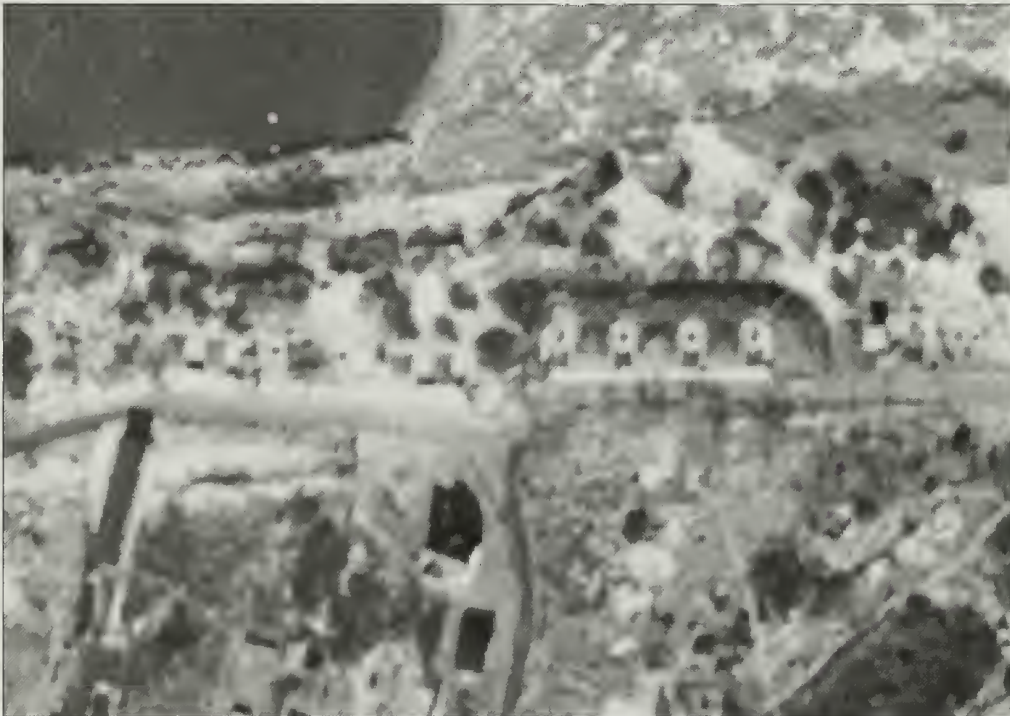
Figure 5.28. Aerial photograph of Batteries Urmston and Morris, January 1933. This photograph indicates that at this time, the concrete surfaces belonging to Batteries Urmston and Morris did not feature a paint, asphalt emulsion, or another darkly hued surface treatment (Coastal and Hydraulics Laboratory, Engineer Research and Development Center).

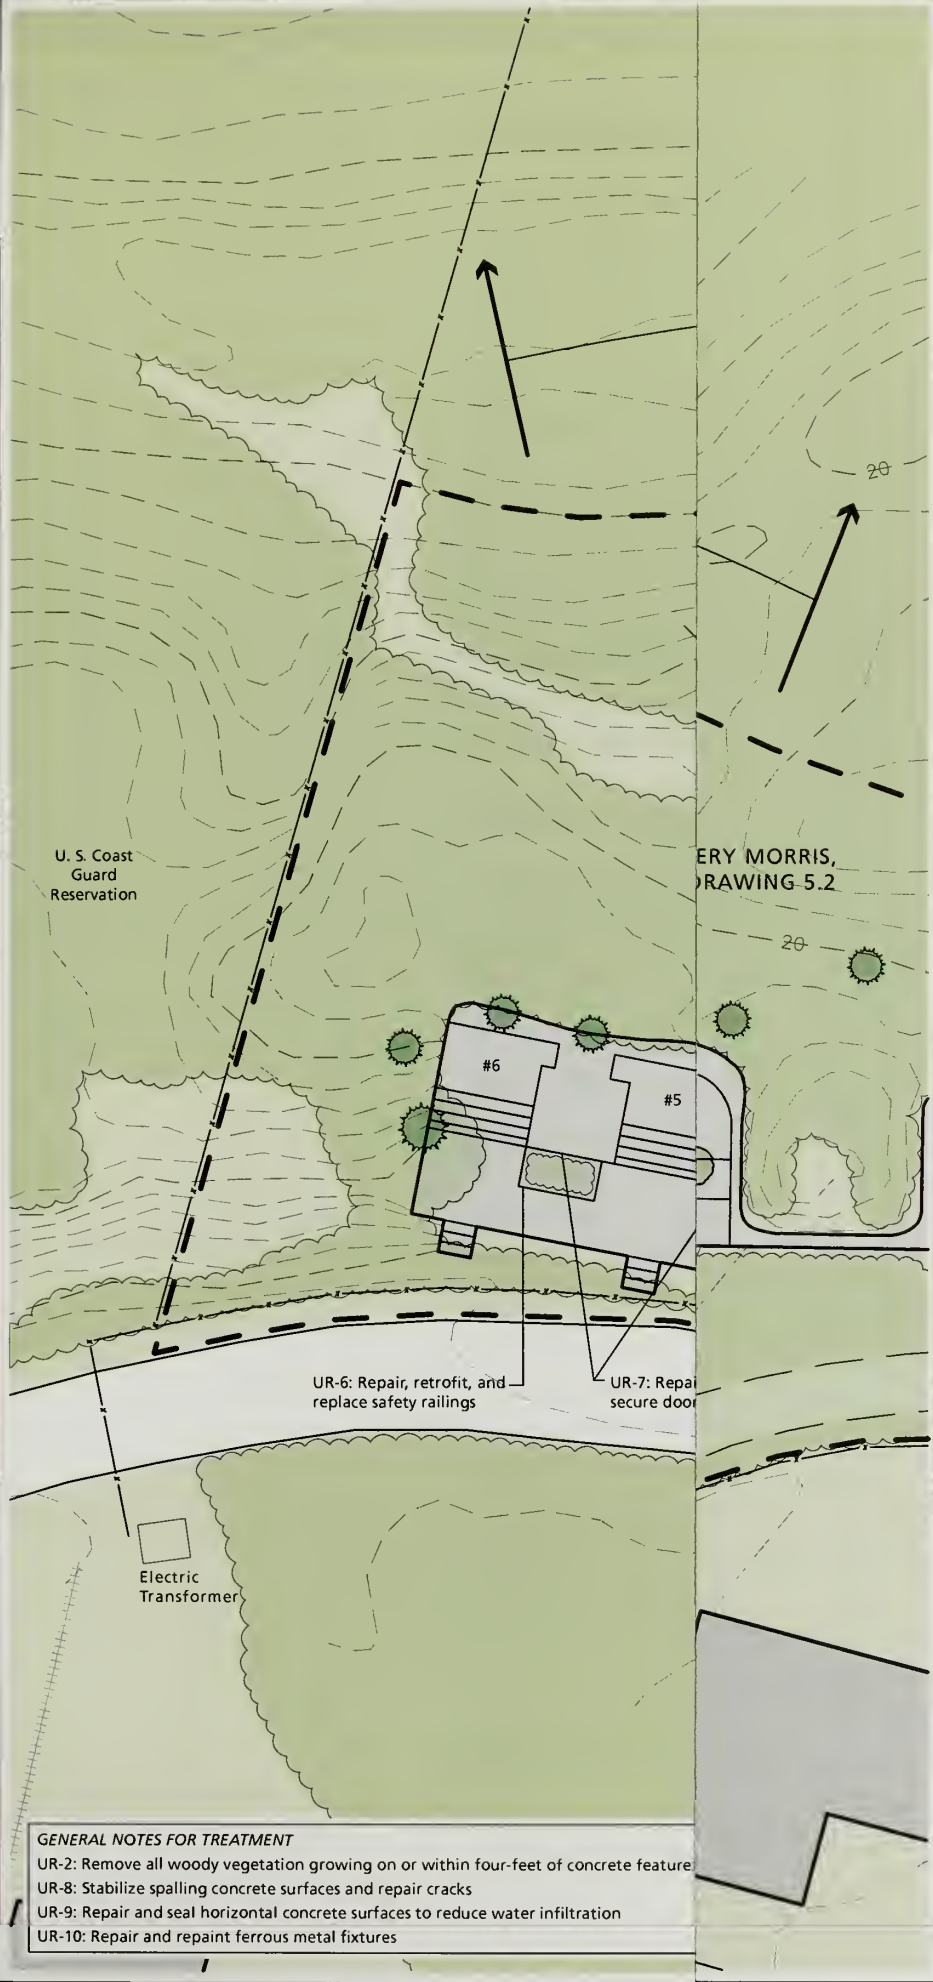
GENERAL NOTES FOR TREATMENT

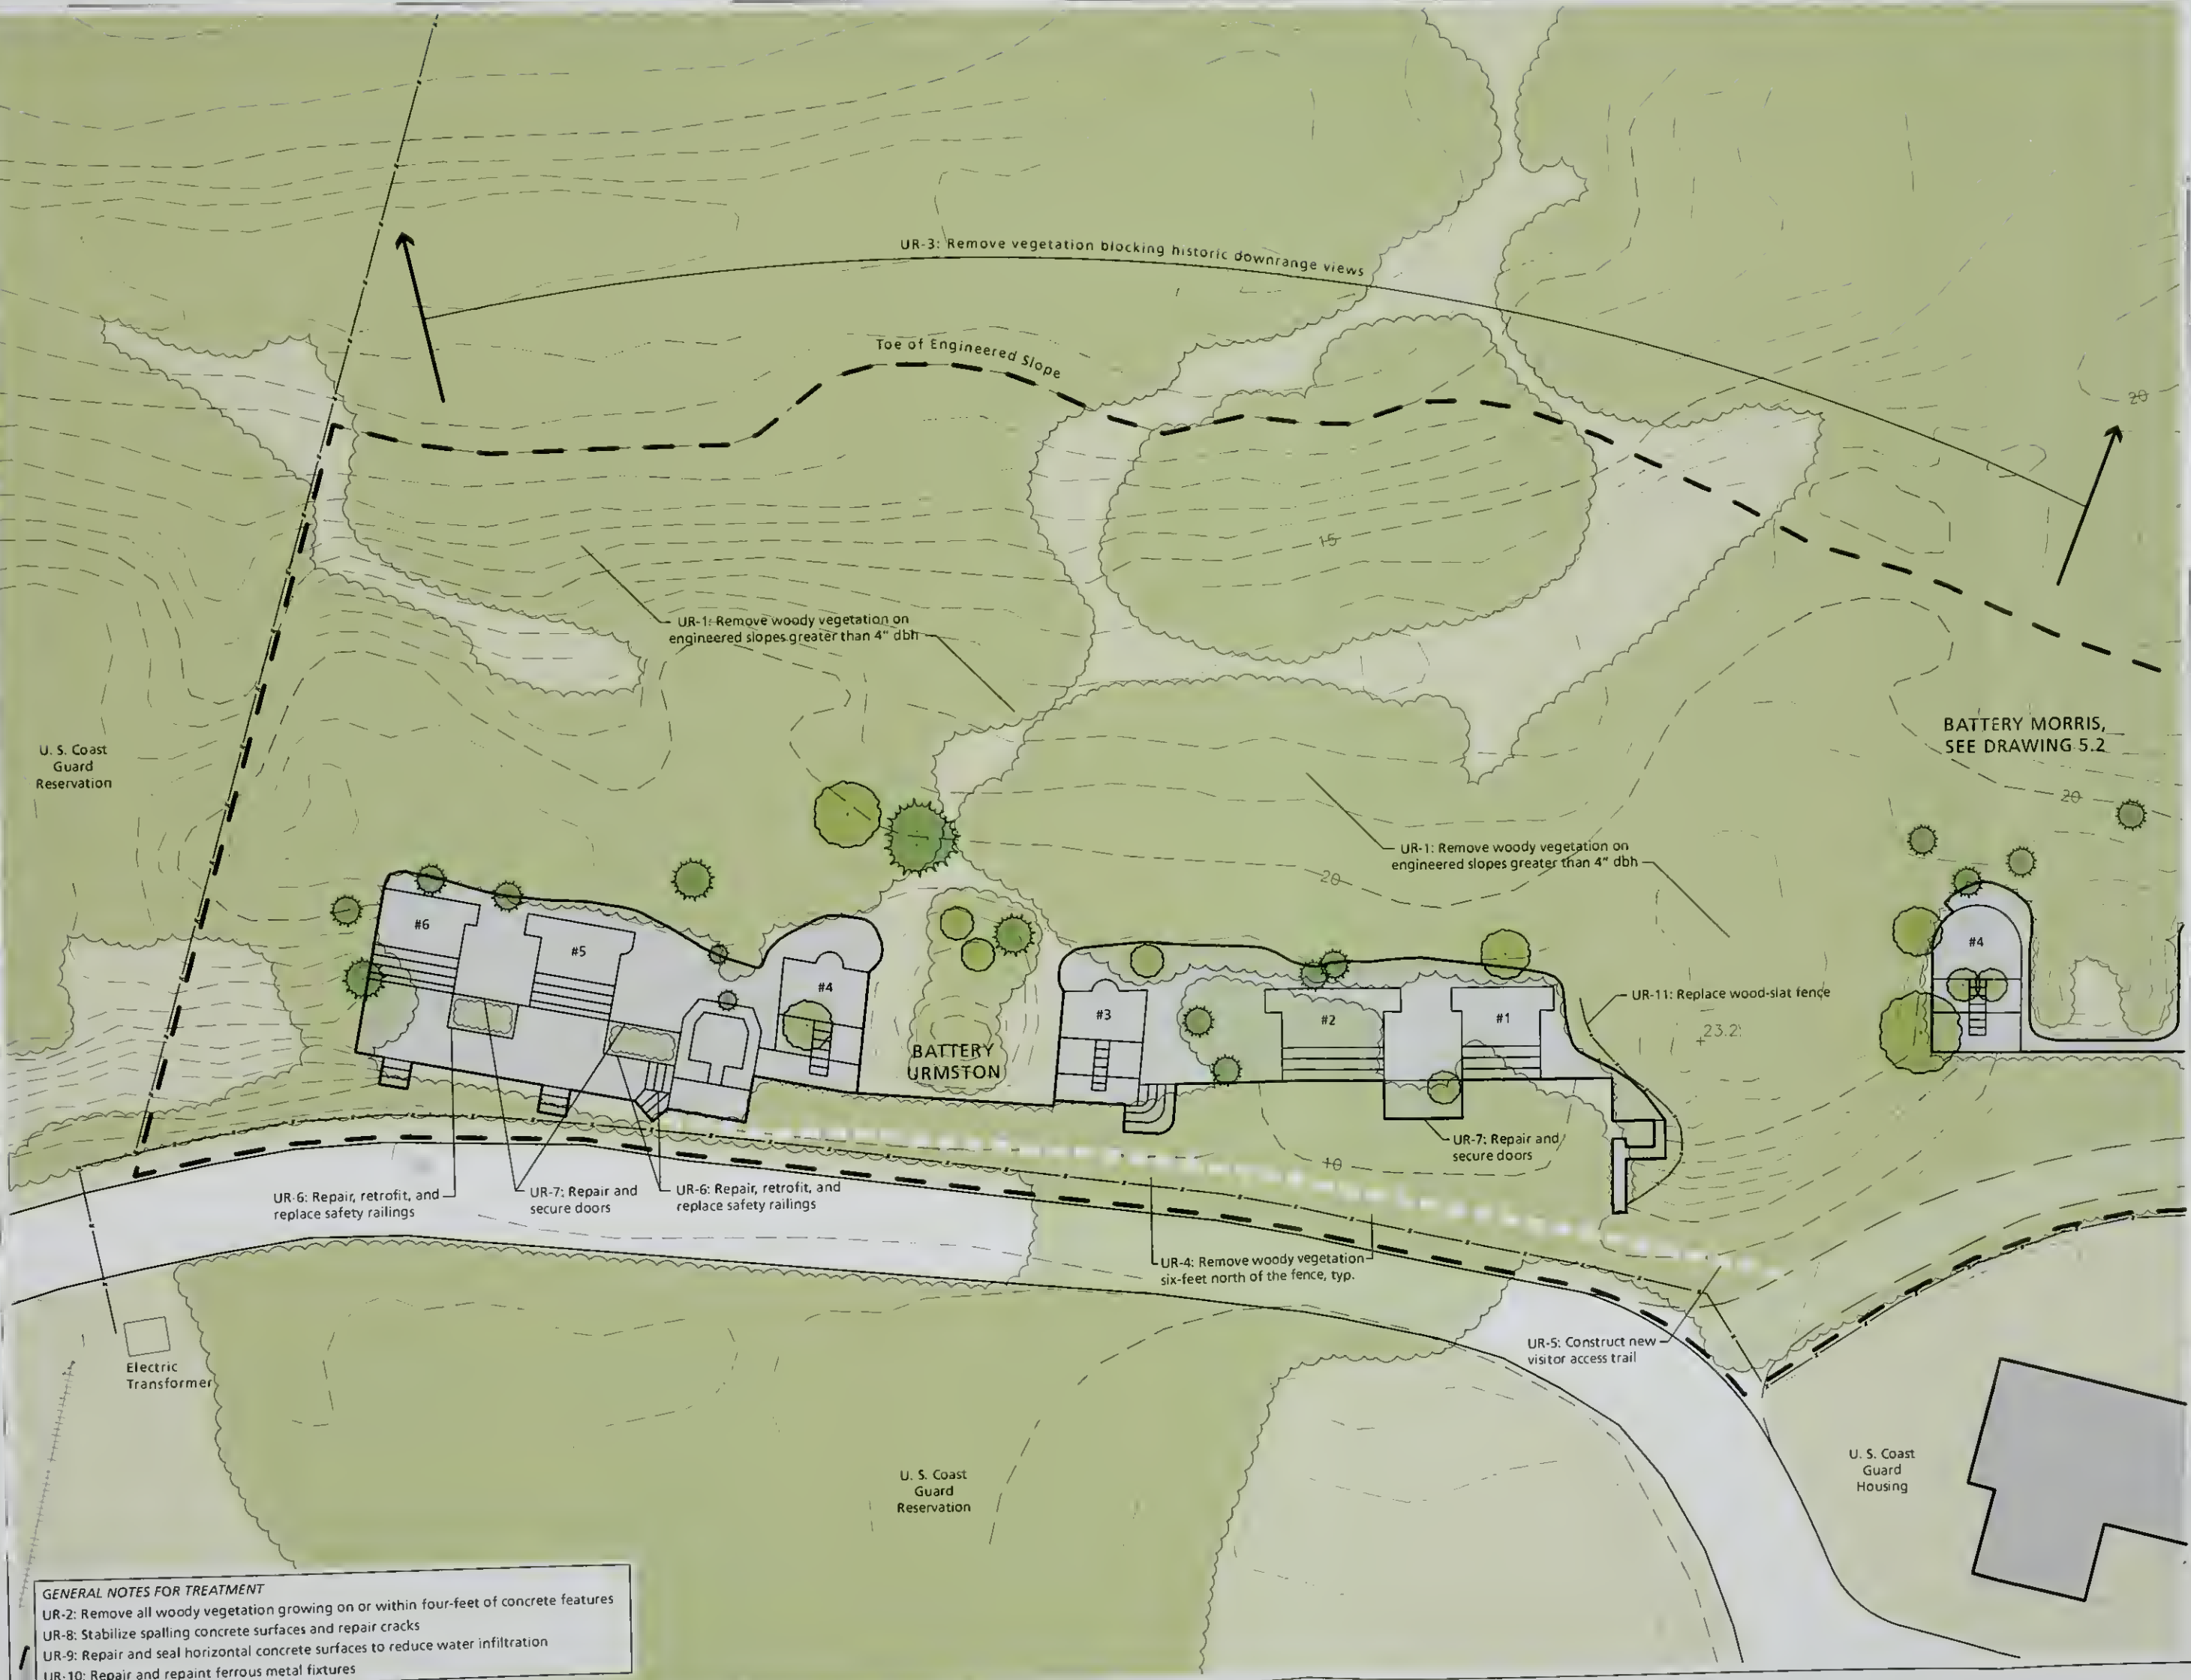
GENERAL NOTES FOR TREATMENT
 UR-2: Remove all woody vegetation growing on or within four-feet of concrete features
 UR-8: Stabilize spalling concrete surfaces and repair cracks
 UR-9: Repair and seal horizontal concrete surfaces to reduce water infiltration
 UR-10: Repair and repaint ferrous metal fixtures

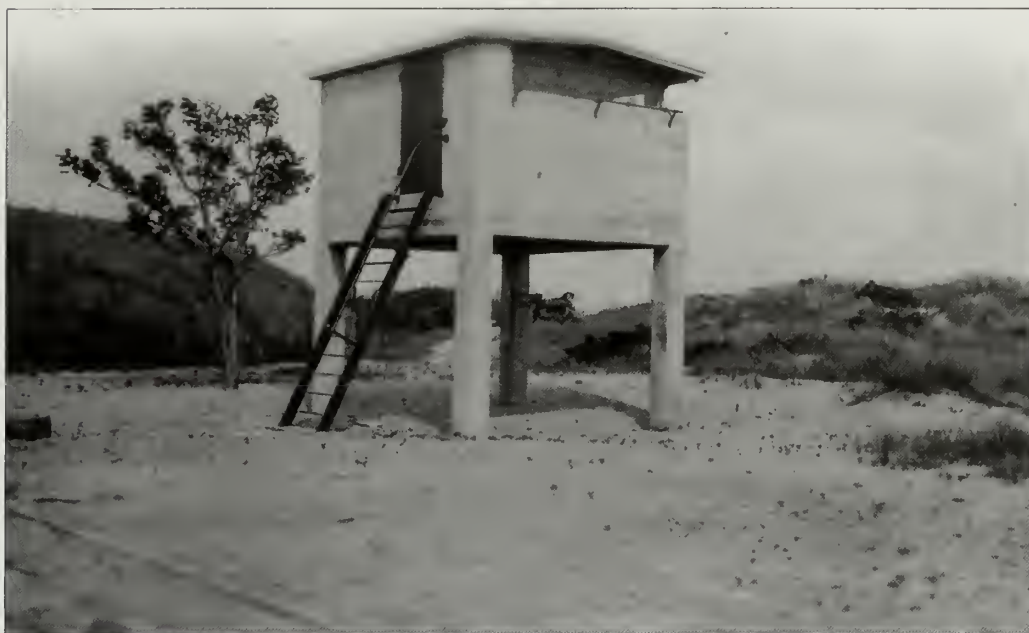
Figure 5.29. Coincidence range finder station, Battery Morris, circa 1920. Note the open character of the adjacent landscape. Woody vegetation should be removed within four feet of the freestanding structure (GATE 7893).

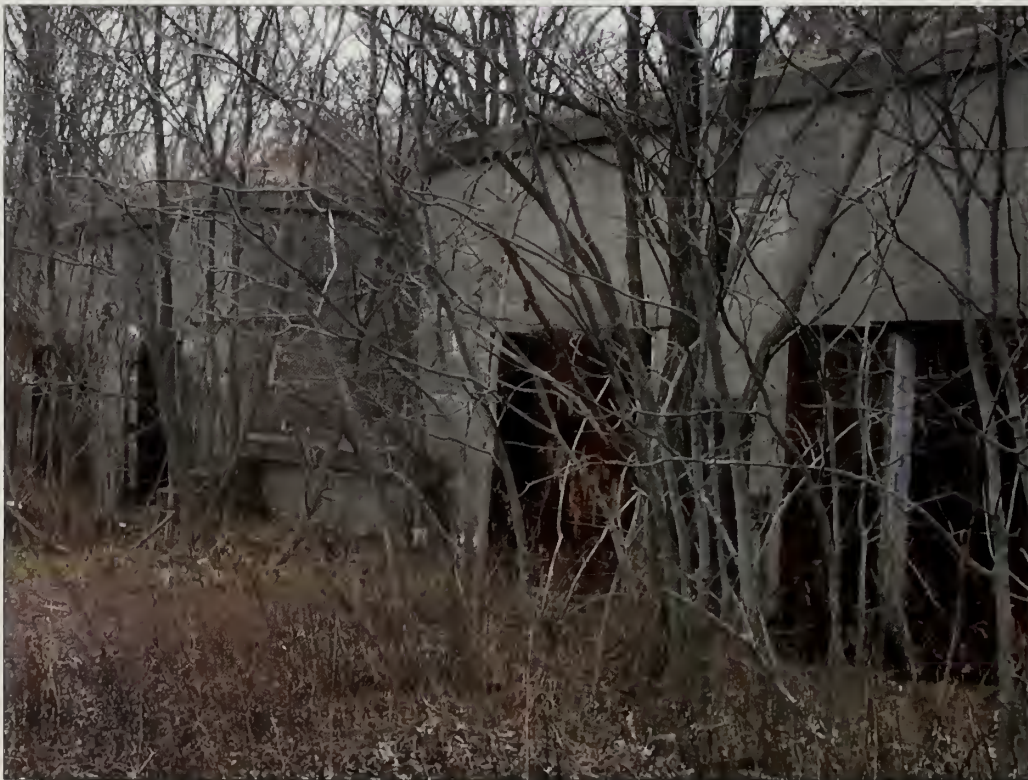
Figure 5.32. View looking northwest at south facade, Battery Morris. Accumulated leaf litter and debris should be removed from the front of the doors in order to remove a source of moisture that accelerates corrosion (Olmsted Center, January 2009).
