I 29.86/4.5 A 5

Clemson University

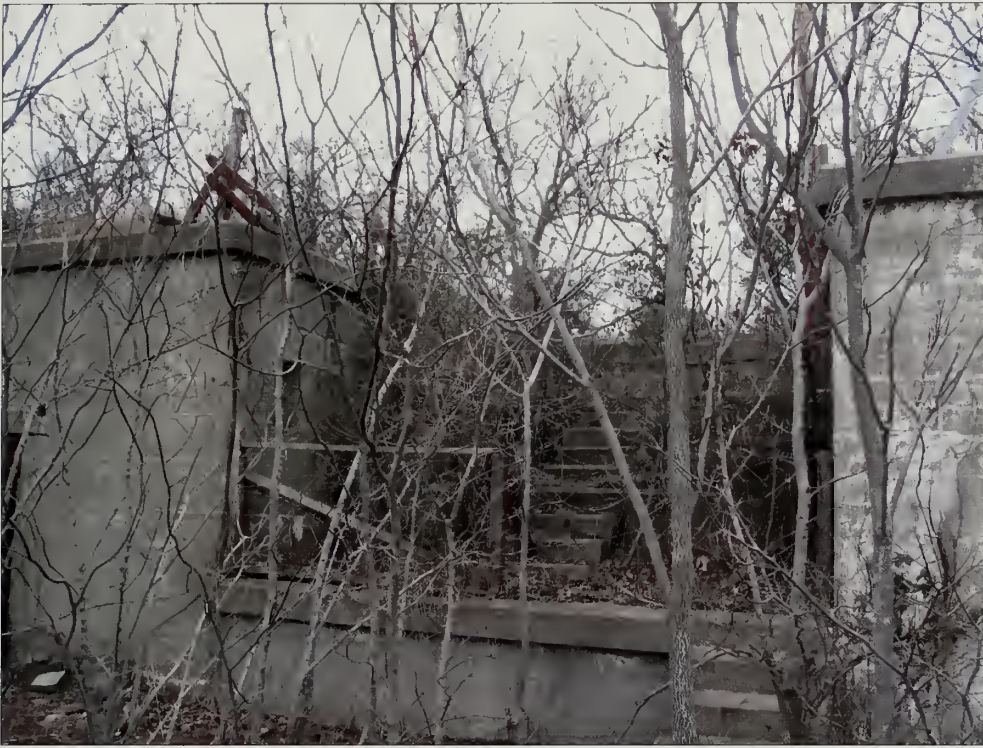
Figure 5.33. Wood guard panels at Battery Morris. The wood panels are not a historic feature and do not comply with safety codes due to the excessive space between the rails and cross brace. The wood guard panels should be removed and great care should be exercised not to damage the historic concrete structures removing fasteners that secured the wood to the concrete (Olmsted Center, January 2009).

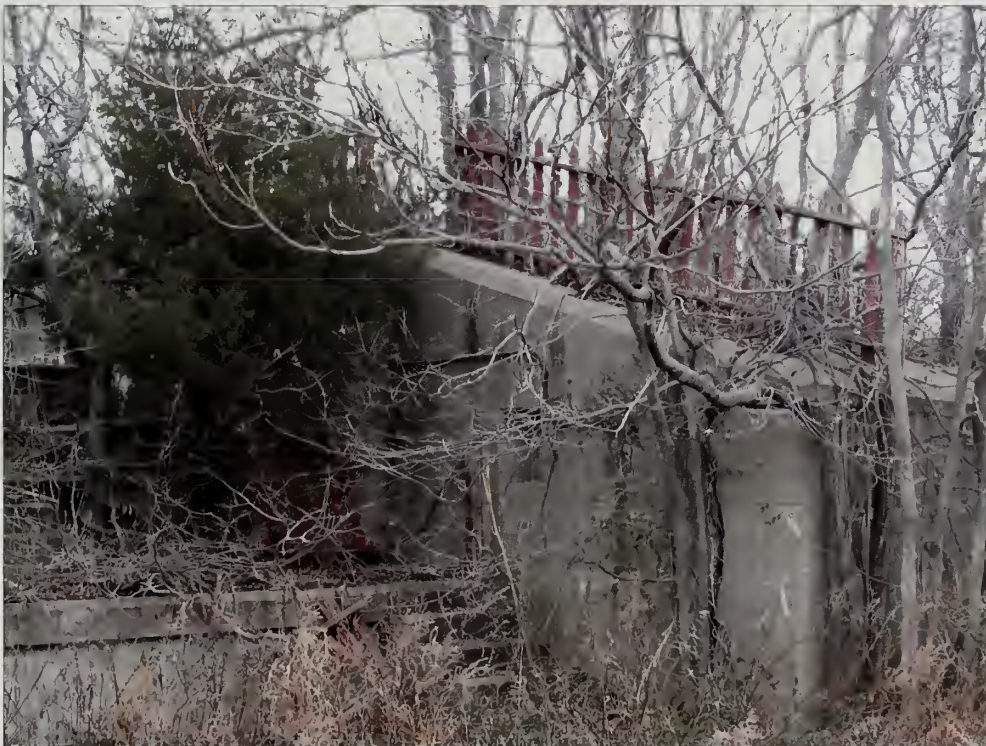
Figure 5.34. Wood picket fence on top of Battery Morris. The entire length of the pictured non-historic fence should be removed. Great care should be exercised not to damage the historic concrete structures and the historic earthwork north of the battery when the posts are removed (Olmsted Center, January 2009).

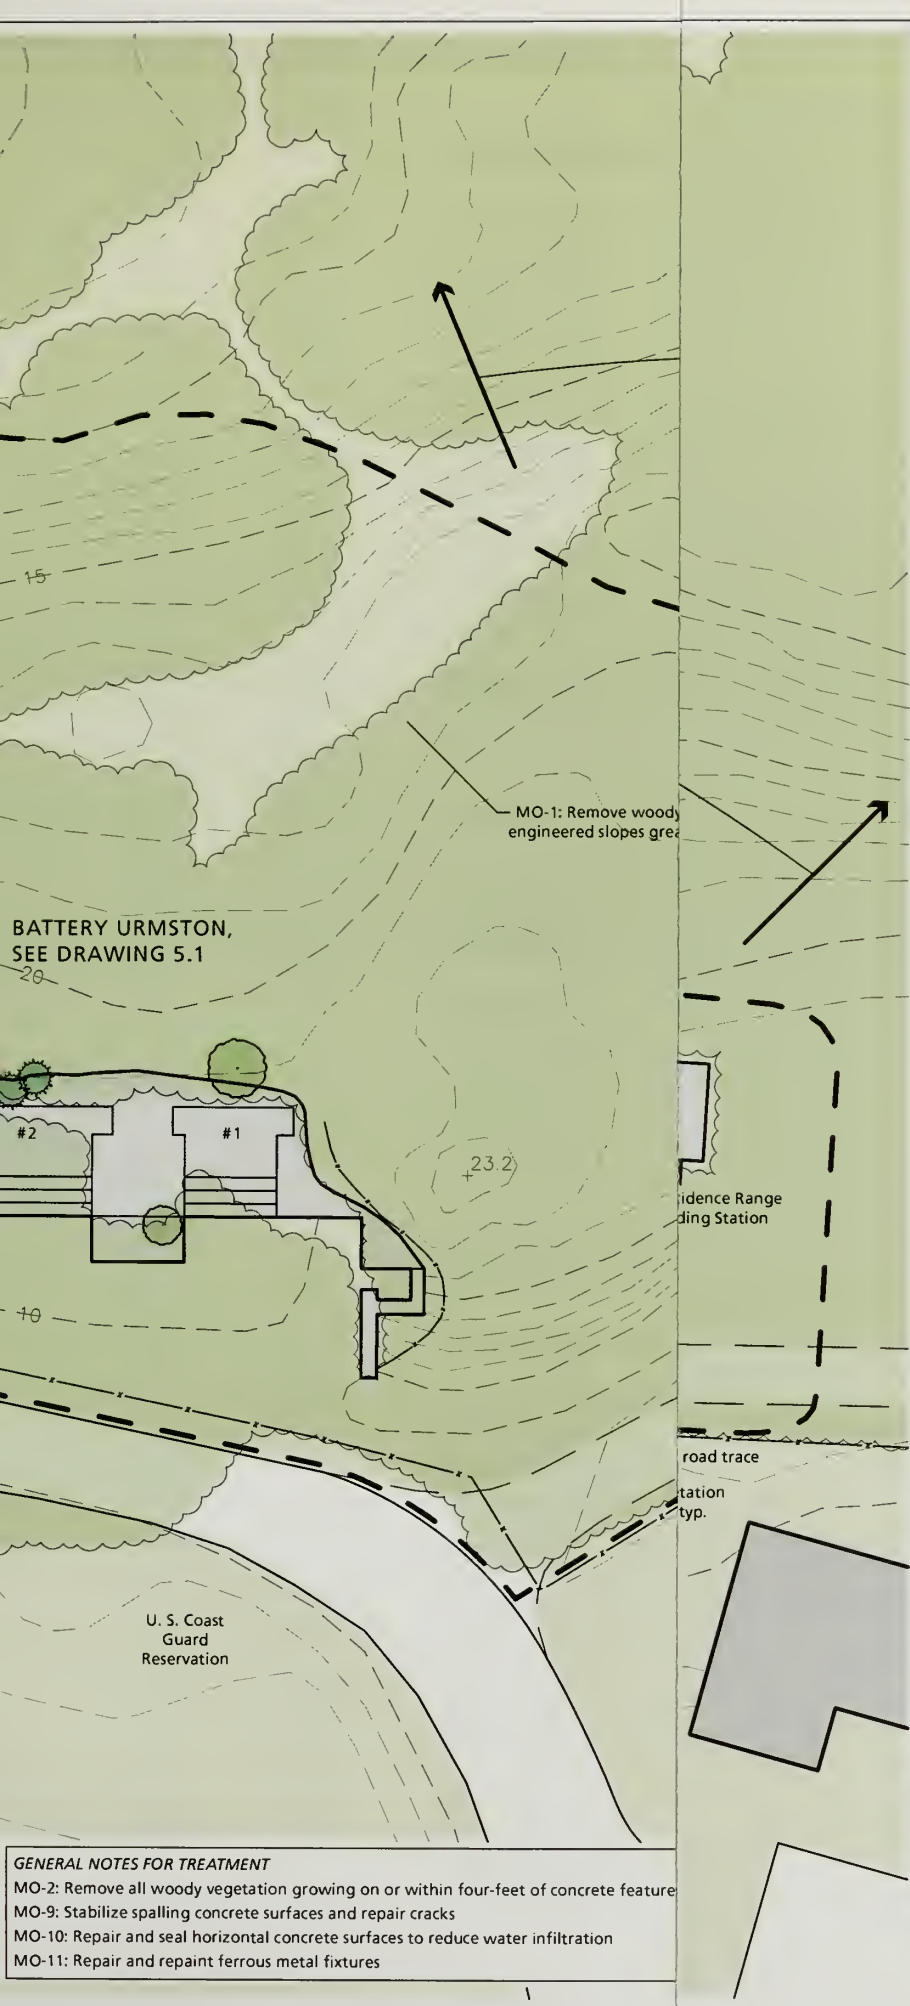
GENERAL NOTES FOR TREATMENT
 MO-2: Remove all woody vegetation growing on or within four-feet of concrete feature
 MO-9: Stabilize spalling concrete surfaces and repair cracks
 MO-10: Repair and seal horizontal concrete surfaces to reduce water infiltration
 MO-11: Repair and repaint ferrous metal fixtures

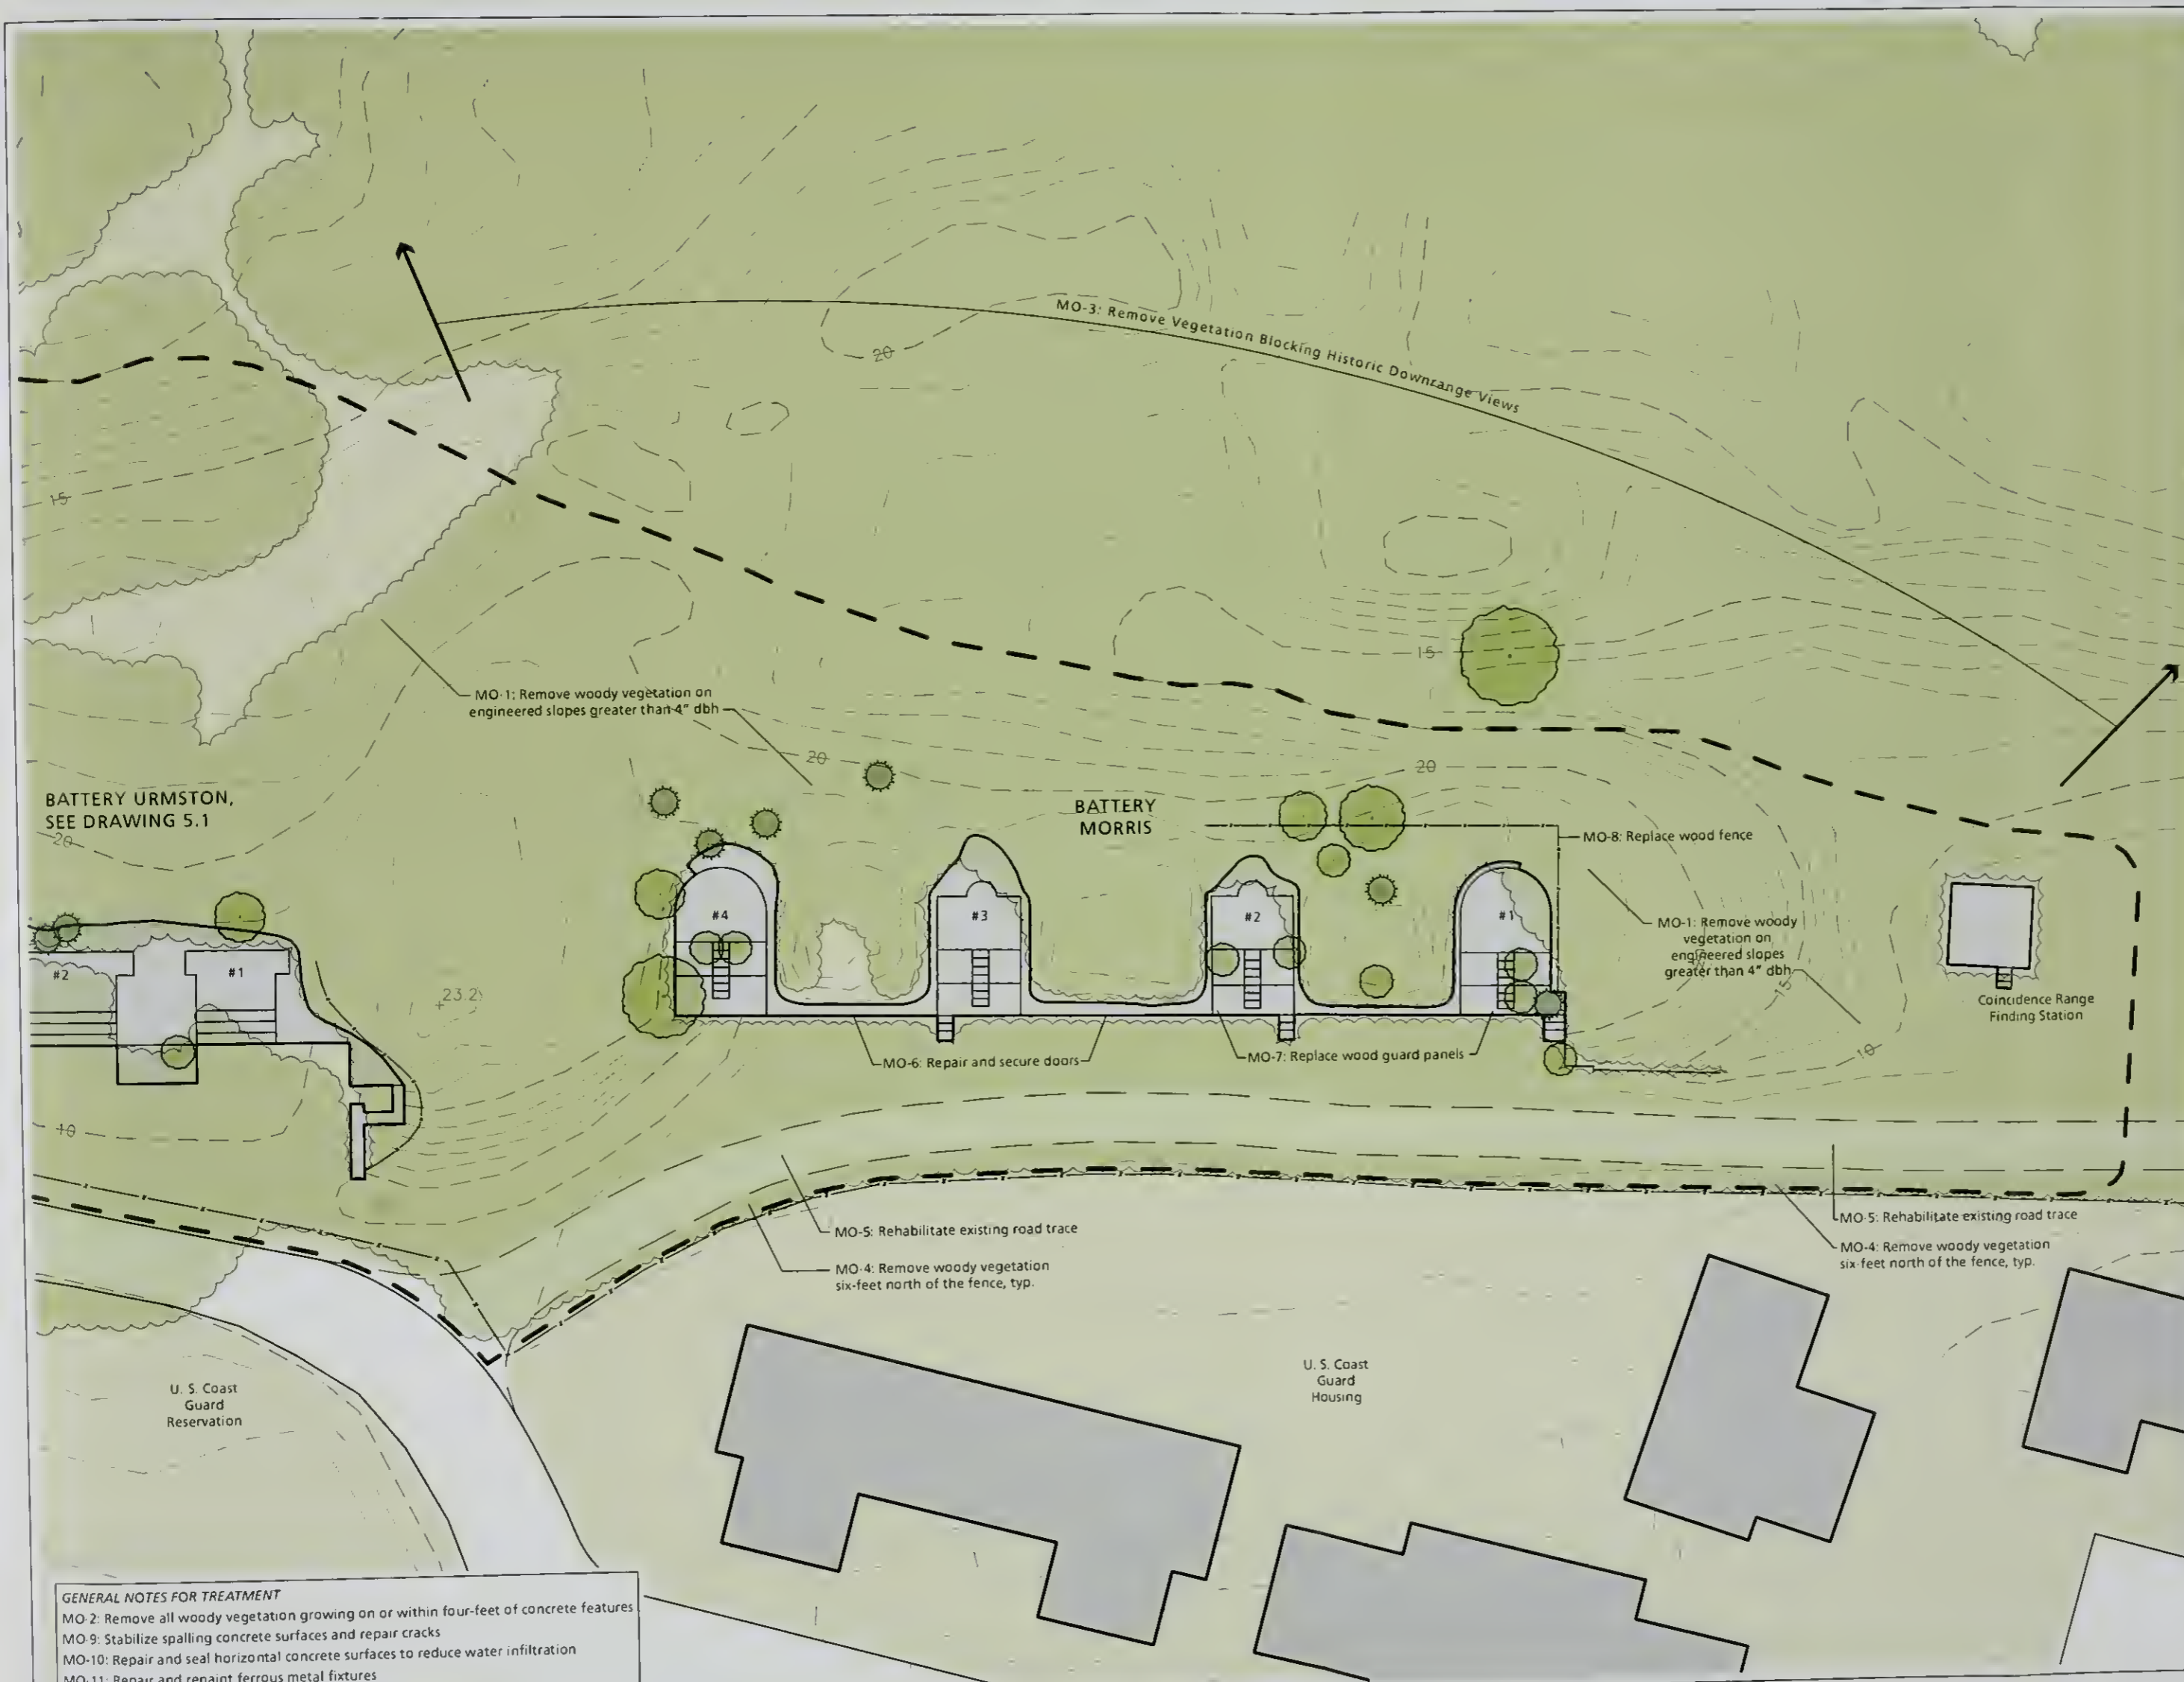
BATTERY URMSTON,
SEE DRAWING 5.1

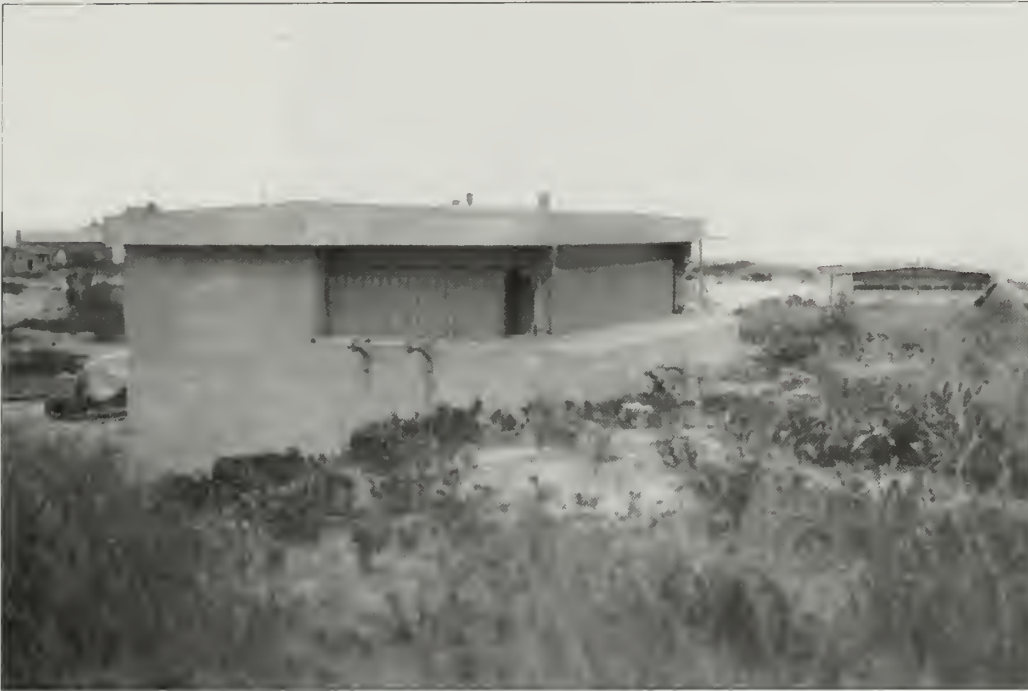
Figure 5.35. Batteries Engle and Peck circa 1920. The battery commander's station for Battery Peck is seen in the foreground. The low concrete structure seen in the background is the coincidence range finder station built into the former gun emplacement of Battery Engle in 1920. Note the low-growing vegetation in this photograph, making possible downrange views and effective operation of the batteries (GATE 7892).

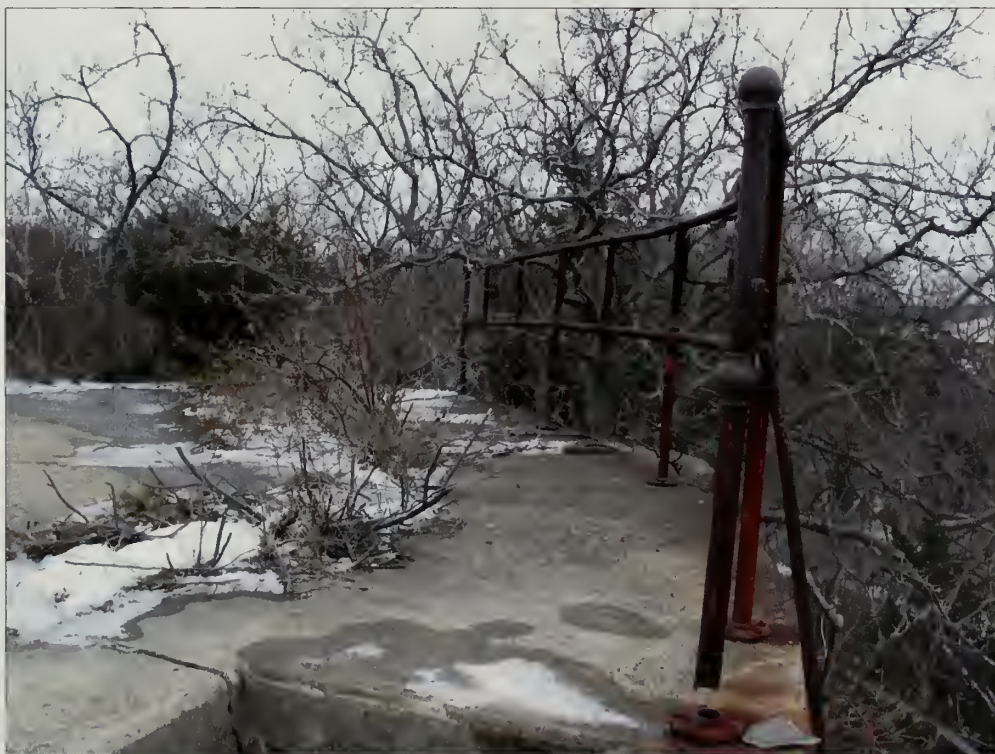
Figure 5.40. View of historic guardrail south of emplacement #1, Battery Peck. Severely deteriorated railing components, such as the vertical post in the foreground, should be removed and replaced with new components that match the original as close as possible. Final painting or a color-galvanized coating should match the historic railing paint finish (Olmsted Center, January 2009).

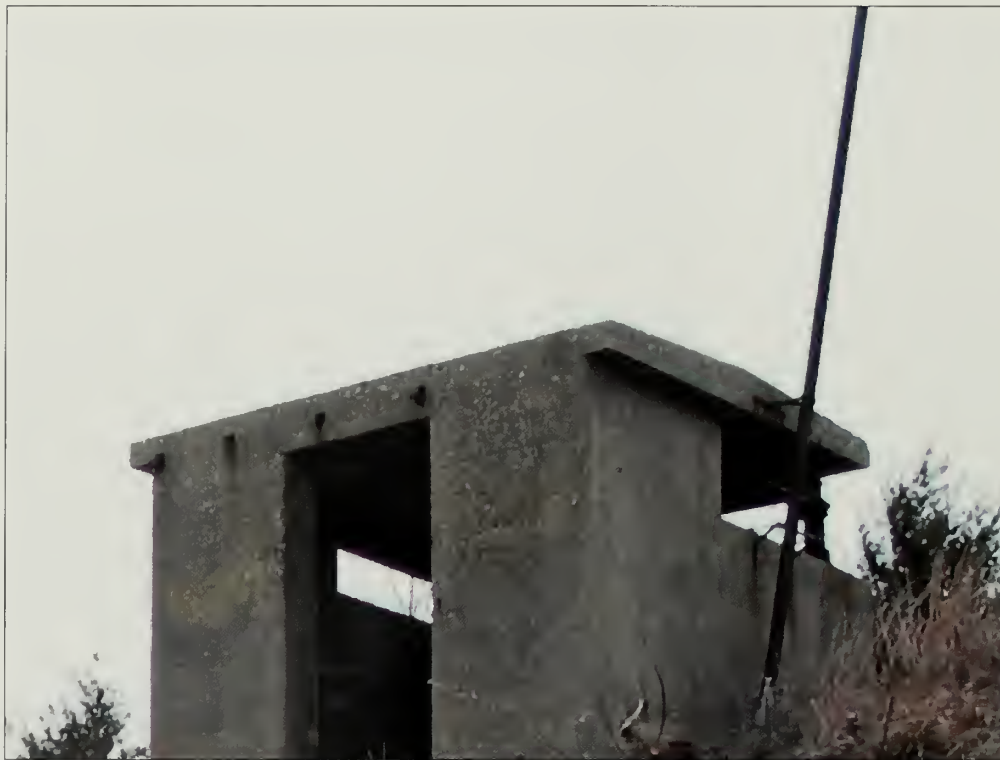
Figure 5.41. View of northwest facade of Battery Peck's commander station. The metal antenna and mounting brackets are features of this structure and should be preserved or replaced in kind. Measured drawings should be prepared to document these features followed by corrosion treatment, priming, and painting to match the historic finish (Olmsted Center, January 2009).

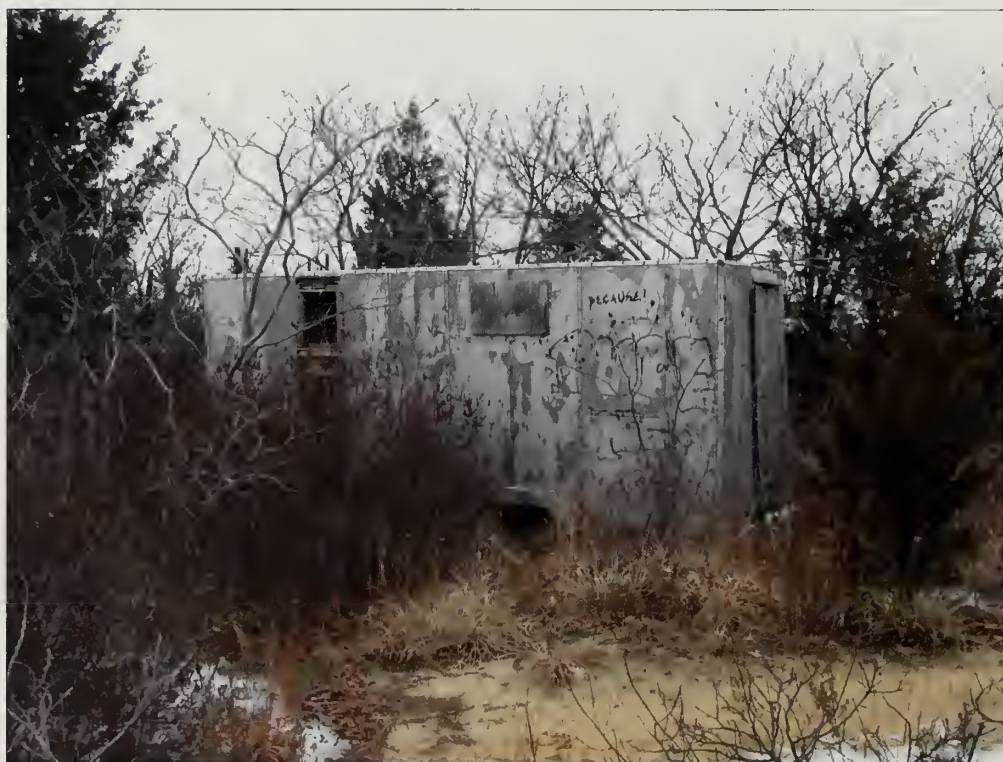
Figure 5.42. View looking north at a post World War II trailer located near Batteries Peck and Engle. The trailer is in a seriously deteriorated condition and, along with an accompanying section of fence, should be removed to improve the visual and spatial connection among Battery Peck's gun emplacements, commander station, CRF station, and the water in the distance (Olmsted Center, January 2009).

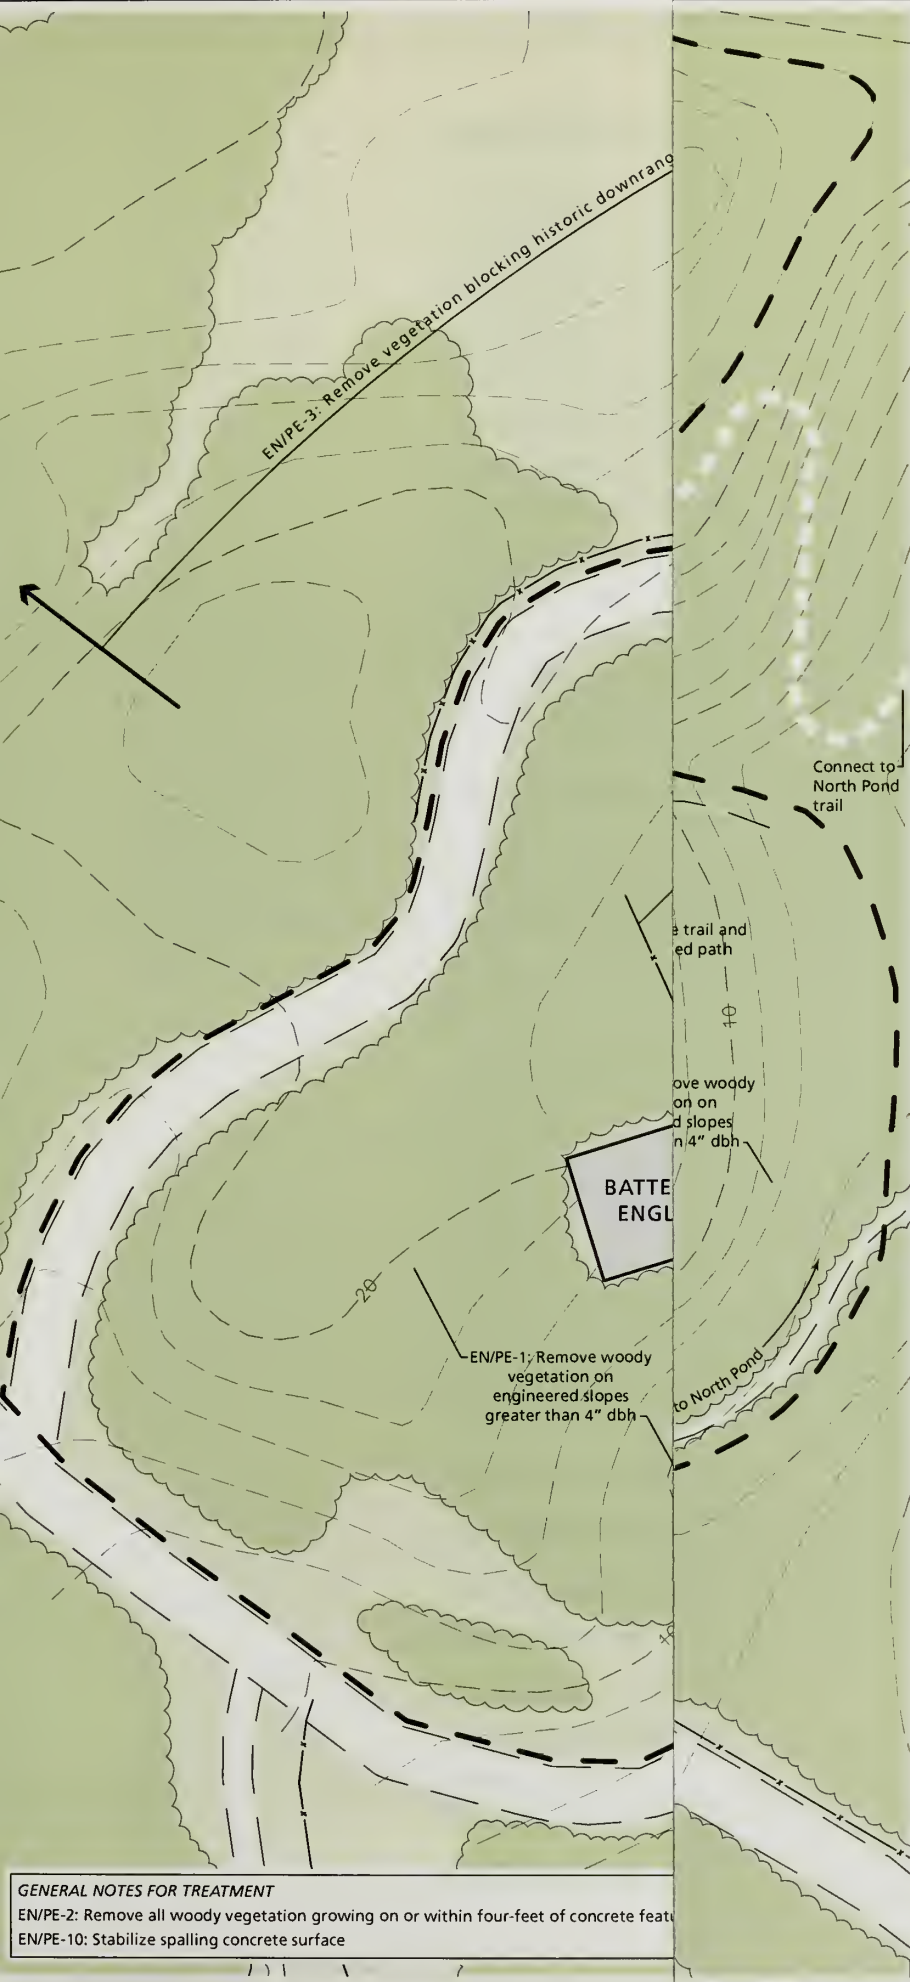
GENERAL NOTES FOR TREATMENT
 EN/PE-2: Remove all woody vegetation growing on or within four-feet of concrete features
 EN/PE-10: Stabilize spalling concrete surface

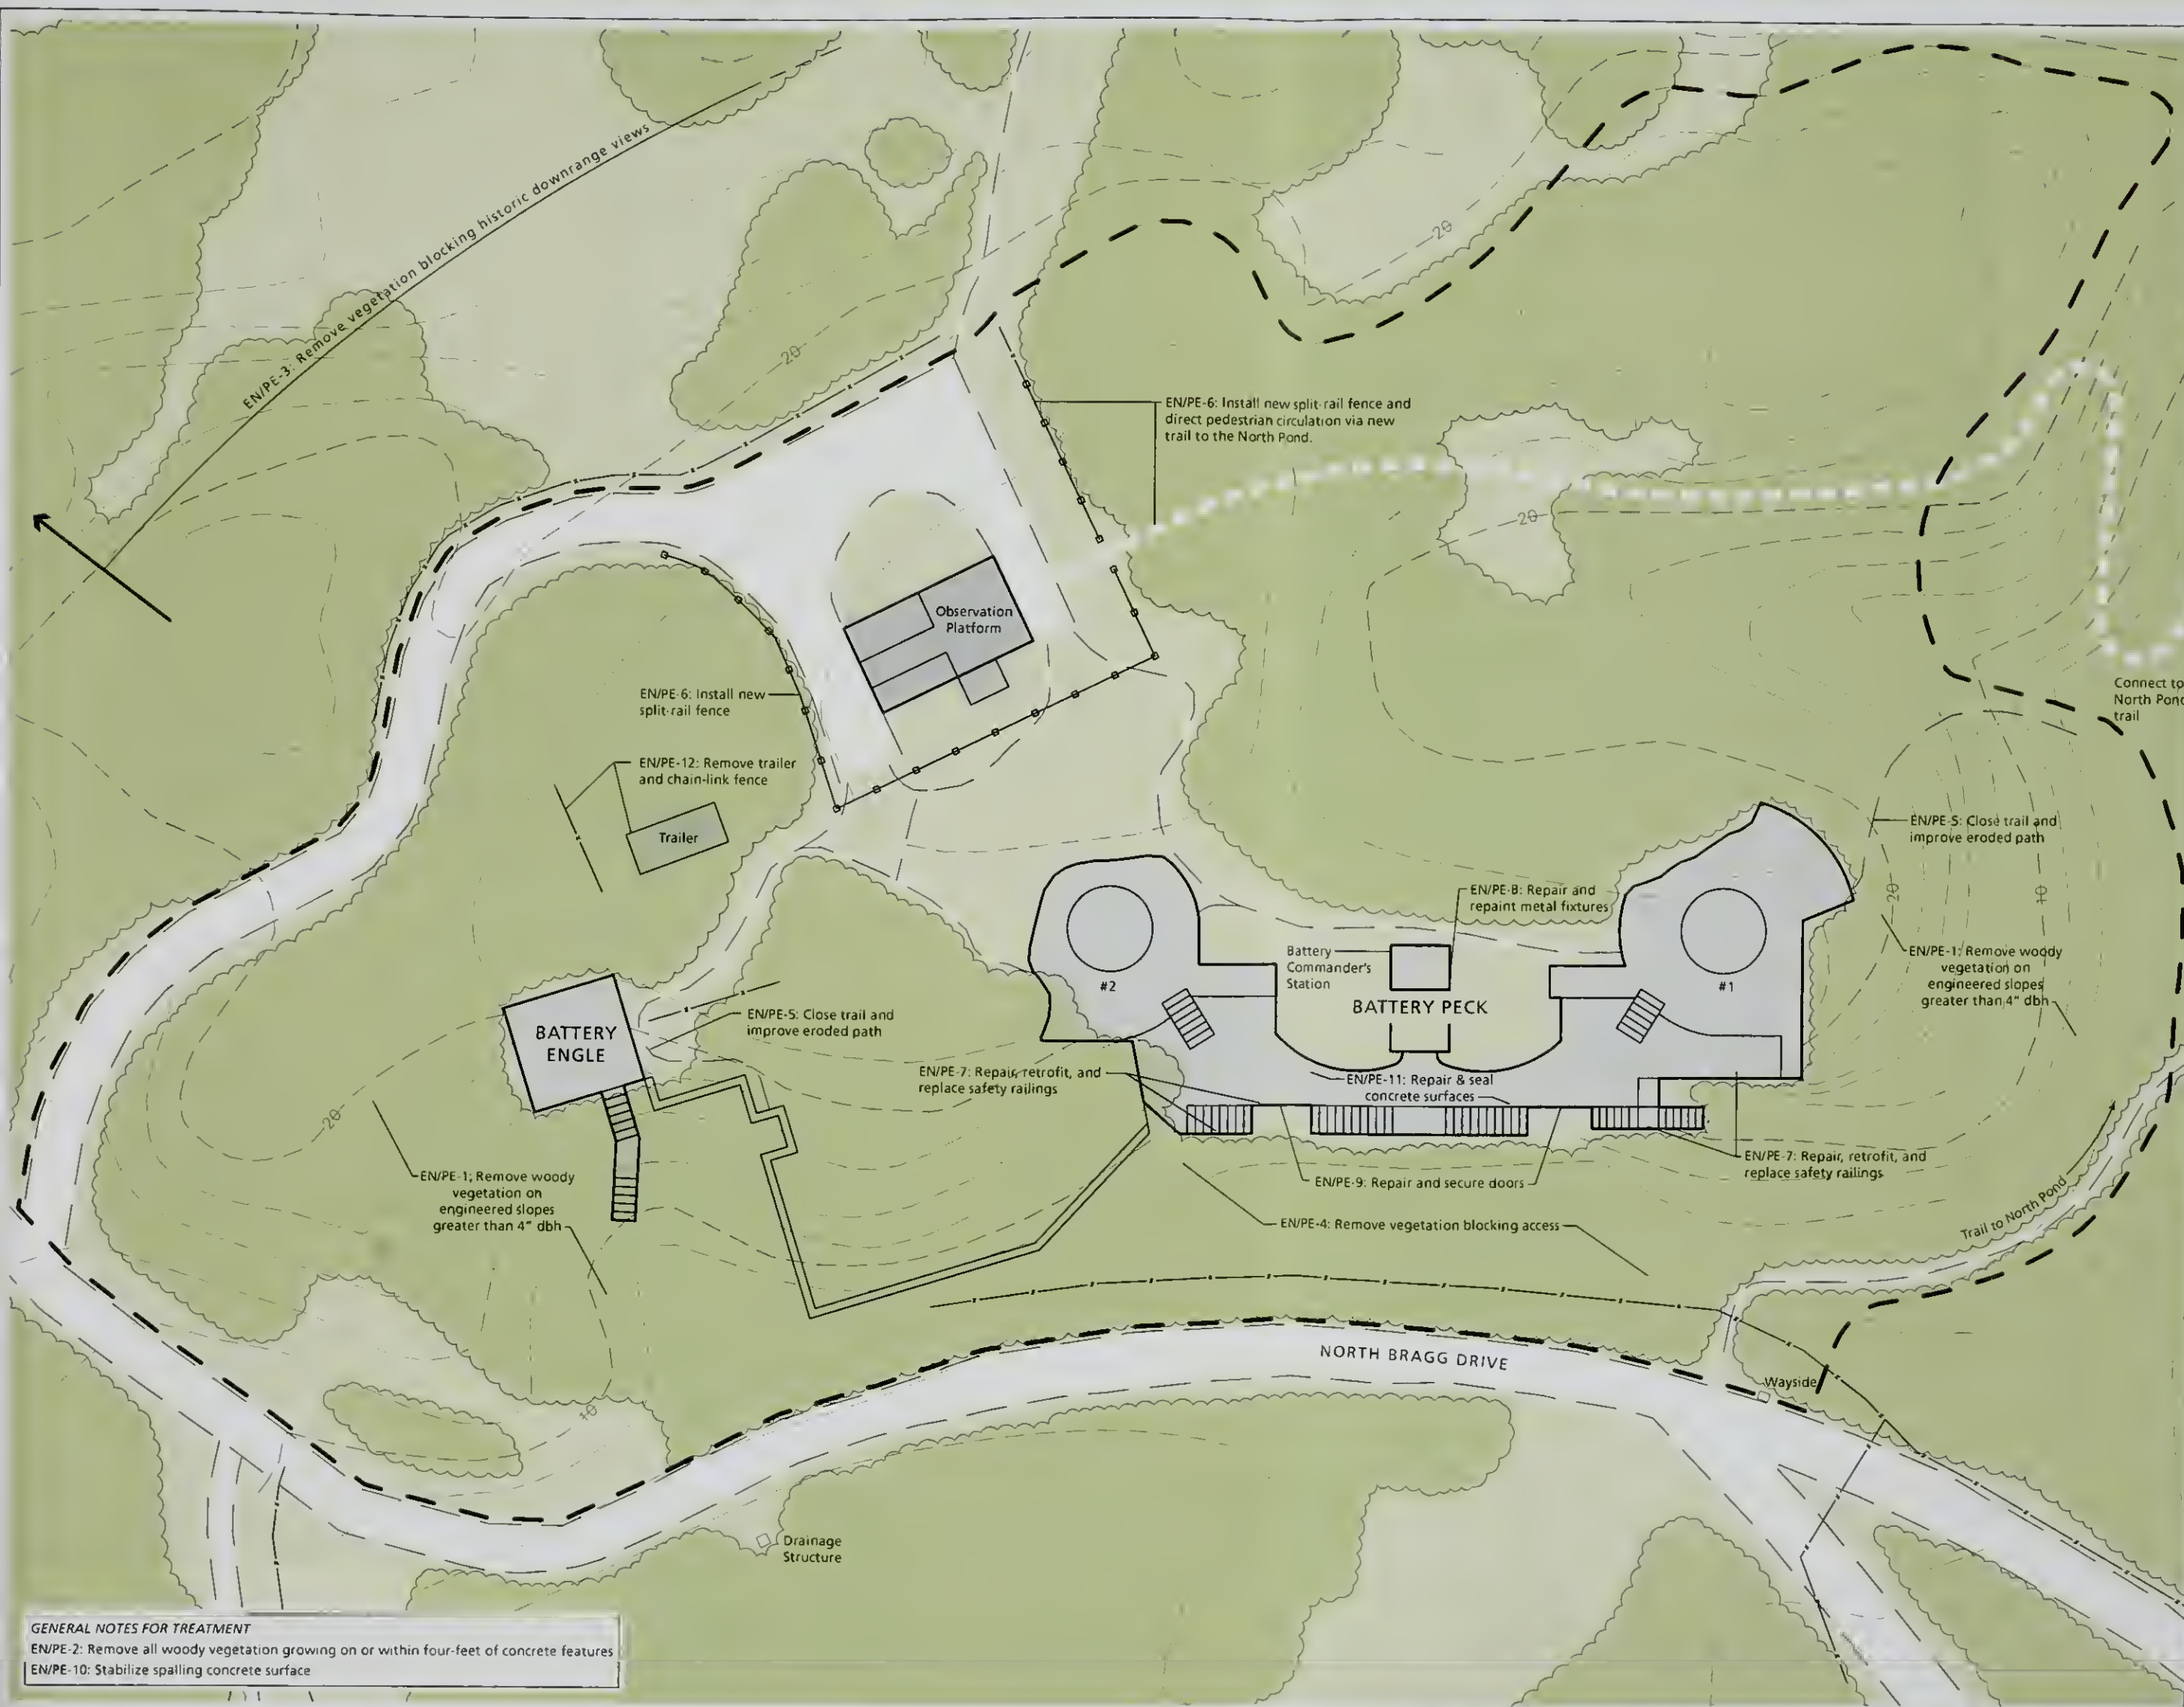
GENERAL NOTES FOR TREATMENT
 EN/PE-2: Remove all woody vegetation growing on or within four-feet of concrete features
 EN/PE-10: Stabilize spalling concrete surface

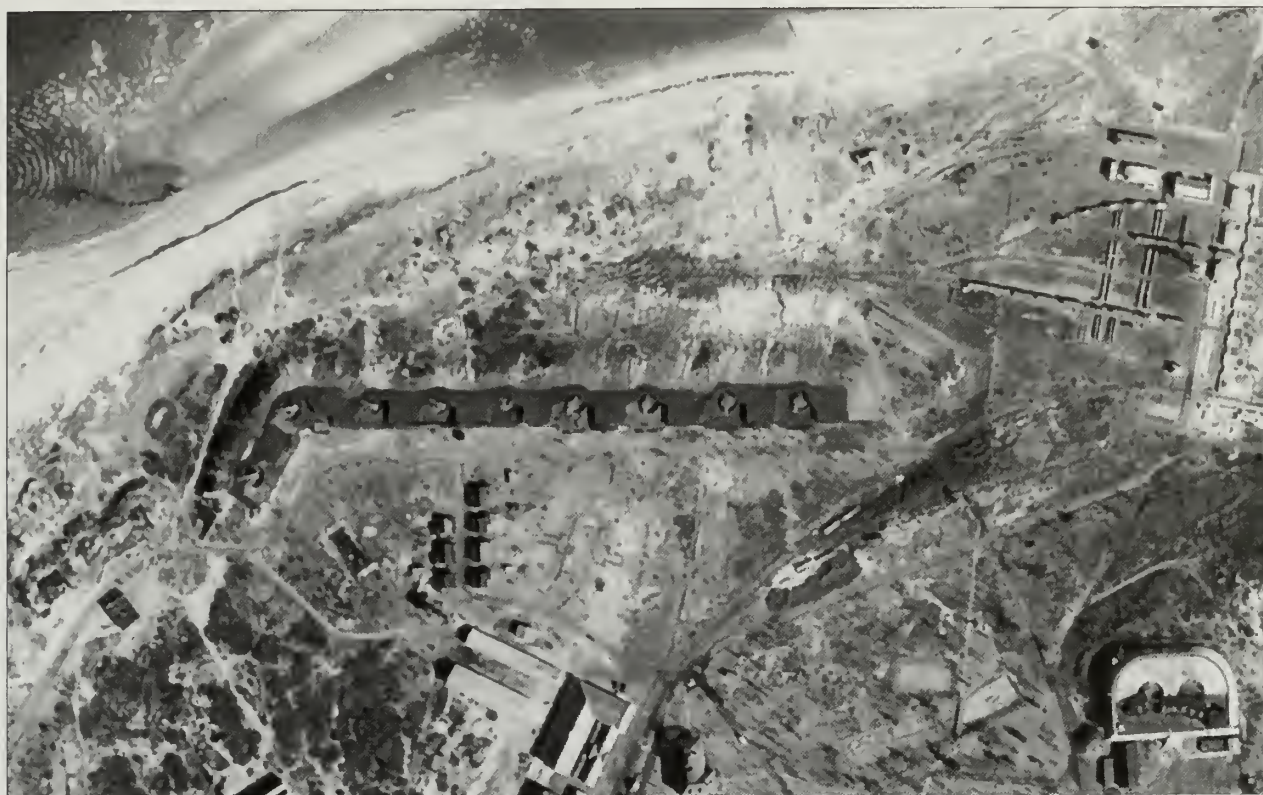
Figure 5.43. Aerial photograph of Nine Gun Battery, January 1933. This photograph shows the engineered slope of Nine Gun Battery with limited vegetation. To protect the earthwork, all woody vegetation greater than four-inches diameter at breast height should selectively removed. The area north of Battery Alexander appears darker in this image because it is the north slope and in shadows (Coastal and Hydraulics Laboratory, Engineer Research and Development Center).

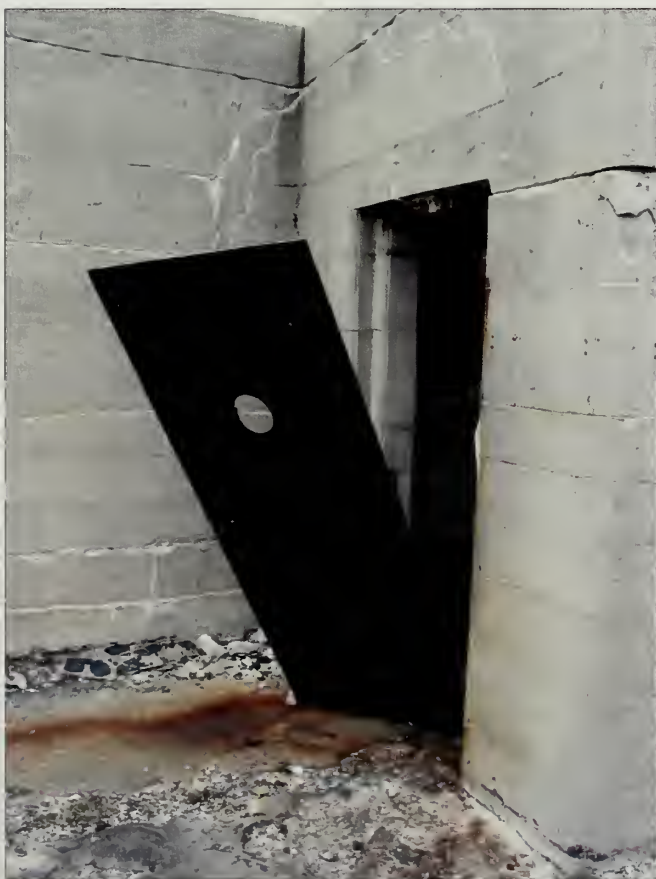
Figure 5.47. View of failing metal door, Nine Gun Battery. Doors and windows should be properly mounted and locked to prevent unauthorized access to interior spaces. While the door in view may be repaired, when a door is damaged or severely deteriorated, a new door should be fabricated to match the existing in materials and finish (Olmsted Center, January 2009).

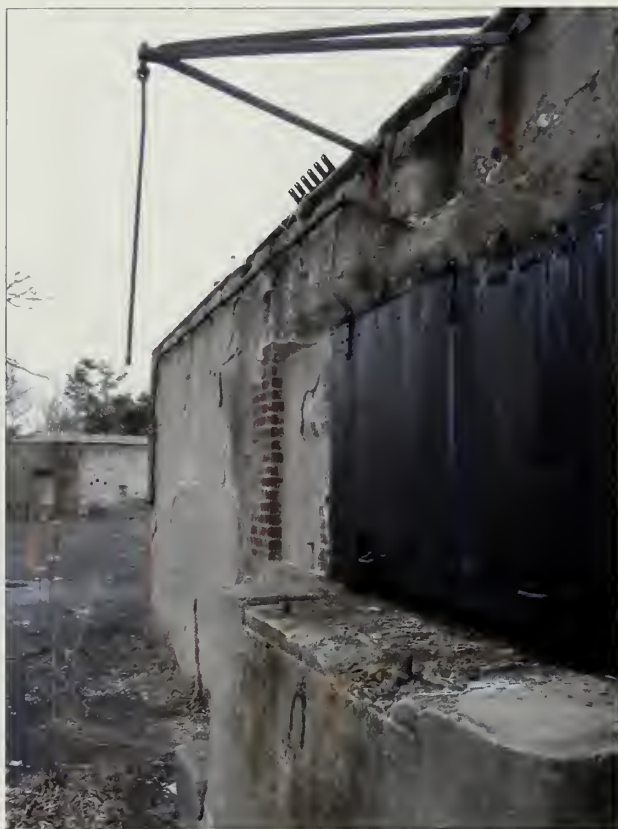
Figure 5.48. View of shell hoist metal door, Nine Gun Battery. Doors and windows should be properly mounted and locked to prevent unauthorized access. If a door is damaged or severely deteriorated, a new door should be fabricated to match the existing in materials and finish (Olmsted Center, January 2009).

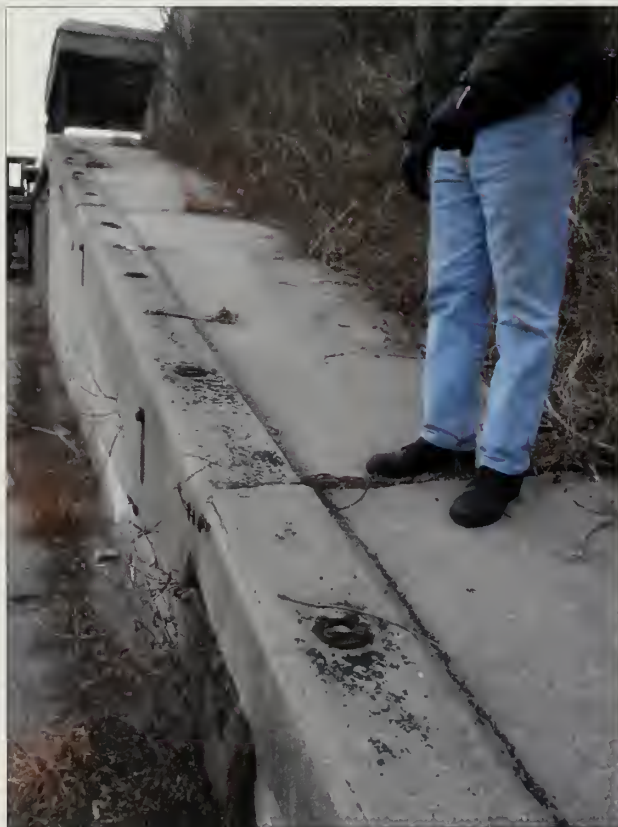
Figure 5.49. View looking northwest at the concrete ramp to gun platform #1, Nine Gun Battery. New safety railings should be installed on the ramp to facilitate visitor access. The rails should either attach to the existing escutcheon plates or be core drilled into the ramp's concrete structure. The new handrail components should match the original pipe railings and ball joint connectors at Nine Gun Battery to the greatest extent practicable (Olmsted Center, January 2009).

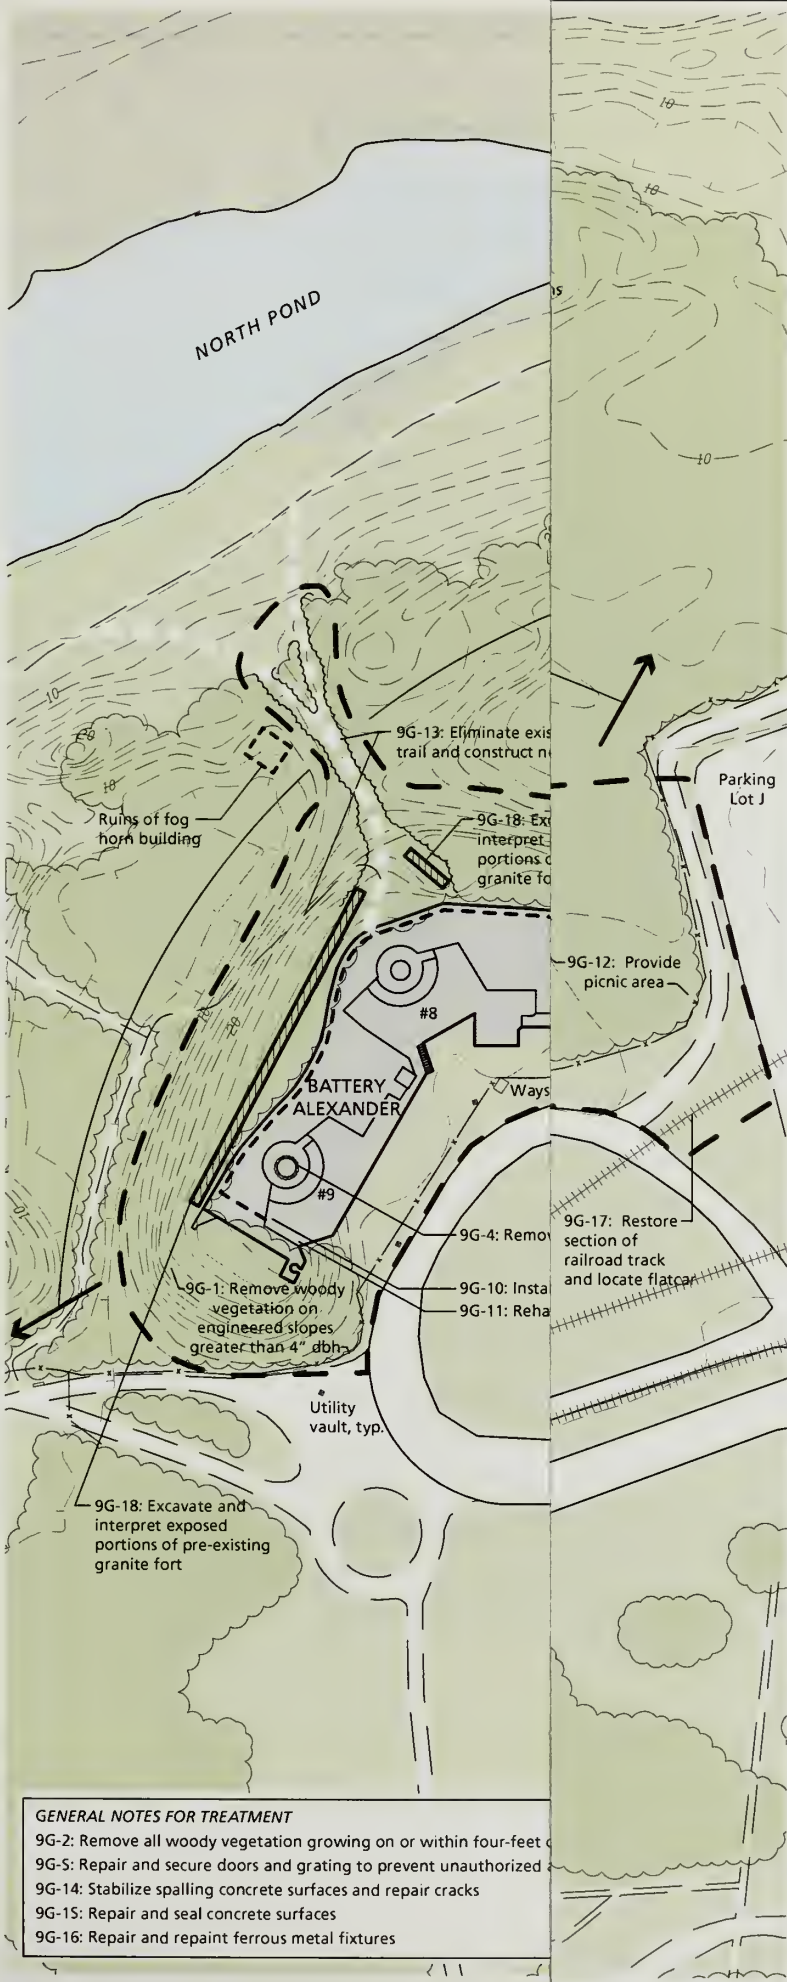
GENERAL NOTES FOR TREATMENT
