I 29.86/4.5 A 5

Clemson University

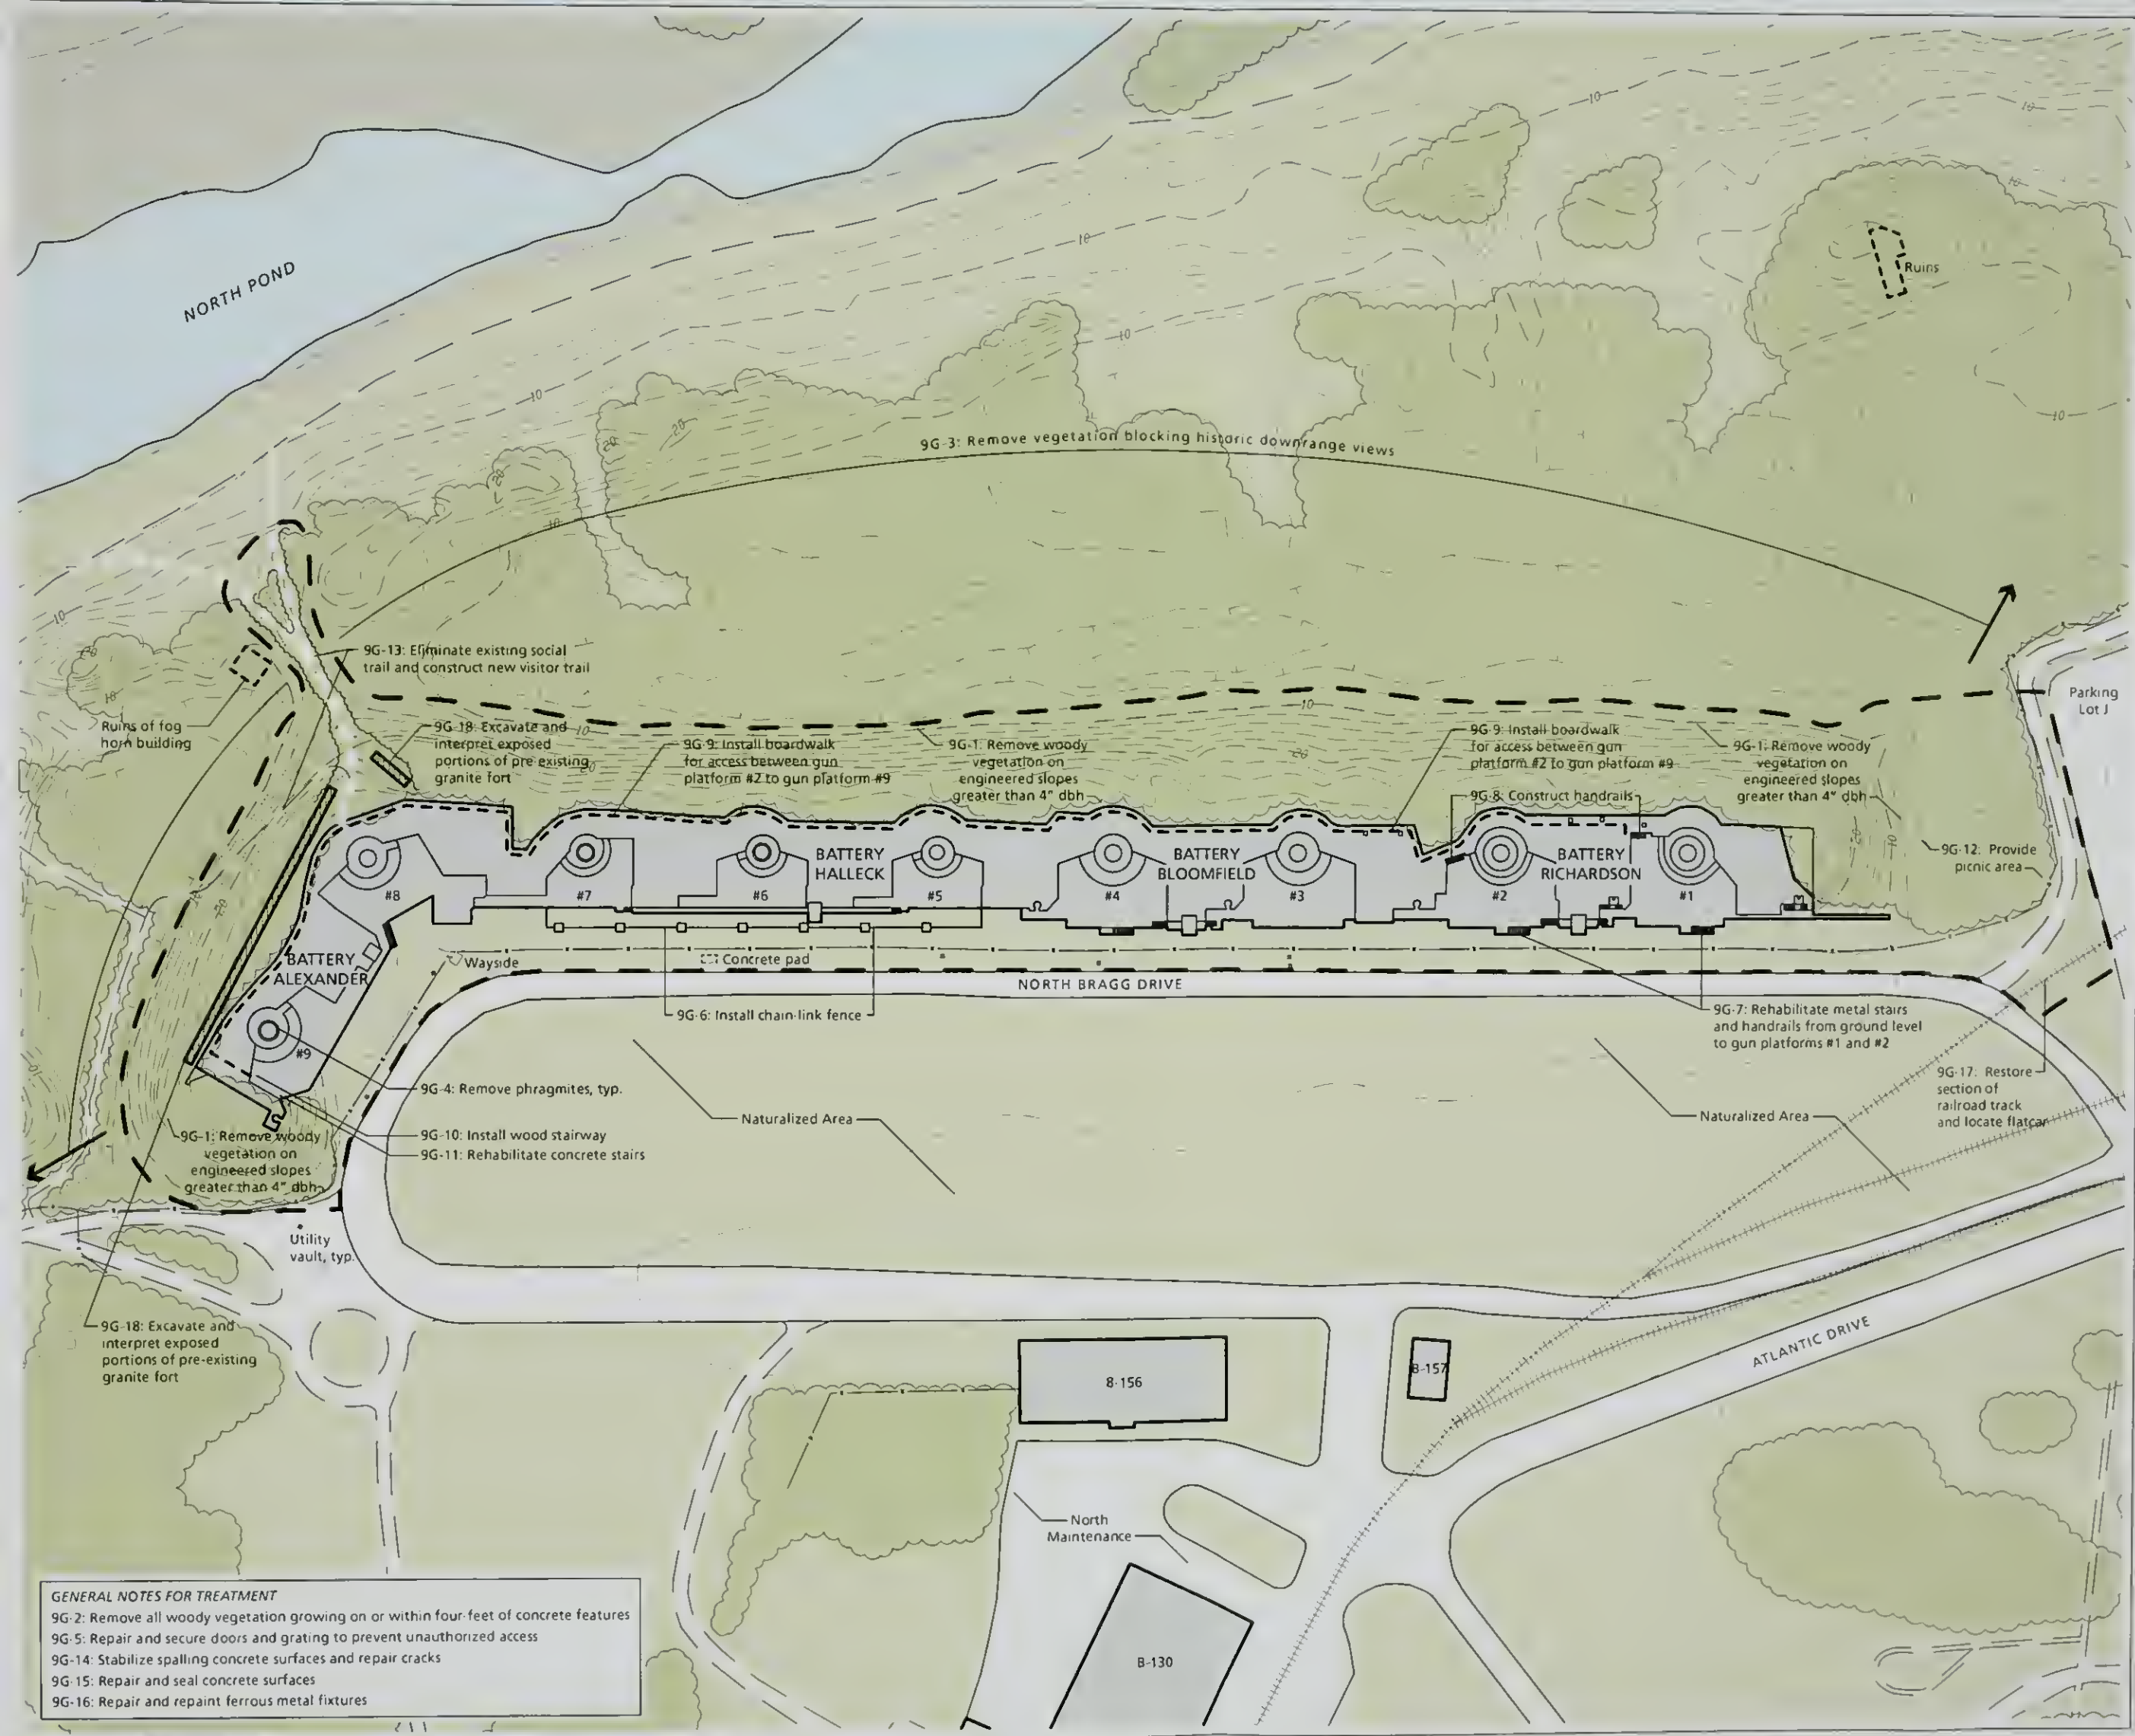
GENERAL NOTES FOR TREATMENT
 9G-2: Remove all woody vegetation growing on or within four-feet of concrete features
 9G-5: Repair and secure doors and grating to prevent unauthorized access
 9G-14: Stabilize spalling concrete surfaces and repair cracks
 9G-15: Repair and seal concrete surfaces
 9G-16: Repair and repaint ferrous metal fixtures

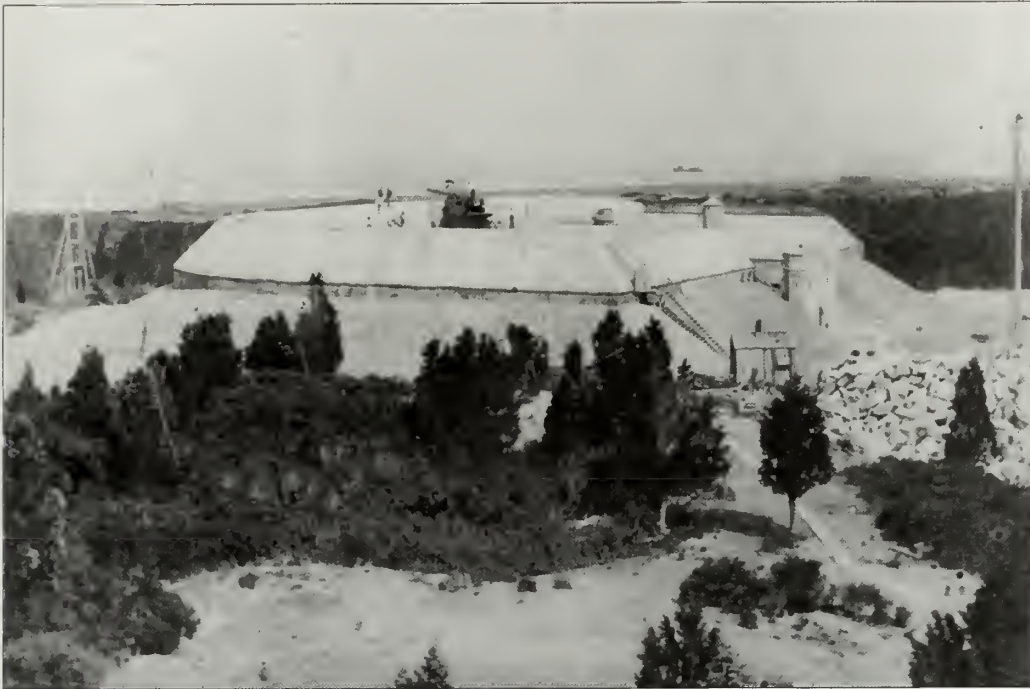
Figure 5.57. View looking southeast at Battery Potter, 1893. The Lift-Gun Battery #1, designated Battery Potter in 1903, was the only coastal defense battery constructed that used a steam-powered hydraulic lift to raise the guns up into firing position after they were loaded behind the protection of a massive concrete fortification (GATE 7811).

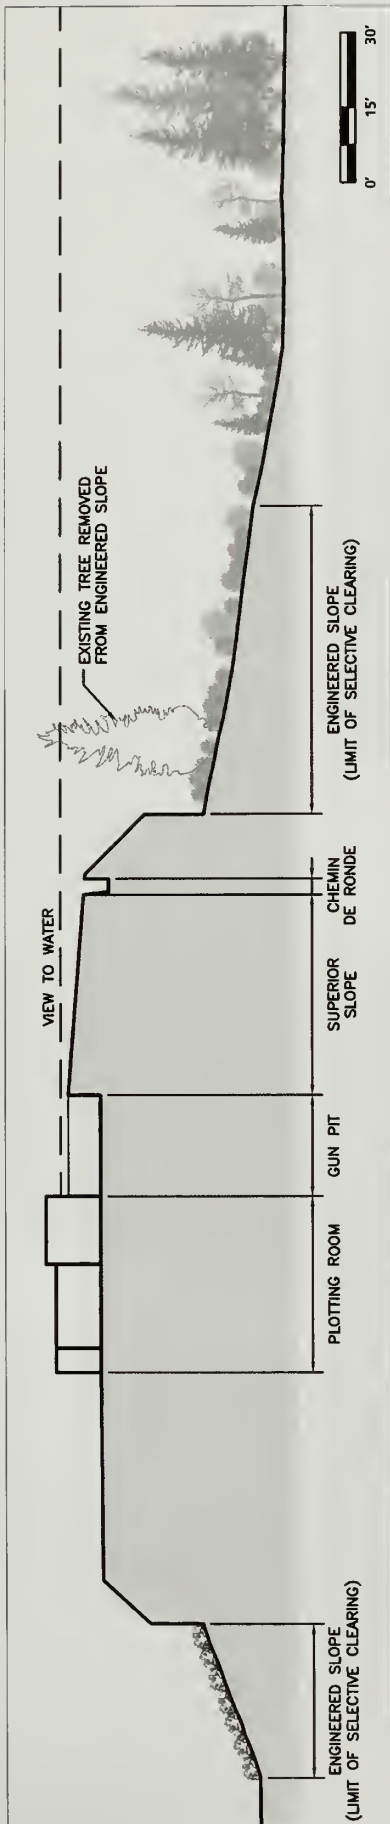
Figure 5.60. Conceptual section through Battery Potter. Existing, large woody vegetation on the engineered slope obstructs downrange views from the plotting rooms and terreplein to the water. Large woody vegetation on the engineered slope should be removed to restore views and protect the historic earthwork from potential damage due to thrown trees. Existing vegetation beyond the toe of the engineered slope may not impact views due to the viewing height on Battery Potter (Olmsted Center, 2009).

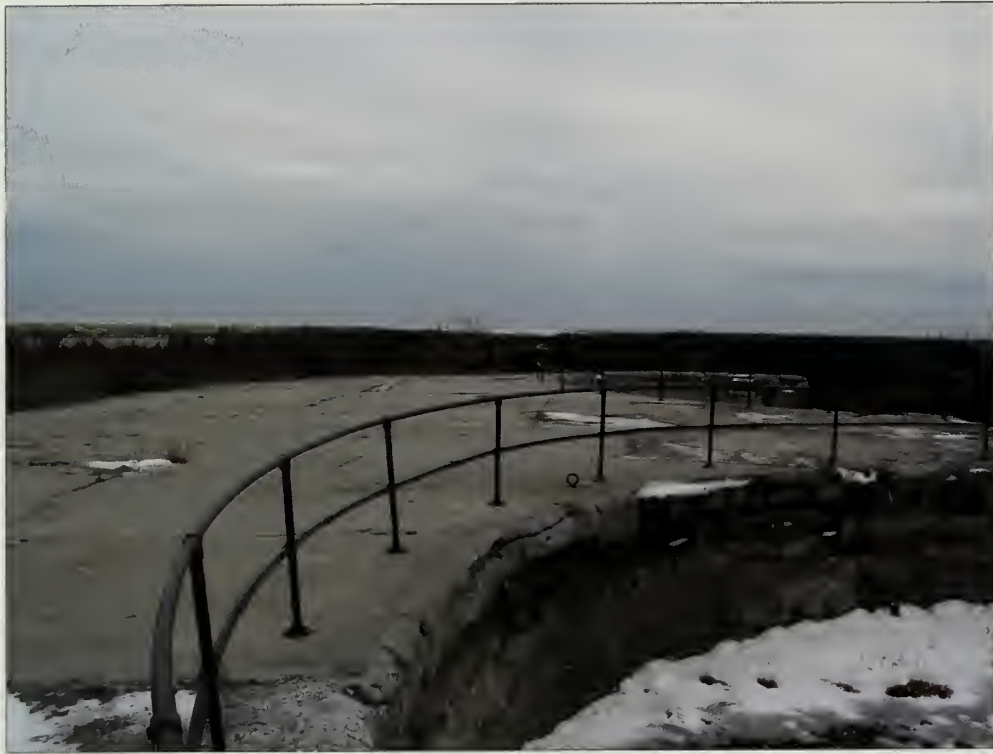
Figure 5.61. Recently installed contemporary safety railing, Battery Potter. Woven-wire may be either installed as infill panel, or the mesh applied with clamps to satisfy life-safety codes (Olmsted Center, January 2009).

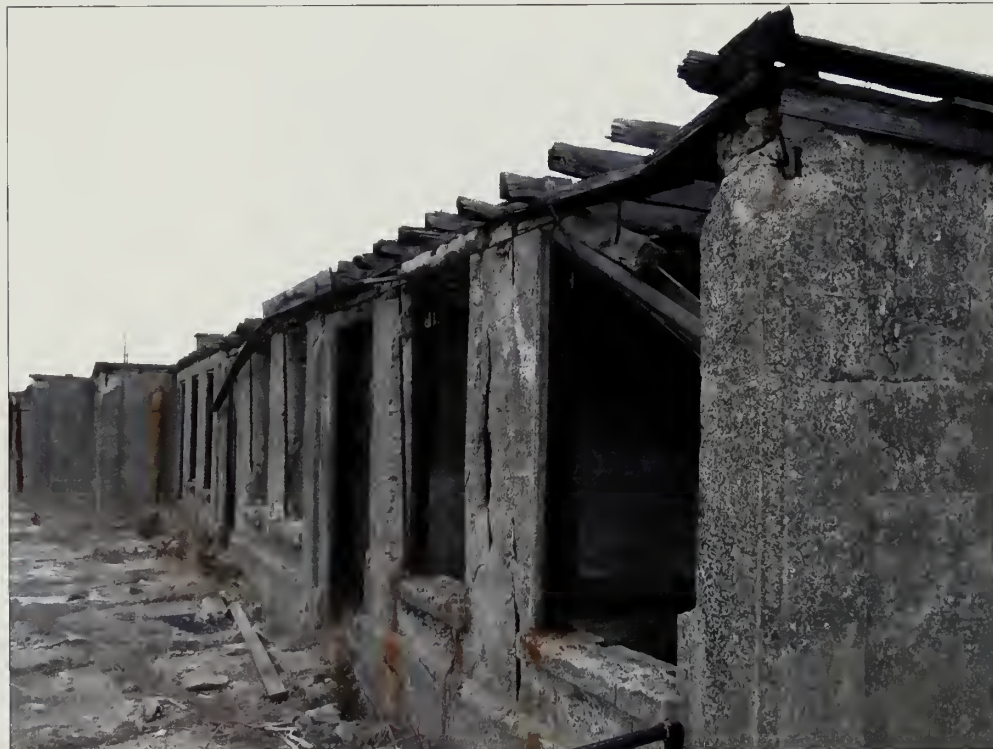
Figure 5.62. Plotting rooms, Battery Potter. In improving physical access to the upper level of Battery Potter for use as an elevated prospect, rehabilitating the deteriorated plotting rooms shown here may be of some value for interpretive purposes. Once the roofs of these buildings are replaced, the interiors may be used to house durable exhibitry. Enamelled interpretive wayside panels may effectively substitute for missing window frames, offering detailed graphic interpretation of Battery Potter and the entire coastal defense system (Olmsted Center, January 2009).

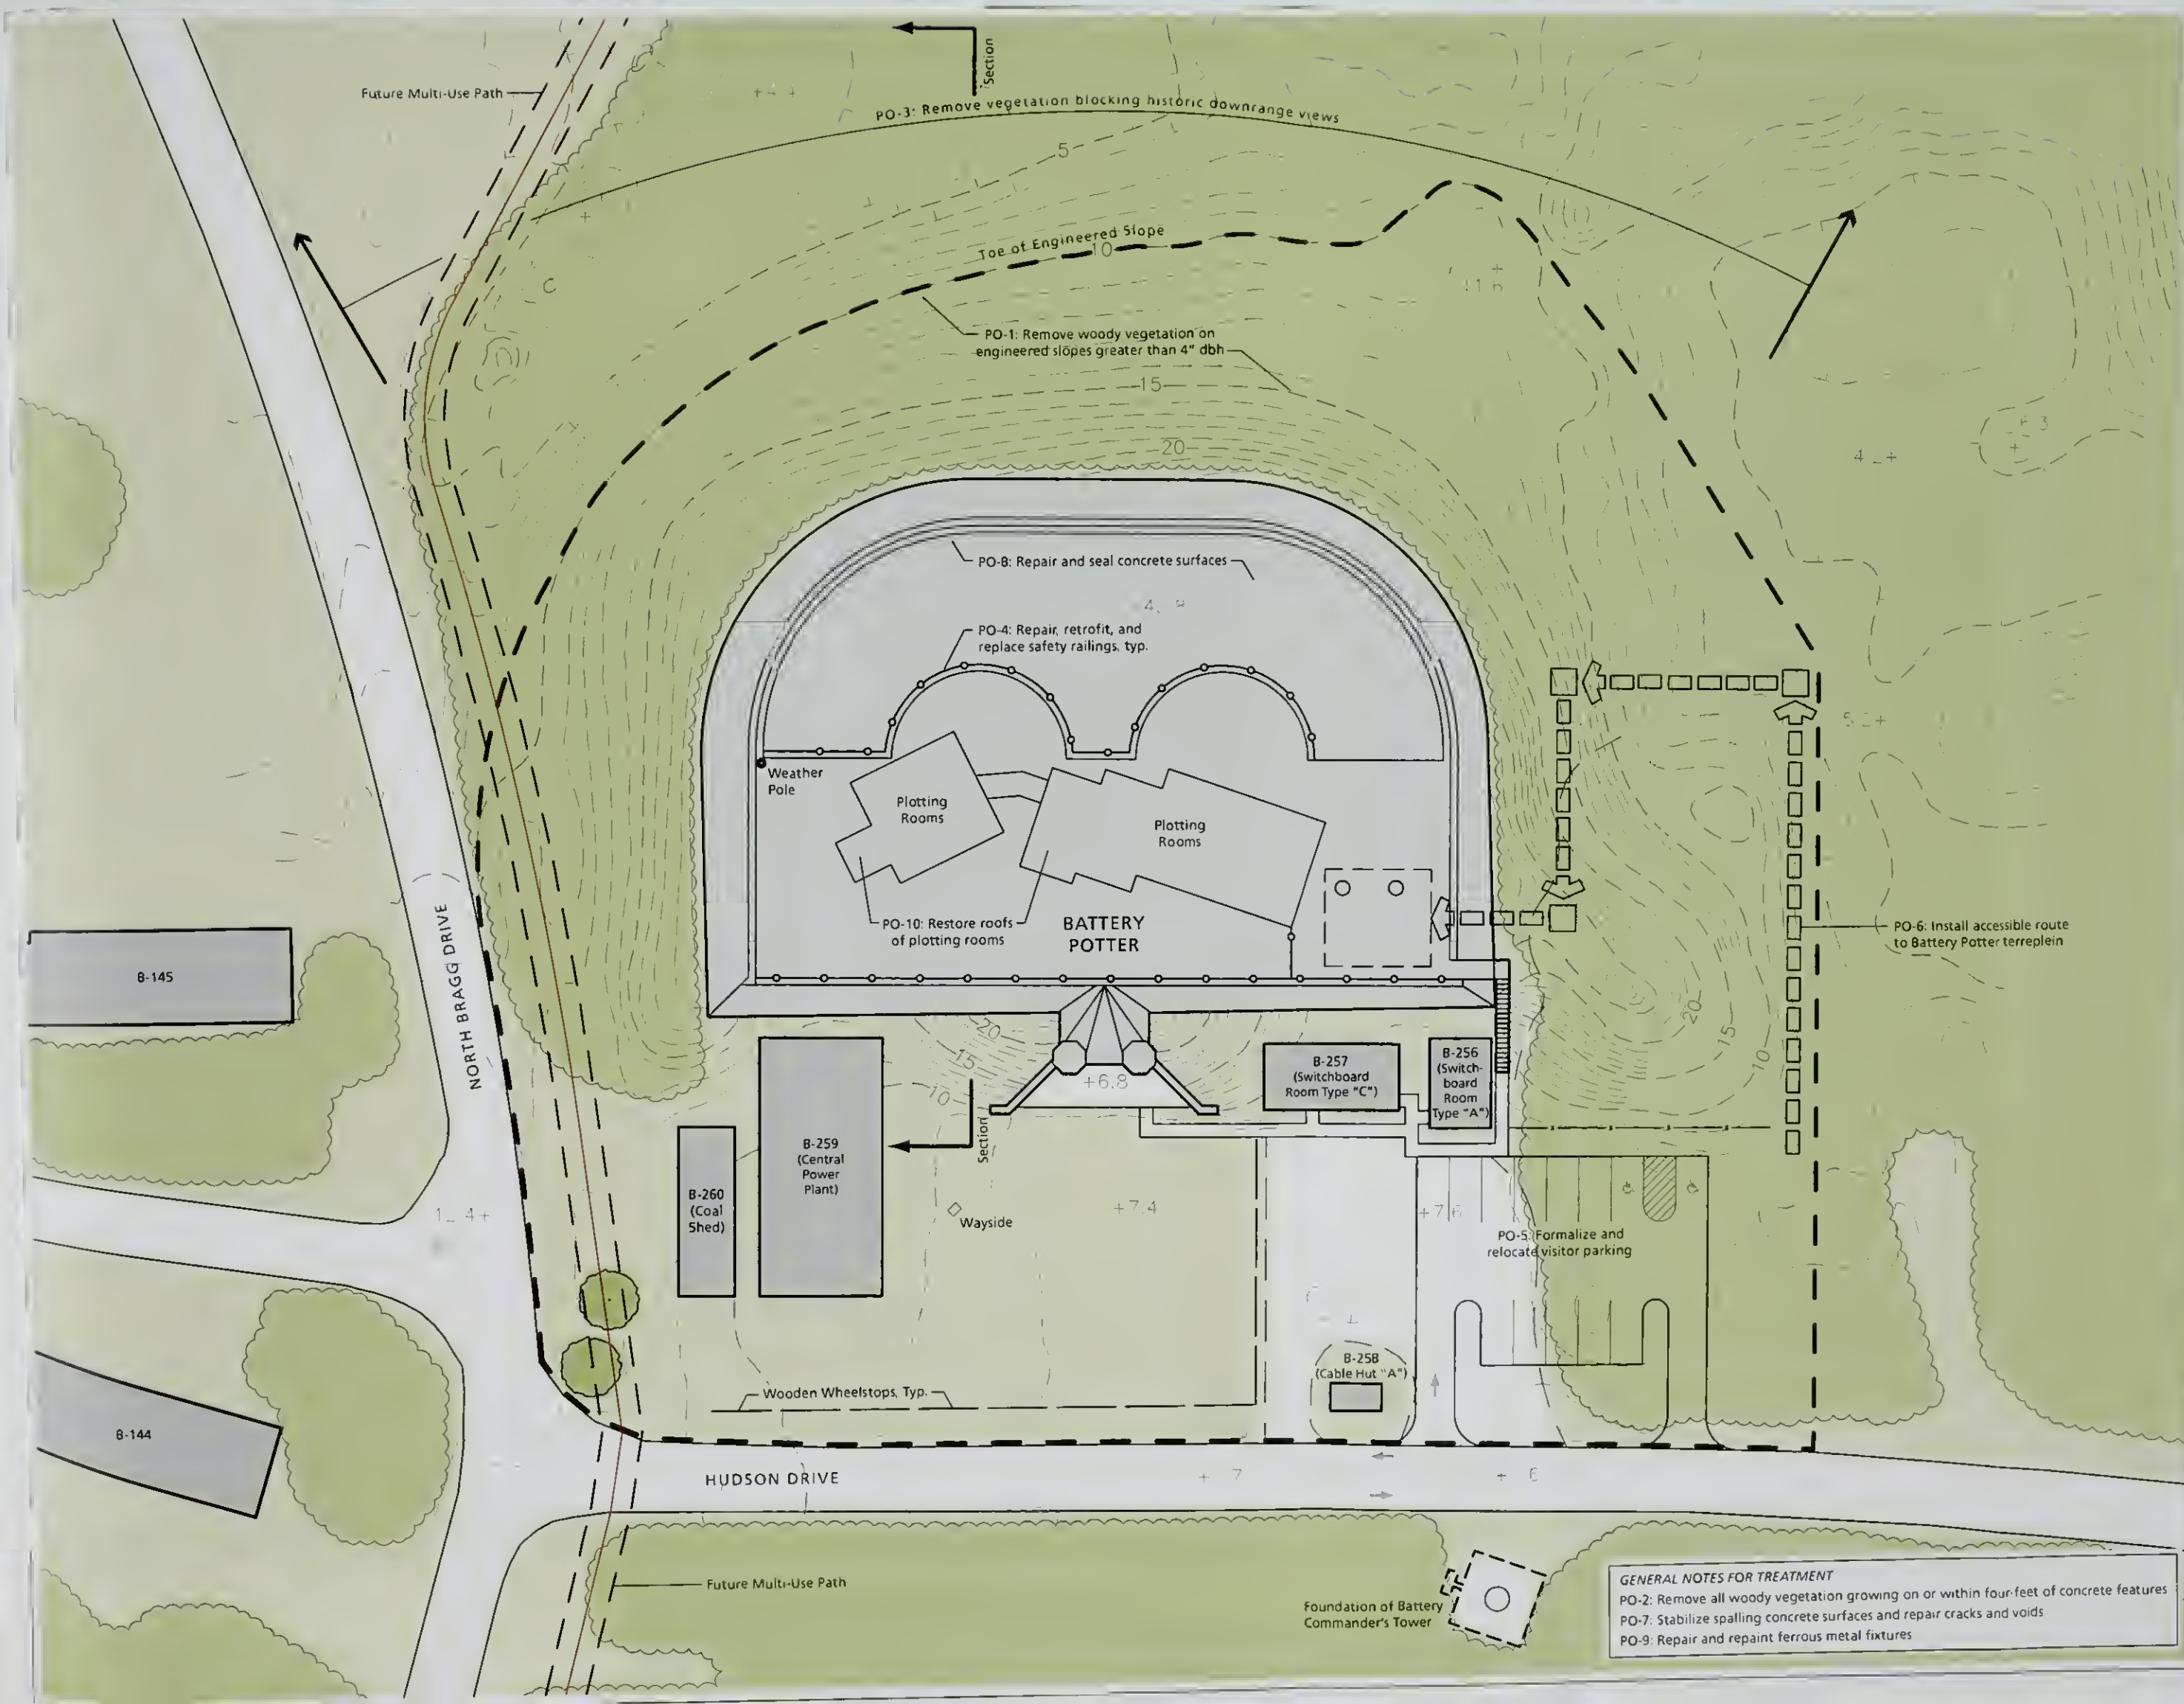
GENERAL NOTES FOR TREATMENT
 PO-2: Remove all woody vegetation growing on or within four-feet of concrete features
 PO-7: Stabilize spalling concrete surfaces and repair cracks and voids
 PO-9: Repair and repaint ferrous metal fixtures

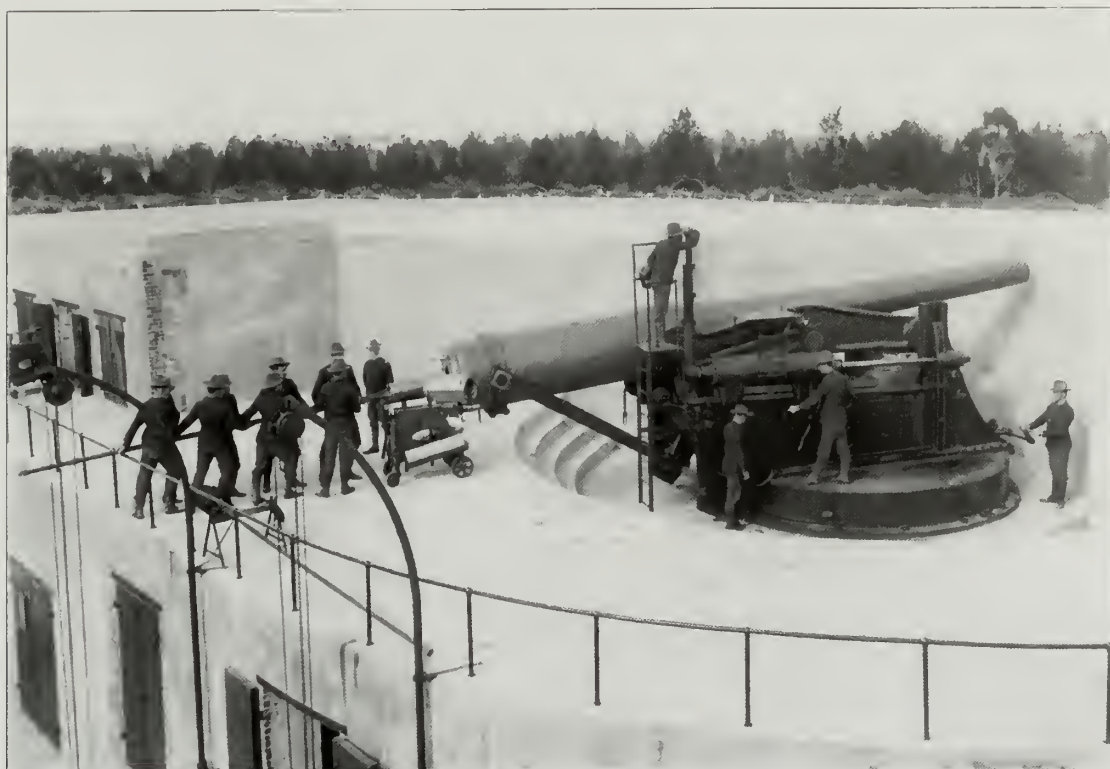
Figure 5.63. Battery Granger, circa 1900. Note the growth of woody vegetation beyond the limits of the engineered slopes. Great effort was made to disturb as little pre-existing vegetation in front of the battery as possible in order to conceal the structure from enemy fire (GATE 7778).

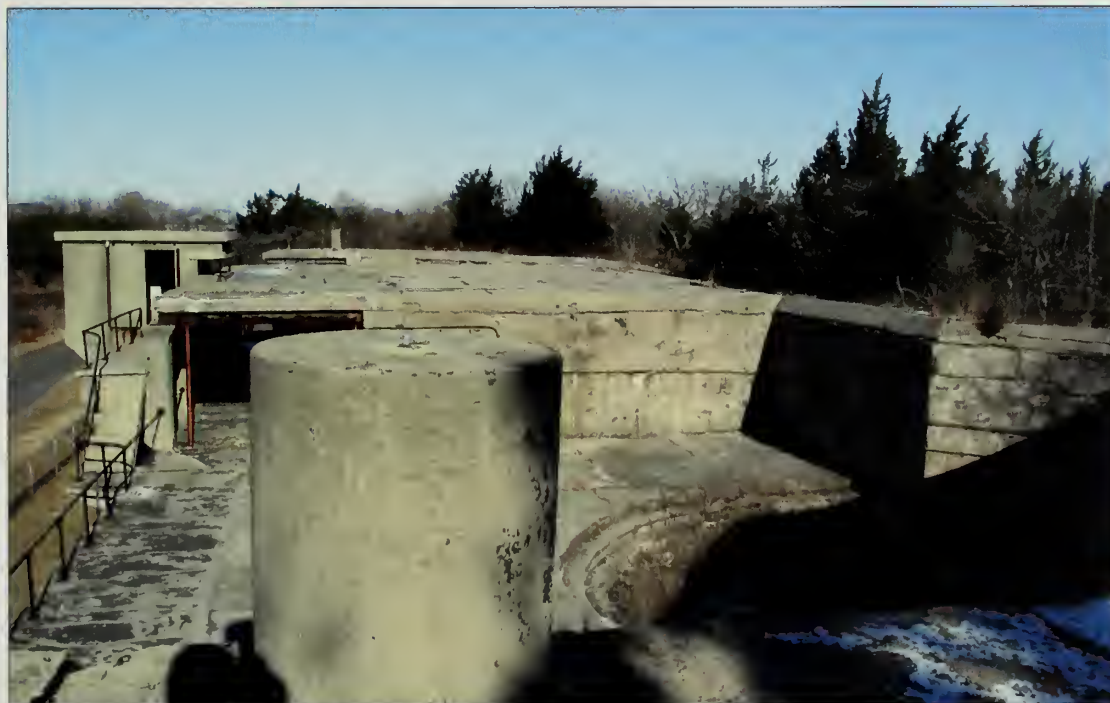
Figure 5.64. View looking north at emplacement #1 and battery commander's station, Battery Granger. Battery Granger is accessed via Hudson Drive, left, and a chain-link fence and signage have been installed between the road and battery to warn visitors of potentially hazardous conditions. Eastern red cedars, right, are heavily concentrated at the interface of the engineered slope and the battery's concrete terreplein (Olmsted Center, January 2009).

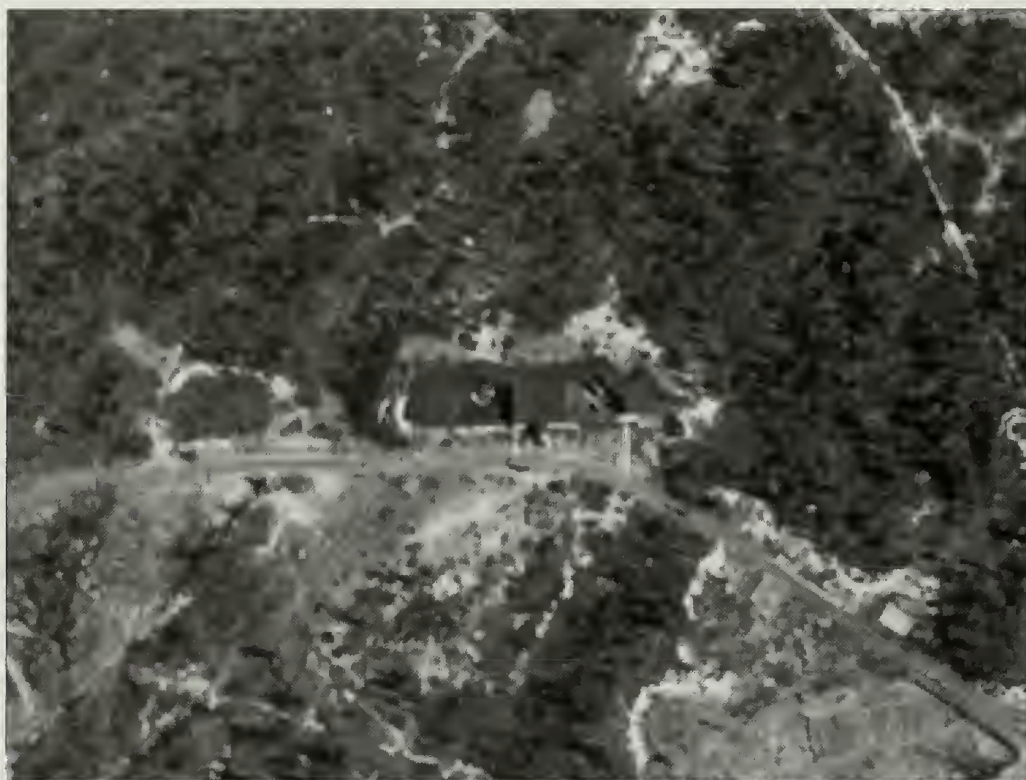
Figure 5.65. Aerial photograph of Battery Granger, January 1933. This photograph indicates management of woody vegetation growing on the engineered slope forward of the battery (Coastal and Hydraulics Laboratory, Engineer Research and Development Center).

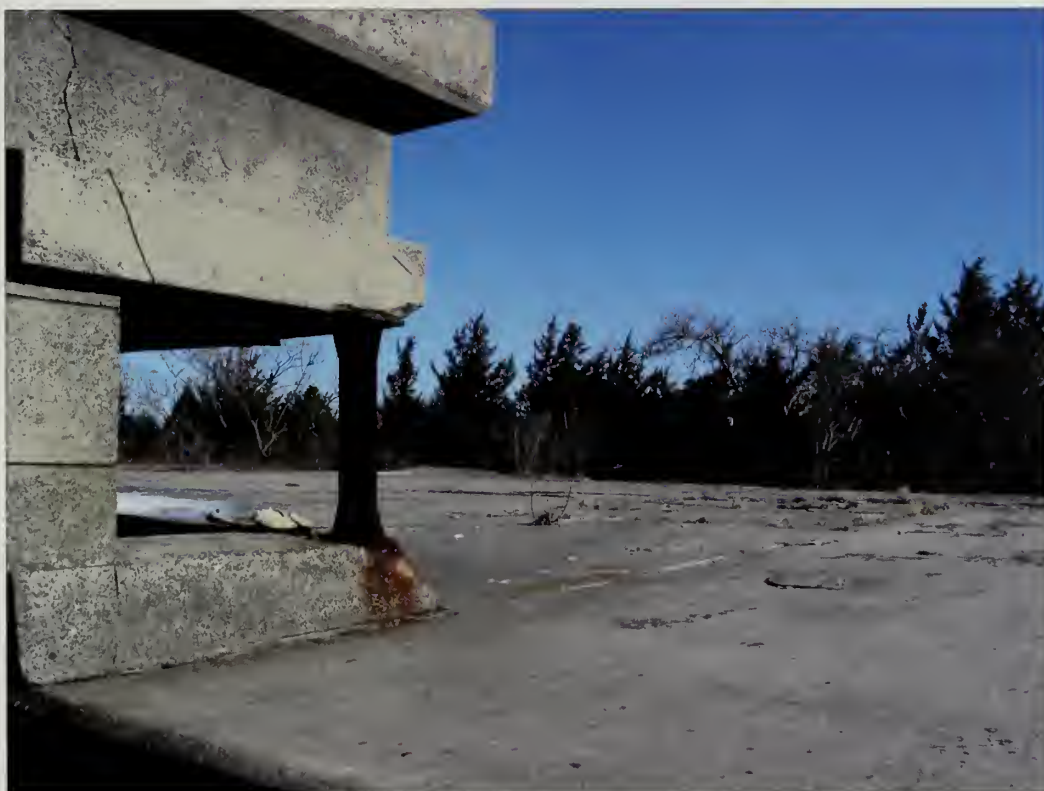
Figure 5.68. Blocked view northeastward from the battery commander's station at Battery Granger. Blocked downrange views to the water makes it difficult for park visitors to understand the historic operation of these coastal defense sites. Note corrosion of ferrous metal building features (Olmsted Center, January 2009).

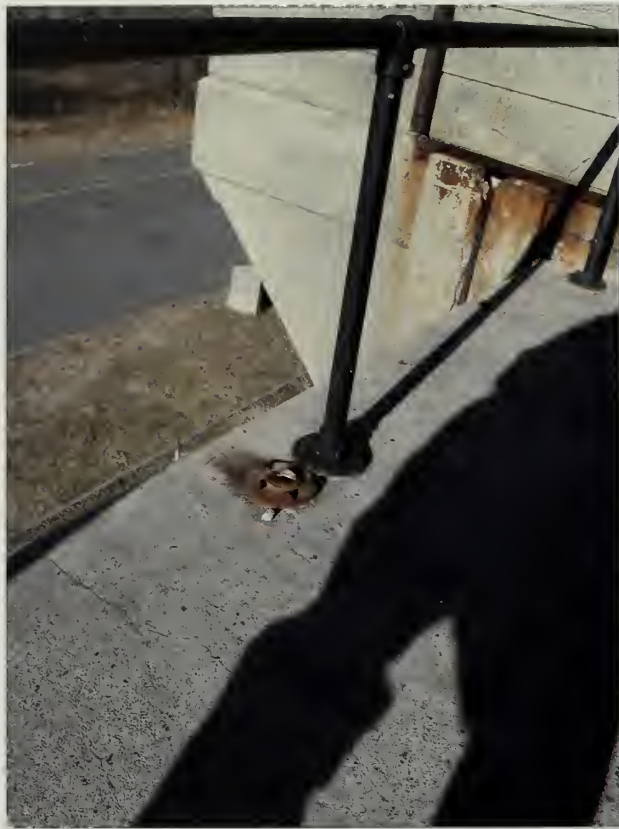
Figure 5.69. Existing safety railings, Battery Granger. At this location and elsewhere throughout Sandy Hook's coastal defense sites, one can see the tangible history of maintenance and repair. This simple railing may be retrofitted with either infill mesh panels or otherwise with woven wire mesh applied with clamps and hardware to satisfy life-safety codes (Olmsted Center, January 2009).

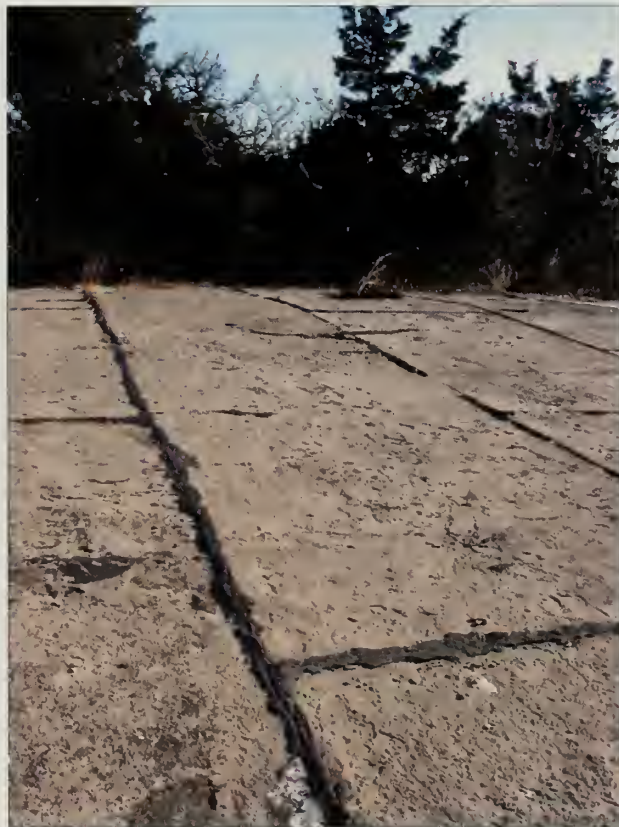
Figure 5.70. Close-up view of existing concrete terreplein, Battery Granger. Existing conditions indicate that joints between concrete panels were once sealed with bituminous material. With the passage of time, this sealant material requires maintenance (Olmsted Center, January 2009).

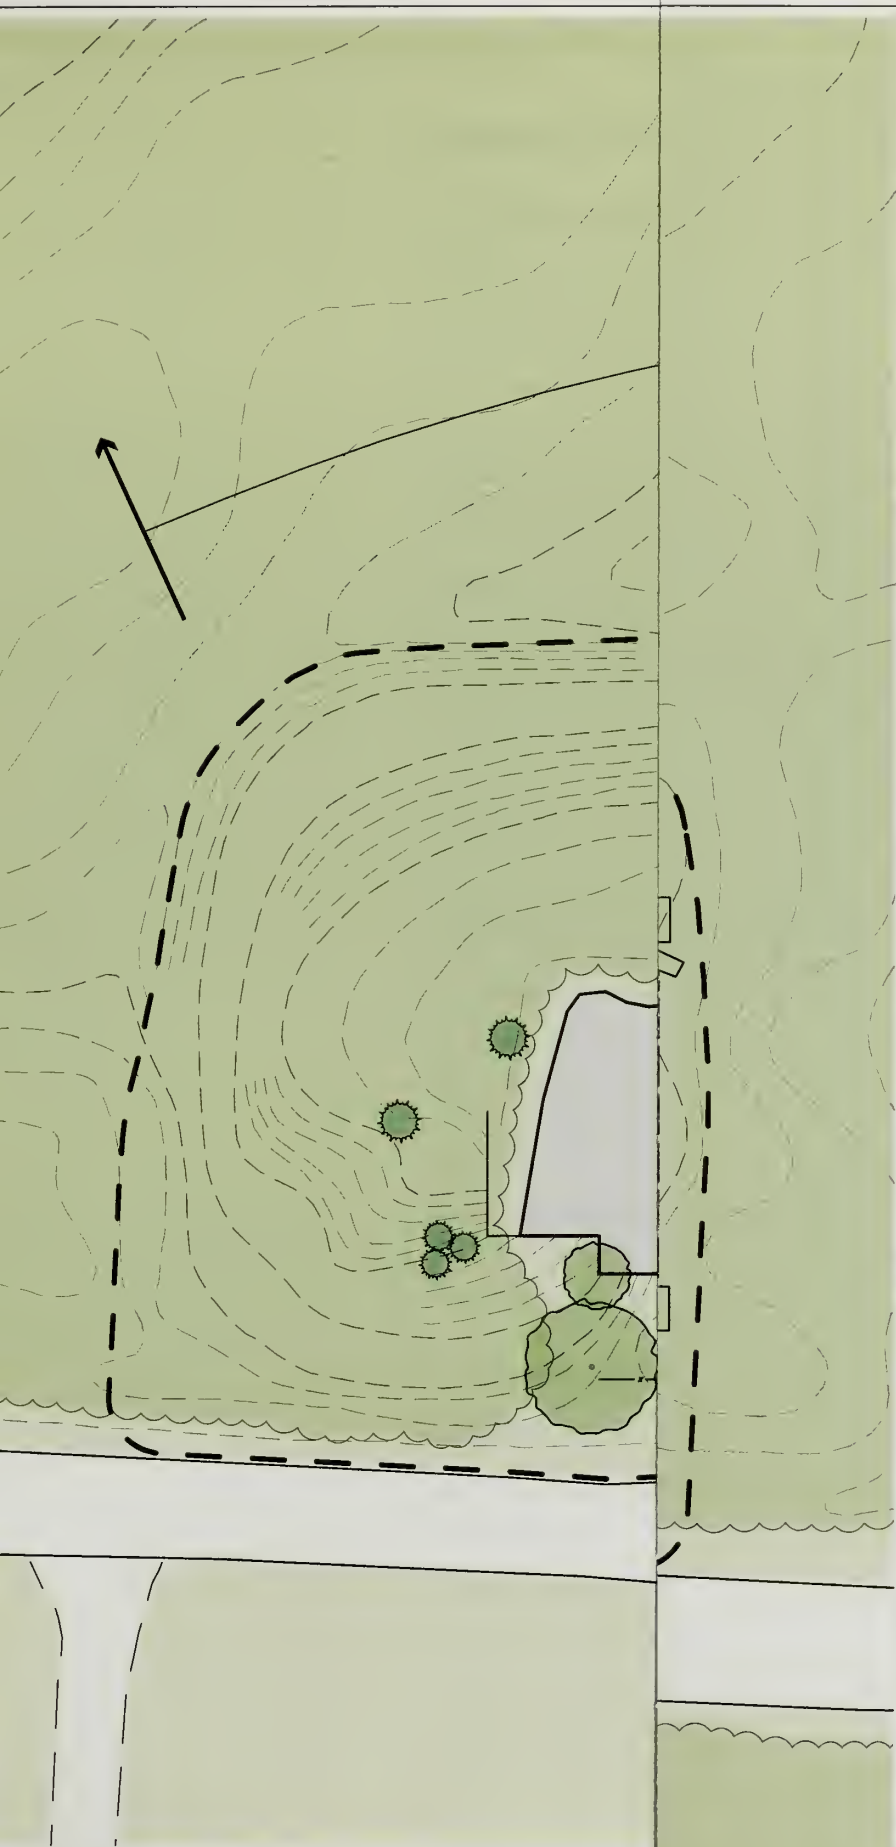
- GR-2: Remove all woody vegetation growing on or within four-feet of concrete feature
- GR-8: Stabilize spalling concrete surfaces and repair cracks and voids
- GR-10: Repair and repaint ferrous metal fixtures

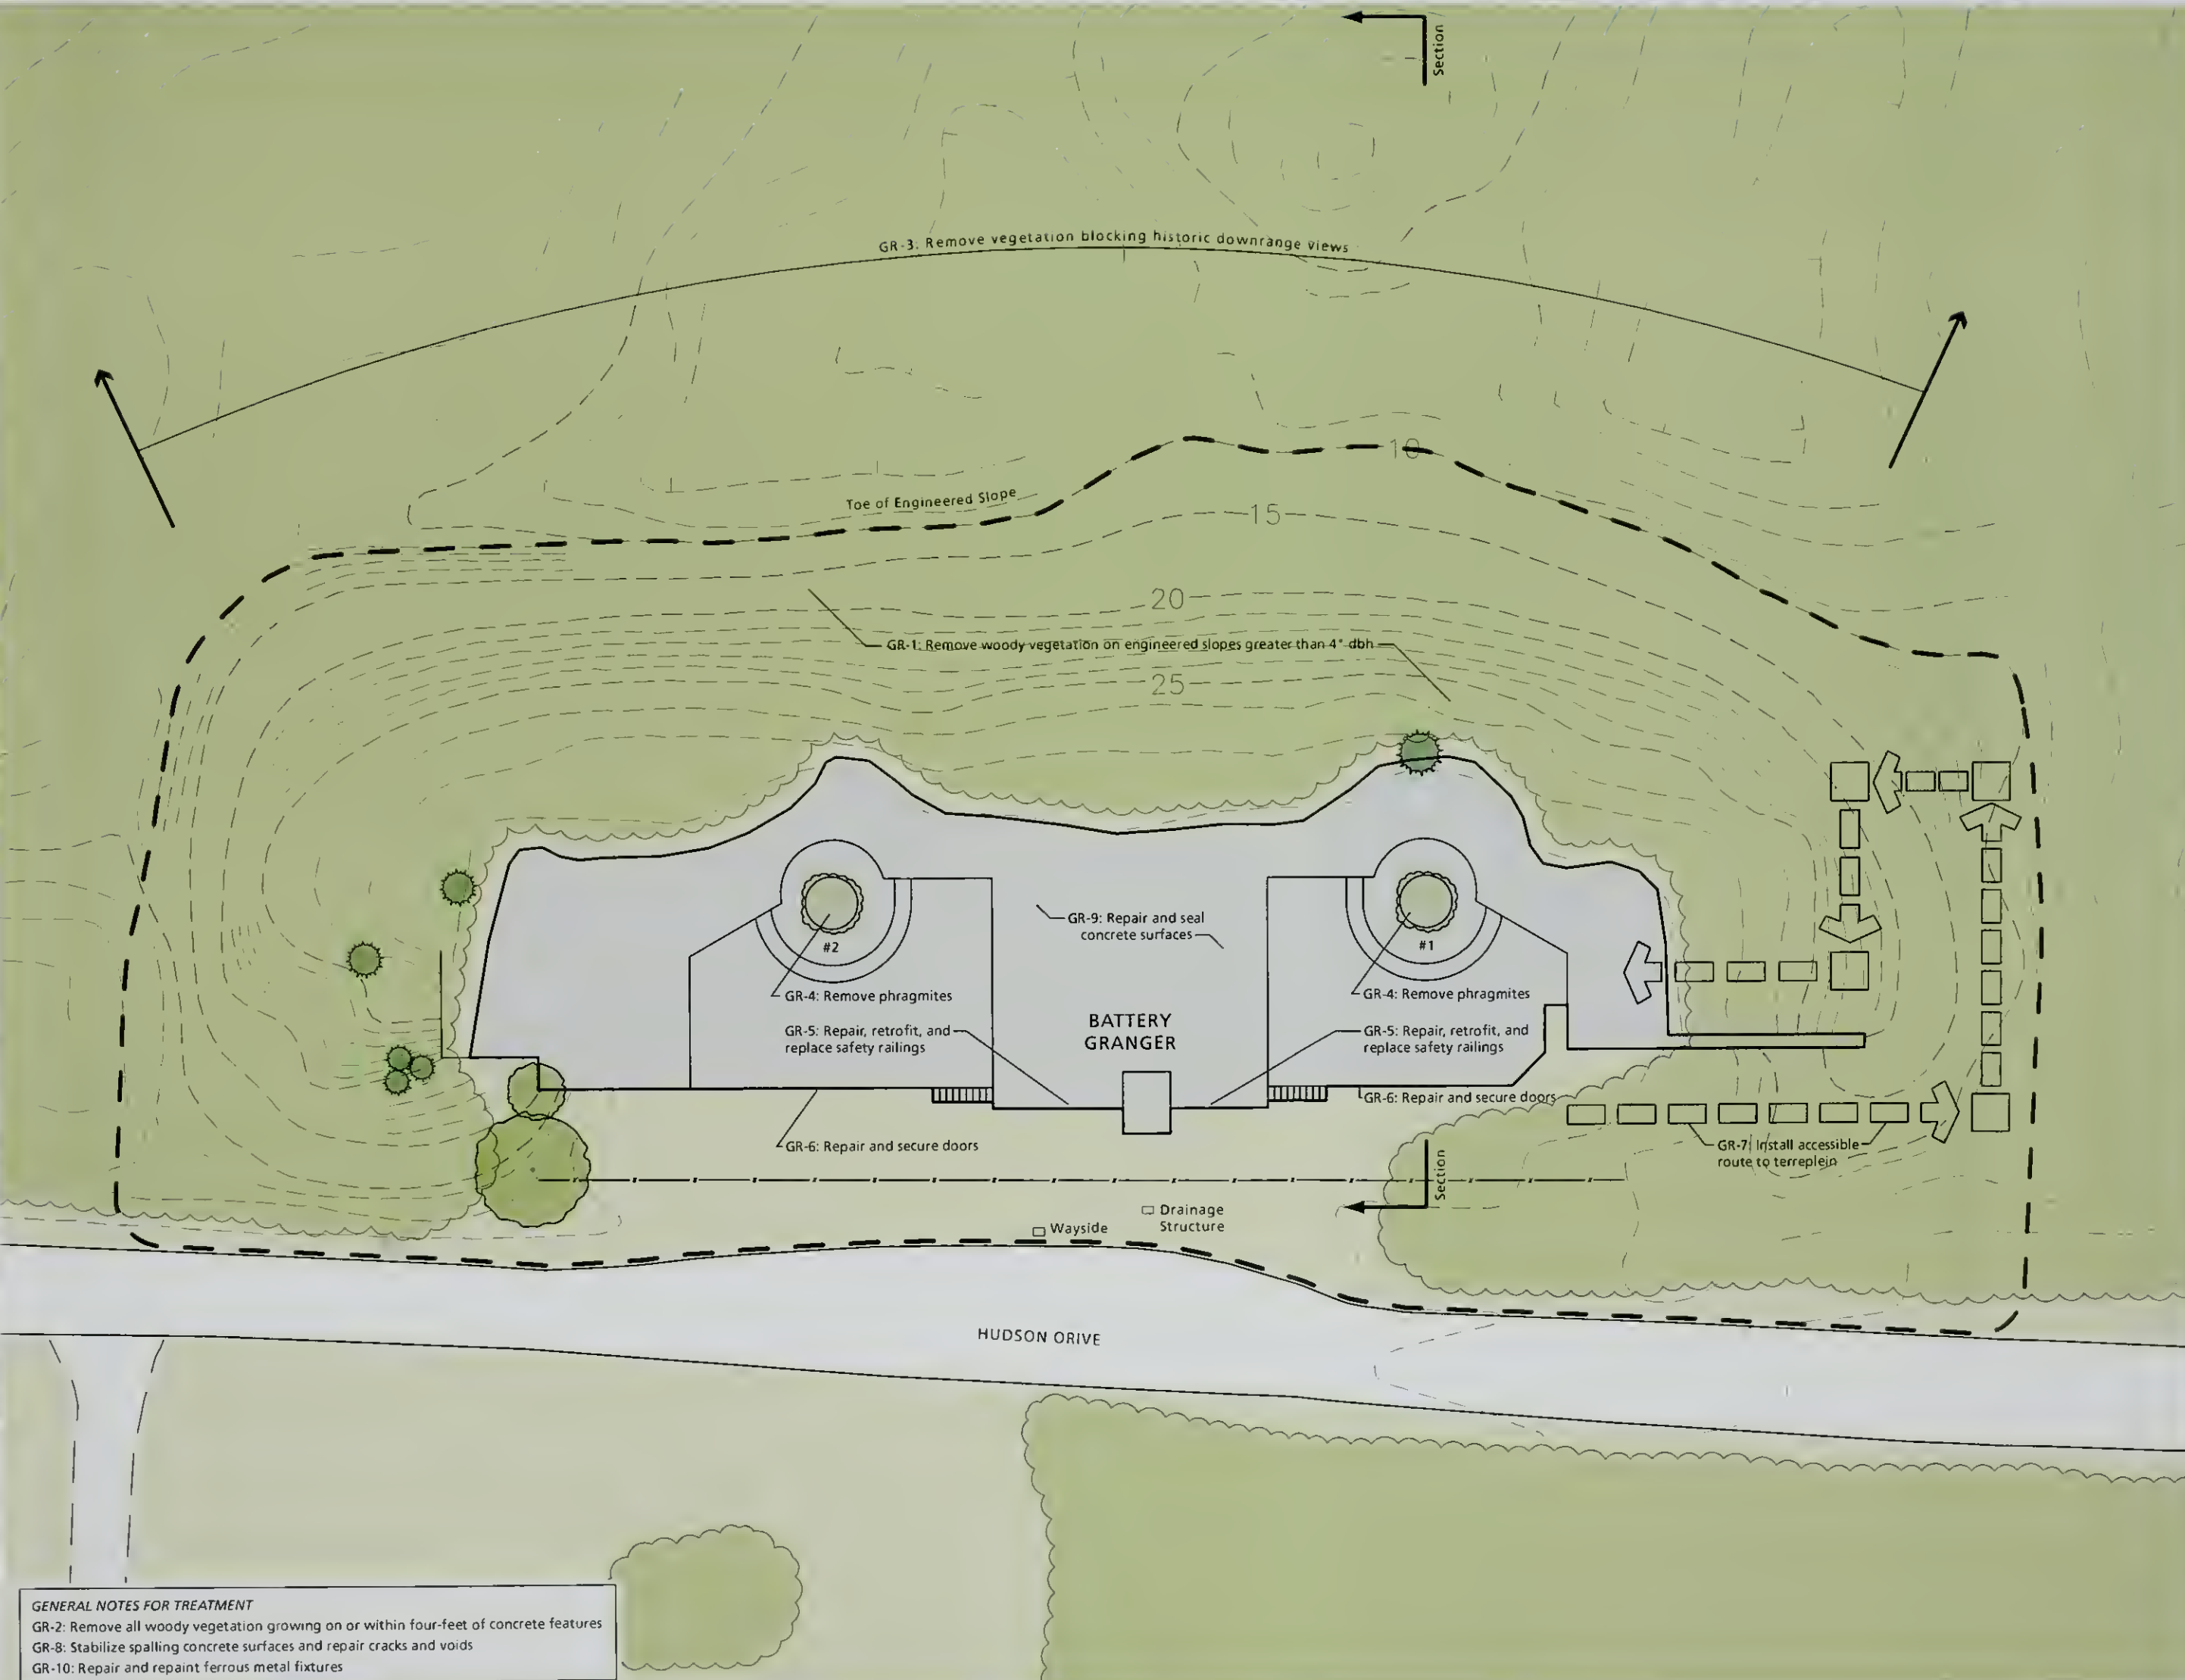
GENERAL NOTES FOR TREATMENT
 GR-2: Remove all woody vegetation growing on or within four-feet of concrete features
 GR-8: Stabilize spalling concrete surfaces and repair cracks and voids
 GR-10: Repair and repaint ferrous metal fixtures

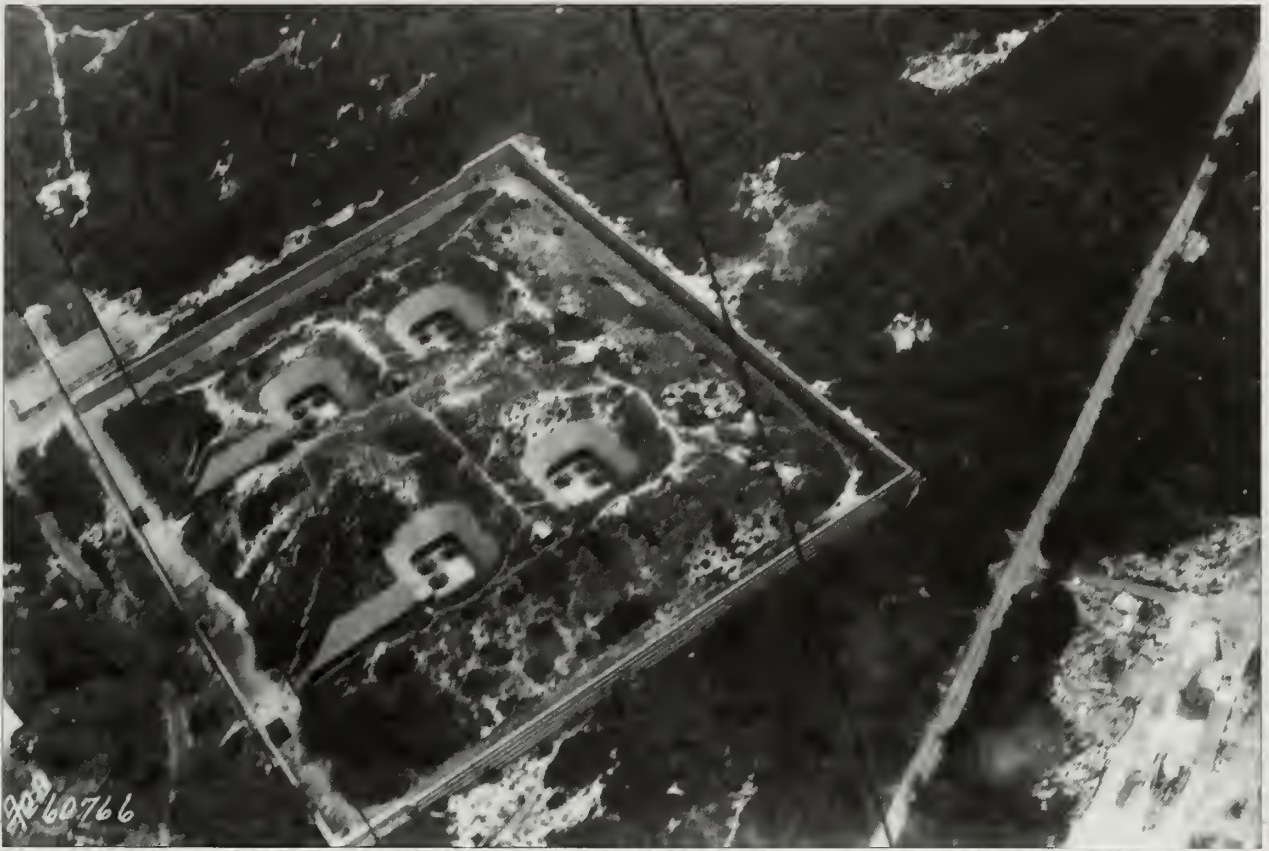
Figure 5.71. Oblique aerial photograph of the Mortar Battery, circa 1917, taken from an Army Signal Corps balloon. Note the low, scrub vegetation growing on the Mortar Battery's engineered landform (GATE 7870).
