I 29.86/4.5 A 5

Clemson University

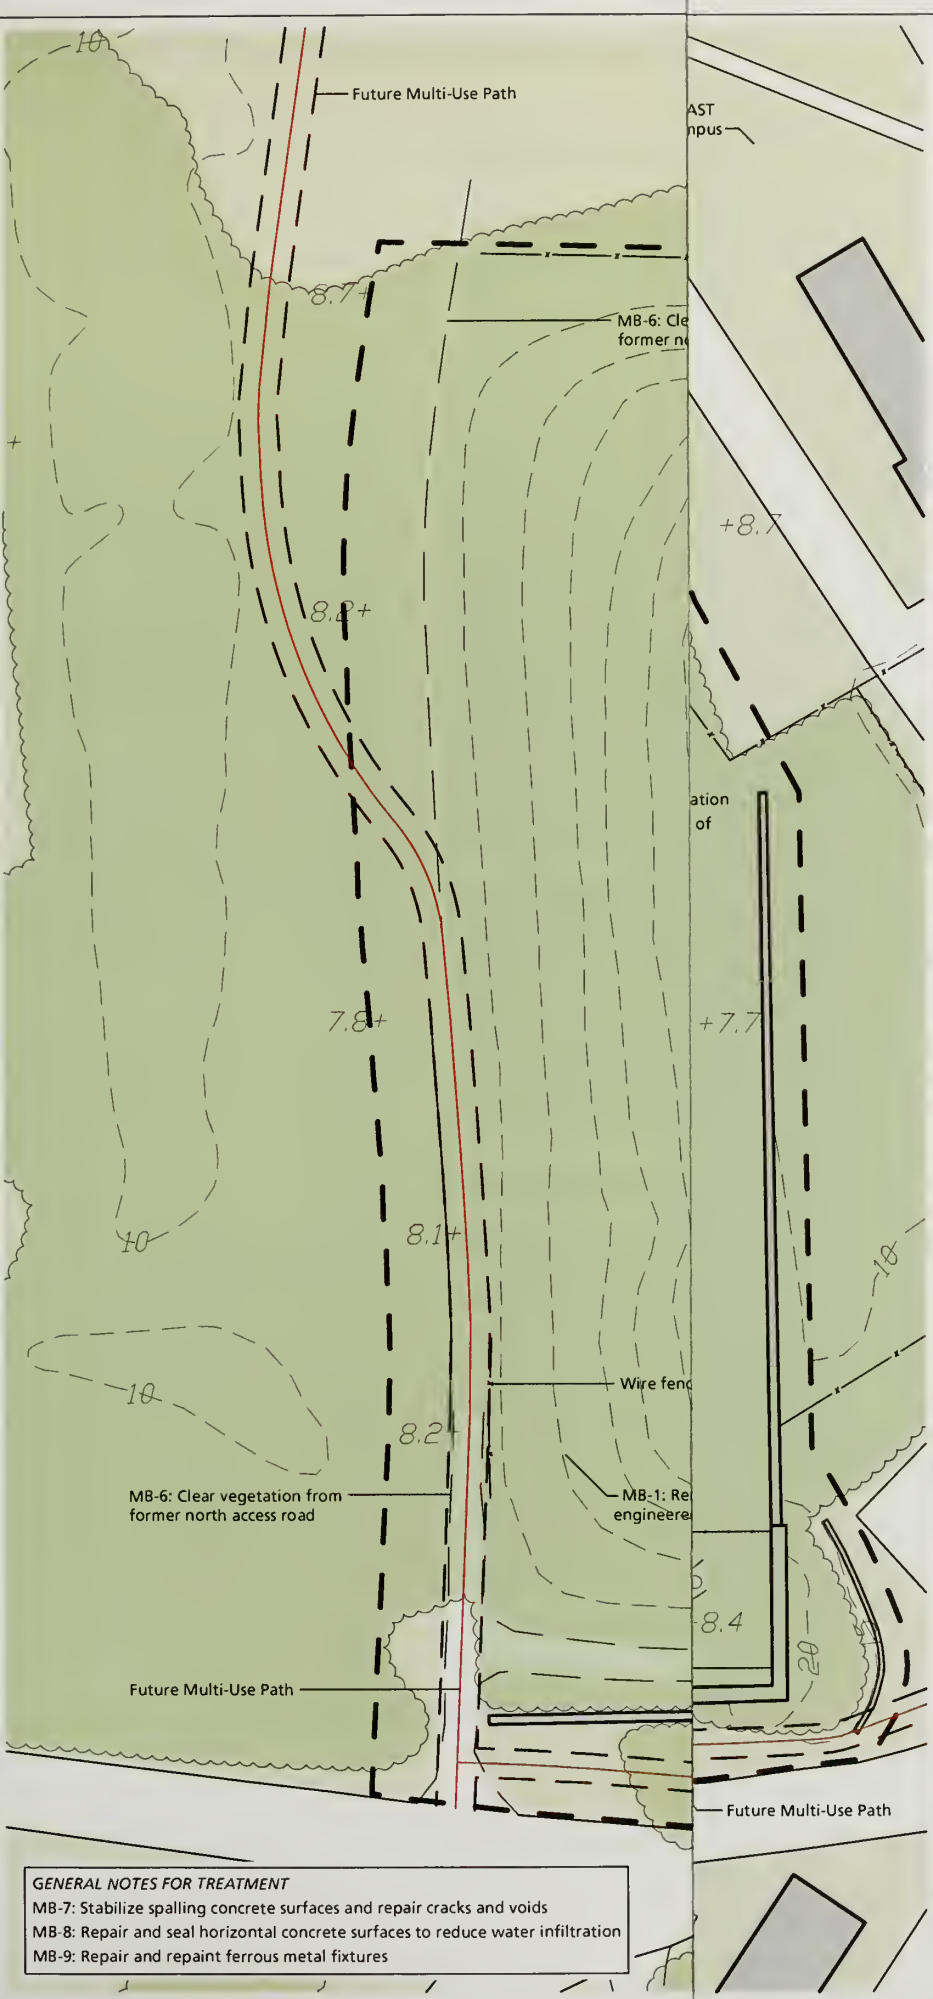
GENERAL NOTES FOR TREATMENT

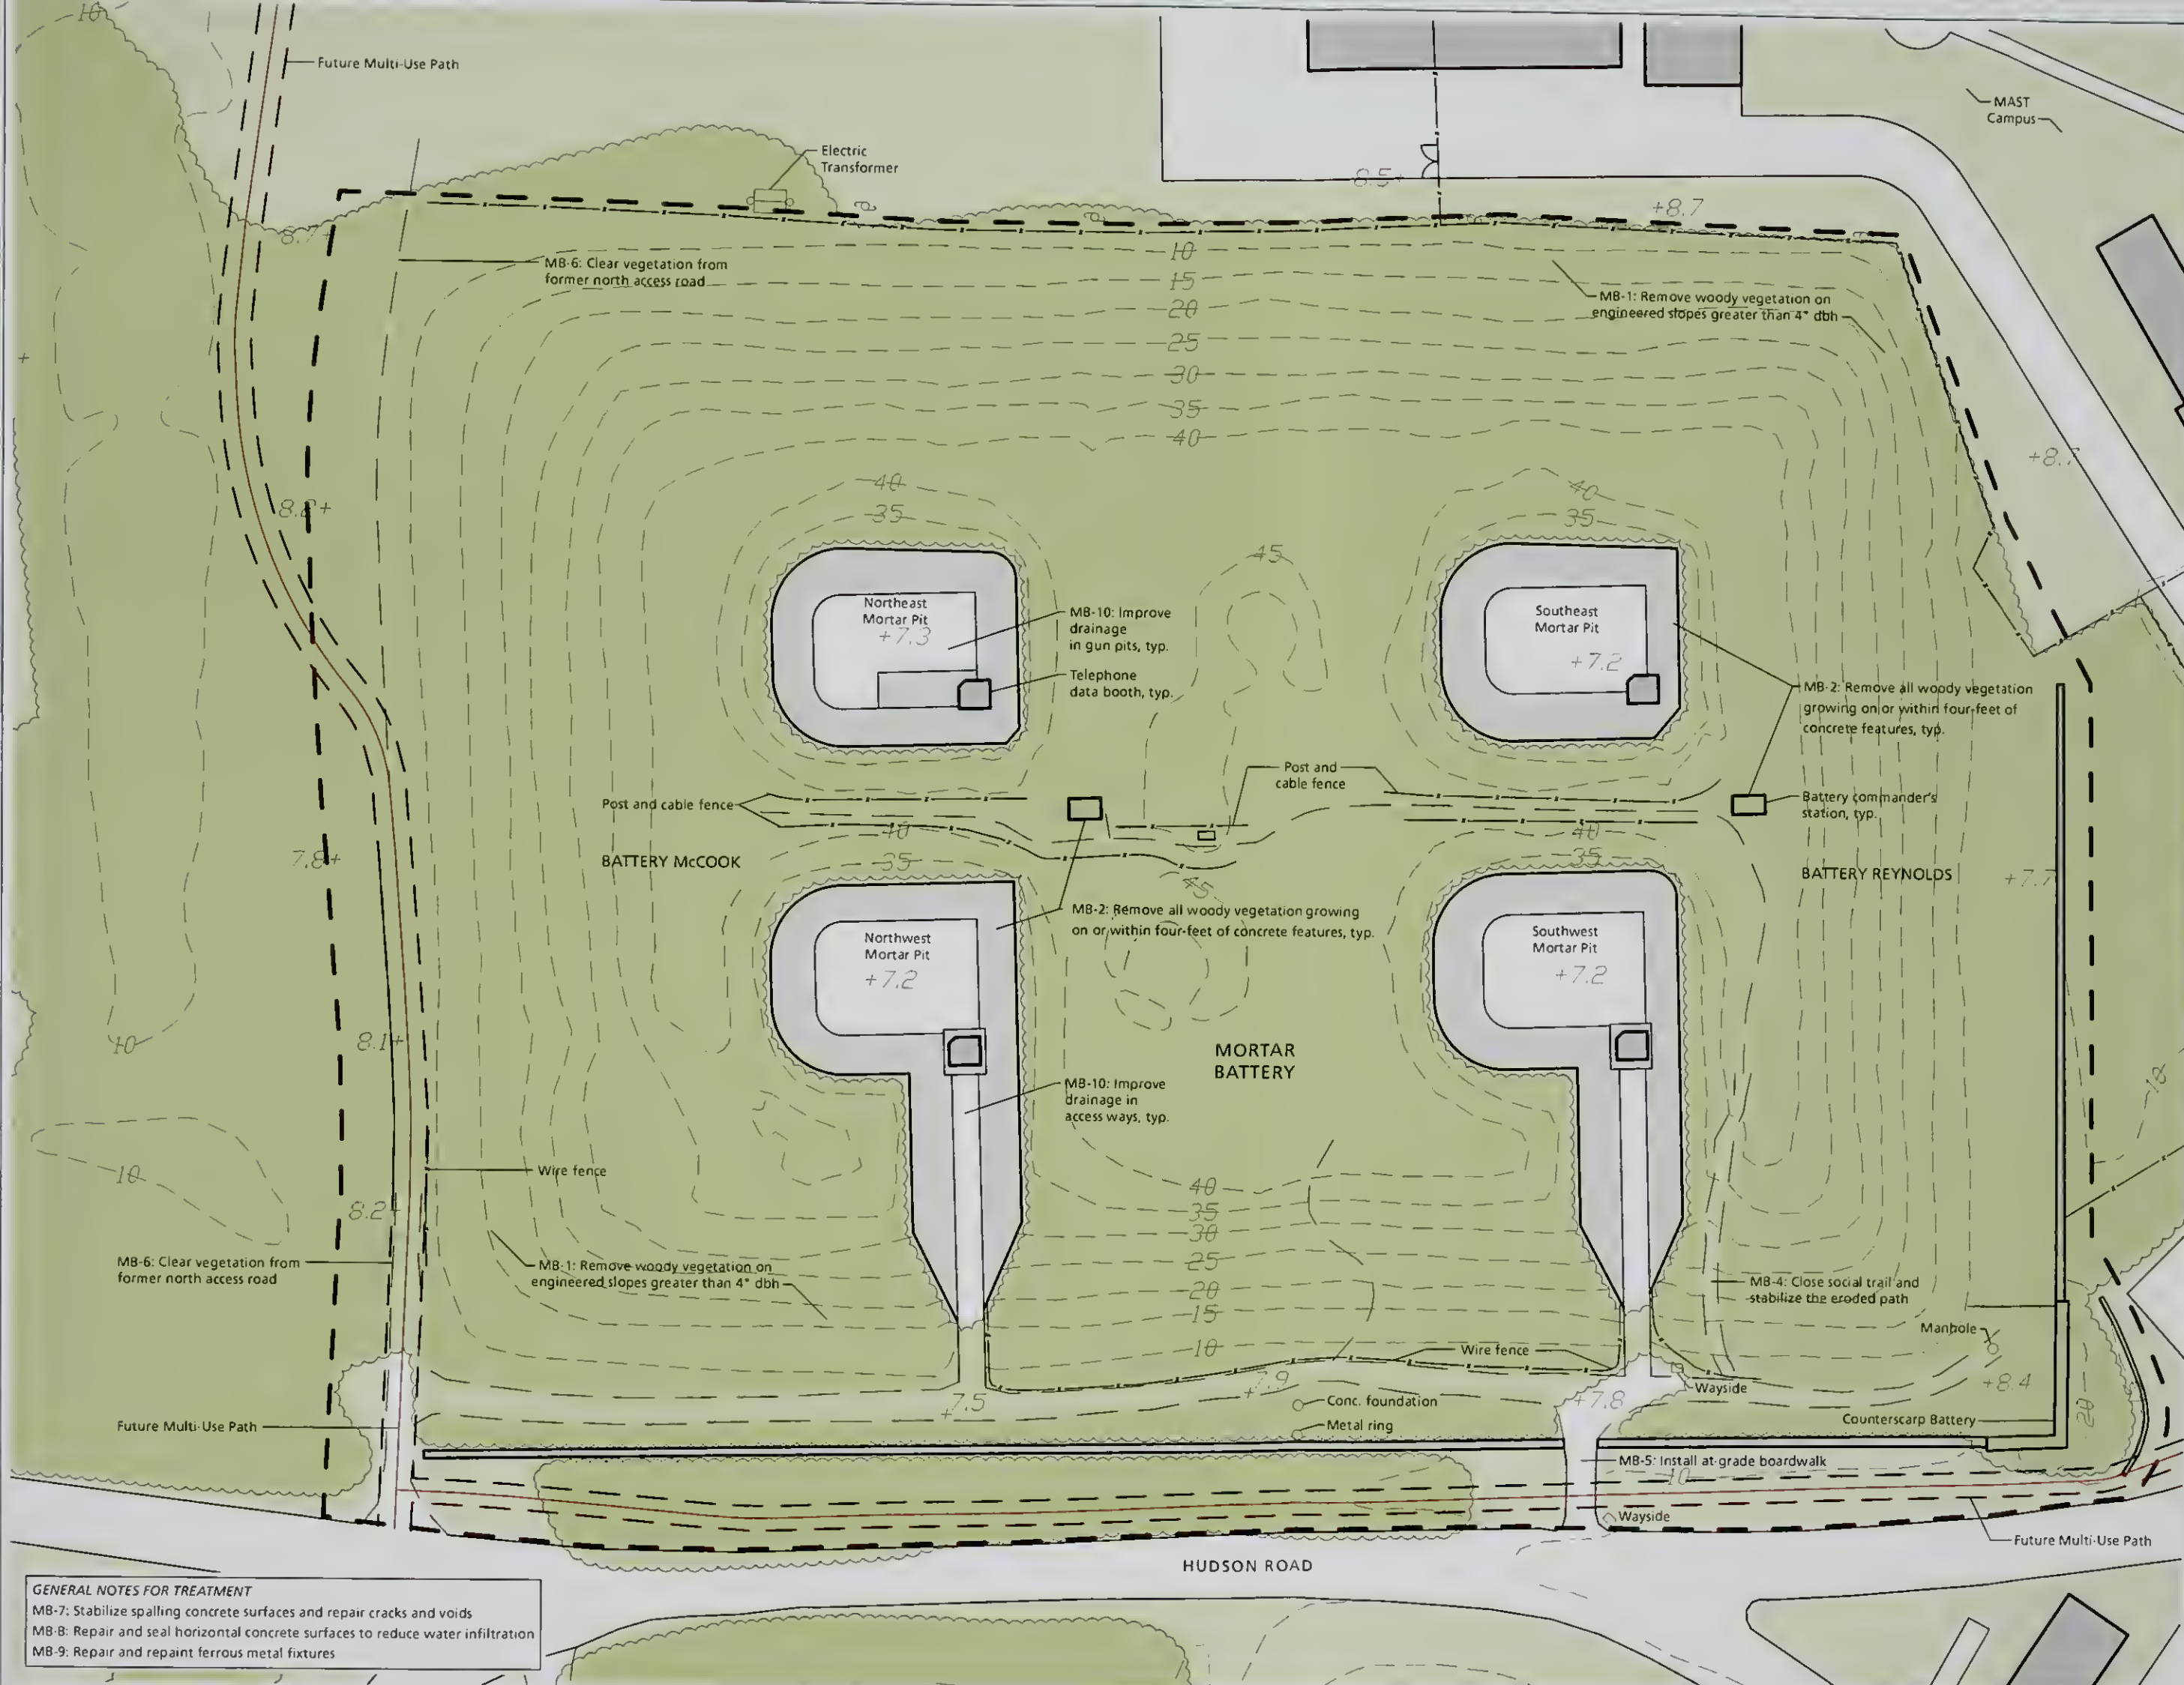
GENERAL NOTES FOR TREATMENT
 MB-7: Stabilize spalling concrete surfaces and repair cracks and voids
 MB-8: Repair and seal horizontal concrete surfaces to reduce water infiltration
 MB-9: Repair and repaint ferrous metal fixtures

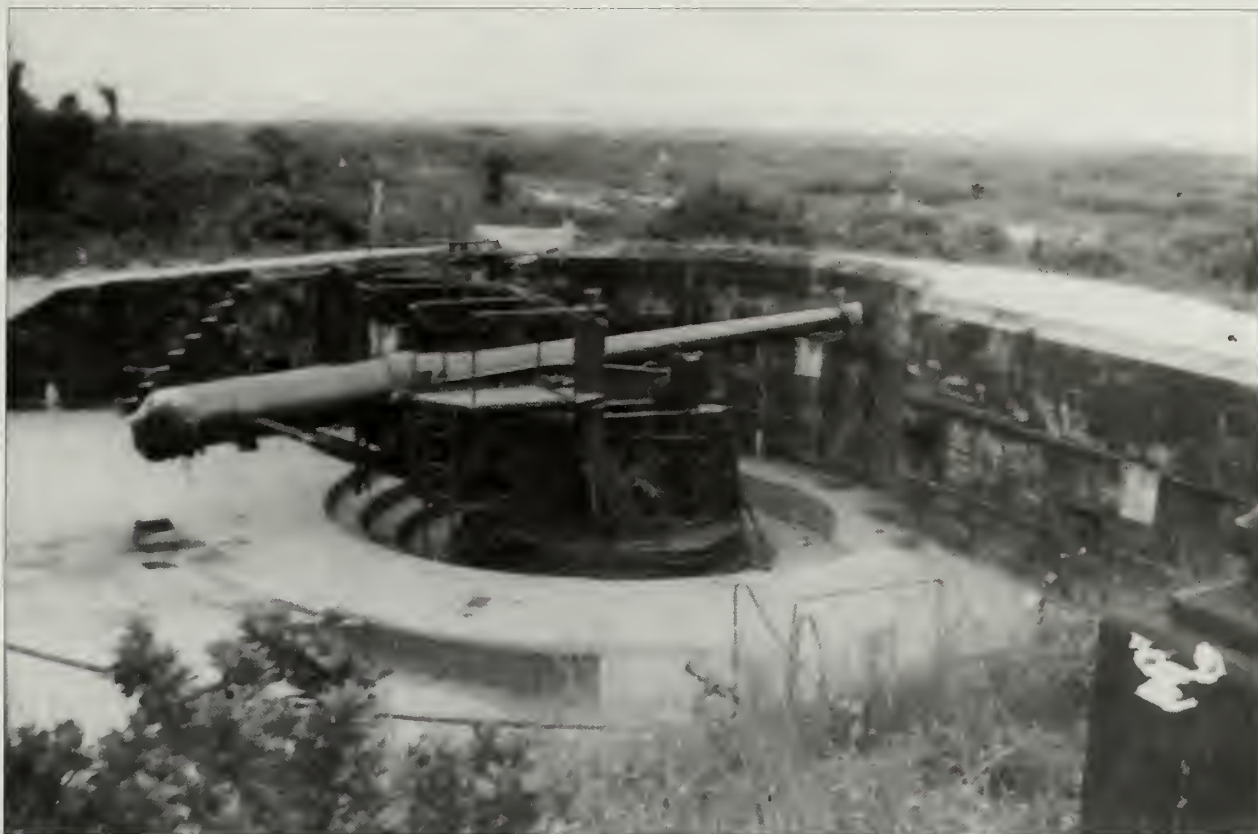
Figure 5.77. Battery Gunnison, circa 1941 prior to converting the battery to barbette mounted guns. Note the predominance of herbaceous vegetation at this time. Also note the weathered black paint on the concrete surfaces (GATE 7834).

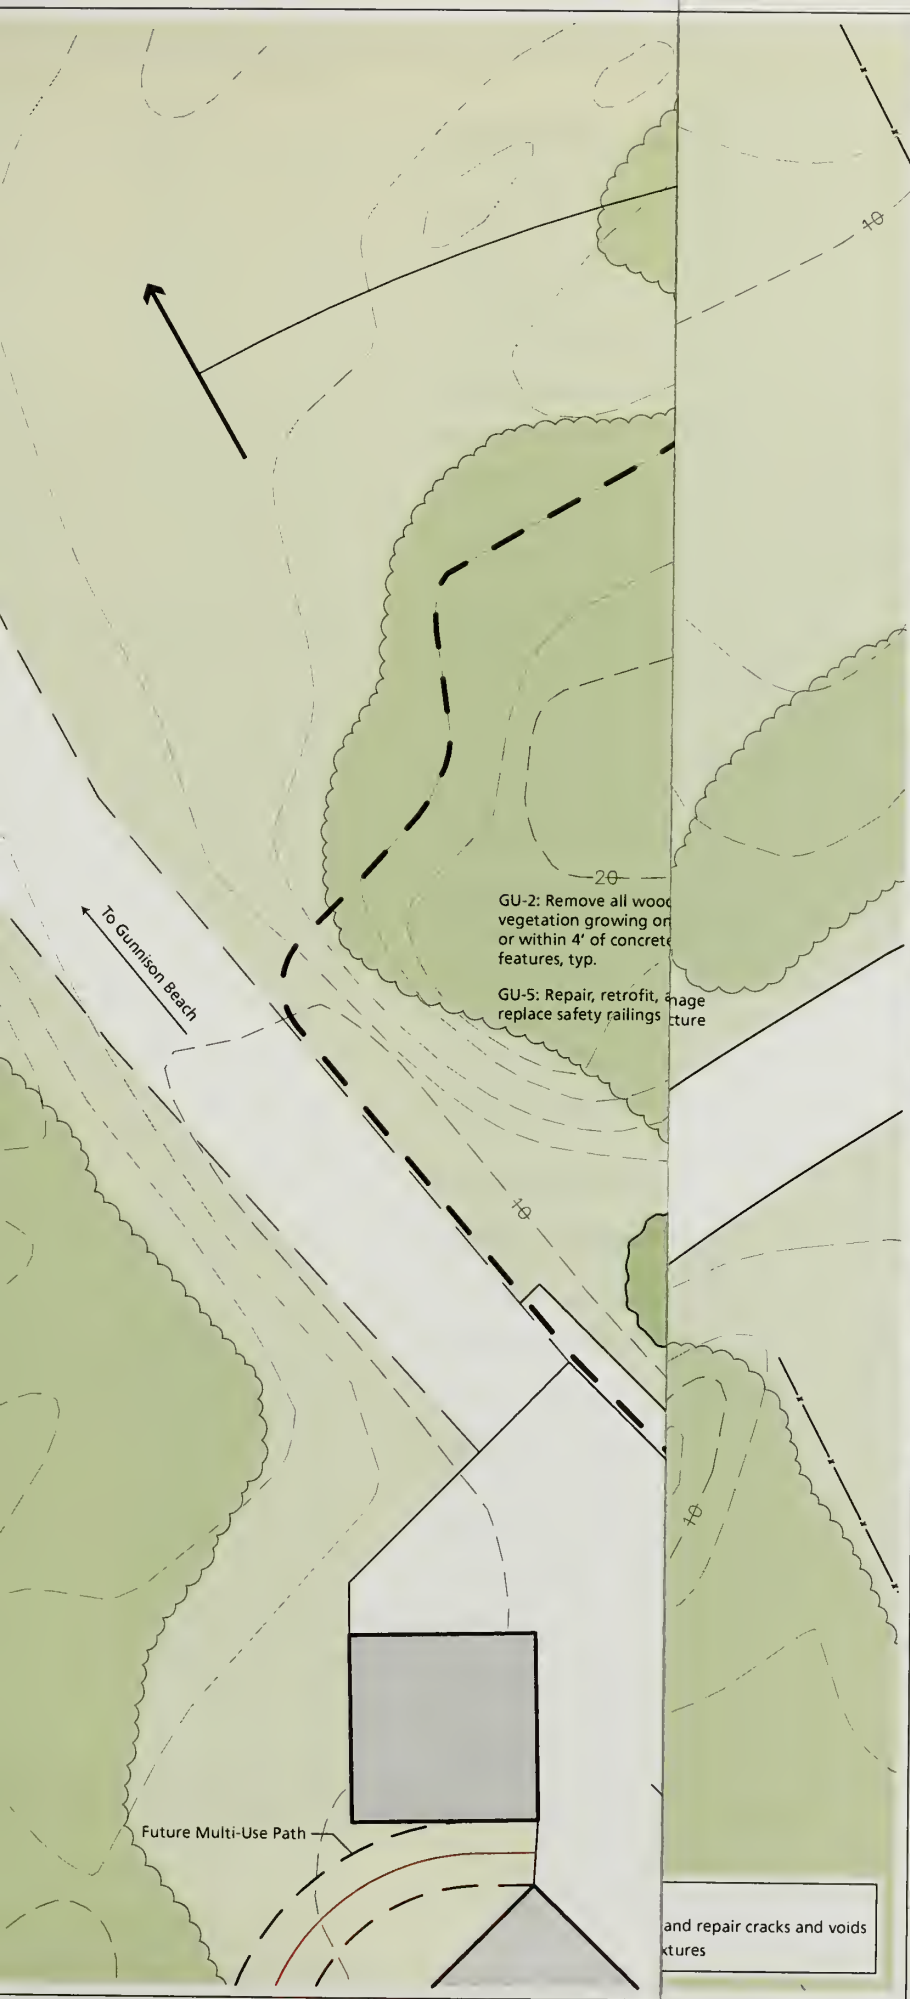
and repair cracks and voids
structures

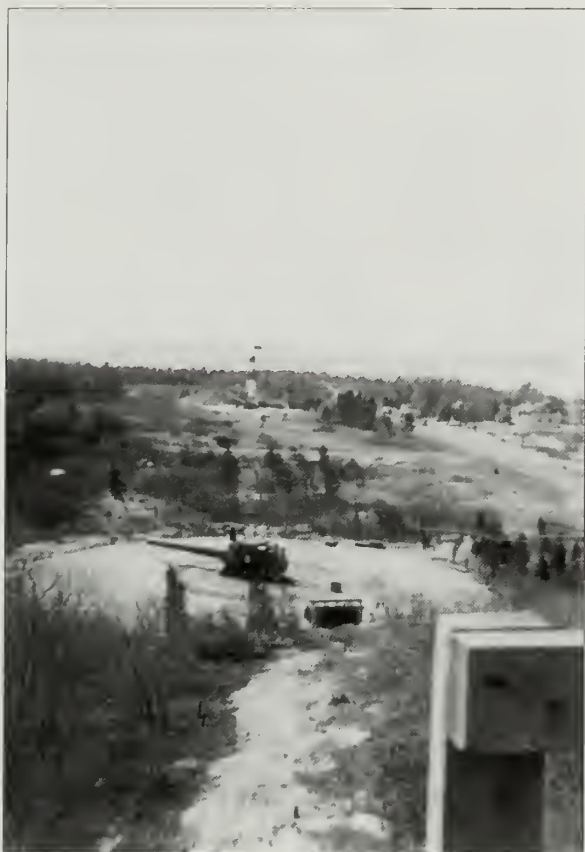
Figure 5.79. View looking north of gun emplacements at Batteries Kingman and Mills. Prior to 1941, the guns were emplaced on open platforms that permitted 360-degrees of rotation and firing. The north emplacement at Mills is in the foreground and beyond that the south emplacement at Kingman (GATE 938).

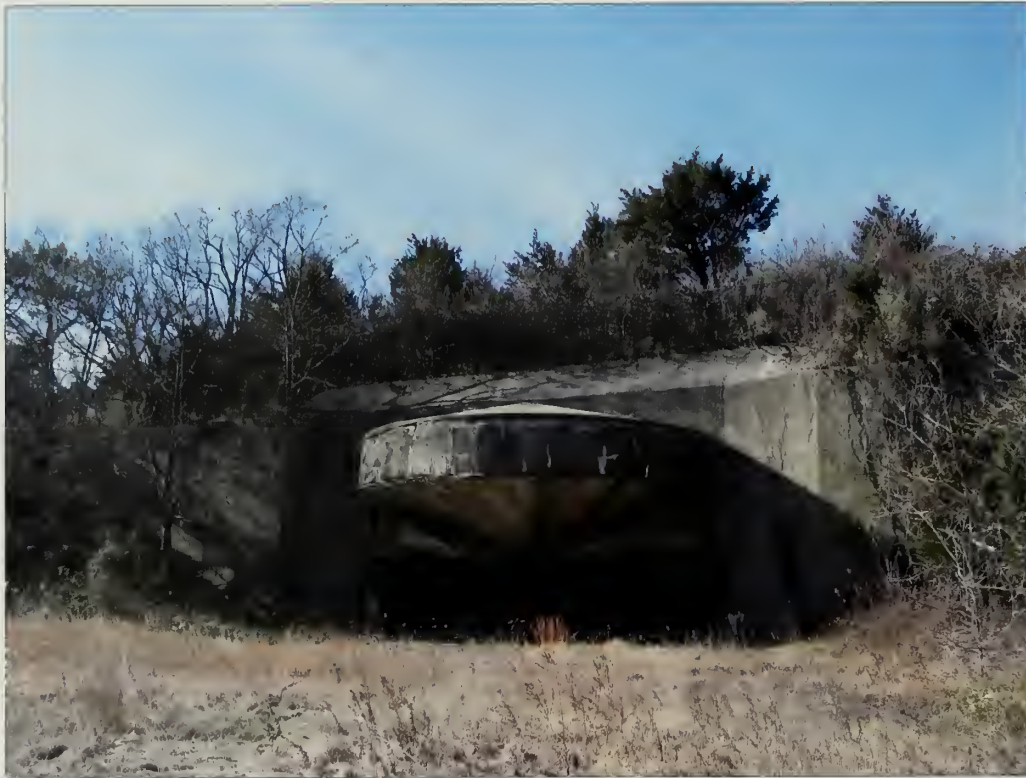
Figure 5.85. View looking southwest at north gun emplacement, Battery Kingman. Although visitors are warned of the hazards of accessing the summit of these batteries, existing chain-link fencing located above the concrete casemate canopies should be maintained for added safety at both Battery Kingman and Battery Mills (Olmsted Center, January 2009).

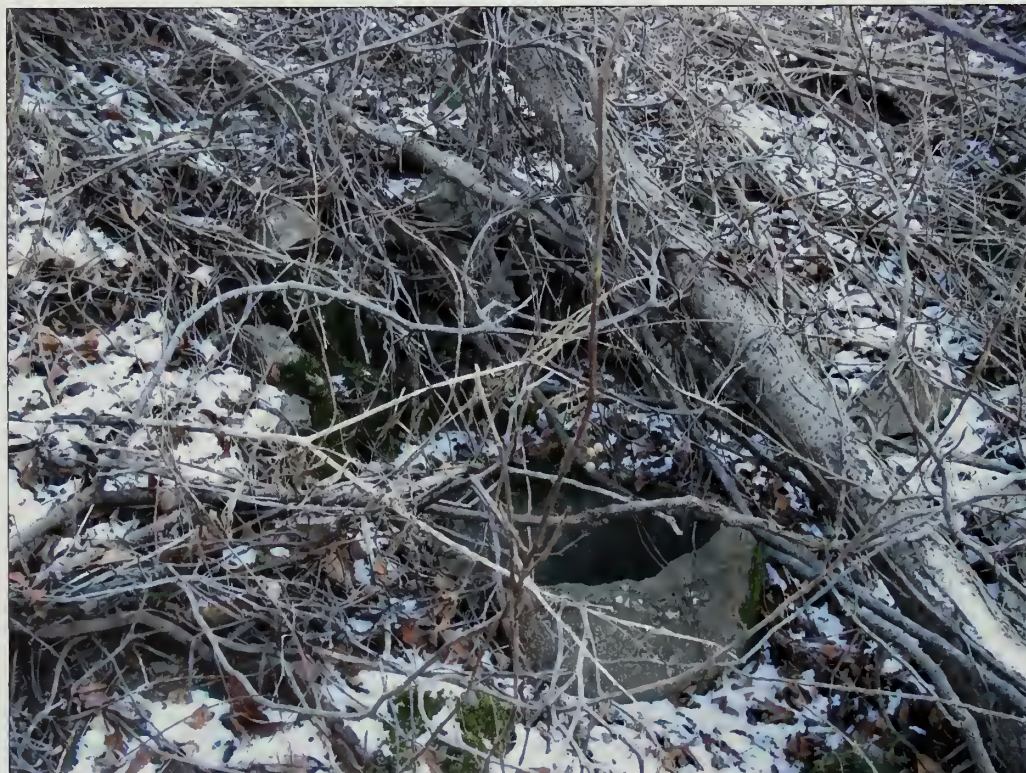
Figure 5.86. Concrete pipe on north slope of Battery Kingman. The concrete pipe should be capped to prevent possible injury and reduce water entering into or around the underground structures (Olmsted Center, January 2009).

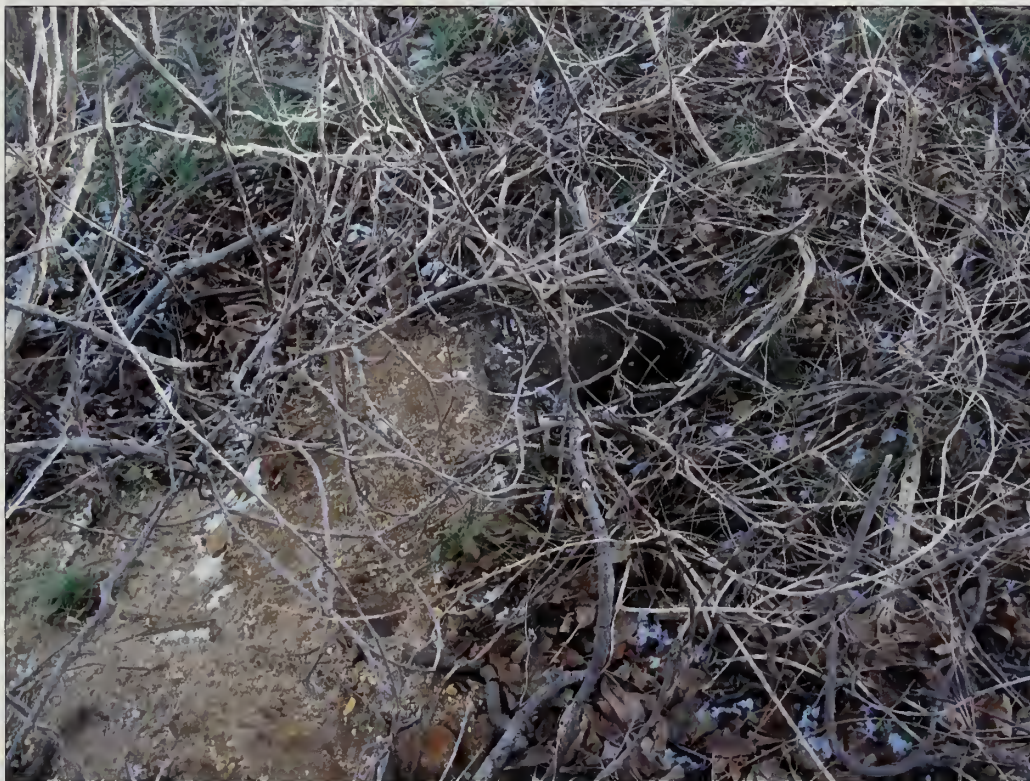
Figure 5.88. Animal burrow on north slope of Battery Kingman. The preferred management recommendation for burrowing animals is to humanely trap the animal and relocate it to an area away from the historic earthwork. The burrow should be filled with soil from a sterile source that does not have the potential to damage archaeological information (Olmsted Center, January 2009).

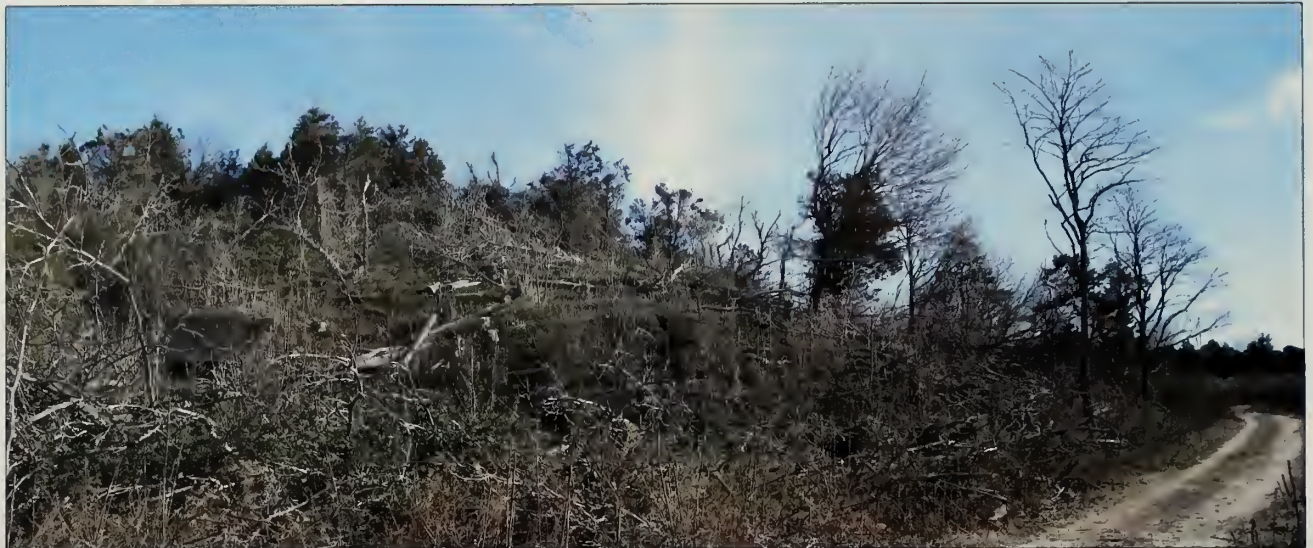
Figure 5.89. View looking east at southern end of Battery Mills. After recent cutting to manage invasive non-indigenous plant species, trunks, limbs, and other fallen debris were not removed. In order to safely and effectively permit future inspections and removals, the trunks and limbs have to be removed (Olmsted Center, January 2009).

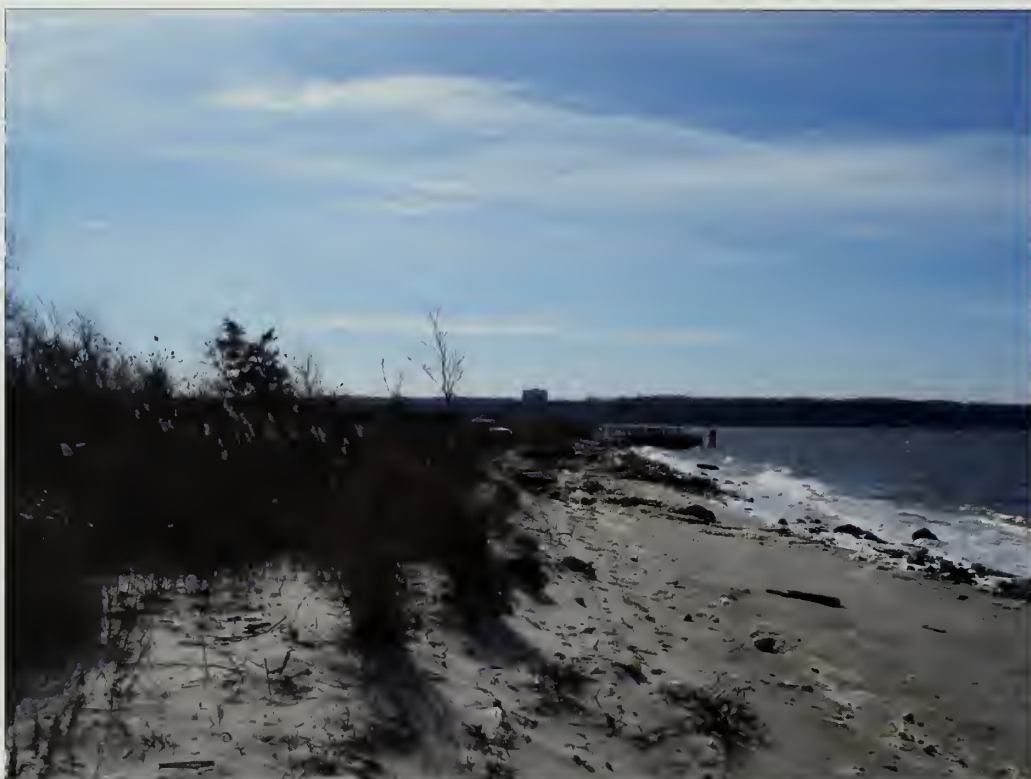
Figure 5.94. Eroded loop road on western side of Battery Mills. To better protect the concrete structures and historic earthworks of Battery Mills, randomly and loosely placed course stones should be installed at the toe of the battery's slope (Olmsted Center, January 2009).

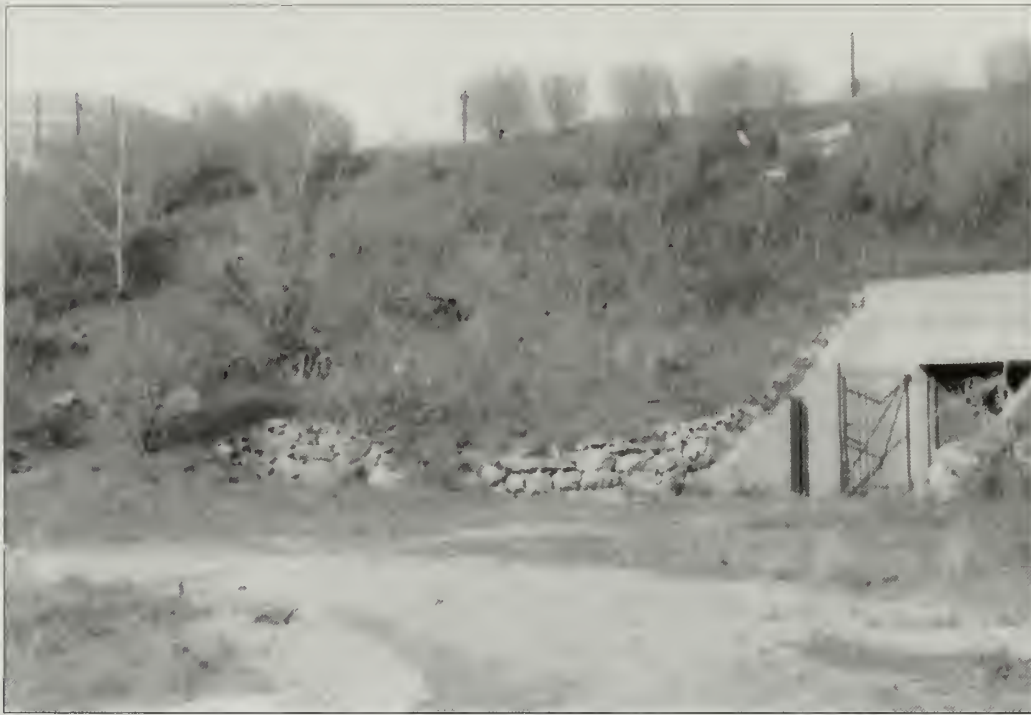
Figure 5.95. View looking northeast at the western side of Battery Mills, circa 1950s. Adding randomly and loosely placed course stones at the toe of the battery's slope would be consistent with a component of its historic appearance. This image shows a stacked stone wall near one of the battery's entries (GATE 20536).

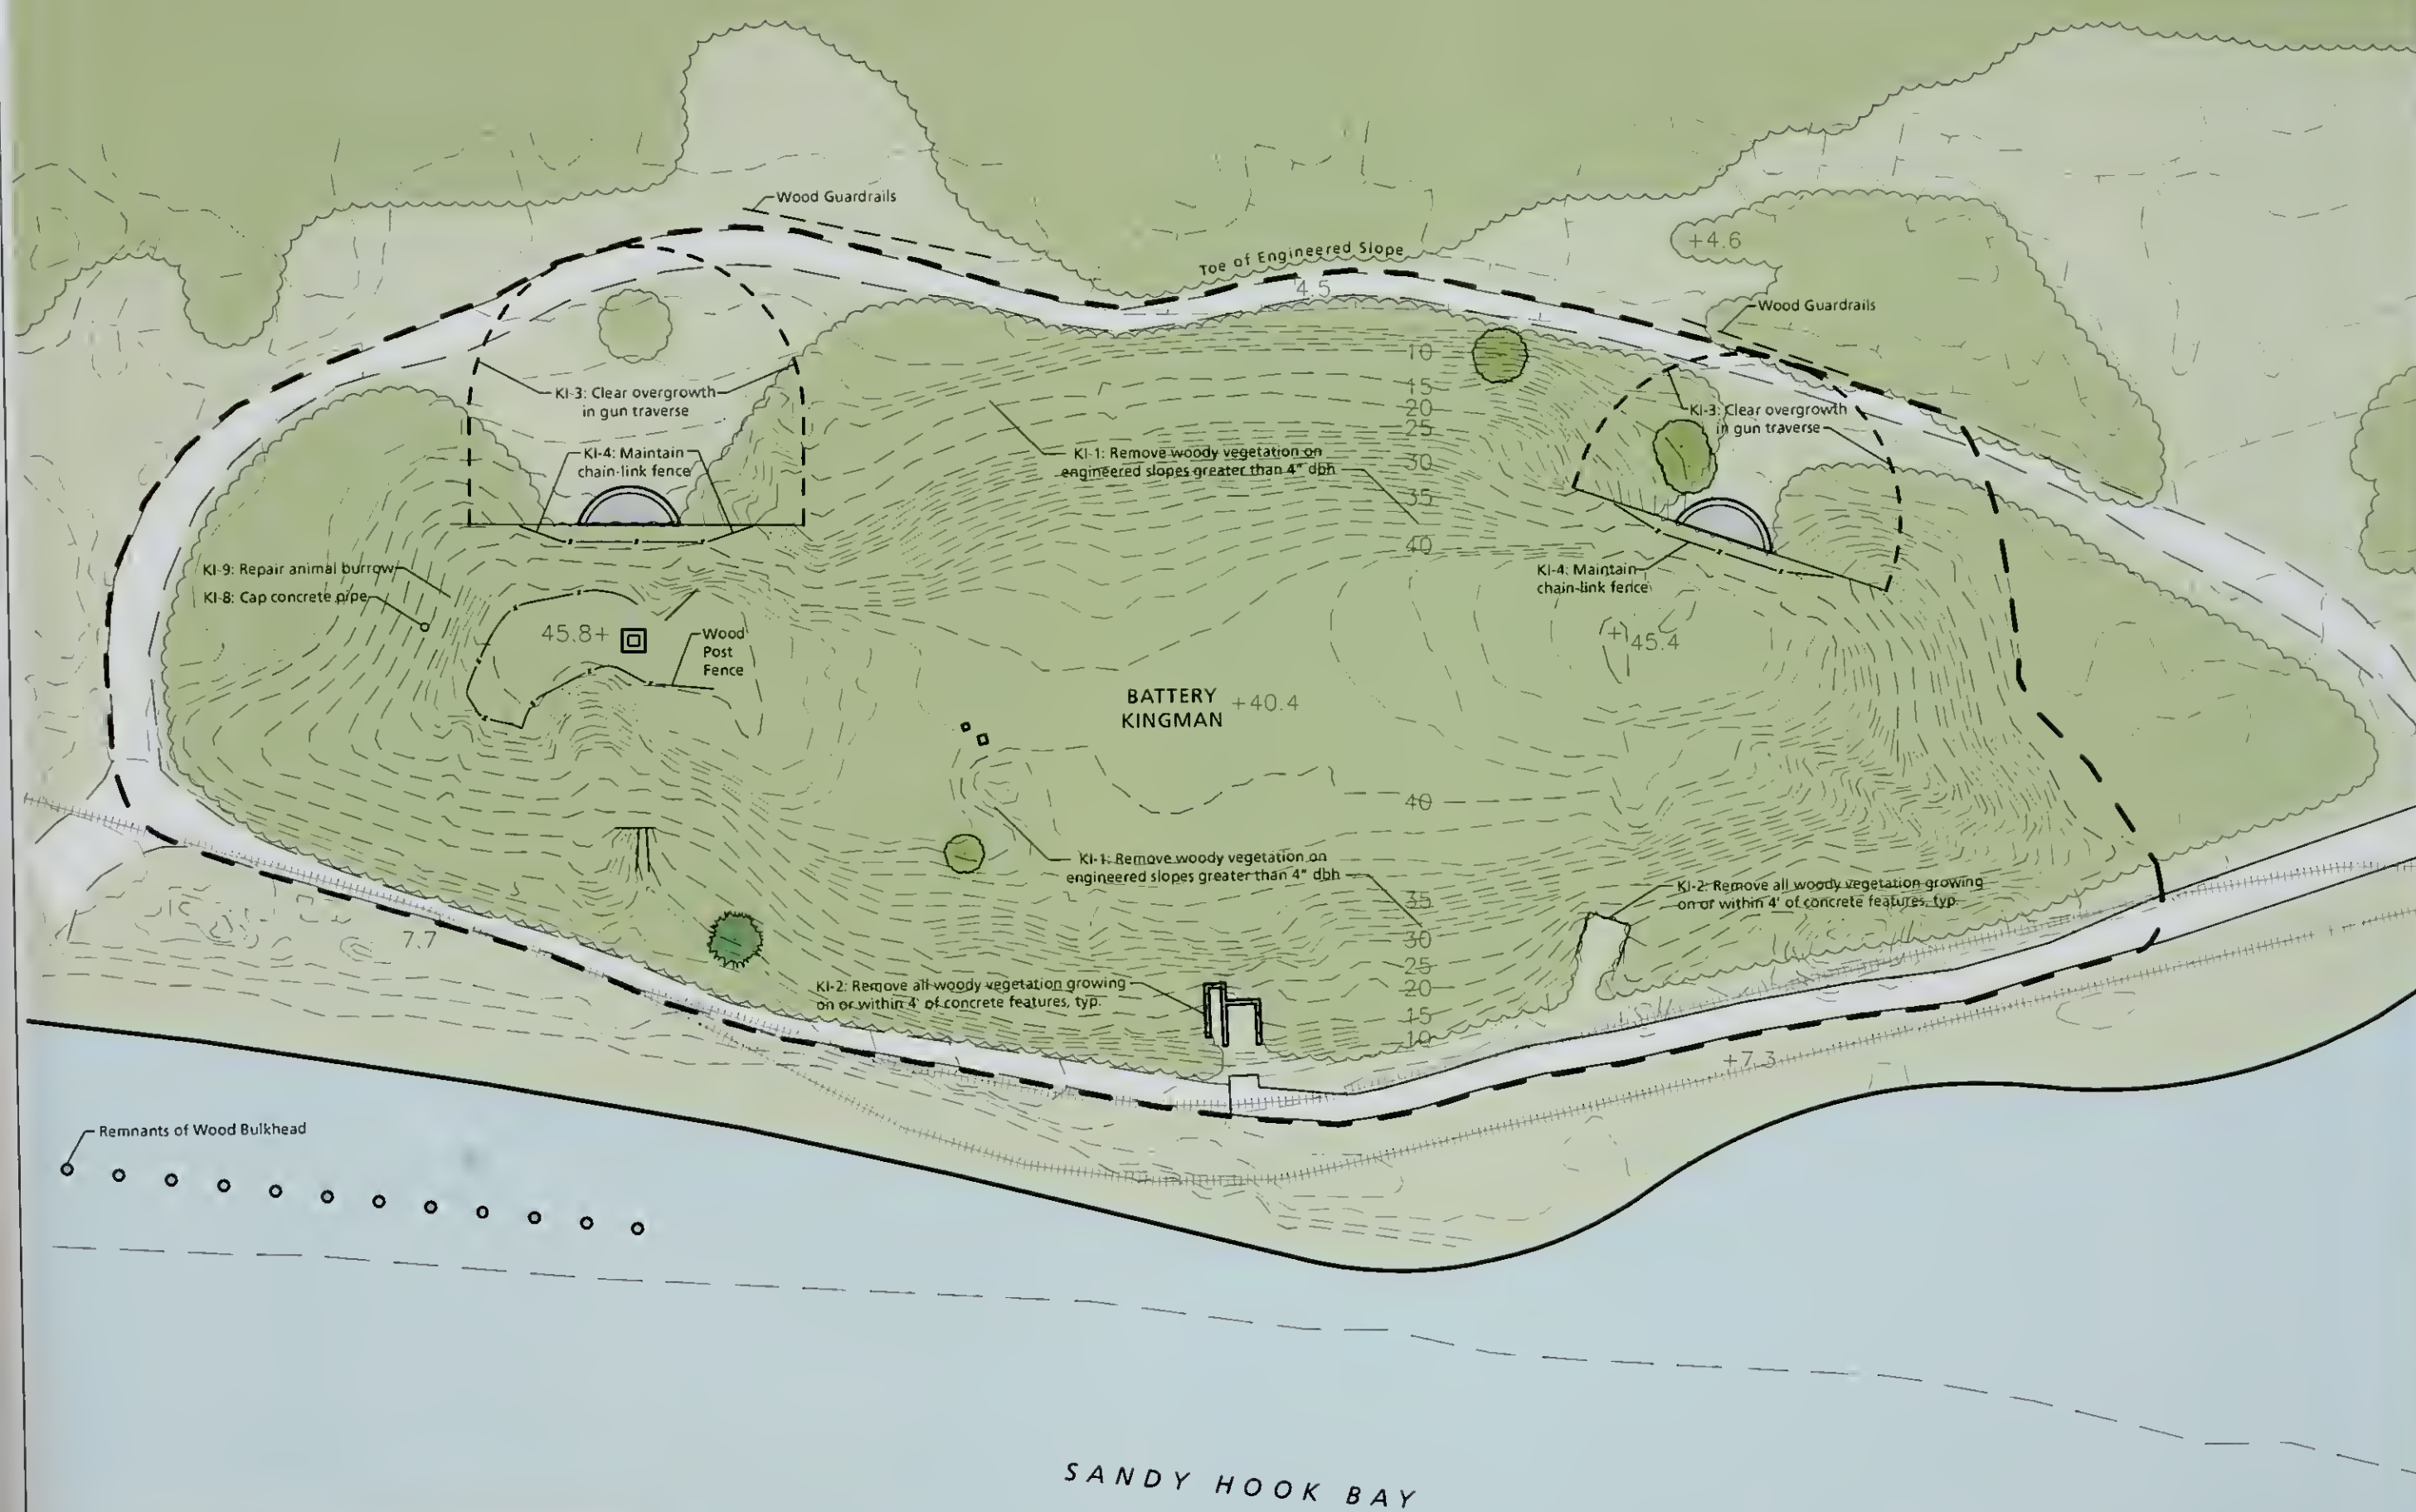
GENERAL NOTES FOR TREATMENT
 KI-5: Stabilize spalling concrete surfaces and repair cracks and voids
 KI-6: Repair and seal horizontal concrete surfaces to reduce water infiltration
 KI-7: Repair and repaint ferrous metal fixtures

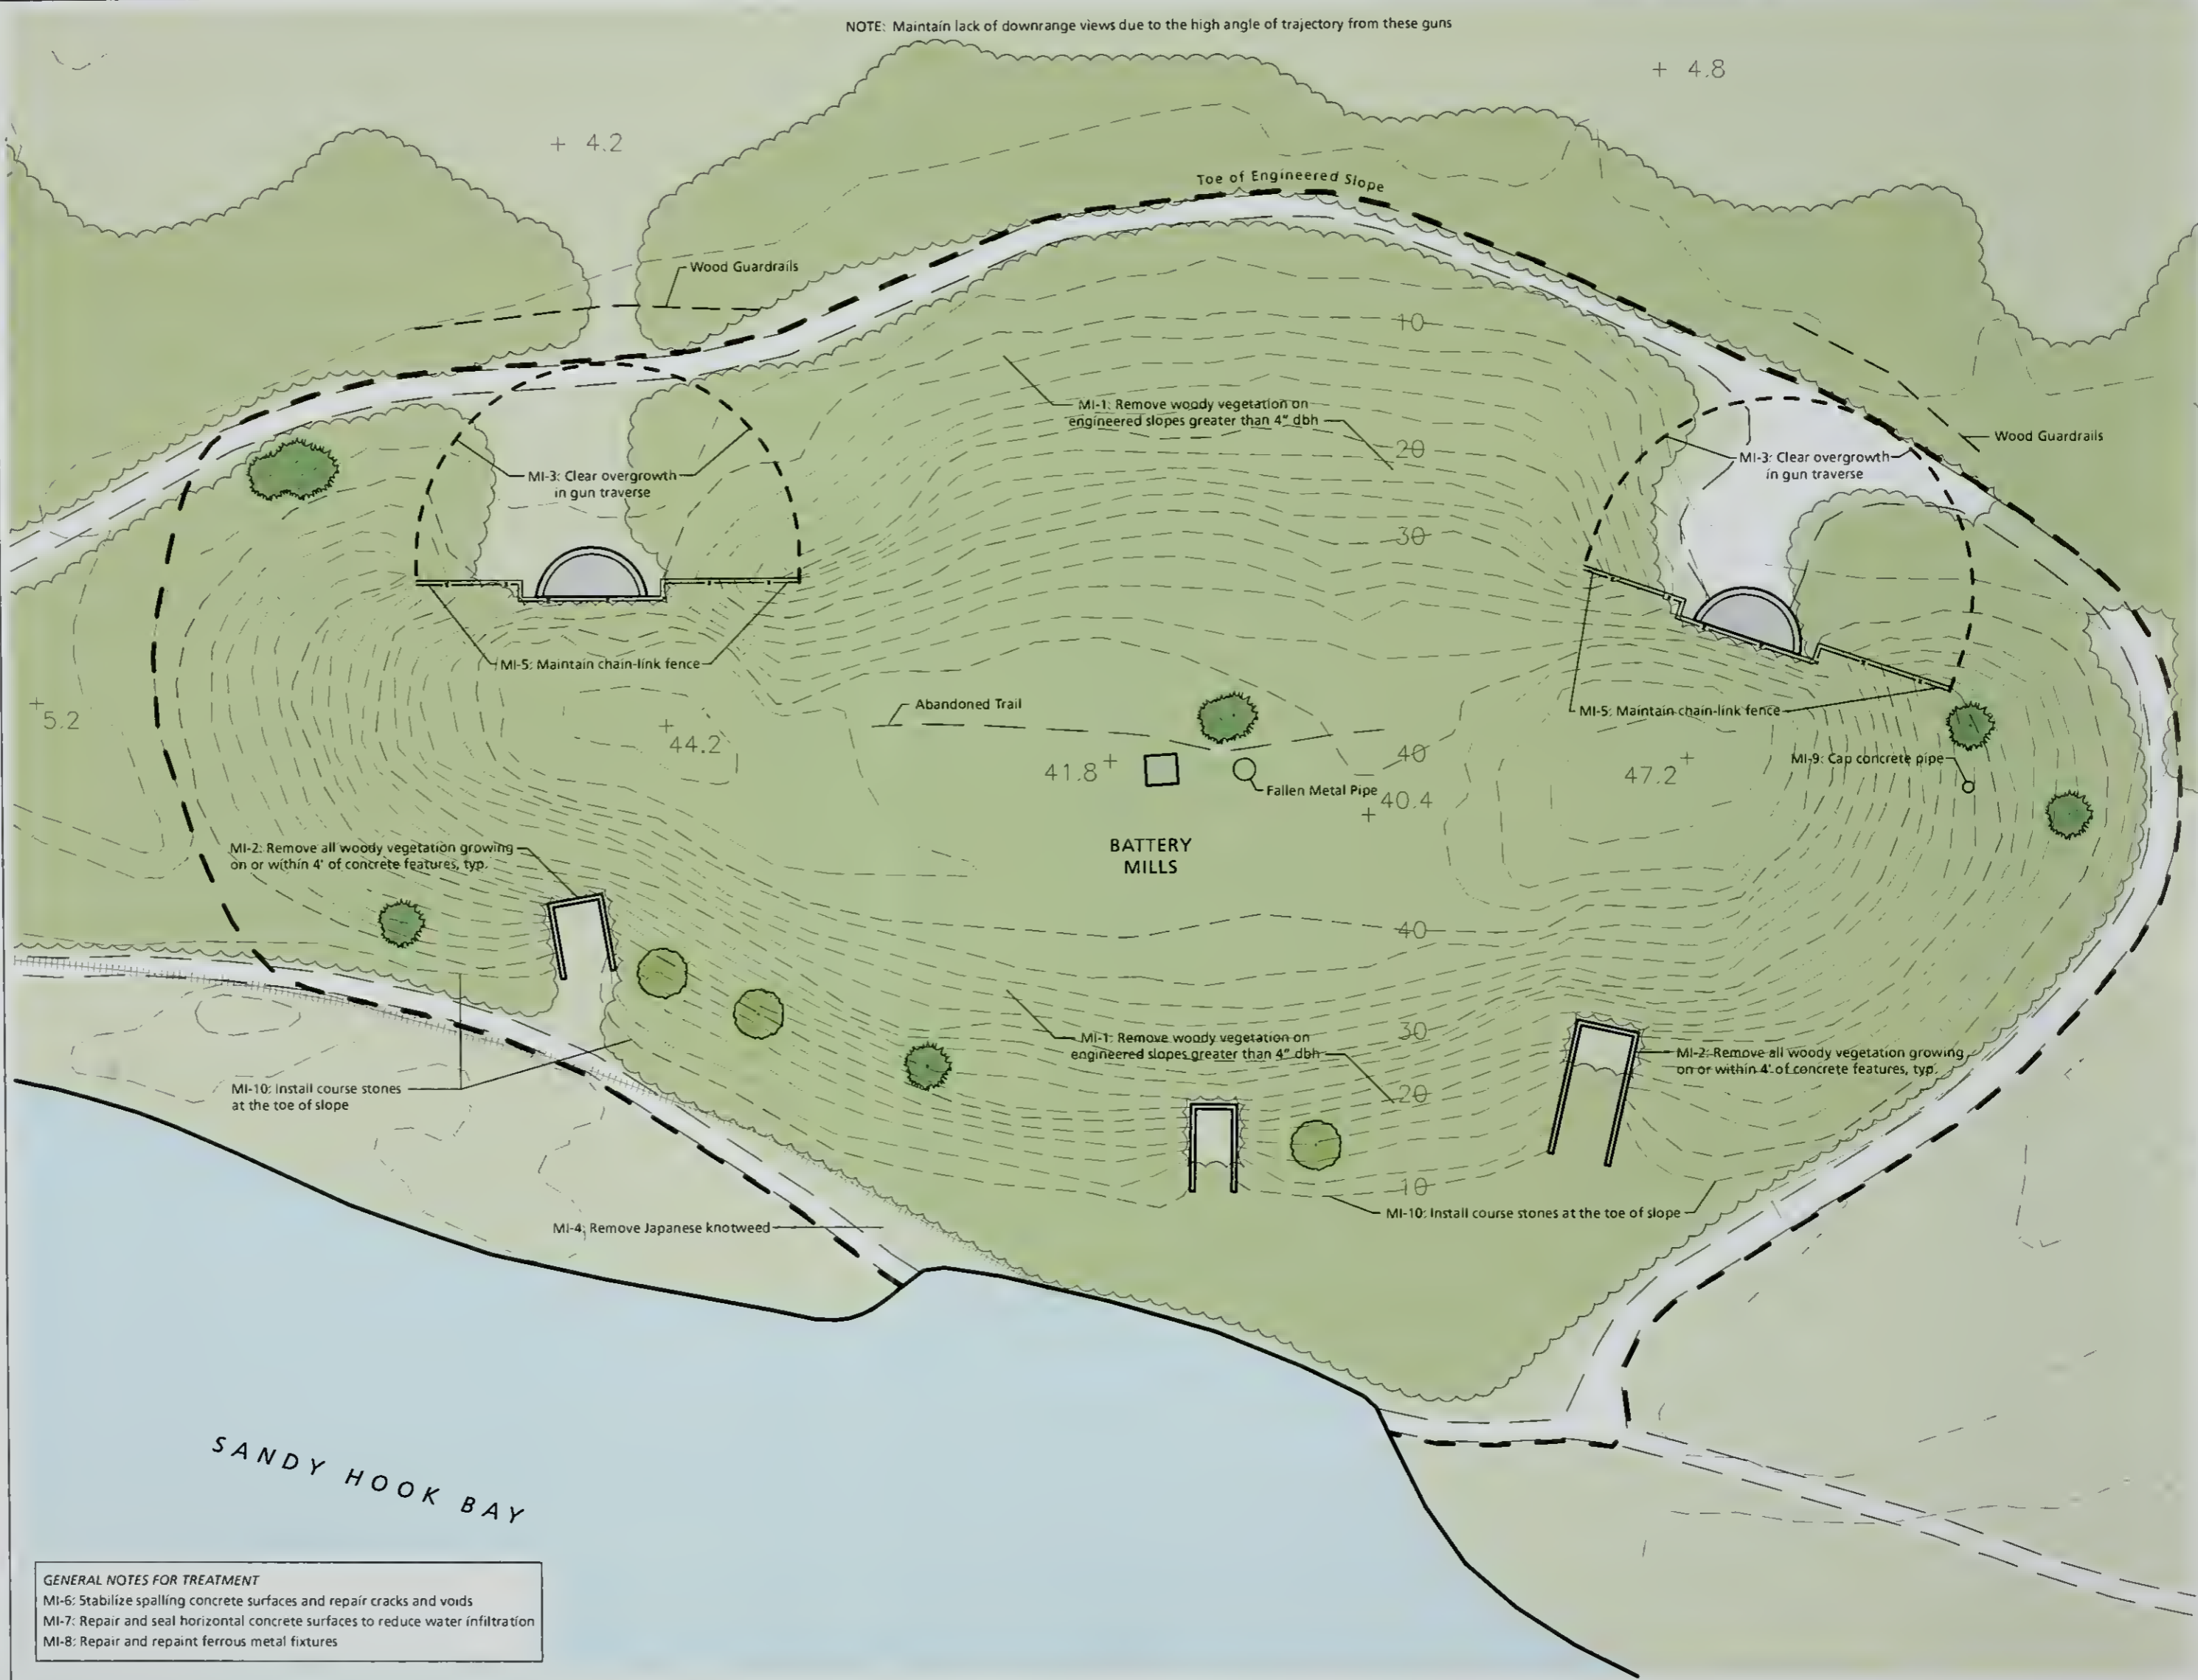
NOTE: Maintain lack of downrange views due to the high angle of trajectory from these guns

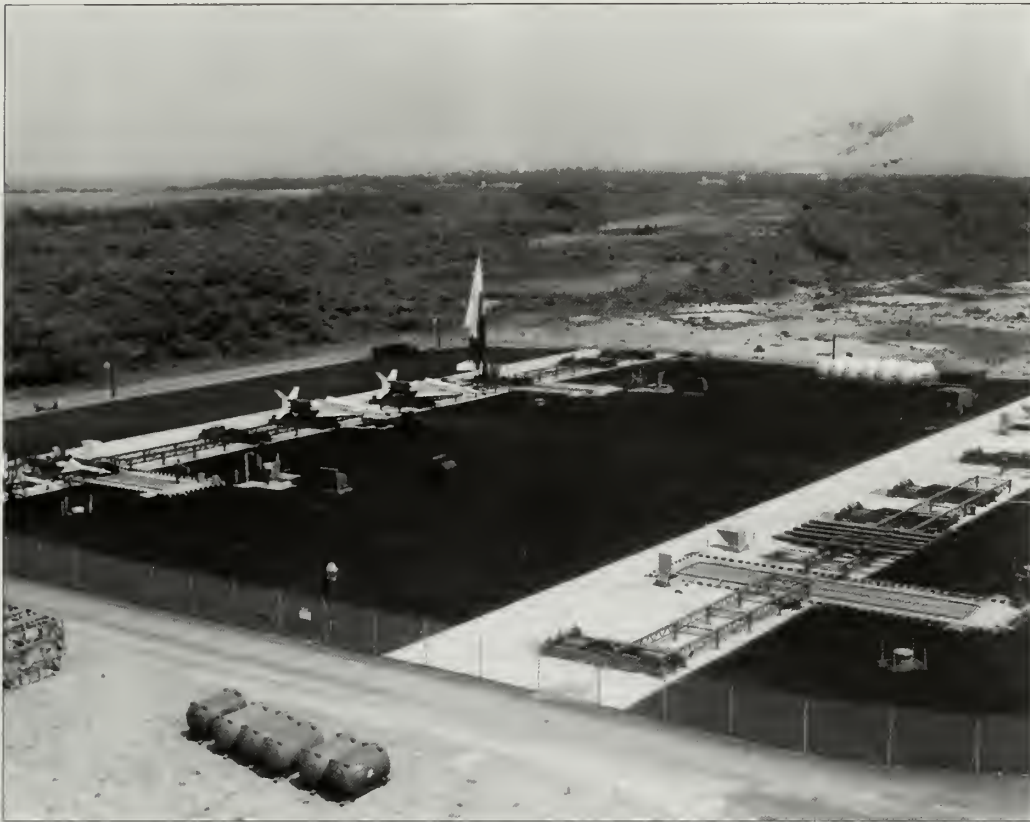
Figure 5.96. View looking northwest at the missile magazines, NIKE launch site, circa 1958. The inner fence surrounding the magazines completely lacked any trace of vegetation when the NIKE facility was operational (GATE 8067).
