I 29.86/4.5 A 5

Clemson University

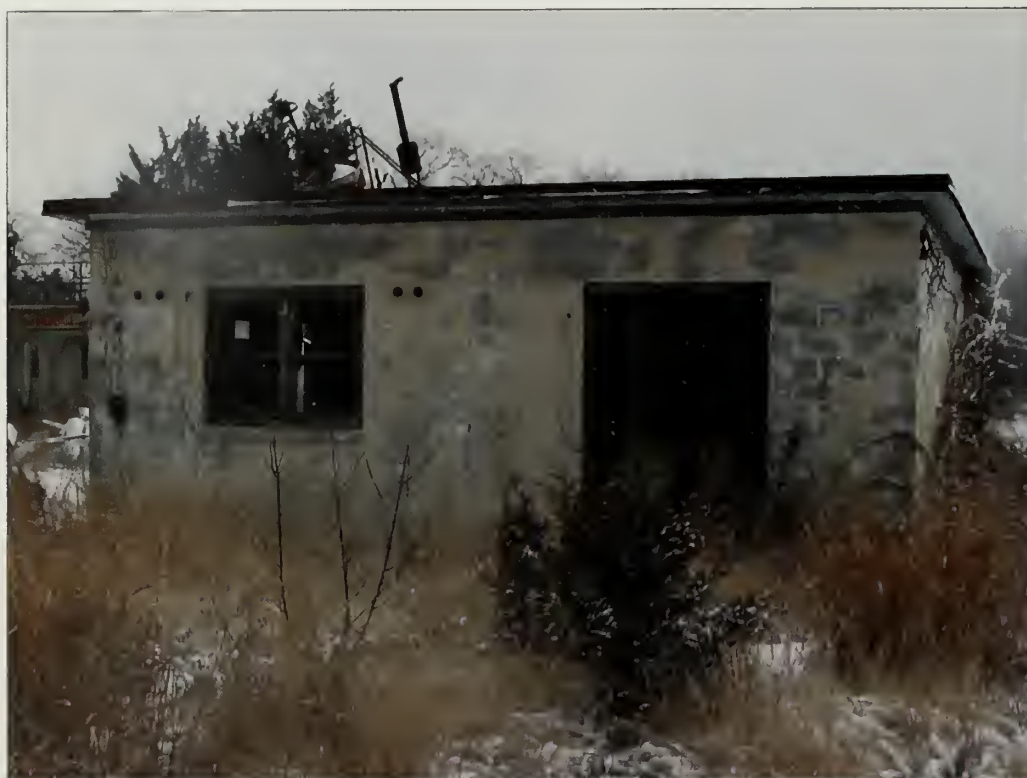
Figure 5.98. View looking southeast at the Generator Building (414), Control Area #1, NIKE radar site. The buildings and structures in the radar site show signs of deterioration in specific building materials that include metal, concrete block, and corrugated siding and roofing. Due to damaged windows and doors, the Generator Building lacks a closed building envelope exposing the interior to water and seasonal temperature fluctuations that advance deterioration (Olmsted Center, January 2009).

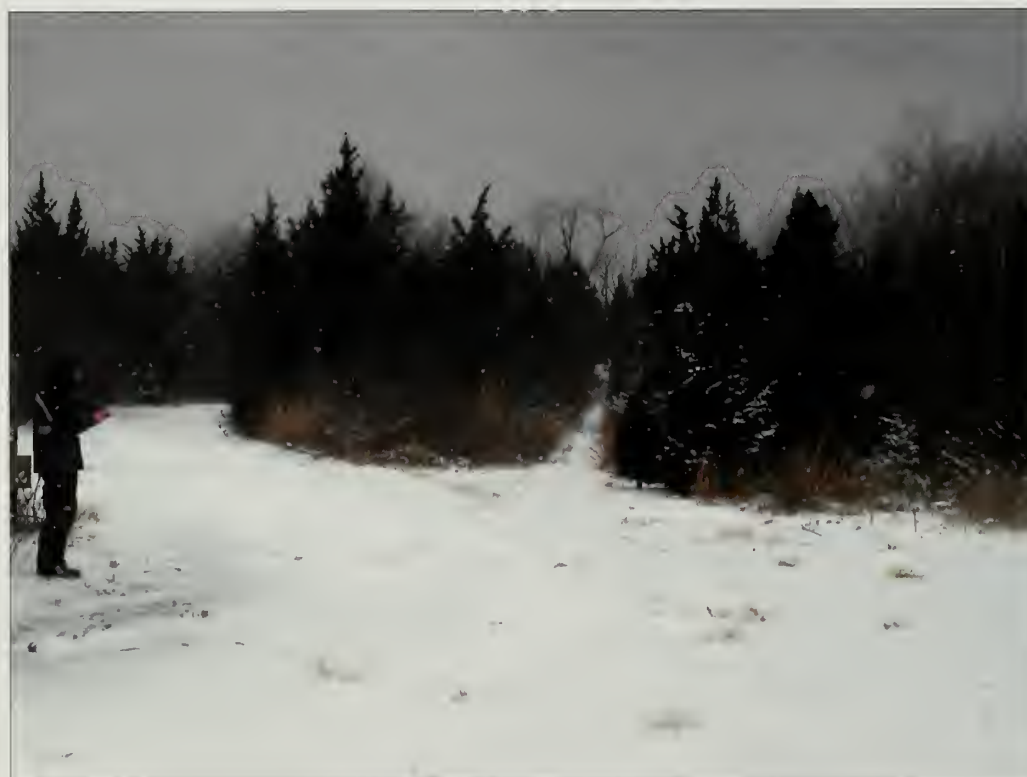
Figure 5.99. View looking northwest at pedestrian walkway, Control Area #1, NIKE radar site. Following the site's closure woody species, especially eastern red cedars, have emerged and are encroaching on pedestrian circulation features as well as buildings and the perimeter fence (Olmsted Center, January 2009).

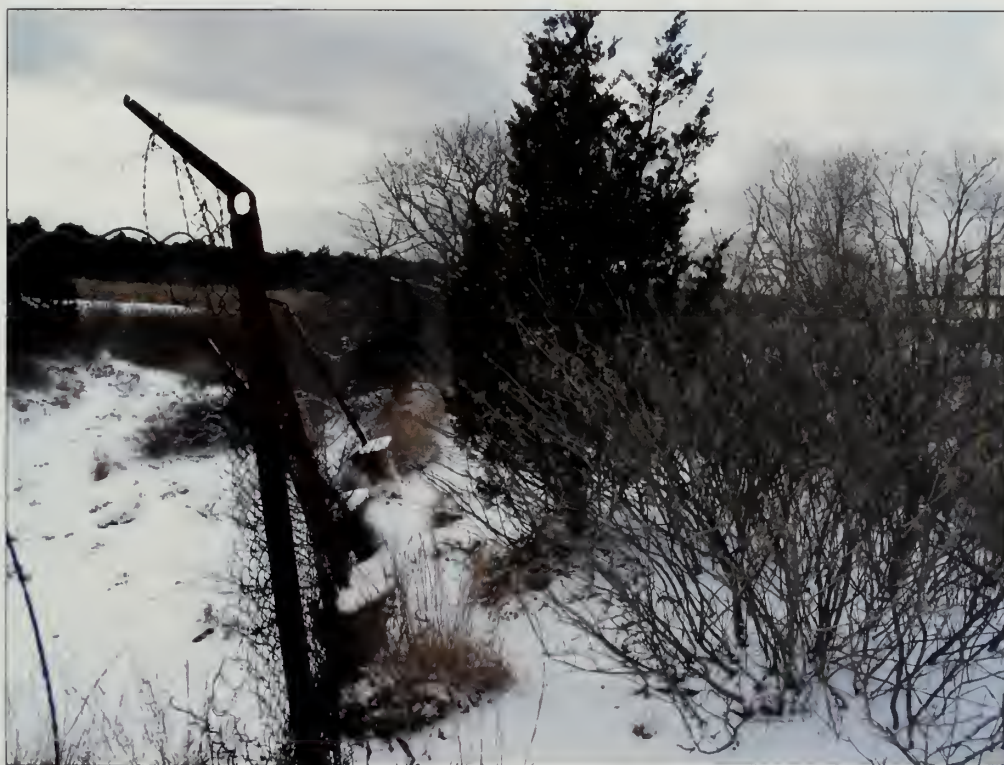
Figure 5.105. Existing perimeter fence, NIKE launch site. The existing perimeter fence at the radar and launch sites should be clearly delineated and maintained by removing all woody vegetation a minimum of four-feet off either side of the fence. The vegetation removals will also aid in inspection and repairs of the existing fence (Olmsted Center, January 2009).

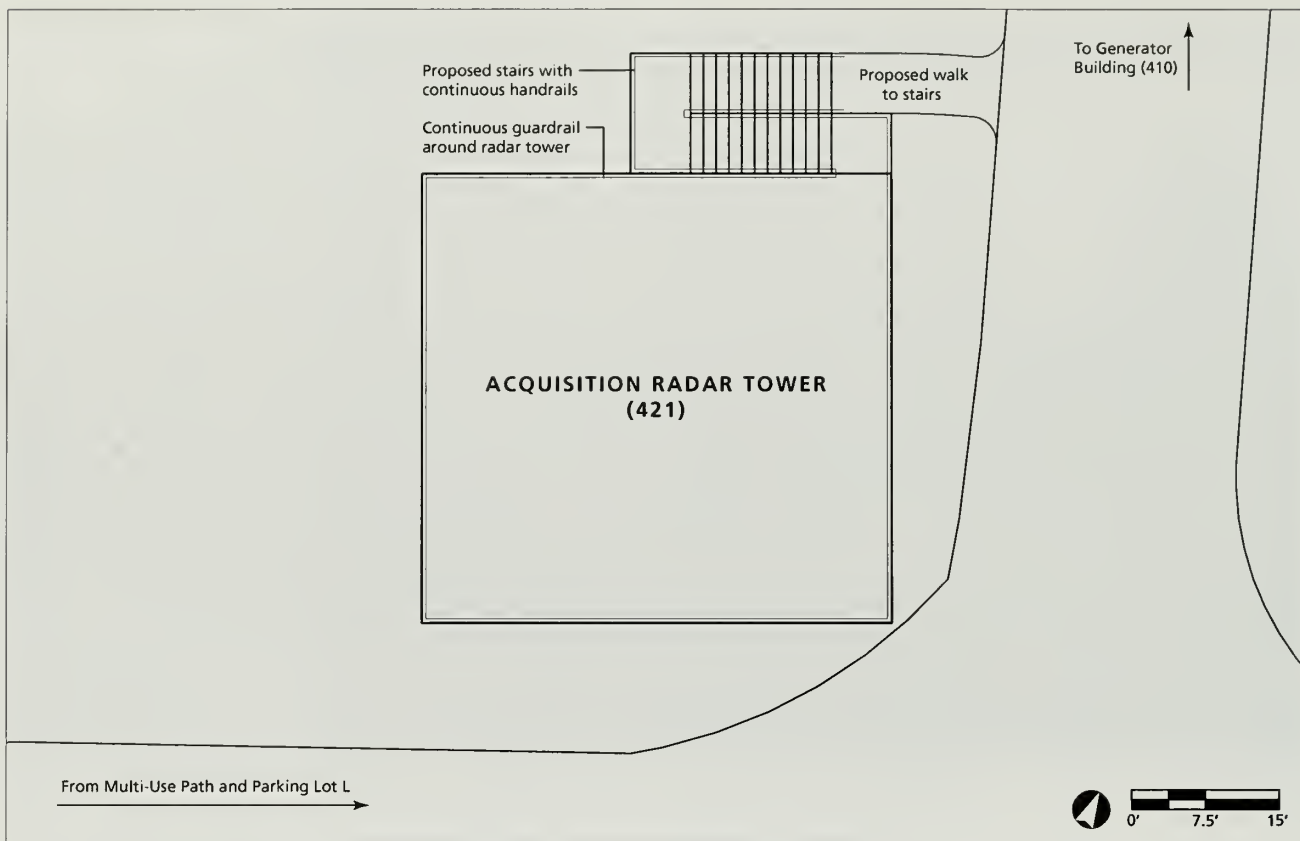
Figure 5.106. Plan of proposed access stairs to acquisition radar tower (Building 421), NIKE radar site. The proposed stairs should be located on the north side of the platform where they will be less conspicuous for visitors viewing the site from the parking lot and multi-use path to the west (Olmsted Center, 2009).

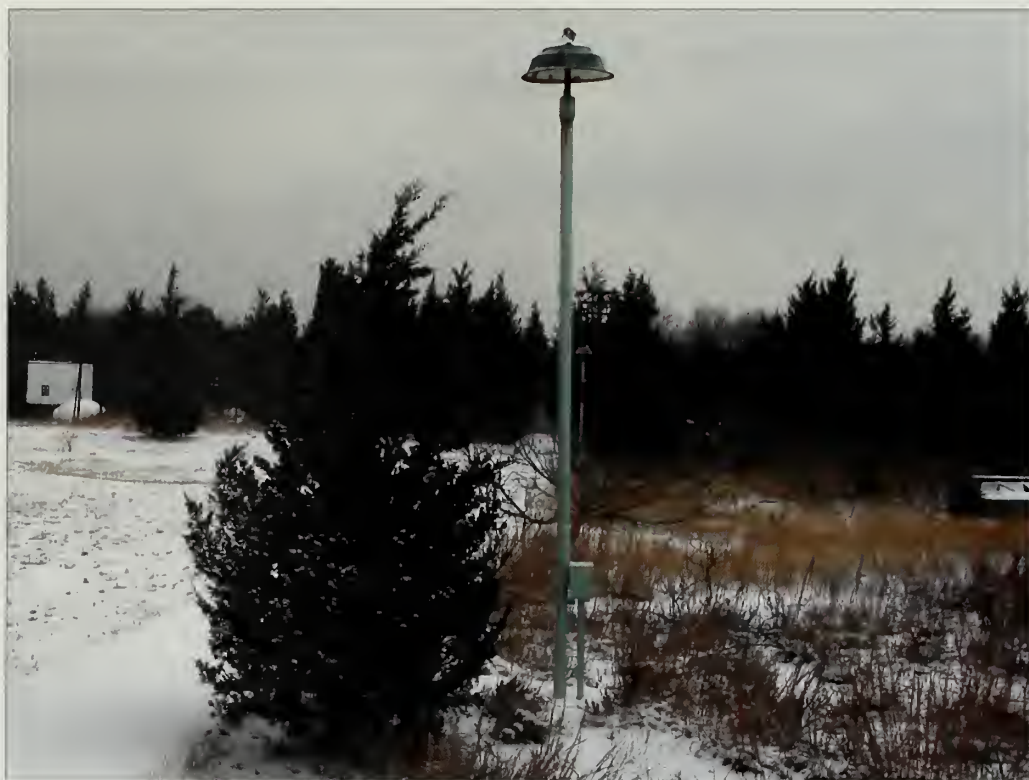
Figure 5.110. Existing light fixture, NIKE radar site. The historic light fixtures should be periodically inspected, have components repaired or replaced as needed, and receive corrosion treatment, priming, and painting to match the historic finish. The eastern red cedar in the foreground should be removed as part of vegetation management along the circulation systems (Olmsted Center, January 2009).

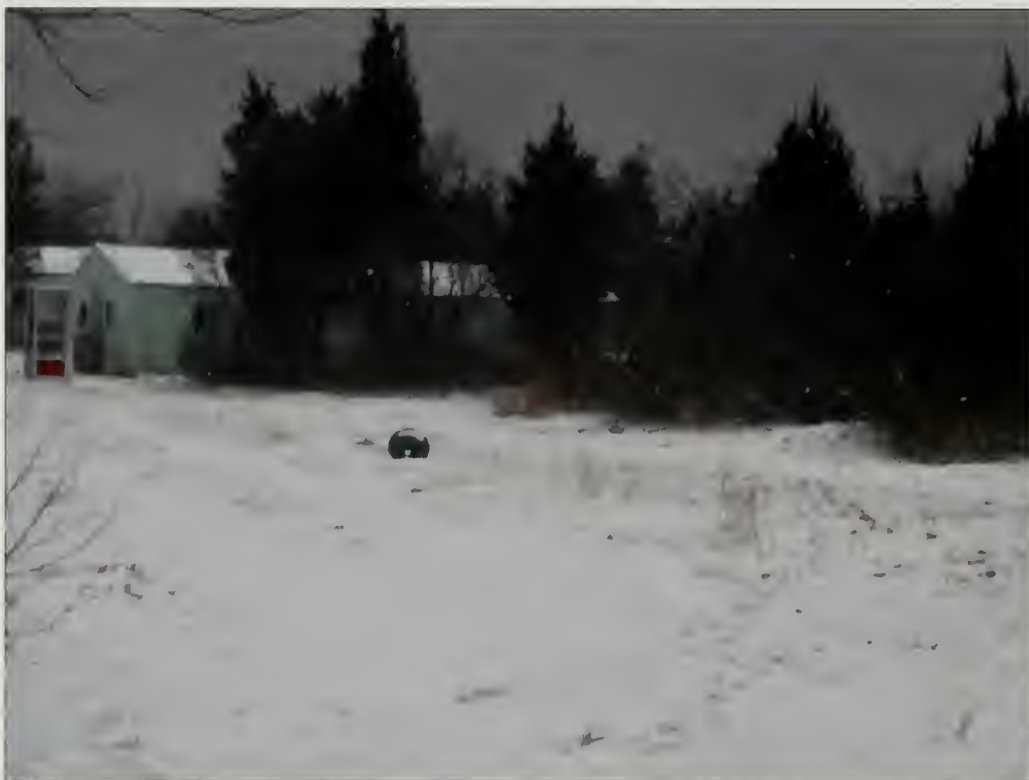
Figure 5.111. Existing light fixture between building 404 and 405, NIKE radar site. The fallen fixture should be reset and will most likely require a new concrete footing and tubular pole. The new pole should match the existing in material, dimensions, and finishing. The fixture's other components should be inspected at this time and repaired or replaced based on their condition (Olmsted Center, January 2009).

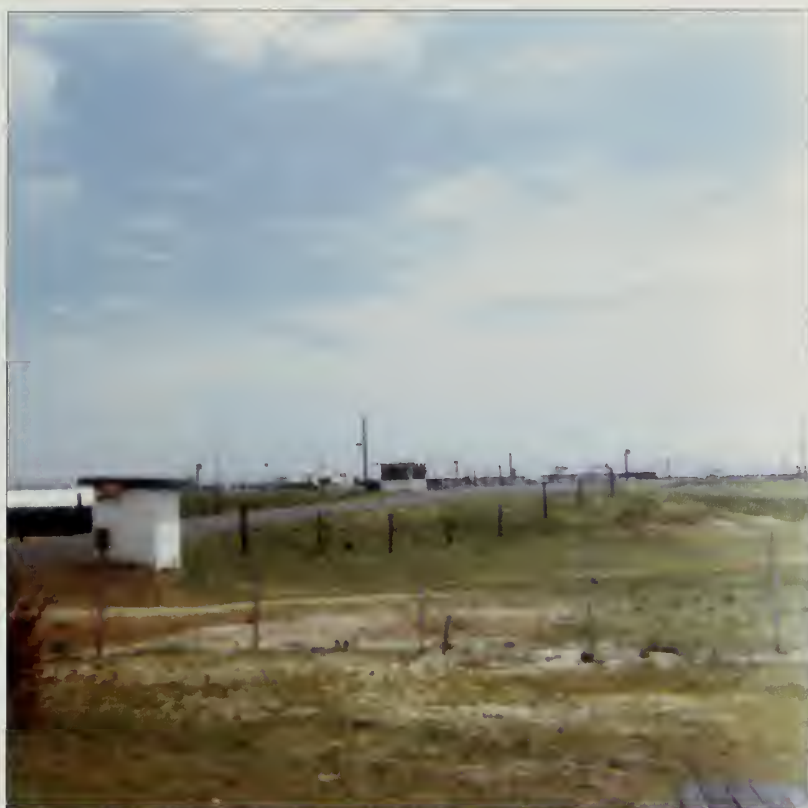
Figure 5.112. View looking northeast at the missile magazines, NIKE launch site, circa 1968. The vehicular connection between the Ready Barracks and the Missile Magazines and Missile Maintenance Area to the east was maintained on either side with a turf mixture (GATE 22041).

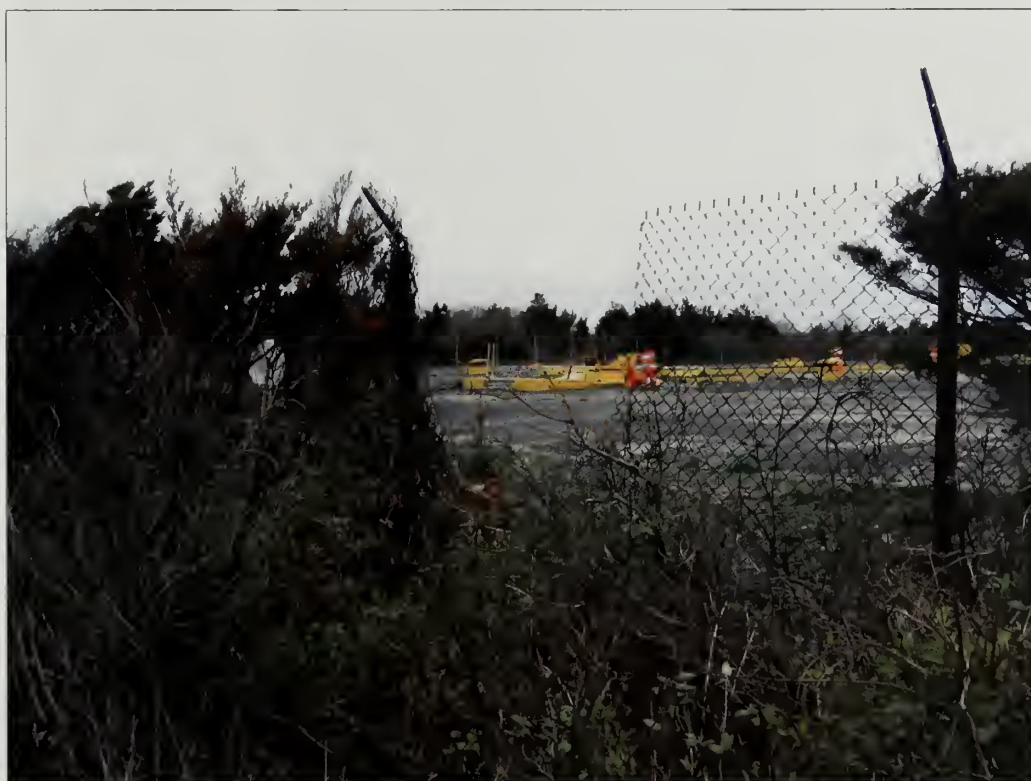
Figure 5.117. View looking east at the missile magazines, NIKE launch site. In contrast to the historic image, extensive vegetation has grown up between the inner fence and perimeter road around the magazines. The dense vegetation will impede repairs to the historic fence (Olmsted Center, April 2008).

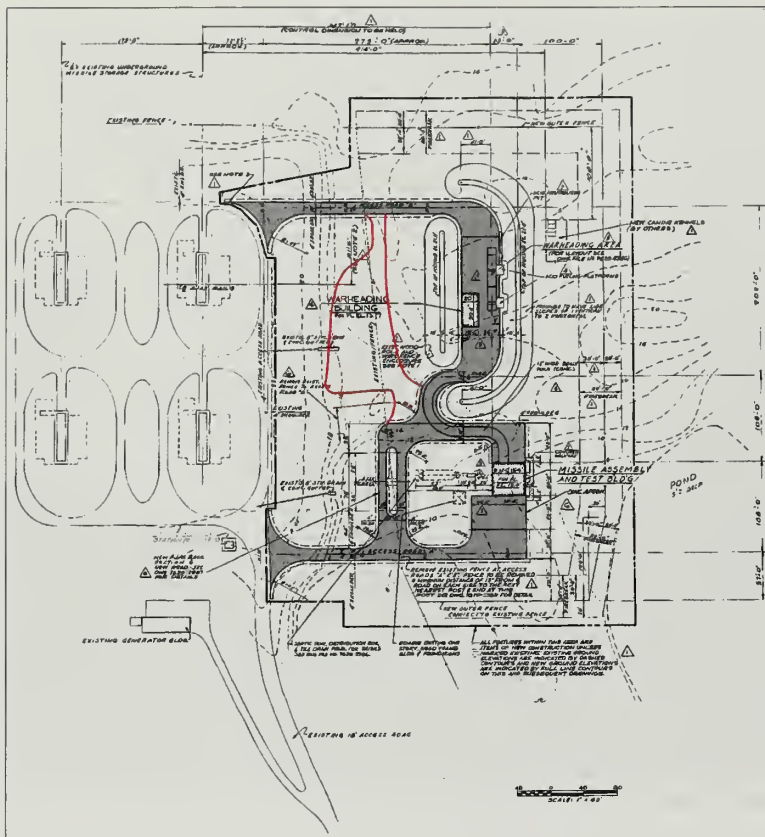
Figure 5.118. Site plan for Missile Maintenance Area, 1958. The gray tone has been added to show vehicular circulation. The current location for beach cleaning equipment (red outline) should be relocated to restore an area that was never intended for vehicular use (GATE 7620-2983 and Olmsted Center).

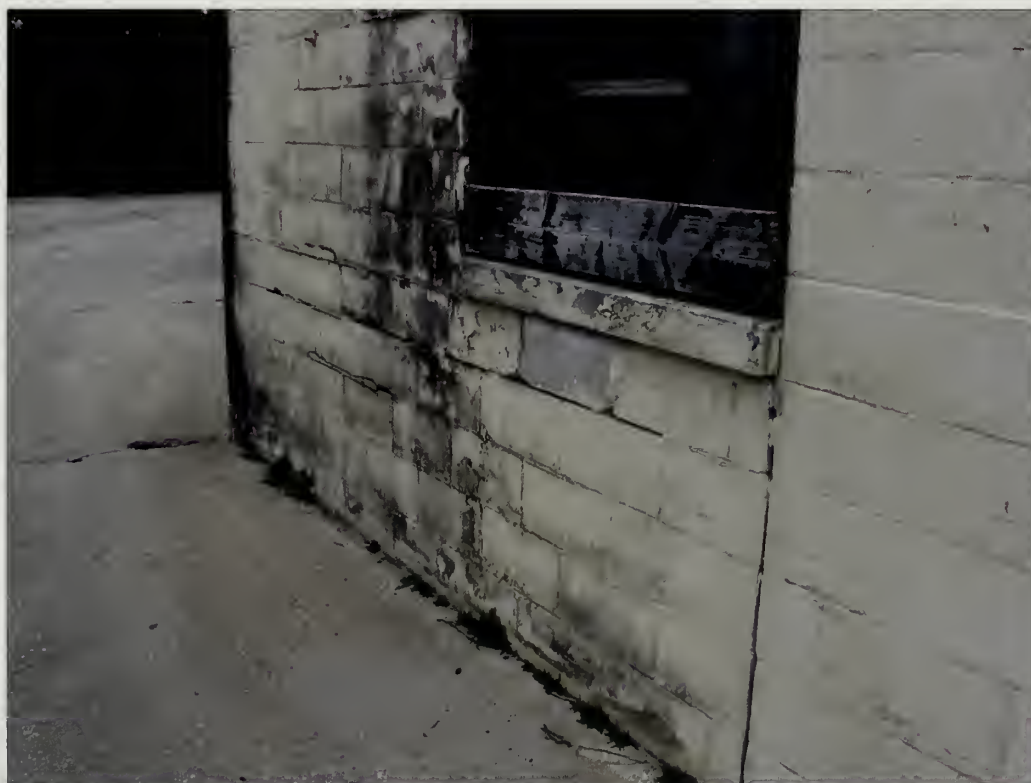
Figure 5.121. View looking northwest at Warhead Building (450), NIKE launch site. Routine maintenance procedures will help stabilize free-standing buildings in the launch site. The water damage seen in this image originates from a metal gutter mounted at the top of the wall that needs to be cleaned and reset so water is carried away from the building (Olmsted Center, April 2008).

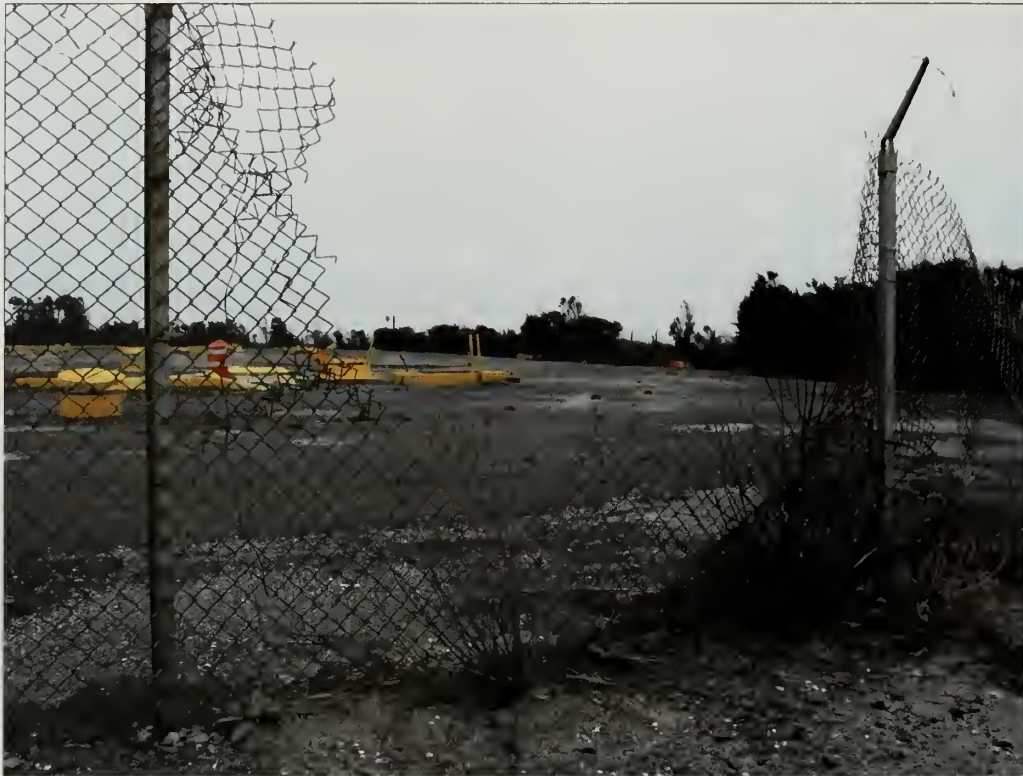
Figure 5.122. View looking northeast across missile magazines, NIKE launch site. After vegetation removals the inner, outer, and kennel fences should be inspected, repaired where needed, and replaced where damaged or severely deteriorated (Olmsted Center, April 2008).

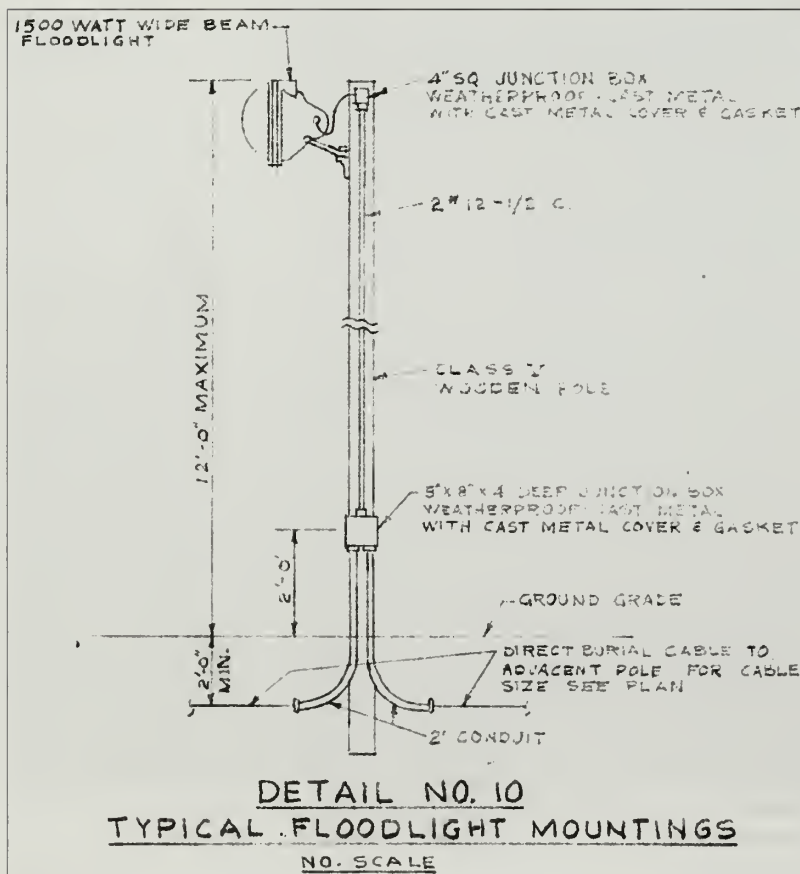
Figure 5.123. Elevation of floodlight, NIKE launch site, 1958. The poles, mounting hardware, light fixtures, and glass lenses should be routinely inspected. Any deficiencies should be corrected and damage components should be replaced to match the existing (GATE 11056).

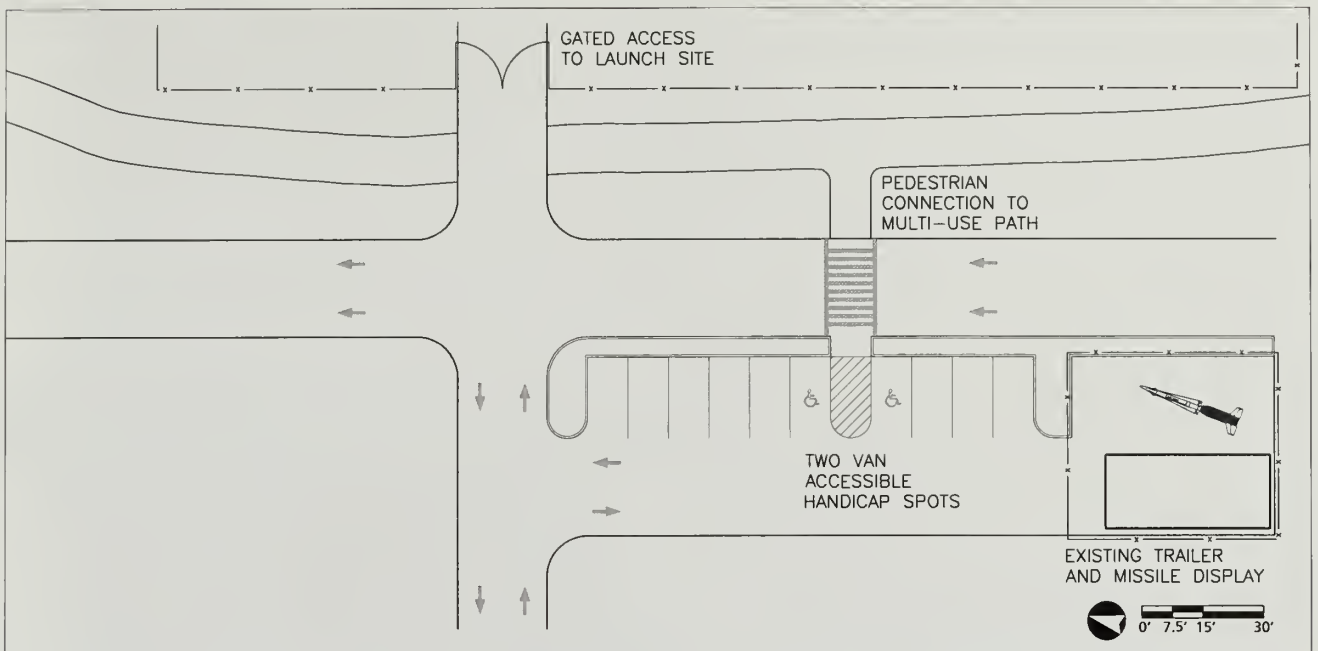
Figure 5.124. Plan for reconfigured visitor parking lot, NIKE launch site. The existing parking lot should be reconfigured to provide handicap accessible parking, a pedestrian crosswalk across Hartshorne Drive, and access to the site via the existing multi-use path (Olmsted Center, 2009).

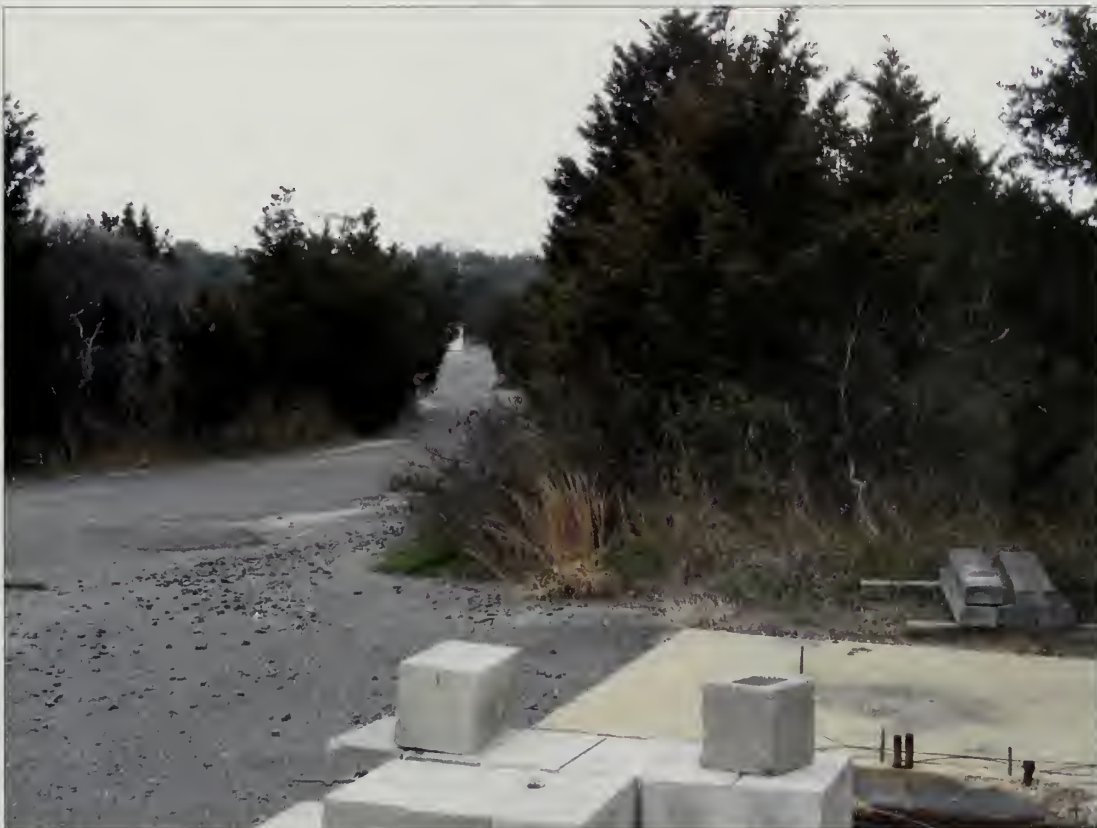
Figure 5.125. View looking northwest toward the Ready Barracks, NIKE launch site. The sentry hut near the missile magazines should be reconstructed as part of plans to prepare the site for visitor access and interpretation. The concrete foundation for the hut is visible in the right foreground (Olmsted Center, April 2008).

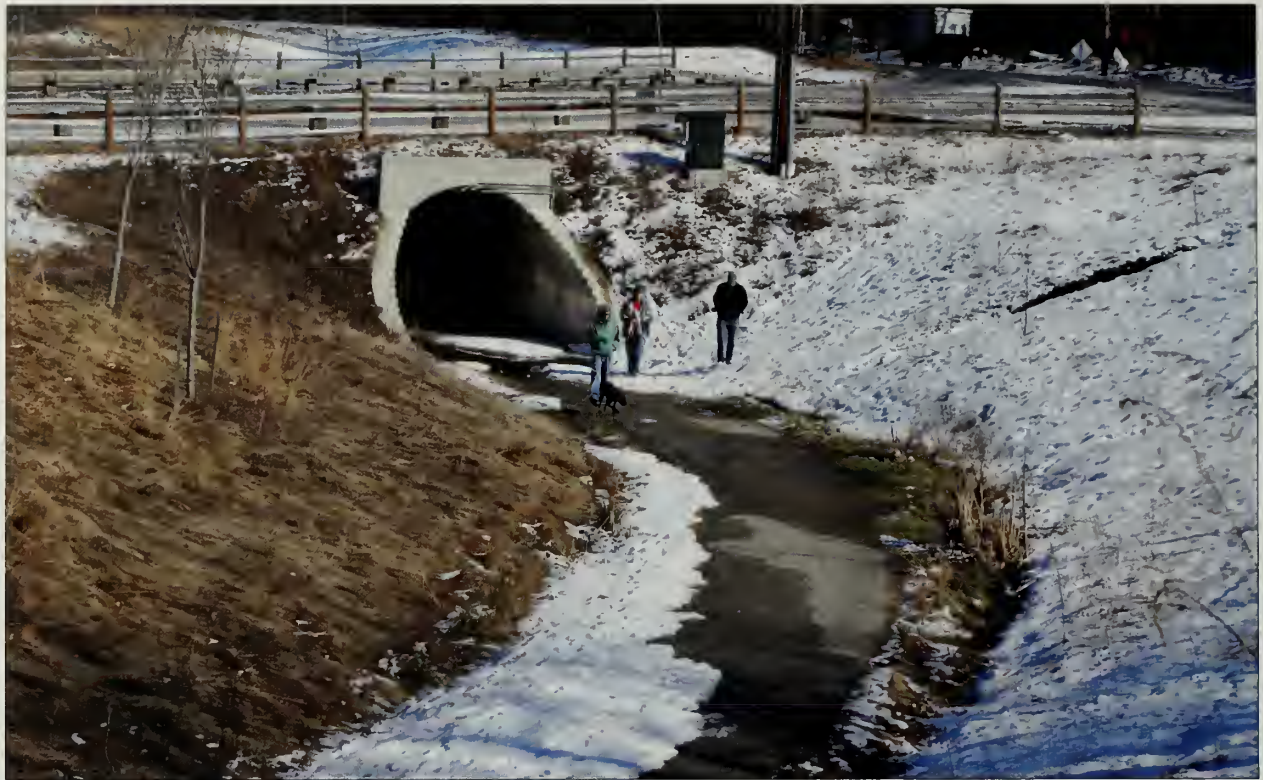
Figure 5.126. Example of a cut and cover tunnel routing the park "Battle Road Trail" below Hanscom Drive, Minute Man National Historical Park. This type of tunnel, installed from prefabricated segments, is under consideration to provide visitor access to one of Sandy Hook's subsurface NIKE missile magazine rooms (January 2009, Minute Man NHP, Massachusetts).

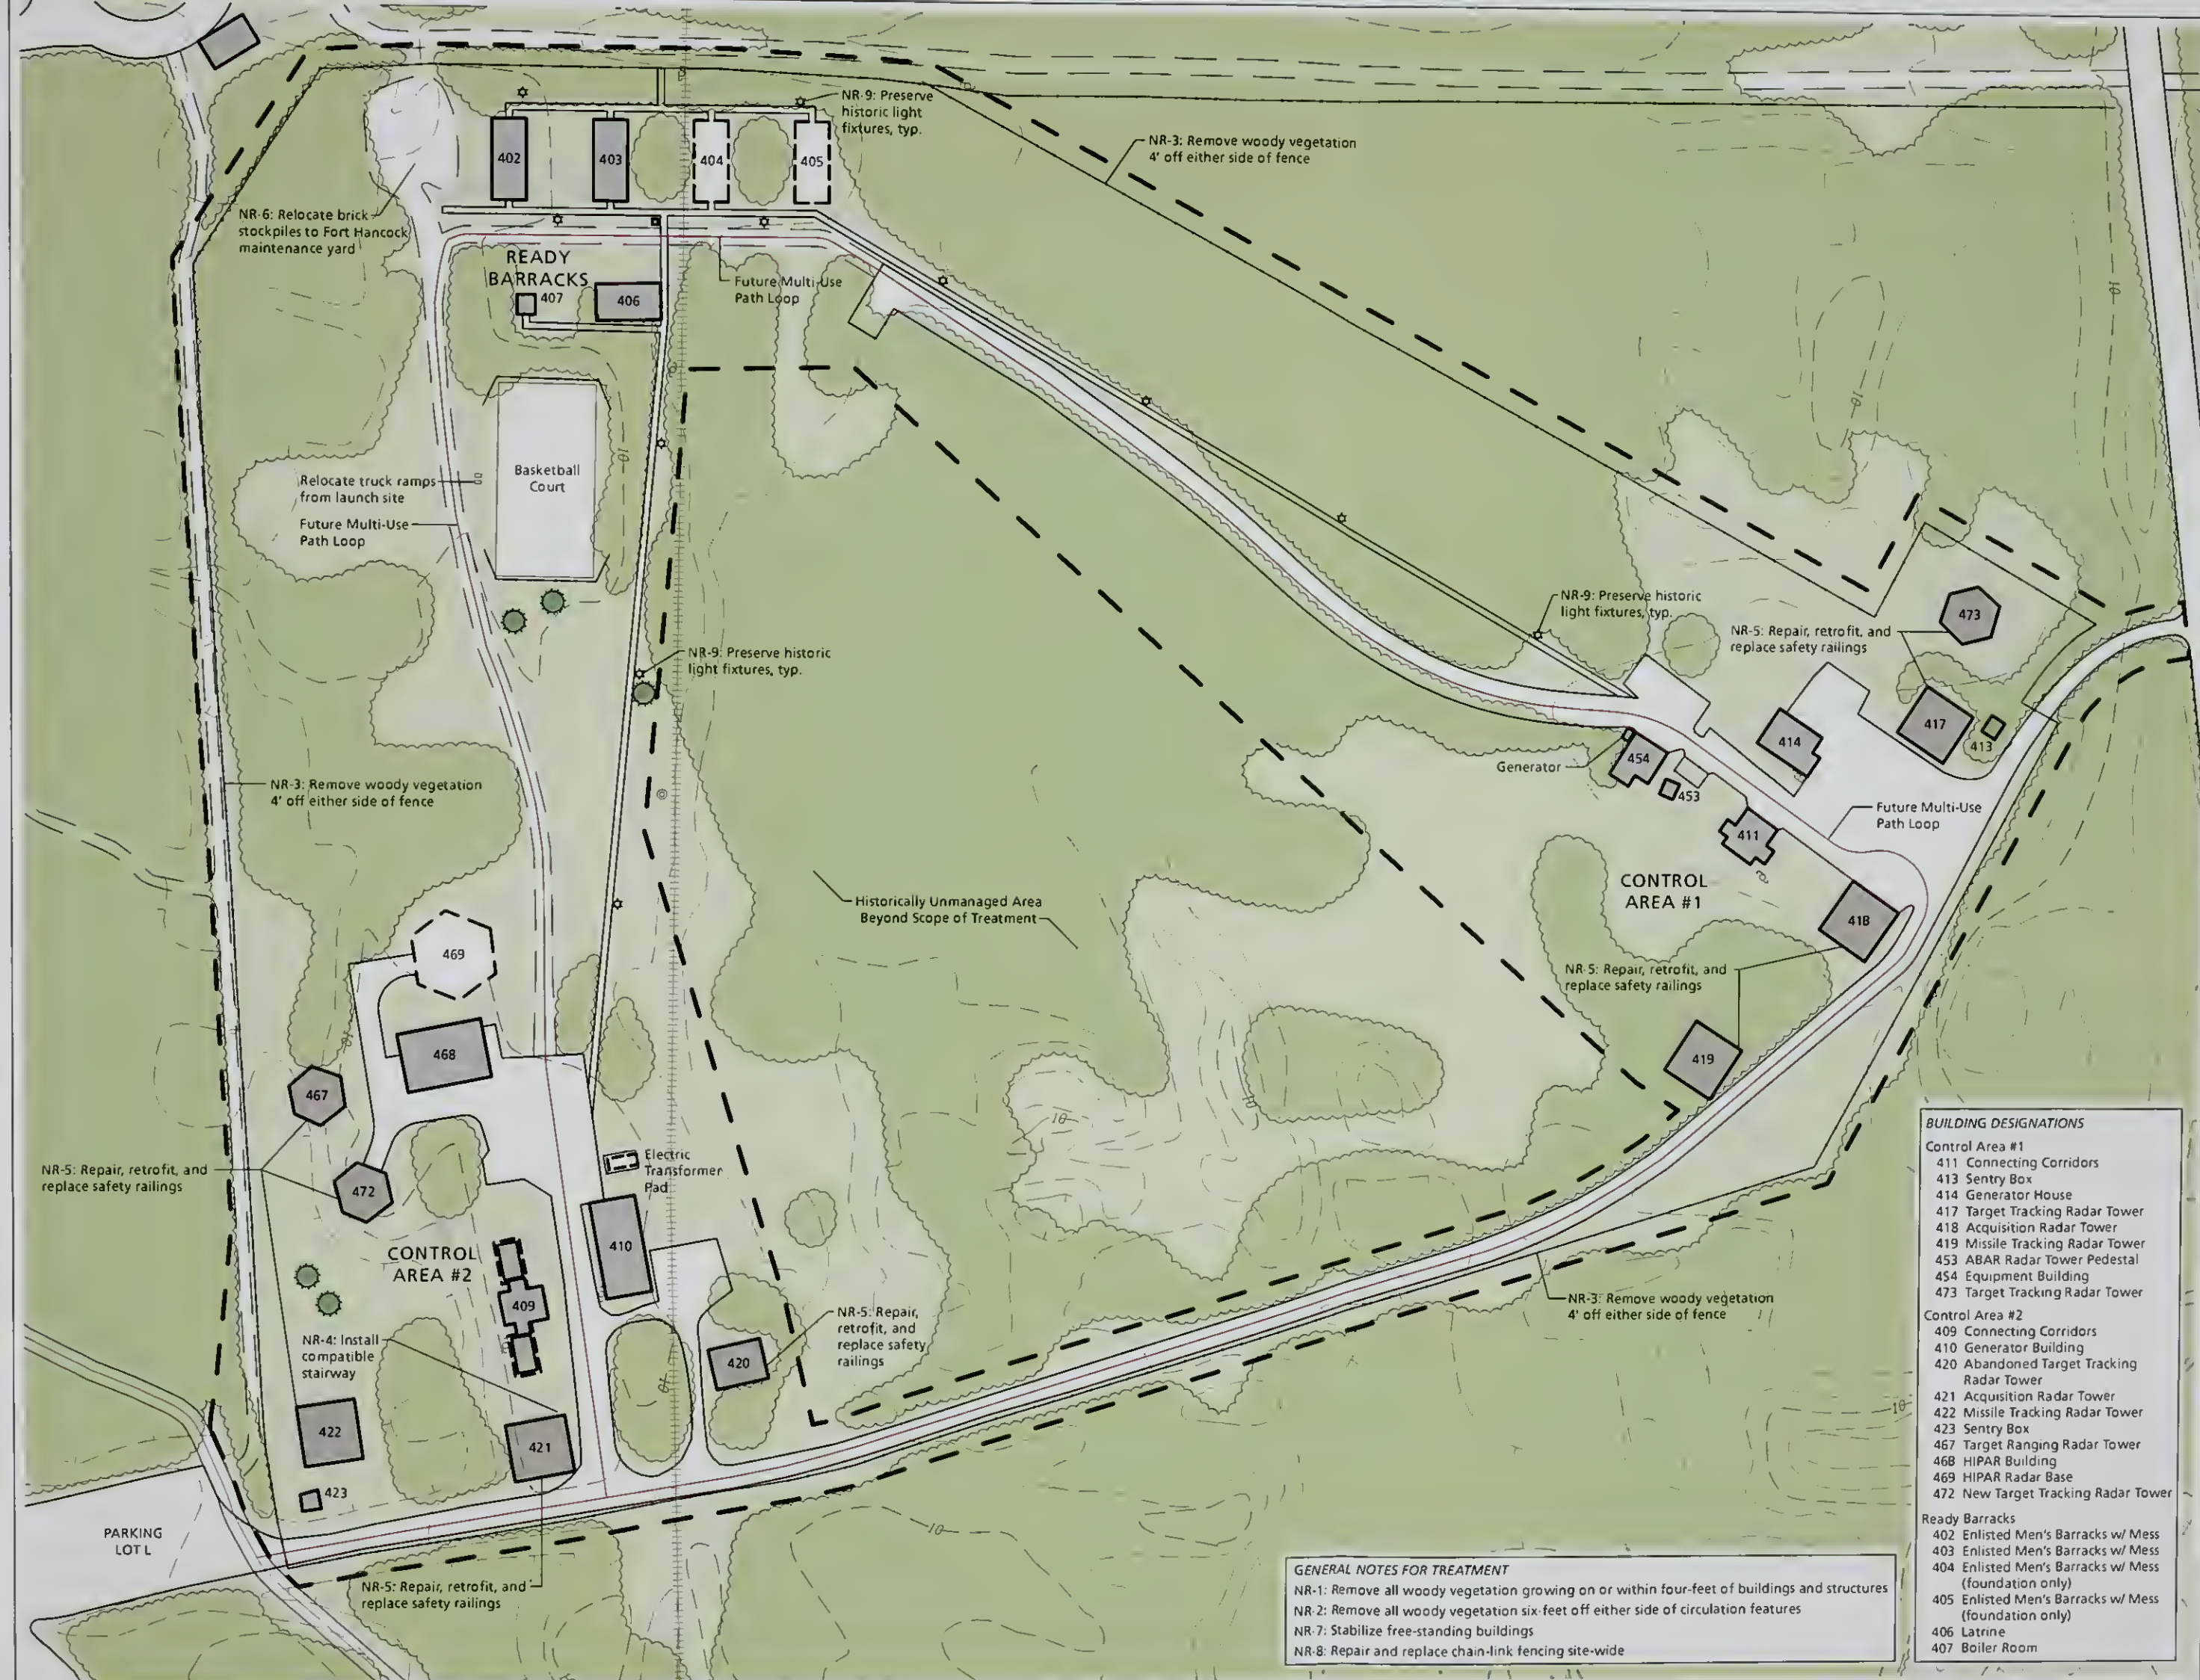
GENERAL NOTES FOR TREATMENT
 NR-1: Remove all woody vegetation growing on or within four-feet of buildings and structures
 NR-2: Remove all woody vegetation six-feet off either side of circulation features
 NR-7: Stabilize free-standing buildings
 NR-8: Repair and replace chain-link fencing site-wide

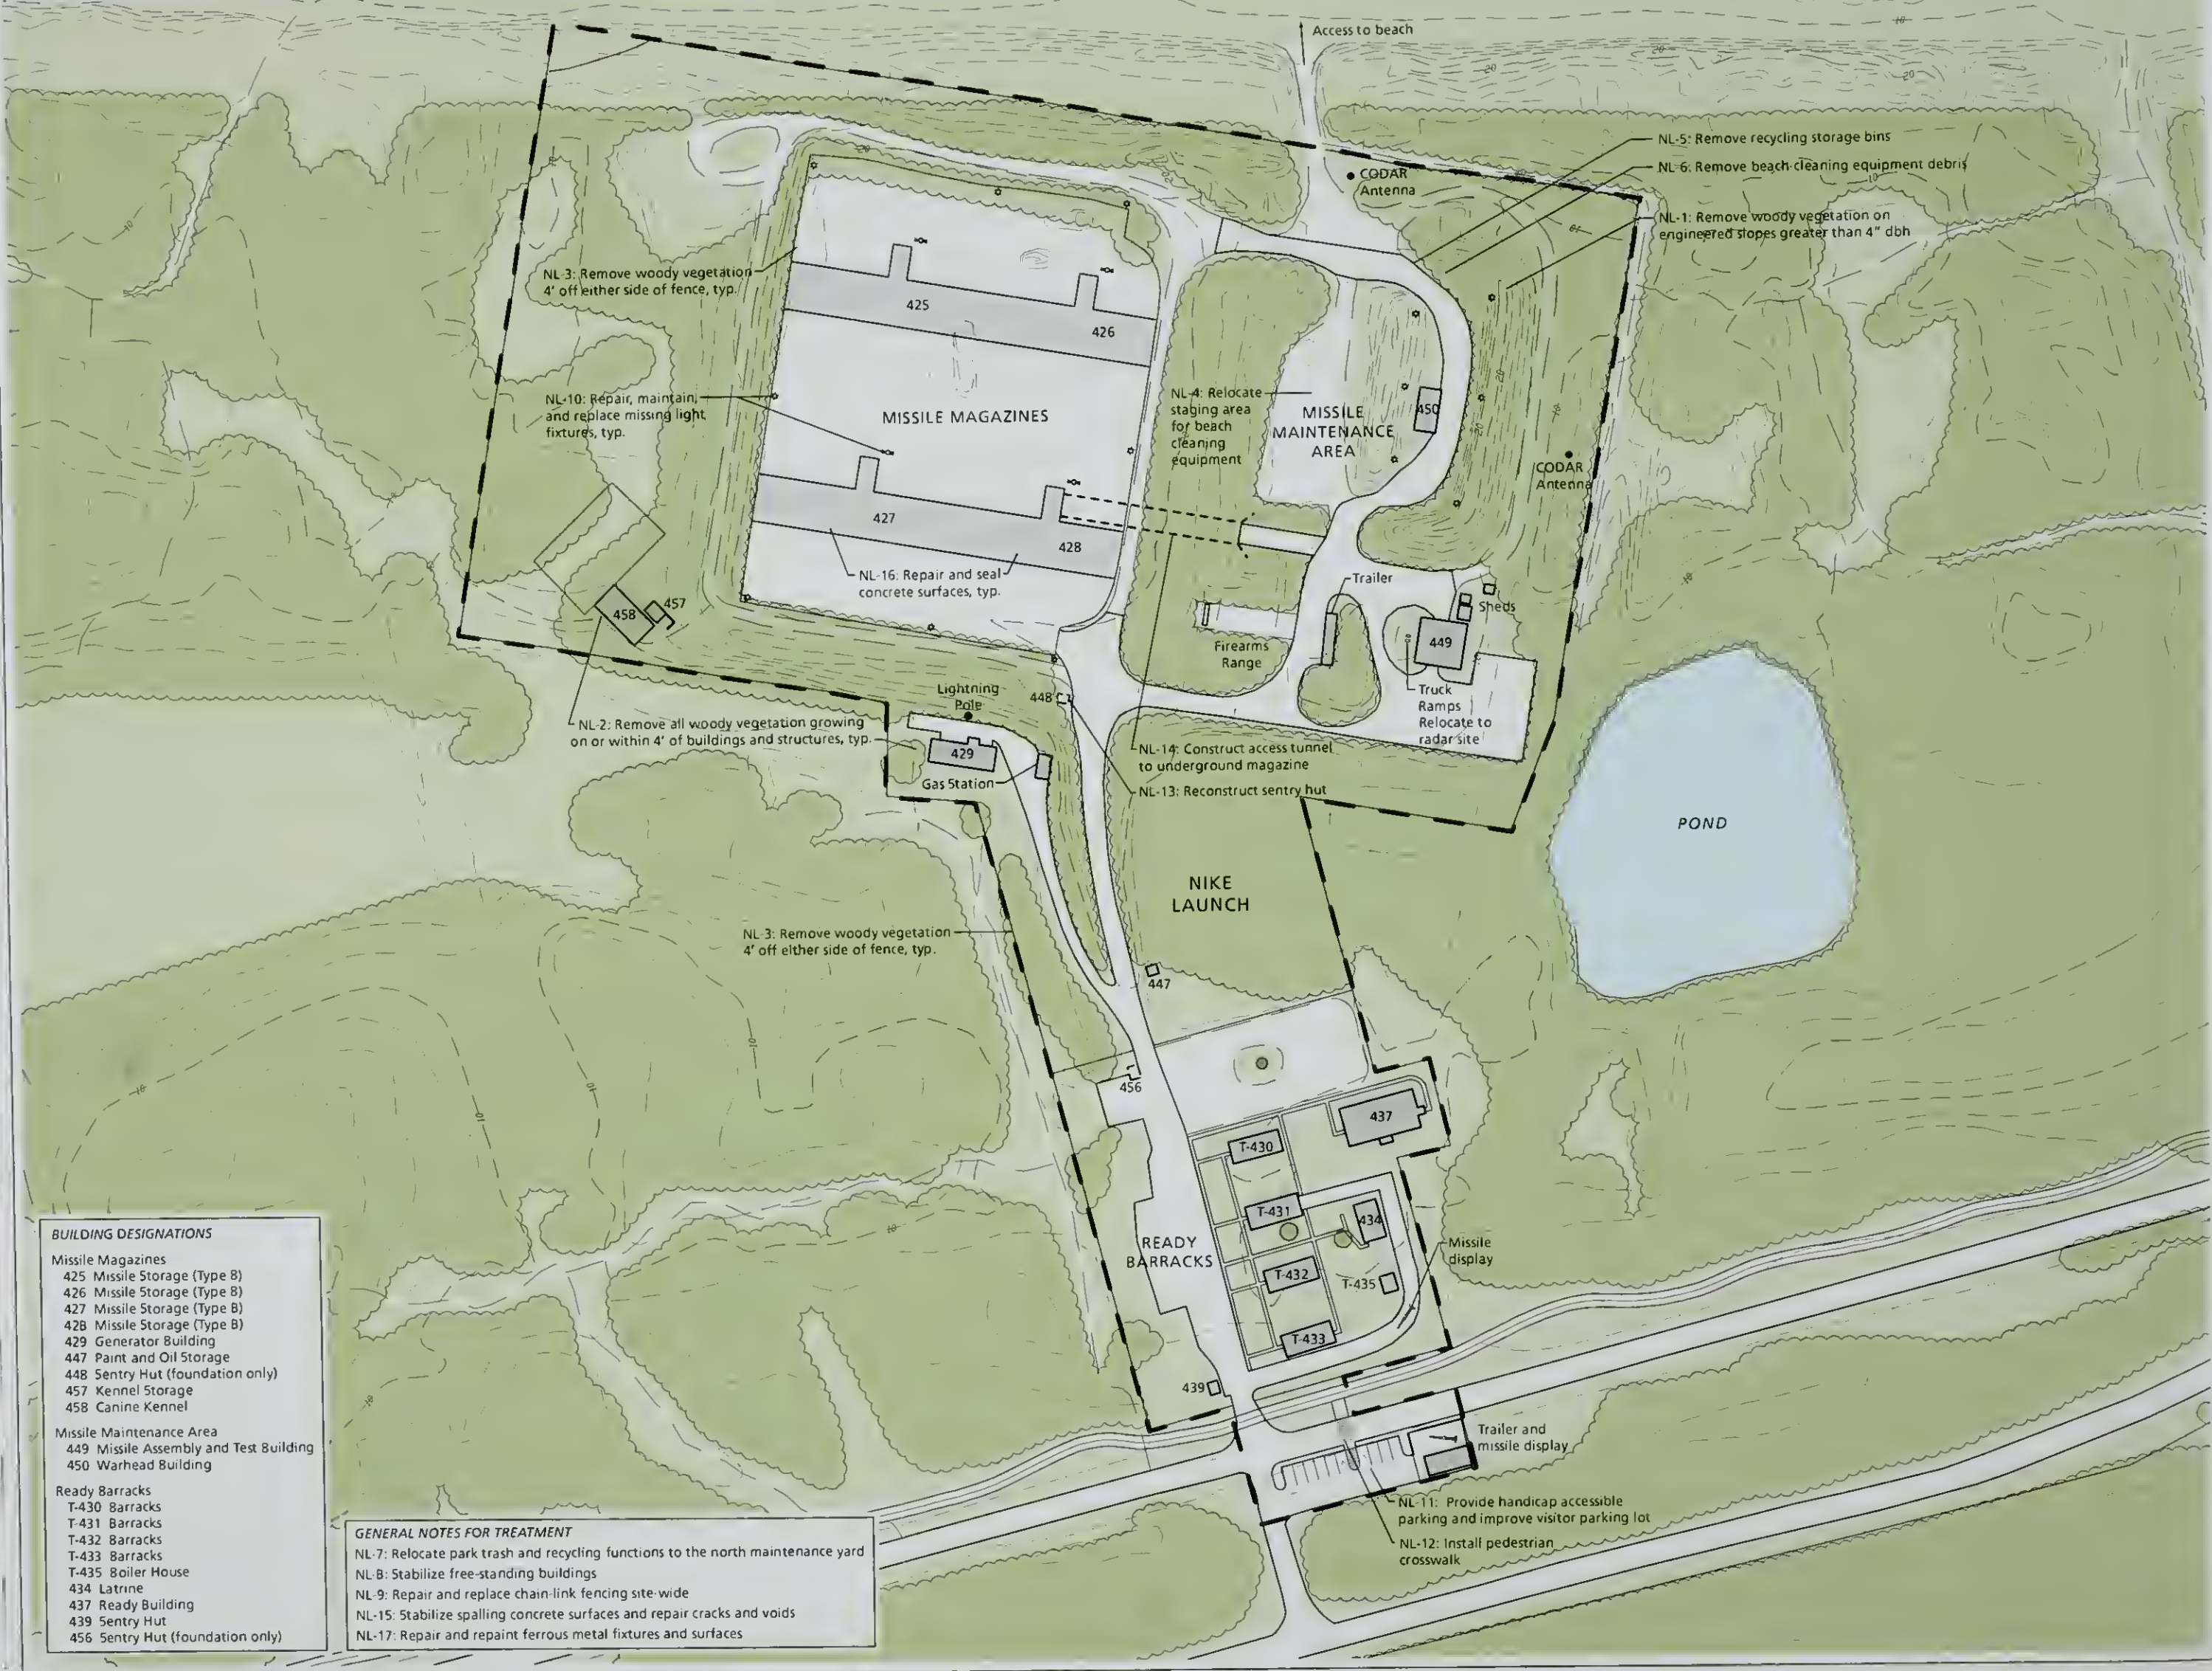
BUILDING DESIGNATIONS
