T. A. Moulton Barn

Preservation Plan
Grand Teton National Park

Prepared by:
Harrison Goodall
Conservation Services, LLC
360.221.8022

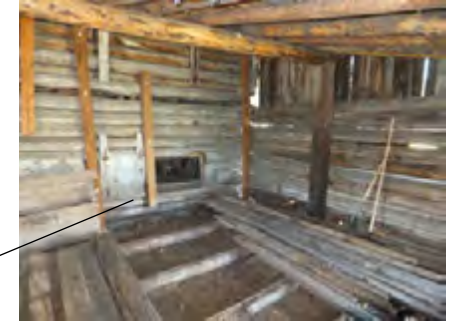
Interior flooring and stalls damaged and deteriorated

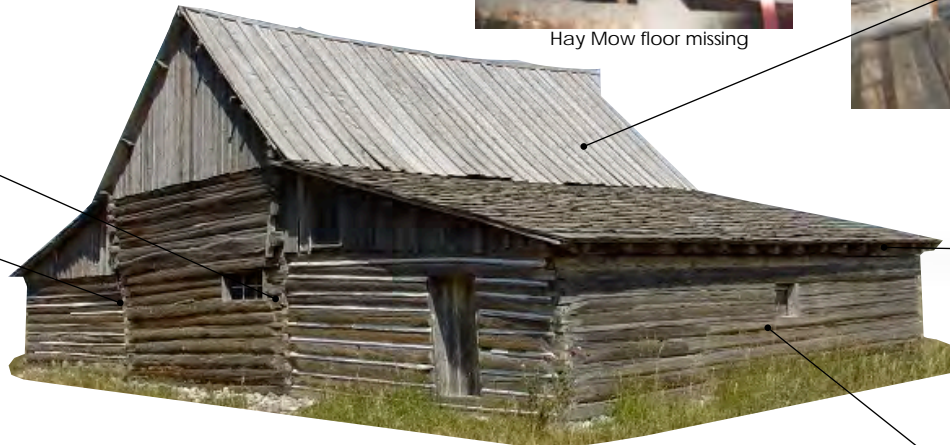
SW Corner

Dirt and organic matter in checks; log faces seriously weathered

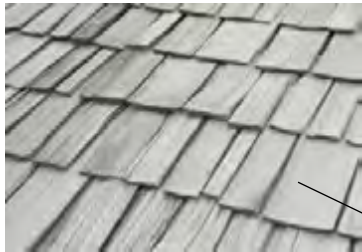
Wood shakes improperly laid, checking. Roof leaks.

Replace shakes with wood shingles

- Remove 1994 (existing) shakes
- Repair or replace any skip sheathing; re-nail
- Install metal eave drip flashing with 1" exposure; paint to blend with sheathing
- Be assured of secure fastening of rafters to plates; concealed screws may be used for fastening
- Lay Ice & water shield, 30# felt at eave edges, and Cedar Breather
- Lay cedar shingles with 5-1/2" exposure
- Nail shingles according to Cedar Shingle and Shake Bureau. Use 5d galv. shingle nails
- Shingles to tuck under flashing and upper roof board and batten
- Place 1 x 6 diagonals inside rafters

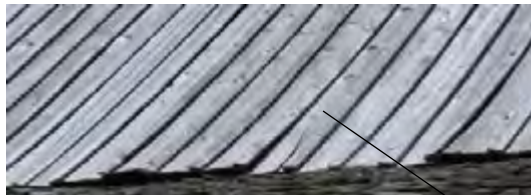
Board and batten roofing with serious check; lifting

Rafter connection to plate logs require additional stabilization

Replace Board & Batten Roof

- Remove 1997 (existing) board and batten roofing
- Reinforce rafter connections to purlins and plates
- Retain the planking underneath; only replace deteriorated planks; refasten - may use screws
- Be assured of secure fastening of rafters to plates; install TimberLoc screws if needed
- Install 24" wide galvanized flashing at roof transition (base)
- Cover gable roof panels and transition with Ice & water shield followed by 30# felt paper and Cedar Breather
- Lay 1x12 rough sawn KD planking; fasten with 2" galv. screws
- Install 1x4 rough sawn KD battens; fasten with 2" galv. screws

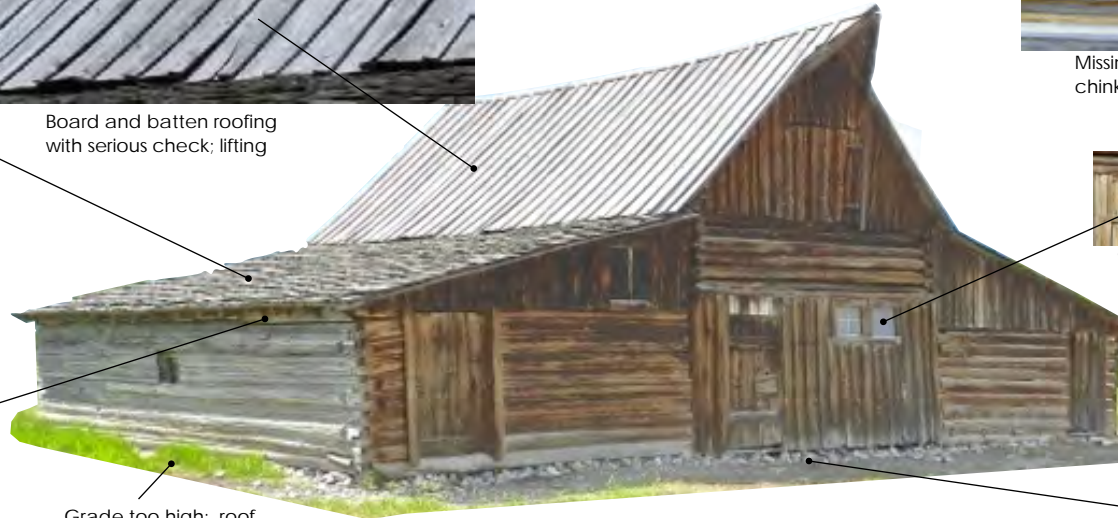
SE Corner

Window sash deteriorated, missing

Rafter ends deteriorated

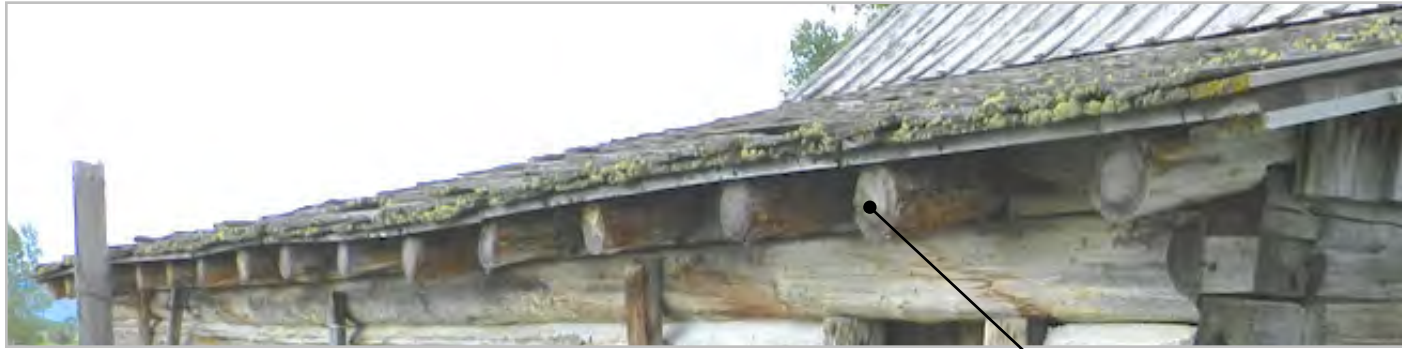
Condition Description:

- Many rafter ends have been continuously wetted from the roof edge causing decay.

- If decay is allowed to continue the rafter ends will lose structural stability leading to replacement and massive disruption to the building fabric.

Apply Preservative to Rafter Ends

Saturate rafter ends with BoraCare preservative

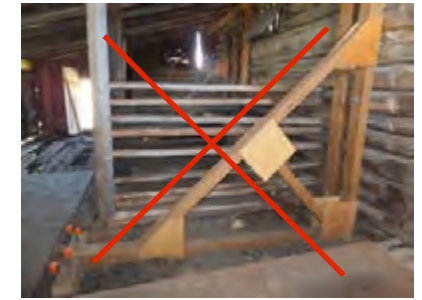
Condition Description:

- FEMA bracing is unsafe for interior visitor interpretation and provided no support to the upper wall logs. Installation of the braces damaged much original flooring and mangers. 30% of the original flooring is either missing or seriously damaged.

Remove existing FEMA type braces (may reuse materials)

- Remove FEMA bracing. Construct compatible bracing at existing structural posts. Lower sole plate to be below flooring.
- Regrade interior dirt flooring; Replace deteriorated sleepers and planking.
- Reconstruct feed boxes and replace and repair original mangers.
