# Conservation Guide

Murie Ranch Historic District , Moose, Wyoming

August 2007, Prepared by Harrison Goodall

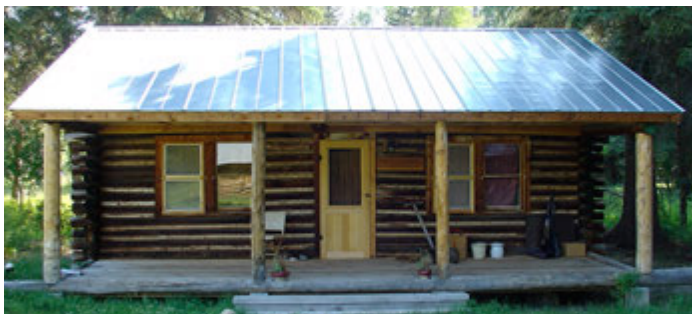
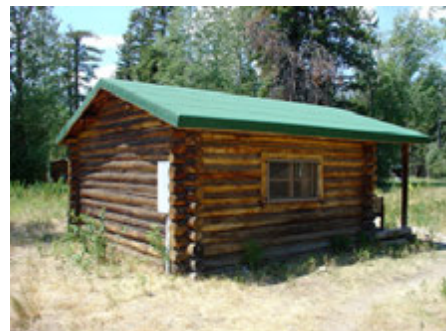
Most of the roofs are covered with “5V” metal roof panels, 36” wide green granual rolled roofing, and corrugated metal panels. Most of the roofs are insulated with a foam board between the sheathing exposed on the interior and the roof covering. All of the “5V”

All of the “5V” roofs and rolled roofing roofs are in good condition. The exception is the roof on the Woodshed next to the Murie House. The corrugated roof on the Murie House has loose panels and should be refastened now prior to the major rehab work which is in the planning stages. It is of the highest priority that roofs be in good condition and do not leak. Roofs must be free of leaves, needles, and other organic matter to prevent water flow and corrosion / deterioration.

Roofs must be inspected carefully annually for leaks, popping nails or fasteners, loose or lifting panels, and open seams. Always clean roofs with organic matter on them and make repairs to loose panels or lifting roll roofing. Note when the roof covering is on its last five years of life cycle.

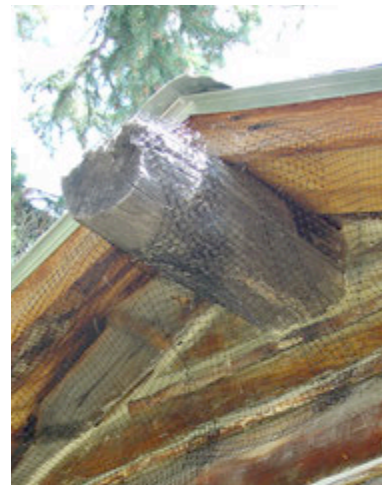
Most of the roofs have a log purlin structure with vertical rough sawn plank sheathing. Originally and historically, the log purlins extended out beyond the roof edges and had a pointed end applied with an axe. On some buildings the purlins have deteriorated and been cut back under the roof line with some being repaired with epoxy or another stabilizing material. Others, such as the Garage, were rehabbed in early 2000 incorrectly and are only compatible to the cut off purlins.

Although log purlins that extend out into the weather are bound to deteriorate and are unquestionably a poor construction technique, they clearly define the historic and architectural character of the buildings. They require constant attention to retard decay and their extending ends may require replacement.

Attempt to prolong the deterioration of the purlins; their form and workmanship. They should be cleaned and have a BoraCare preservative applied periodically. Do not cut off purlins under the roof line to get rid of the decay problem. Replace by splicing if and when needed.

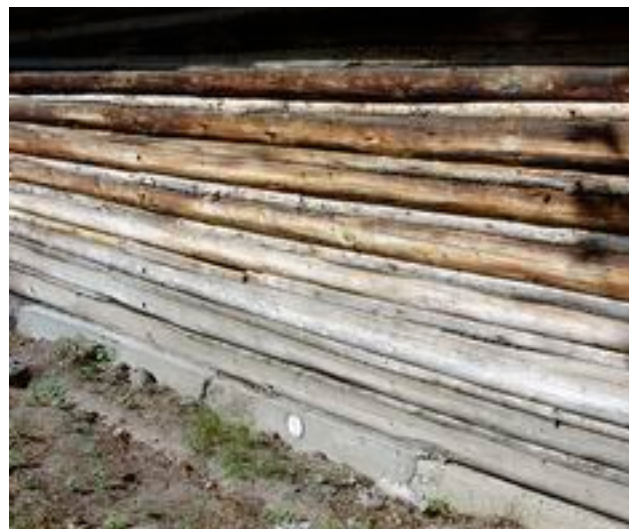
With exception of the Bathhouse, which is not historic, all of the logs in the buildings are weathered and degraded due to UV, especially on the south facing walls, and are heavily checked, but have only minor decay areas. The rehab process in the 2002 to 2004 included the replacement of most of the seriously deteriorated logs. But all logs have organic matter, blow dirt, needles, and pollen in their checks. The upward faces have a heavy mold growth and their downward faces are dirty. Logs near the top of the walls and under the roof overhang still have some finish from about 30 years ago, all lower logs have lost their color to leaching due to splash and constant wetting. The surfaces of these lower logs are more brittle, dry, and more absorbent than the upper logs. Fungal and mold growth and dirt degrade the logs and create a poor appearance.

It appears that the log walls have not been cleaned or that they have had a protective finish on them for decades. There is also evidence of ants and mice in the walls.

All log walls require an initial comprehensive cleaning to remove many years worth of dirt, mold, and growth. Follow the recommended cleaning procedure for the initial cleaning. After that only mild periodic cleaning will be needed. Log surfaces, checks, connections, and areas susceptible to decay and insect infestation should be treated with a borate preservative. Use a glycol base borate (BoraCare) if exposed to the weather, a water based borate (TimBor) if it is to be covered with a protective finish. Inject BoraCare or a concentrated borate preservative into checks that face upward or that show signs of decay.

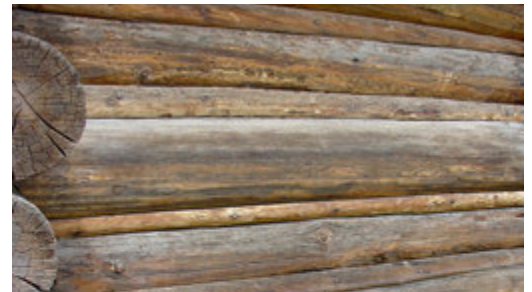
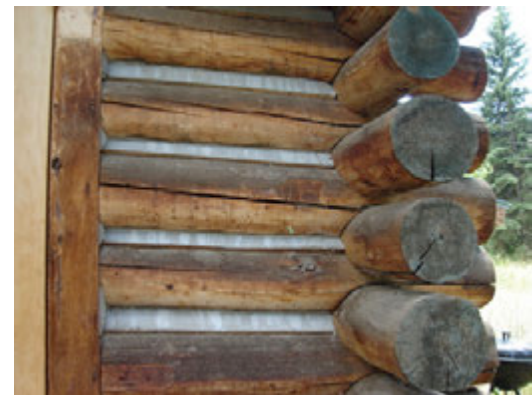
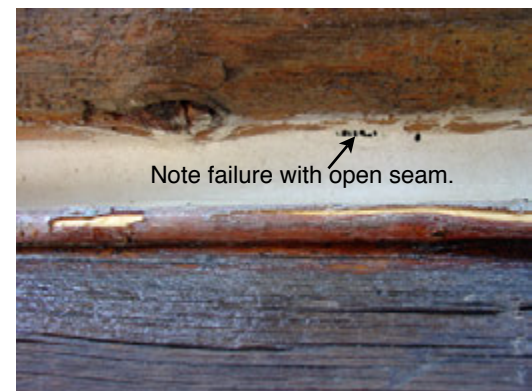
Mortar daubing (chinking) was used originally on some of the cabins. A willow sapling was nailed along the upper part of each log to hold the daubing in place. Mortar daubing can be found on Chena Cabin. All of the cabins on west side of the site that originally had historic mortar daubing were inappropriately converted to a synthetic latex chinking - Perma Chink.

works fine if installed properly. When the logs and wood walls expand and contract the latex chinking gives and remains adhered to the logs. When using synthetic chinking on logs exposed to the weather for more than a few months, a year, 20 years, or 80 years, as the logs expand and contract the chinking stays adhered to the very surface of the weathered wood but shears from the log beneath. Because of this in over 50 or more applications where synthetic chinking has been used on historic buildings I have seen 100% failure. The chinking pulls away from the log leaving a gap allowing water to become trapped beneath. Also, synthetic chinking does not look like mortar daubing. It does not have the same profile, color, texture, or appearance. Next, it is not necessarily more “maintenance free”. With 100% failure it requires more maintenance than mortar. But above all it is not historic. If the mission of the site and objective of preserving the structures is to keep them looking historic by not altering their architectural character then synthetic chinking should not be used. Just like painting a historic building pink when it has always had a log oil on it, the same analogy can be said for synthetic chinking. Further, the Secretary of Interior’s Standards does not recommend it.

Maintain the existing wood chinking and mortar daubing. Keep the Perma Chink synthetic chinking until multiple open seams occur. Then remove it being careful not to damage the historic logs. Admittedly, this will be very difficult and quite time consuming. Replace with the original - mortar daubing. Daubing with a formula of 9 sand, 4 Type S lime, and 1/2 to 1 part grey portland cement has worked well on most historic buildings. But make test samples and allow them to fully dry before daubing the entire building.

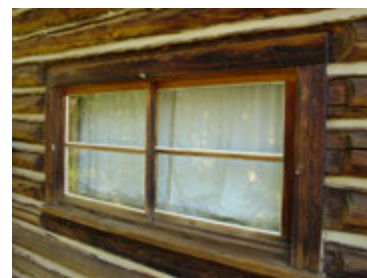
Typical conservation problems with windows include broken glass, deteriorating or missing glazing, deterioration or loose sash, especially at the lower corners, damaged, loose, or deteriorated jambs, sills, or trim. But

in almost all cases the finish is no longer providing protection to the window units.

All window units need periodic cleaning. The wood get coated with mold, dirt gets in the tracks or on the sills, and the window elements become loose and weathered. All repairs and general maintenance should preserve the appearance and workmanship of the original windows and their materials. Since the buildings are being occupied there is a need for the windows to be functional otherwise they are likely to become damaged. Periodically the window units require a finish for protection from the elements.

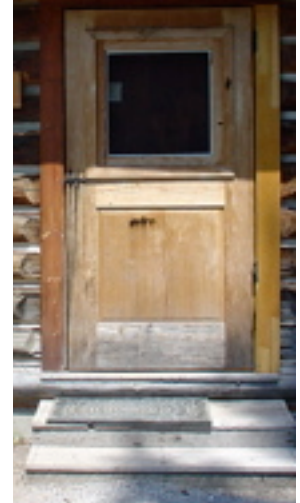
The wood screen and storm units on the windows and doors are not historic and do not match the original screens that were on the building originally. Indeed, their appearance and construction are not appropriate for the historic buildings, especially as historic landmark buildings. Although made out of wood they are not compatible to the visual period of the cabins, the craftsmanship and hardware does not match the period, the screen have an aluminum frame around them that is visually intrusive. Indeed, the screens are most difficult to make repairs because some of the aluminum cannot be easily be removed.

The screens and storms may be functional but they are not appropriate to the site or to each building they are on. They detract from the rustic character of the buildings.

Clean and maintain the existing screens and storms until a decision is made to replace them with ones that match the period and materials of the originals. This has yet to be defined. Research other dude ranches or similar buildings in the area for reference.

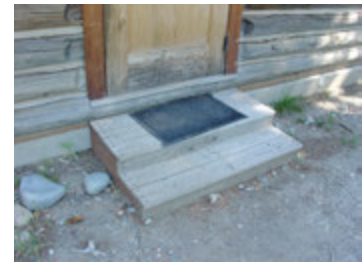
The steps, stoops, and porch floors were all reconstructed in 2002 and are not historic. The appearance and construction of the originals are not known. Perhaps this can be found in historic photographs. The current units are constructed of varying widths of 1" rough sawn planks nailed to a box frame.

Most of the steps, stoops, and porch floors are either setting on the dirt or are very close to it. Moisture from rain, wet soil, and snow melt are creating moisture within the wood. Dirt accumulates between the spacing in the planking which also retains moisture against the wood. These conditions accelerate fungal deterioration and encourage insect infestation.

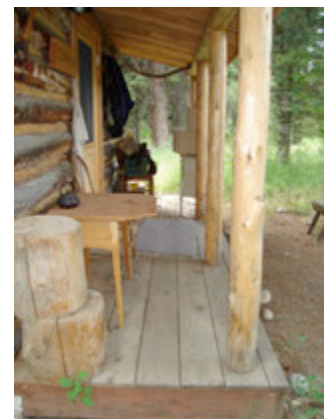
Some of the steps and stoops are sloping toward the building causing water runoff to drain against the sill logs and foundation rather than run away from the walls.

Water runoff from the eave ends of roofs can drip unto the plank surfaces and splash against the doors causing staining and accelerated deterioration.

Constant wetting and drying causes increased expansion and contraction of the wood causing the nails to lift above the surface. This can create a safety issue.

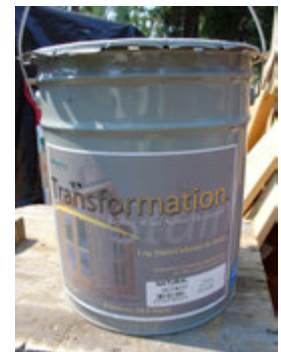
For practical purposes, all of the buildings as of 2007 have no functional finish on the exteriors. Originally or at an early period of time, a clear log oil of some type was applied to all of the wood elements. Only a crystallized coating of this can be observed on the upper portions of the walls under the cover of the roof overhangs. The lower portions of the logs the finish has been weathered or flushed to the extent where it is worn or no longer exists. Sunlight, constant wetting, and freeze-thaw cycles have leached out the natural color from the wood and decomposed the lignin and other extractives causing a silvery gray color. On the upper portions of the logs and in other locations on the trim microorganisms such as fungi, mold, and mildew have formed. This is caused by a combination of intense radiation from the sun and fed by the linseed oil in the early finish. Additionally, it appears that the exterior walls have not been cleaned in many years, if at all, and have layers of grime on the upper surfaces.

The weathering effect is a natural process for unprotected wood. This chemical and mechanical damage occurs on the surfaces and gradually deepens inward. As it does additional moisture is absorbed increasing the swelling, shrinkage resulting in increased stresses in the wood and causing intracellular cracks and checks. The wood becomes brittle, pockets of decay form, and the wood begins to fragment.

Cleaning the exterior initially will require considerable more effort and more harsh chemicals than subsequent periodic cleaning. In all cases use the mildest cleansers on the structure and be sure to

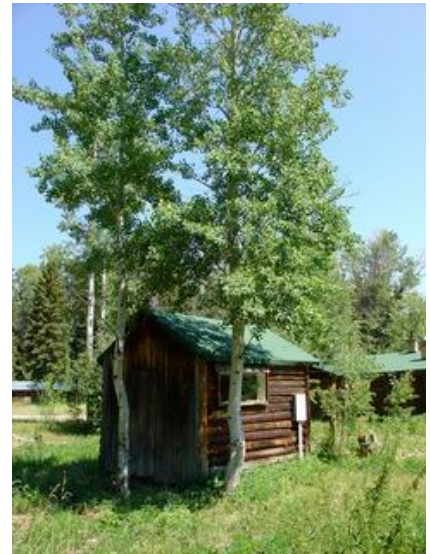
Trees, limbs, and downed dead wood is an EXTREME FIRE HAZARD and potentially damaging historic buildings should they fall on or against the buildings. Trees close to a structure, especially when snow drifts and bridges between them and a roof can be damaging during the thaw process. And, vegetation near a wood structure restricts air movement and retains snow and ice accumulation.

Remove all live and dead trees within 25' of buildings. Plant one or more to replace it 35' to 50' away. Remove all dead wood within 50' of buildings and keep vegetation cut to the ground within 5' of buildings.
