National Park Service  
Cultural Landscapes Inventory  
2011

Beaver Creek Administrative Area  
Grand Teton National Park

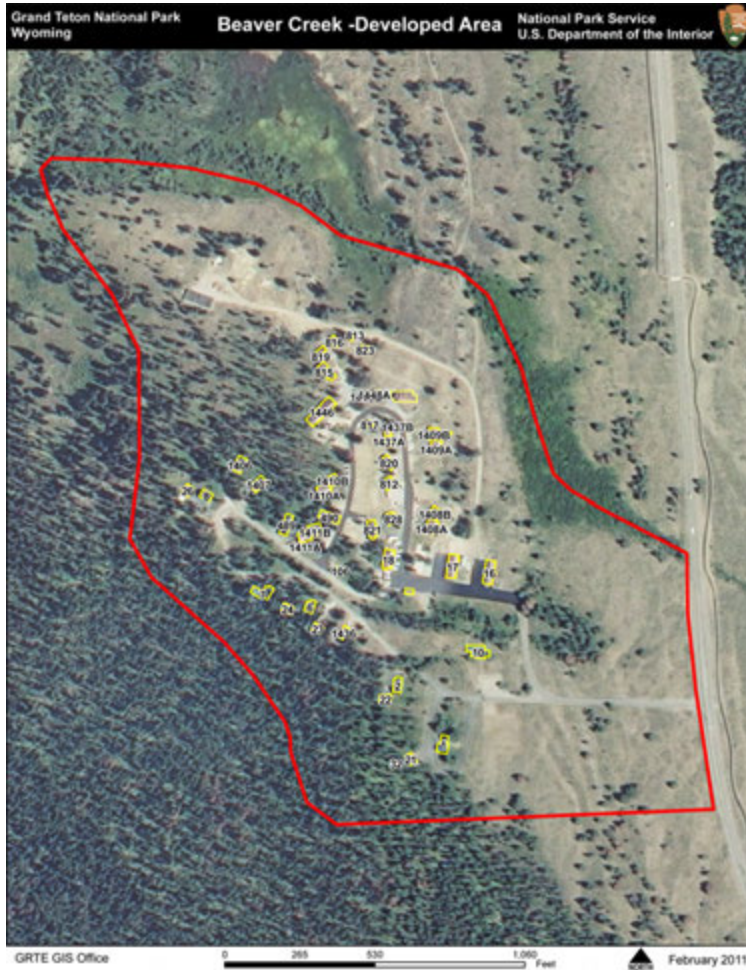
Site plan showing boundary addressed in this CLI. Source: GRTE GIS files.

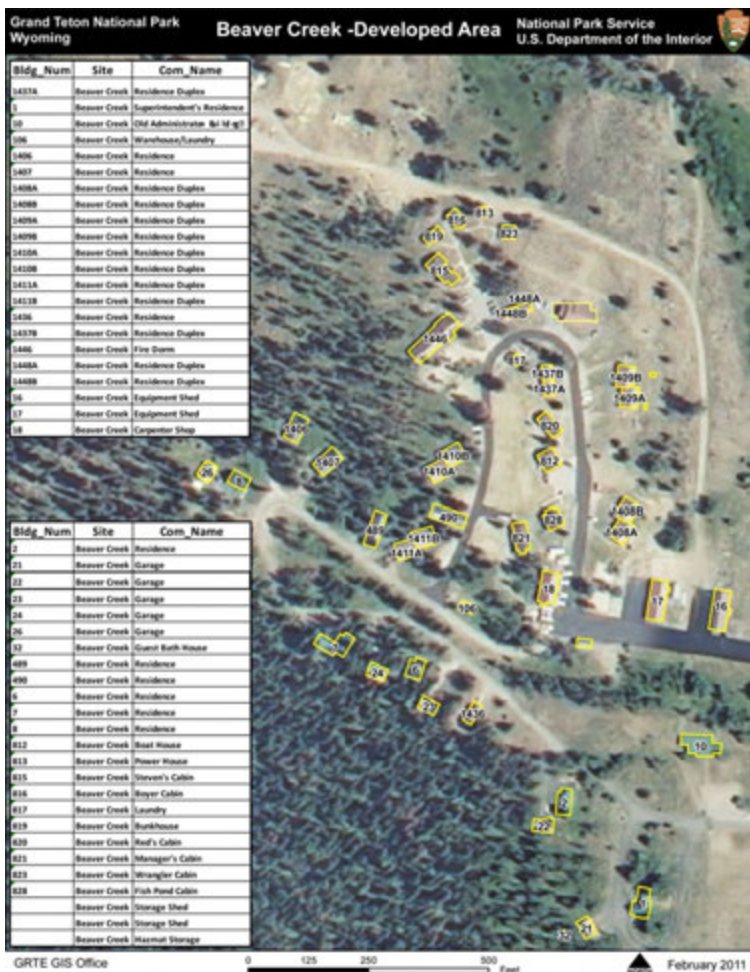
Detailed site plan showing buildings and structures addressed in this CLI. Source: GRTE GIS files.

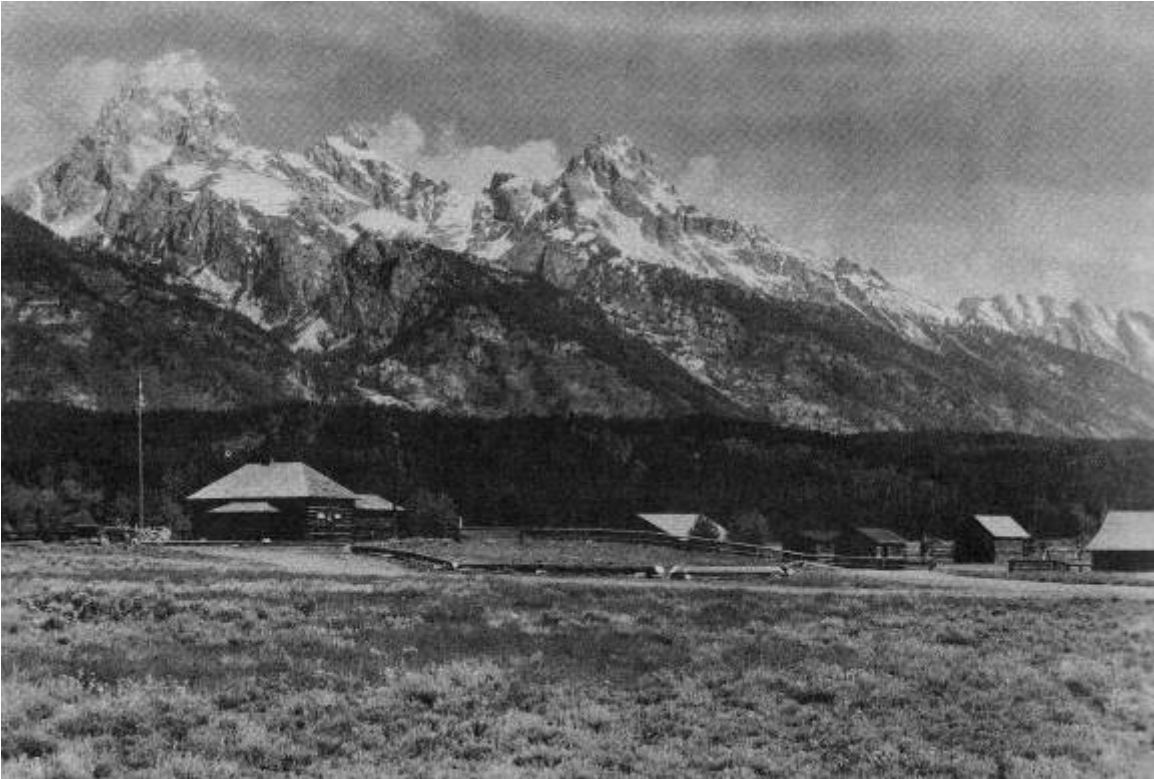
Cluster of early park buildings showing Administration Building (HS-10) and utility area buildings to the north, 1929-1934. Source: GRTE Cultural Resource files.

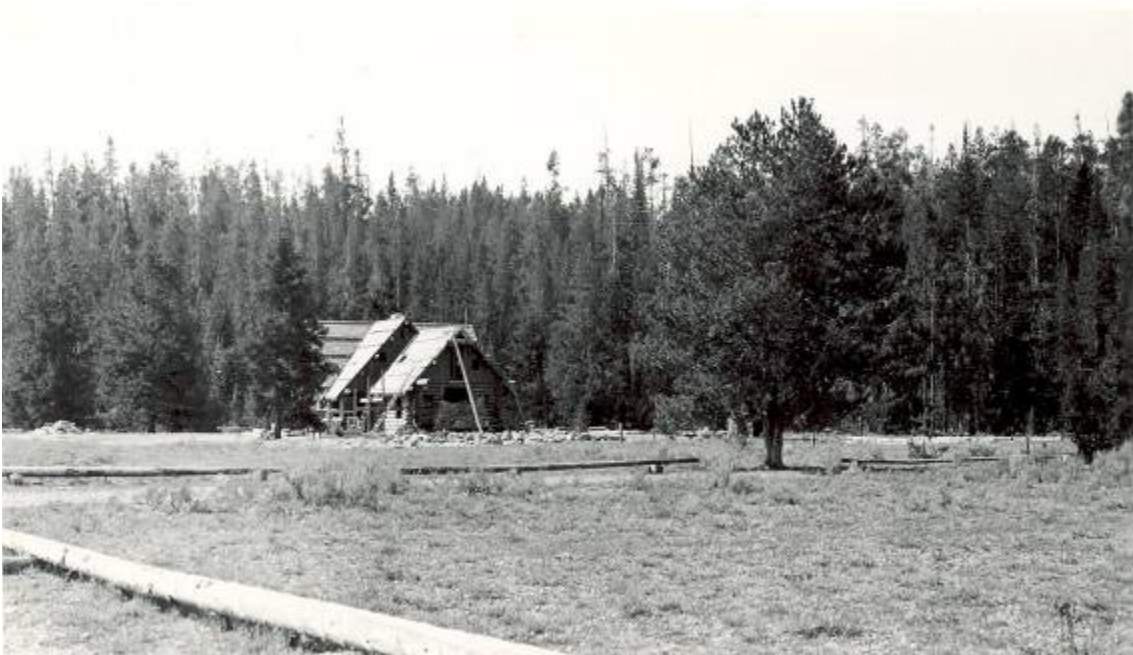
Superintendent's residence (HS-1) under construction, summer 1934. Also note log fencing lining the parking and drive areas. Source: GRTE Cultural Resource files.

This 1 ½-story residence at the Beaver Creek Administration Area is a log building constructed on a concrete foundation. The saddle-notched log walls support a roof of intersecting gables covered in wood shingles. The plan is "T" shaped, oriented north-south, with a north wing.

Designed by NPS Branch of Plans and Design, GEM, February 9, 1934, construction of the building was complete by the end of November that same year. The building was later remodeled in 1940 with the addition of a dormer on the west elevation. The building was later stabilized in 1980 and most recently, repaired by Harrison Goodall in 2005. Today, the superintendent's residence is occupied by the superintendent of the park.

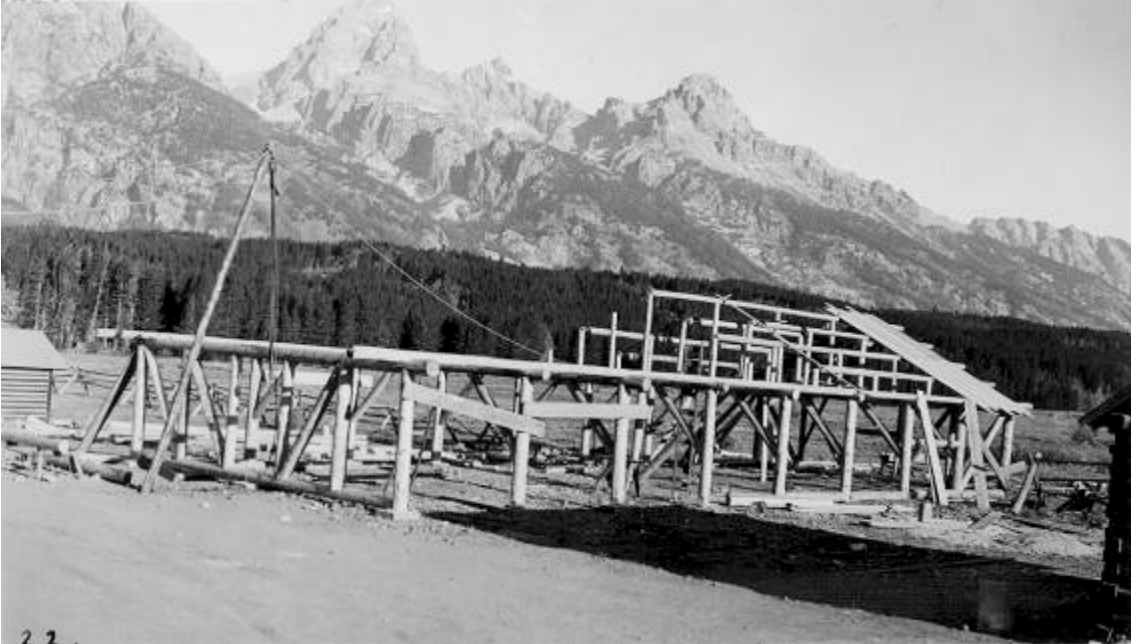
22  
Construction of the Equipment Shed (HS-17), 1937. Source: GRTE Cultural Resource files.

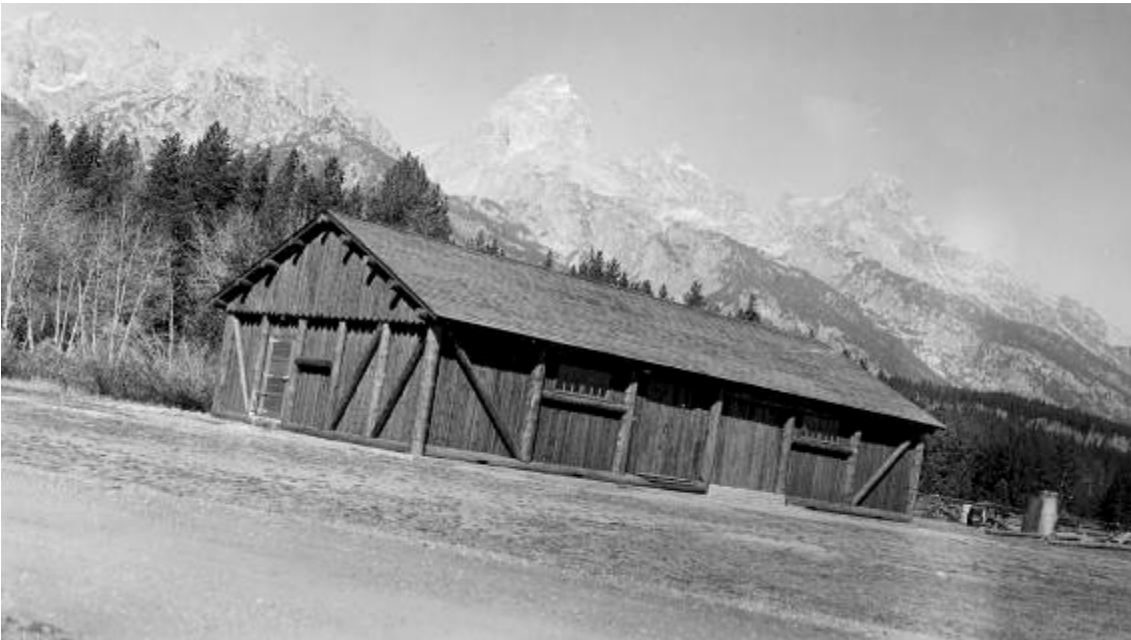
The Hay, Grain, and Ice Storage Building, (Carpenter Shop, HS-18), circa 1946. Source: GRTE Cultural Resource files.

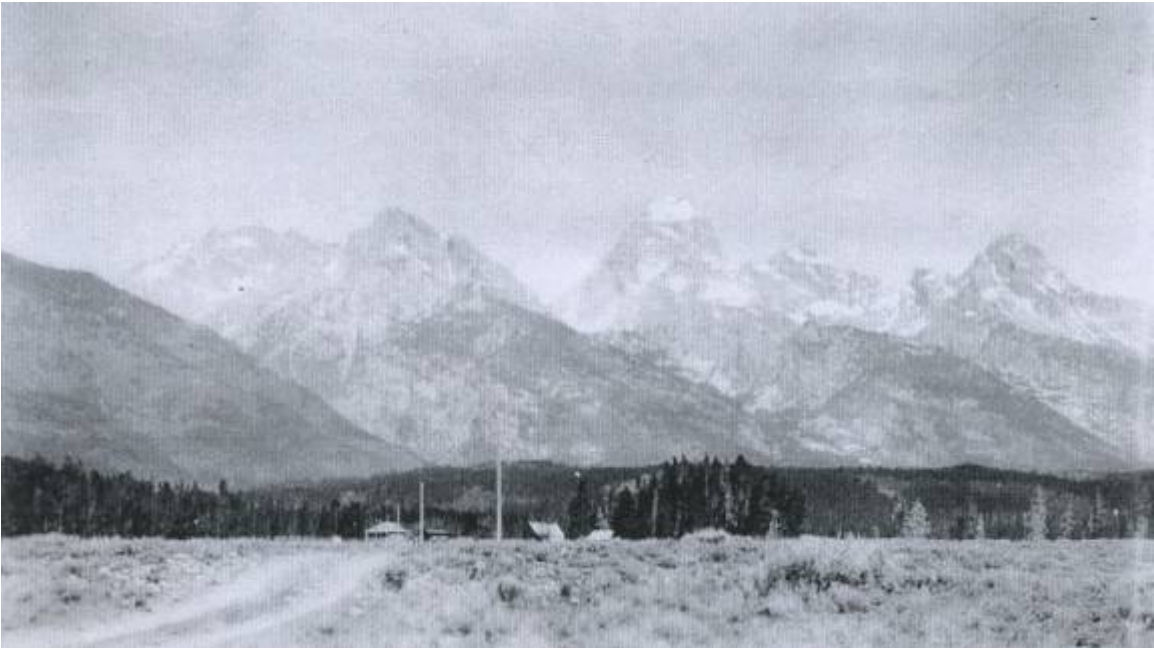
Early angled entrance drive to Beaver Creek Administrative Area, no date. Source: Jackson Hole Historical Society.

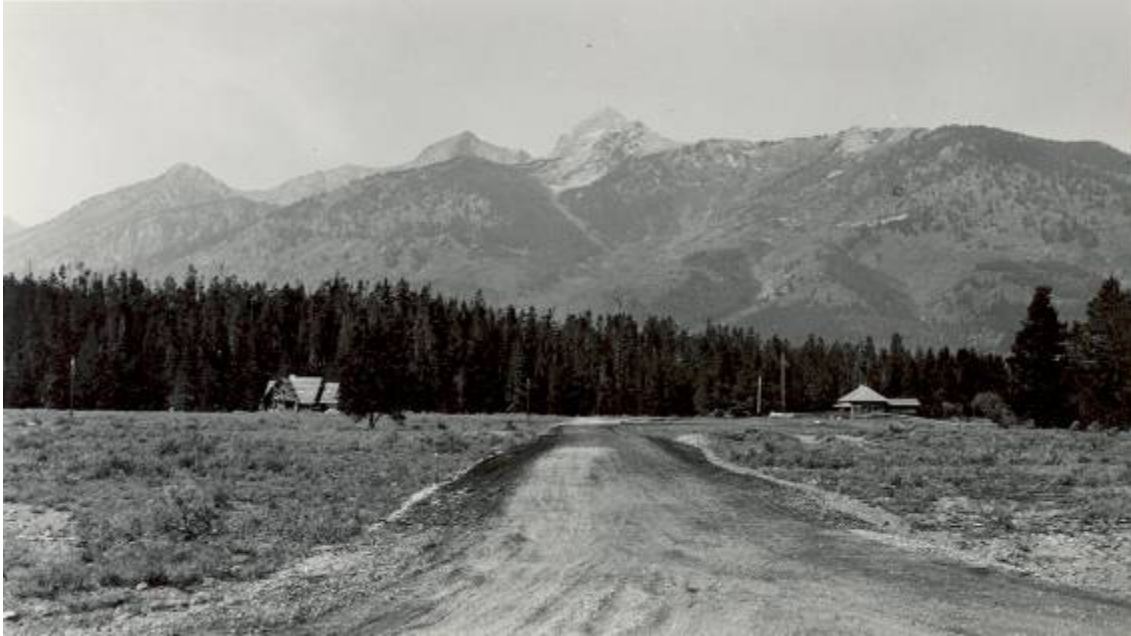
East-west entrance road leading to Beaver Creek with Superintendent's Residence (HS-1) on left and Administration Building (HS-10) on right, circa 1936. Source: GRTE Cultural Resource files.

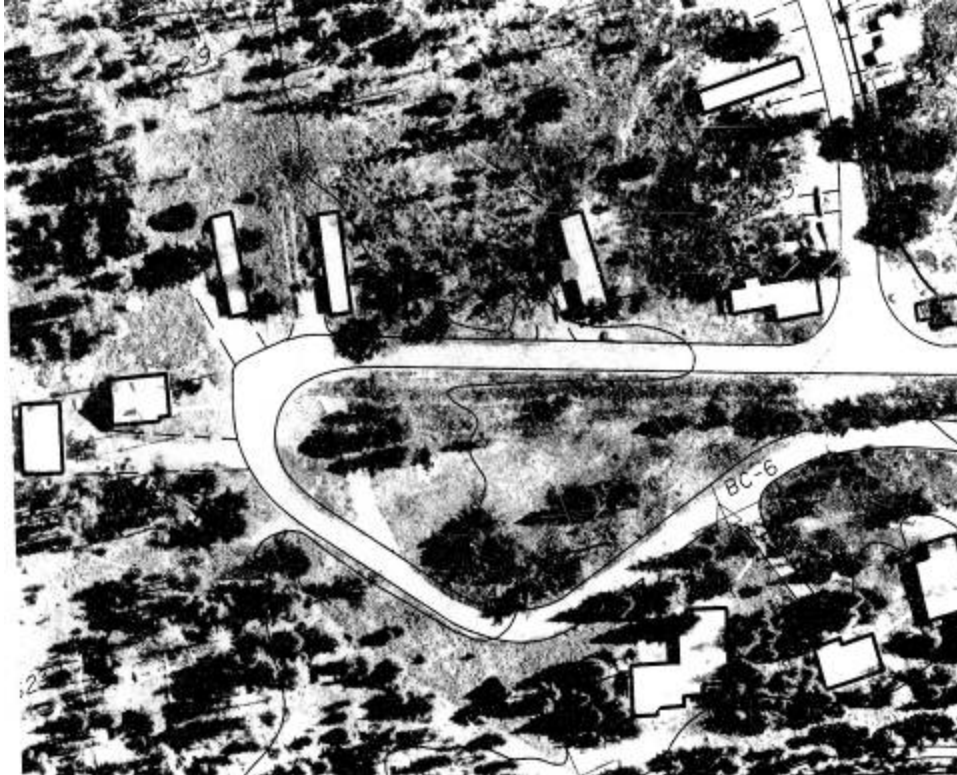
Aerial photograph showing loop drive east of employee residence (HS-8), 1984. The loop was likely removed in the late 1980s or early 1990s. Source: NPS e-TIC.

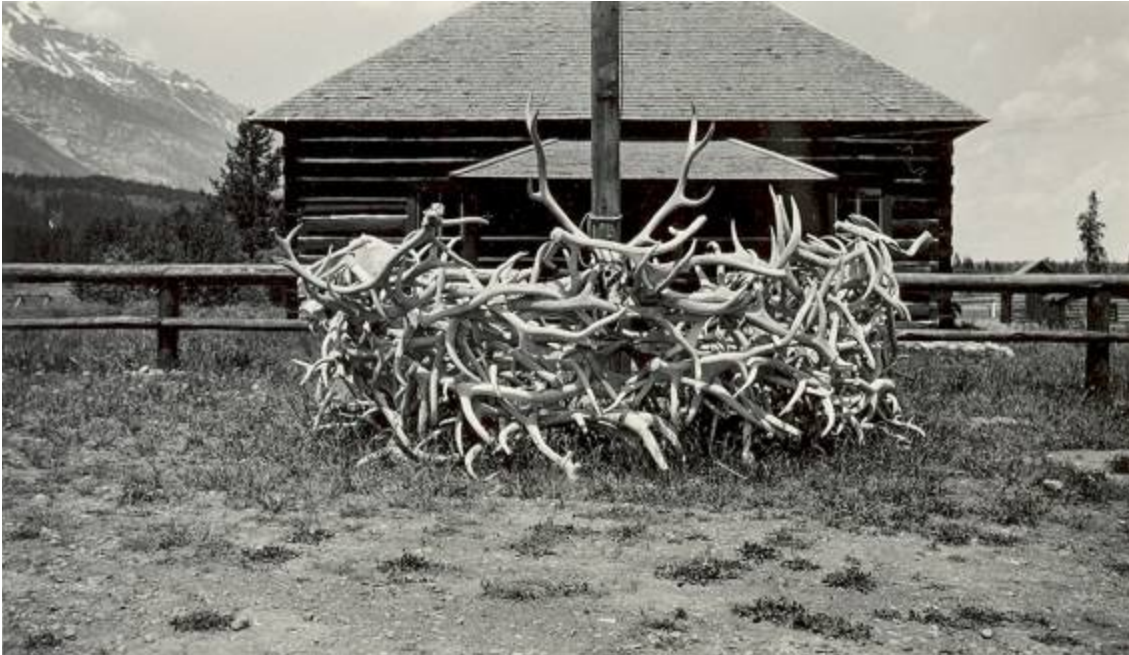
Early small-scale features found at Beaver Creek Administrative Area included a post and rail fence, flagpole, and antler pile, circa 1929. Source: GRTE Cultural Resource files.

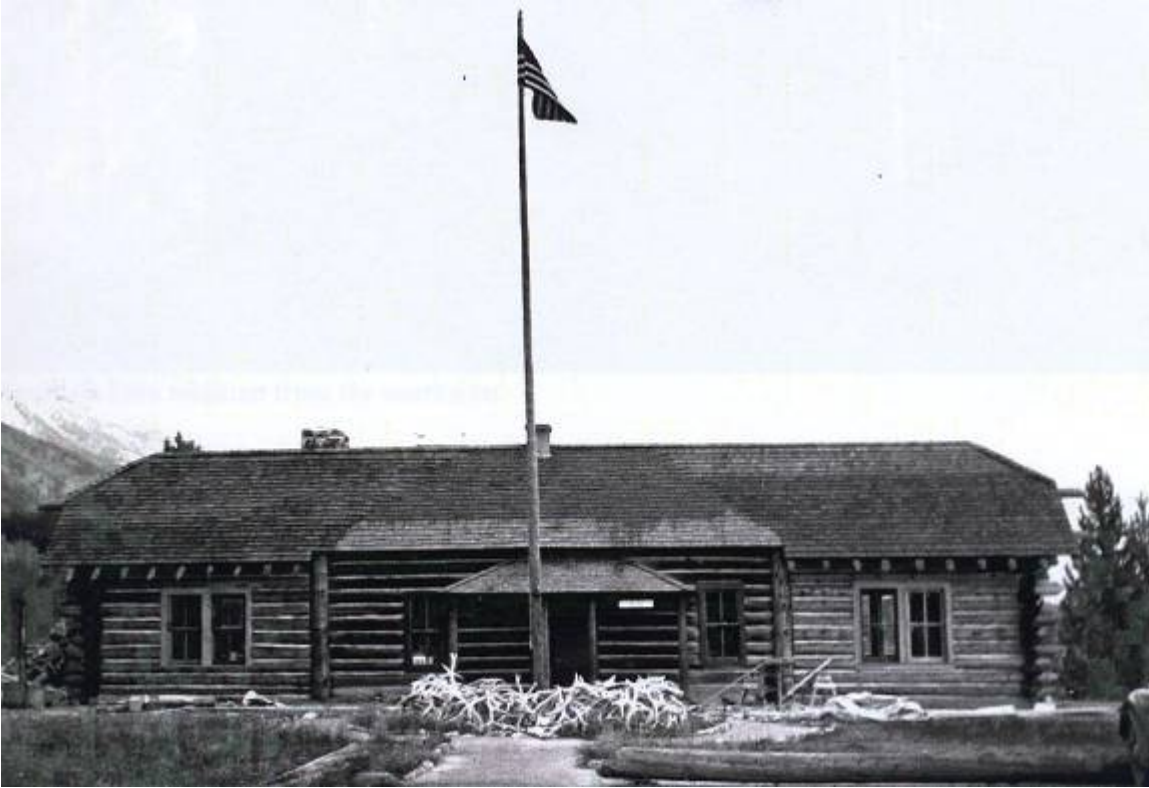
Later small-scale features included log fencing around parking and drives, flagpole, stone cobble edging along walks, circa 1940. Note the removal of the post and rail fence. Source: GRTE Cultural Resource files.

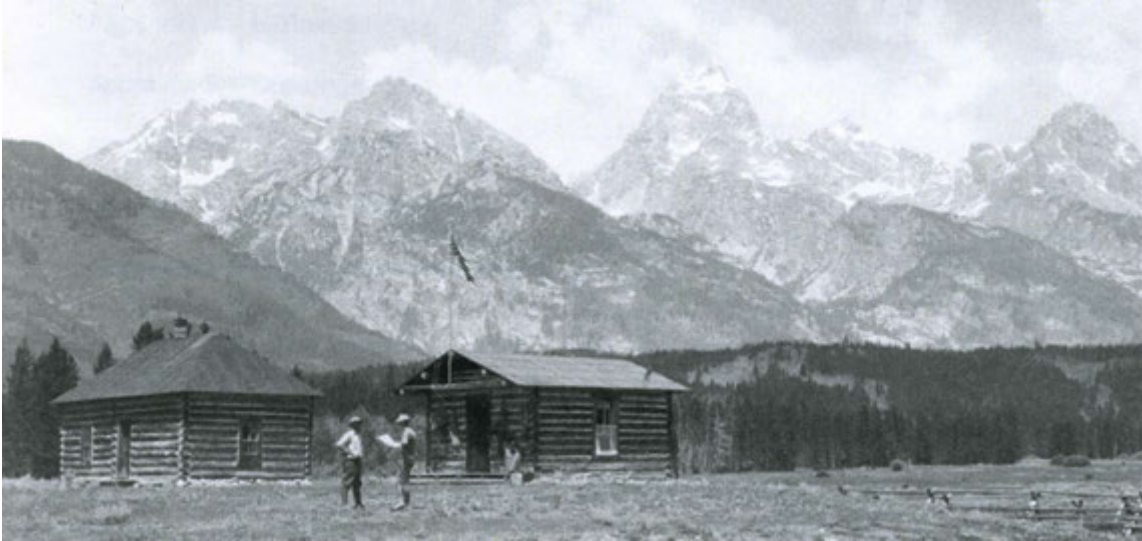
Forest Service Ranger Station and residence, circa 1908. Note the location of flagpole and buck and rail fence. Source: GRTE Cultural Resource files.

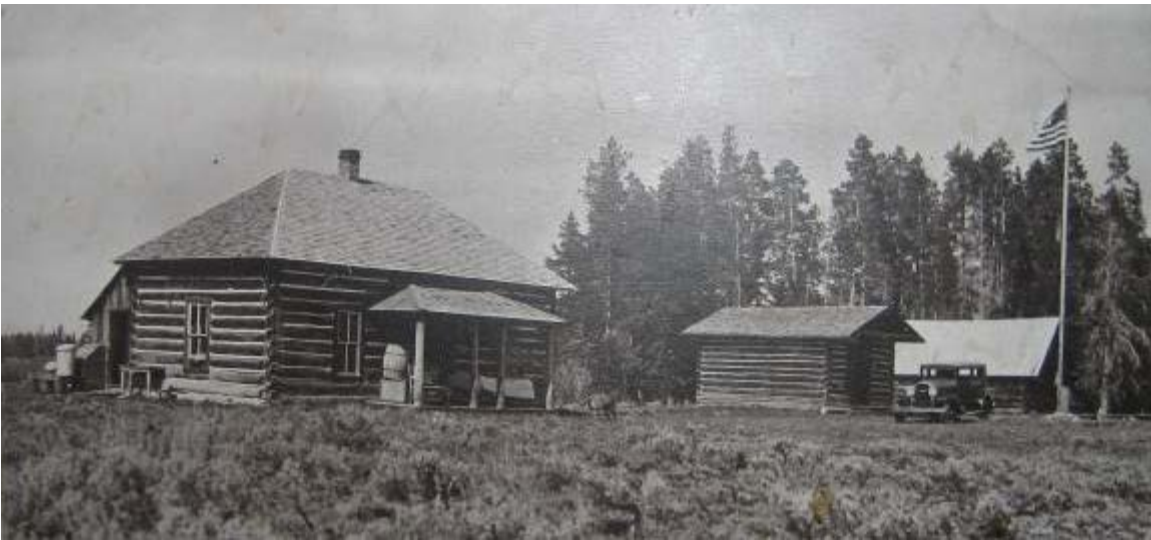
Forest Service Ranger Station, residence, and unidentified building sometime between 1908 and 1929. The Ranger Station and residence were later joined to create the Administration Building HS-10. Also note the loop drive with central flagpole. Source: GRTE Interpretive panel, Maud Noble cabin.

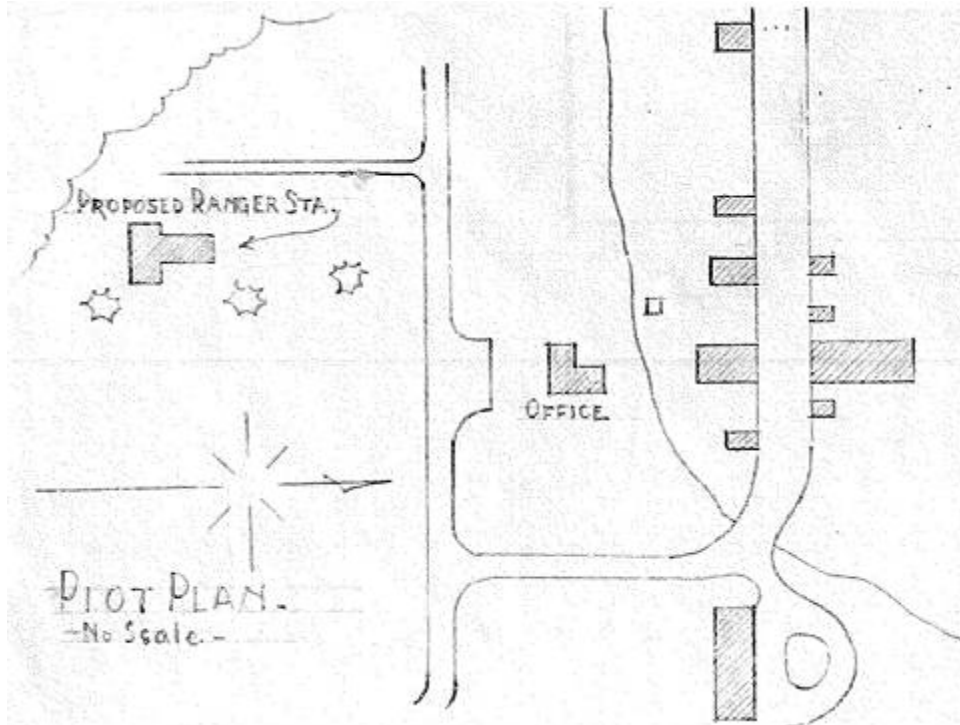
Plot plan for the proposed “Ranger Station at Headquarters” (Superintendent’s Residence, HS-1) showing existing buildings at Beaver Creek, 1934. Source: NPS e-TIC.

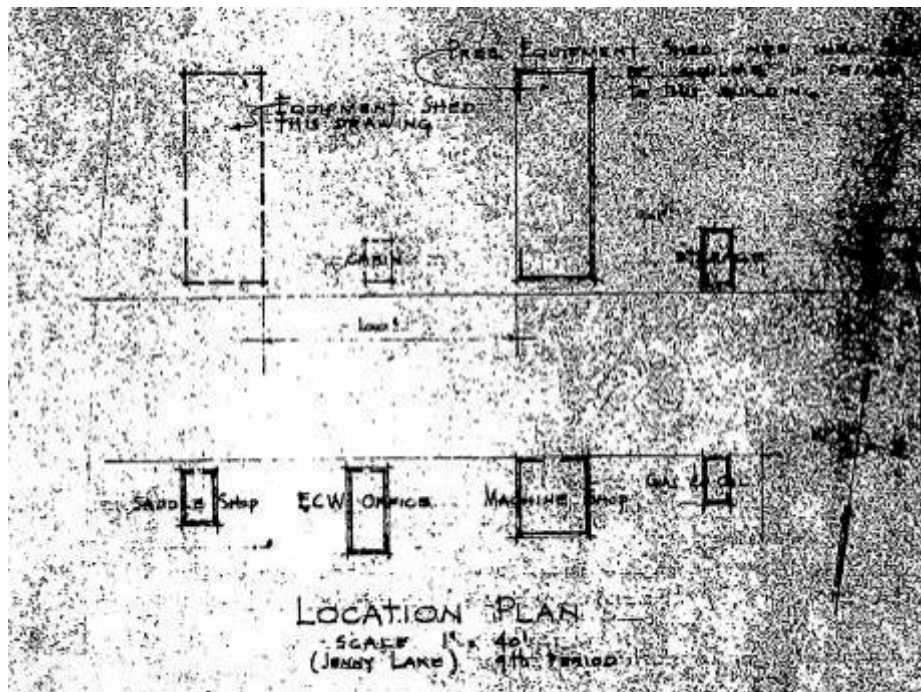
Location plan from “Equipment Shed” blueprints, showing existing and proposed buildings within the utility area, 1937. Source: NPS e-TIC.

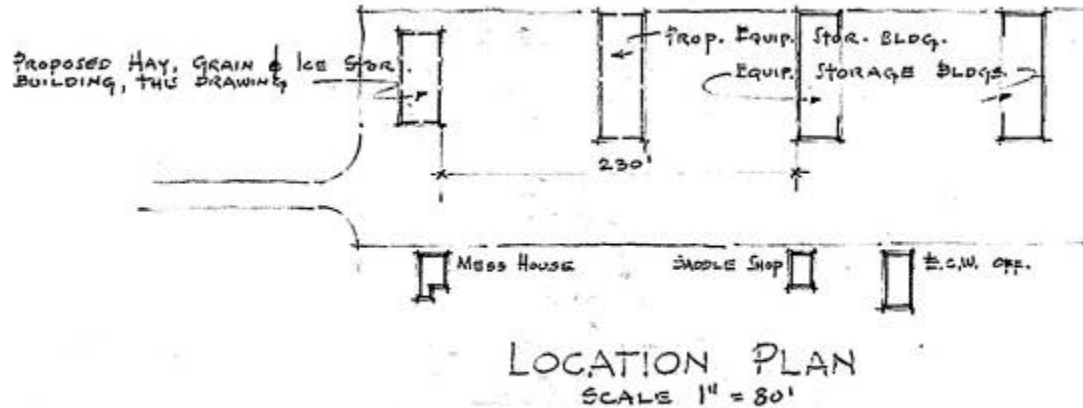
Location Plan from "Hay Grain & Ice Storage Building" plans showing existing and proposed buildings and spatial arrangements within the utility area, 1938. Source: NPS e-TIC.

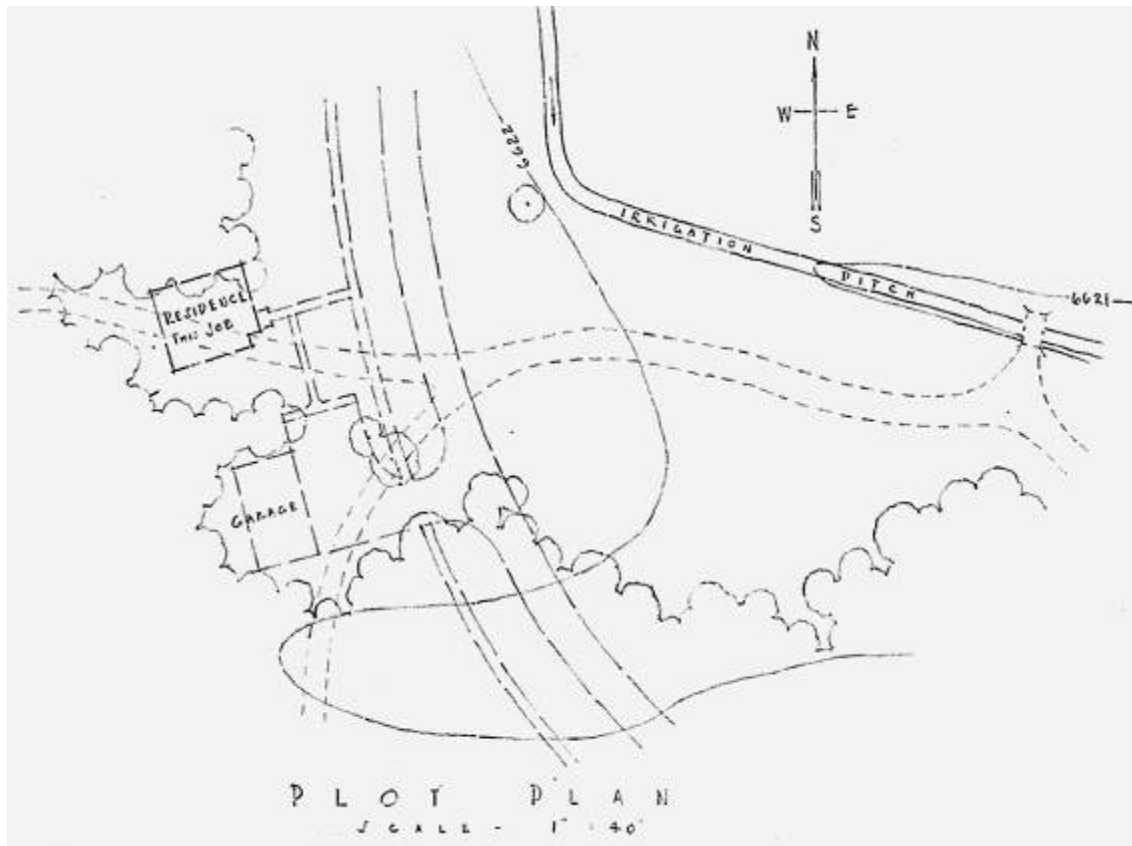
Plot Plan from "Employee's Residence" (HS-8) showing existing and proposed circulation patterns, buildings, irrigation ditch, and vegetation, 1938. Note: The residence HS-8 was built farther north than the location indicated here. Source: NPS e-TIC.

During this same time, plans were drawn for an expansion of the residential area to the south. The plot plan for an employee's residence (HS-8) shows the spatial organization of the western section of the residential area in 1938. An existing curvilinear road crossed the irrigation ditch and branched to the west and east. The western segment of the road continued toward the proposed site for HS-8, where it branched again in a "Y" to the west and southwest. This road was proposed to be replaced with a road in a sweeping curve that provided access to the residence from the southeast. A proposed parallel sidewalk mirrored the road to the west and connected to residential walks leading to the house and parking area near the garage. Despite the plan, the residence was later built in a slightly different location to the north, and the sidewalk was never built (Employee Residence, 1938).

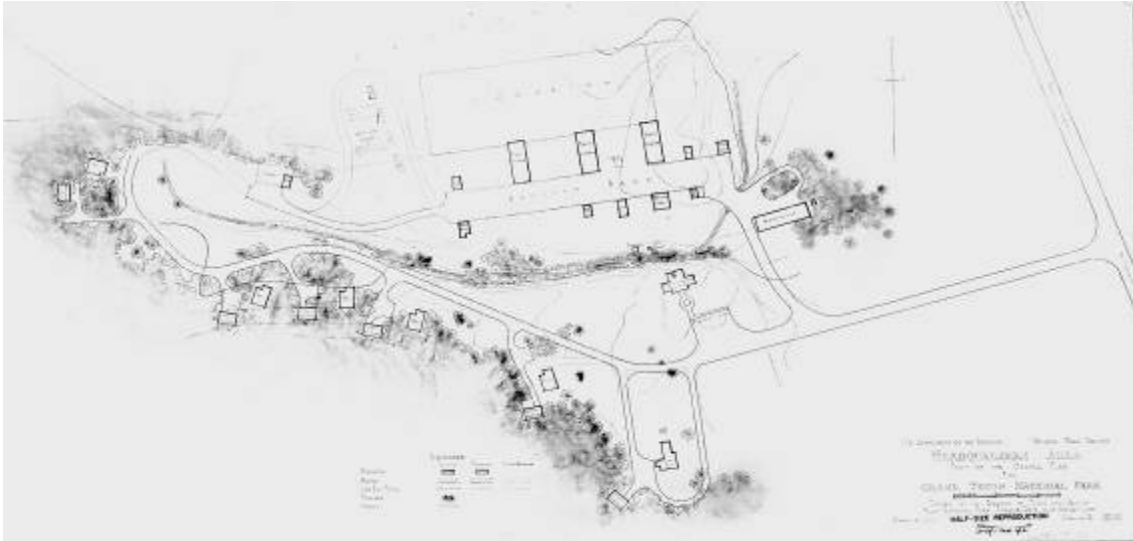
"Headquarters Area, Part of the Master Plan" showing existing and proposed spatial organization of the Beaver Creek area, 1939. Source: NPS e-TIC.

Proposed circulation routes on the 1939 master plan mainly focused on changes to vehicular circulation patterns in the west end of the residential area and the west end of the utility area. Beginning at the loop road north of employee residence (HS-2), the loop road and the road segments extending to the west were proposed to be removed. To replace it, the road was to be realigned farther north, away from the residences, turning north to the proposed location of employee residence (HS-8). Branching off of the realigned access road were proposed driveways and parking areas for each of the employee residences (Headquarters Area, Part of the Master Plan for Grand Teton National Park, 1939).

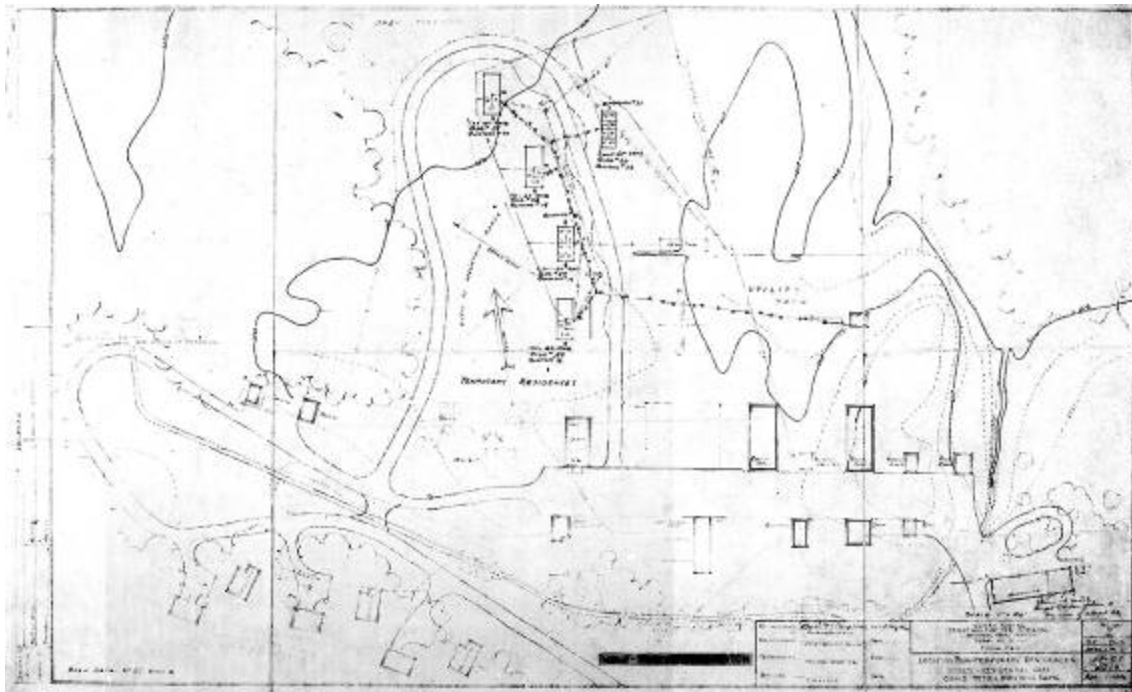
"Location Plan for Temporary Residences" showing new residences and northern loop road to the northwest of the utility area, 1946. Source: NPS e-TIC.

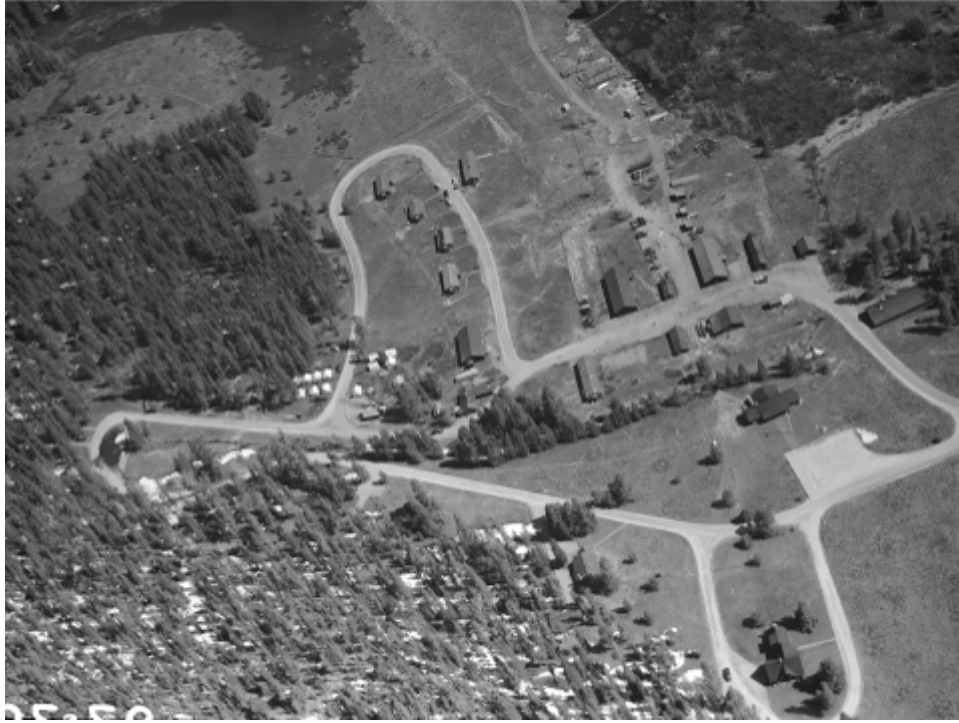
Aerial oblique view of Beaver Creek Administrative Area with new temporary residences and northern loop road, circa 1946. Source: GRTE Cultural Resource files.

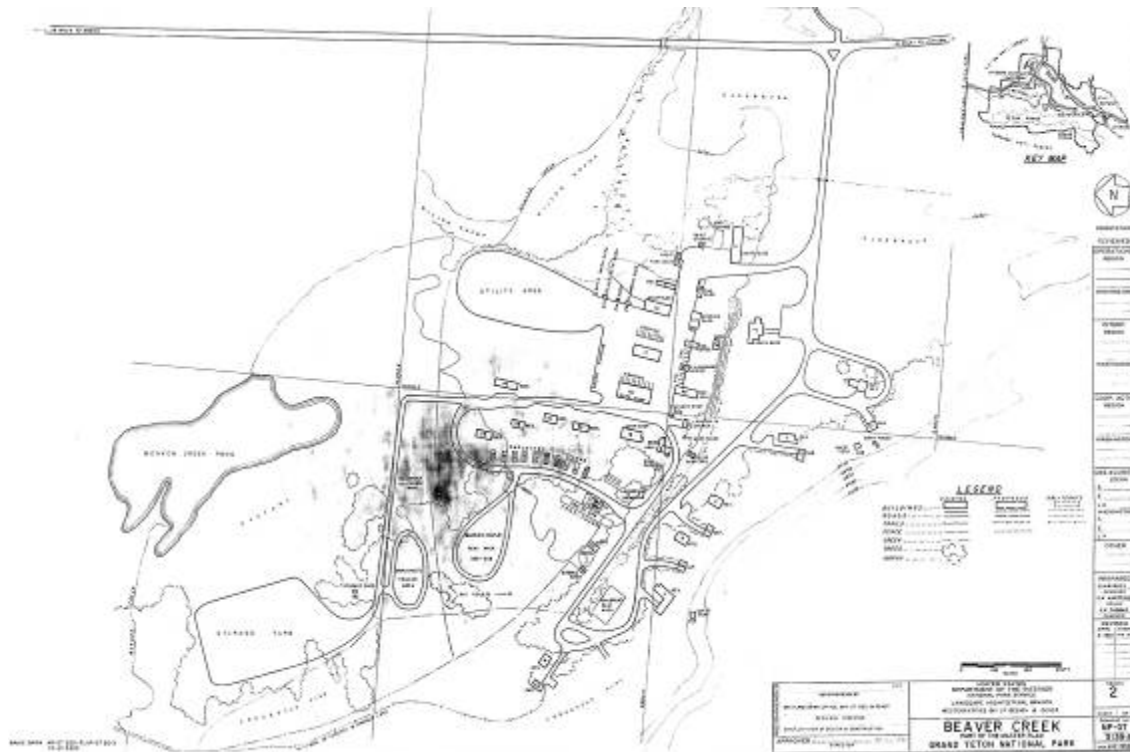
"Beaver Creek, Part of the Master Plan" showing existing and proposed spatial organization, 1956. Source: NPS e-TIC.

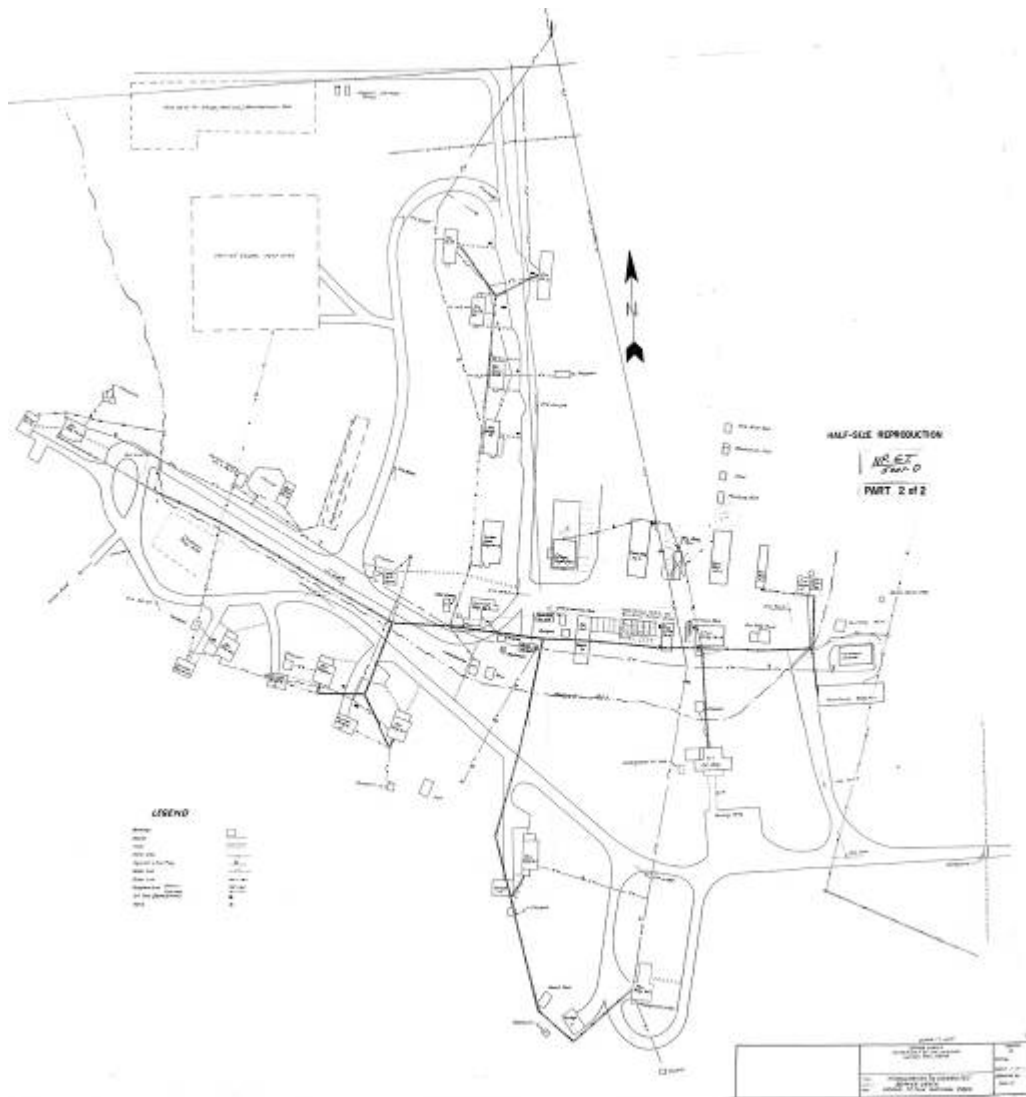
"Headquarters As Constructed" showing spatial organization, 1961. Note the density and arrangement of buildings throughout the residential area and utility area. Source: NPS e-TIC.

By 1961, the spatial organization of the area remained relatively unchanged from that of 1956. The drawing "Headquarters as Constructed" shows changes included the removal of the dorm (#78), removal of the auto storage building (#131), and addition of a residential trailer (#4) within the utility area. The foundation of the auto storage building (#131) is noted as an "outdoor dance floor". However, the plan shows an "X" through the outdoor dance floor and the residential trailer (#4) indicating that these were later removed. Other changes on the plan include the addition of a radio aerial pole east of the radio building (#27), a coal pile north of the equipment building (#16), and tents east of the cooks quarters (#103) and southeast of HS-5 (Headquarters as Constructed, 1961).

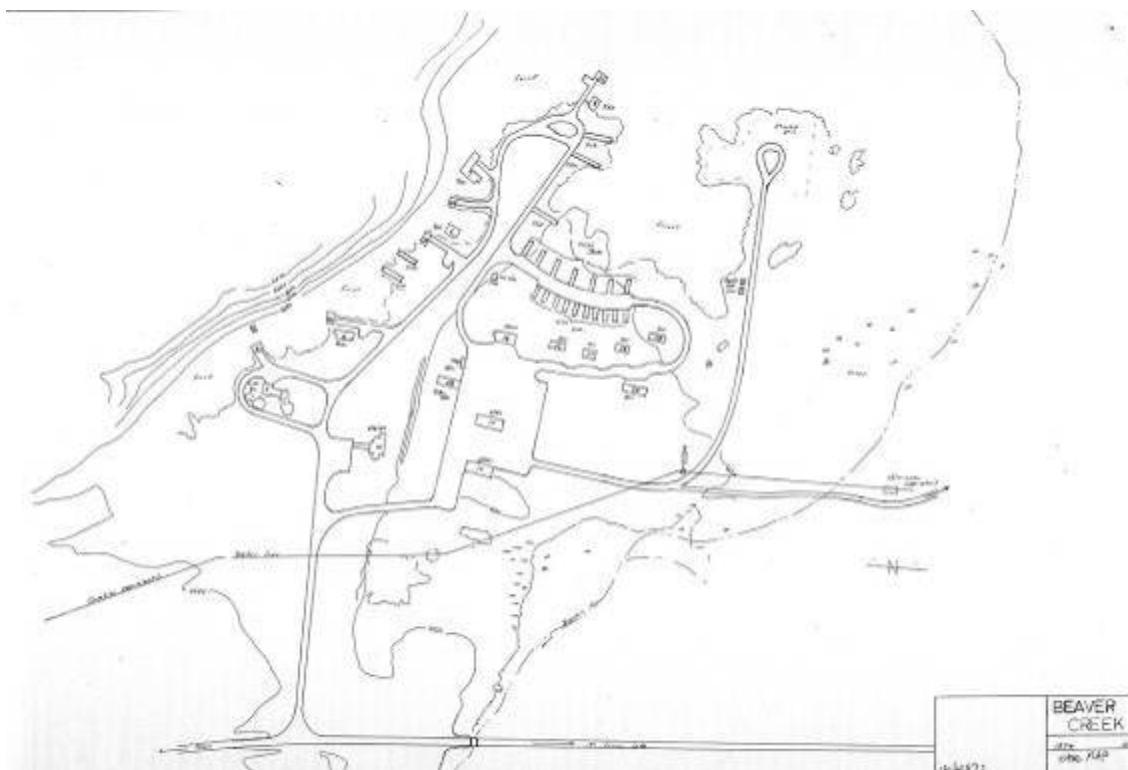
“Beaver Creek, Base Map” showing spatial organization, 1974. Note the loss of buildings throughout the utility area. Source: NPS e-TIC.

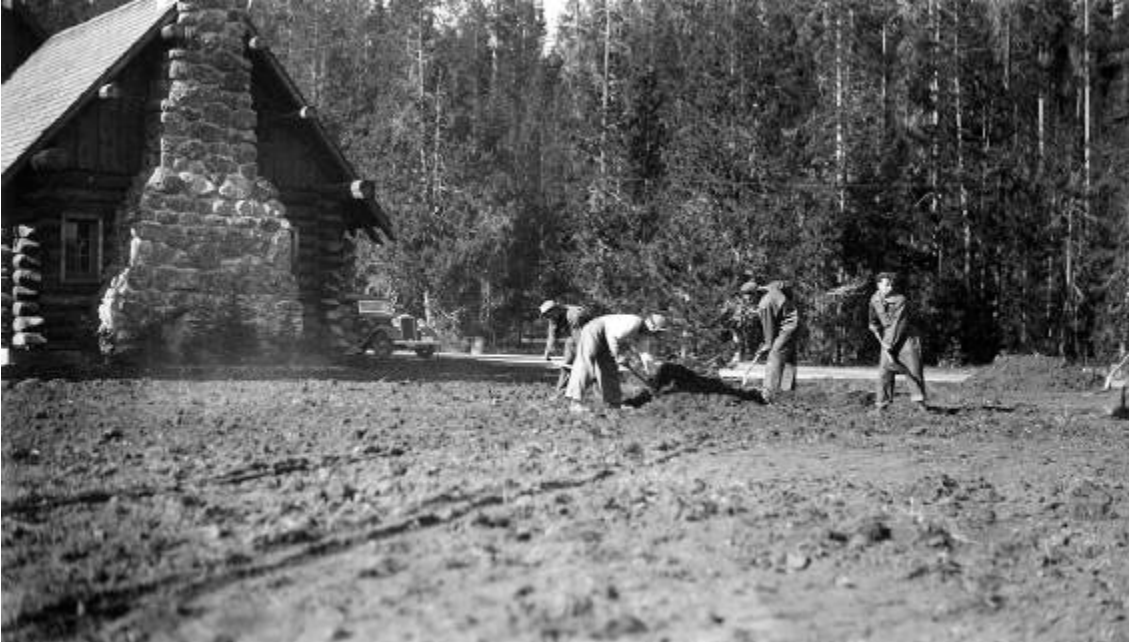
CCC crews installing the landscape plan around the Superintendent's residence (HS-1), circa 1936. Source: GRTE Cultural Resource files.

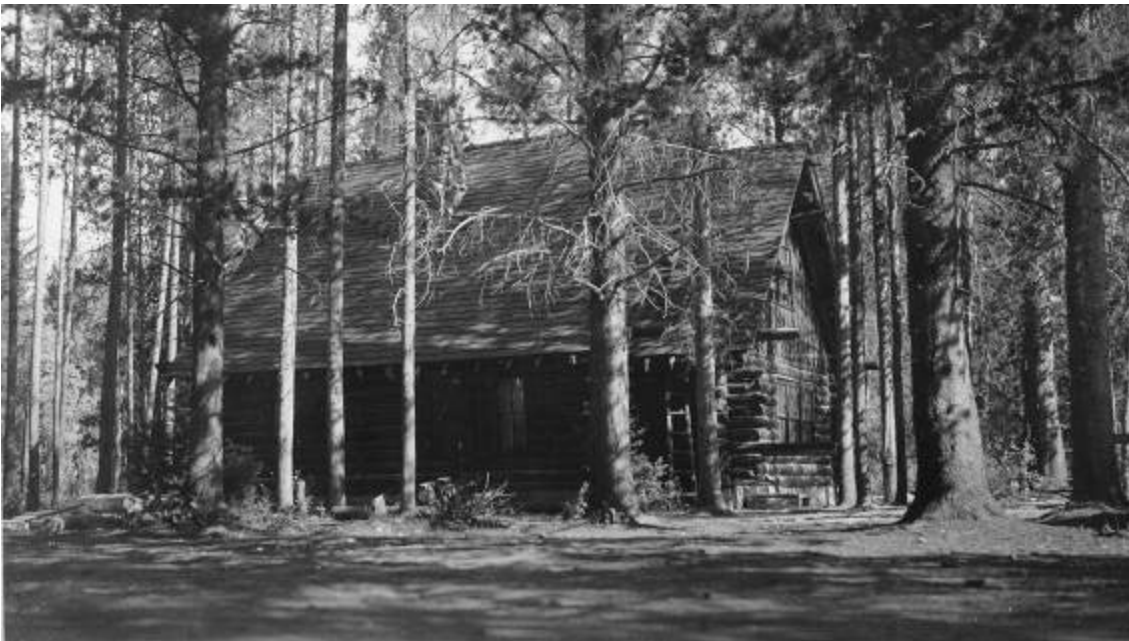
Vegetation surrounding Employee Residence (HS-8), circa 1939. Trees near the building have been removed over time due to safety and fire concerns. Source: GRTE Cultural Resource files.
