Situated on the bluffs overlooking Pensacola Bay, Fort Barrancas was built to protect the United States from foreign invaders. Once considered vital to national defense, today Fort Barrancas illustrates the evolution of military technology and American values.

## Guide to Fort Barrancas

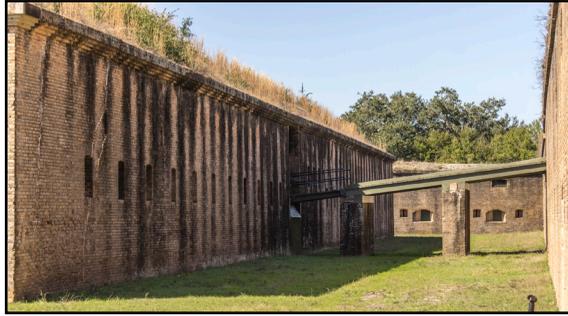
**2. Scarp and Counterscarp:** The main walls (scarp) supported the barbette which provided defense against both ships and infantry. The outer walls (counterscarp) supported the glacis and provided loopholes for muskets and embrasures for cannon to fire into the ditch.

**3. Ditch:** A dry ditch covered two sides of the fort. Assaulting infantrymen who entered the ditch would suffer heavy casualties from musket and cannon fire through openings in the walls.

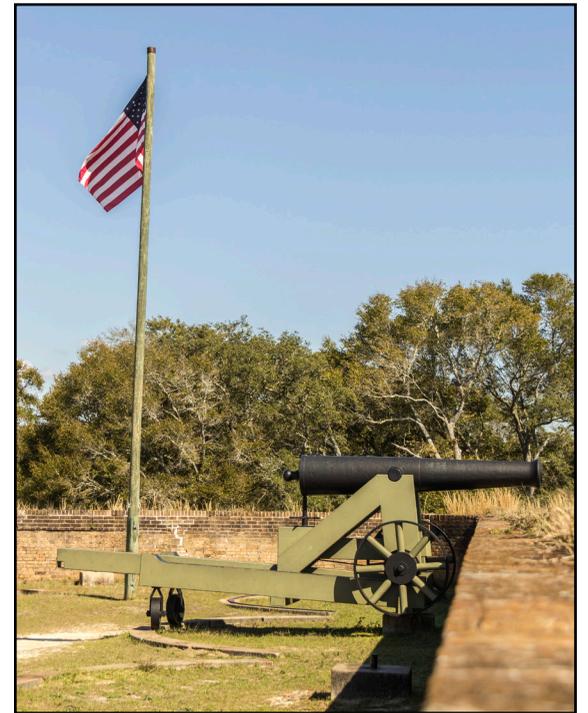
Spanish Water Battery

Built between 1839 and 1844, Fort Barrancas was the third fort established on the bay. It was constructed over the ruins of a 1798 Spanish fort named Fort San Carlos de Barrancas. Situated below the barrancas (Spanish for bluffs) was a 1797 water battery named Bateria de San Antonio. The water battery was retained and modified for use by the Army.

**10. Water Battery:** The tunnel from the parade leads to the water battery. Cannon projectiles from the battery ricocheted off of the surface of the bay to hit ships at the water line.

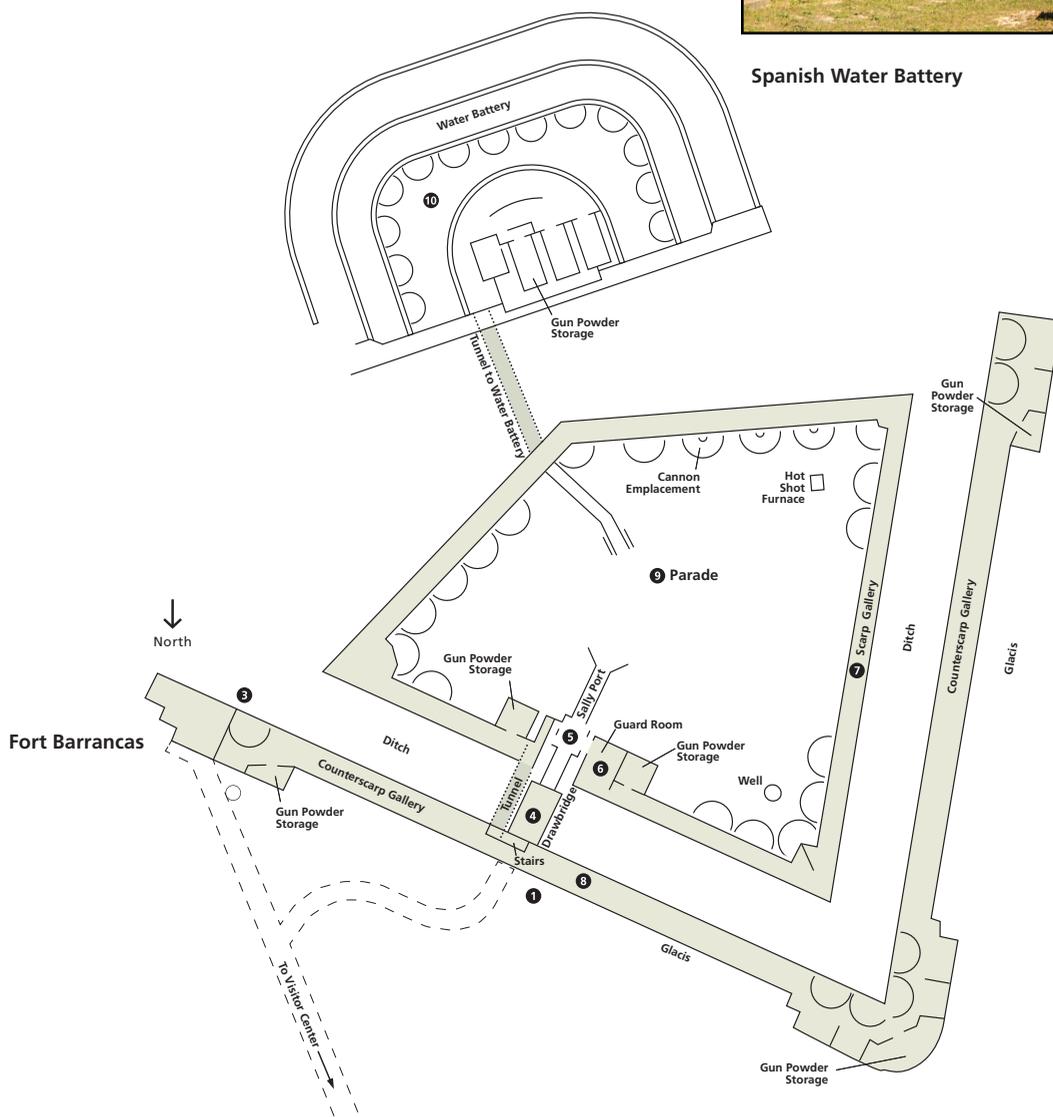
**1. Glacis:** This gentle earthen slope protected the fort from land-based artillery while exposing attacking infantrymen.

**4. Drawbridge:** Operated by a counterweight and winch, it pivoted at the center. It could be raised to isolate the fort's scarp from a land-based attack.

**5. Sally Port:** The main entrance to the fort was guarded by heavy oak doors. A small wicket gate allowed entry without opening the main doors.

**6. Guard Room:** This room had four bunks and a six-man guard detail. Soldiers rotated with two men on guard duty (2-hours on, 4-hours off, for 24-hours) while four men rested. The main barracks were to the east of the fort.

**7. Scarp Gallery:** A series of arches supported the sand fill and allowed access to the loopholes for muskets. Vertical vents above the loopholes allowed smoke from the guns to escape.

**8. Counterscarp Gallery:** A tunnel under the ditch leads to this casemated area, containing loopholes for muskets, embrasures for cannon, and powder magazines to allow reverse fire into the ditch.

**9. Parade:** This open area is where troops were inspected or drilled. The foundation in the corner indicates where a hot shot furnace, in which round shot was heated before firing, once stood.
