**National Park Service  
Cultural Landscape Inventory  
2006**

**Crater Rim Historic District  
Hawaii Volcanoes National Park**

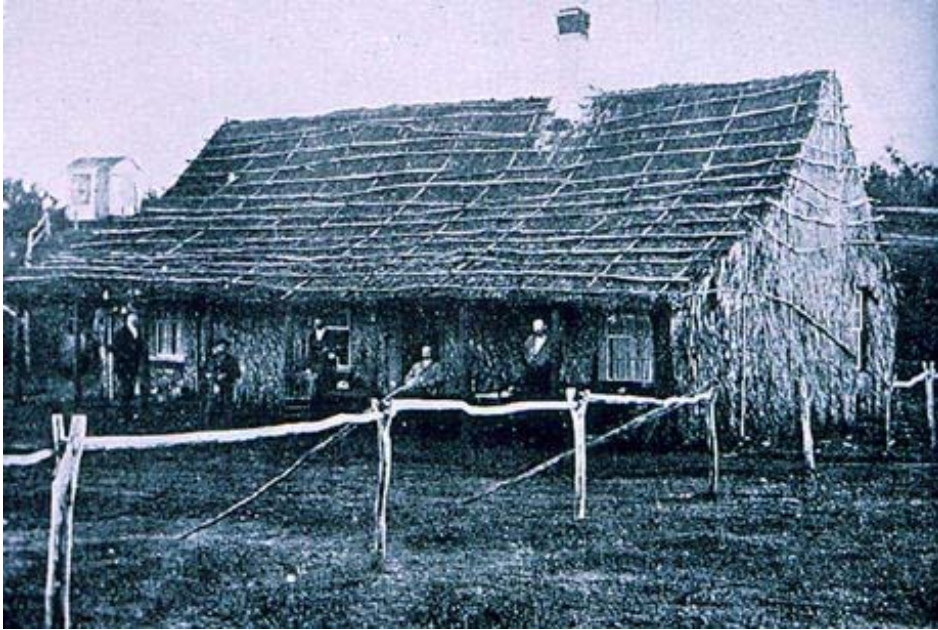
History #1. The grass thatch and ohia pole Volcano House built in 1866. It was here that Mark Twain stayed during his visit to Kilauea the same year. (Olson 1941)

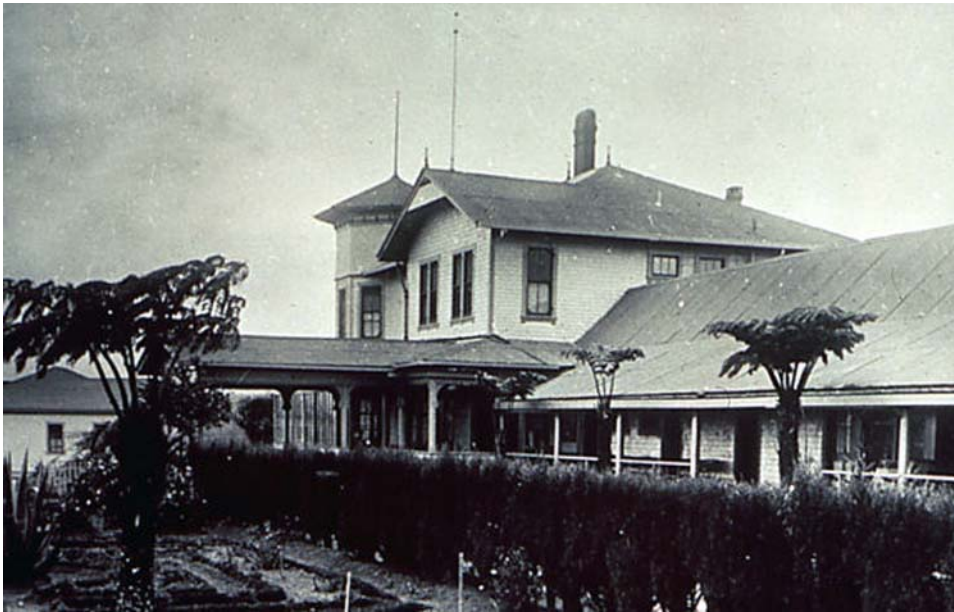
History #2. The Volcano House 1896-1921. The 1877 structure is visible on the right side of the photo; on the left is the two-story 1896 addition with the porte-cochere. (Olson 1941)

In 1877, the ohia pole and grass thatch Volcano House was replaced with a larger wooden hotel of Western architecture (see photo History #2). Mill work, such as doors and windows, hardware, and shingles, plus some other building materials and furniture, were landed at Keauhou Landing in Puna and transported via mule and horseback to Ainahou stables, part way between the ship landing and the hotel. At Ainahou, the materials were loaded onto two-wheel carts and hauled to the construction site. Rafters, studs, and posts were cut locally from ohia lehua trees. (Old Volcano House National Register Nomination)

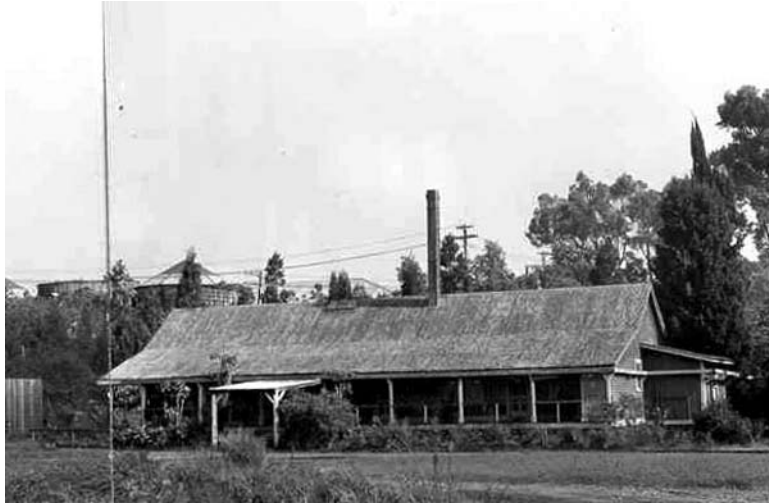
History #3. The 1877 Volcano House structure was moved approximately 90 feet from its original location when the 1921 additions were added. The 1877 Volcano House is seen here ca. 1945. (NPS Travelogue 1945)

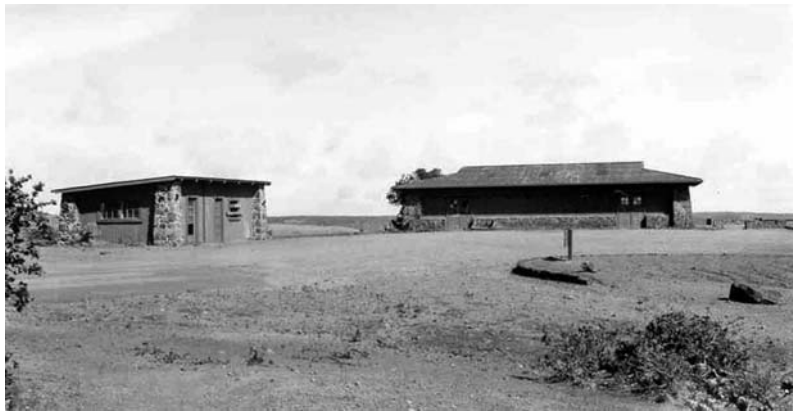
History #4. The museum (right) and comfort station (left) at Uwekahuna Bluff. These original buildings were built in 1927 by the Hawaii Volcano Research Association. (NPS Travelogue 1945)

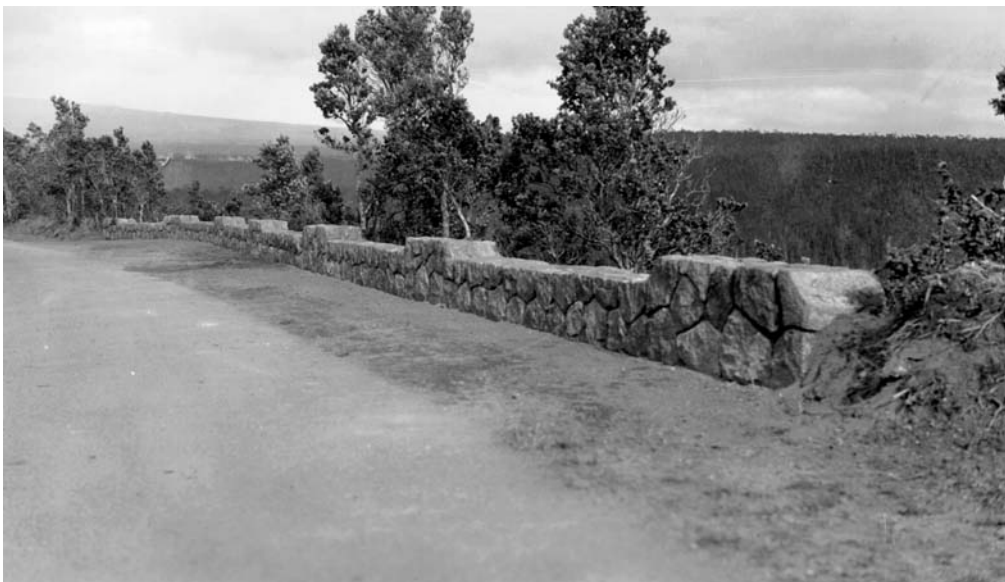
History #6. 1934 photo of the Kilauea Iki parapet guard wall. (HAVO Landscape Architect's Reports 1934)

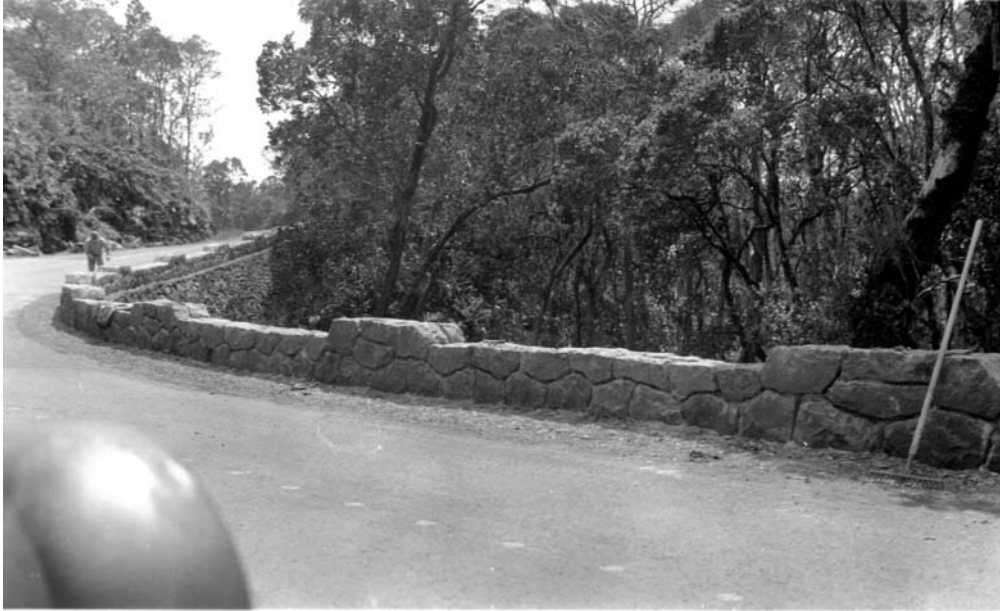
History #7. 1934 photo of the parapet guard wall at Thurston Lava Tube parking lot. The earlier stone retaining wall on which the guard wall was built is visible on the outside of the wall. (HAVO Landscape Architect's Reports 1934)

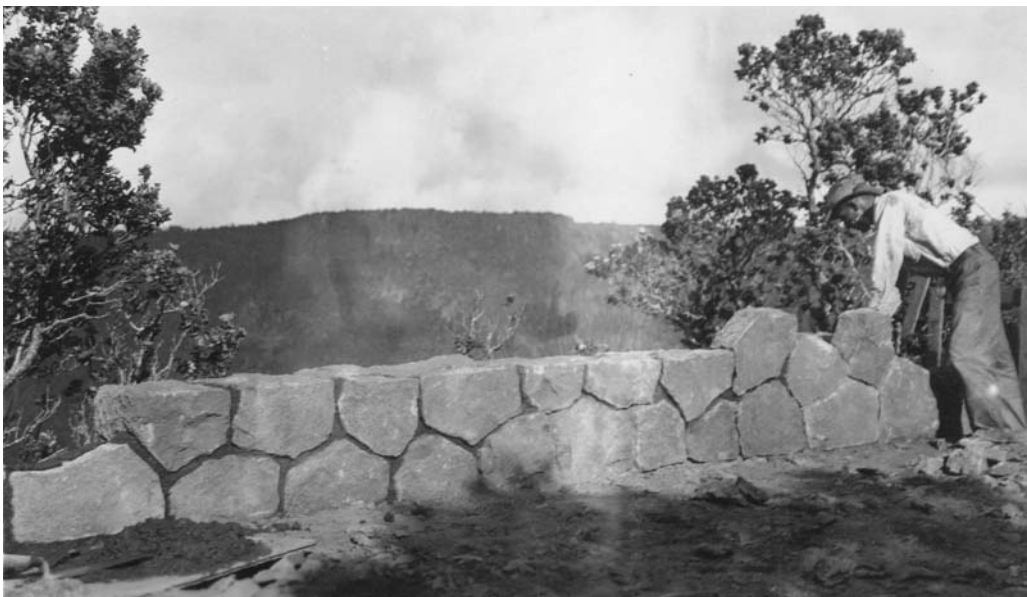
History #8. Parapet guard wall under construction in 1934. All of the guard walls constructed along Crater Rim Drive conformed to the specifications for the Type 2 guard wall developed by the NPS landscape department. (HAVO Landscape Architect's Reports 1934)

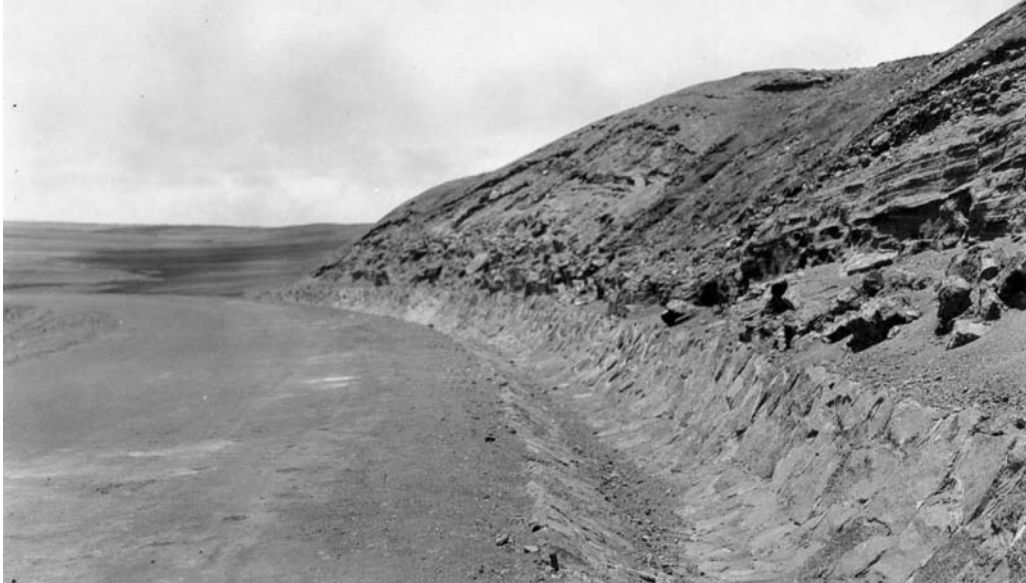
History #9. This stone-lined ditch was built by the CCC after heavy rains damaged the newly-built Uwekahuna-Bird Park road. This ditch is located on the grade just west of Halemaumau. (HAVO Landscape Architect's Reports 1934)

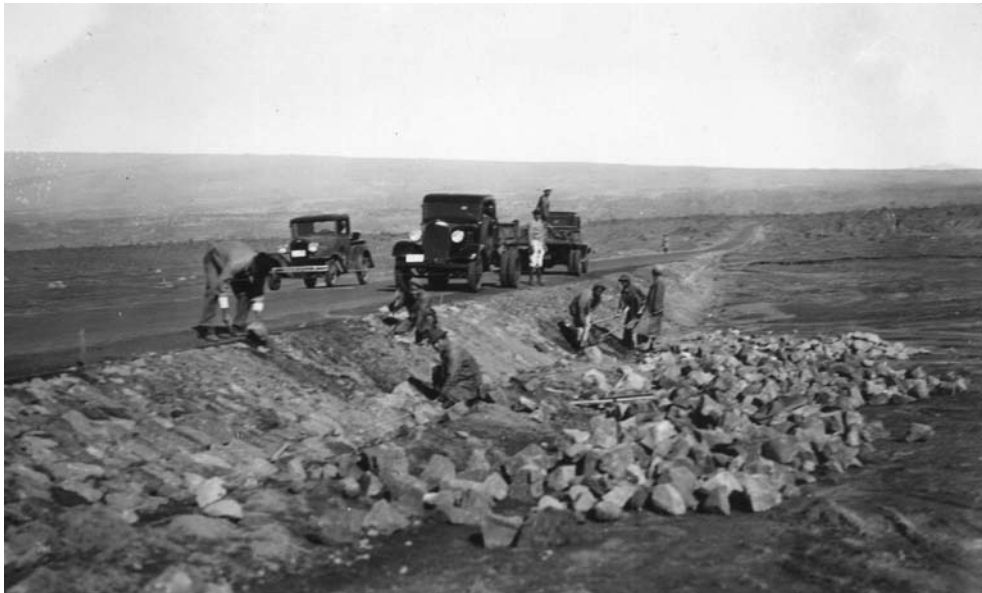
History #10. CCC crews installing mortared stone embankment facing on a section of Crater Rim Road in the Southwest Rift Zone in 1934. (HAVO Landscape Architect's Reports 1934)

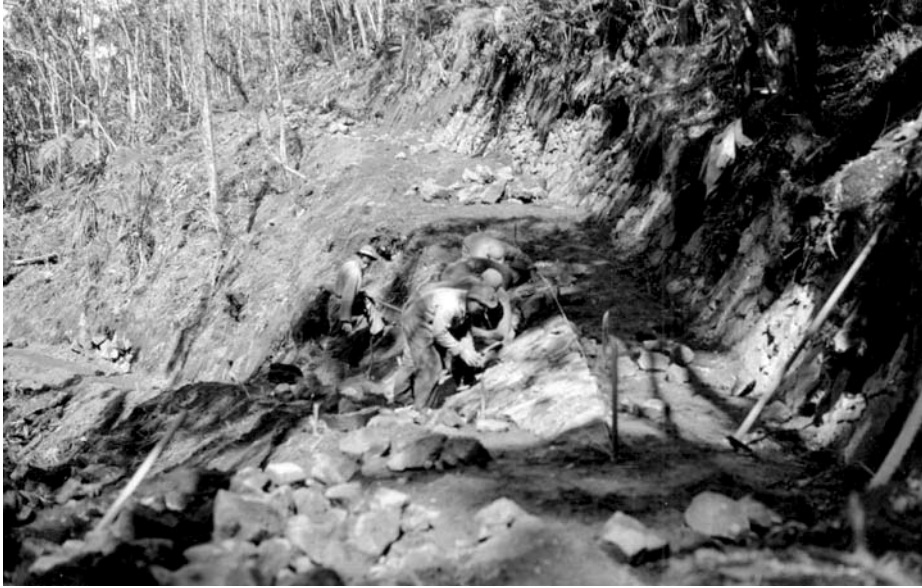
History #11. CCC crew laying stone embankment facing on a switchback of the Kilauea Iki trail in 1934. (HAVO Landscape Architect's Reports 1934)

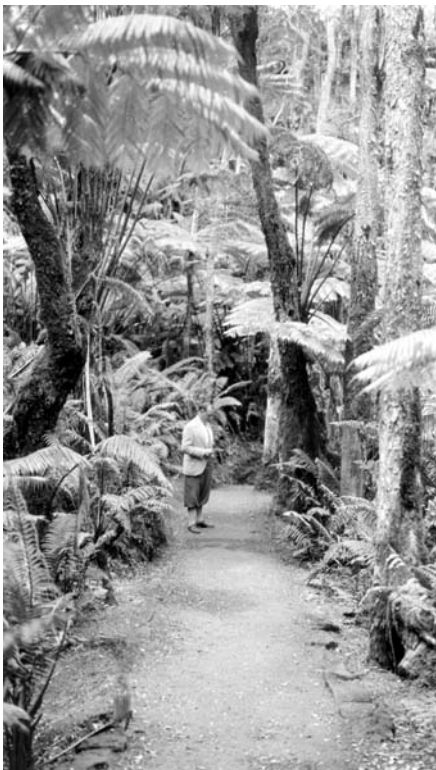
History #12. The Thurston Lava Tube trail as it appeared in the 1930s. The lush fern forest contrasted sharply with other parts of the caldera rim area. (HAVO Landscape Architect's Reports 1934)

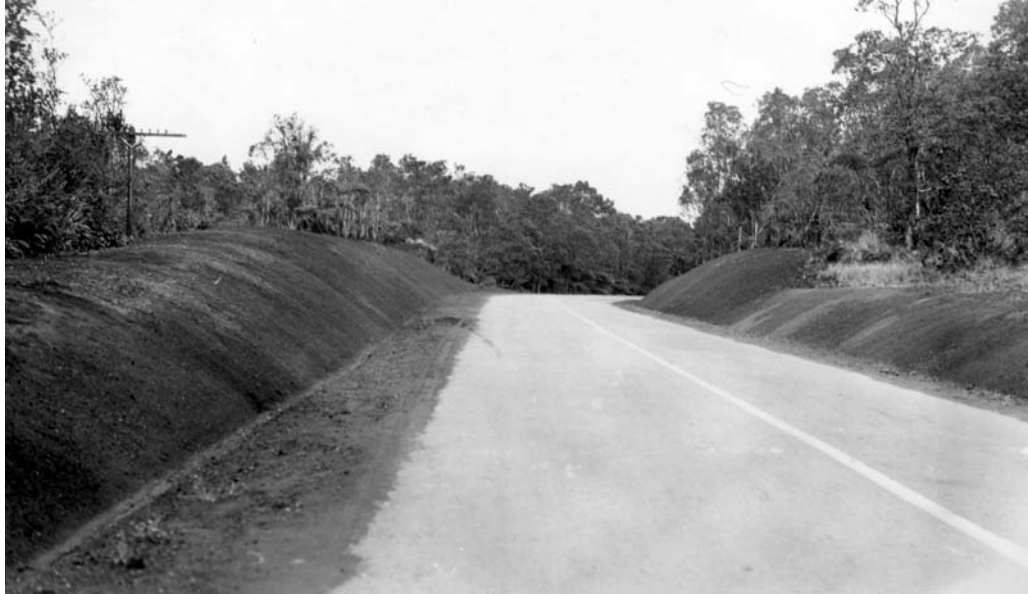
History #13. CCC crews rounded the slopes of road cuts and planted them with native vegetation to create a more naturalistic appearance and reduce erosion. The slopes are shown here in c. 1934, after they were rounded but before replanting. (HAVO Landscape Architect's Reports 1934)

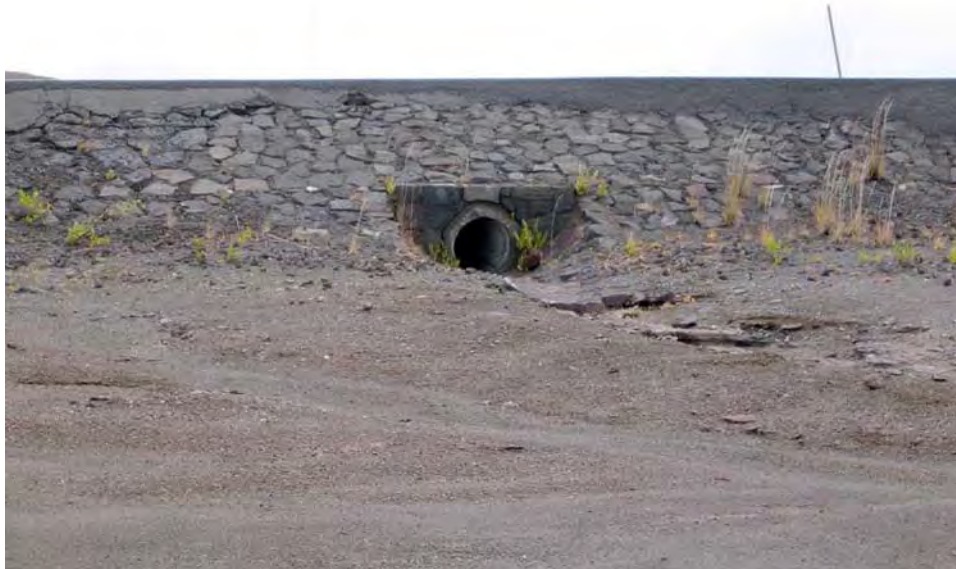
Circulation #1. Contemporary photo of the mortared-stone embankment facing and raised roadbed with culvert, located in the Southwest Rift Zone. Asphalt covers the top of the embankment from successive road paving. (PWRO 2005)

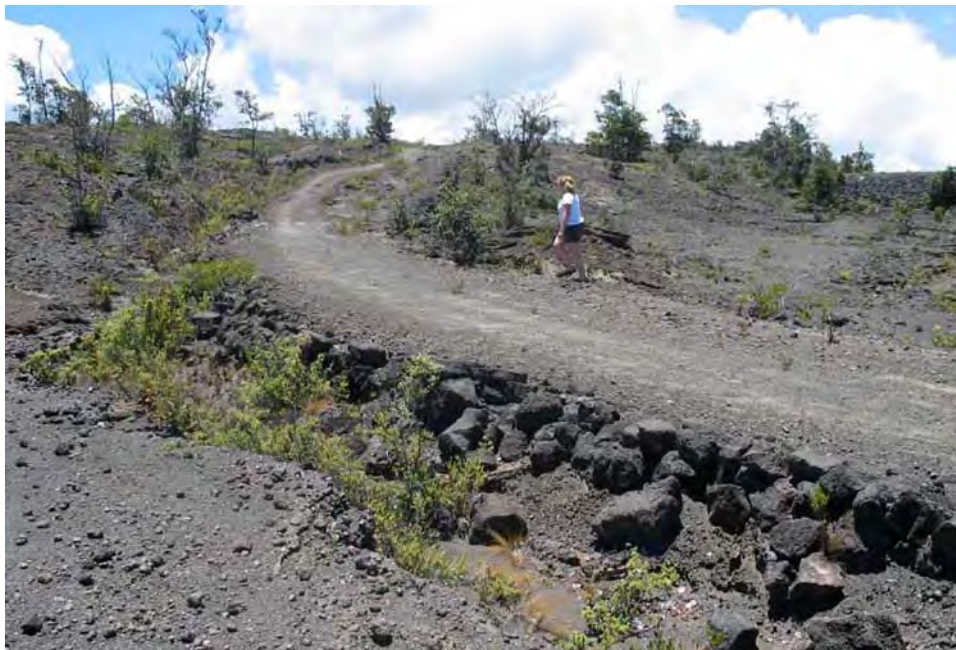
Circulation #2. Road traces and remnant retaining walls, most likely from Leavitt's Road from Uwekahuna to Halemaumau built in 1931, are today part of the Crater Rim Trail in the northwest corner of the caldera. (PWRO 2005)

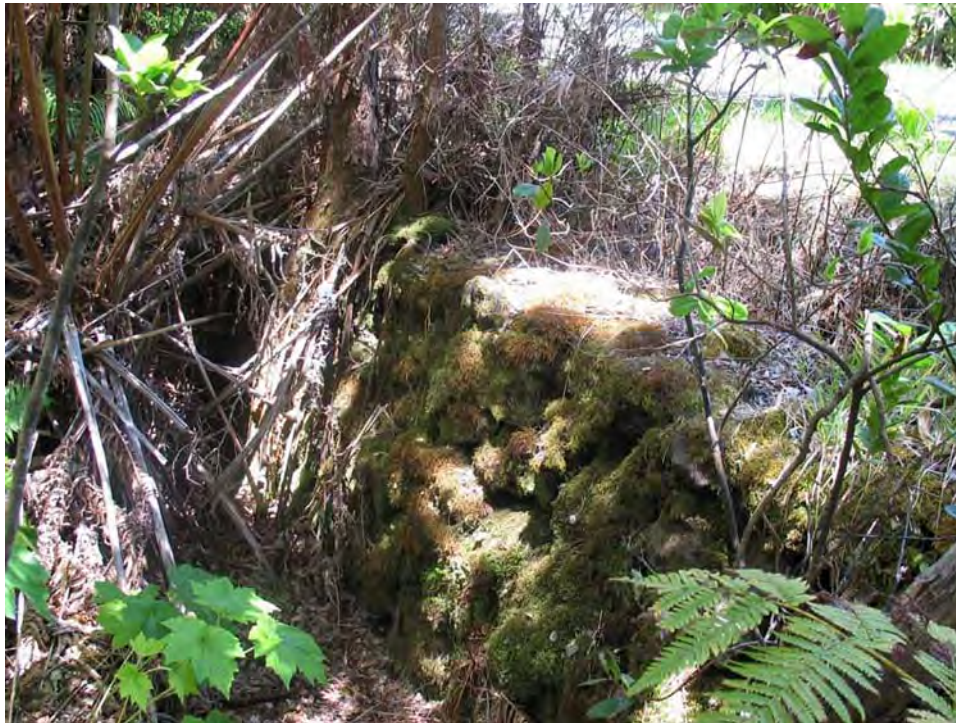
Circulation #3. Several remnants of retaining walls mark former road alignments of Crater Rim Drive. The wall remnants, which date to before the 1920s, are mostly hidden in the dense vegetation near the current road south of Thurston Lava Tube. (PWRO 2005)

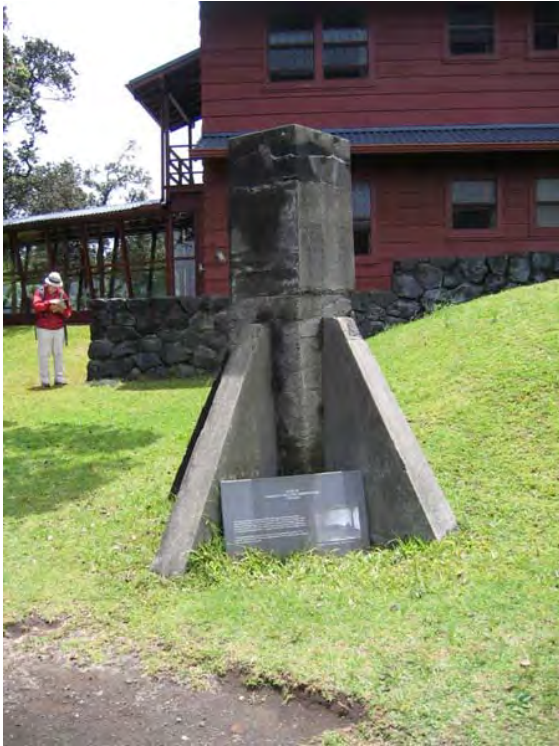
Buildings and Structures #3. Contemporary photo of the concrete pillar at the Whitney Seismograph Vault. The vault is beneath the mound in the background. (PWRO 2005)

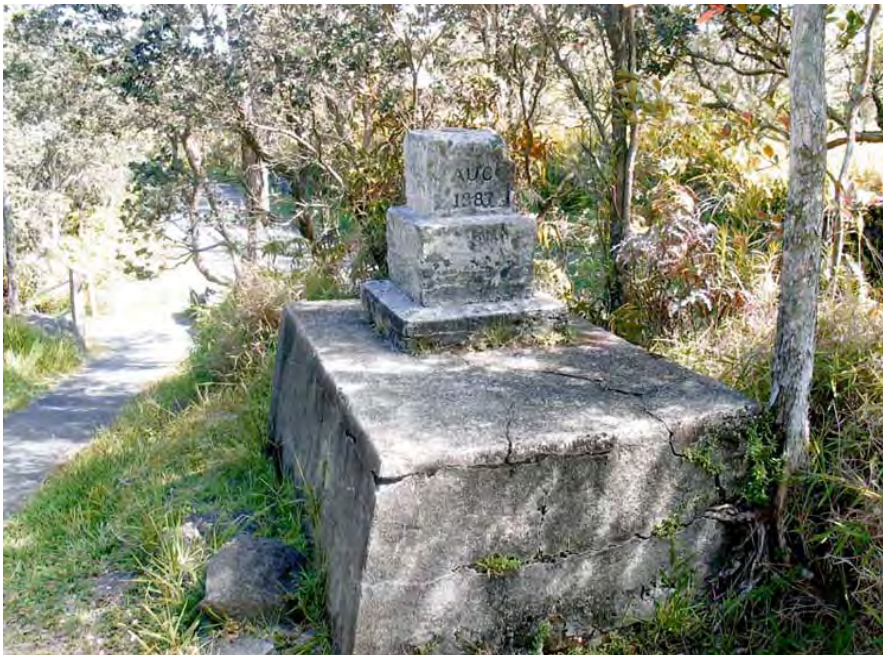
Buildings and Structures #4. The concrete marker, inscribed "AUG 1887", may be a monument marking the completion of Peter Lee's road from Pahala to the Volcano House. (PWRO 2005)

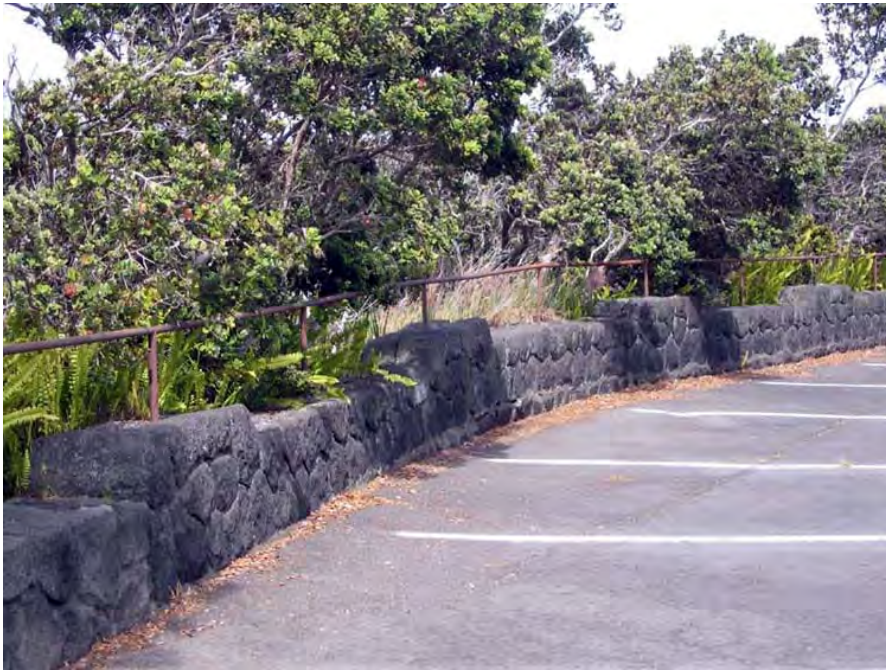
Buildings and Structures #5. The stone guard wall at Puu Puai parking lot was once along the Crater Rim Drive alignment. The metal guard rail was installed after the period of significance. (PWRO 2005)

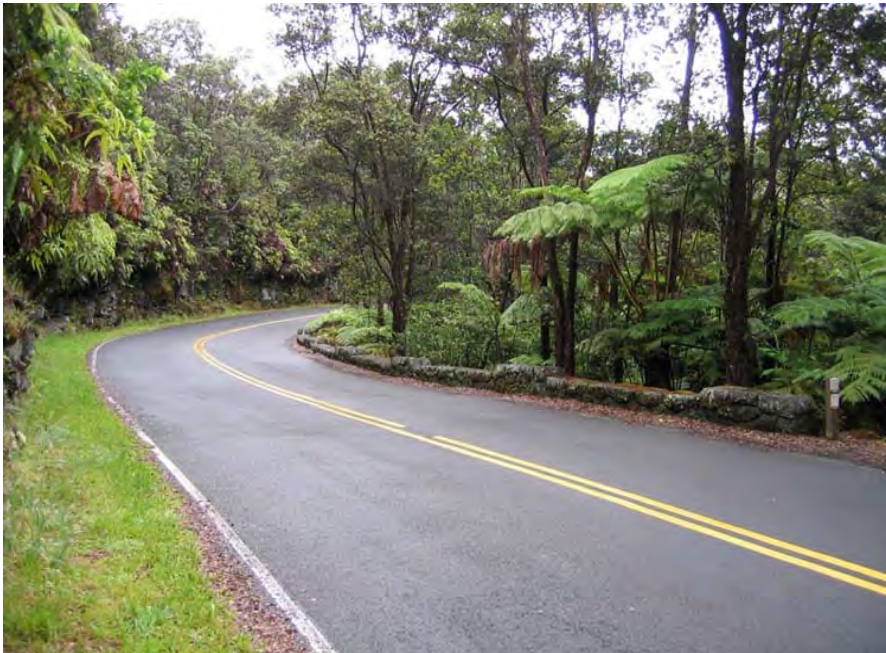
Buildings and Structures #6. The guard wall at the Thurston Lava Tube parking lot is lower than when it was constructed, either from settling, a build-up of paving matrix, or a combination of both. Compare with photo History #7. (PWRO 2005)

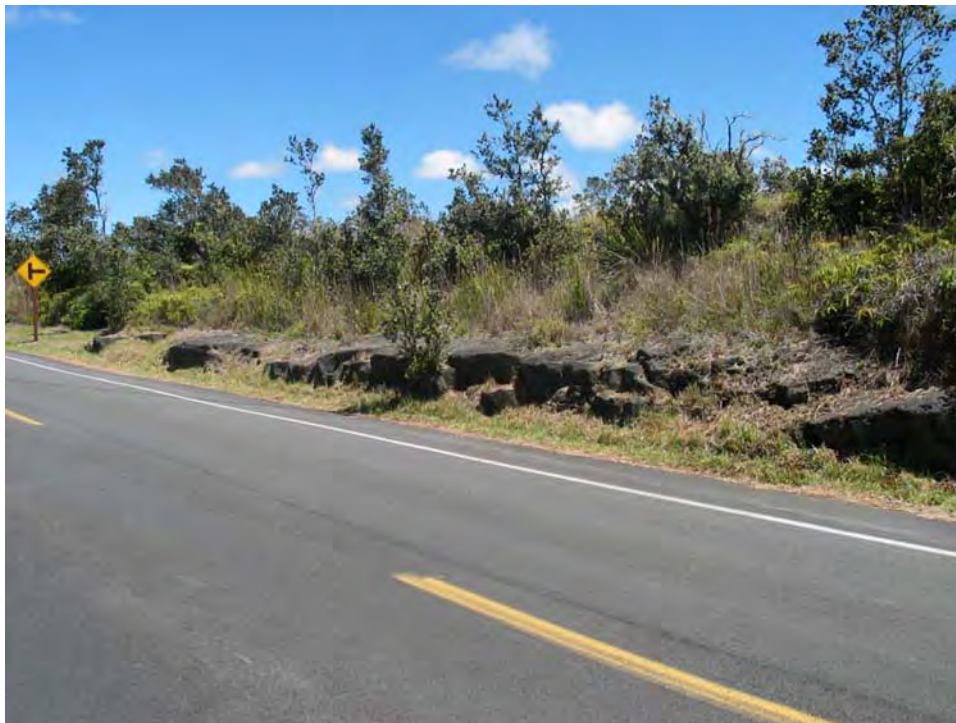
Topography #1. Rock cuts in the dark volcanic rock west of the headquarters site look like natural rock outcroppings. (PWRO 2005)

As the alignment of Crater Rim Drive was adjusted throughout the 1920s, traces of the former roadbed were left alongside the new road. These can be seen today in the near-road topography in the fern jungle and in the Southwest Rift area. In the fern jungle, these road traces are often accompanied by fragments of retaining wall and reveal where the sharp curves of the early road were eased. In the Southwest Rift area, the road traces are from the first road between Halemaumau and Uwekahuna built in 1931.

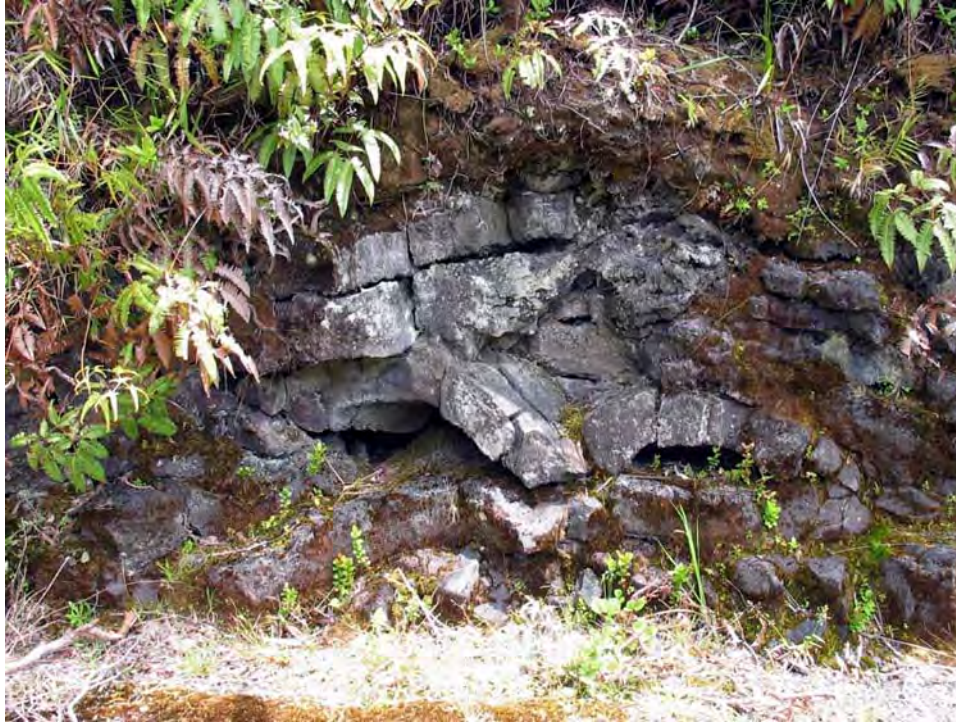
Topography #2. Rock cuts near Kilauea Iki reveal unique volcanic formations. (PWRO 2005)

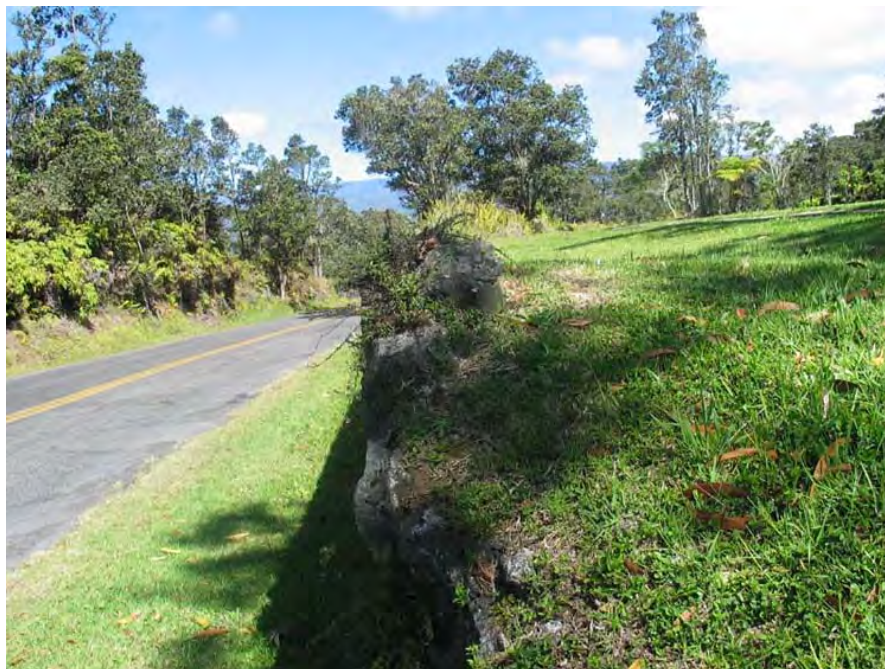
Topography #3. The terrace that held the Volcano House before 1940 is retained by a combination of stone retaining wall and natural rock cut. (PWRO 2005)

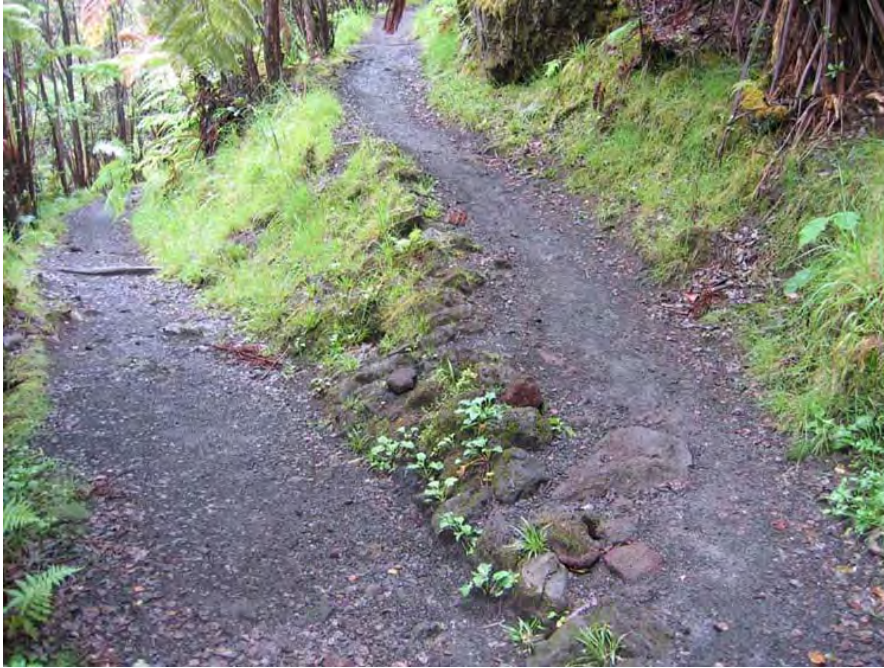
Topography #4. Contemporary photo showing grading on the Kilauea Iki Trail, built by the CCC in 1934. Stone riprap and dry-stacked retaining walls were used to support the steep slopes and switchback corners. (PWRO 2005)

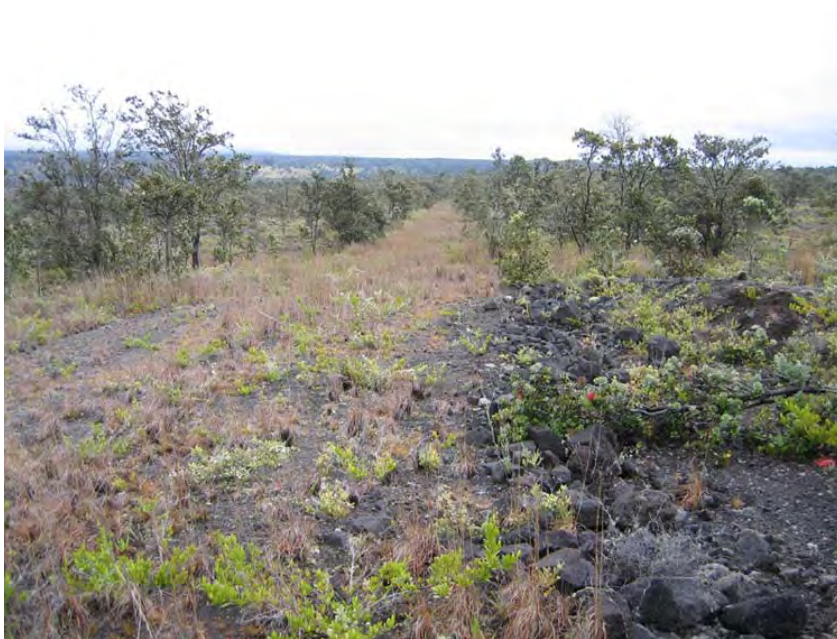
Archeological Sites #1. Although not visible from Crater Rim Drive, the Uwekahuna-Bird Park Road trace is evident from the topography and vegetation patterns. (PWRO 2005)

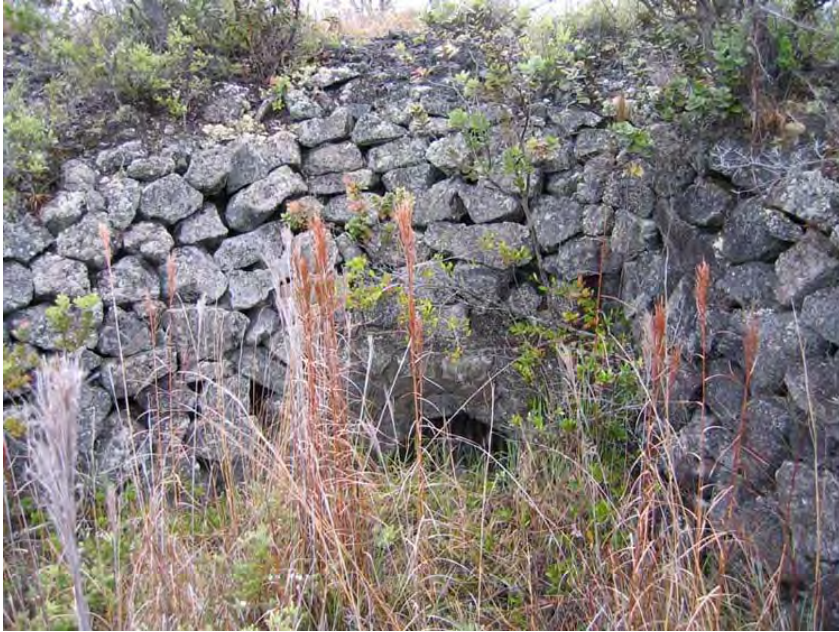
Archeological Sites #2. Several culverts, including this one with a dry-stacked retaining wall above it, remain on the abandoned Uwekahuna-Bird Park Road trace. (PWRO 2005)

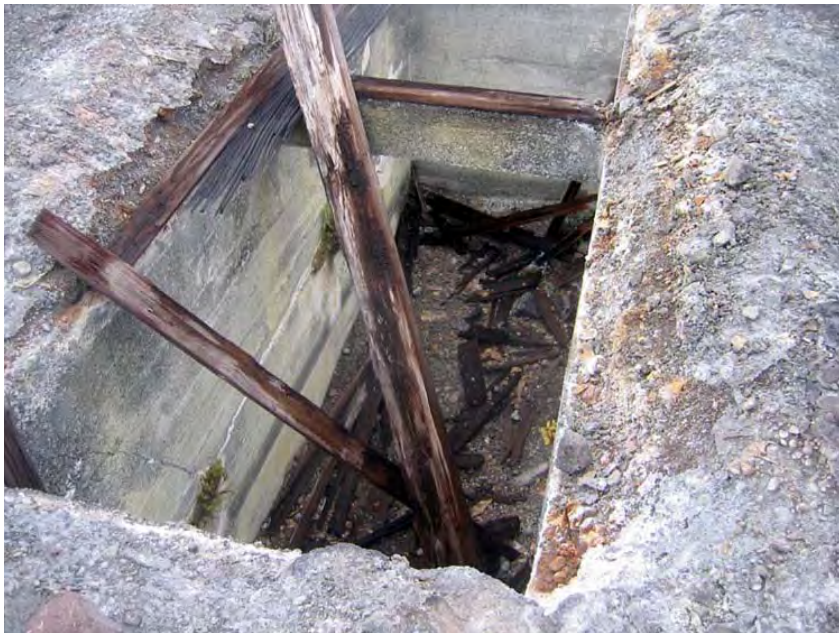
Archeological Sites #3. One of two concrete vaults cut into the lava near the Halemaumau parking lot. These vaults were likely the two comfort stations built sometime in the 1920s or 1930s. (PWRO 2005)

Two concrete vault located near the Halemaumau parking lot are likely the remnants of restrooms that were located there in the 1930s. The vaults are approximately 4 feet by 10 feet and 6 feet deep. Remnants of timber framing are in and near the vaults.

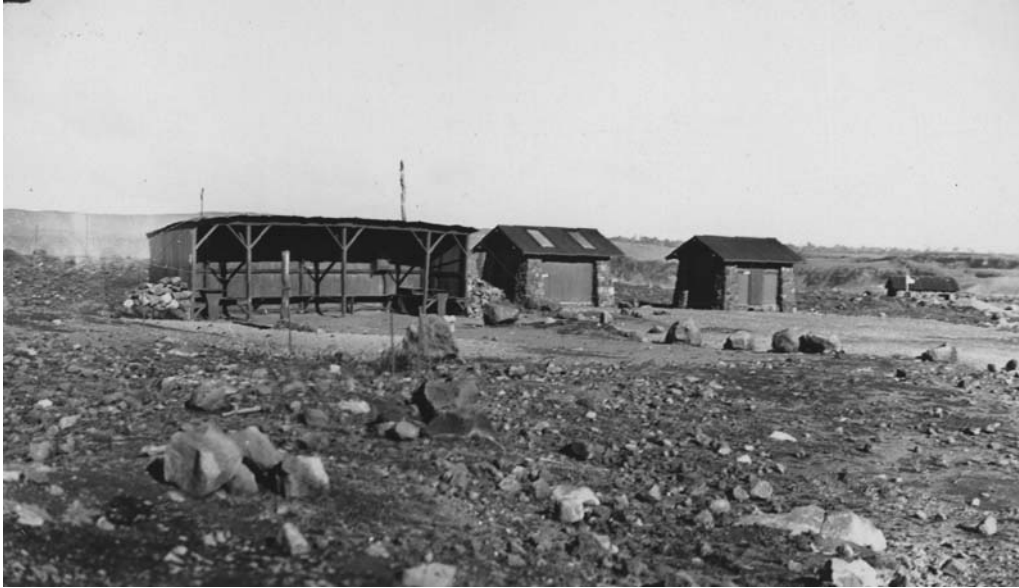
Archeological Sites #4. The shelter and two comfort stations at Halemaumau, c. 1934 (no longer extant).  
(HAVO Landscape Architects Reports)

#### Halemaumau Vaults (see photos Archeological Sites #3 and #4)
