**ORGAN PIPE CACTUS NATIONAL MONUMENT**

**Alamo and Kuakatch Wash floods of the 2012 monsoon: a short  
summary from Organ Pipe Cactus National Monument Natural  
Resources Division**

November 13, 2012

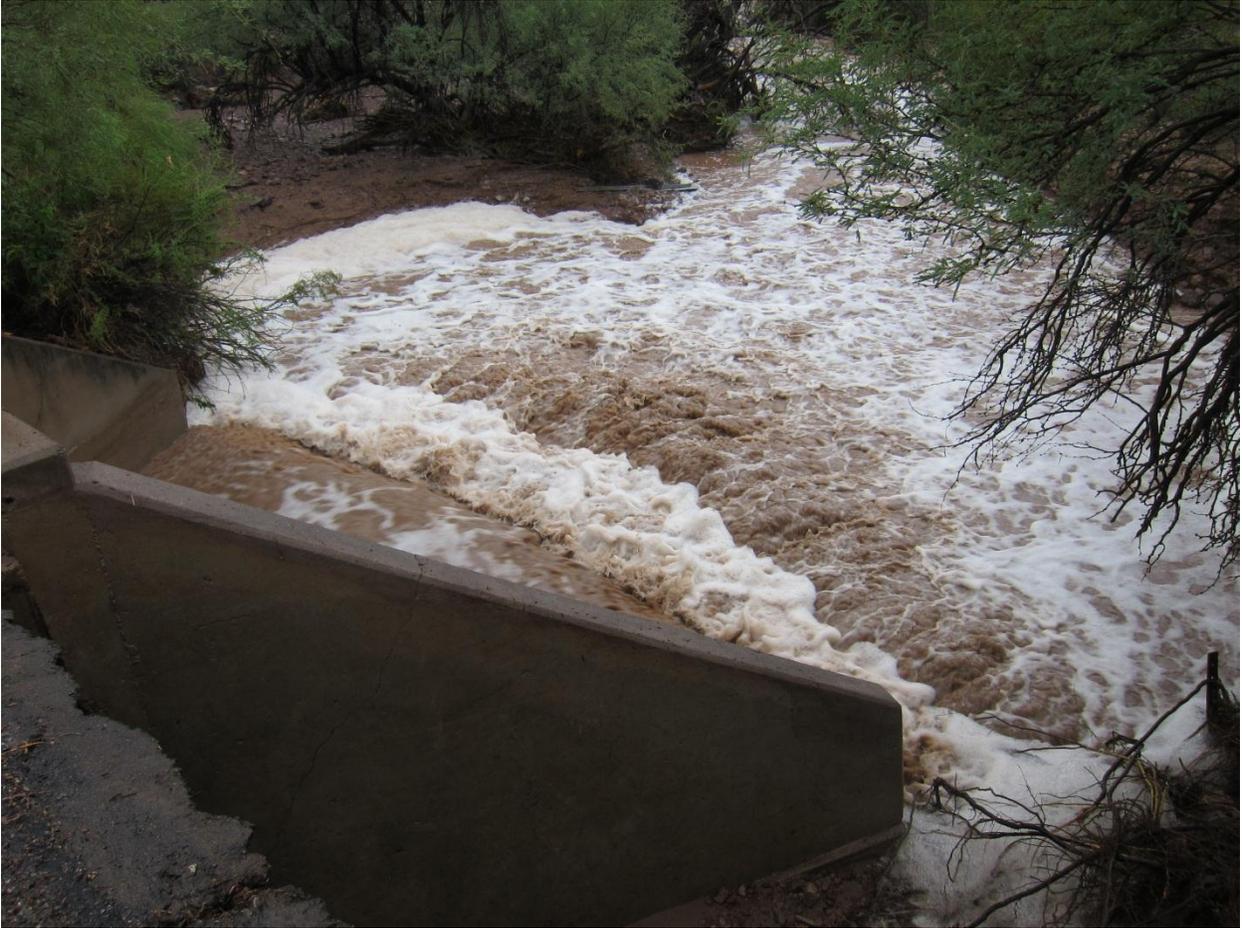
Figure 3. The culvert crossing at mile 66.5 after floodwaters reached Highway 85, August 16, 2012.

The combination of drainage area and the timing of rainfall, led to two major flood events in larger canyons of the Ajo Range. The first occurred on August 16 when 2.3 inches fell in early afternoon west of Tillotson Peak, joined by 2.8 inches in Alamo Canyon in mid-late afternoon. By that evening, floodwaters were rushing through the culvert located at mile 66.5 on Highway 85 (Fig. 3) and Monument employees driving home were delayed by floodwaters across the highway, especially at Kuakatch Wash further north on Highway 85 (Fig. 4). Significant rain had already fallen the previous day.

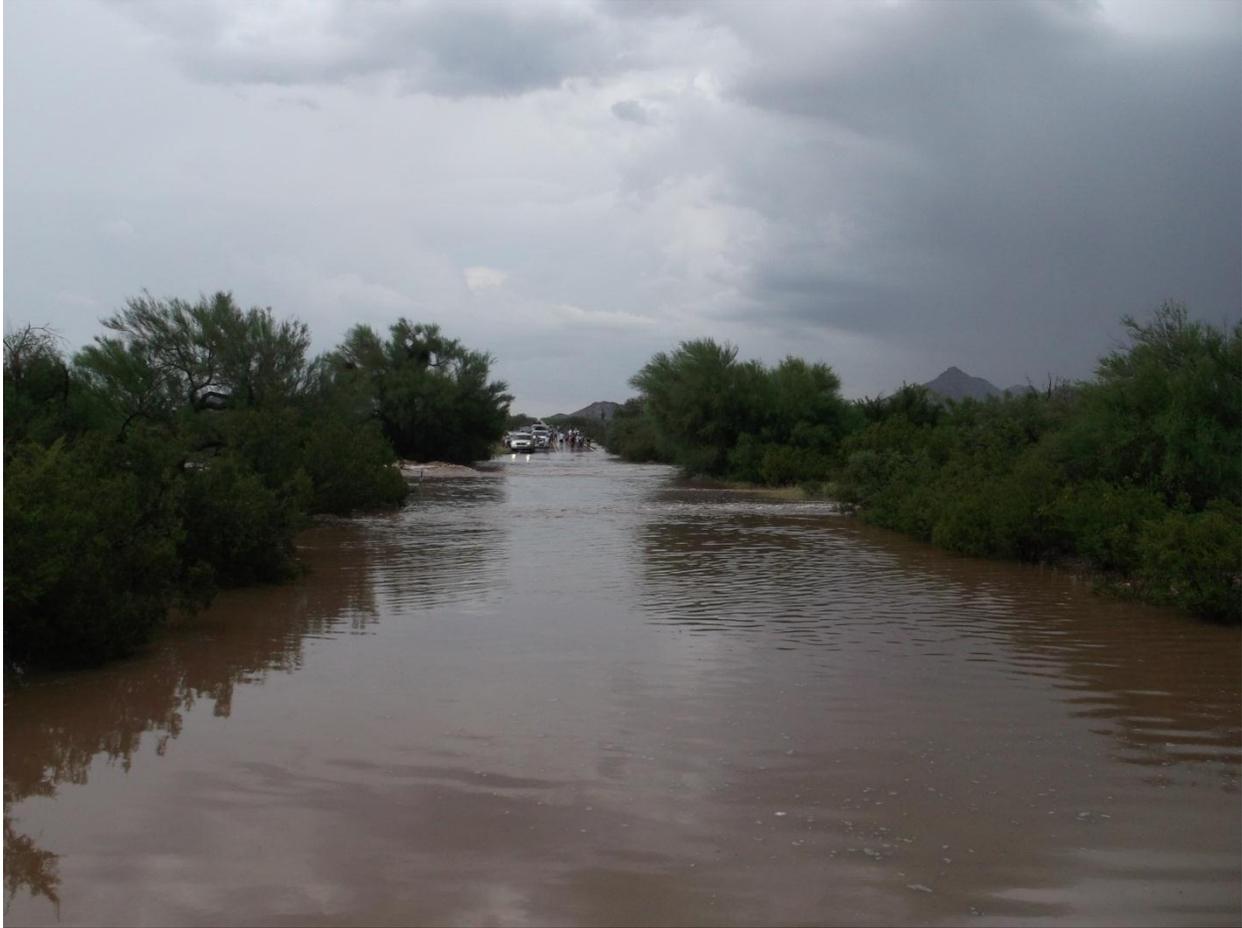
*Figure 4. Highway travelers waiting for floodwaters to subside at one of the Kuakatch Wash crossings on Highway 85, August 16, 2012.*

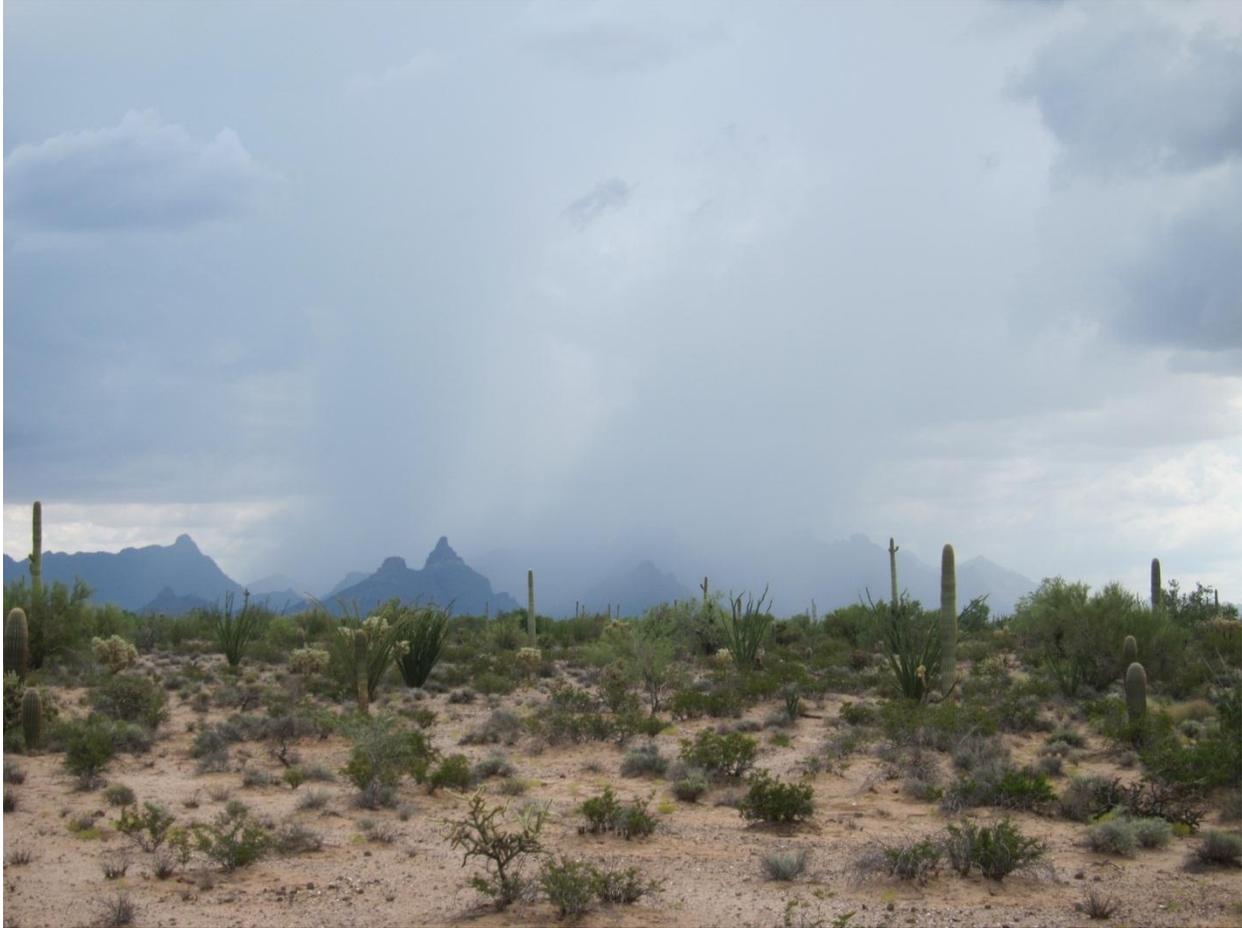
*Figure 5. The first storm to hit the Ajo Mountains during a series of early September storms, on September 6, 2012.*

On the first day, September 6, the weather station in Alamo Canyon recorded 2.0 inches of rainfall from 2:00 PM to 11:00 PM (Fig. 5). Rain began again the following morning on September 7, dropping another 0.5 inches between 7:00 AM and 10:00 AM. On the third day, September 8, 0.3 inches of rain fell 3:00 PM and 10:00 PM. On the fourth day, September 9, 0.9 inches of rain fell between 5:00 PM and 9:00 PM. The greatest daily and one-hour totals occurred on September 10 when 3.5 inches fell between 8:00 PM to 11:00 PM and 2.7 inches fell in the first hour. Although the subsequent flooding may have been caused by just the storm event of the 10<sup>th</sup>, the preceding four days of rain undoubtedly enhanced the size of the flood due to near- or already-saturated soil conditions. The rain finally came to a close on 11 September, dropping a final 0.6 inches between 8:00 AM and 2:00 PM.
