Restoring Salmon and Trout Habitat at East Schooner Creek, Point Reyes National Seashore

Project Overview: *As part of the Coastal Watershed Restoration Project, the Seashore replaced existing road-crossing facilities at Mt. Vision Road and Estero Road on East Schooner Creek, a freshwater stream supporting federally threatened steelhead trout.*

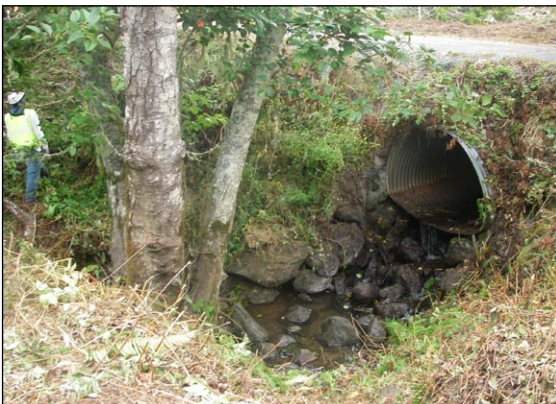
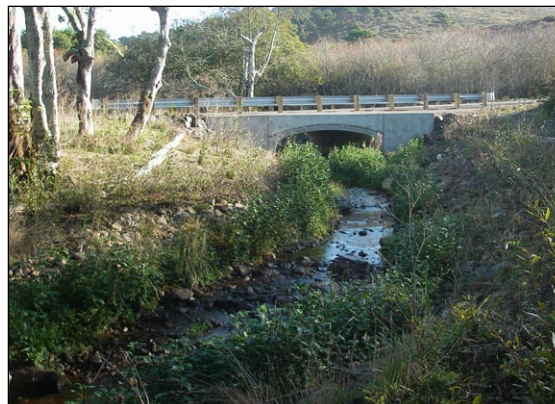
(Left: Before; Right: After) The culvert at Estero Road crossing, before and after replacement. Fish can now pass freely through the bottomless arch culvert, and vegetation is re-establishing.

The existing metal culverts at Mt. Vision and Estero Roads were in very poor condition, and the sites, one mile apart, were densely vegetated and deeply incised downstream. A five foot vertical downstream drop at Mt. Vision and a three foot drop at Estero prevented fish passage. The culverts were also too small to adequately convey existing flood flows and frequently overflowed. Water was piping outside of both culverts on a routine basis.

Work took place in fall 2007, with pumps moving streamflow around the sites. Contractors replaced the old, failing culverts with larger concrete bottomless arch culverts that more than doubled the conveyance capacity of Estero and more than quadrupled that of Mt. Vision. These structures span the channel and maintain a natural streambed bottom that can adjust with changes in the adjacent streambed. The culverts provide fish passage, will easily convey a 100-year flood, and will reduce long-term maintenance. At each site, the project required regrading and reconstruction of the stream corridor upstream and downstream of the project area, providing stable transitions between the altered channel and the existing channel. Contractors created a roughened rock ramp with step-pool structures for this purpose.

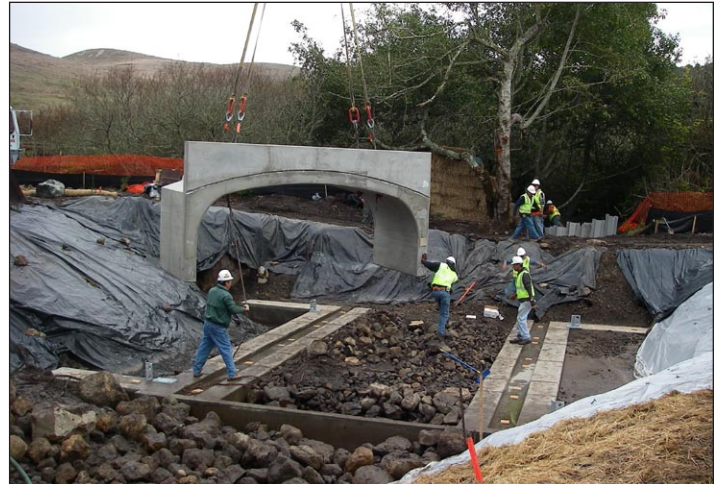
Workers place a piece of the bottomless culvert at the Estero Road crossing.
