National Register of Historic Places Registration Form

Historic name: Singhi Double House
Other names/site number: Millay House
Name of related multiple property listing: N/A
(Enter "N/A" if property is not part of a multiple property listing)

Street & number: 198 - 200 Broadway
City or town: Rockland State: Maine County: Knox
Not For Publication: N/A Vicinity: N/A

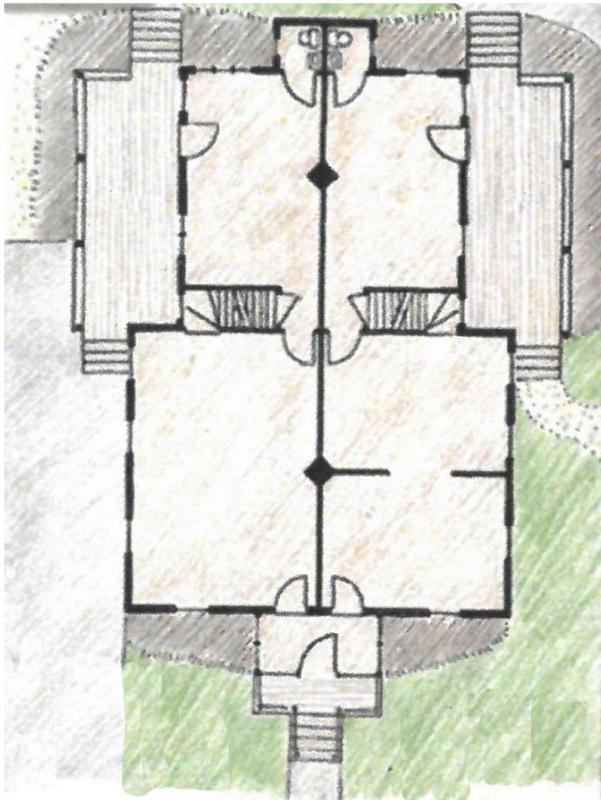
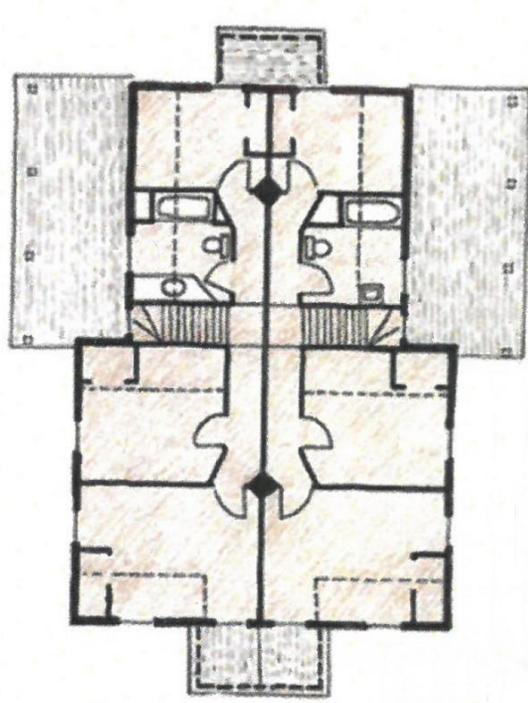
Figure 1 First and second floor sketch plans. Not to scale.

Inside the building a center wall extends the depth and height of the building dividing it into two equal halves with no interior passage between. Through the north front door, a wide living room extends the full width of the unit. A wall with a wide center opening divides the living room from the dining room to the west. From the dining room, the stair to the second floor is through a door in the northwest corner and a door way in the southwest corner leads to the kitchen. Off the southwest corner of the kitchen, a door opens to half bath.

The second floor is reached by the stair with winder treads in the dining room. The top of the stair ends at the center of a hall along the common wall. To the east are two bedrooms each with a small closet. To the west of the stair is a bathroom and a smaller bedroom with closet. Each of the second-floor rooms has one section of ceiling that is sloped to accommodate the roof pitch and half story wall height. The common wall of the hallway has two triangular in plan projections as a result of chimneys. Each extension of the wall occurs at the north and south running wall that divides rooms. Typical finishes are wide board floors, plaster walls and ceilings, four-panel doors, flat stock baseboards, and fluted casings mitered at the corners. (See Figure 1 for sketch floor plans.) The south side is a mirror image of the north side with the exception of the following alterations. The partition with a large rectangular opening between the living room and dining room was removed to make one large room on the south.

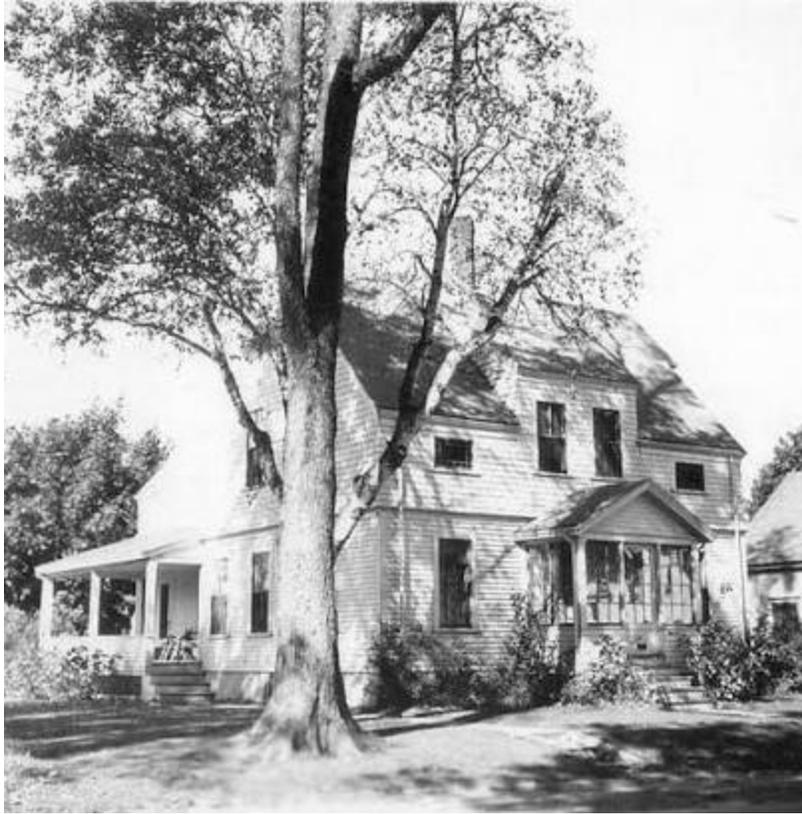
Figure 3 ca. 1945 image of Singhi Double House
