APPENDIX A: SPRINGDALE STREETScape, PARKING, AND SHUTTLE STOP INVENTORY

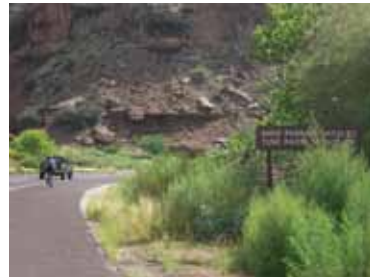
Looking East - A

- A** “Avoid Parking Hassles Tune Radio to 1610 AM” sign is small in scale and beginning to be obscured by vegetation. Recommend vegetation maintenance.
- B** “Parking in Zion Full” sign is small in scale.
- C** Gravel pull out here

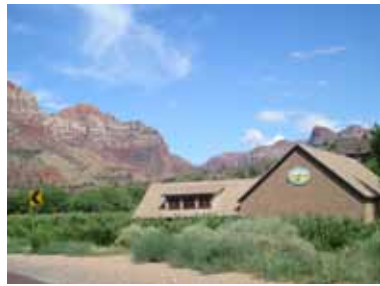
Looking East - A

- Ⓑ “Park In Springdale Sign” is small in scale.
- Ⓒ Large gravel pull out here

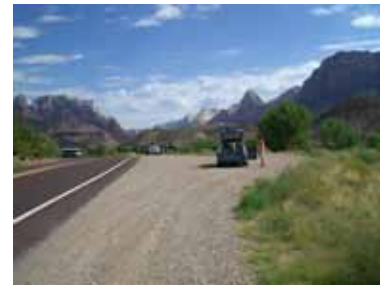
Looking Northeast - B

- (A)** Springdale Zion Canyon Gateway sign
- (B)** Traffic is slowing, many cars pulling off into gravel lot to take photos.

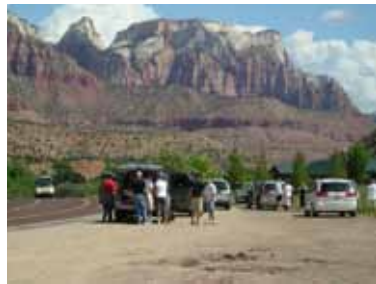
Undeveloped Pull Off - Looking North - F

- (E)** The pavement is buckling and potholing due to the shuttle layovers and general use. Restriping should be performed following pavement repairs.
- (F)** This informal pull off is an attraction to visitors entering Springdale who want to coordinate their day as they enter the corridor. Several groups of people and cars stop to take pictures of the surrounding canyon in addition to planning their trip.

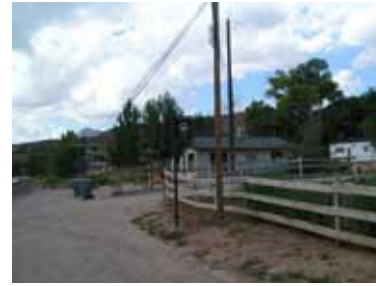
Silver Bear Flag Stop - Looking South - C

- (C)** Undeveloped Shuttle Stop. No sidewalks, crosswalks, curb/gutter, or sidewalk/roadway separation exists.
- (D)** This Shuttle Stop is used by mostly local residents.

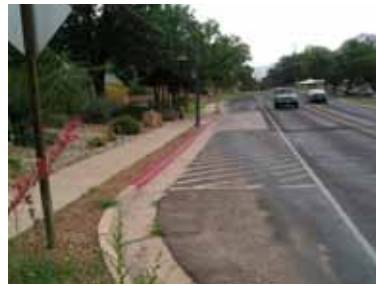
Shuttle Stop - Looking North - F

- (E)** All four of the identified locations on this map provide safe pedestrian travel ways to the Shuttle Stops.
- (F)** The Shuttle Stop shelters, sidewalks, and Shuttle Stop features (both northbound and southbound) are in good condition. Cleaning and minor maintenance upkeep is necessary.

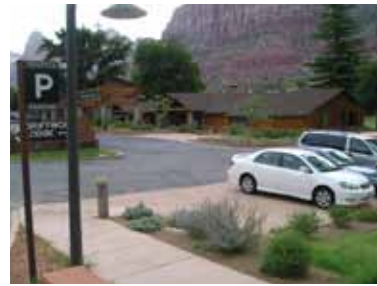
Driftwood Parking Area and ID Sign - B

- (A)** 46 - Shuttle parking is not provided or was not clearly identified at Quality Inn & Suites Montclair. A good sidewalk connection exists from the southbound Shuttle Stop to the hotel parking lot.
- (B)** 47 - Driftwood Inn provides shuttle parking spaces. These spaces are identified with colored concrete and blue signage. Seven of the spaces are located adjacent to the northbound Shuttle Stop. The other shuttle parking spaces are located at the north end of the hotel parking lot.
- (C)** 48 - Chevron does not allow parking for shuttle users. Sometimes the attendant must notify parking visitors to move their car to the Driftwood Inn.
- (D)** 49 - The LDS Church has a large lot but has not identified spaces for shuttle parking. Signs are posted stating "No Overnight Parking."

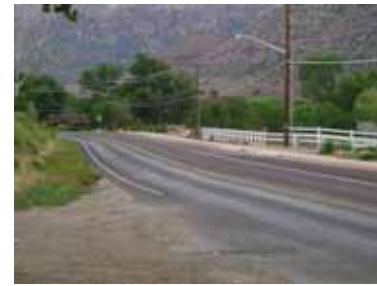
Zion Rock and Gem - Looking South - C

- Ⓐ Shuttle parking is not identified at either Zion Rock and Gem or Bike Zion.
- Ⓑ A wide roadway shoulder on the west side of the road provides ample parking for the businesses.
- Ⓒ The pedestrian environment is a rural, unimproved condition and is not conducive for safe pedestrian movement.

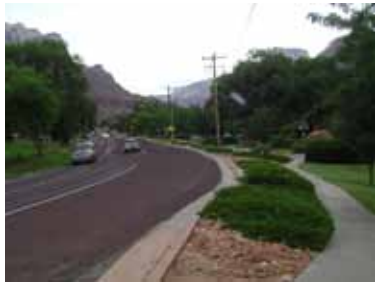
Zion Park Inn Sidewalk - Looking North - C

- (A)** Shuttle parking are identified at the Zion Park Inn.
- (B)** The Bit & Spur provides a large quantity of daily spaces for visitor shuttle parking.
- (C)** The Zion Park Inn has constructed a great walkway offset from the road extending from the southern property edge to the northern property edge, but falling short of the Shuttle Stop.

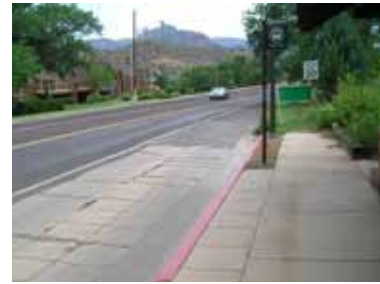
Pavement Condition at Bit & Spur Shuttle Stop

- (D)** Adequate street improvements exist at the southbound Shuttle Stop. One missing pedestrian connection is the Bit & Spur parking lot to the roadside sidewalk at the southbound Shuttle Stop location.

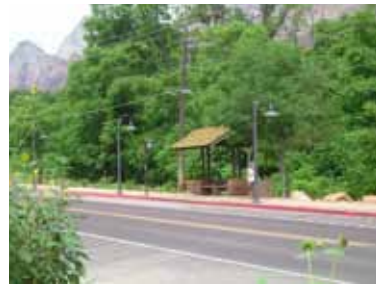
Zion Park Inn Shuttle Stop - E

- (D)** Adequate street improvements exist at the southbound Shuttle Stop. One missing connection is the Bit & Spur parking lot to the roadside sidewalk at the southbound Shuttle Stop location.
- (E)** The northbound Shuttle Stop is separated from the southbound Shuttle Stop location. The northbound stop is isolated and has no direct connection with adjacent business or residential areas.
- (F)** The Shuttle Stop shelters, sidewalks, and Shuttle Stop features (both northbound and southbound) are in good condition. Cleaning and minor maintenance upkeep is necessary.

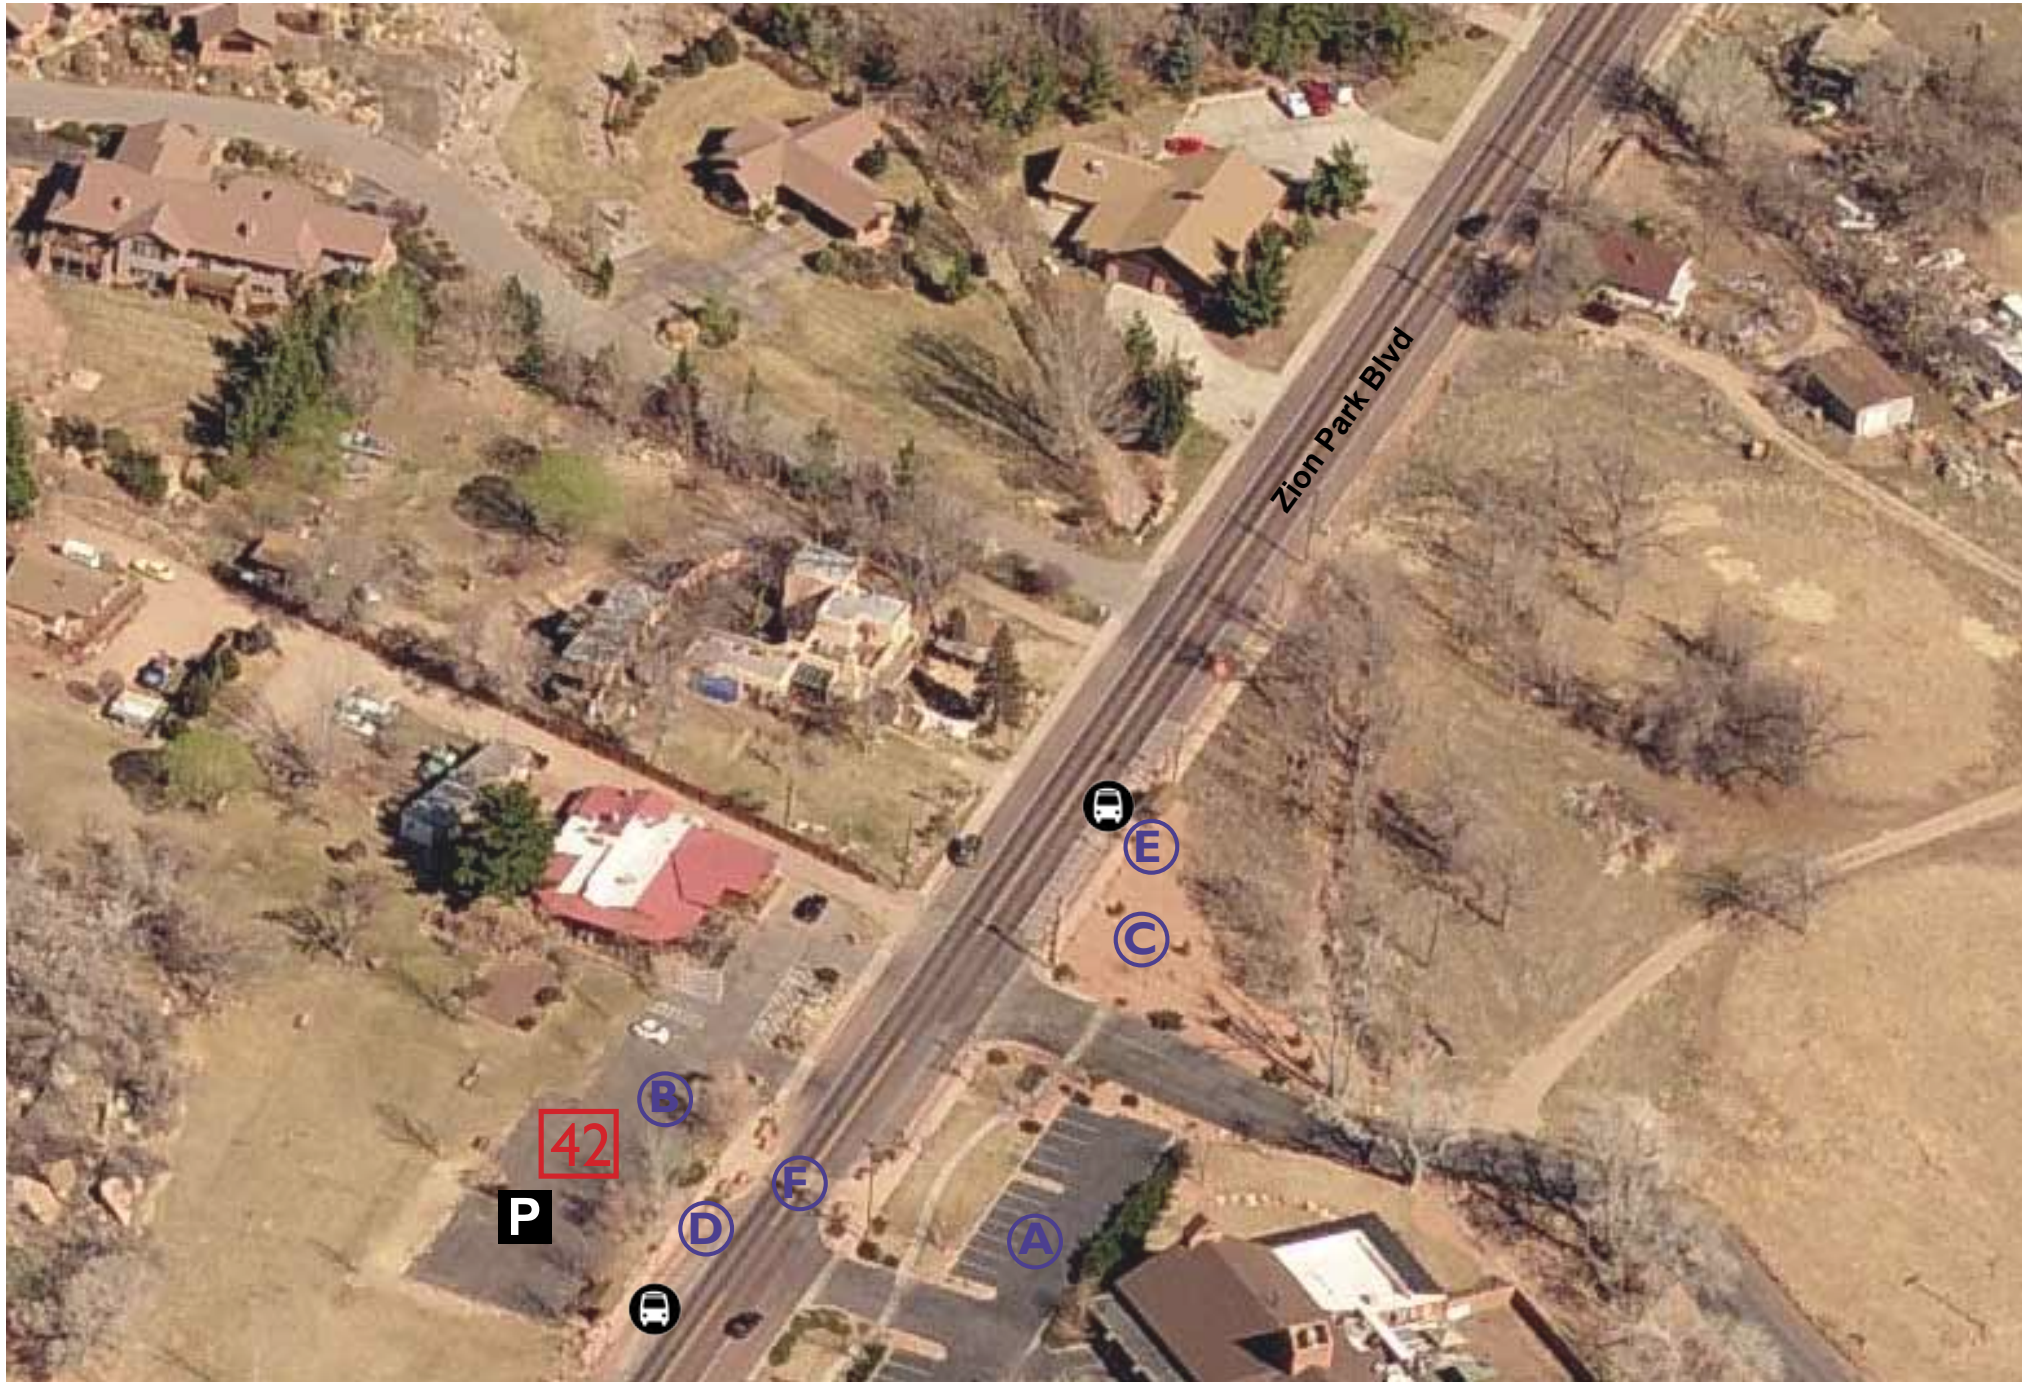
Zion Park Boulevard - 42 Bit & Spur

- (A)** Shuttle parking for drive in visitors is not designated at the Zion Park Inn.
- (B)** The Bit & Spur provides a large quantity of daily spaces for visitor shuttle parking.
- (C)** The Zion Park Inn offset walkway does not connect with the northbound Shuttle Stop. A sidewalk adjacent to the roadway connects the Zion Park Inn walkway with the Shuttle Stop.

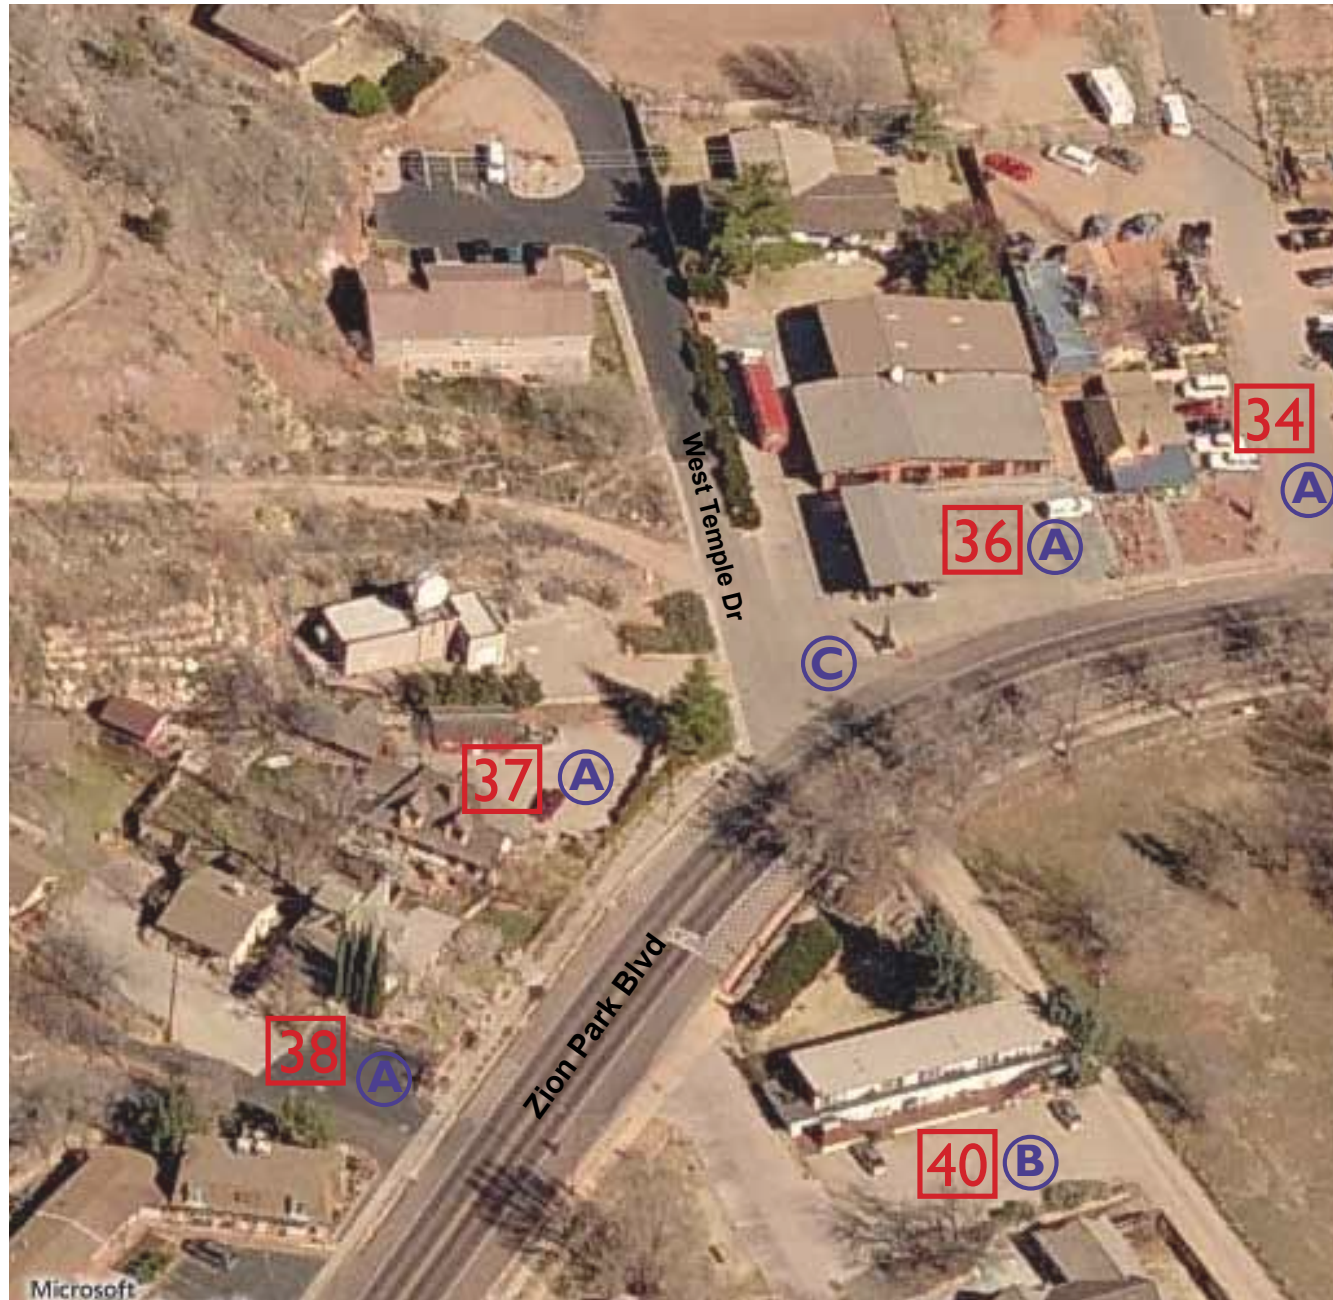
Zion Park Boulevard - **40** El Rio, **38** Red Rock Jewelry and B&B, **37** Under the Eaves, **36** Shell Station, **34** Lazy Lizards/Oscars

- (A)** Parking for customers at businesses. Not enough parking stalls available for shuttle use.
- (B)** Del Rio lacks signage indicating who can use the parking lot. This is a small lot with poor visibility from the street.

- (C)** Sidewalk gap between West Temple Drive and Lazy Lizards. It is currently a concrete surfaced drive entrance for the Shell Station. Concrete is spalling in many areas presumably due to heavy amount of vehicular traffic circulating in and out of business.

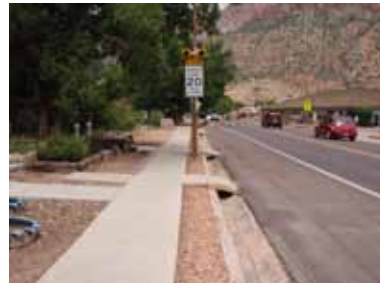
Mean Bean - Looking East - H

- (H) Flashing school speed limit sign here - 20 mph

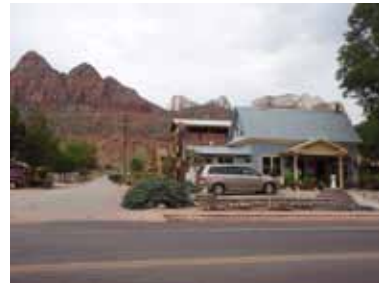
Mean Bean - Looking North - A

- (A) Parking at Mean Bean is limited, used by customers.
- (B) Parking availability at school fluctuates between seasons. Best kept for school use.

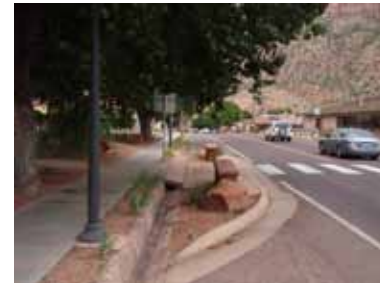
School Crosswalk - Looking East - E

- (E) Sidewalk from Springdale Elementary Driveway to ditch is approximately five to six feet wide with narrow gravel band, sandstone curb and gutter, and an asphalt parking lane. All are in good condition. Street parking is restricted along school frontage.

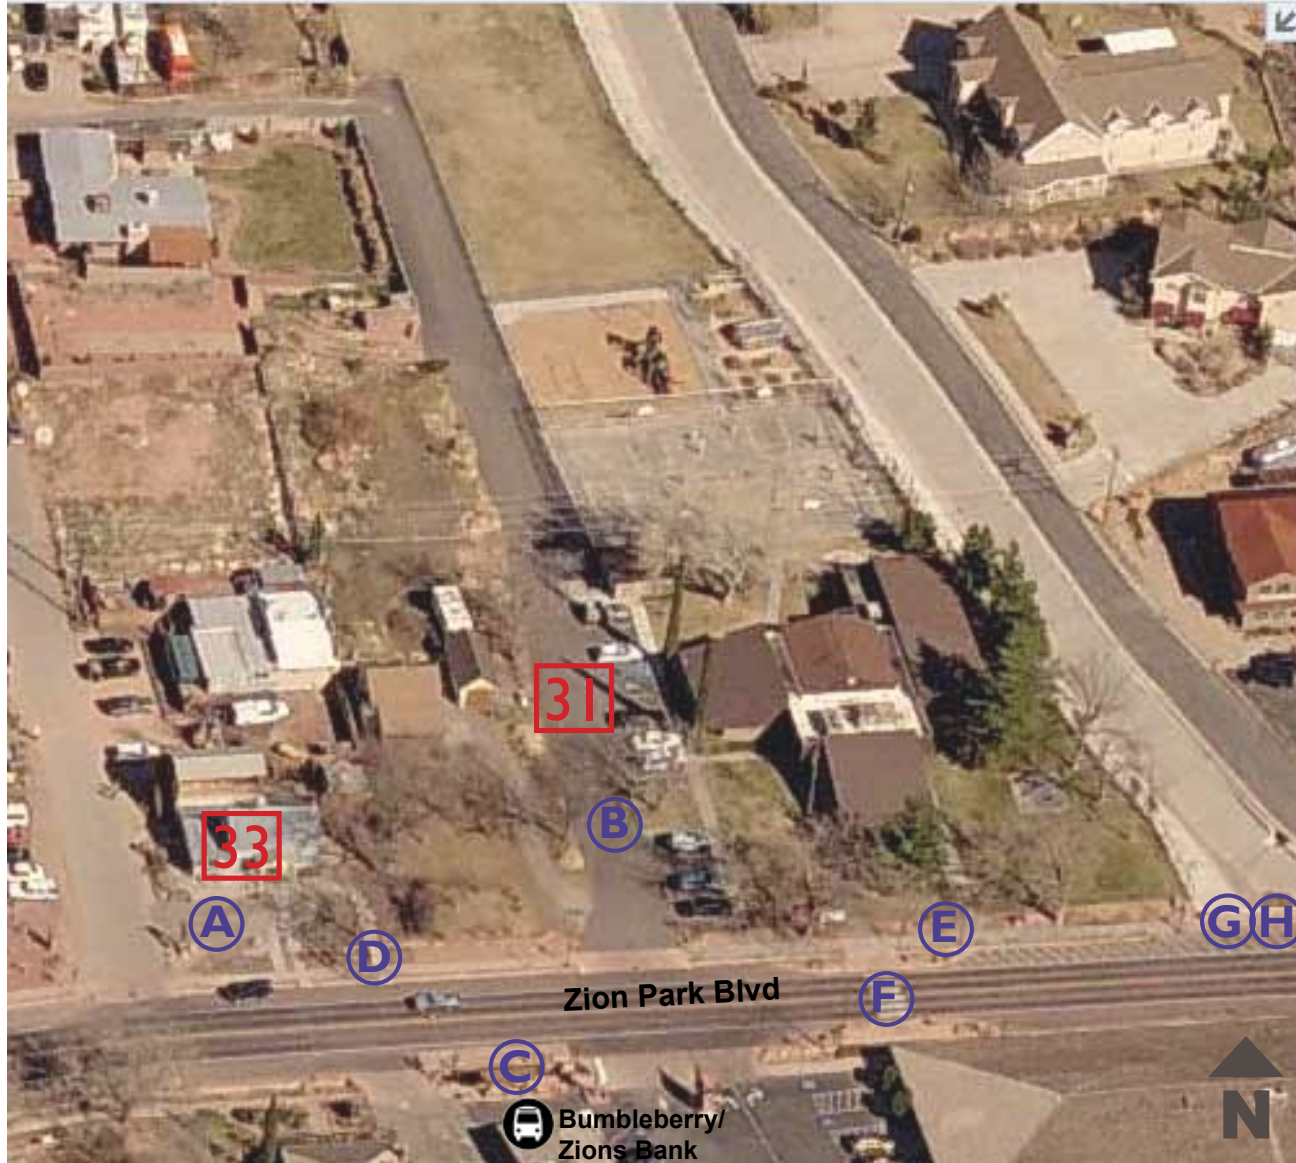
Zion Park Boulevard - **33** Mean Bean, **31** Springdale Elementary School

- (D) Sidewalk from Shell Station to Springdale Elementary Drive is narrow, approximately four feet wide with narrow gravel band, sandstone curb and gutter, and an asphalt parking lane. All are in fair/good condition, exhibiting some wear and tear. Asphalt edge along gutter is not eroding as much at this location as compared to others.

- (F) Crosswalk is beginning to fade. Concrete bulbout is in good condition. Gravel beginning to wear away in planting beds.
- (G) Sidewalk at ditch is approximately four feet wide with concrete curb, in good condition. Street parking is not permitted here.

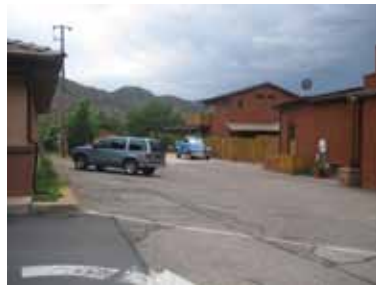
Canyon Offerings - Looking South - B

- (A)** There are a number of signs in the Bumbleberry parking lot that indicate it is for customer parking only. It is clearly defined who can park here. If shuttle users are allowed to park here it should be clearly indicated.
- (B)** The Zions Bank and Canyon Offerings parking lots are fairly small and best serve customers.

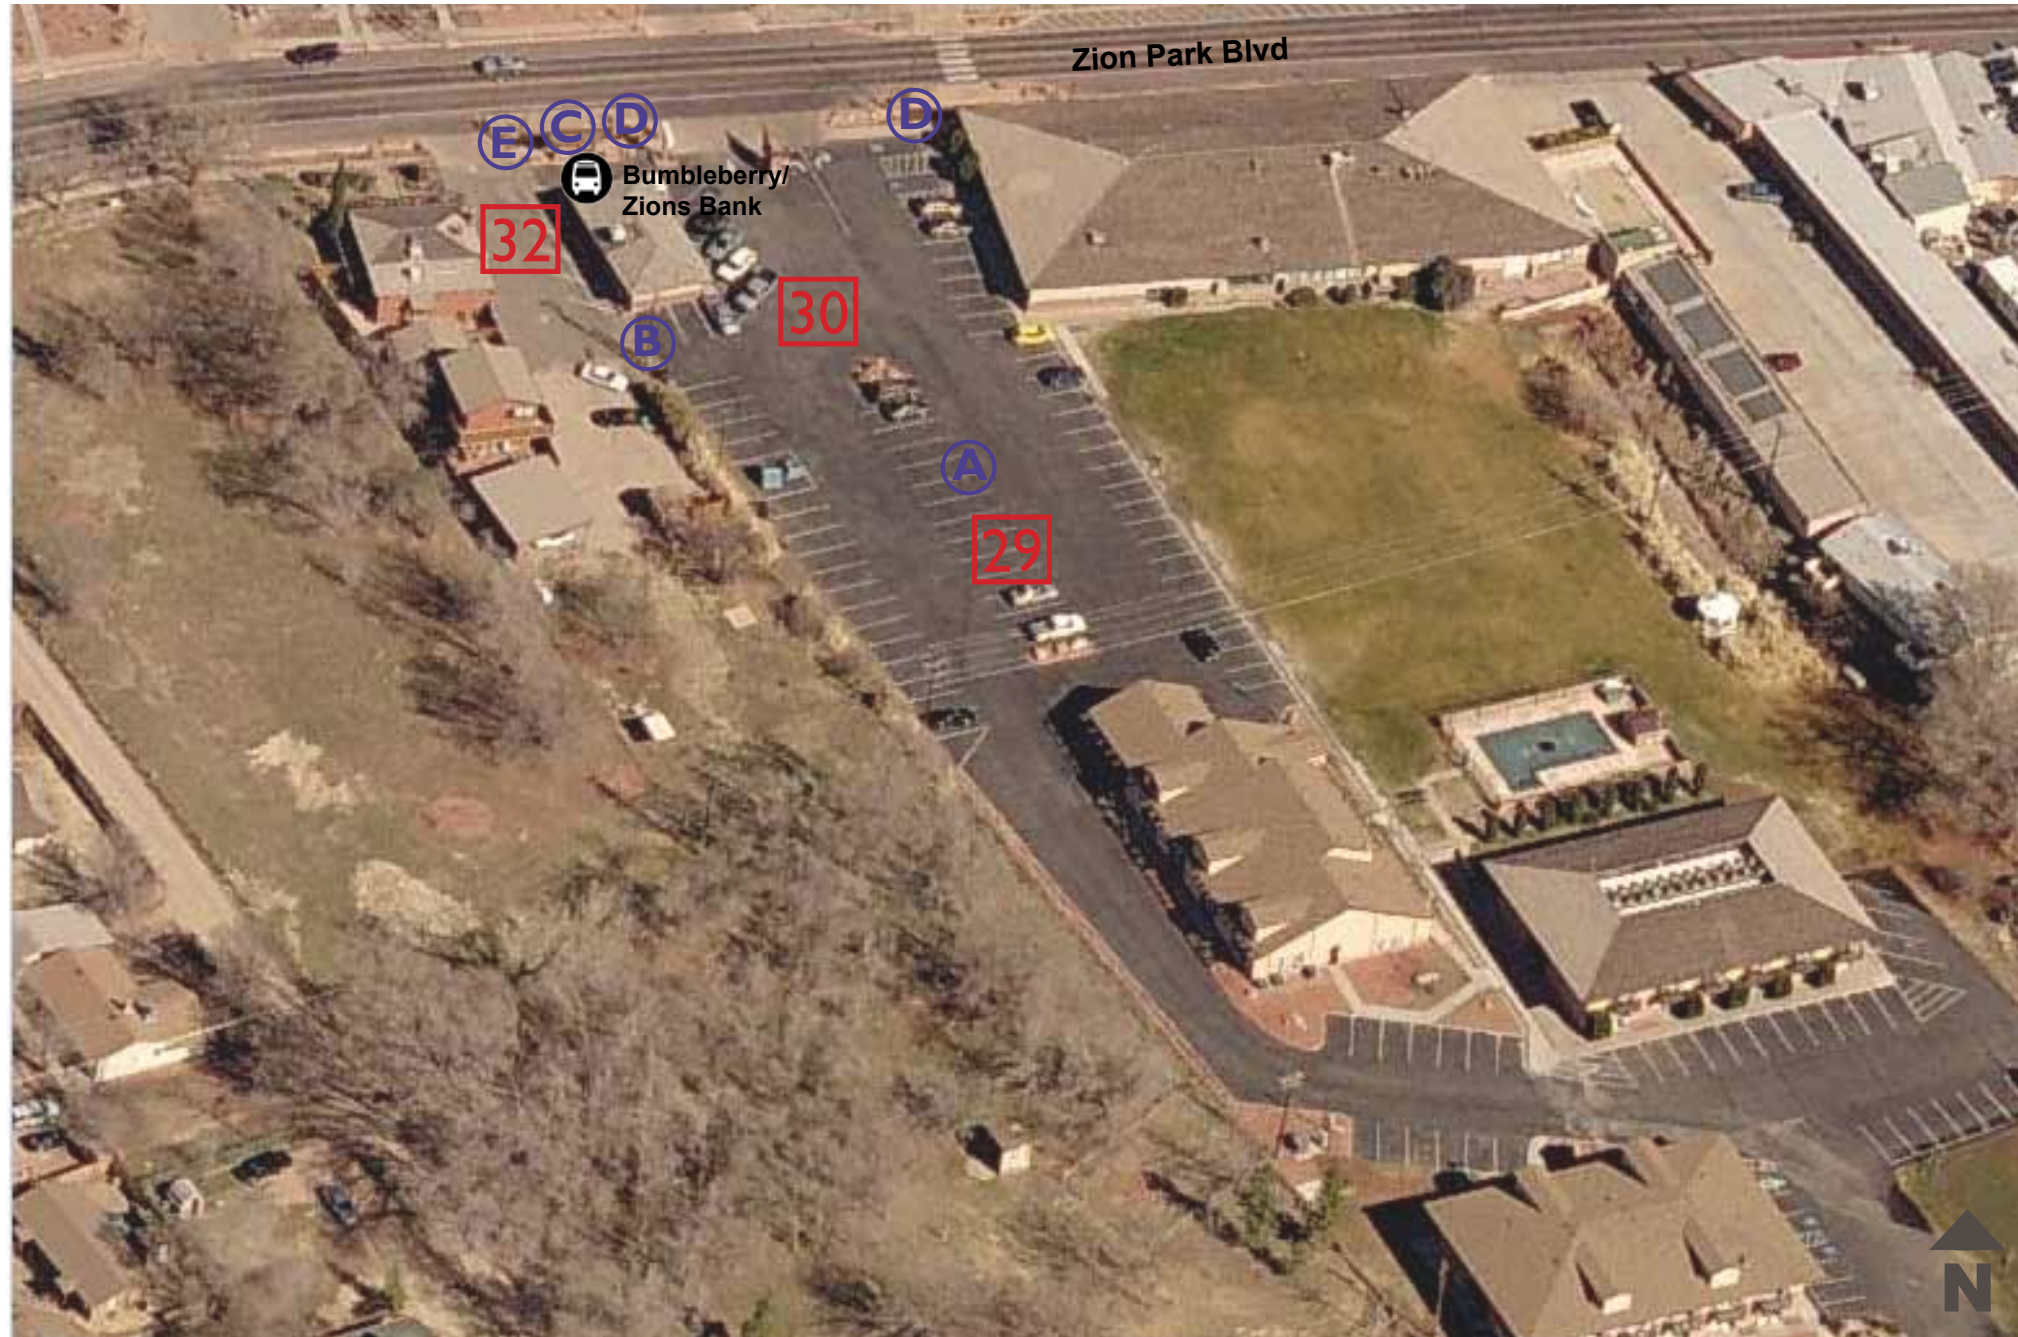
Zion Park Boulevard - **32** Canyon Offerings, **30** Zions Bank, **29** Bumbleberry

- (C)** The Bumbleberry/Zions Bank shuttle stop is located at a blind curve and drivers have commented that it is a dangerous spot to pull out of. The ground plane at this location also tilts drastically toward sidewalk, making it challenging for passengers to embark and disembark. This Shuttle Stop has shelter in excellent condition. Many drivers and others have commented that relocating this Shuttle Stop to the front of the Zion Park Motel (28) would place it directly across the road from Pizza & Noodle. This could potentially increase safety and legibility.

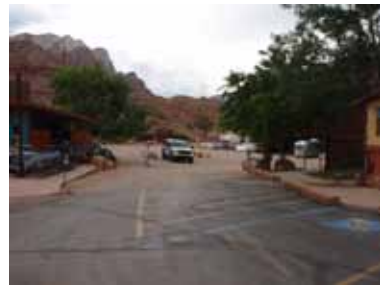
Park And Ride - Looking North - B

- Ⓐ Parking at Pioneer Lodge and Zion Park Deli best serves customers due to size and because lodge guests can keep car parked and use shuttle.
- Ⓑ Park and Ride sign for Zion Pizza & Noodle is small, difficult to spot from vehicle unless driver knows what they are looking for. Parking lot is dirt with a few no parking signs placed at entrance, which may deter some visitors. It is not clear where people can park to use shuttle. No arrow on sign indicating where park and ride is located specifically.

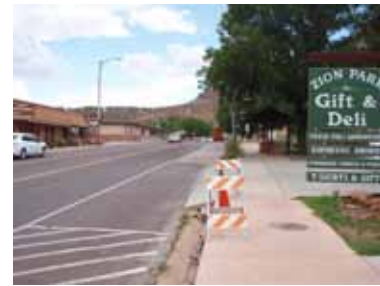
Looking West - E

- Ⓓ Sidewalk is approximately ten feet wide at Shuttle Stop and narrows at driveway apron to Zion Park Deli. In good condition.
- Ⓔ Cones on the sidewalk here to prevent cars from driving into sandstone curb and gutter. Sidewalk is eroding where it hangs over sandstone curb and gutter. There is no gravel strip between sidewalk and curb here. Curb and gutter are old, in fair condition.
- Ⓕ Sidewalk is in good condition here, approximately 5.5 feet at Pioneer Lodge and approximately four feet east of Pioneer Lodge.
- Ⓖ Concrete curb here, in excellent condition.
- Ⓗ Asphalt edge is eroding where it meets sandstone curb and gutter.
- Ⓘ A lot of pedestrian activity in this location. People cross at various locations. No crosswalk located here.

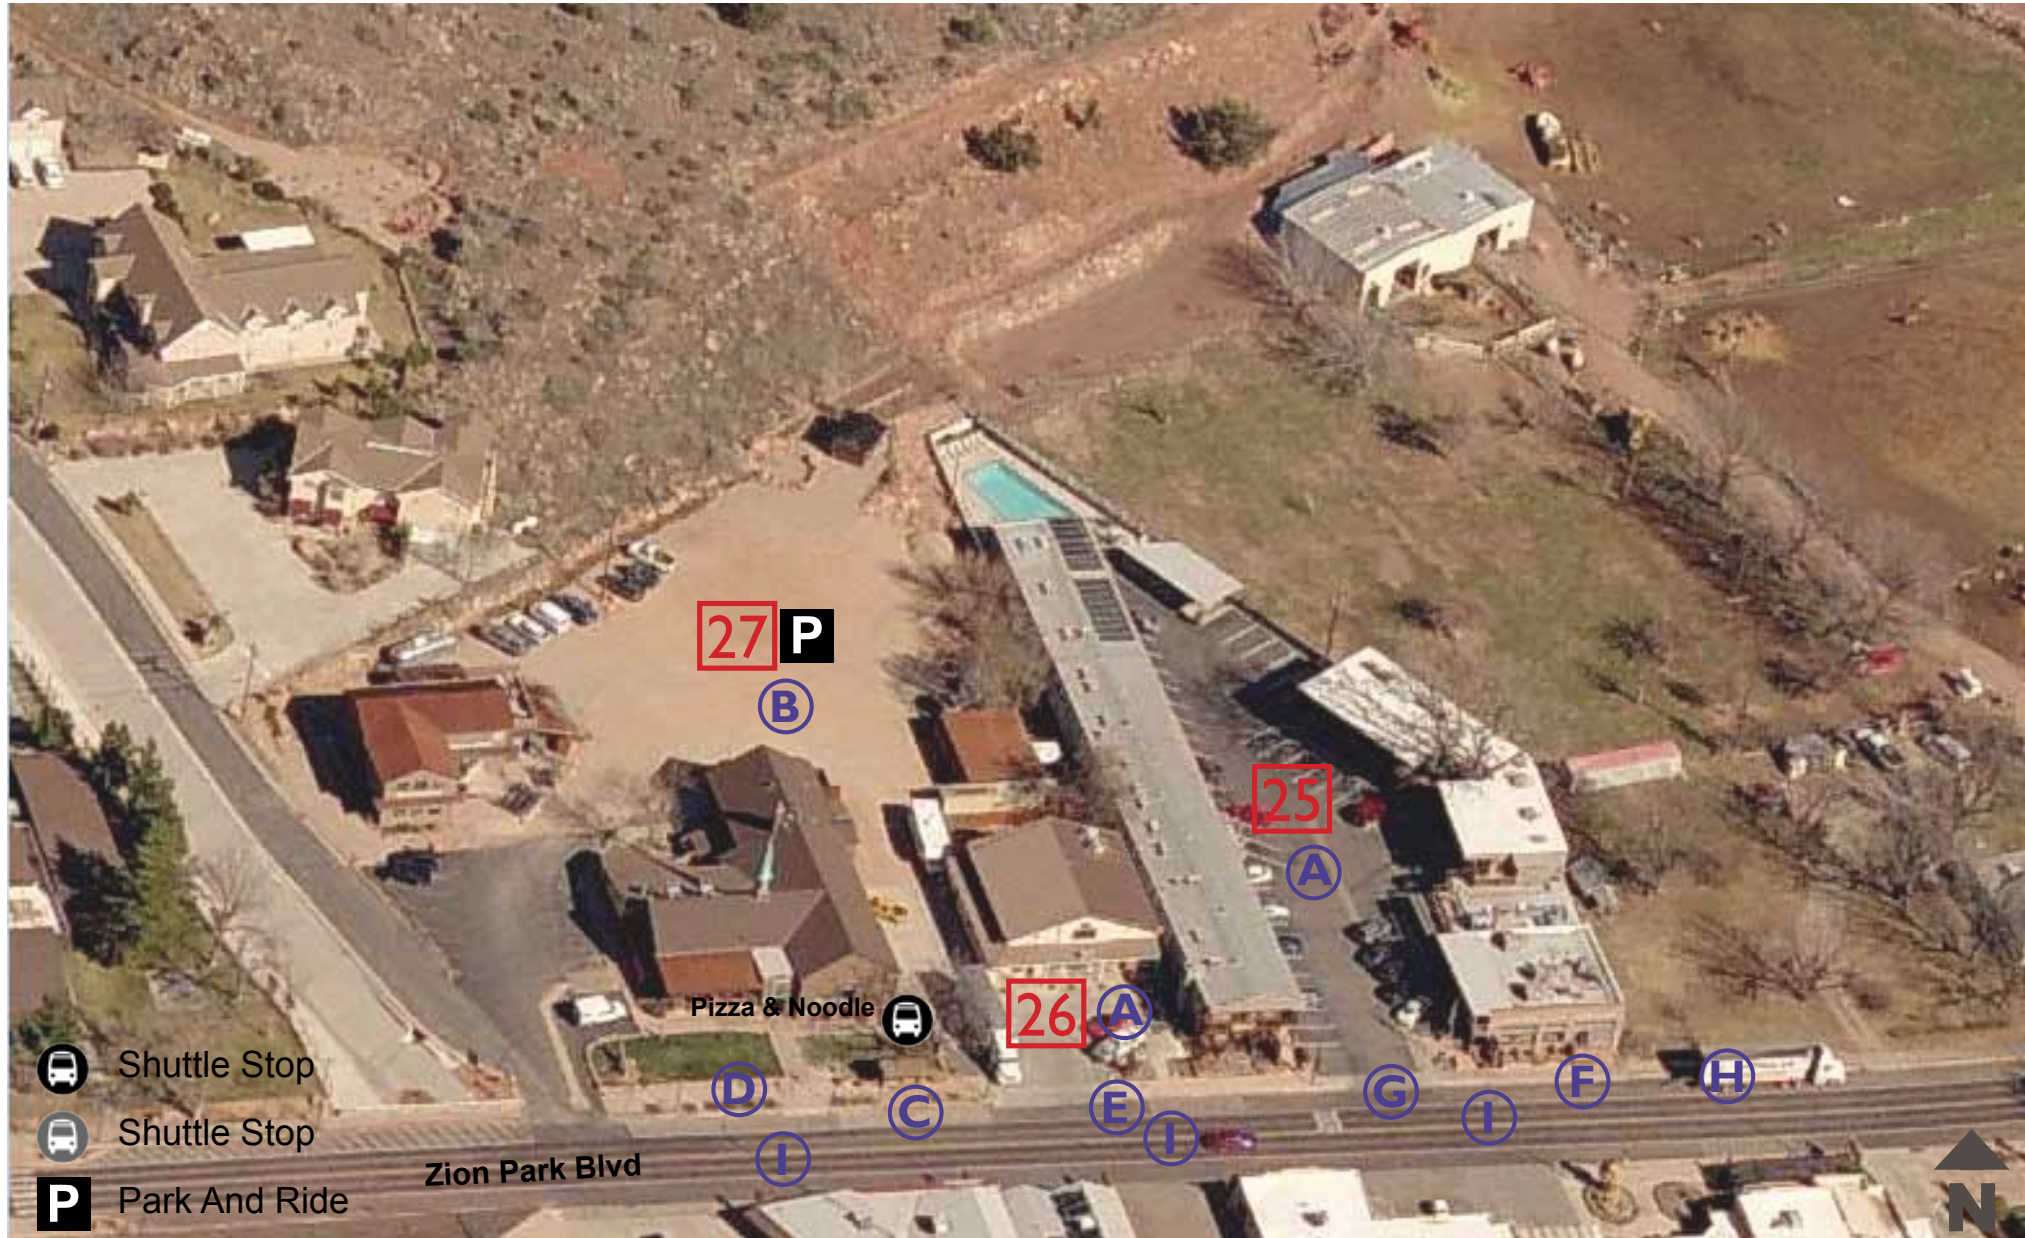
- Ⓒ Concrete shuttle pad is eroding and cracking. "Zion Pack Day Trips" sign on pole is faded and cracked. Shuttle route map on shelter is faded and ripped. Information kiosk is hard to spot, blocked by vegetation. Shelter is in excellent condition, with ample seating.

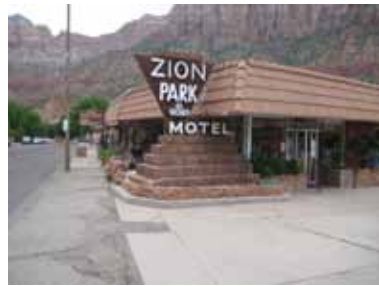
Looking East - C

- (C)** Sidewalk in fair/poor condition in driveway for Zion Park Motel parking.
- (D)** Sidewalk in fair/poor condition this area.
- (E)** Identified location for moving Zions Bank Shuttle Stop, see page A-15 for Zions Bank Shuttle Stop observations.

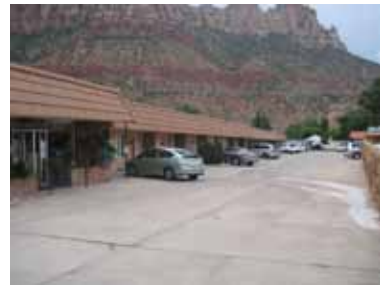
Zion Park Motel Parking - Looking South - B

- (A)** There seem to be four suitable areas to park providing many spaces. However, these areas are not clearly defined as to who can park here. Some of these areas are unpaved and would require some work to be a more suitable parking environment. There is one parking area that is adjacent to the laundromat. This is a small lot and seems to be heavily used by people using this facility.
- (B)** There is a lack of signage in this parking lot indicating who can park there and for what uses. Parking appears to mainly be used by customers.

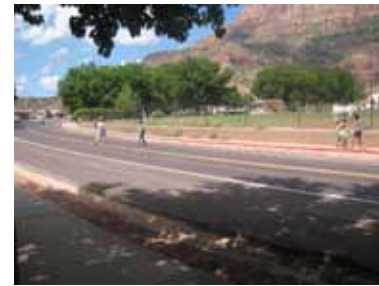
People Crossing Road - Looking Southwest - I

- (E)** Sidewalk in fair condition, displaying spalling and wearing at edges, joints, and corners.
- (F)** Extreme spalling at utility cover here.
- (G)** Asphalt parallel parking is tight, eroding at sandstone curb and gutter edge. Curb and gutter is old, eroding in places. Narrow gravel strip is in fair condition.
- (H)** Sidewalk is covered with gravel and is cracking profusely at driveway to Desert Pearl vacant lot.
- (I)** Many people cross street here to reach the ranch.
- (S)** Shuttle Stop
- (SF)** Shuttle Stop (Flag)
- (P)** Park And Ride

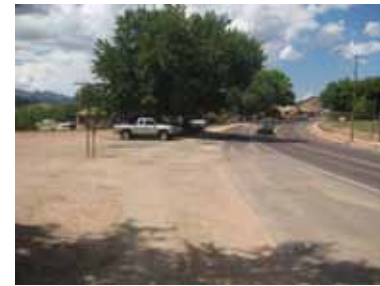
Desert Pearl Vacant Lot - Looking Southwest - B

- (A)** Not many spaces available for shuttle parking. Customer parking only.
- (B)** This area is a large unpaved, dirt parking lot that is not clearly defined for its allowable uses. There are a lot of people who park here and cross the street to get to the ranch. There is signage along the perimeter of the parking lot. The northeast portion of the lot is reserved for "Desert Pearl Employee Parking Only." There is a sign when you first enter announcing "No Overnight Camping or Parking." There is also a "Private Property No Trespassing" sign near the entrance of the lot.
- (C)** There is an area in the back of the Worthington Gallery that doesn't appear to be used.
- (D)** This lot is very small and set back from the street. Best serves customers.

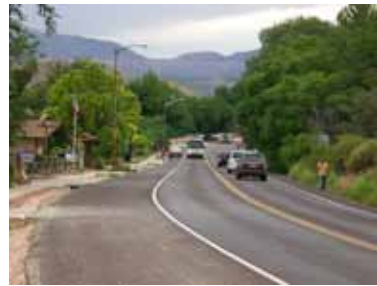
Looking Southwest - C

- Ⓑ Sidewalk in vicinity of post office is in variable condition, narrow and spalling in some locations. Asphalt edge is wearing away at sandstone curb/gutter.
- Ⓒ No sidewalk on southbound side of road but there is wide shoulder that people use to walk on.

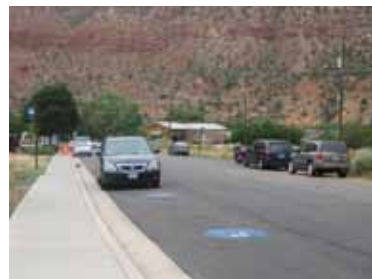
Lion Blvd - Looking West - A

- (A)** Lion Blvd. provides plenty of parallel parking spaces along both sides of the road. Zion Adventures may sometimes cone off a few spaces to park vans and trailers for loading and unloading.

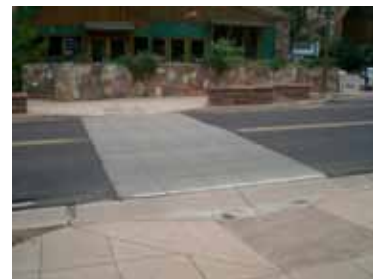
Crosswalk - Looking West - K

- (H)** Sidewalk ends just north of Flanigans (Spotted Dog Restaurant). No sidewalk between Flanigans and Cliffrose flag stop.
- (I)** Curb on south edge of driveway is broken and cracking, in need of repair.
- (J)** Bulbout at crosswalk is in very good condition. Sidewalk nice and wide here.
- (K)** Crosswalk concrete is cracking, could be made more visible.
- (L)** Bent culvert located here. Recommend removing culvert.
- (M)** Concrete curb/gutter begins here and continues north.
- (N)** Access across Koritas/Quality Inn driveway is not ADA compliant.
- (O)** Unattractive assortment of remnant posts/poles and lack of vegetation just north of Koritas/Quality Inn driveway. Recommend improving this area

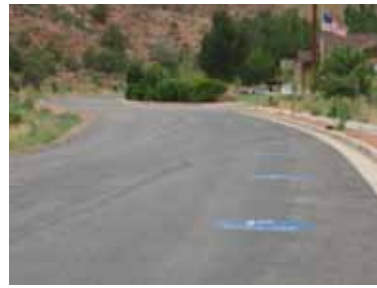
Lion Blvd - Looking Northwest - B

- A** Lion Blvd. provides plenty of parallel parking spaces along both sides of the road. Zion Adventures may sometimes cone off a few spaces to park vans and trailers for loading and unloading.
- B** The Lion Blvd. parallel parking spaces extend along the north side of the road from Zion Park Blvd. to the library and community center. A sidewalk provides a good pedestrian walkway along the north parking spaces, but it is a long walk from the spaces near the library to the nearest Shuttle Stops.
- C** The sidewalk along Lion Blvd. needs vegetation maintenance and the south edge parking area at Zion Blvd is without a sidewalk.
- D** Blue markings on pavement designating Park And Ride are fading all the way to Zion Park Blvd.

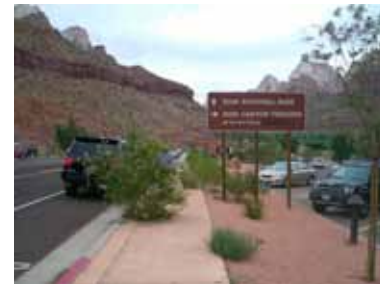
Looking Northeast - F

- (E) Sidewalk in front of Takach Building has small area of landscape strip of red rocks and spiny plants. Plants are not very pedestrian friendly.
- (F) Sidewalk is approximately six feet wide, in excellent condition, with concrete curb and gutter.
- (G) Curb is broken and curb is exposed at southern edge of first driveway to lower parking for theater. The ramp at this corner does not meet ADA, very wide radius.
- (H) No sidewalk on this side of driveway.
- (I) Only area with sidewalk on this side of roadway.
- (J) Jersey barrier at slide area, constricts roadway.
- (K) Anthills encroaching sidewalk.
- (L) No crosswalk here.

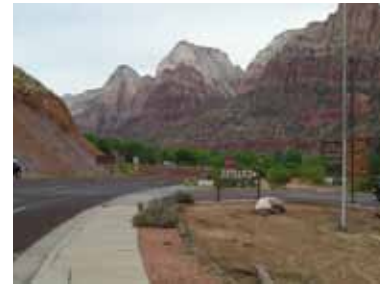
Northern Driveway (2nd) - Looking Northeast - A

- A** According to shuttle drivers and others, many visitors get confused by the “Entrance” sign at the second driveway to the theaters. Visitors think it is the entrance to the park, while it is actually the entrance to the theaters. Drivers recommend placing a Zion National Park entrance sign adjacent to this one with an arrow pointing straight ahead.
- B** On-street parking is very well used here.
- C** No sidewalk on this side of driveway. Signs and more sidewalks and crosswalks would help direct people to pedestrian park entrance.
- D** Parking designated for customers only.

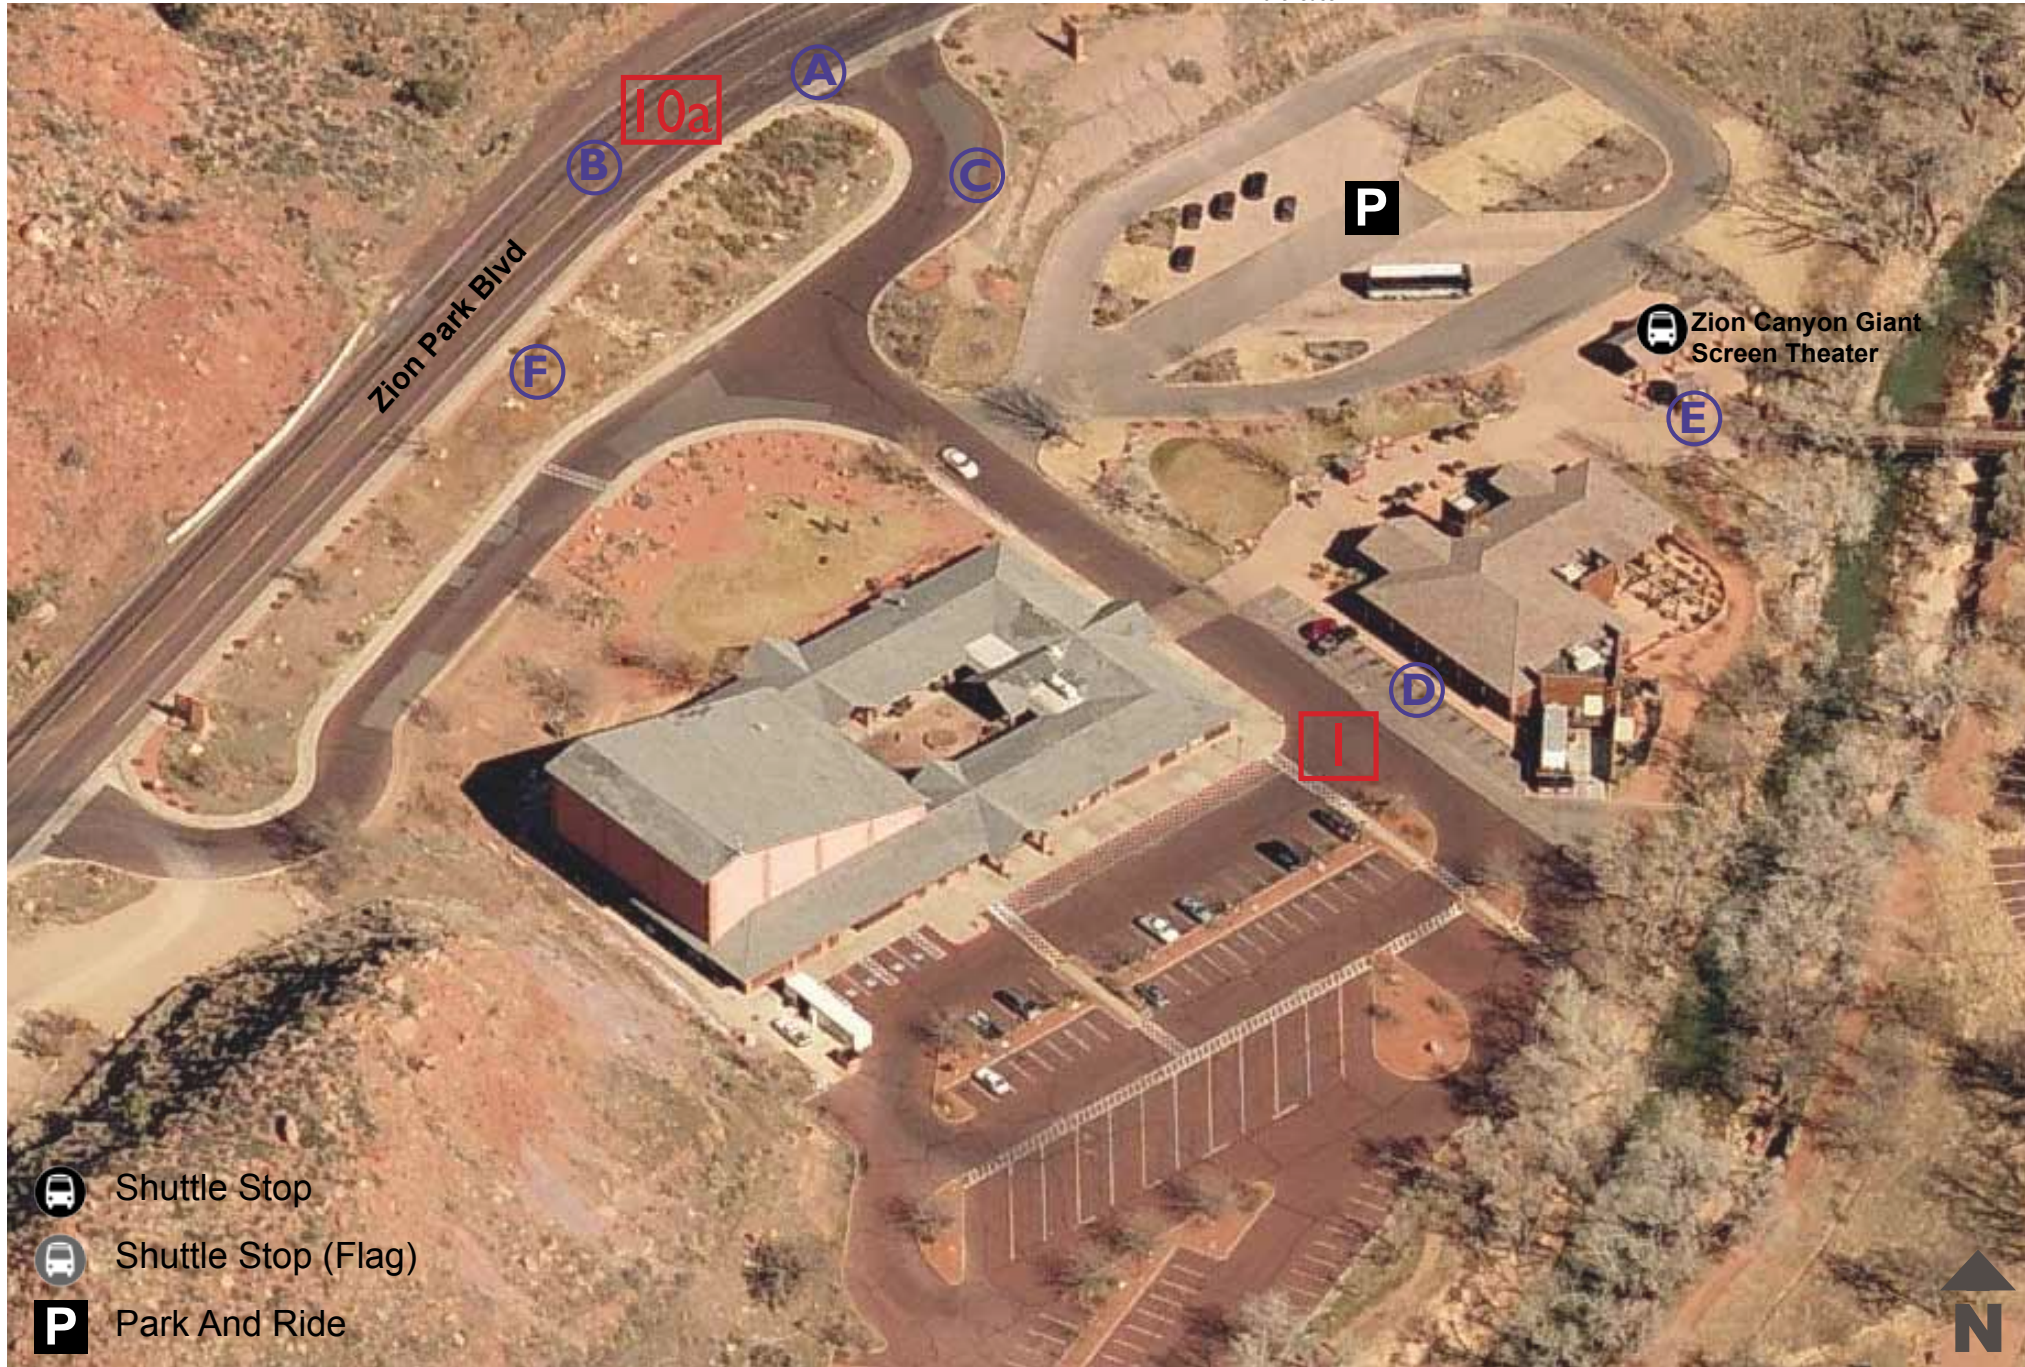
Zion Park Boulevard - **10a** On-Street Parking, **I** Giant Screen Theater Complex Upper Lot

- F** Landscaped area between driveways to lower parking is not attractive. Under construction? Should be planted/improved with people-friendly native vegetation, extending the feel of the park
