CAPE LOOKOUT NATIONAL SEASHORE
Cape Lookout Lighthouse
Keeper's Dwelling (1907)
**HISTORIC STRUCTURE
REPORT**

**Historical Architecture, Cultural Resources Division
Southeast Regional Office
National Park Service**

2002
Historic Structure Report
Cape Lookout Lighthouse Keeper's Dwelling
(1907)
Cape Lookout National Seashore
LCS#: 091838

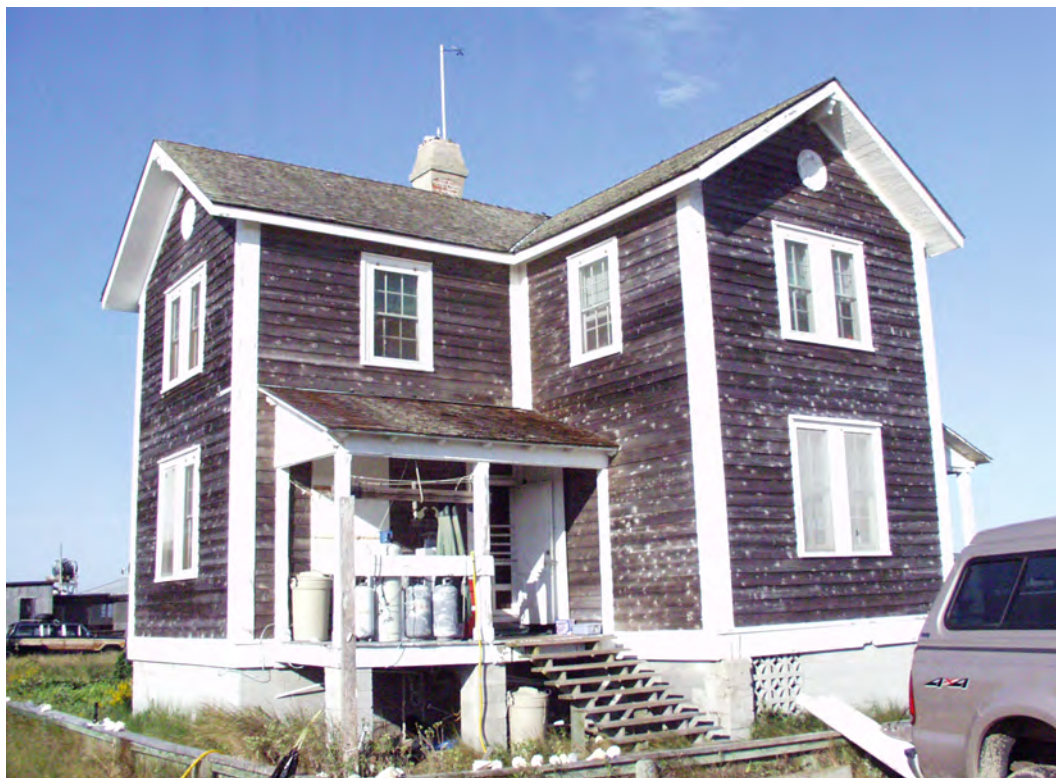
may simply be the result of old damage and repairs to the door, which closely resembles the door indicated on the original architectural drawings for the house. Vandals recently broke one of the back door's beveled-glass lights.

Figure 10 View to west of rear of Barden House. (NPS-SERO-CR, 2002)

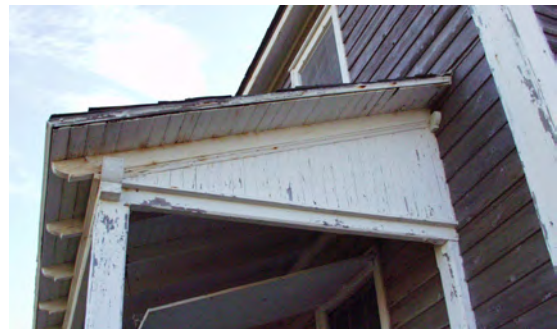
Most of the material on the two porches is historic, except for the front porch floor framing, which has undergone major repairs. Floor joists are typically 2" by 4" on about 18" centers. Flooring is tongue- and- groove, 1- 1/8" by 3", except on the west end of the front porch where the flooring is around 1- 1/8" by 2- 1/2". Posts are 5- 3/4" by 5- 3/4", nearly 8' tall, and have chamfered edges. Headers also have chamfered edges and measure around 2- 3/4" by 6". The ends of the headers project beyond the

Figure 12 View of west end of front porch. (NPS-SERO-CR, 2002)

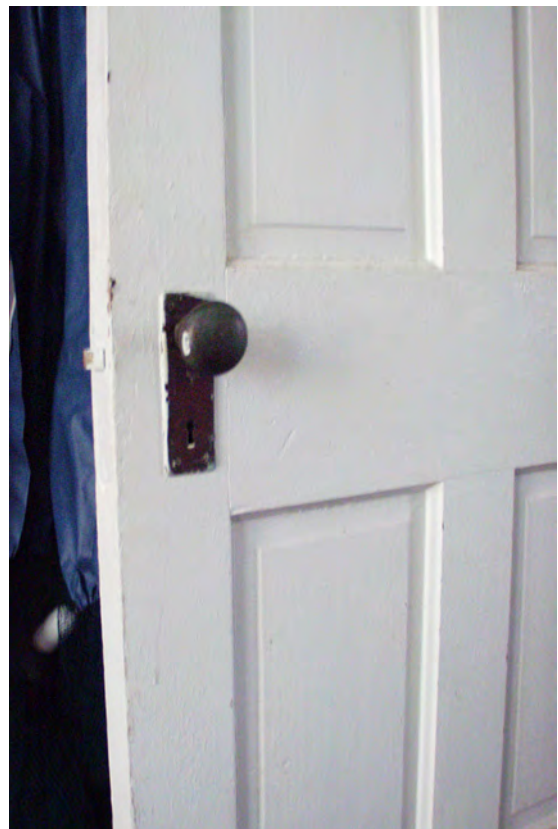
Doors: The door from the hall and the two closet doors are all 2’- 6” by 7’- 0” by 1- 3/8” with four vertical panels. Mortise locks are present at all three doors, but the knob is missing from one of the closet doors. The closet door knob is plain metal while the hall door knob is also metal but has a design impressed in its face. The closet door knob is probably typical of the original hardware.

Figure 21 Detail of closet door in Room 101. (NPS-SERO-CR, 2002)

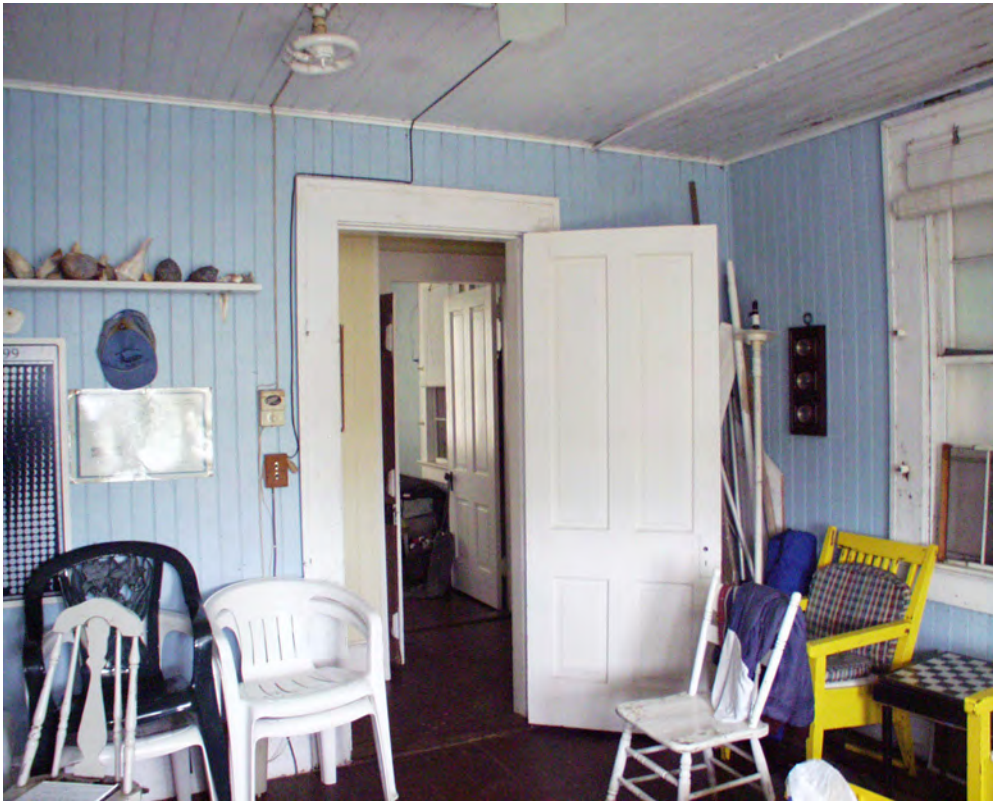
Doors: The door from the hall is 2'- 6" by 7'- 0" by 1- 3/8" with four vertical panels. A mortise lock is present but the knob is missing. In addi-

Figure 23 View to west in Room 102. (NPS-SERO-CR, 2002)

tion, the door has been damaged and the hinges bent, with the damage only partially repaired.
