CAPE LOOKOUT NATIONAL SEASHORE
Coast Guard Station Boat House
**HISTORIC STRUCTURE
REPORT**

2004
Historic Structure Report
Coast Guard Station Boat House
Cape Lookout National Seashore
Cape Lookout Village
LCS#: 09t830

Historic Structure Report

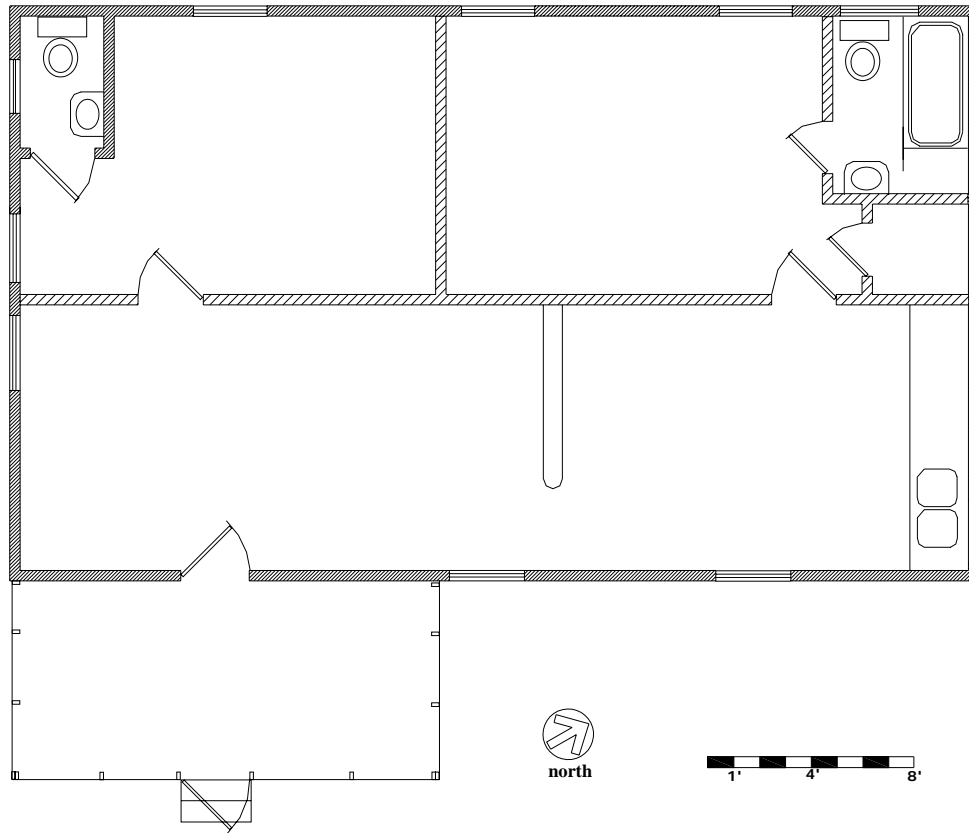
Alterations to the doors was the first major change. The single door on the southeast side of the building was removed and the opening closed by a wall and a conventional front door. The exterior of the wall was sided with drop

Figure 22 Plan of Boat House showing alterations in the 1960s. (T. Jones, NPS-SERO-CR, 2003)

siding that matched the original siding, but it is not clear if the existing front door was installed at that time or if it is a later replacement. At the northeast end of the building, the old double doors were simply fixed in place and the exterior covered with drop siding. The roof was also shingled with wood at the same time.

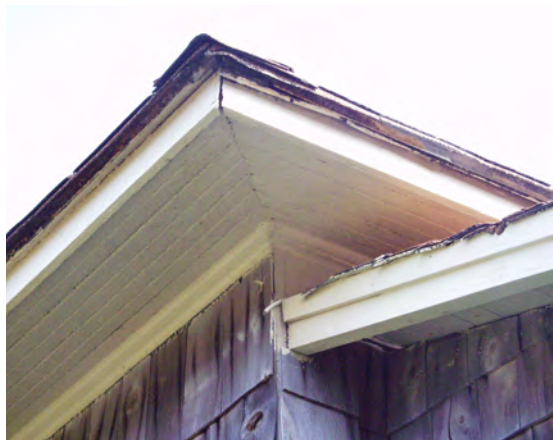
Figure 26 View of south corner and typical eave detail. (NPS-SERO-CR, 2002)

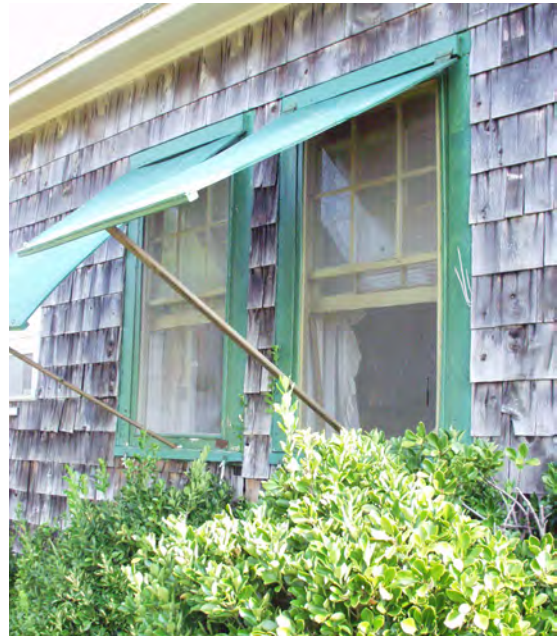
Figure 28 View of historic windows on northwest side of house with modern awning shutters. (NPS-SERO-CR, 2002)

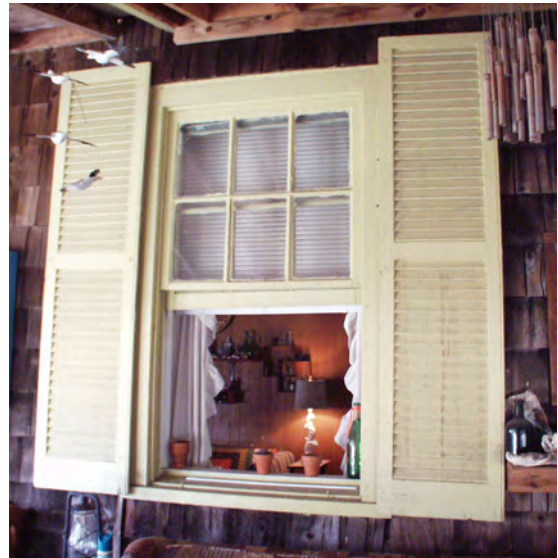
Figure 29 View of historic window on front porch with salvaged shutters added by present owner. (NPS-SERO-CR, 2002)

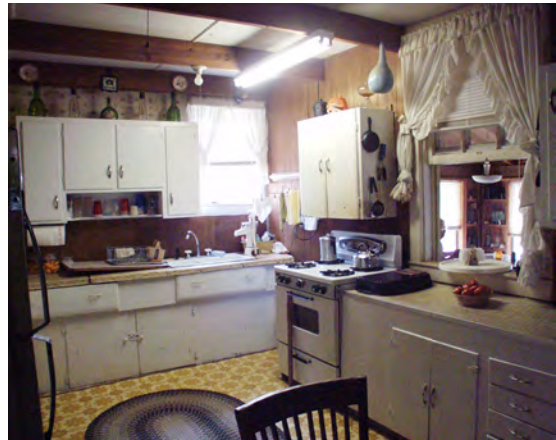
Miscellaneous: A wooden base cabinet approximately 27" wide runs the width of the northeast end of the room. According to the house's present occupant, who moved the building in 1958, this cabinet was part of a somewhat longer workbench that was originally located on the northwest (rear) wall of Room 102. Dimensions of wood used in its construction suggests that the cabinet dates to the building's original construction. The base cabinet door openings may not be original but the two drawers appear to be so. Both have faces 8-1/2" by 33", with broadly chamfered edges. Beneath the cabinet, part of the original boat doors at that end of the building are visible. The door was constructed with double-V-joint, tongue-and-groove, similar to that used on the building's soffit.

Figure 32 View to east in Room 101. Base counter at center left is part of a work bench that was originally in the space now occupied by Room 102. (NPS-SERO-CR, 2002)

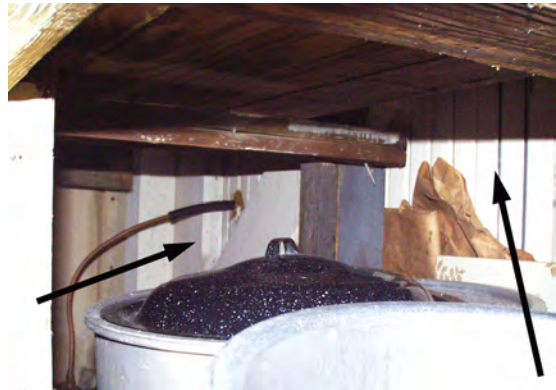
Figure 33 View of part of original boat doors under kitchen counter. Arrows indicate chamfered framing of door, left, and V-joint paneling used to finish doors, right. (NPS-SERO-CR, 2002)

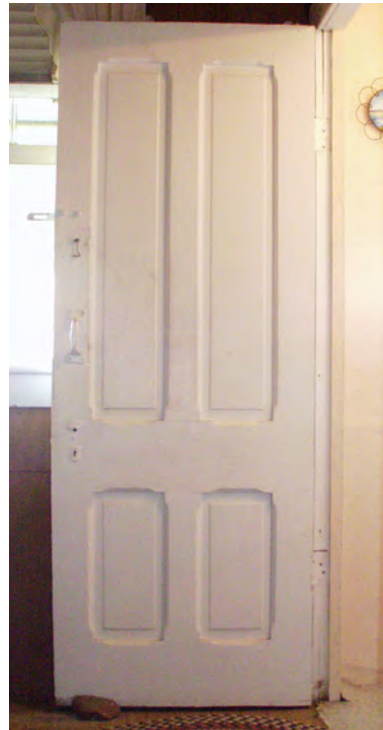
Figure 36 View of door to Room 102, believed salvaged from Life- Saving Station when it was remodeled in 1924. (NPS-SERO-CR, 2002)

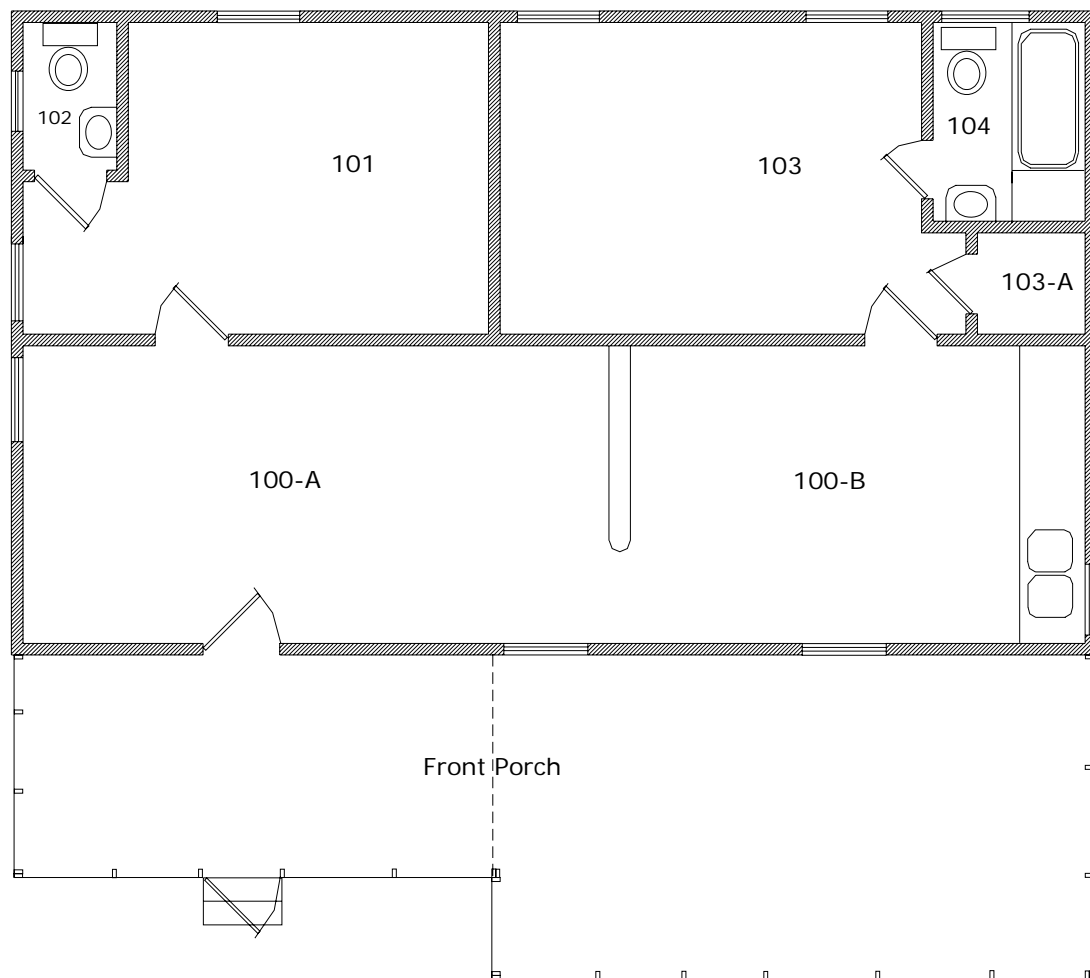
Figure 40 Plan of existing building. (T. Jones, NPS-SERO-CR, 2003)
