Cape Lookout National Seashore  
Portsmouth  
**GEORGE DIXON HOUSE**  
**HISTORIC STRUCTURE**  
**REPORT**

2004  
Historic Structure Report  
George Dixon House  
Cape Lookout National Seashore (CALO)  
Portsmouth, NC  
LCS#: 12519

## Historic Structure Report

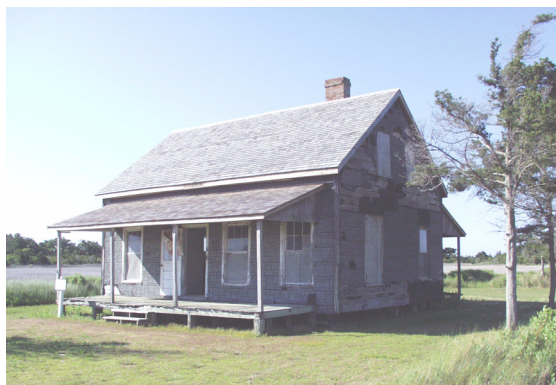
**Figure 9** View of front and north side of Dixon House. (NPS-SERO-CRS, 2002)

*Siding:* The house is presently finished with asphalt- composition panels installed after World War II. Measuring 16" by 36", these panels have a design meant to imitate random- range, dressed- face ashlar. On the southeast end of the house, all of the panels have been replaced by rolled asphalt roofing. On the northwest end, a quarter or more of the panels are missing, leaving the underlying wood sheathing exposed. Panels are badly damaged elsewhere.

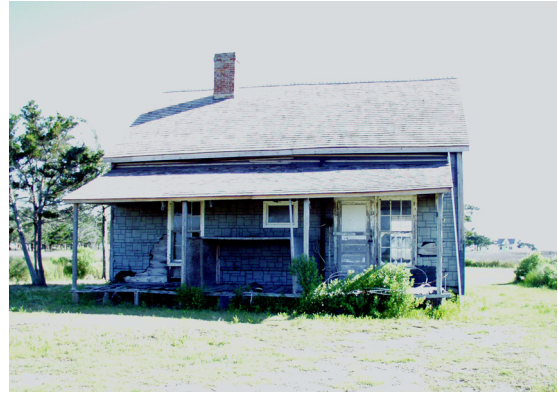
**Figure 10** View of rear or southwest side of Dixon House. (NPS-SERO-CRS, 2002)

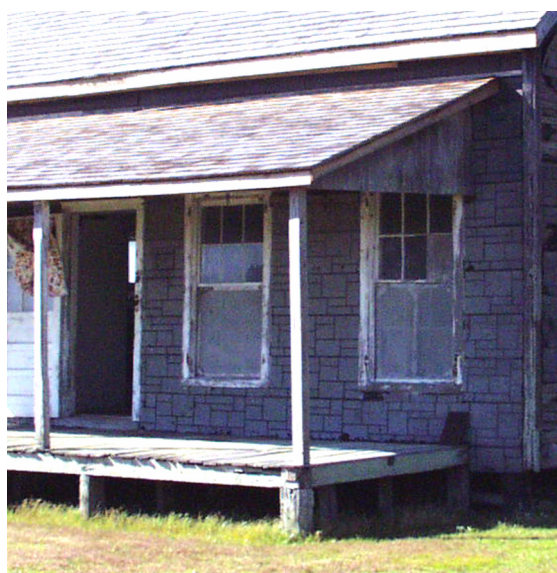
**Figure 15** View of front porch; column at left is original. (NPS-SERO-CRS, 2002)

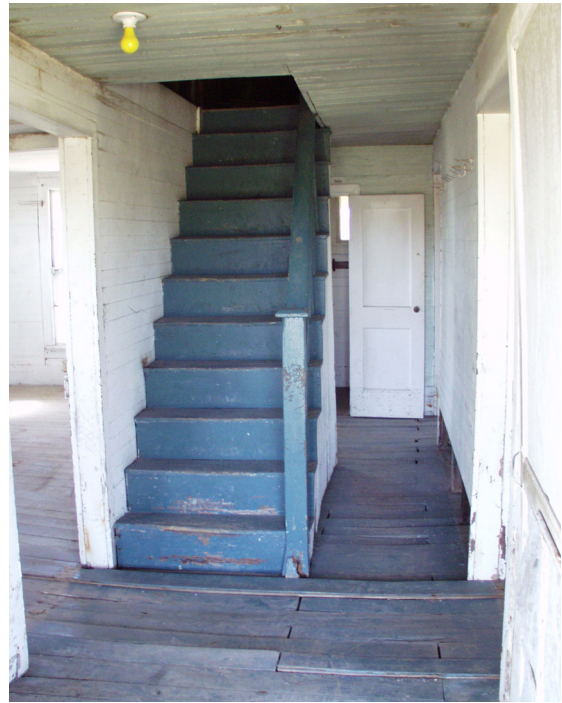
**Figure 16** View of hallway (Room 100) from front door. (NPS-SERO-CRS, 2002)

caused major deflection of the floor around the middle of the hall.

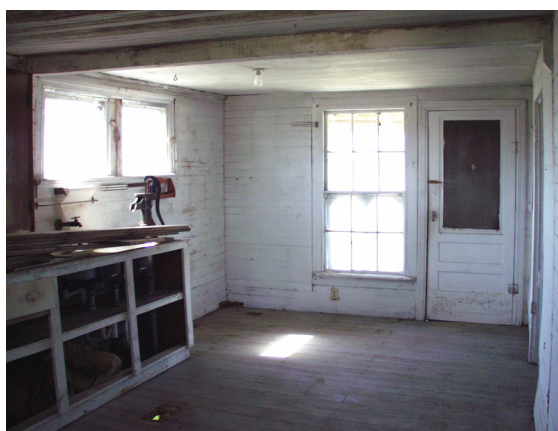
**Figure 21** View west showing what was Room 103, now combined with Room 104. (NPS-SERO-CRS, 2002)

Alterations will be necessary to windows if the exterior of the house is to be restored. The pair of post- WWII windows on the southwest wall of Room 103 should be eliminated and the original single window opening, which matched the

others on the first floor, should be restored. The sash now located on the porch side of Room 102 was probably taken from this location and, with restoration of a door in that location, could be returned to its original location.
