Cape Lookout National Seashore
LEWIS - DAVIS HOUSE

HISTORIC STRUCTURE REPORT

**Historical Architecture, Cultural Resources Division
Southeast Regional Office
National Park Service**

2004

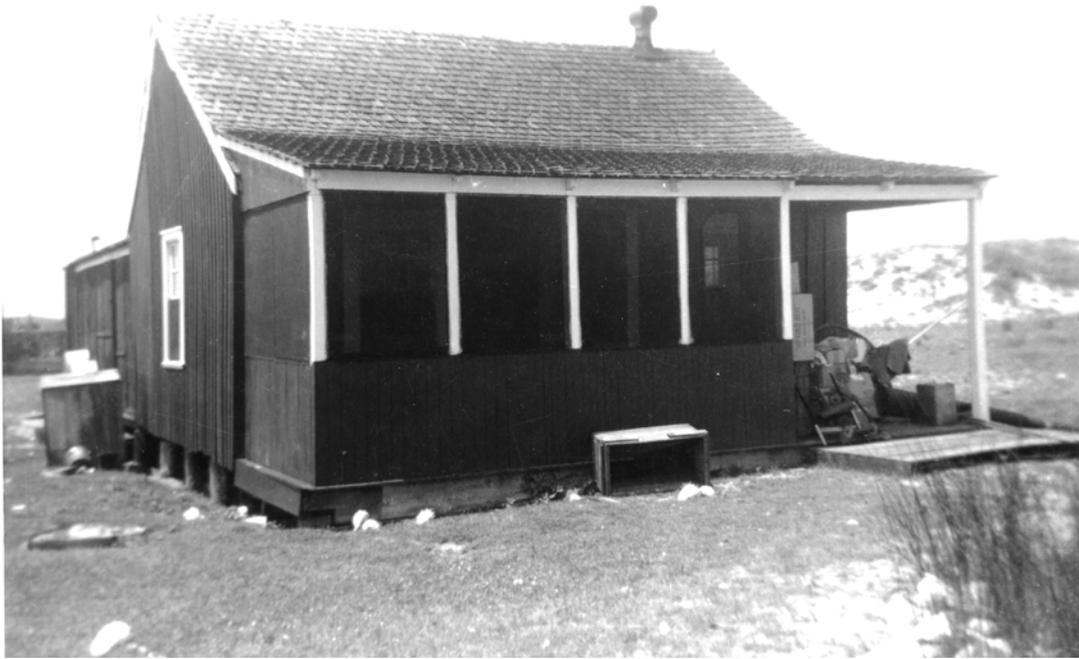
Figure 13 View of Lewis-Davis House during World War II. (CALO Coll., Royer photograph)

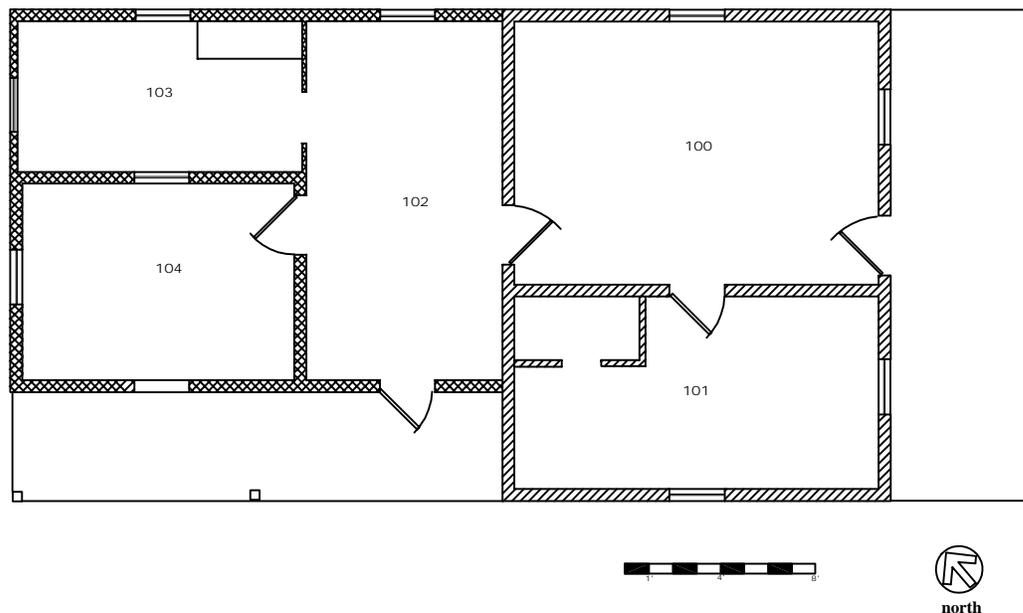
The front half of the present house (Rooms 100 and 101) was a wood- framed, two- room structure, measuring about 16’ by 20’ with the roof gabled on the short sides. It appears to have been quite similar to “Bull Hunter’s store,” a photograph of which is in the CALO collection of photographs (see Figure 14).

Figure 14 Reconstructed floor plan of house as it was constructed in the 1920s. (T. Jones, NPS-SERO-CR, 2002)

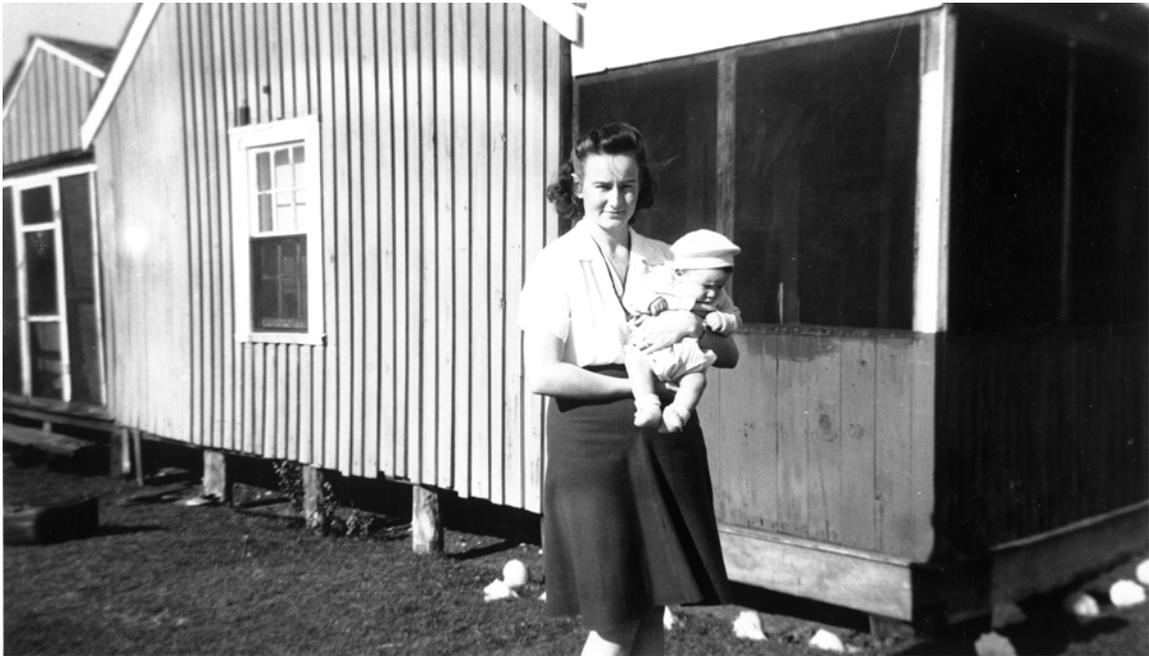
Figure 16 View of Lewis-Davis House in 1942. (CALO Coll., Royer photographs)

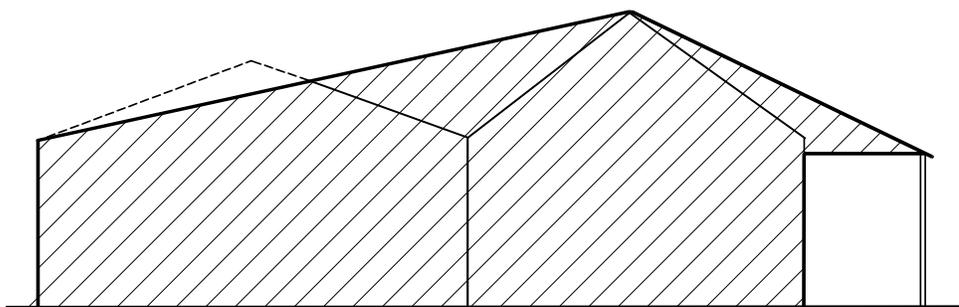
Figure 17 Side elevation of Lewis-Davis House illustrating changes to roof line after WWII. (T. Jones, NPS-SERO-CR, 2002)

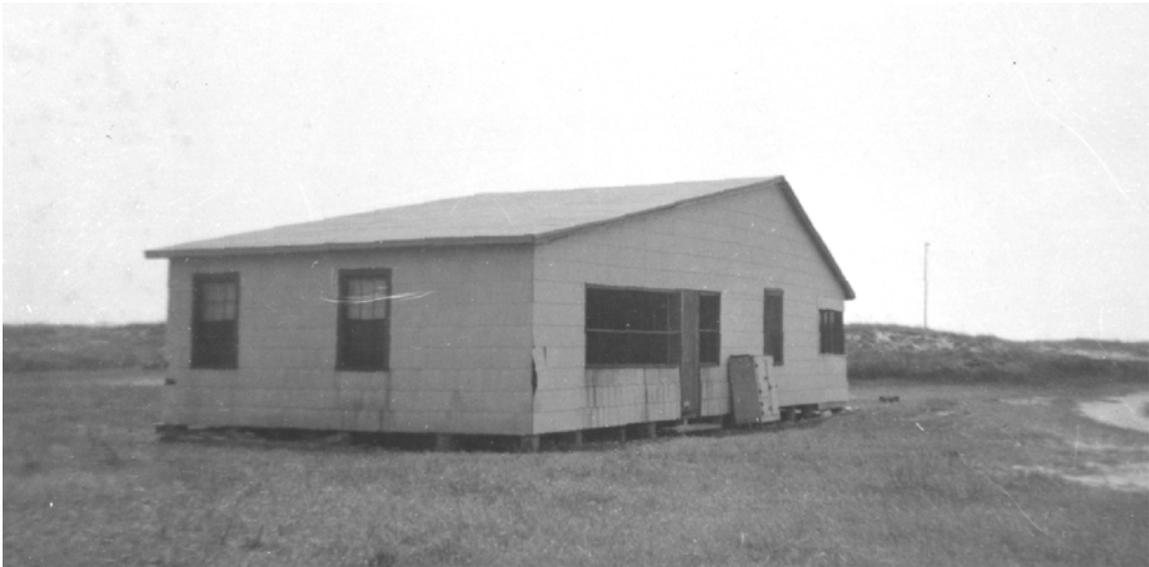
Figure 18 View to east of Lewis-Davis House in August 1958. (CALO Coll.)

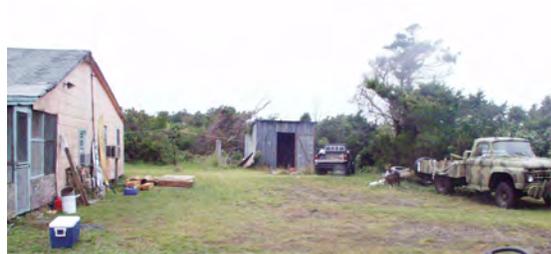
Figure 21 View to northwest, showing metal storage building in rear yard. (NPS-SERO-CR, 2002)

Like the Gaskill- Guthrie House, the house was built on a lot 50' by 220' that combined two of the original lots laid out by the Cape Lookout Development Company in 1915. In the rear yard is a modern metal storage building, 12'-3" by 15'-3". Partially-burned piles of refuse litter the grounds.

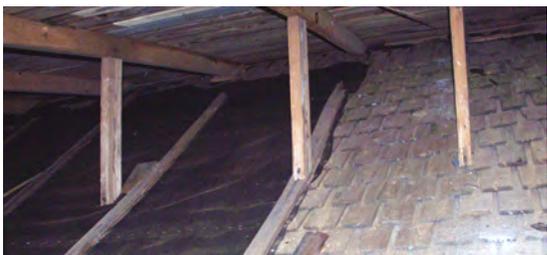
Figure 27 View of wood shingle roof on original structure encompassing Rooms 100 and 101. (NPS-SERO-CR, 2002)

Rafters: There are three main rafter systems in the present structure: one over Rooms 100 and 101, which could not be examined, and another separate system over the rear rooms. When the two halves of the house were joined, a new roof structure was built to cover both of the earlier roofs (see Figure 10). Rafters of this third roof are around 1- 3/4” by 3- 3/4”, on 30” centers, and woefully undersized for their span and pitch. Rafters at the rear of the house have been severely damaged by termites.

The present roof also has a solid deck, mostly 1" by 6", except on the modern additions where plywood is used. The present roof covering is modern, asphalt, "hurricane" shingles that have been heavily patched with tar or other coatings. The roof covering is leaking badly, especially at the rear of Room 104 and near the center of the house.

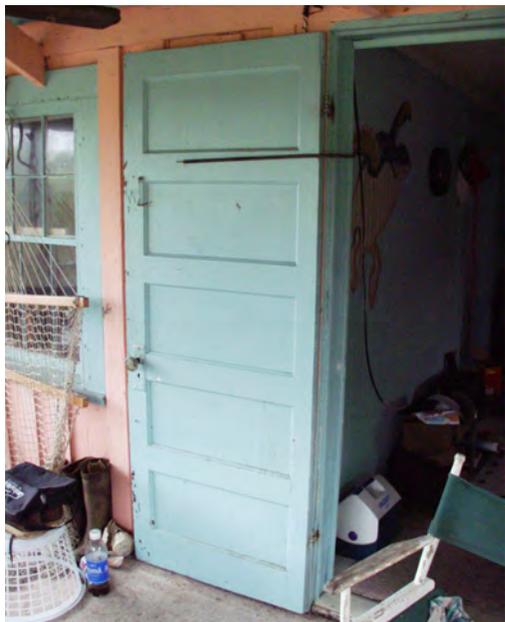
Figure 30 View of front door D-1. (NPS-SERO-CR, 2002)

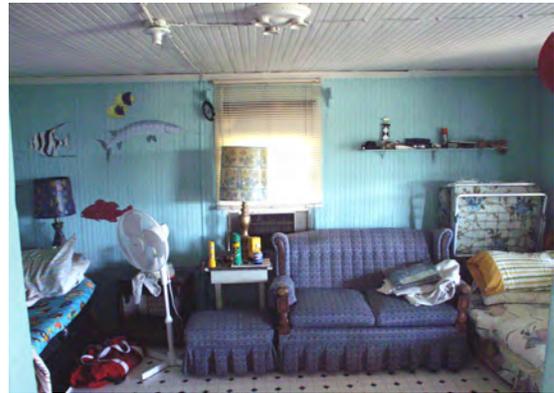
The front door opens into this room, which is about 11' by 15'- 3". Most of its historic features remain intact and in good condition.

Figure 32 View to northeast in Room 100. (NPS-SERO-CR, 2002)

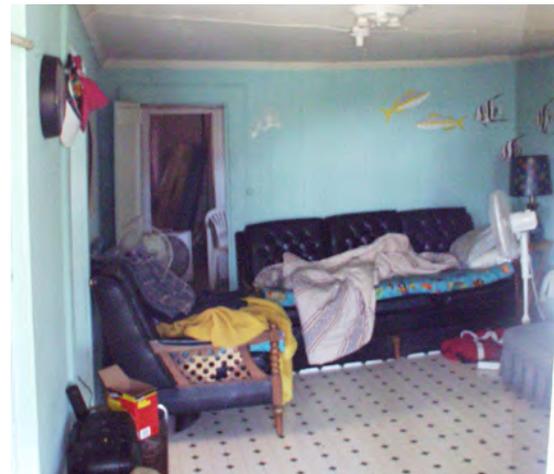
Figure 33 View to northwest in Room 100. (NPS-SERO-CR, 2002)

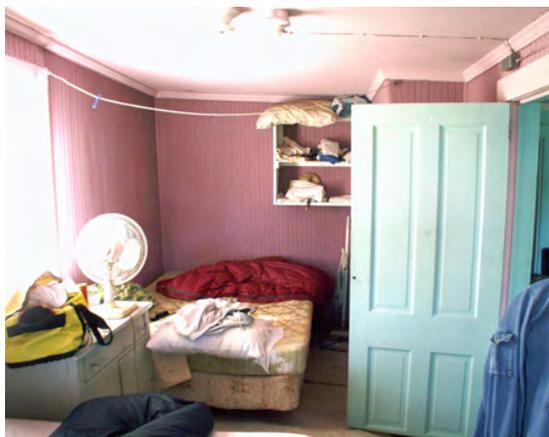
Figure 34 View to west in Room 101. (NPS-SERO-CR, 2002)

The floor is in dangerous condition and appears to be collapsing due to major deterioration of floor joists and/or piers under this part of the house.

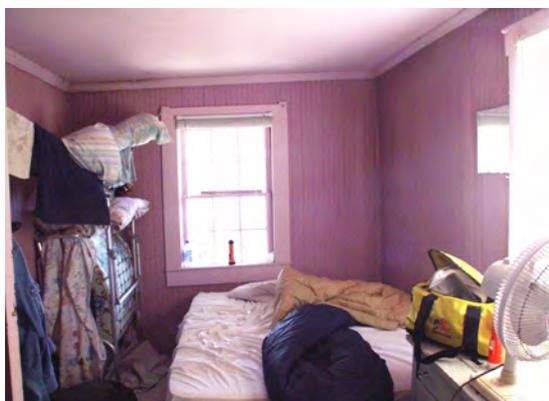
Figure 35 View to southeast in Room 101. (NPS-SERO-CR, 2002)

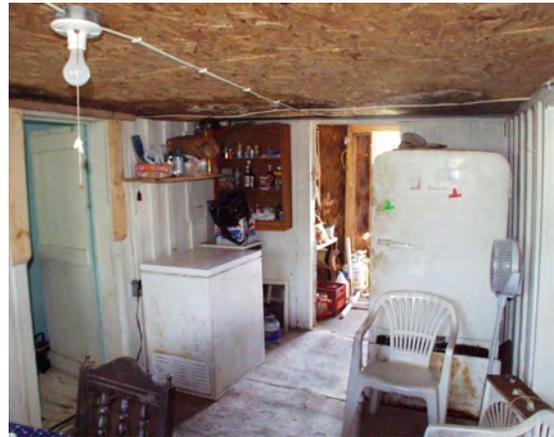
This room measures 8'-2" by about 15'. All of the rooms in the house except Room 101 open to this room. Major damage is ongoing where the roof is leaking along the wall adjoining Room 100.

Ceiling: The ceiling is set at about 7' and covered by sheets of wafer board. Original tongue- and-groove boards, 3-1/2" wide, probably V-joint, remain in place beneath the wafer board, but many are probably damaged or deteriorating due to water penetration. The ceiling has been braced along the middle of the

Figure 36 View to south in Room 102. (NPS-SERO-CR, 2002)

the east wall because water-damaged joists are collapsing in that area.

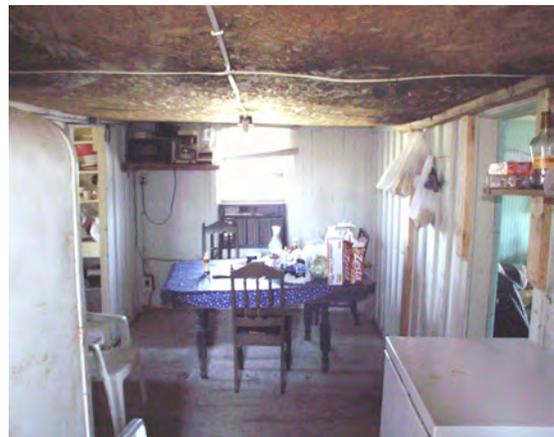
Figure 37 View to northeast in Room 102. (NPS-SERO-CR, 2002)

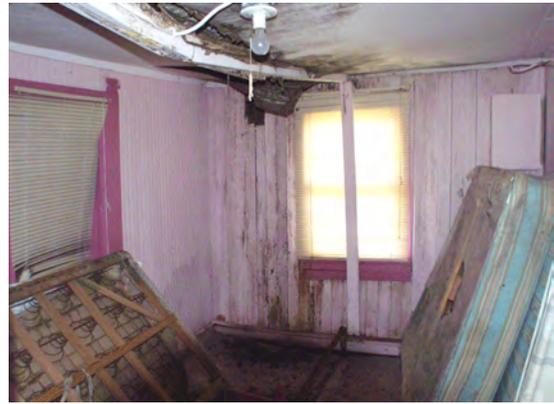
Measuring 8'- 4" by 11'- 6", this room is in extremely poor condition.

Floors: The floor is carpeted over plywood, although there appears to be an underlying layer of historic tongue- and- groove material. Water penetration and termites have destroyed the connection between the joists and the rear sill, allowing the entire floor to collapse at that end of the room.

Ceiling: The ceiling, like the floor, is on the verge of total collapse due to severe termite and water damage. It was originally finished with double- V- joint, tongue- and- groove boards, 3- 1/2" wide.

Figure 40 View to west in Room 104. (NPS-SERO-CR, 2002)

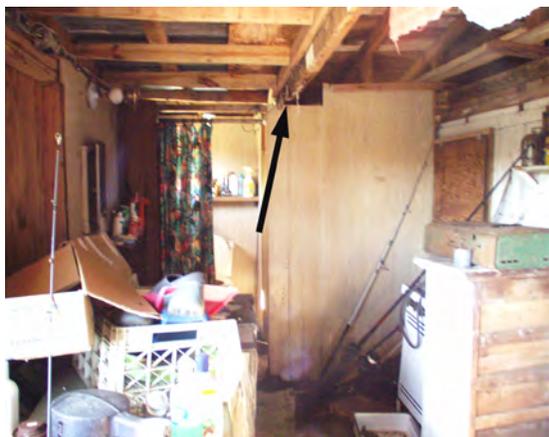
Figure 42 View northwest in Room 105. Arrow marks header at outside of historic porch. (NPS-SERO-CR, 2002)

Floor: The floor is modern plywood and is suffering from severe water damage near the entrance to the bathroom area.

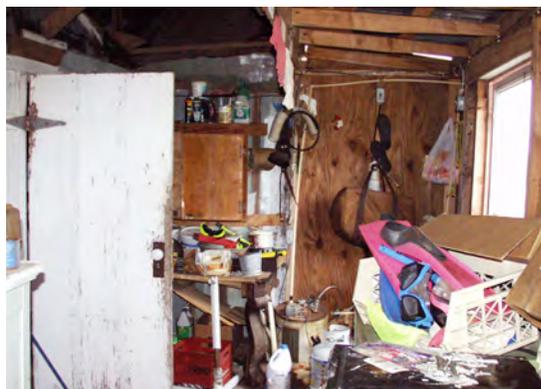
Figure 43 View to southeast in Room 105. (NPS-SERO-CR, 2002)
