Cape Lookout National Seashore

Portsmouth Life- Saving Station

# Historic Structure Report

2006

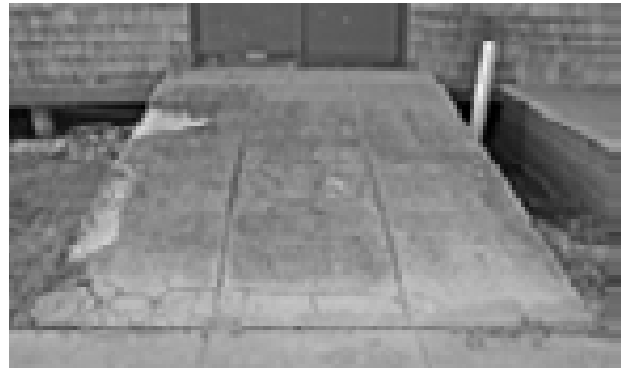
FIGURE 59. View of ramp to Boat Rooms doors D-5. (T. Jones, NPS, 2005)

*Condition:* The ramp from the easternmost door on the northwest side of the building is basically sound, but the finish layer of concrete on the other two ramps is spalling away from the base along part of the edges of the ramps.

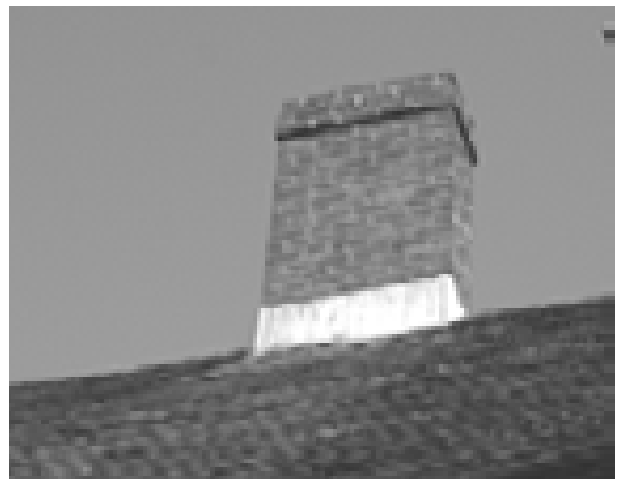
FIGURE 60. View of southeast side of chimney. (T. Jones, NPS, 2005)

*Condition:* The chimney stack is only visible in the attic and above the roof. In the attic, the brick has been stuccoed, and the stucco remains mostly intact and in good condition. Above the roof, the original chimney stack appears to remain intact, although the original stepped flashing has been replaced.

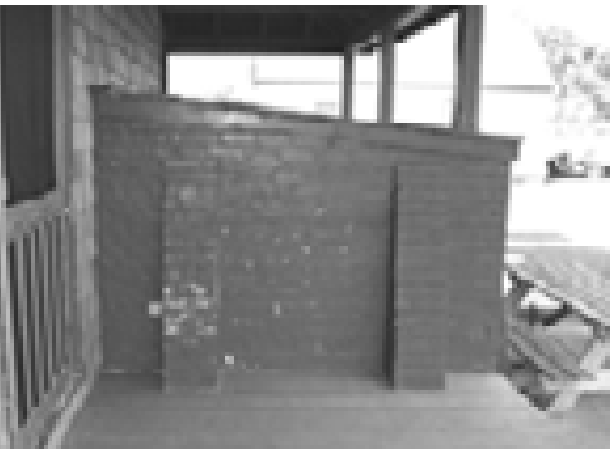
FIGURE 62. View southwest of cistern. (T. Jones, NPS, 2005)

*Condition:* The cistern appears to be in sound condition, but downspouts from the gutters no longer

keep it filled. The wooden cover is in fair condition. The hatch that provides access to the interior of the cistern is nailed shut, and the condition of the interior of the cistern was not inspected.

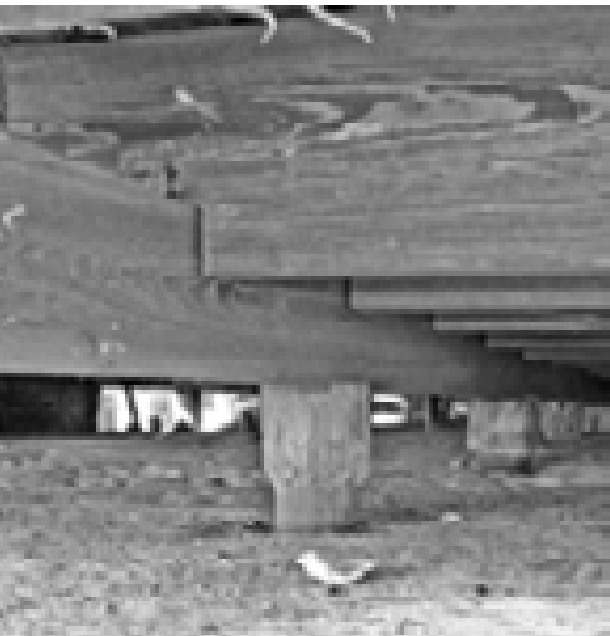
FIGURE 63. View west under boat room. (T. Jones, NPS, 2005)

*Condition:* There is no indication that the pilings are not original to the building, and many of them have lost a considerable amount of wood, mostly due to erosion from sand- laden water that periodically sweeps the site.

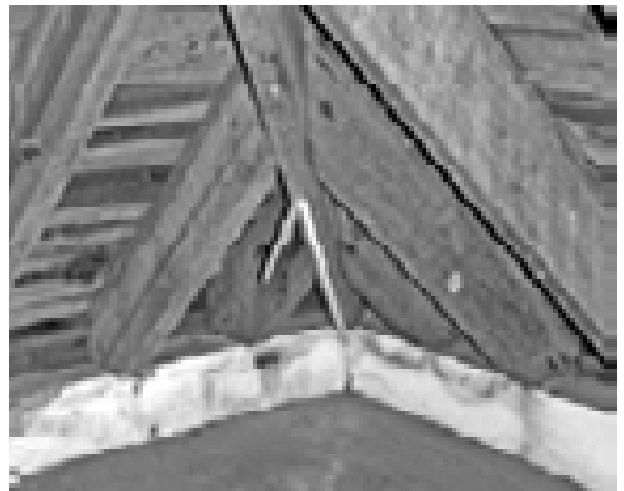
FIGURE 65. View of roof hip and junction of rafters and top plate of second floor walls. (T. Jones, NPS, 2005)

*Condition:* Framing material is in generally good condition, but there are isolated areas of termite damage, including some in the rafters of the main roof. The sills along the northeast end of the building and on the northwest side in the vicinity of the boat room doors have deteriorated, and at least part of them will need to be replaced. In addition, during Hurricane Isabel in 2003, water rose as high as 22" inside the station, doing significant damage around the north corner of the Boat Room. Several floor joists were lifted completely away from the sills, buckling and dislodging much of the interior flooring in the process. Some of the joists are now missing, apparently washed away in a nor'easter that struck Portsmouth in the spring of 2005. The storms also destroyed the wall beneath window W- 6, and the area is now covered with plywood.

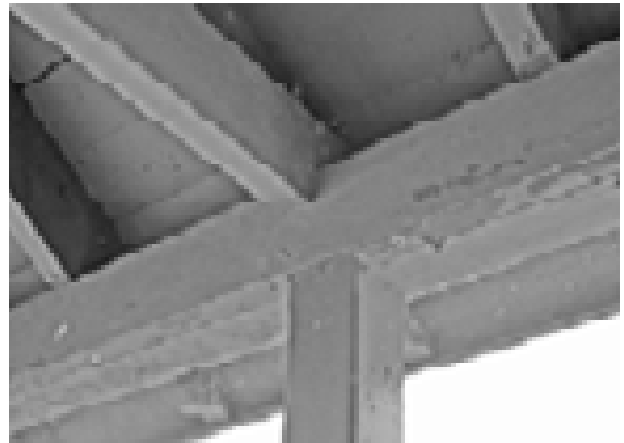
FIGURE 71. View of typical header and post on porch. (T. Jones, NPS, 2005)

*Condition:* Most features of the porch, including the flooring, are in good condition. The bottoms of some of the columns are deteriorating, but none of the damage necessitates column replacement. Some quarter-round that finishes the header on the southwest side of the building is missing, and several runs of the bed molding between the rafters at the walls of on the northwest side of the house are also missing.

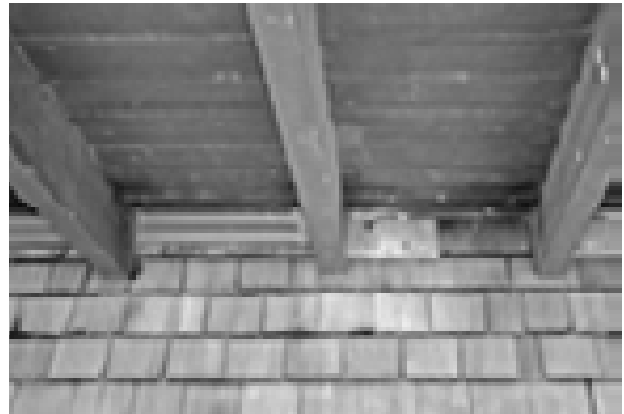
FIGURE 72. View of junction of porch rafters and walls. (T. Jones, NPS, 2005)

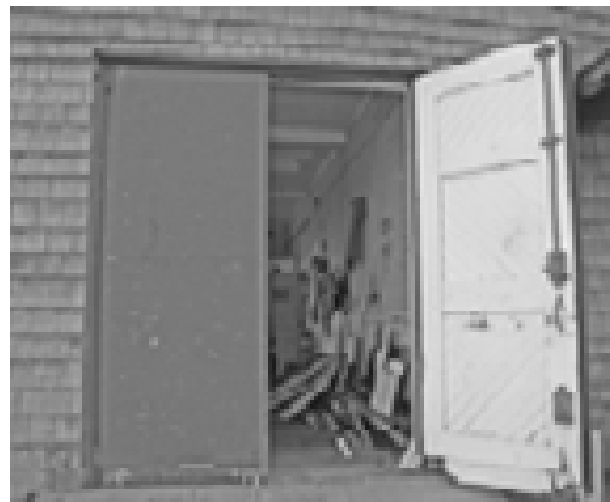
FIGURE 80. View of Door D-5. (T. Jones, NPS, 2005)

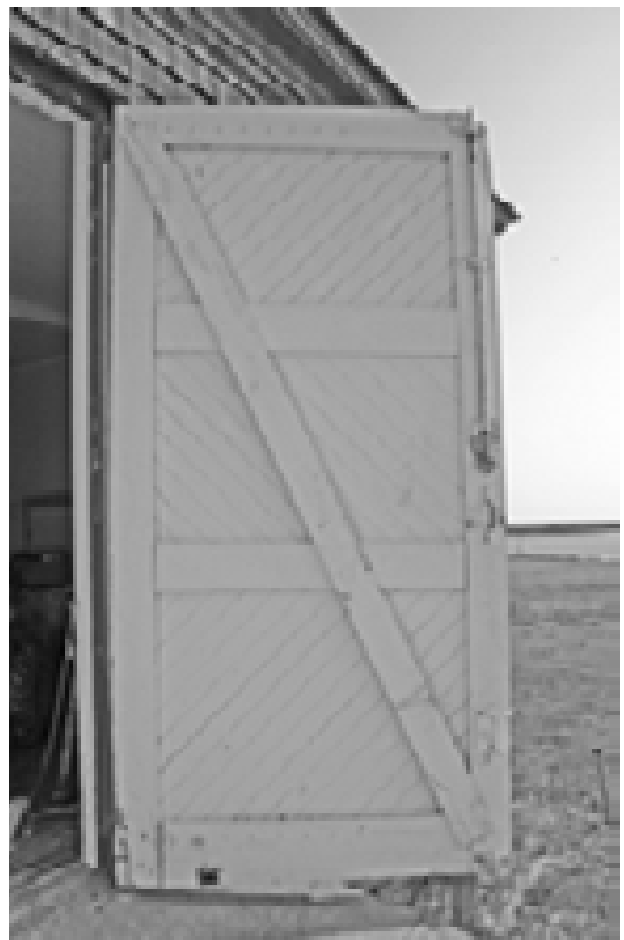
FIGURE 82. View of one leaf of Boat Room door D-3. The diagonal brace is not an historic feature. (T. Jones, NPS, 2005)

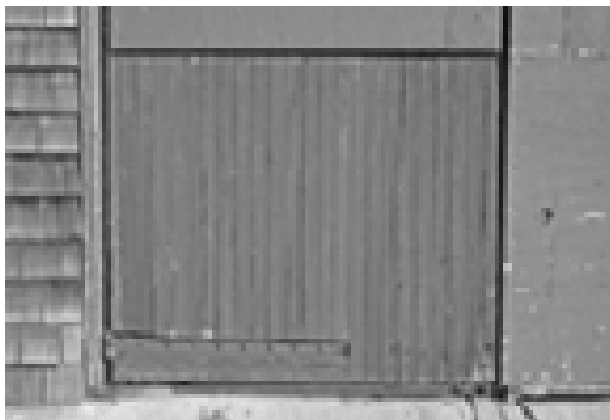
FIGURE 85. View of one leaf of double doors at D-3, showing typical original hinge and added layers of tongue-and-groove material and plywood. (T. Jones, NPS, 2005)

and appear to be overlaid with 7/8" by 3" beaded tongue- and- groove boards set diagonally into the same grooves in the stiles and rails. In addition, another layer of vertical tongue- and- groove boards (historic but not original) is visible on the exterior of Door D- 4 and is probably present on the other doors as well. All three sets of doors are covered on the exterior with modern 1/2" plywood installed on top of the historic tongue- and- groove material.

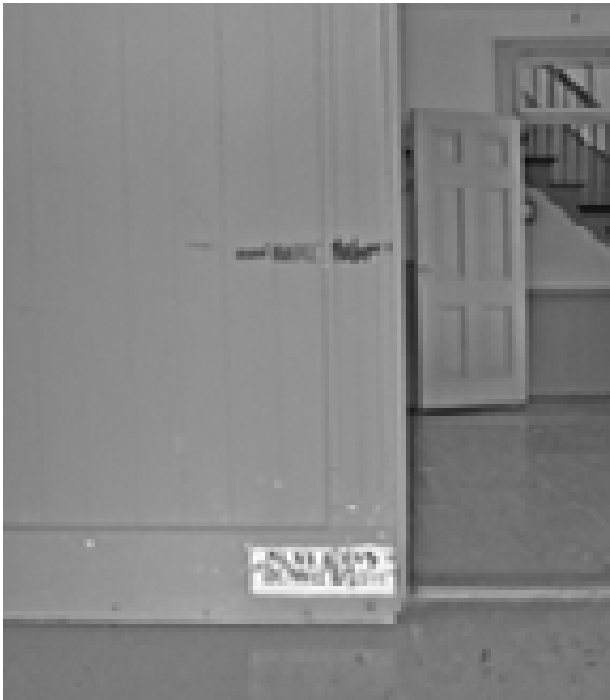
FIGURE 103. View of marks showing high-water marks for recent hurricanes. (T. Jones, NPS, 2005)

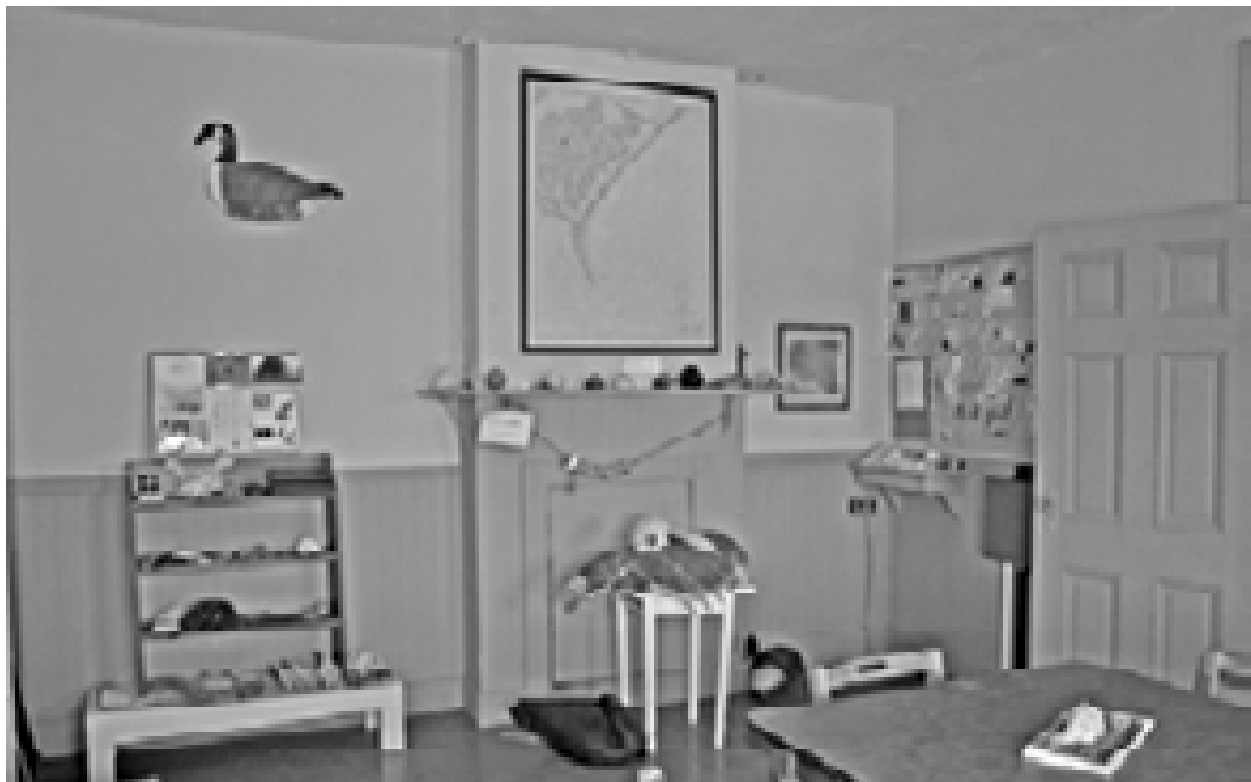
*Flooring:* The entire floor is laid with painted, 2- 1/2" wide, tongue- and- groove flooring, the only floor in the building laid entirely with the narrower flooring. As a result of storm flooding, flooring is severely buckled on the northwest side of the room.

FIGURE 112. View north in Room 104. (T. Jones, NPS, 2005)

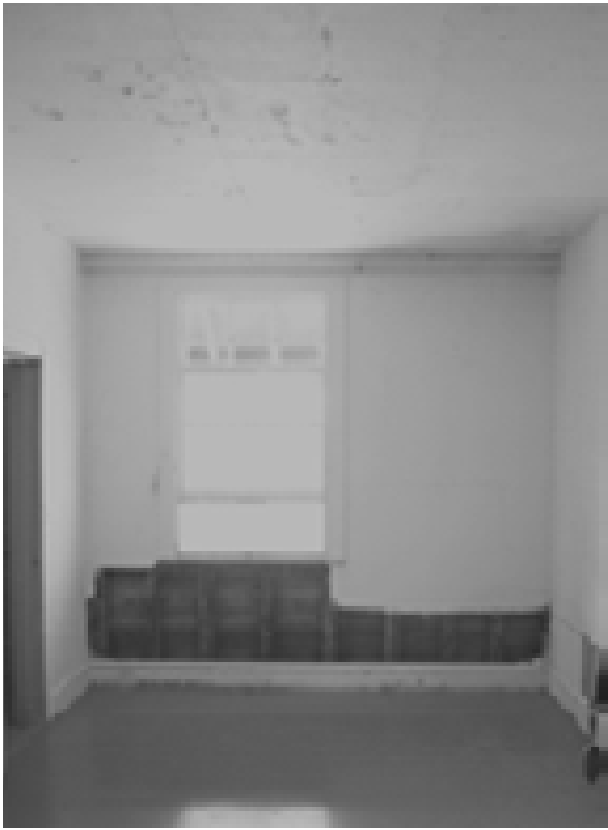
FIGURE 116. View northwest in Room 106. (T. Jones, NPS, 2005)

*Walls and Ceilings:* Walls and ceiling are finished with plaster on plaster board. Recent flooding badly damaged the lower portions of the walls, and some of the plaster board has been removed. Residue from the original plaster on wood-lath walls is visible on exposed studs.

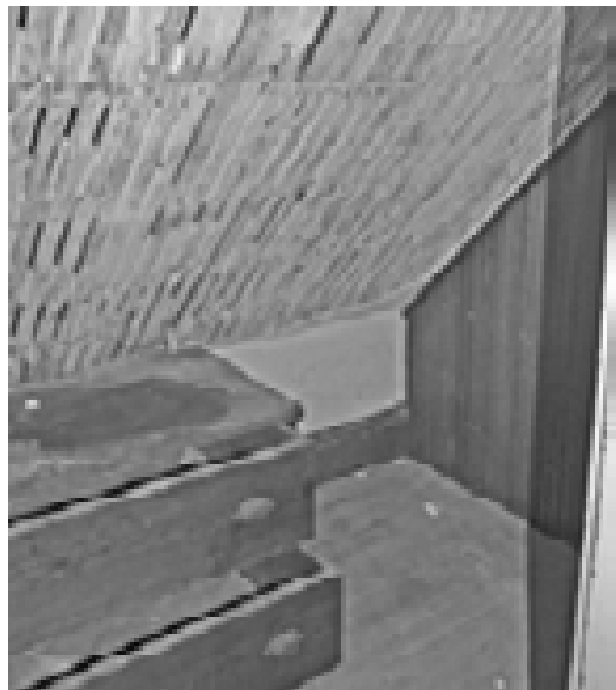
*Walls:* Walls are plaster on plaster-board, except in the closets where the original plaster on wood lath - remains intact, although much of the plaster has fallen from the lath.

FIGURE 136. View of typical closet in Room 201. (T. Jones, NPS, 2005)

*Miscellaneous:* Each of the closets has a small, built-in chest of drawers. Each has two drawers and measures 21" deep, 36" long, and 22" high. Birds nesting above the ceiling in the closets on the southwest side of the building have soiled the space with their droppings and contributed to damage to the plaster.

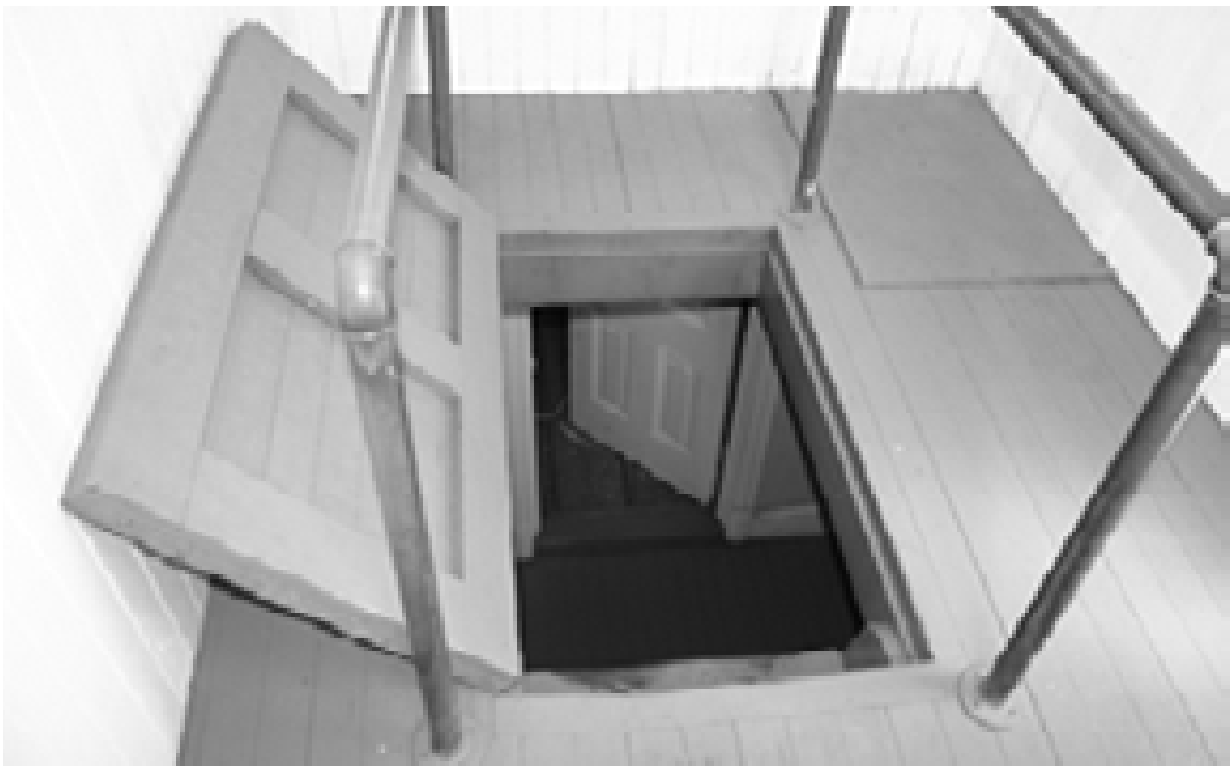
*Windows:* The room has seven windows, not eight as shown on some plans of the building. Two are located on each of the northwest, southwest, and southeast walls, with one located on the northeast wall. Sash are 20- 1/2" by 28", top hinged, and divided into three lights. Both sash are missing from

FIGURE 150. View west of watch room's hatch door. (T. Jones, NPS, 2005)

the two windows on the northwest side of the room, and the openings are now covered by plywood.

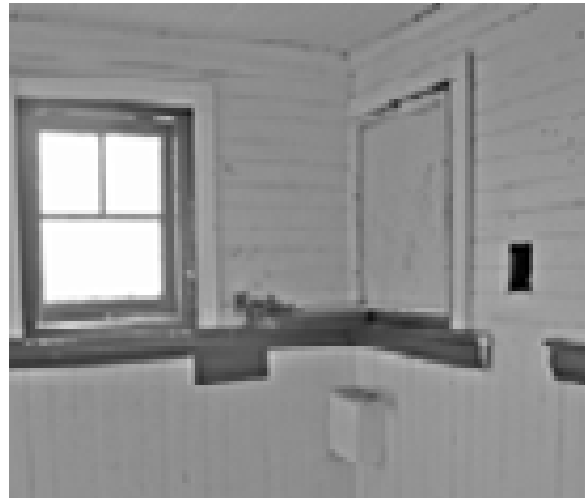
*Miscellaneous:* A small wooden box is mounted on the east corner of the room and may have once held the time clock used to record the watchman's time on duty. For unknown reasons, a 6" by 8" hole has been opened in the southeast wall and a portion of the chair rail is missing in that location.

FIGURE 151. View of east corner of room. (T. Jones, NPS, 2005)
