## Cape Lookout Village Cultural Landscape Report

Cape Lookout National Seashore  
Carteret County, North Carolina

9 May 2005

## **Cultural Landscape Report**

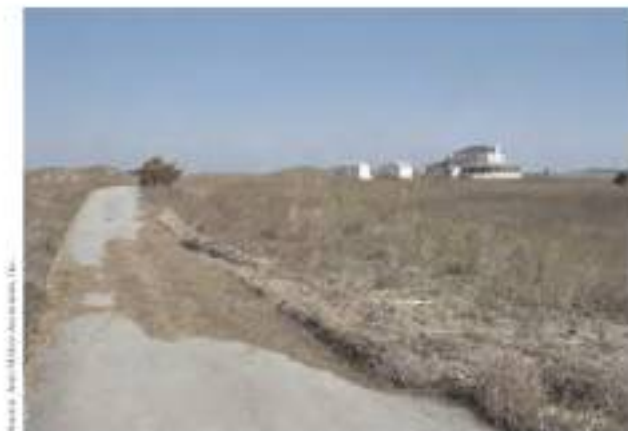
Figure 3-59. Another view of the Concrete Road looking towards Coast Guard. Stormwater has deposited rock across the road surface.

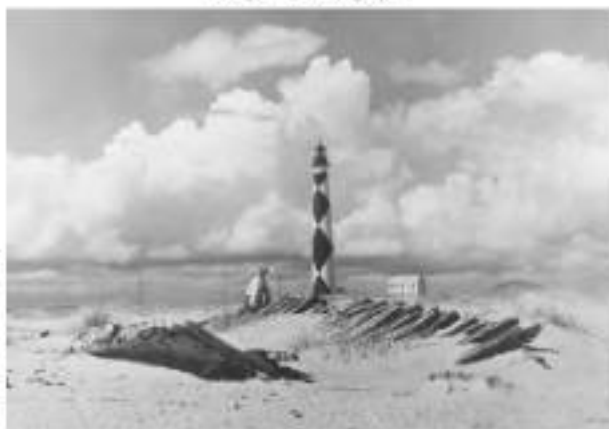
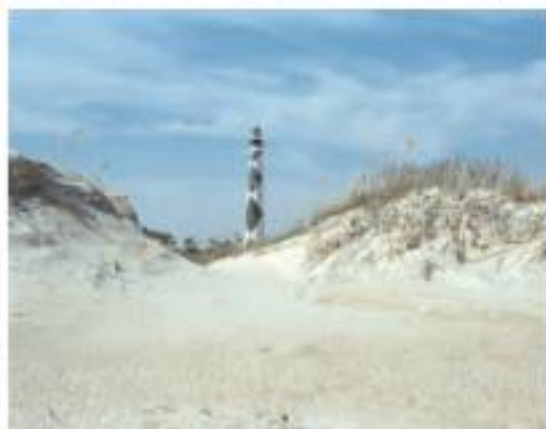
Photo Pair 1.

View towards the Cape Lookout Lighthouse and 1873 keeper's dwelling, ca. 1938 from a shipwreck.

The same view in 2005. Note the change in dune vegetation obscuring the view to the keeper's dwelling.

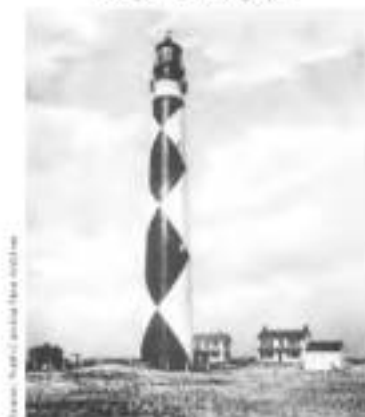
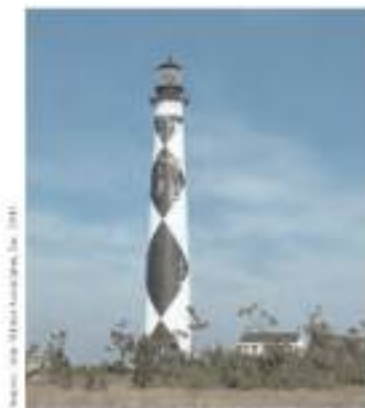
Photo Plate 2.

Lighthouse complex looking west, ca. 1913. Copy of hand-colored post card from Beaufort Drug Company.

The same view in 2005. Note that kinkadee plants are ring the base of the lighthouse. While the 1977 keeper's dwelling is visible on the right, the 1907 keeper's dwelling behind the lighthouse and an outbuilding to its right are no longer in evidence. The fence line visible in the historic post card exists only as a few remnant posts today.

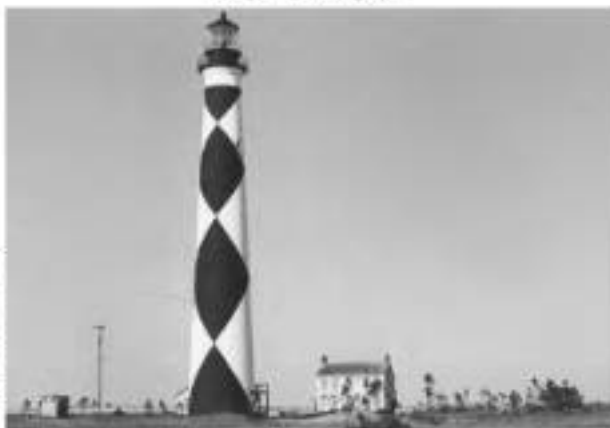
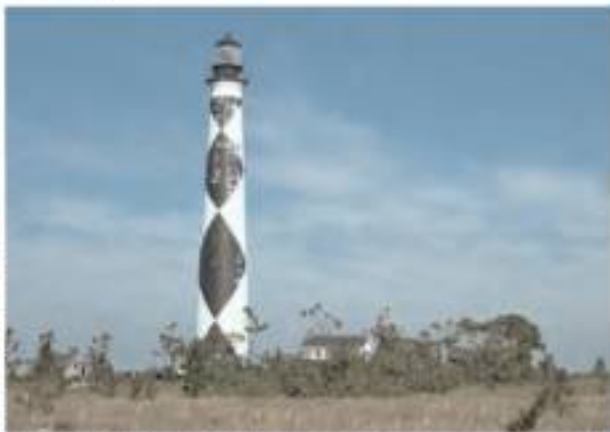
Photo Plate 5.  
Lighthouse complex looking west, ca. 1978.

The same view in 2003. Note that the tall pine trees enclosing the Lighthouse have grown considerably, and the point on the lighthouse is peeling. The utility pole on the left in the photo has been removed.

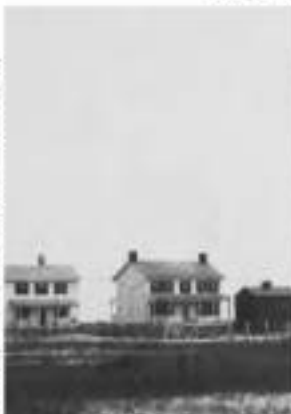
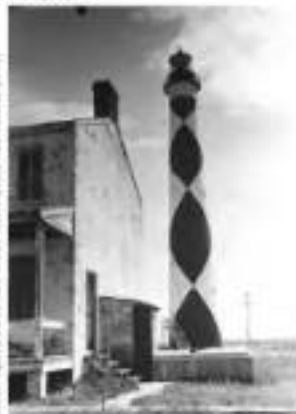
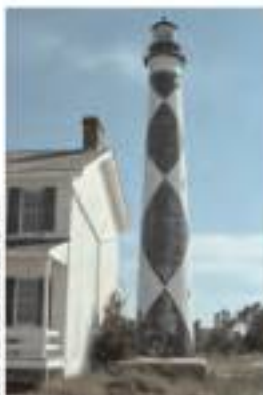
Photo Pair 4:

Lighthouse keeper's dwelling and lighthouse, 1943 (left), 1970 (right). Photo left indicates original features retained as shown before, and the building, right, as it had been modified.

The same view, 2003. Note that the 1875 keeper's dwelling covers have been extended, the downspouts replaced, shutters have been added, the deck removed, a side door bricked over, and the front porch has received a new railing. A concrete sidewalk has also been removed. The utility post is gone and the wooden stairs on the side of the lighthouse have been replaced.

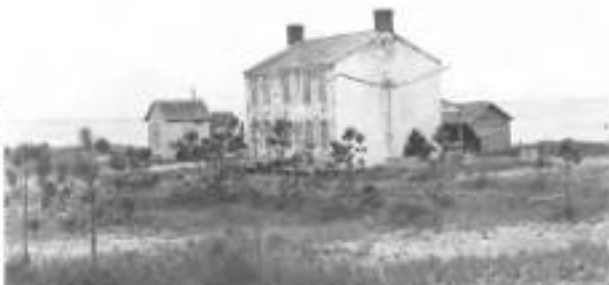
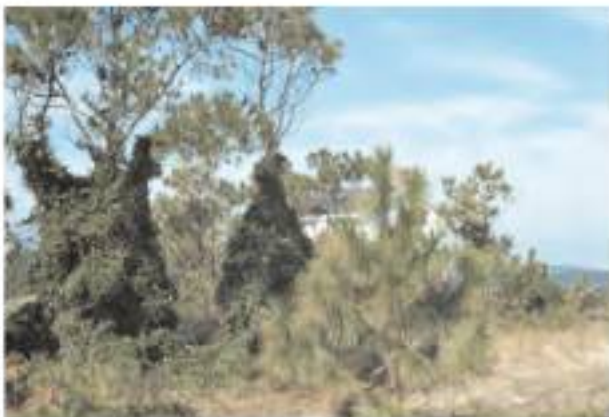
Photo Plate 2.

Lightkeeper keeper's dwelling and associated outbuildings, and young pine trees, looking southwest, ca. 1978.

The same view in 2005. Although this view has become overgrown with pine trees and grassland trees, it is still obvious that many of the outbuildings were there are no longer extant, and changes have been made to the walling of the keeper's dwelling.

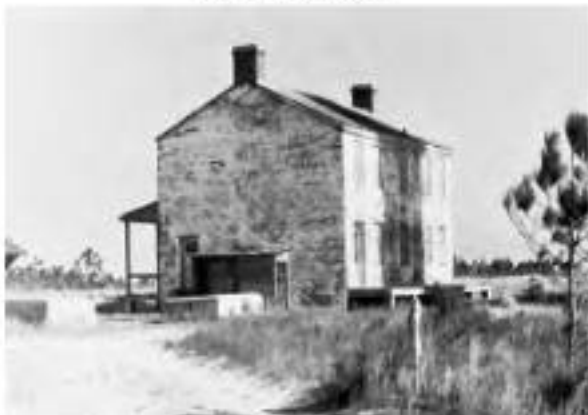
Photo Plate 6:

Lighthouse keeper's dwelling established in 1873, looking north, ca. 1978. Note a faint line where former dormer windows have been removed.

The same view in 2005, after the building has undergone restoration: a new porch has been added, the front porch has received new railings, the eaves of the roof have been extended, shutters have been added, the dormer windows replaced, the shed on side of building removed, and the door to the left of the shed has been bricked over. The concrete column, left in the photo, survives but is obscured from view by the damaged shed.

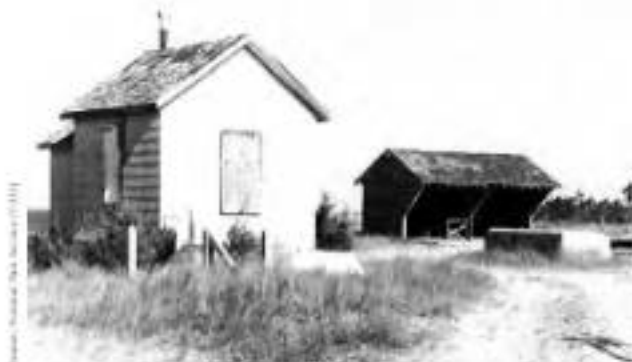
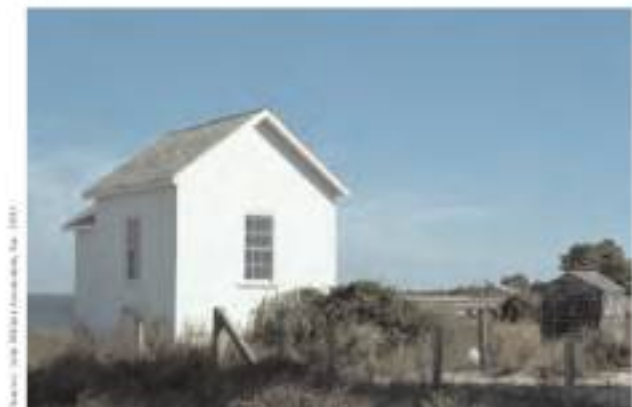
Photo Pair 7.

Summer kitchen and woodshed, with concrete cinder right, at the lighthouse complex, looking north, ca. 1978.

The same view, 2003. Note that the woodshed was lost to Hurricane Isabel in September 2003. The concrete cinder is blocked from view by vegetation, and a wooden shed has been added. The windows of the summer kitchen are arched and the chimney has been removed. The fence line has been extended.

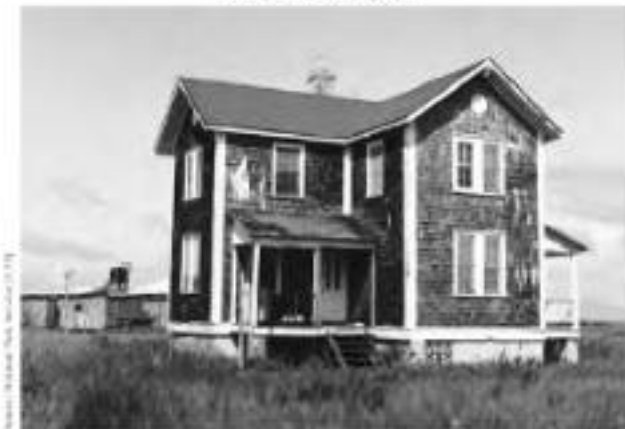
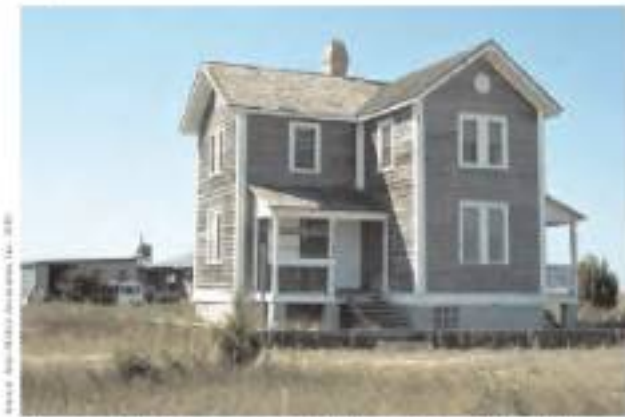
Photo Plate 8:

Side view of Bartles house (1907 keeper's dwelling after relocation), looking south, ca. 1976, showing over porch.

The same view in 2005. Note that a overfall adjoins the house and an entrance has been added atop the driveway.

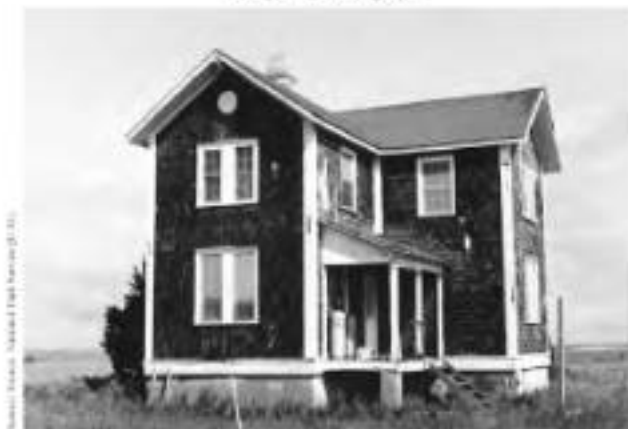
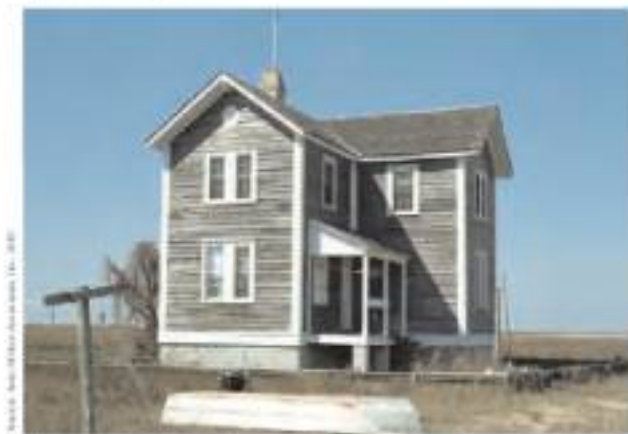
Photo Plate 9.  
The Stables house; date unknown.

The same view today. Note the addition of a chimney, a new porch, and the replacement of the wood on steps leading onto the porch.

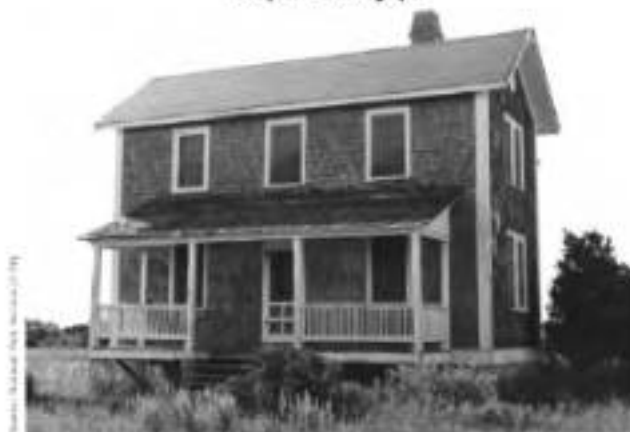
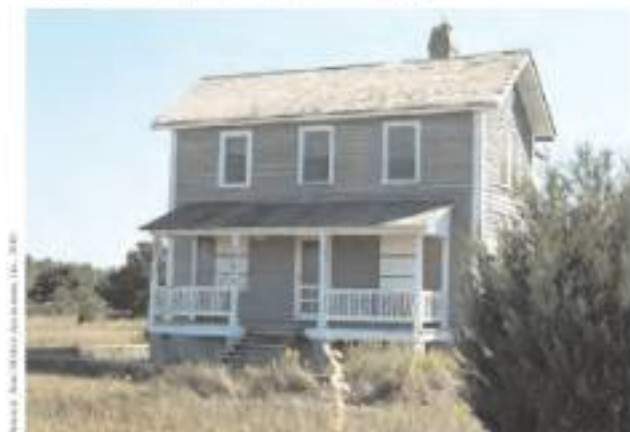
Photo Pair 10.  
Front view of Barker house, looking east, ca. 1970s, showing front porch.

The same view in 2005. The view is very similar although the vegetation has grown up slightly.

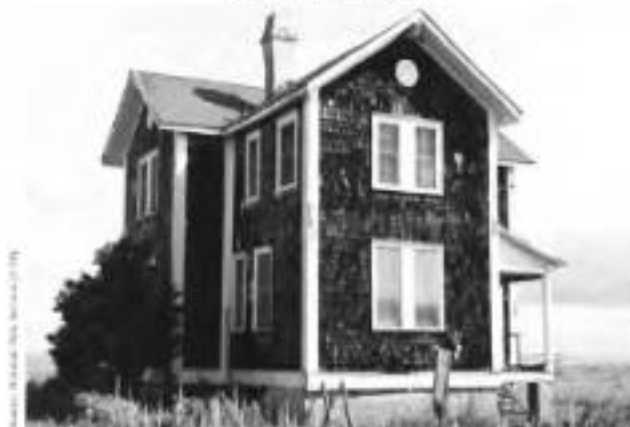
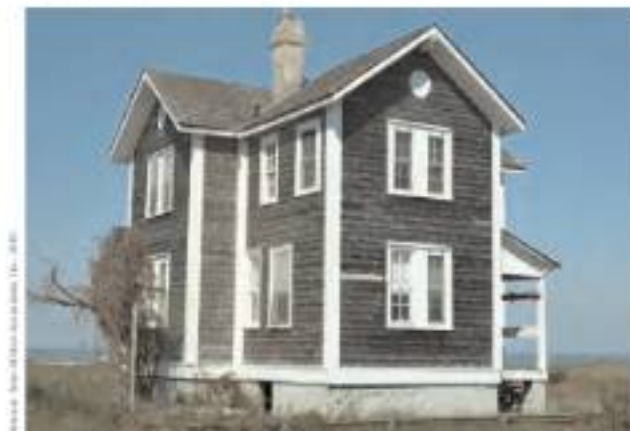
Photo Pair 11:  
View of Hamilton House, looking southeast, ca. 1970s

The same view in 2007. The walls have been lost, but otherwise the views are remarkably similar.

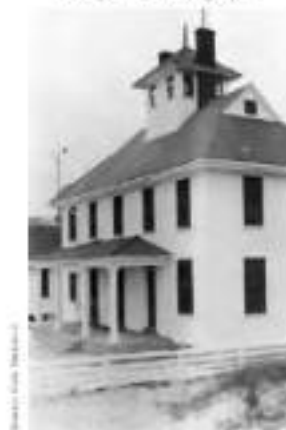
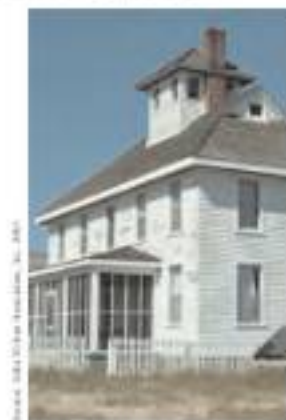
Photo Pair 12.  
Cape Lookout Coast Guard Station looking northwest, ca. 1936

The same view in 2005. Note that the porch and rail fencing has been replaced with a picket fence. The porch has been removed, a chimney removed from the far side of the cupola. The tall structure (radio tower?) in the left background is gone. There are new solar panels in the right foreground.

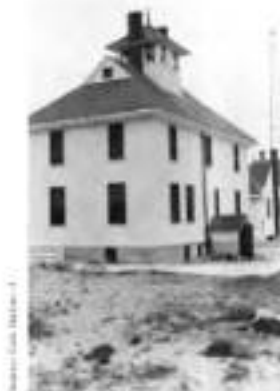
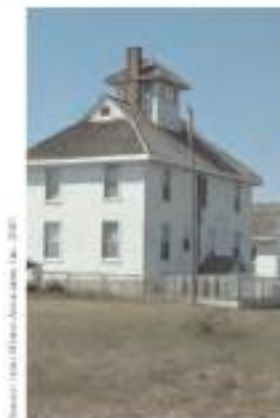
Photo Pair 13  
Cape Lookout Coast Guard Station looking southwest, ca. 1900

The same view in 2003. As noted previously, the post and rail fence has been replaced with a picket fence that wraps around the back of the building. The chimney on the back of the main kitchen has been removed, so has the radio tower in the distance. A tall pole has been added outside the fence.

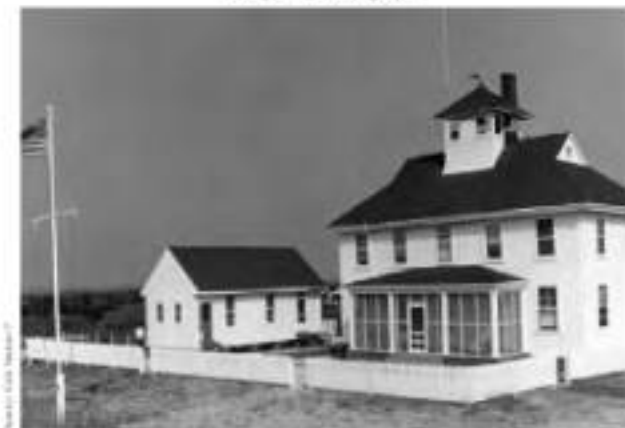
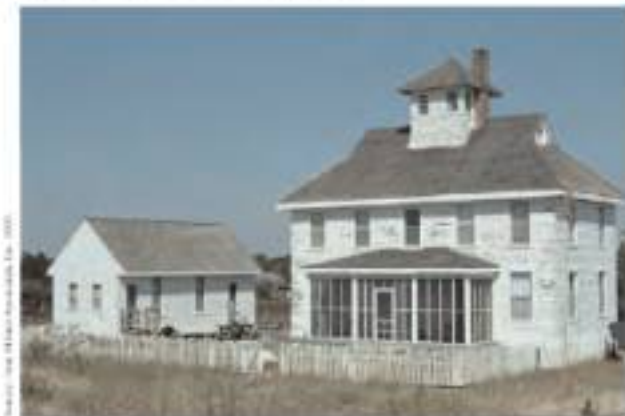
| Flagpole at Coast Guard Station | Fair | Rusted, tipped down, not in use |

Photo Pair 14  
Cape Lookout Coast Guard Station looking northwest, n.d.

The same view in 2005. The cupola has been removed from the main building, and new railings have been added to the entrance to the main building. With shutters have been placed in top of the fence pickets. The flagpole is tilted down, no longer in use.

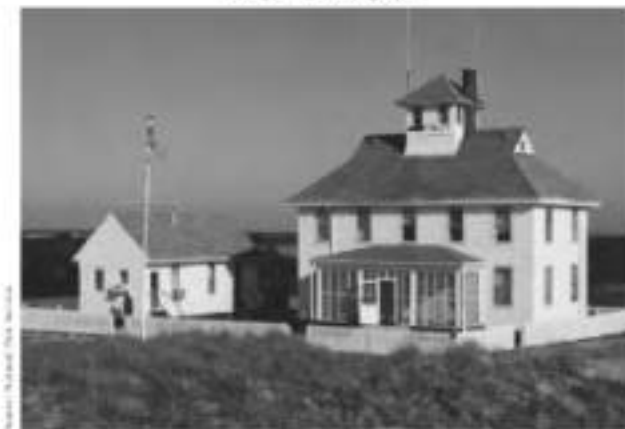
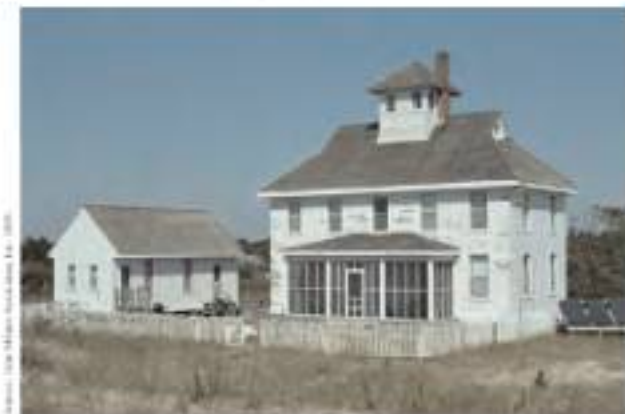
Photo Plate 15.  
Cape Lookout Coast Guard Station, looking north, ca. 1970.

The same view in 2003. Note that the flagpole has been moved. The main porch on the eastern side has been replaced, and an air conditioning unit and window removed. Some plants have been added, see right in the photo. Antennae have been removed from the main building.

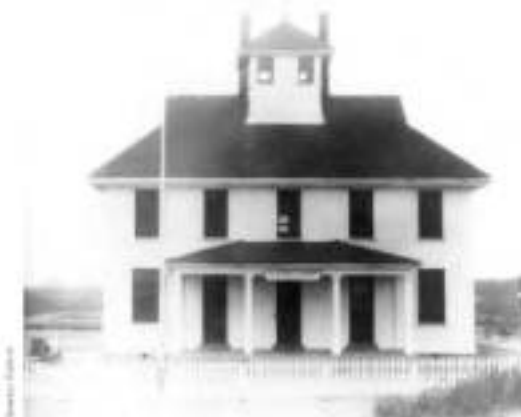
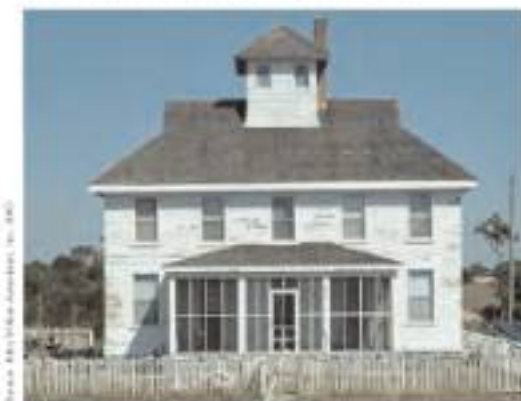
Photo Pair 16  
Cape Lookout Coast Guard Station, main building looking north, ca. 1934

The same view in 2003. Note, the sign has been removed and the porch widened in. A gate has been added to the picket fence, with shutters placed over the tops of the pickets, and a lift door (depicted) installed in the center foreground. A chimney has been removed from the left side of the cupola. Some patches have been added to the right in the photograph.

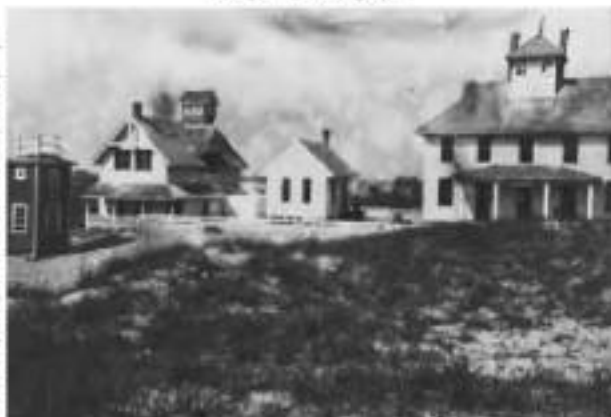
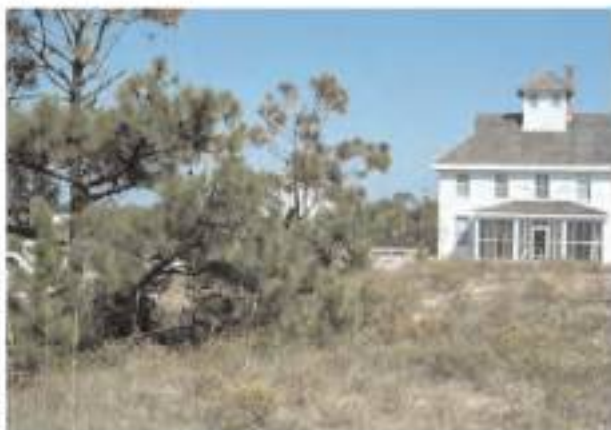
Photo Plate 17.  
Cape Lookout station looking north, ca. 1920s. Complex features include the radio shack, Navy Store, kitchen, and Coast Guard Station.

The same view in 2003. Note that the two buildings to the left in the historic photo are no longer visible. Pines have grown up to obscure this former view.
