# Portsmouth Village Cultural Landscape Report

Cape Lookout National Seashore  
Carteret County, North Carolina

## Cultural Landscape Report

December 2007

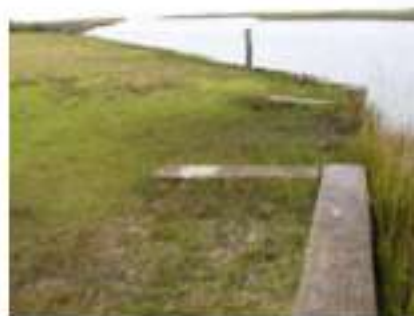
**Coast Guard Creek.** Coast Guard Creek extends south from the Life-Saving Station to Ocracoke Inlet along the eastern margin of the historic district (Fig. 27). This creek was an important consideration in the siting of the Portsmouth Life-Saving Station. While the building is sited far enough inland to be relatively sheltered, access to the coastal waters for the Life-Saving Station rescue boats was afforded via this creek. In 1908, the Life-Saving Station crew dammed the western end of Coast Guard Creek just east of the station and backfilled with sand, which significantly shortened the creek.<sup>121</sup> A seawall and ramps were constructed in 1918 along the edge of the creek to facilitate access to the water for rescue boats. Siltation has occurred within the creek, evidenced by the portions of the seawall now embedded in its banks. Otherwise, this tidal creek appears to be in good condition.

FIGURE 27. View northeast along Coast Guard Creek.

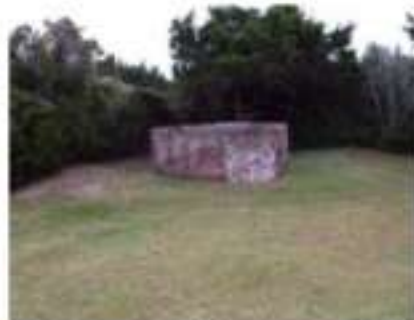
**FIGURE 40.** Cisterns like the U.S. Marine Hospital structure shown here are used to store rainwater on the island and are the primary source of fresh water.

**Cisterns and wells.** Most residents of Portsmouth Island derived their fresh water from the collection of rainwater stored in cisterns (Fig. 40). Most properties within the historic district have a cistern or water box. The condition of wells, water boxes and cisterns on the island and their ability to provide and store drinking water is not currently known.

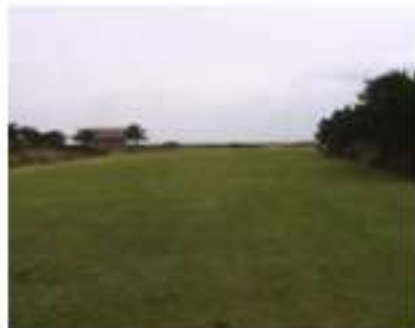
FIGURE 42. View northeast along the island's airstrip established in the 1940s with limited grading.

(Fig. 42). This landscape feature continues to be maintained in mown grass and is in good condition.

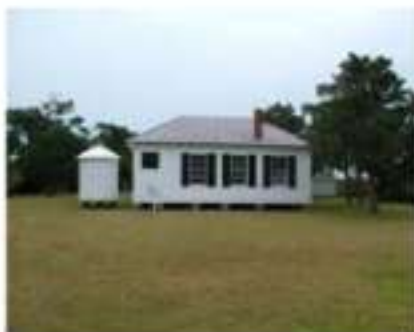
**Siting of Schoolhouse.** The current entrance to the schoolhouse faces southwest, away from the existing access road to the building (Fig. 45). The original entrance to the building was located on the east facade, behind the existing cistern.

FIGURE 45. The original entrance to the schoolhouse was at the end wall where the cistern is now located. This former entrance was closed up when the building was converted to living quarters circa 1940s.

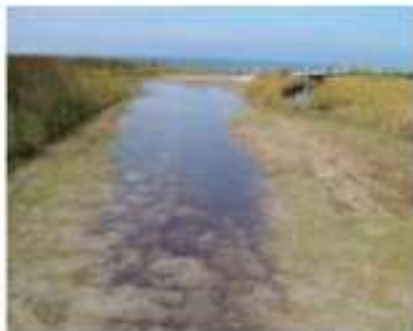
**Haulover Point Road.** This road is a long, straight, sand road that extends between Haulover Point and the Old Straight Road (Fig. 47 and Fig. 48). The northern portion of the road frequently floods, and remains wet, causing visitors difficulty when they arrive on the island. The road is generally in good

FIGURE 48. Haulover Point Road, as seen here, often exhibits ponding and standing water, which can be a problem for visitors.

condition, except for where ponding occurs near the boardwalk.

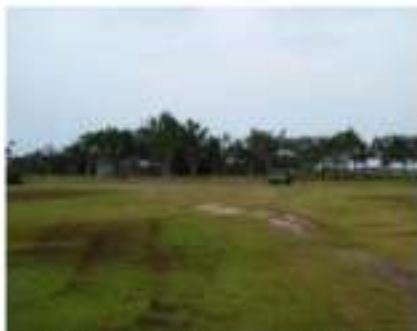
FIGURE 56. View west along the access road to the Ed Byron House.

**Access Road to Ed Stryon House.** This access road leads northeast from the vicinity of the Portsmouth Methodist Church (Fig. 56). It has a mown-grass surface. The road has been damaged by heavy vehicles and the NPS is working to mitigate the damage.

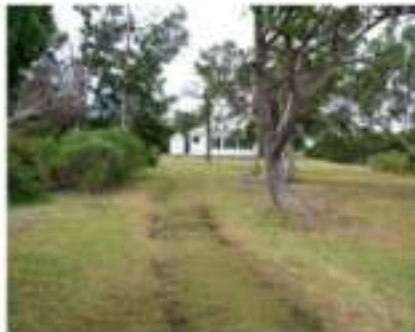
FIGURE 55. View south along the access road to the Schoolhouse and the Carl Gilgo House.

**Access Road to Schoolhouse and Cecil Gilgo House.** This access road arises at the intersection of Hanover Point Road and the Old Straight Road (Fig. 55). It has a mown-grass surface and provides access to the Cecil Gilgo House and the Schoolhouse. This road is generally in good condition, although there is vegetation along its perimeter in some areas that must be maintained to keep the road passable.

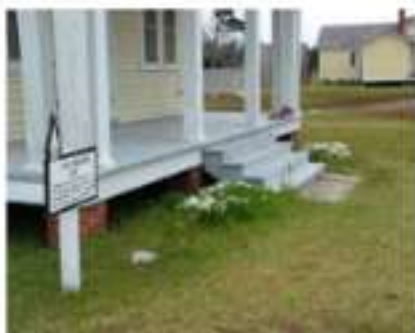
FIGURE 62. Steps lead to the porch at the Jesse Babb House.

**Wooden steps leading to front porch, Jesse Babb House.** A flight of four painted wood steps without handrails lead to the front porch of the Jesse Babb House (Fig. 62). A brick landing sits at the base of the steps. The steps appear to be in good condition.

**Flowering bulbs in front of the Jesse Babb House.** Fall flowering bulbs were observed in October 2006 growing on either side of the steps leading to the Jesse Babb House porch (Fig. 62). The plantings

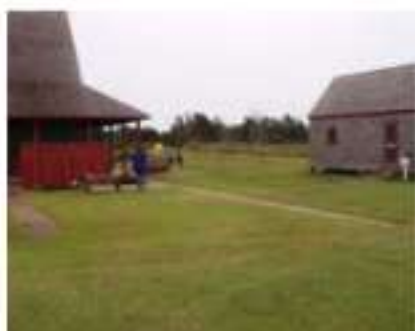
**Concrete walks associated with the Portsmouth Life-Saving Station.** Concrete walks approximately three feet wide edge the Life-Saving Station along its front facade and lead from the station to the summer kitchen, extend toward the stable, and edge the side of the building where two concrete ramps lead inside (Fig. 63). This system of concrete walks was built in 1914-1918, except for the walk to the summer kitchen, which was added in 1942. The paths are exhibiting evidence of deterioration, including cracking and spalling, and vegetative growth within many of the control joints. They are in fair to good condition.

FIGURE 63. Concrete walks extend between the Portsmouth Life-Saving Station and summer kitchen, as well as into the landscape.

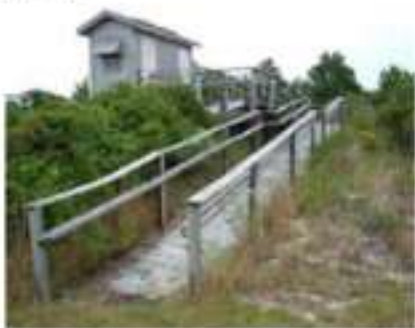
FIGURE 64. Wooden ramp and steps leading to the comfort station along the Road to the Beach.

**Wooden ramp/steps leading to the comfort station along the Road to the Beach.** A long ramp system and flight of wooden steps provides access to the

comfort station along the Road to the Beach (Fig. 64). These features include handrails at two heights, one for wheelchair accessibility. The ramp and stairs appear to be in good condition.

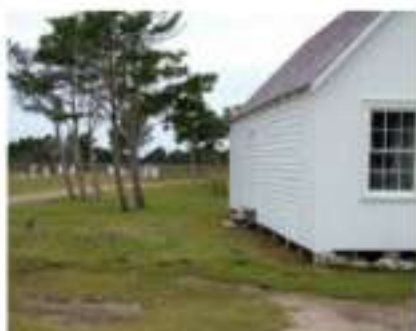
**Eastern red cedars.** There are Eastern red cedar trees located in association with most of the residential properties within the district. At the Post Office and General Store, for example, Eastern red cedars edge the building on two sides. Some of the trees in the line to the south appear to have recently been lost. (Fig. 68) Eastern red cedars are also a primary component of the landscape surrounding the Robert Wallace House. (Fig. 69) These native evergreens are also associated with many of the cemeteries within the district, including the Keller-Seyron Cemetery (Fig. 70) Many of the trees within the cemetery appear to be suffering from damage due to storms or salt spray and are stunted. They range individually from good to poor condition.

FIGURE 68. Eastern red cedars are prevalent throughout the historic district. Shown here is a line of trees that edge the Post Office and General Store.

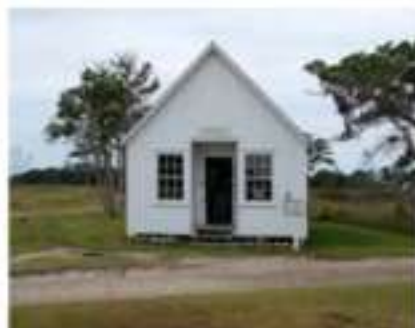
FIGURE 71. Irises are planted in the rock-lined bed in front of the Post Office and General Store.

**Irises in planting bed at Post Office.** What appear to be bearded irises were observed growing in the rock-lined planting bed in front of the Post Office and General Store in October 2006 during CLR fieldwork (Fig. 71). These bulbs appear to be in good condition.

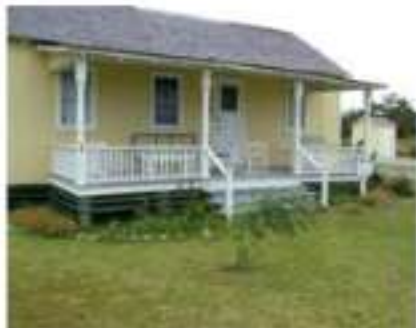
FIGURE 72. A rock-lined planting bed edges the McWilliams-Dixon House porch, and is planted with perennials such as gaillardia.

**Perennials, annuals, rose bush in front of the McWilliams-Dixon House.** A rock-lined planting bed edges the McWilliams-Dixon House porch, and there is a circular planting bed in the yard in front of the house (Fig. 72). Perennials such as gaillardia are growing in these beds. A rose bush has been trained on the picket fence in front of the house. What appear to be cannas are growing next to the steps leading to the back door. The stump of a poplar is also evident in the front yard. Except for the poplar, the plantings appear to be relatively well tended and in good condition.

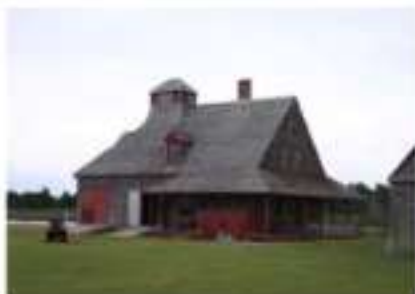
FIGURE 76. View of the Life-Saving Station from the southwest.

constructed in 1894. The station is rectangular in plan with a hip roof. A hip-roof porch is located at the south end of the station, wrapping around to the east and west sides. At the north end of the roof is the lookout tower. The exterior wall and roof surfaces are covered with wood shingles. Most of the windows are double hung units with divided lights. The building is supported on wood posts, and there is a central brick chimney. The station was restored in the early 1980s and was assessed in good condition in 2006 for the LCS.

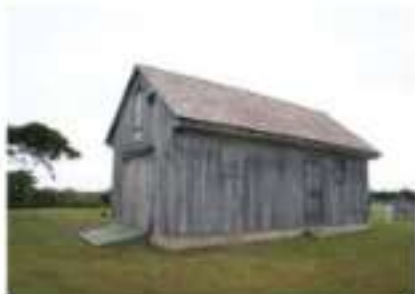
FIGURE 78. The stable at the Life-Saving Station.

The existing stable (Fig. 78, LCS 012534) was apparently constructed in 1928, replacing earlier stables destroyed by a hurricane. After the last horses left the station in 1932, the building was used for storage and as a garage. The stable is a rectangular gable-roof structure. The stable has a concrete foundation, board-and-batten siding, and a wood shingle roof. The stable was assessed in fair condition in 2006 for the LCS due to damage that occurred from Hurricane Ophelia in mid-September 2005.

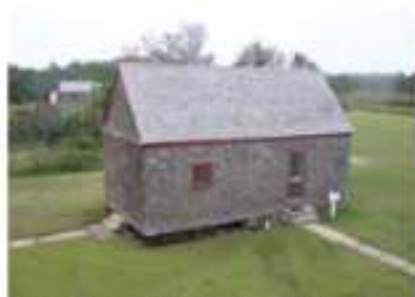
FIGURE 77. The summer kitchen adjacent to the Life-Saving Station. The generator shed is visible beyond at left.

The Life-Saving Station includes two ancillary outbuildings. The summer kitchen (Fig. 77, LCS 09745) was likely constructed in 1908 and originally consisted of a single room with shingled exterior walls. Circa 1942, the kitchen was extended east with a dining room addition that was finished

with shiplap siding. The kitchen is a gable-roof structure with wood shingles covering exterior wall and roof surfaces. The kitchen has small six-light rectangular windows. The older portion of the kitchen is supported on a concrete foundation, while the dining room addition is supported on wood posts. There is a brick chimney at the west gable end. In 1980, the NPS installed shingles over the entire building. The kitchen was assessed in good condition in 2006 for the LCS.

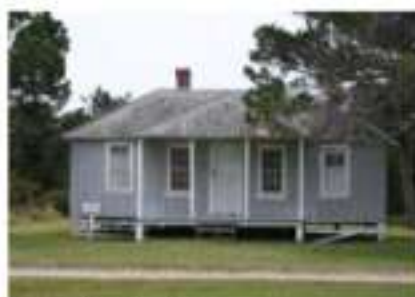
FIGURE 79. Roy Robinson House.

**Roy Robinson House.** The Roy Robinson House (Fig. 79, LCS 012533) was built circa 1926 on the foundation of the Marine Hospital and moved to its current site in 1935.<sup>127</sup> Roy Robinson was chief of the Portsmouth Coast Guard Station from 1925 to 1933. The Robinson House is a one-story, hip-roof structure supported on wood posts. The house is rectangular in plan with a hip-roof porch along the north front and an open platform porch at the

southeast rear corner. The walls are board-and-batten siding painted blue. The double-hung windows are generally two-over-two, aside from two windows at the front porch which are six-over-six. The roof is wood shingle, with a brick chimney; localized areas of the roof were replaced following Hurricane Isabel in 2003. The house was assessed in fair condition in 2006 for the LCS.

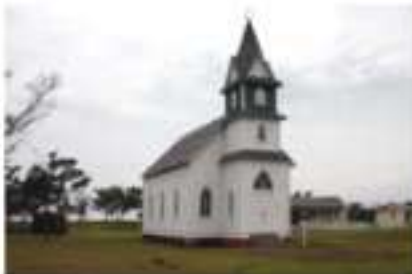
FIGURE 84. Portsmouth Methodist Church.

**Portsmouth Methodist Church.** West of the McWilliams-Dixon House is the Portsmouth Methodist Church (Fig. 84, LCS 012518), constructed in 1915 after the previous church

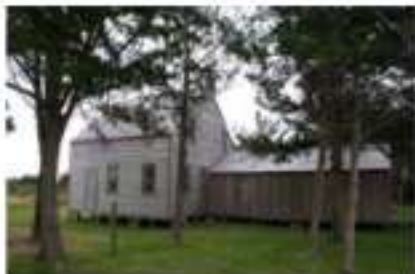
FIGURE 85. Washington Roberts House.

**Washington Roberts House.** South of the church on the opposite side of the village road is the Washington Roberts House (Fig. 85, LCS 091783), constructed in the late 1840s, with a kitchen/dining room wing added circa 1910.<sup>141</sup> The wing was reconstructed by the NPS after it was destroyed by Hurricane Isabel in 2003. The house is supported on wood posts and is clad with unpainted clapboard siding and has a wood shingle gable roof. The windows are nine-over-six double-hung units. The house includes two building masses: a main 1-1/2-story gable roof portion and an attached one-story wing at the west end. Wood posts mark the location of a missing rear porch. The house was assessed in poor condition in 1998 for the LCS. Based on recent restoration work, the CIR assesses its condition as fair.

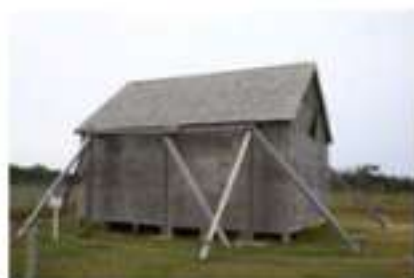
FIGURE 86. George Dixon House.

**George Dixon House.** The George Dixon House (Fig. 86, LCS 012519) stands along the Village Road in open marsh land west of the church and the Washington Roberts House. The house was built around 1887 by George and Martha Dixon. The house was severely damaged by Hurricane Isabel in 2003. Currently, the walls are completely boarded up with plywood, and wood structural shores stabilize the walls of the house. Prior to the hurricane, the house had asphalt composition siding, six-over-six double-hung windows, a brick chimney, and front and rear porches. The house historically also had a kitchen/dining room wing. In the late 1990s, the house had a wood shingle roof installed. The house was assessed in poor condition in 2006 for the LCS.

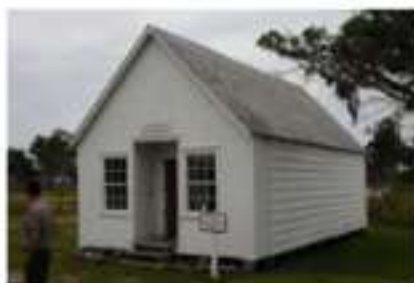
FIGURE 87. Portsmouth Post Office.

Store (Fig. 87, LCS 012526), constructed circa 1900, which stands at the crossroads of the village. The gable roof structure supported on wood posts has painted clapboard and vertical wood board siding, and a wood shingle roof with galvanized metal ridge cap. The front gable end has a central door and a pair of six-over-six double hung windows. The house was assessed in fair condition in 2006 for the LCS.

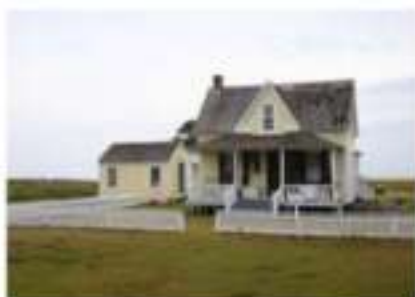
FIGURE 88. Henry Pigott House.

**Henry Pigott House.** At the end of the access road leading northeast from the village crossroads stands the Henry Pigott House (Fig. 88, LCS 002520), constructed circa 1900. The house is T-shaped in plan, with a front-facing gable at the base of the T. The house is supported on wood posts and has clapboard siding painted yellow, a wood shingle roof with a galvanized metal ridge cap, and a brick chimney. The windows are four-over-four double hung units. The yard is partially enclosed by a wood picket fence. Other structures in the yard include a

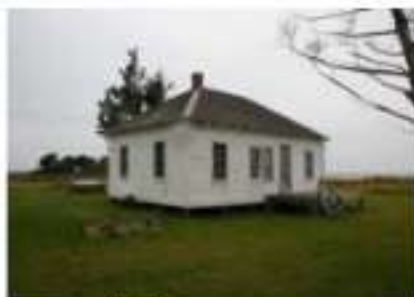
FIGURE 92. Frank Gaskill House.

**Frank Gaskill House.** The Frank Gaskill House (Fig. 92, LCS 012529) stands closer to the shore of the inlet. It was constructed circa 1930 and has a hip roof covered with wood shingles and galvanized metal ridge caps. The house is supported on wood posts and has painted clapboard siding. At the front door is an open platform porch. The house has a

brick chimney and six-over-six double-hung windows. Also part of the property is a shed with sheet metal walls, which is located at the shore of the inlet. The shed appears to be in good condition. The house was assessed in good condition in 2006 for the LCS.

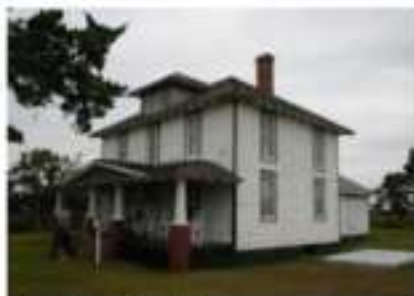
FIGURE 93. Dixon-Salter House.

**Dixon-Salter House.** Just northwest of the Post Office and General Store near the village crossroads, stands the Dixon-Salter House (Fig. 93, LCS 012527). This large two-story structure with rear one-story wing was constructed circa 1900 and moved to its current site circa 1930. The hip roof is wood shingled, and the walls are clad with painted clapboard. The house is mainly supported on wood posts but includes brick porch posts and several brick chimneys. The front porch has tapering wood columns and a front-facing gable on its hip roof. The windows are two-over-two double-hung units. Around the house are several outbuildings, including a cool house, a shed, and a privy. The

house was assessed in good condition in 2006 for the LCS. The shed was assessed in fair condition in 1998 for the LCS. The privy was assessed in fair condition in 1998 for the LCS. The cool house was assessed in poor condition in 2006 for the LCS.

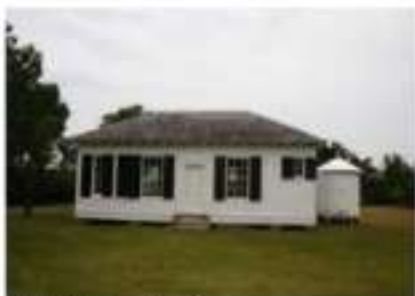
FIGURE 95. Portsmouth School House.

**Portsmouth Schoolhouse.** Beyond the Cecil Gilgo House is the Portsmouth Schoolhouse, built in the 1910s (Fig. 95, LCS 012524). The hip roof structure is supported on brick piers and has walls clad with painted clapboard siding. The wood shingle roof has galvanized metal ridge caps. The windows are mainly six-over-six double-hung units with dark green painted shutters. The school has a brick chimney and sits adjacent to a cylindrical cistern. Near the school is a two-part shed: the front part has a brick foundation, clapboard walls, and a wood shingle roof; the rear part is supported on wood posts and has asphalt composition shingle roofing and wall cladding. The schoolhouse was assessed in fair condition in 2006 for the LCS. The shed was assessed in good condition in 2006 for the LCS.

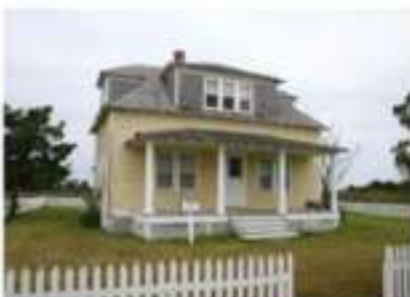
FIGURE 96. Styron-Bragg House.

**Styron-Bragg House.** From the village crossroads, a road runs west-northwest. West of the Post Office and General Store along this road is the Styron-Bragg House (Fig. 96, LCS 012520). The house was built circa 1928 as a sportsman's lodge. The 1-1/2-story house with one-story rear wing has a wood shingle hip roof with four dormers and galvanized metal ridge caps. The walls are clad with clapboard painted yellow. The house is supported on wood posts and has brick chimneys, Colonial Revival type porch columns, and two-over-two double-hung windows. A painted wood picket fence partially encloses the yard, which contains a cool house, a shed, and a contemporary plastic septic tank. The house was assessed in good condition in 2006 for the LCS. The shed was assessed in good condition in 1998 for the LCS. The cool house was assessed in

fair condition in 1998 for the LCS. The LCS includes a privy associated with the Seyron Bragg but this structure does not exist.

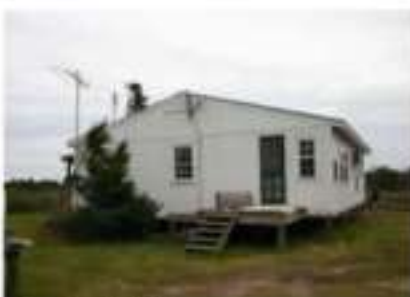
FIGURE 97. T. T. Porter House.

**T. T. Potter House.** A southwest branch off the road to the Seyron Bragg House leads to the T. T. Potter House (Fig. 97, LCS 012531) near the shore of the sound. This 1952 house is a larger, ranch-type house supported on wood posts. The walls are clad with composition board siding, and the roof is asphalt shingle. The house has a mix of window types and a large porch along the north side. Also on the site are two outbuildings, a contemporary plastic septic tank, and an outdoor fish cleaning table with sink. The house was assessed in good condition in 1998 for the LCS.

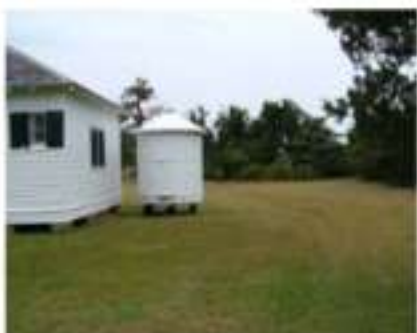
FIGURE 98. View north toward the Schoolhouse cistern.

**Schoolhouse cistern.** The Schoolhouse cistern is a cylindrical structure composed of vertical boards with a conical metal roof capped with a short metal pole (Fig. 98, LCS 091756). The structure is approximately eight feet in height, and sits on wooden posts one to two feet off of the ground. The structure is painted white. The cistern was assessed in good condition in 2006 for the LCS.

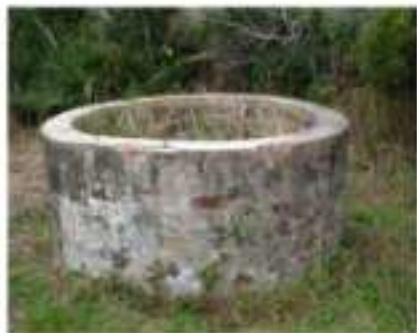
FIGURE 100. The Mattie Gilgo cistern.

**Matthe Gilgo site cistern.** The cistern associated with the Matthe Gilgo site is a circular parged brick structure, similar to those located near the Keller-Seyron Cemetery (Fig. 100). Approximately three feet tall and ten feet in diameter, the cistern is open to the air, and there are plants growing inside. It is exhibiting some signs of deterioration such as efflorescence, chipping of the mortar slurry that covers the brick and biological growth. It is in fair condition.

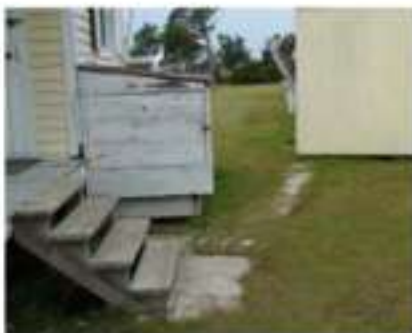
**Jesse Rabb water box.** Similar to the McWilliams-Dixon House, the Jesse Rabb House has a wooden water box that is connected to the roof gutters (Fig. 101). It is located adjacent to the rear facade of the building. This water box appears to be in relatively good condition.

FIGURE 101. The Jesse Rabb water box is attached to the side of the house.

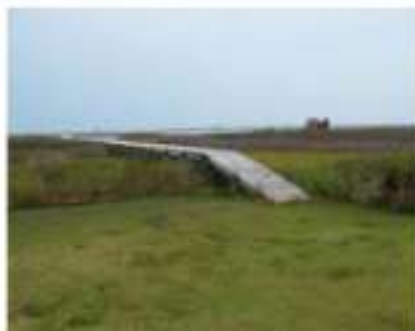
FIGURE 103. View north of the dock and boardwalk at the T. T. Potter House.

A second dock and boardwalk are located near the T. T. Potter House. The boardwalk extends across marsh land to a dock on Ocracoke Inlet (Fig. 103). The dock was established by the NPS for their use in

bringing equipment, housed in the T. T. Potter House sheds, to the island. This dock and boardwalk complex appear to be in good condition.

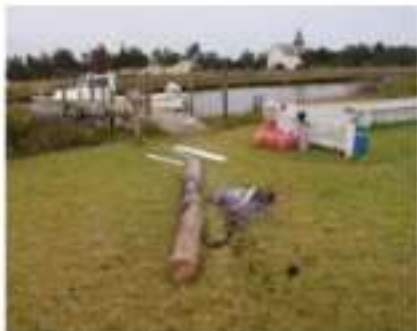
FIGURE 105. View south of the dock east of Henry Pigott House.

There is also a dock and boardwalk complex behind the Seyron Bragg House (Fig. 104) that appears to be in good condition except for one damaged section. Additionally, a dock extends into Doctor's Creek behind the Henry Pigott House (Fig. 105). This dock appears to be in good condition.

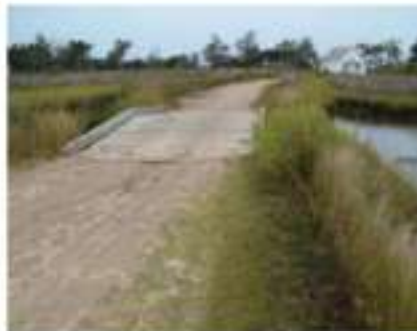
FIGURE 106. View west along the Village Road of one of the three wood bridges located within the village.

**Three wooden bridges along Village Road.** The Village Road crosses wet areas, creeks, and channels in three locations. Each crossing is associated with a V-shaped wood bridge, constructed of tightly set timbers laid perpendicular to the road, and edged by 6 inch by 6 inch wood timbers nailed to their

margins (Fig. 106). These bridges appear to be in good condition.

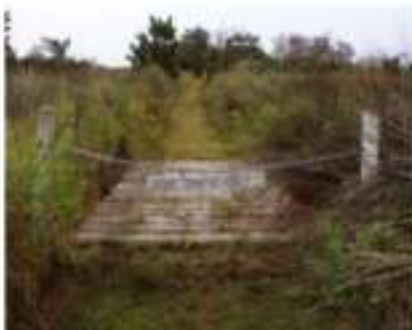
FIGURE 107. View northeast of the wooden bridge along the Old Straight Road.

**Wooden bridge along Old Straight Road.** A wood plank bridge is located along the Old Straight Road to provide access across a wet area (Fig. 107). This bridge has grass growth through its plank surface but appears to be in relatively good condition.

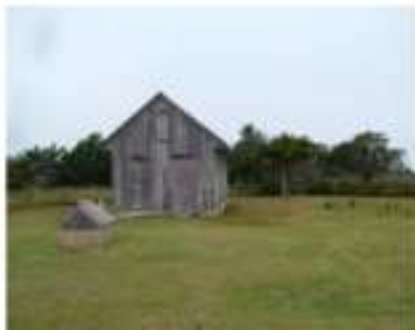
FIGURE 108. The well house near Portsmouth Life-Saving Station stable.

This small structure, set in the ground adjacent to one of the concrete walls near the Life-Saving Station, is composed of a concrete block base with a wood shingle gable roof (Fig. 108). The pump house is approximately eight feet long, three feet wide, and four feet tall. It appears to be in good condition,

although some of the shingles are in need of repair or replacement.

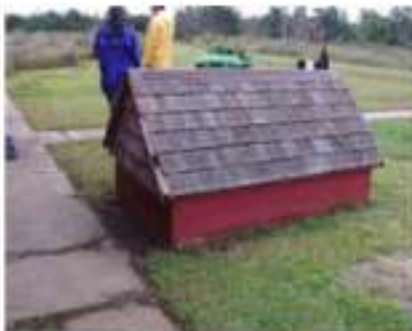
FIGURE 109. The pump house near the Portsmouth Life-Saving Station.

**Stable.** The well house is a small, three foot by four foot structure consisting of a concrete block base and a wood shingle gable roof with a vent (Fig. 109). The structure is set in the ground. It appears to be in good condition.

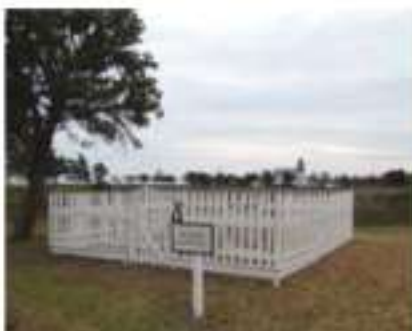
FIGURE 114. Grace Cemetery is surrounded by a picket fence.

**Picket fence around Grace Cemetery.** Grace Cemetery is a small family cemetery surrounded by a white picket fence (Fig. 114). A gate provides access into the cemetery along the side facing the road. The fence is constructed with simple unadorned squared pickets attached to three cross boards and anchored by corner posts. The three cross boards extend horizontally along the faces of the fence at even intervals beginning at the midpoint of the pickets. The lowest cross board is near the base of the fence. This fence appears to be in good condition.

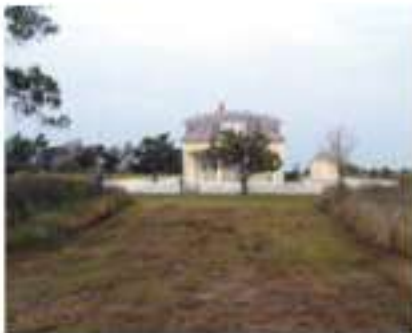
FIGURE 116. The picket fence around the Styron-Bragg House precinct.

White-painted picket fencing surrounds the Styron-Bragg House precinct (Fig. 116). The pickets are cut to rounded points at the top. They are nailed to two cross boards, one near their top, and the other along the base of the fence. Corner posts are set inside the fence sections. There is an opening in the front that is off-center from the door of the house; this may have included a gate at one time. Sections of the fence in the rear have been removed and are stored against the wall of the shed. This fence is in relatively good condition where it exists. The missing segments lower the overall condition rating to fair.

a gate located along the southwestern face (Fig. 116). The area enclosed by the fence is primarily rectangular, with a small bump-out along the southeastern side. This fence is in good condition.

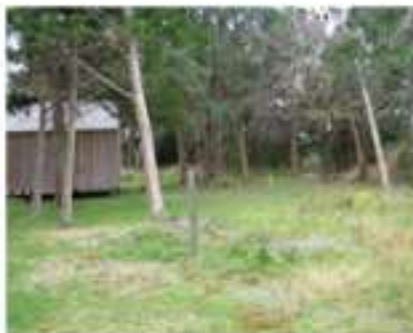
FIGURE 117. A remnant fence post west of the Washington Roberts House.

**Remnant fence posts west of Washington Roberts House.** Simple wood fence posts are also present near the house (Fig. 117). These posts are also remnants of an incomplete system that is in poor condition.

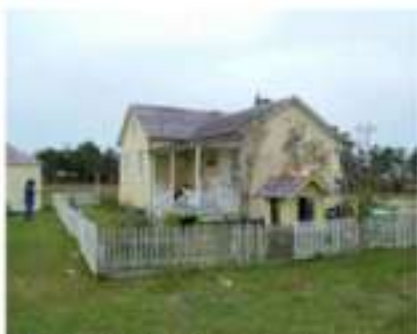
FIGURE 116. The picket fence around the McWilliams-Dixon House precinct.

**Picket fence around McWilliams-Dixon House precinct, four gates.** This fence is similar to other picket fences within the district (Fig. 118). The fence is badly in need of paint, but otherwise appears to be in good to fair condition.

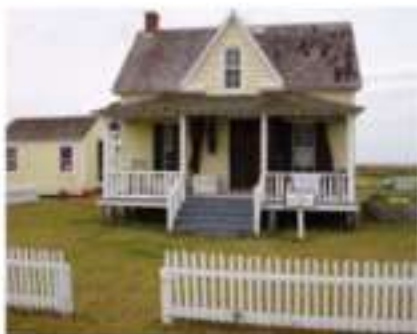
FIGURE 118. The picket fence around the Harry Pigott House precinct.

**Picket fence with missing gate around Harry Pigott House precinct.** This fence is similar to other picket fences within the district (Fig. 119). The fence is generally in good condition but is missing the front gate and some sections in the rear and is thus rated in fair condition.

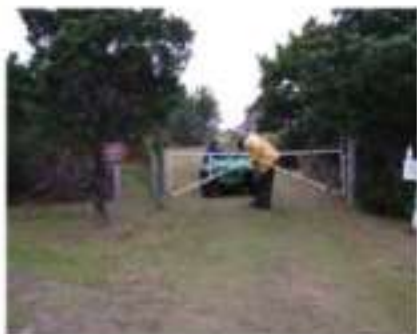
**Metal gate and wood posts limiting vehicular access to the village from the Road to the Beach.** A metal gate hung on wood posts limits vehicular access to the historic district from the beach (Fig. 120). Wood posts with chains are set to the sides of the posts, providing a structure to support the gate when it is open and a means for securing it. This gate system is in good condition.

FIGURE 120. A metal gate and wood posts limit vehicular access to the village from the Road to the Beach.

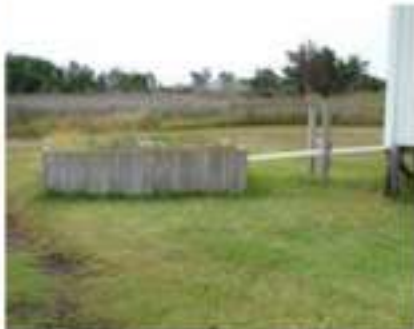
FIGURE 123. An above-ground septic tank at the Y. Y. Potter House.

**Above-ground septic tank and wooden enclosure, T. I. Potter House.** This septic system is similar to the Seyron-Bragg cistern described above (Fig. 123). A long section of white PVC pipe leads from the house into the tank. This feature appears to be in good condition.

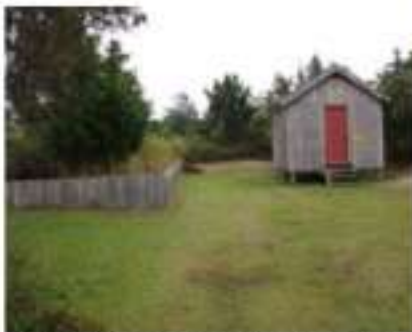
FIGURE 122. The septic leach field shown at left is near the airstrip.

**Septic leach field near airstrip.** A large wood retaining wall is located near the generator shed associated with the Portsmouth Life Saving Station (Fig. 122). The wall retains a raised soil area approximately 3 1/2 feet high used as a septic leach field. This feature appears to be in good condition.

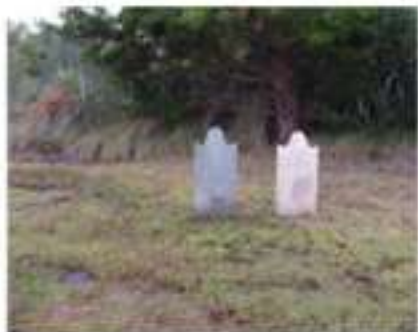
FIGURE 135. The headstones of the Two Seamen's Graves.

**Two Seamen's Graves.** The headstones associated with Two Seamen's Graves are relatively large and ornate in comparison with others within the district (Fig. 135). They include detailed funerary carvings. These gravestones appear to be in fair condition due to deterioration of the inscriptions.

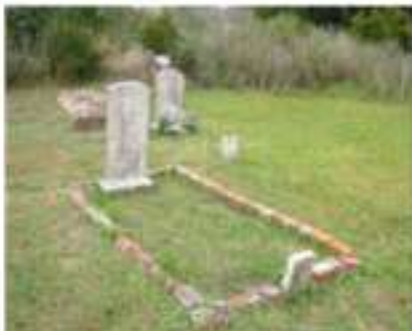
FIGURE 136. The Keller-Styron Cemetery.

**Keller-Styron Cemetery headstones.** This cemetery includes ten grave sites and is maintained in mown grass (Fig. 136). Headstones exist for seven

graves. The burials date between 1866 and 1922. The headstones are marble and granite. There are a few footstones. One grave is outlined in a single row of mortared brick.

Some of the headstones are eroding. The brick outline is losing some of the bricks. Some of the headstones are broken, others are leaning. The cemetery is in fair to poor condition.

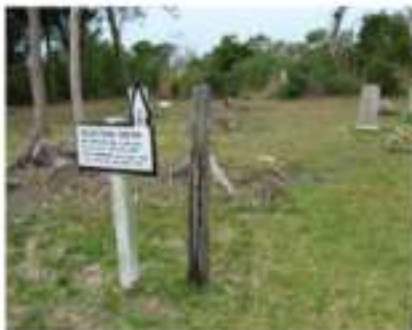
FIGURE 132. Remnant fence post at the Keller-Styron Cemetery.

**Fence posts at Keller-Styron Cemetery.** Several 4-inch by 4-inch wood posts mark the extent of a fence system that once enclosed the Keller-Styron Cemetery (Fig. 137). The fenced precinct appears to have formed a rectangle forty-two-and-one-half feet by fifty-seven feet in size. Remnants of wire remain attached to the posts, suggesting that the fence was used to limit access by livestock. The fence is in poor condition.

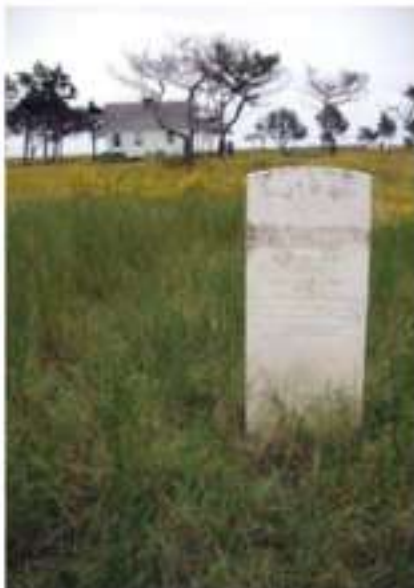
FIGURE 138. The Elijah Gaskill headstone.

**Elijah Gaskill headstone.** A single marble headstone marks the grave of Elijah Gaskill (Fig. 138). The grave is located near the Carl Dixon House. The headstone is in fair condition.

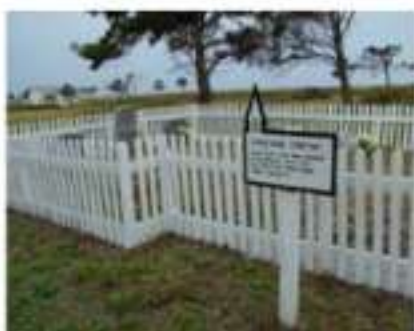
**Painted wooden signs marking historic properties.** A unified sign system is utilized within the historic district to identify historic structures and provide interpretive information. These signs are composed of painted square wood posts and painted wood boards nailed to them that have a rectangular area for text (Fig. 139). The rectangular area is oriented with the long dimension running horizontally. The upper left corner is punctuated by a carved extension fashioned to recall the Portsmouth Methodist Church steeple. They are generally in good condition. The signs are painted white, with a black border and black text. These signs are located:

FIGURE 139. One of the painted wooden signs that mark most of the historic properties within the historic district.

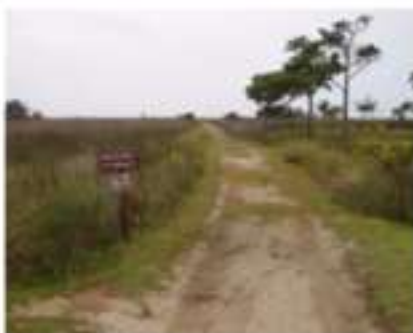
**Directional sign noting "Haulover Point Dock" along road to dock.** A brown painted wood sign indicates the route leading to Haulover Point Dock (Fig. 140). This approximately three-foot high sign is set on a square wooden post painted brown. The text is routed letters and an arrow, painted white. A metal sign indicating that vehicles are not permitted within the district is also nailed to the lower half of the sign. The sign is in good condition.

FIGURE 140. One of the brown-painted wood signs with routed text located within the district.

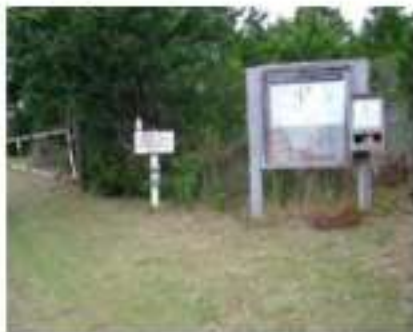
**Identity sign at gate along Road to Beach.** A larger identity sign (Fig. 141) located at the access control gate along the Road to the Beach welcomes visitors to Portsmouth Village and Cape Lookout National Seashore. The sign is in good condition.

FIGURE 141. An informational sign along the Road to the Beach provides guidance to visitors and information about the village.

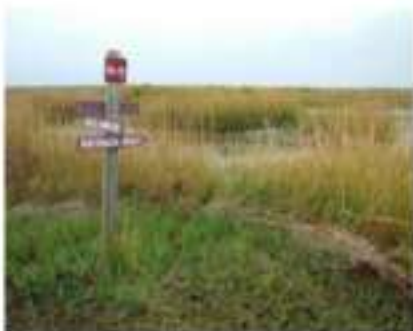
**Brown painted wood sign indicating "Foot Traffic Only" along the Road to Beach.** This sign is comprised of a small rectangular wood sign plate mounted on an unpainted wood post. The sign text is routed into the wood. The routed letters are painted white and the sign face NPS brown. The

FIGURE 142. This directional sign is located along the Road to the Beach.

sign stands approximately three feet in height. The sign is in good condition.

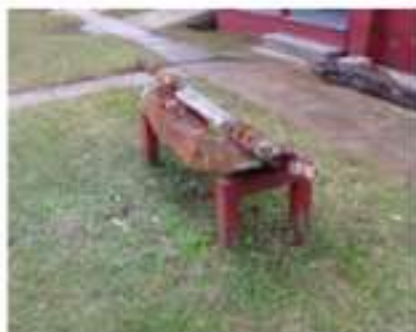
**Wood boat relic, mounted for display near the Portsmouth Life-Saving Station.** To the west of the Life-Saving Station building are artifacts associated with a boat wreck (Fig. 143). The remains are bolted to two wood posts. The exhibit is in good condition.

FIGURE 143. A shipwreck relic displayed near the Portsmouth Life-Saving Station.

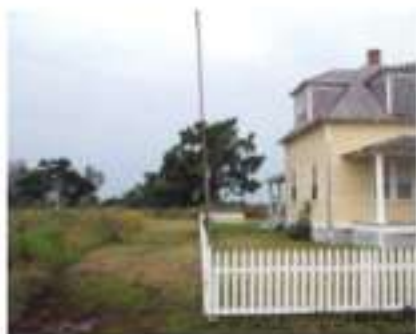
FIGURE 144. There is a flagpole within the Styron-Bragg House precinct.

**Flagpole at Styron-Bragg House.** At the corner of the picket fencing surrounding the Seyron-Bragg House precinct is a metal flagpole that no longer includes flag-raising hardware (Fig. 144). The flagpole is rusted and is in fair condition.

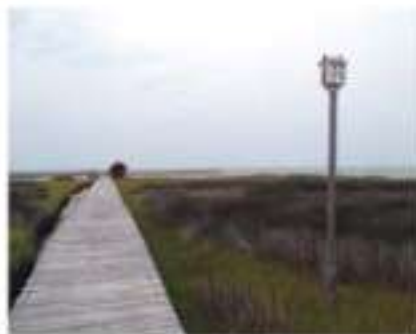
FIGURE 145. Along the dock behind the Styron-Bragg House is a bird house.

**Bird house along the dock behind the Styron-Bragg House.** Along the dock leading across the marsh west of the Seyron-Bragg House is a large bird house set on a tall wood pole (Fig. 145). The house has four openings. It is fashioned to look like a two-story Colonial house with a brick chimney and a shingle roof. The birdhouse is in good condition.

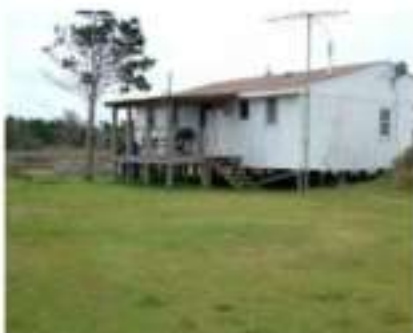
FIGURE 146. The T. T. Potter House includes a television antenna.

**Antenna at T. T. Potter House.** A metal television antenna is located along the rear facade of the T. T. Potter House (Fig. 146). This antenna appears to be in good condition.

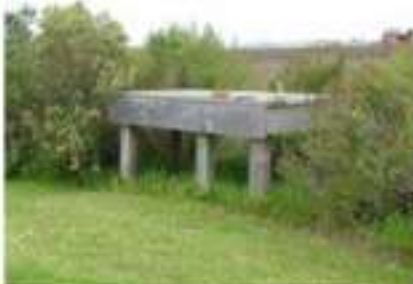
FIGURE 147. Near the T. T. Potter House is a fish cleaning table with a sink.

**Fish cleaning table, T. T. Potter House.** A simple wooden table on sturdy wooden legs sits to the side of the yard of the house (Fig. 147). A metal sink and faucet are set into the table. It is assumed that the table is used to clean fish. This table is in good condition.

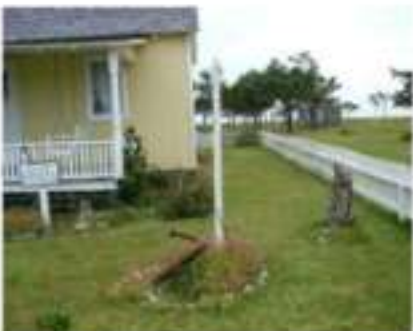
FIGURE 148. The yard in front of the McWilliams-Olsen House includes a rock-lined planting bed decorated with an anchor and a pole.

**Metal pole and anchor set within a circular planting bed, McWilliams-Dixon House.** A decorative feature in the front yard of the McWilliams-Dixon House is a circular planting bed edged with small round rocks, inset with a metal anchor, and a five foot tall wood pole (Fig. 148). It is not clear what function the pole serves. These features appear to be in good condition.

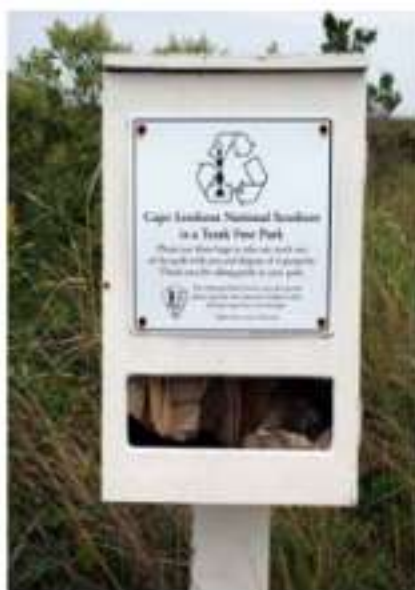
FIGURE 146. Trash bag receptacles are located along Haulover Point Road and the Road to the Beach.

**Trash bag receptacles along Haulover Point Road and the Road to the Beach.** Cape Lookout National Seashore is a rustic park that assumes that visitors will leave the park carrying any trash they may have generated during their visit. Along Haulover Point Road near the end of the boardwalk, and at the entrance into the historic district from the Road to the Beach, the park has placed trash bag dispensers where visitors may secure a bag for holding their trash (Fig. 149). A sign on the dispensers notes that "Cape Lookout National Seashore is a Trash Free Park." The dispensers are

white painted wood boxes with an opening along the bottom where bags can be removed and a metal fabricated sign that is screwed onto the face of the box. The wood boxes are affixed to painted square wood posts. These features are in good condition.

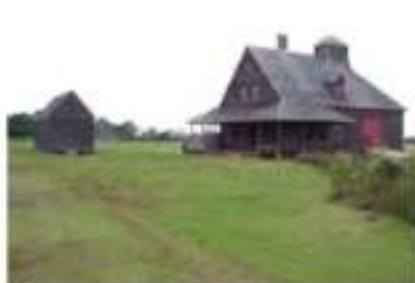
FIGURE 152B. The same view in 2006 illustrating the loss of various buildings, such as, from left to right, the carriage or cart house, boathouse, oil house, and privy (far right), as well as the board fencing around the station precinct. The summer kitchen and stables survive.

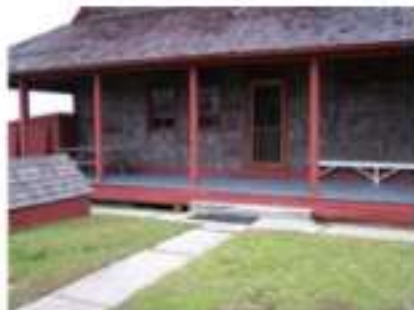
FIGURE 158B. The same view today. Note the addition of the pump house. Most of the other features remain remarkably similar.

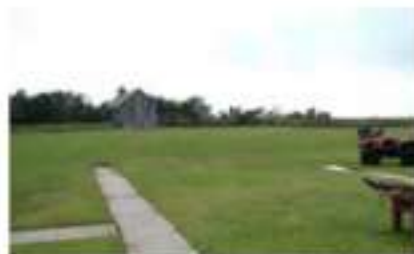
FIGURE 159B. The same view in 2006. The paths and the stable remain relatively similar, but the shed that once sat to the right of the stables is no longer extant. There is much more vegetation in the vicinity of the complex today than during the period of significance. A portion of the concrete walk above has been lost since the earlier photograph.

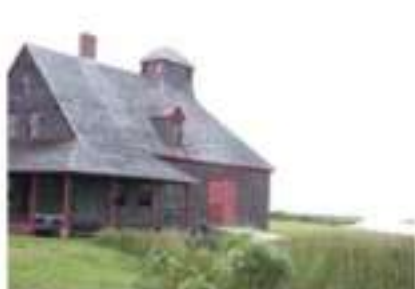
FIGURE 100B. The same view in 2006. Changes apparent in the contemporary photo include the loss of a water tank near the ramp, and a small shed to the right of the station. This building is one of ten surviving examples of numerous Quonset-hut-style stations built during the late nineteenth/early twentieth centuries.

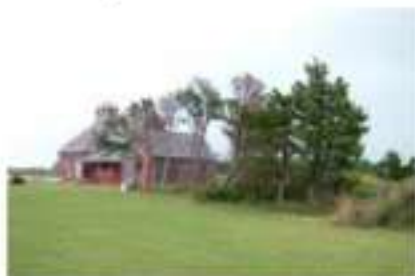
FIGURE 101B. The same view in 2006 indicating the loss of the wreck pole, warning tower, board fencing, and oil house. There is more vegetation within the vicinity today than during the period of significance.

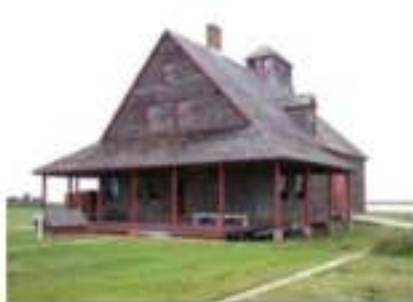
FIGURE 162B. The same view in 2006, indicating the filling of Coast Guard Creek that has occurred.

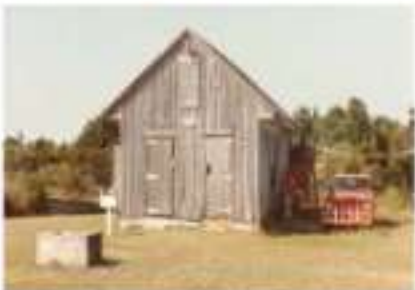
FIGURE 163A. The Portsmouth Life-Saving Station stable looking west toward Portsmouth Village, circa 1983.

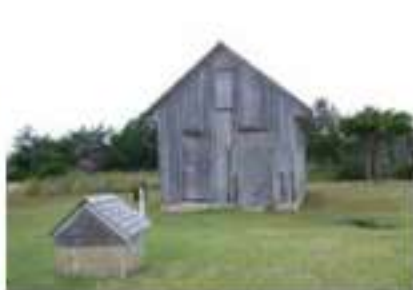
FIGURE 163B. The same view in 2006, showing that the well house has been covered with a small wood roof.

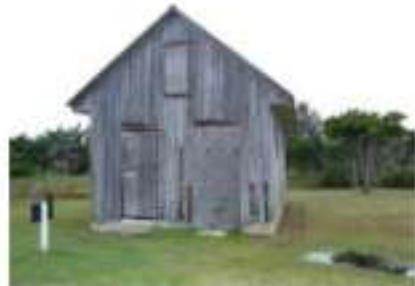
Ophelia in 2005. The LCS prepared in 2006 noted damage from Hurricane Ophelia in 2005 to exterior siding, sills, and wall framing, and the need for repair of three windows and doors at this building.

FIGURE 164B. The same view in 2006 showing the 1928 stable built in the same location as previous stables. This view illustrates the loss of the four-board fencing associated with the use of the building as an active stable for horses.

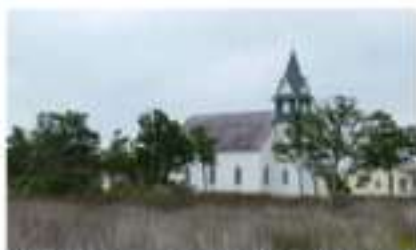
FIGURE 165B. The same view in 2006 illustrates the differences in vegetation that have occurred in the vicinity of the church.

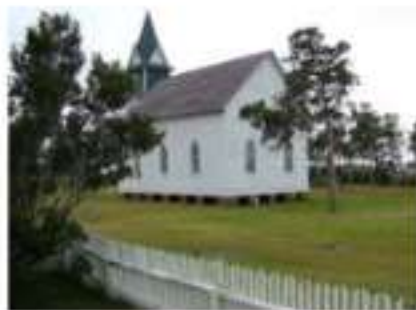
FIGURE 166B. The same view in 2006. Note the loss of shrubby vegetation around the church today, and the increase in grass.

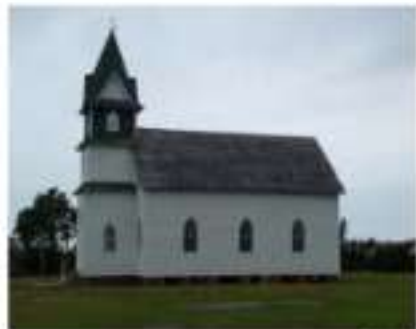
FIGURE 167B. The same view in 2006. Note the loss of the low fence near the base of the church, and foundation vegetation. Mown grass characterizes the landscape around the church in both photographs.

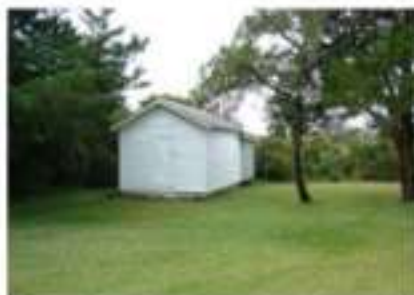
FIGURE 169B. The same view in 2006. Although the door appears to have been replaced and the roof reshingled, the shed looks very similar today.

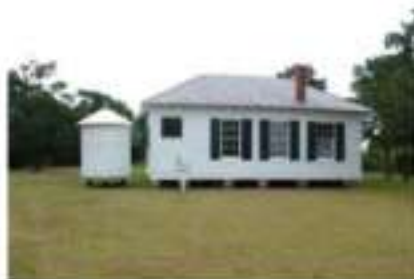
FIGURE 170B. The same view in 2006. Note that the windows are no longer boarded up and the antenna has been removed. Otherwise these features look very similar today.

acquisition of the structure in the mid-1970s. This building is currently vacant. A funding request was submitted for 2008 to restore the Schoolhouse, including leveling, reinforcing, and repair of walls, and repair or replacement of the roof, windows, and doors. Two outbuildings survive in association with the Schoolhouse: the cistern and a shed. A priory mentioned in the National Register nomination is no longer present.

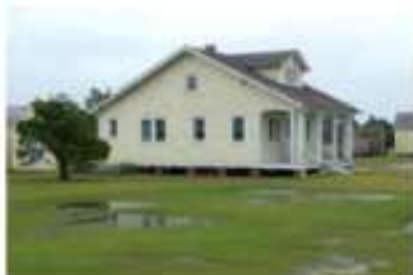
**FIGURE 171B.** The same view in 2006. Changes to the property include the loss of the low fencing, similar to that shown at the church, and the loss of the plantings edging the fence. The septic tank has been added since the earlier photograph was taken.

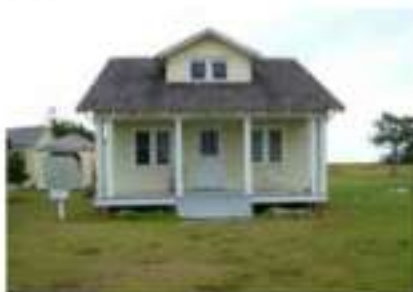
**FIGURE 172B.** The Jesse Babb House is very similar today to its earlier appearance as shown left, although the picket fence is missing. Note also the loss of vegetation behind the house.

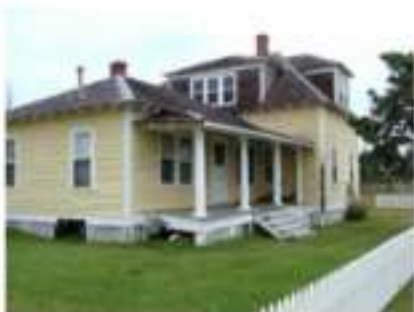
FIGURE 173B. The same view in 2006. Changes to the building include shingling of the dormers and removal of the screened porch. The picket fence has been painted white, and many of the trees are gone.

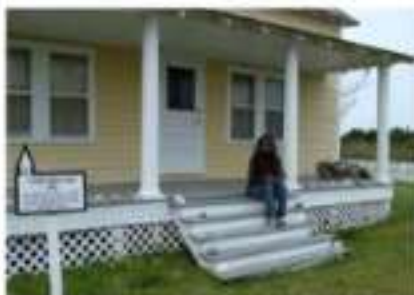
FIGURE 174B. The same view in 2006. Changes to the building include the removal of an air conditioning unit beneath the left-hand window, and the addition of new steps and lattice work under the porch.

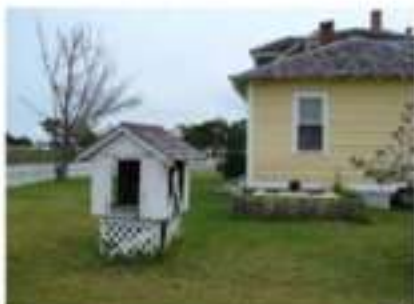
FIGURE 175B. The same view in 2006. Note the loss of the picket fence, as well as much of the vegetation around the house precinct.

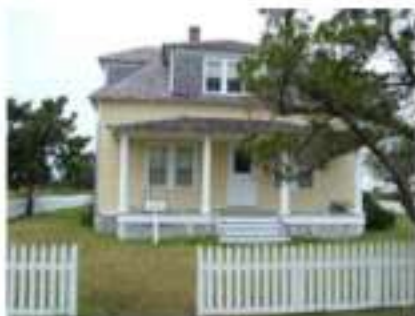
FIGURE 176B. The same view in 2006. Note the shingling of the second story, change in lattice under the porch, the addition of the picket fencing, and the loss of some

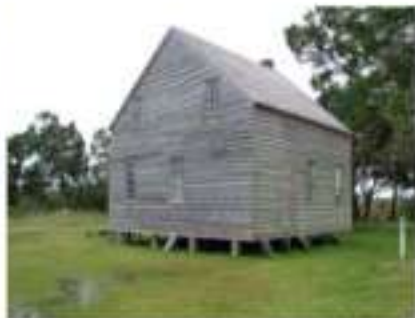
FIGURE 177B. The Washington Roberts House in 2006 is no longer boarded up. Many of the trees around the house have been lost, however.

House is one of the surviving examples of this house type. The house was rehabilitated in 2007, receiving new exterior siding, doors, and windows. The remains of an outbuilding appear to exist to the east of the main house, and mounds around the property may suggest the presence of other former outbuilding sites.

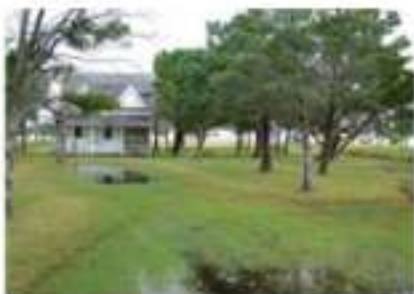
**FIGURE 179B.** The same view in 2006, illustrating changes in vegetation, and the loss of the long building extension (kitchen wing) to the right of the Robert Wallace House.

constructed circa 1850. It is currently vacant and under repair. A new roof was put on the building in 2005. In 2006, the house required leveling, reinforcement, repair and painting of some walls, and repair and replacement of windows and doors.

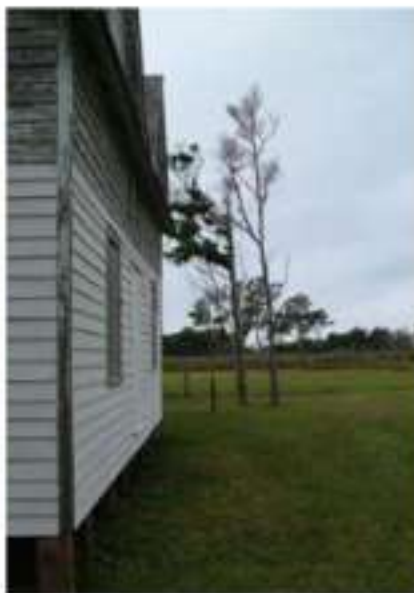
**FIGURE 180B.** The same view in 2006. The contemporary photograph illustrates changes in the building roof line, the loss of a stoop leading out of the building, and the dramatic loss of vegetation behind the house.

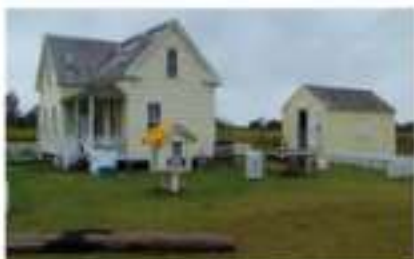
**Pigott cool house.** Constructed circa 1932, this structure is currently mothballed. At the time of the 2006 LCS, structural deterioration, staining, and a lack of screens were observed in association with the building.

**FIGURE 181B.** The same view in 2006, illustrating changes to the property such as the loss of picket fencing in the rear, the chimney on the outbuilding, and the tree along the fence; deterioration of the Cool House; and replacement of the pink

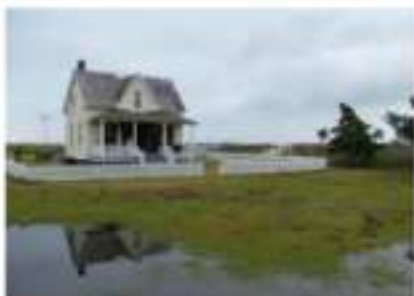
**FIGURE 182B.** The same view in 2006 illustrates that the property is much the same except for the exterior paint color, and the loss of the radio tower behind. NPS management of building precincts has led to a change in vegetative cover including replacement of warm-season grasses with cold-season grasses.

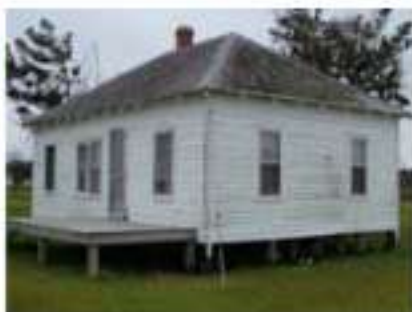
FIGURE 184B. The same view today. Note the loss of the roof overhang associated with the porch and the wood stain and landing along the side of the house. The vegetation is now mown cool-season grass, whereas the earlier view suggests native warm-season grasses were present previously. Cabling is currently stabilizing the structure.

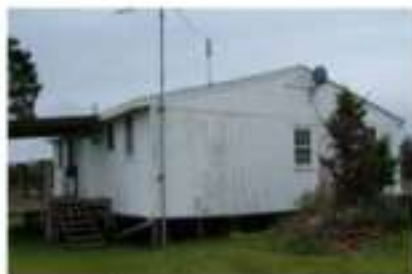
FIGURE 185B. The same view in 2006. Note the addition to the building along its rear facade, the removal of the screened porch, replacement of the siding, and the addition of a deck.
