# Portsmouth Village Cultural Landscape Report

Cape Lookout National Seashore  
Carteret County, North Carolina

## Cultural Landscape Report

December 2007

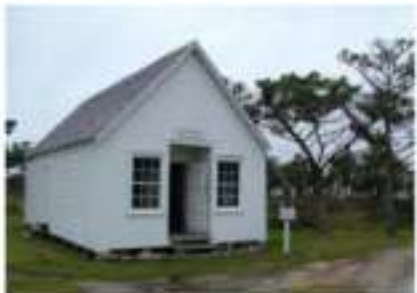
FIGURE 187B. the same view today. Changes since the 1930s include the loss of the addition, and removal of the porch and overhang. The vent pipe in the rear is also gone. The side door indicates the former connection between this building and the missing addition.

photographs taken in the 1930s. The post office was stabilized in 1997. In 2006, the ICS reported that the building exhibited interior damage from Hurricane Isabel. As noted in the *George Dixon House Historic Structures Report*,

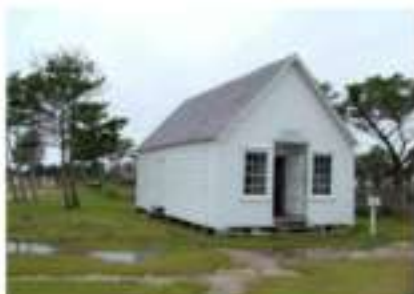
**FIGURE 188B.** The same view today. Changes since the 1930s include the loss of the addition, and removal of the porch and overhang. The vent pipe in the rear is also gone.

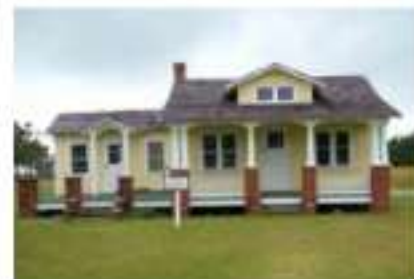
**FIGURE 189B.** The same view in 2006. Note the loss of the decorative trellis on the porch, the pickets along the side addition, the low fencing like that at the Tallie House, and the change in mortar associated with the brick.

1920s. The house was restored in 1980–1985. Several capstones on the brick pillars on the front of the house have cracked or are missing material. One outbuilding is associated with the property.

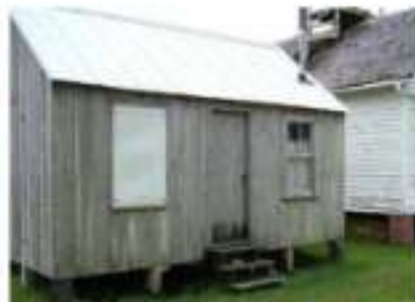
FIGURE 102B. The same shed in 2006. Changes visible between the photographs includes the boarded window, different cladding of the shed, the addition of a vent pipe, replacement of the door, addition of wooden steps, lack of paint, and the addition of the widow's walk to the roof of the adjacent Carl Dixon House.

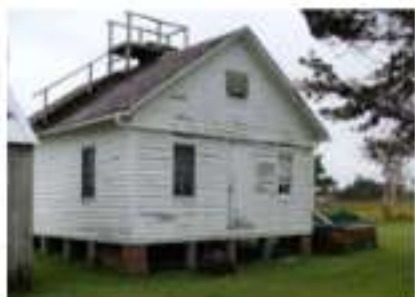
FIGURE 163B. The Carl Dixon House in 2006. Changes since 1979 include loss of the front porch, addition of the widow's walk, replacement of the roof, and a change in paint color.

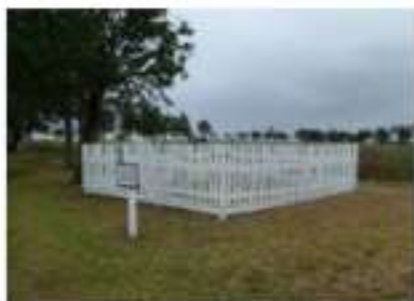
FIGURE 107B. The same view in 2006. Note the loss of much of the vegetation behind the cemetery, the addition of the interpretive marker, and the repair and painting that has been done on the fence.

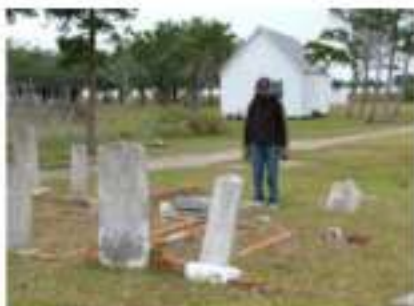
**Community Cemetery.** This cemetery includes thirty headstones associated with the graves of members of the Babb, Dixon, Seyron, Williams, Daly, Gilgo, and Roberts families. There are twenty-four commercial headstones and associated foot markers and grave plots edged by brick and concrete borders (Fig. 199 and Fig. 200). The cemetery was established in 1885. Many features are in need of repair.

FIGURE 188B. The same view in 2006. Note the deteriorated condition of some of the headstones, and the change in the view behind the cemetery.

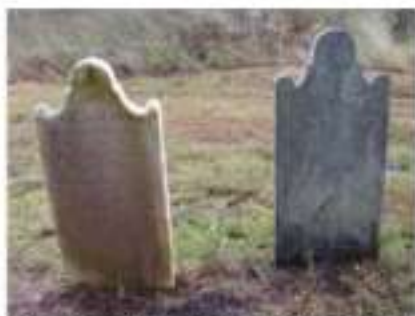
- **Displacement.** Markers may be out of plumb or not level due to installation, design problems, or environmental factors (Fig. 206).
- **General Soiling.** Soiling is caused by foreign matter (inorganic or organic) which accumulates on materials over time. Fig. 207 is a typical example of the type of soiling observed at Portsmouth Village.

**FIGURE 207.** General soiling affects many of the markers in the district, such as the two women's grave markers. Evidence of rising damp is also visible here.

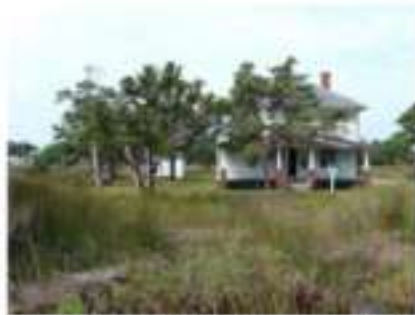
**Description.** The amount of woody vegetation within the Portsmouth Village historic district has increased since the period of significance due to a lack of maintenance as the community declined prior to NPS acquisition of the property. There is also a pine plantation on the island, that may have been planted by the Boy Scouts or another well-intentioned group, which does not reflect the community's cultural lifeways. In many places, thickness of trees and shrubs have grown up, blocking historic views and changing the historic open character of the village landscape. The park has expressed a desire to reestablish the historic character of the village if inadvertent damage to the environment can be avoided. To this end, portions of the existing woody vegetation should be cleared or thinned to restore important sight lines and the predominant visual aesthetic present when the community was an active place. See Fig. 210 through Fig. 213 for examples of proposed clearing.

FIGURE 210. Views of the Dixon-Salter House are obscured by trees, as shown in this 2006 photograph.

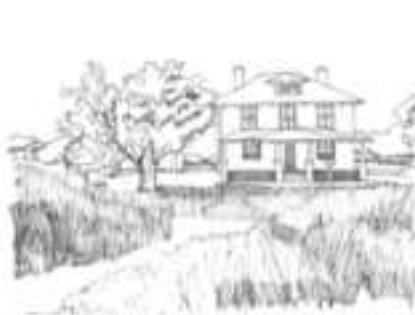
FIGURE 211. Sketch showing the effect of proposed clearing on views to the Dixon-Salter House.
