# **Cape Lookout National Seashore**

# **Washington Roberts House**

## **Historic Structure Report**

### **Developmental History**

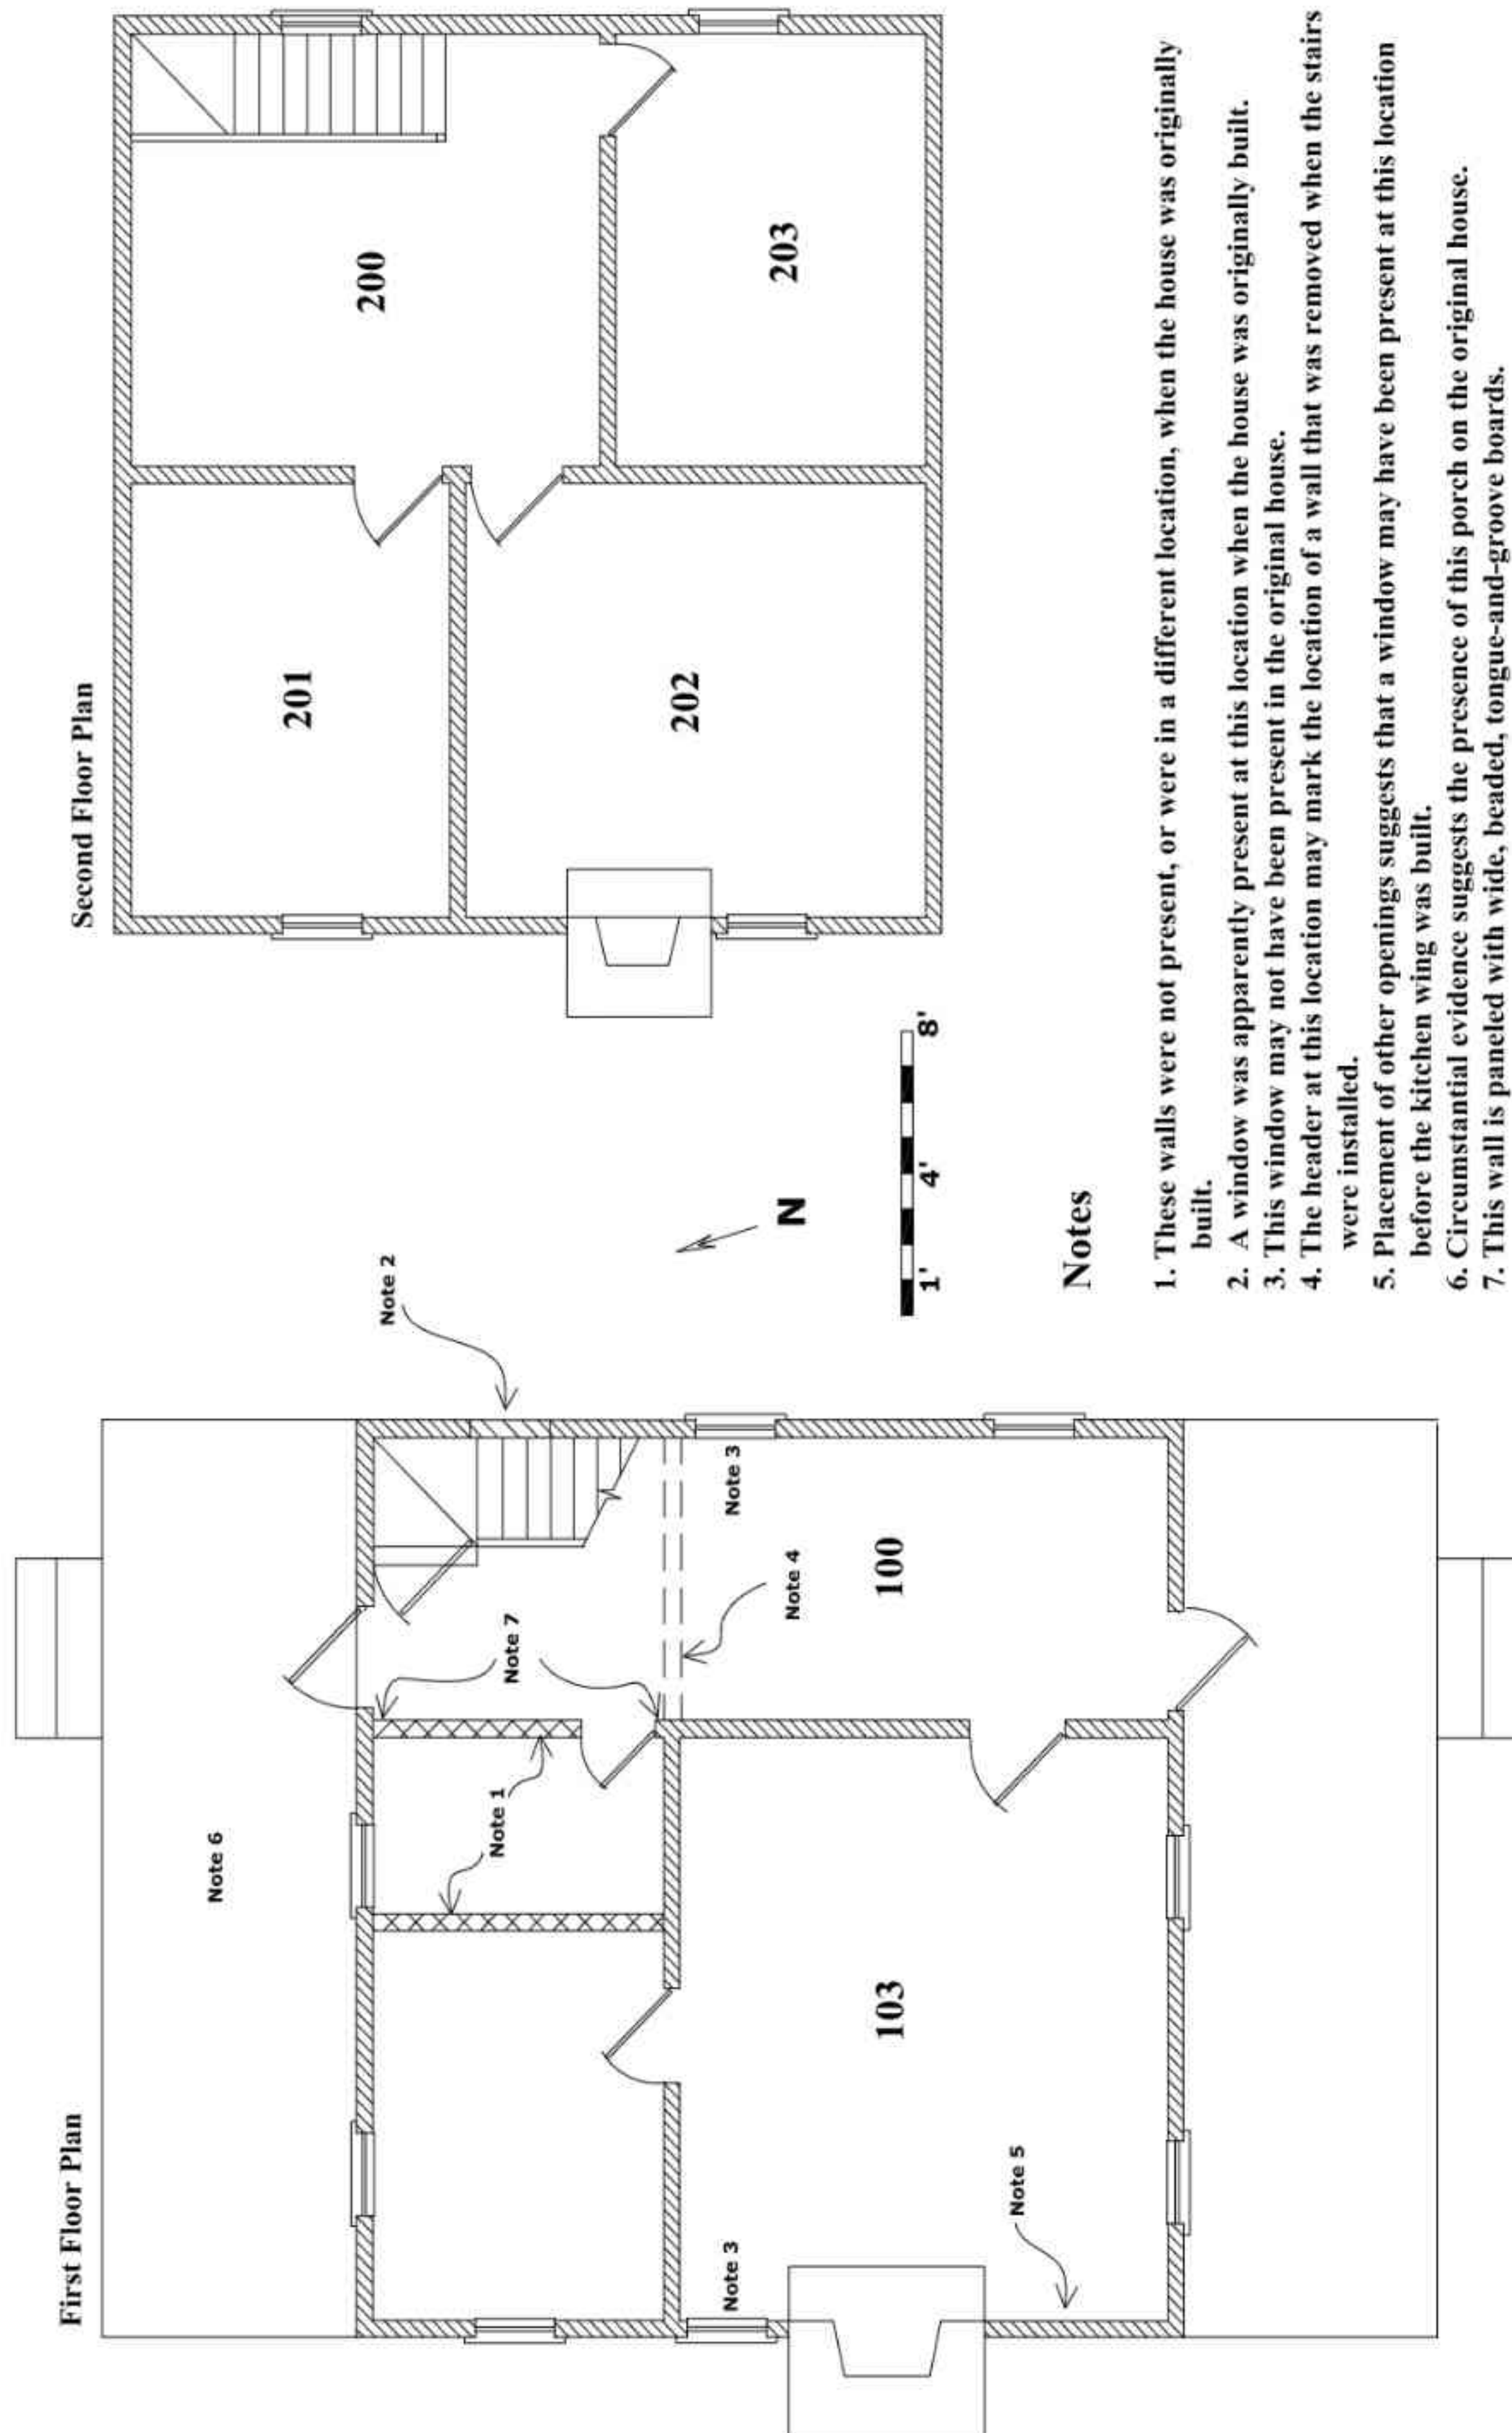
FIGURE 17. Plan explaining some of the changes to the original house. (T. Jones, SERO-CRD, 2003).

Less clear is the original floor plan of the house (see Figure 16). The fact that baseboards run behind the east and west walls of Room 101 indicates that those walls were constructed (or reconstructed) after the house was originally constructed. The east wall of Room 103 may be in its original location, but that is

not certain. The cross wall that forms the north wall of Room 103 and which corresponds to the beam running north to south in the floor framing is probably in its original location. In addition, what appears to be a closed window opening near the north end of the east wall of the house is now blocked by the stairwell, suggesting that the stairway is not in its original location.

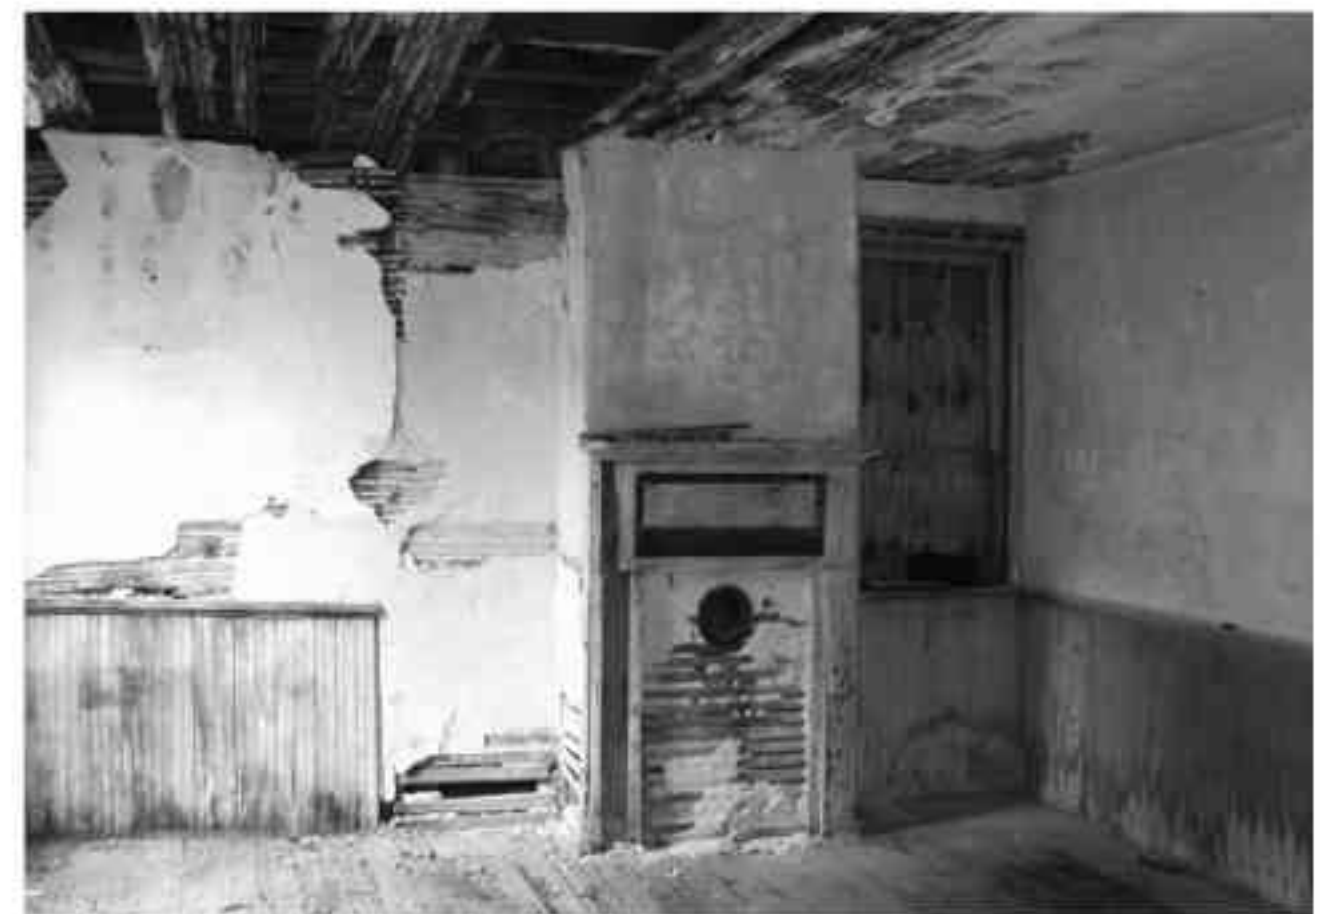
FIGURE 18. View of chimney in Room 103, absence of wainscot indicating extent of original chimney. (NPS-SERO-CR, 2003)

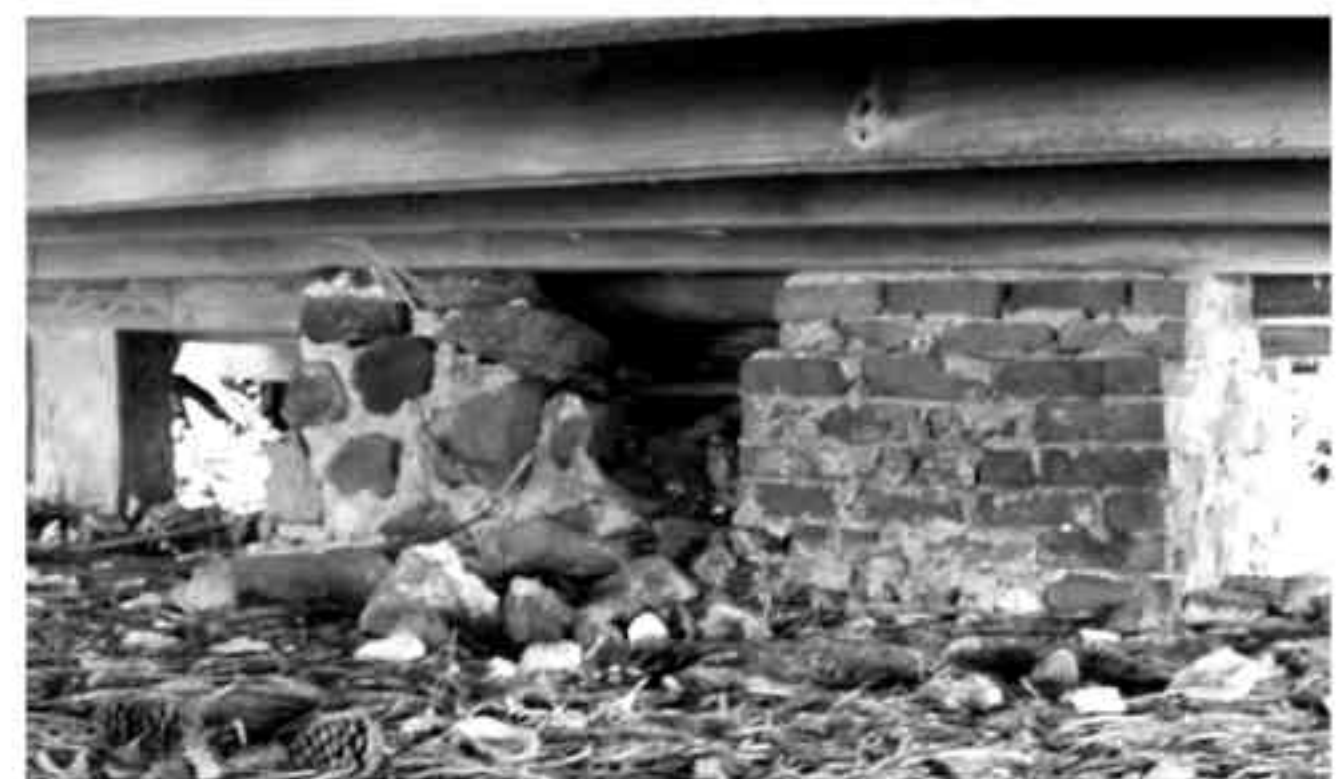
FIGURE 20. View of chimney base, with original stone chimney base at left, existing brick chimney at right. (NPS-SERO-CR, 2003)

The present inside chimney replaced the original outside chimney which sat in the same location. The foundation for the original chimney appears to have been built of stone, but it is not known if the entire chimney stack was stone as well. The framed opening in the floor apparently accommodated a hearth, while the breaks in the exterior siding show it to have been an outside chimney, with the chimney breast flush with the interior walls and the stack above the second floor fireplace rising outside the walls and not penetrating the roof.

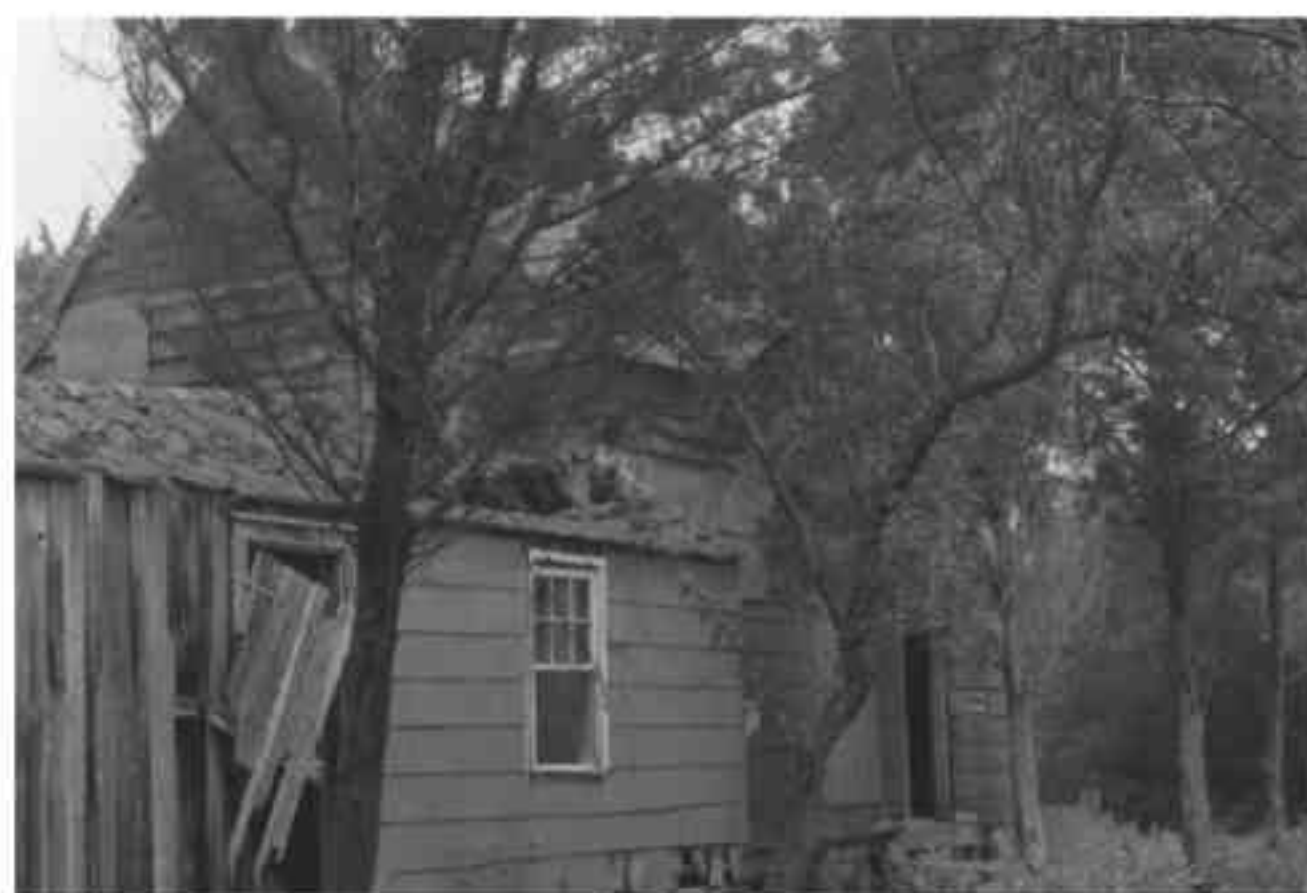
FIGURE 24. View east showing south side of kitchen wing, 1978. (CALO Coll. F-418)

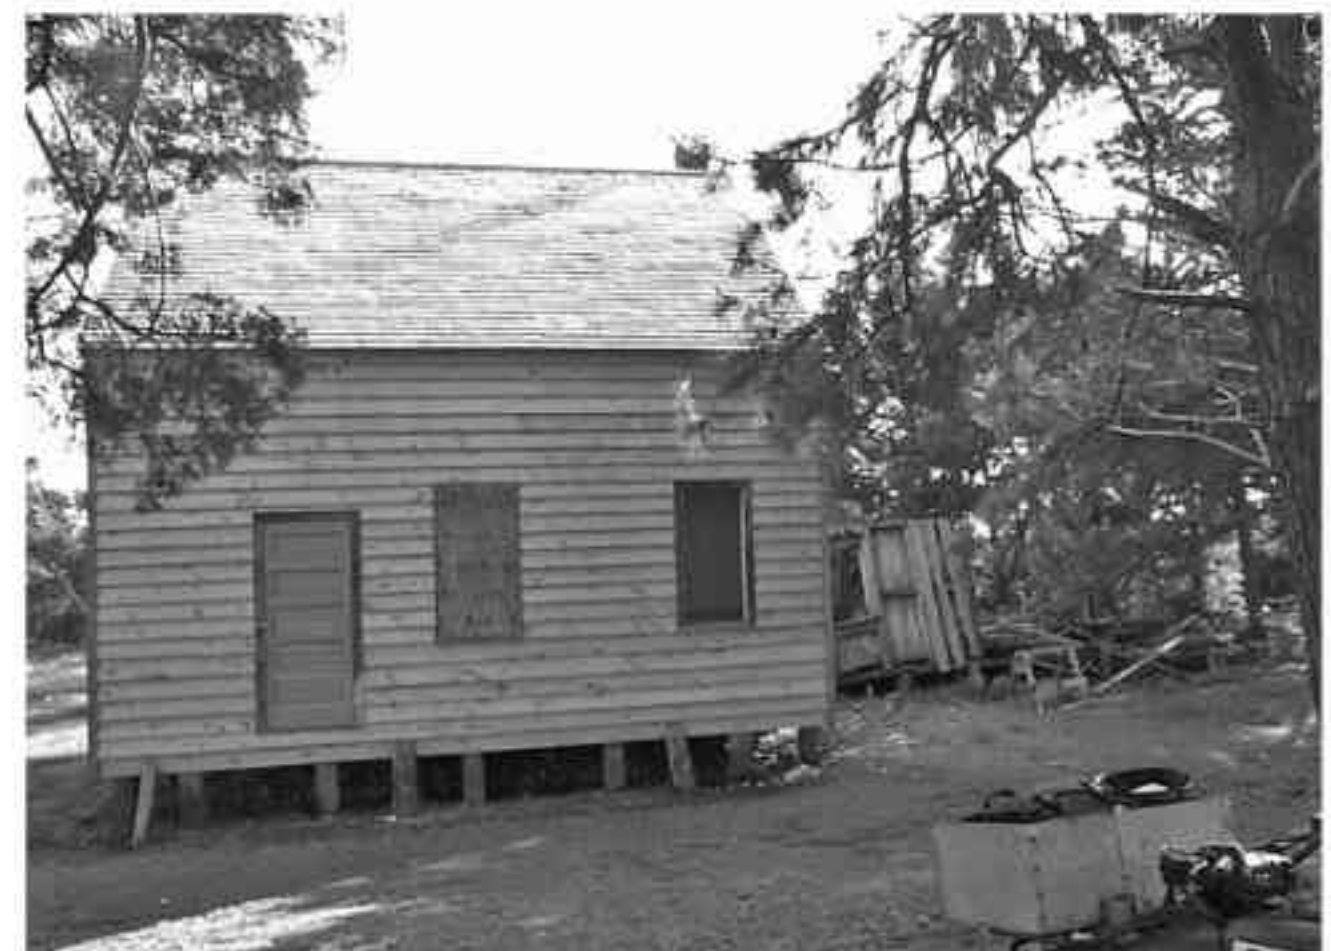
FIGURE 28. View of Roberts House after exterior rehabilitation and Hurricane Isabel. (NPS-SERO-CR, 2003)

In September 2003, as this report was being completed, Hurricane Isabel swept the Outer Banks with the eye coming ashore around Drum Inlet a few miles south of Portsmouth. Although only a Category 2 hurricane, the storm's surge inundated the entire island and a number of structures sustained significant damage. The nearby George Dixon House was severely damaged, but little, if any, damage was sustained by the main block of the Roberts House. Unfortunately, wind and water completed destruction of the house's ruined kitchen wing. It was partially reconstructed in 2006.

In the late 1990s, park staff installed a new metal roof on the main block of the house, but not on the kitchen wing, which by then had fallen into almost complete ruin. Then, in the summer of 2003, park staff replaced all of the historic, but badly-deteriorated, beaded siding on the main house as well as the deteriorated and missing window sash. The new material replicated the beading of the historic siding but in order to stay within the park's budget, a lesser grade of wood was used and some alterations were made to the dimensioning of sash components, which also required alterations to interior stop. In addition, the modern metal roof covering was removed and replaced with cedar shingle roofing.

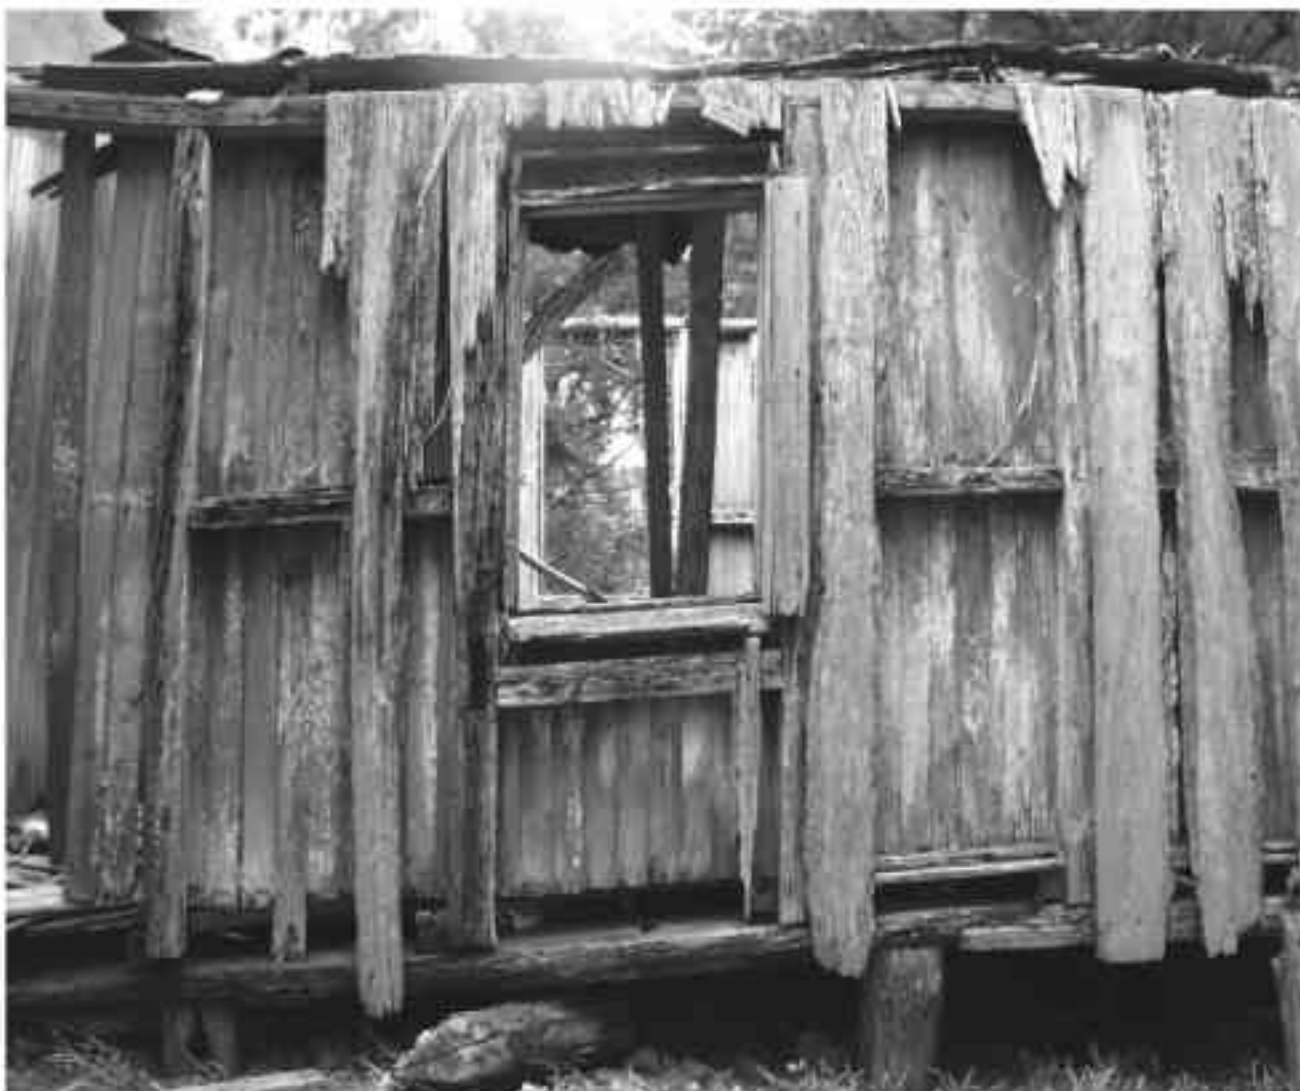
FIGURE 46. View of north side of kitchen wing at Room 104. (NPS-SERO-CR, 2002)

Total neglect of the roof covering has subjected the kitchen wing to water penetration and resulting rot, so that the entire roof structure, the west end wall, and part of the south wall have now collapsed. Except for window sash and doors, however, the character and dimension of all of the original materials and the original floor plan can be identified in the the existing ruins of the building.

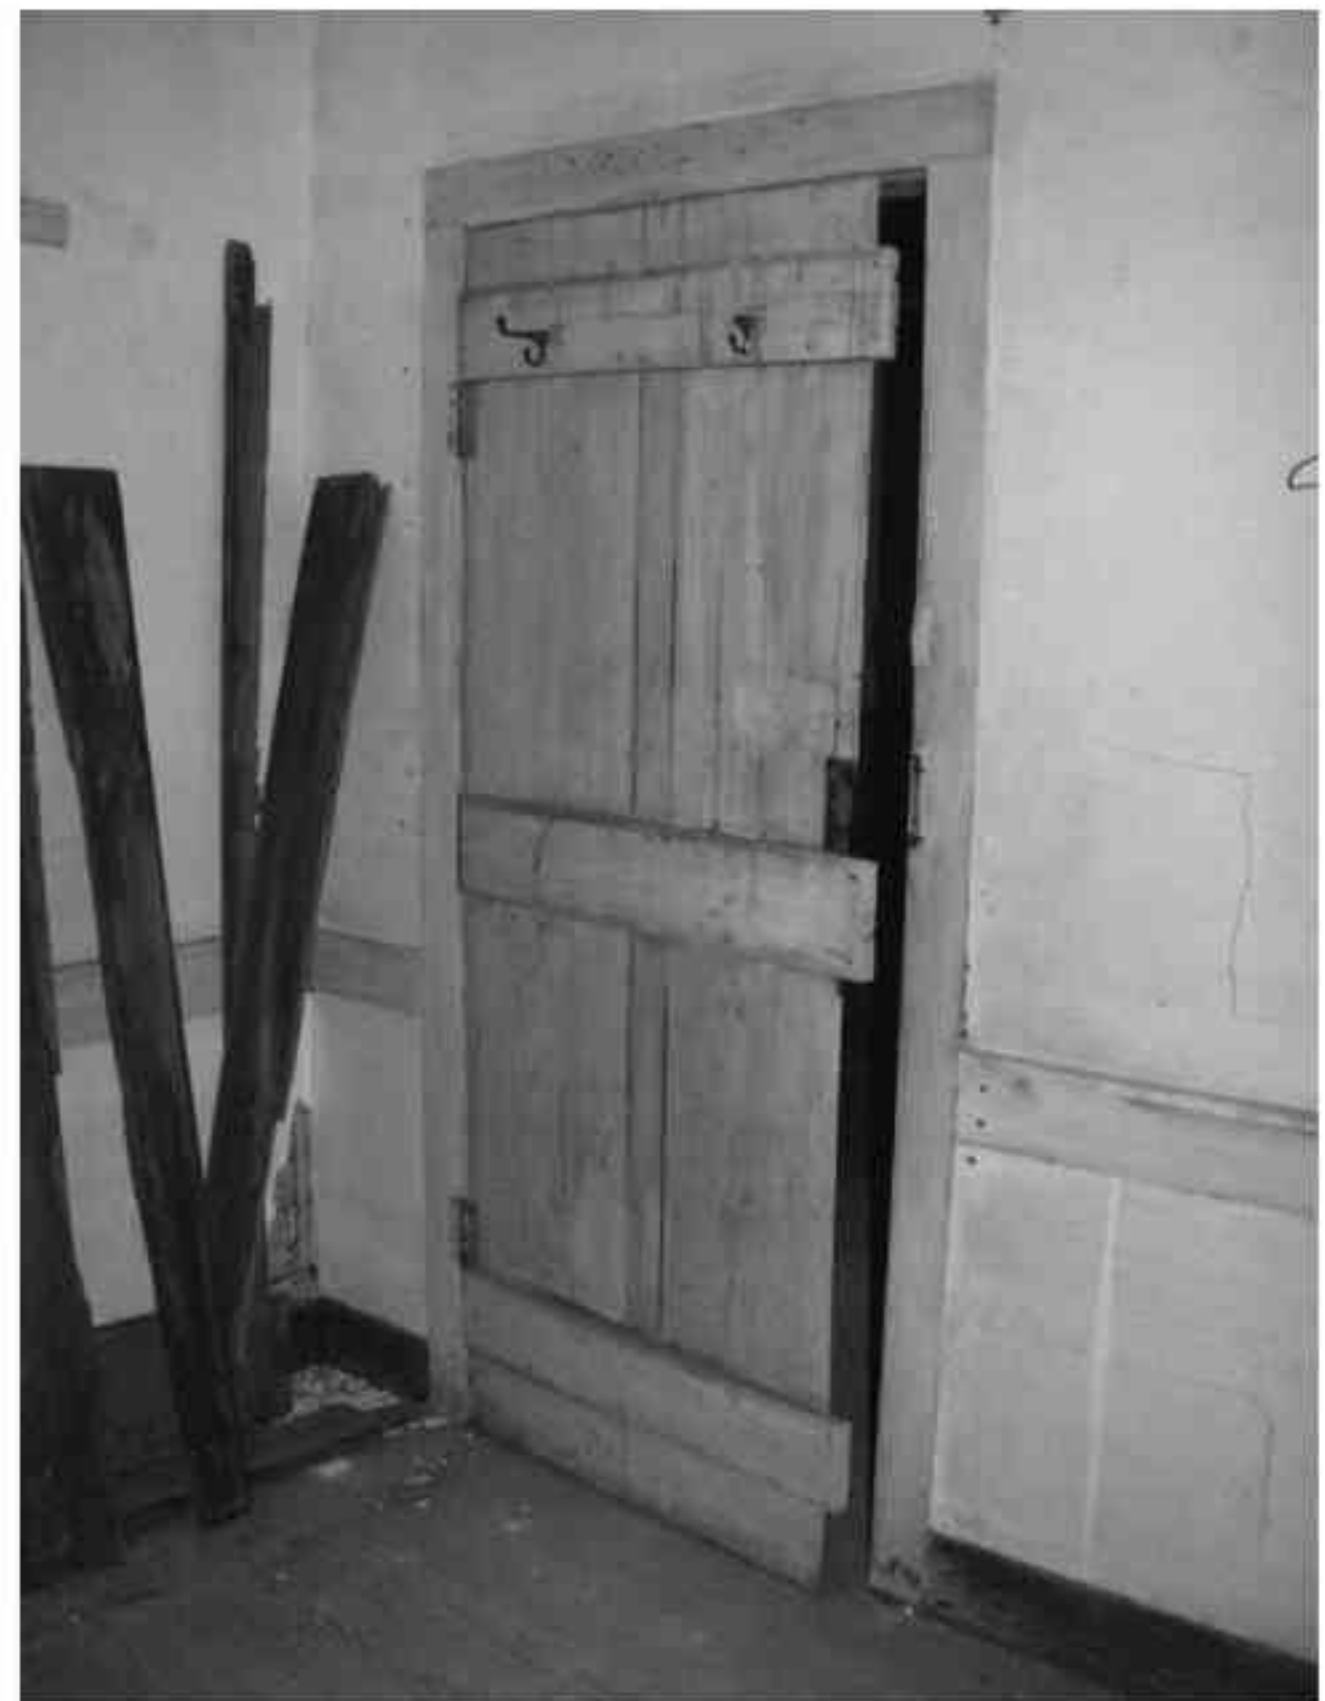
Neither of the interior doors in the kitchen addition could be identified, although evidence may survive under the collapsed roof. Except for the door between Rooms 102 and 103, all of the interior doors in the main block of the house are also missing, most of them torn from their frames. The surviving door is historic and is probably typical of the original interior doors. Measuring 6'-6" by 2'-9", it is constructed with three beaded boards, two around 12" wide, and a center board about 5" wide, held together by three chamfered ledger boards. The door is hung on 4-1/2" butt hinges and originally was fitted with a large rim lock. Only the lock catch remains in place on the jamb, the lock having been ripped off by thieves, splintering the door in the process.

FIGURE 48. View of inside face of door between 102 and 103. (NPS-SERO-CR, 2002)

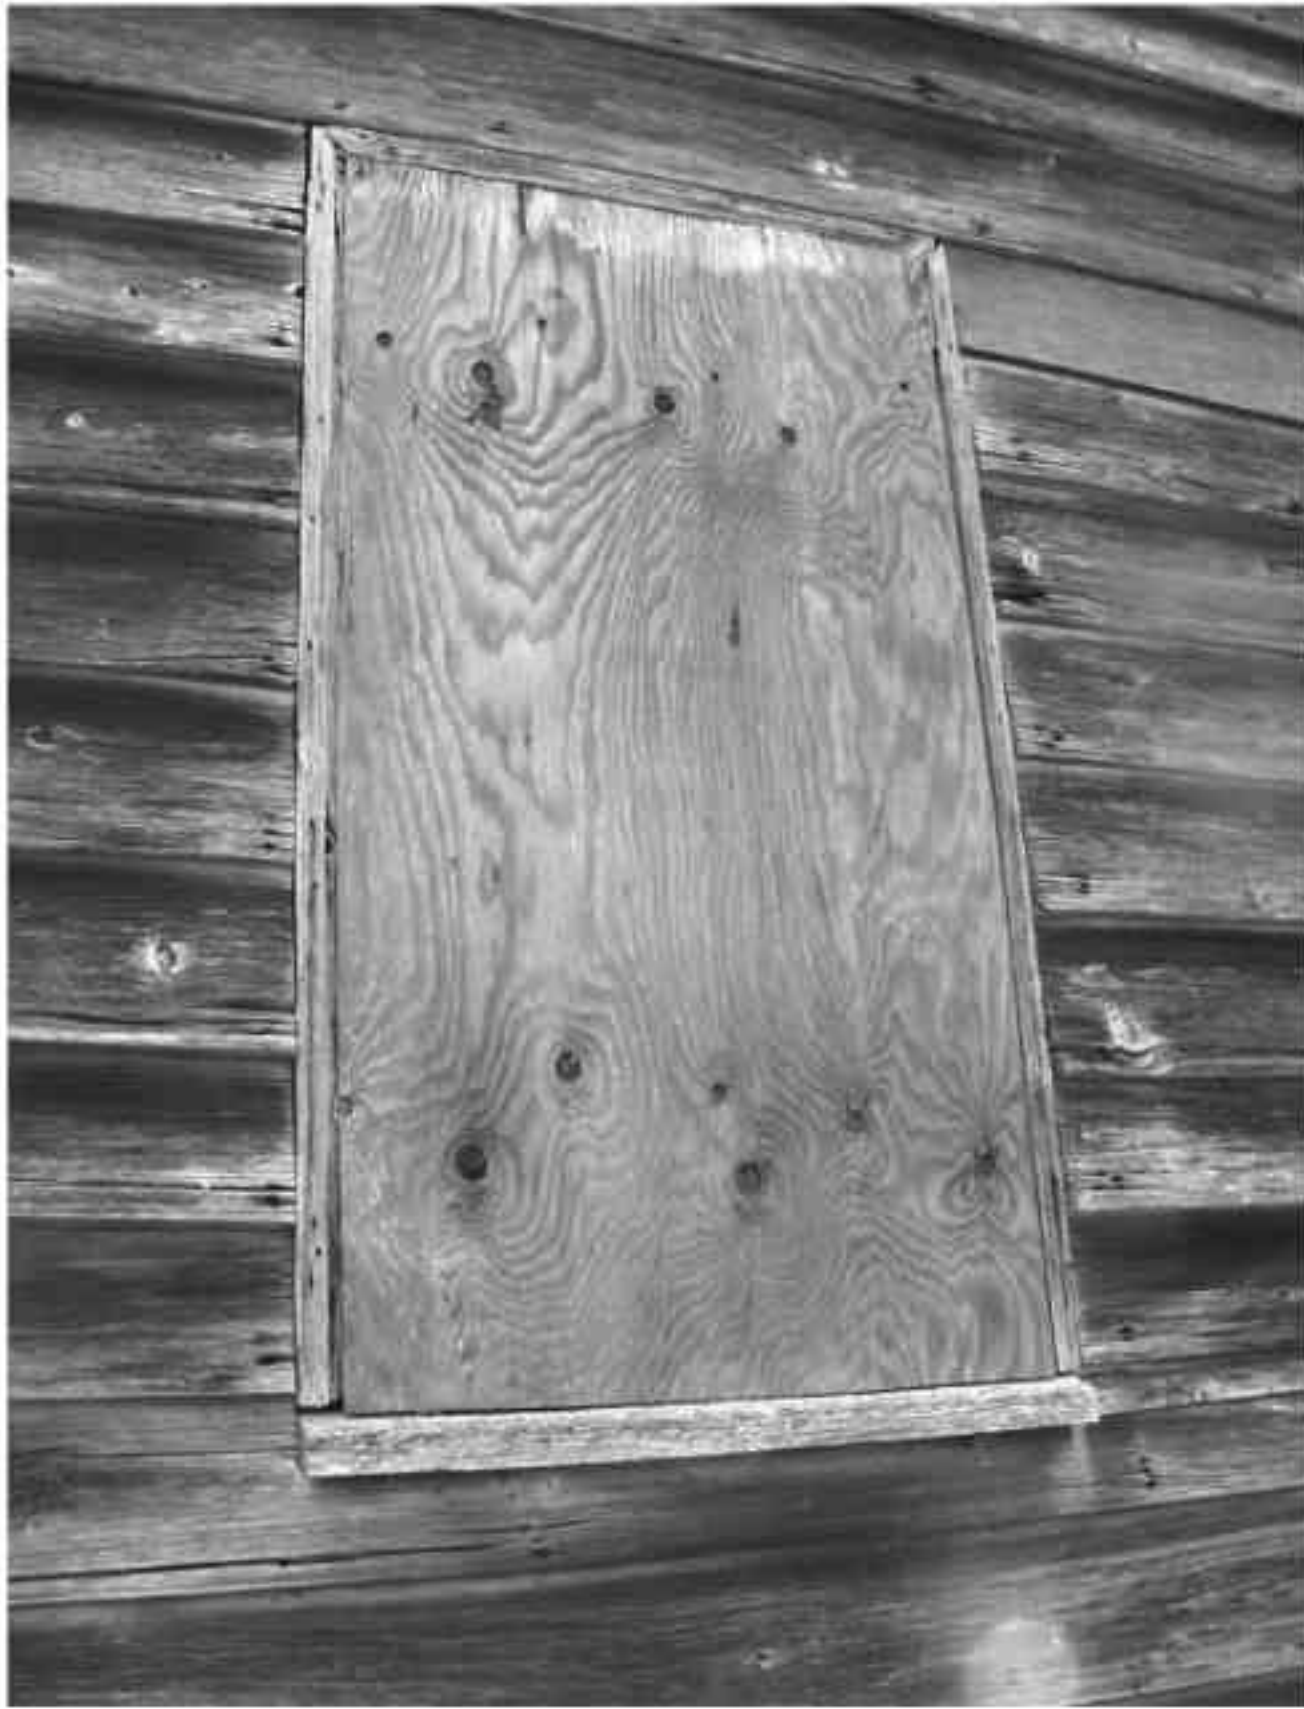
FIGURE 49. View of W-1 with original exterior sill and casing intact. (NPS-SERO-CR, 2002)

**W-1:** 2'-4" by 4'-6", six-over-nine sash, both sash missing; top of frame damaged; interior stop missing on right side and at header; interior casing and backband complete; one of two windows with exterior sill, casing and backband essentially intact, although badly eroded.

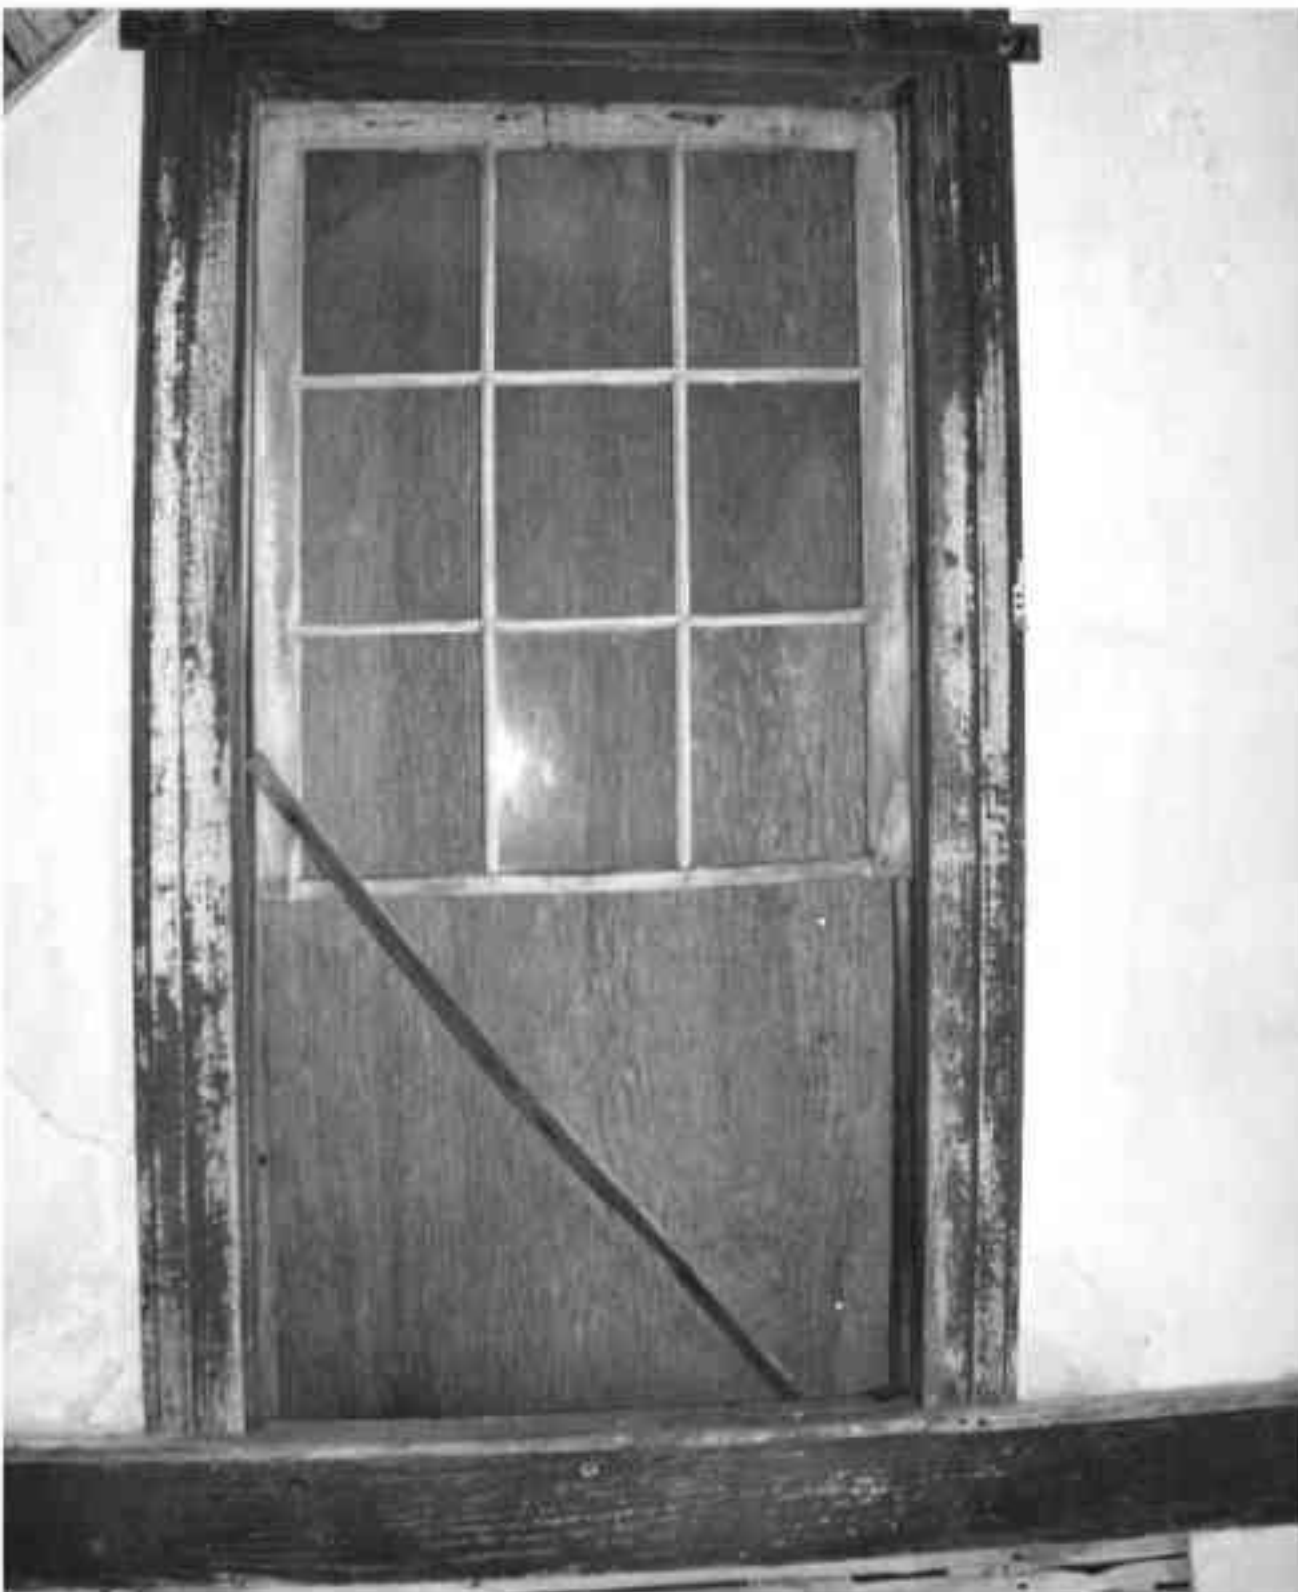
FIGURE 50. View of W-2 with sash and trim typical of first floor windows. (NPS-SERO-CR, 2002)

**W-2:** 2'-4" by 4'-6", six-over-nine sash, both sash missing; top of frame damaged; interior stop missing on right side and at header; interior casing and

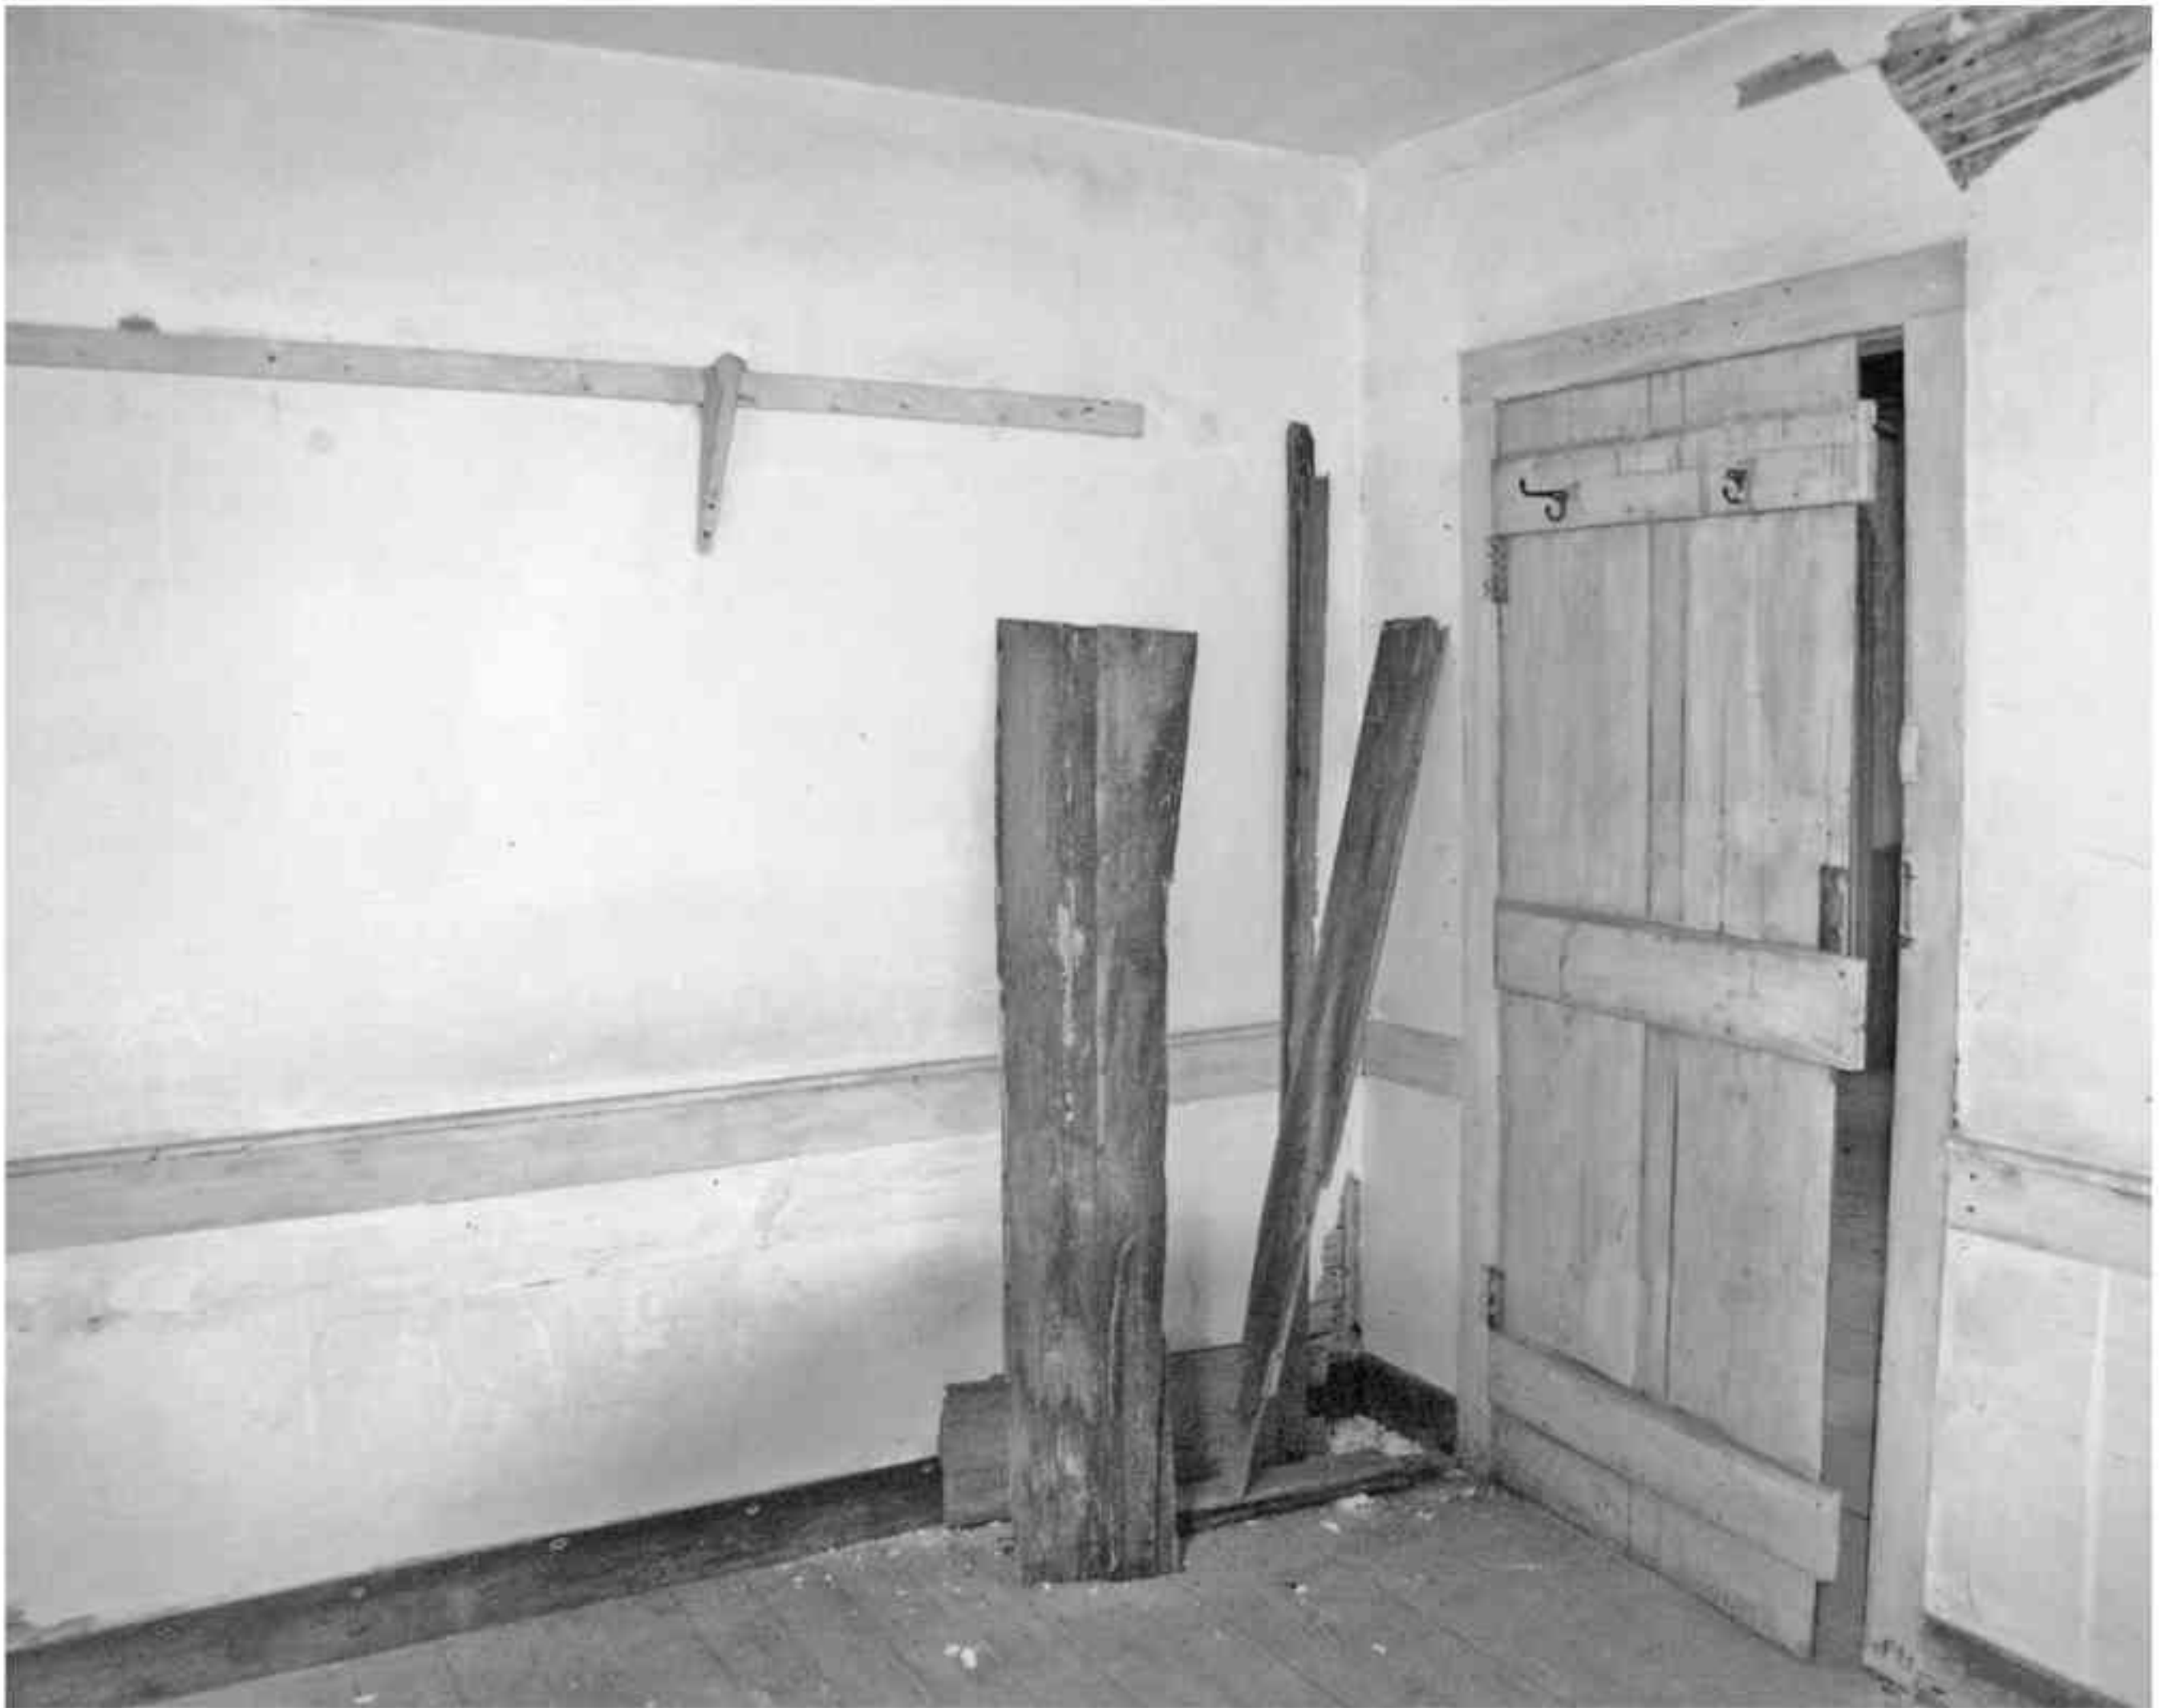
FIGURE 61. View south in Room 102, showing the only original door remaining in the house. (NPS-SERO-CR, 2002)

Used as a bedroom, this space, like Room 101, appears to have been created after the house's initial construction. The room measures 8'-6" by 10'-9". It has the only original interior door remaining in the house, although it has been damaged by vandals.
