# **Cape Lookout National Seashore**

# **Washington Roberts House**

## **Historic Structure Report**

### **Developmental History**

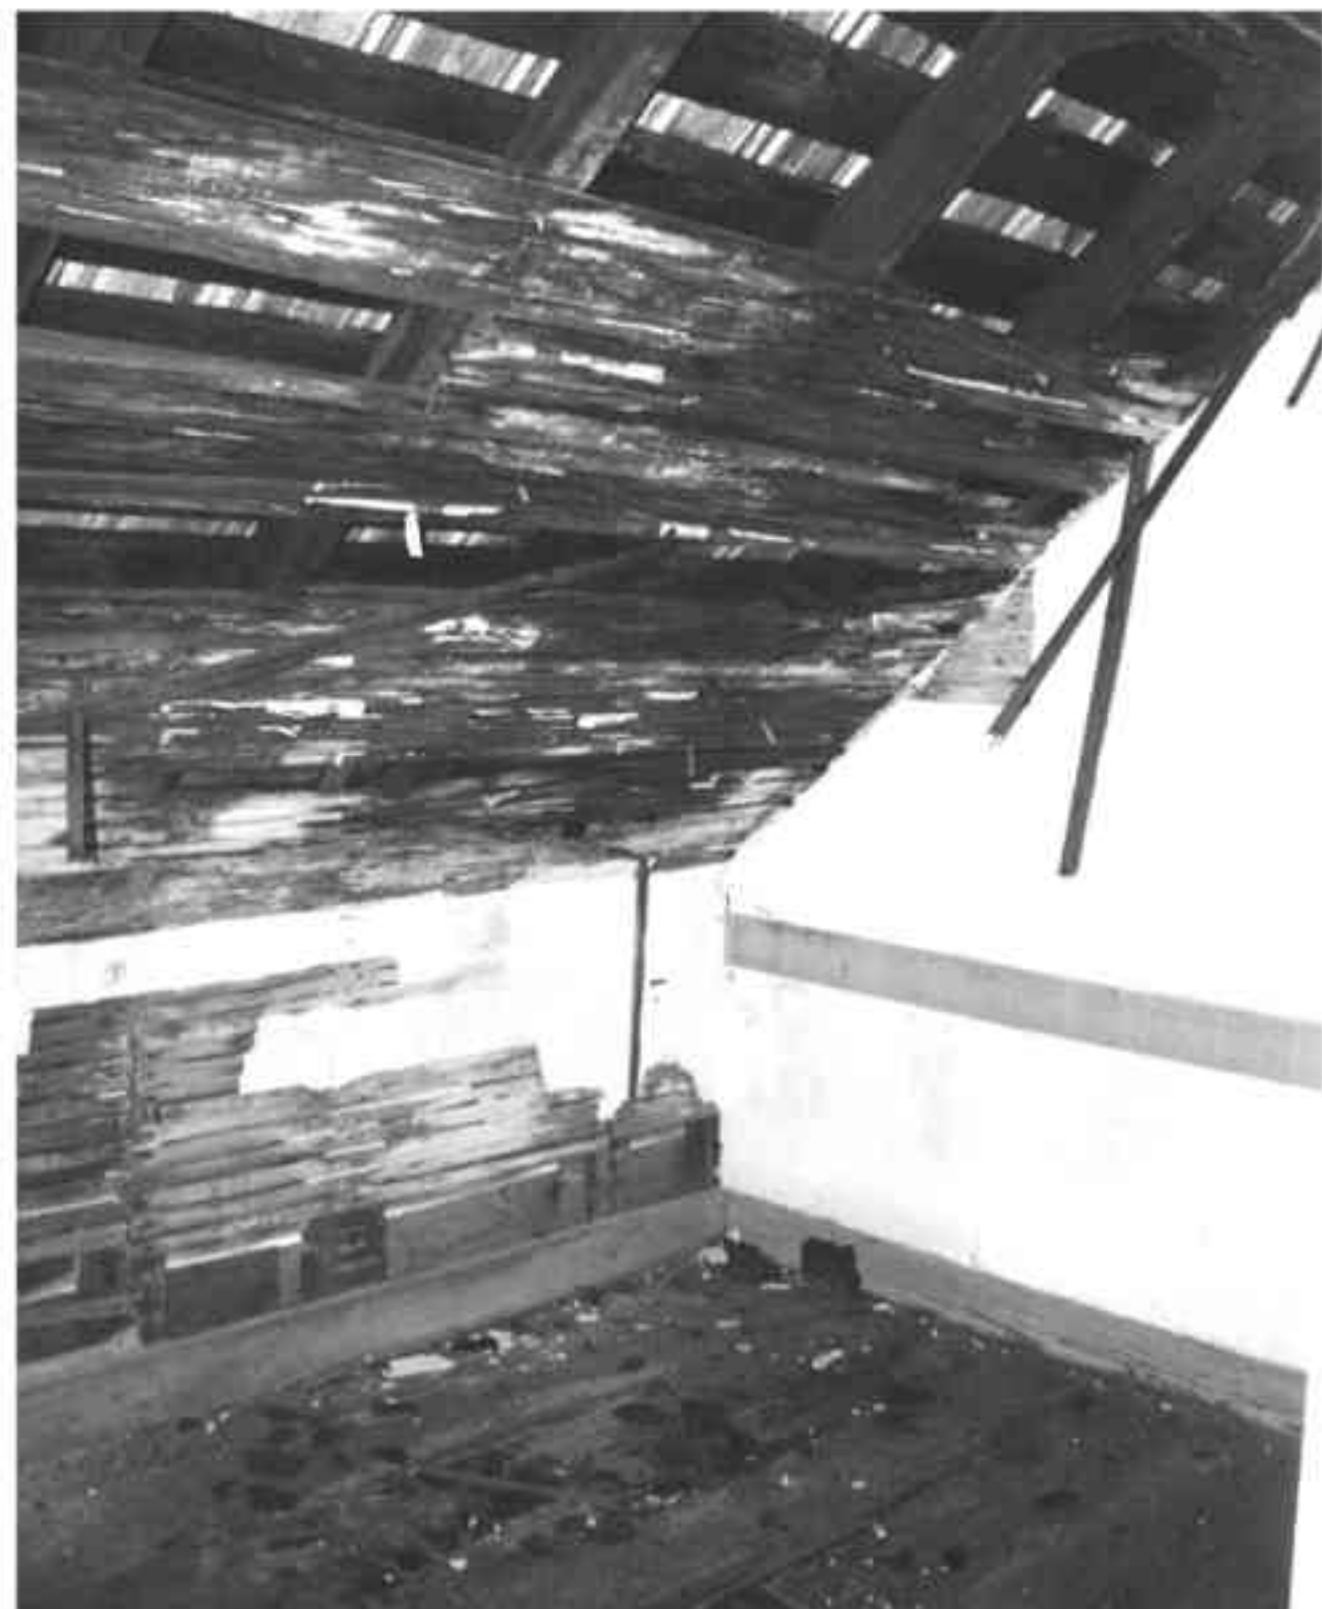
FIGURE 72. View southwest in Room 203. (NPS-SERO-CR, 2002)

**Floor.** Flooring is a random mixture of tongue-and-grooved boards, 8" to 12-1/2" wide. The southwest quadrant of the floor has suffered majordamage from water penetration through a failed roof covering.

**Walls and Ceiling.** Walls and ceiling were plastered over split lath, but most of the plaster has been lost from the ceiling and the south and east walls.

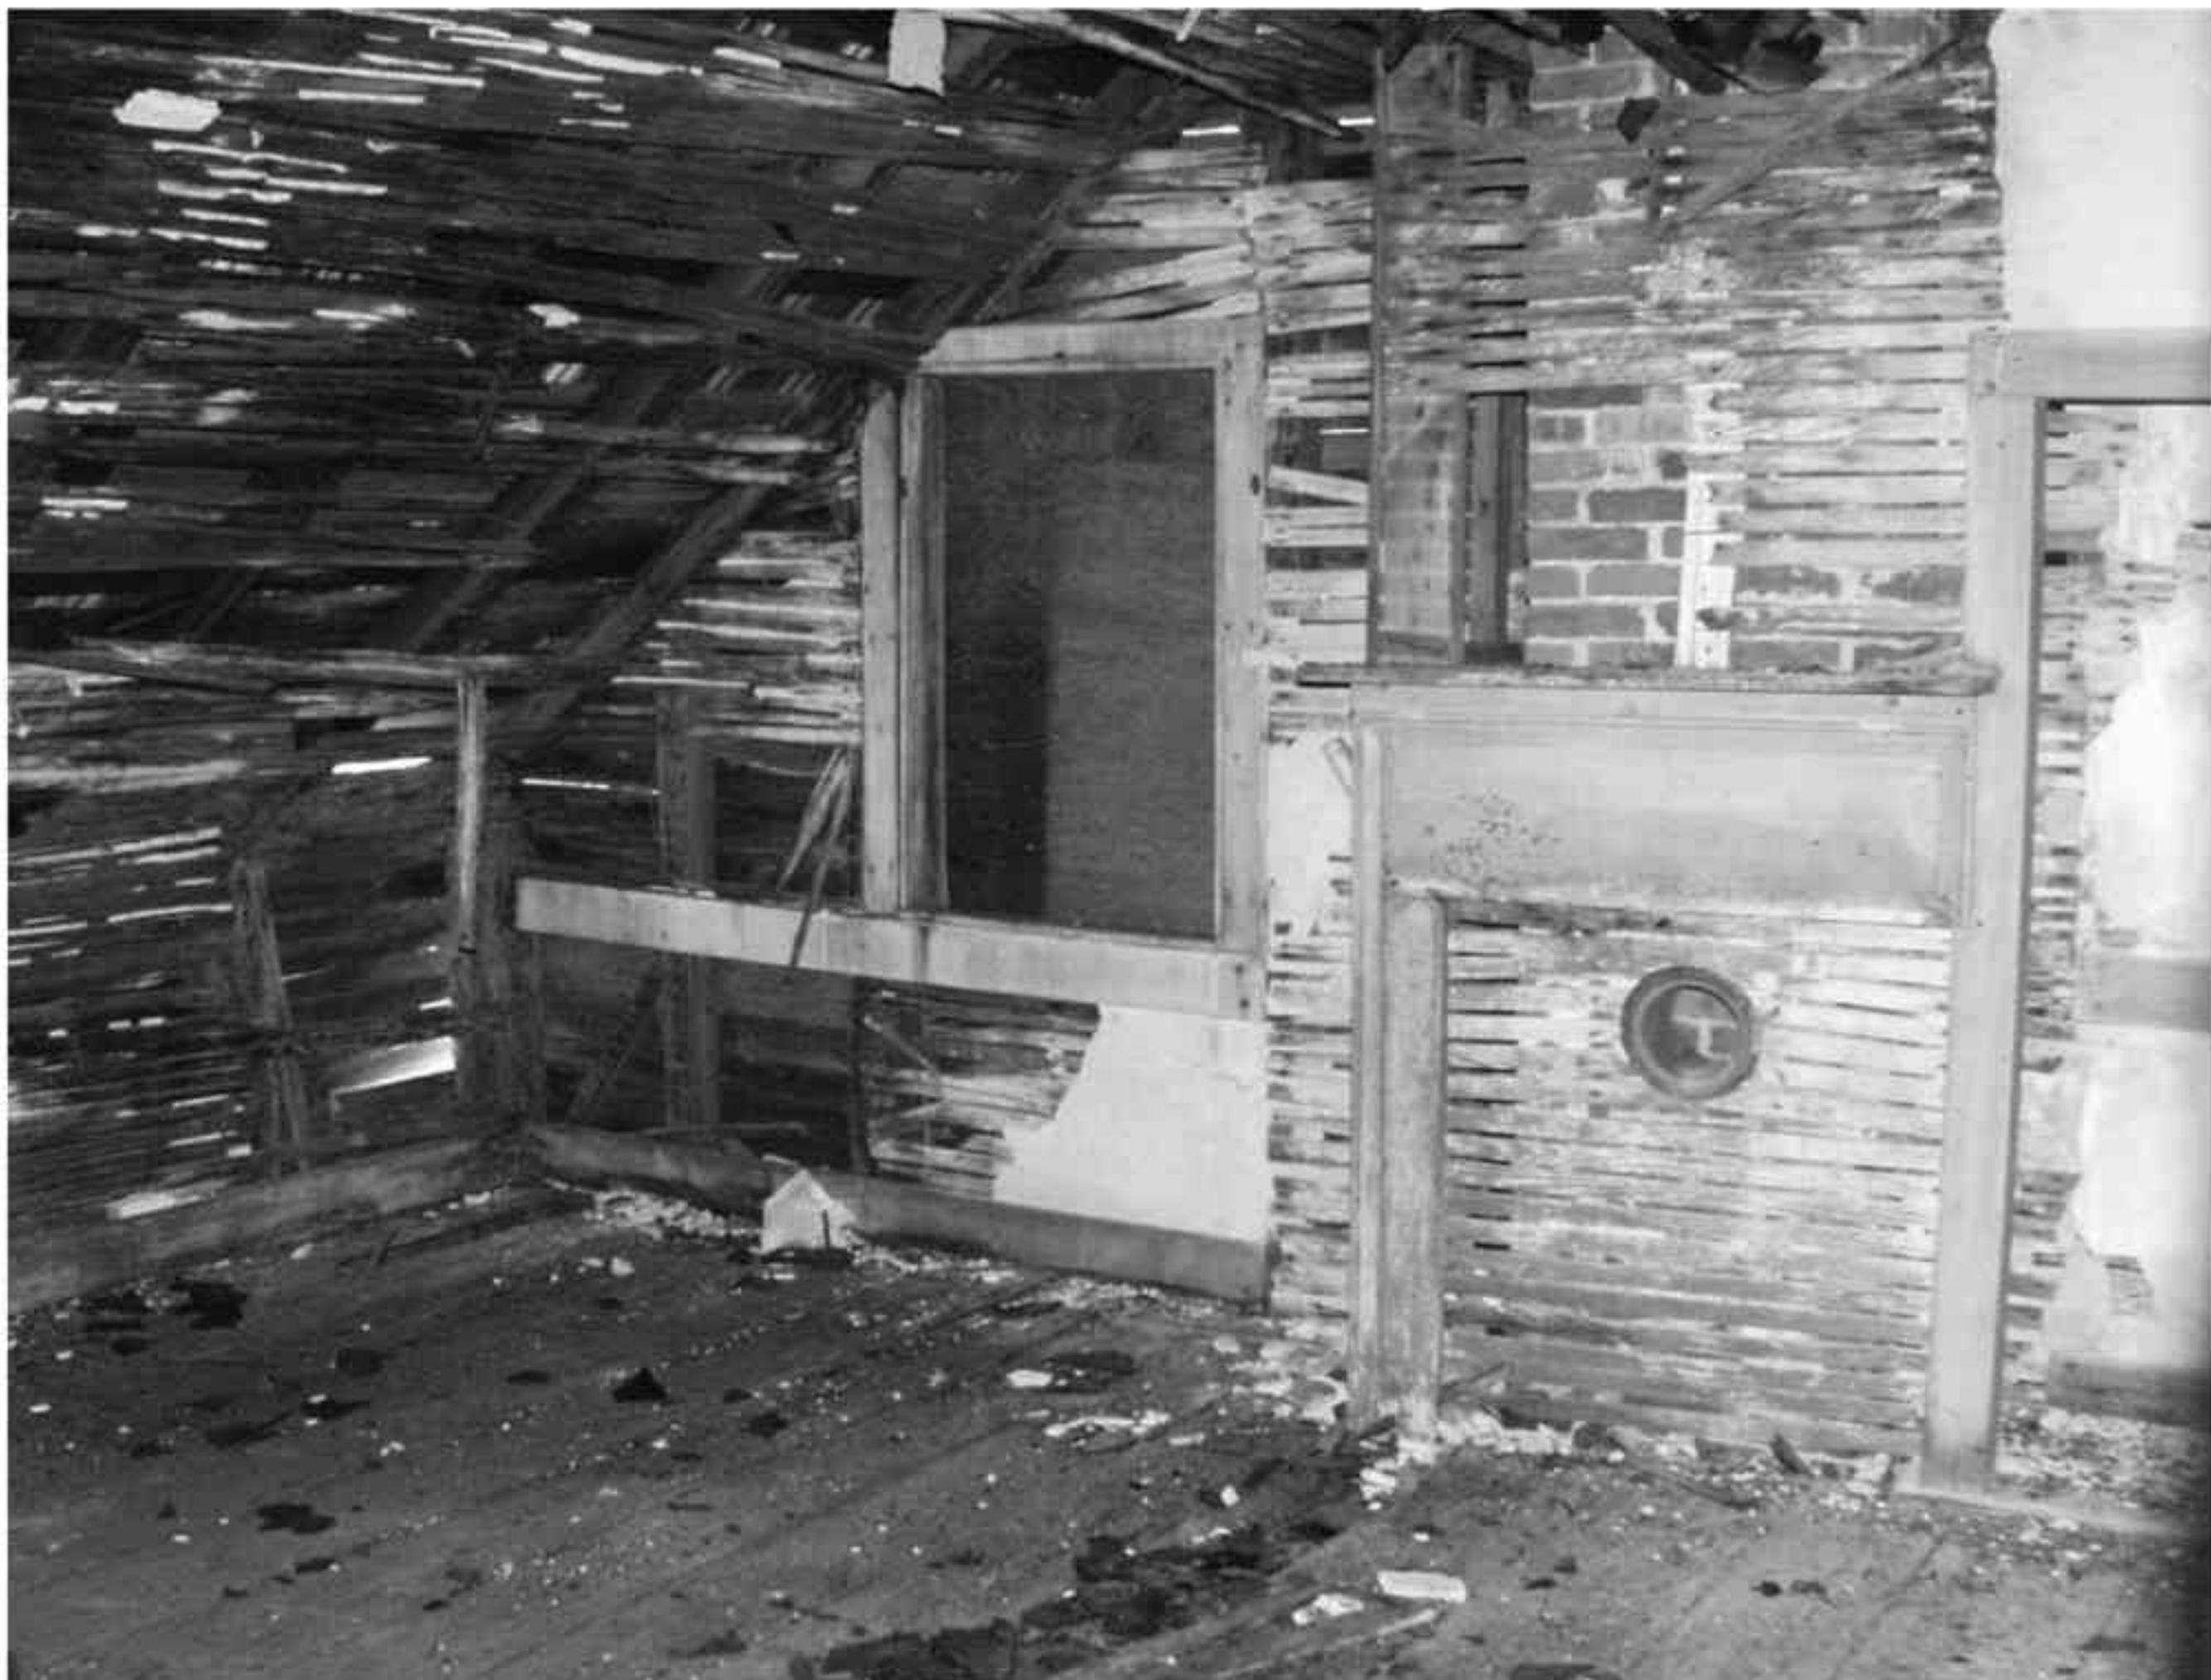
Water penetration has seriously damaged much of this room. Measuring 12'-3" by 13'-5", this is the largest of the three bedrooms and the only one that was heated. The fireplace and the closet were apparently added along with the new fireplace on the first floor.

damage from water penetration along the west side of the room.

**Window.** The single window in this room is missing both sash.

FIGURE 71. View west in Room 202. (NPS-SERO-CR, 2002))

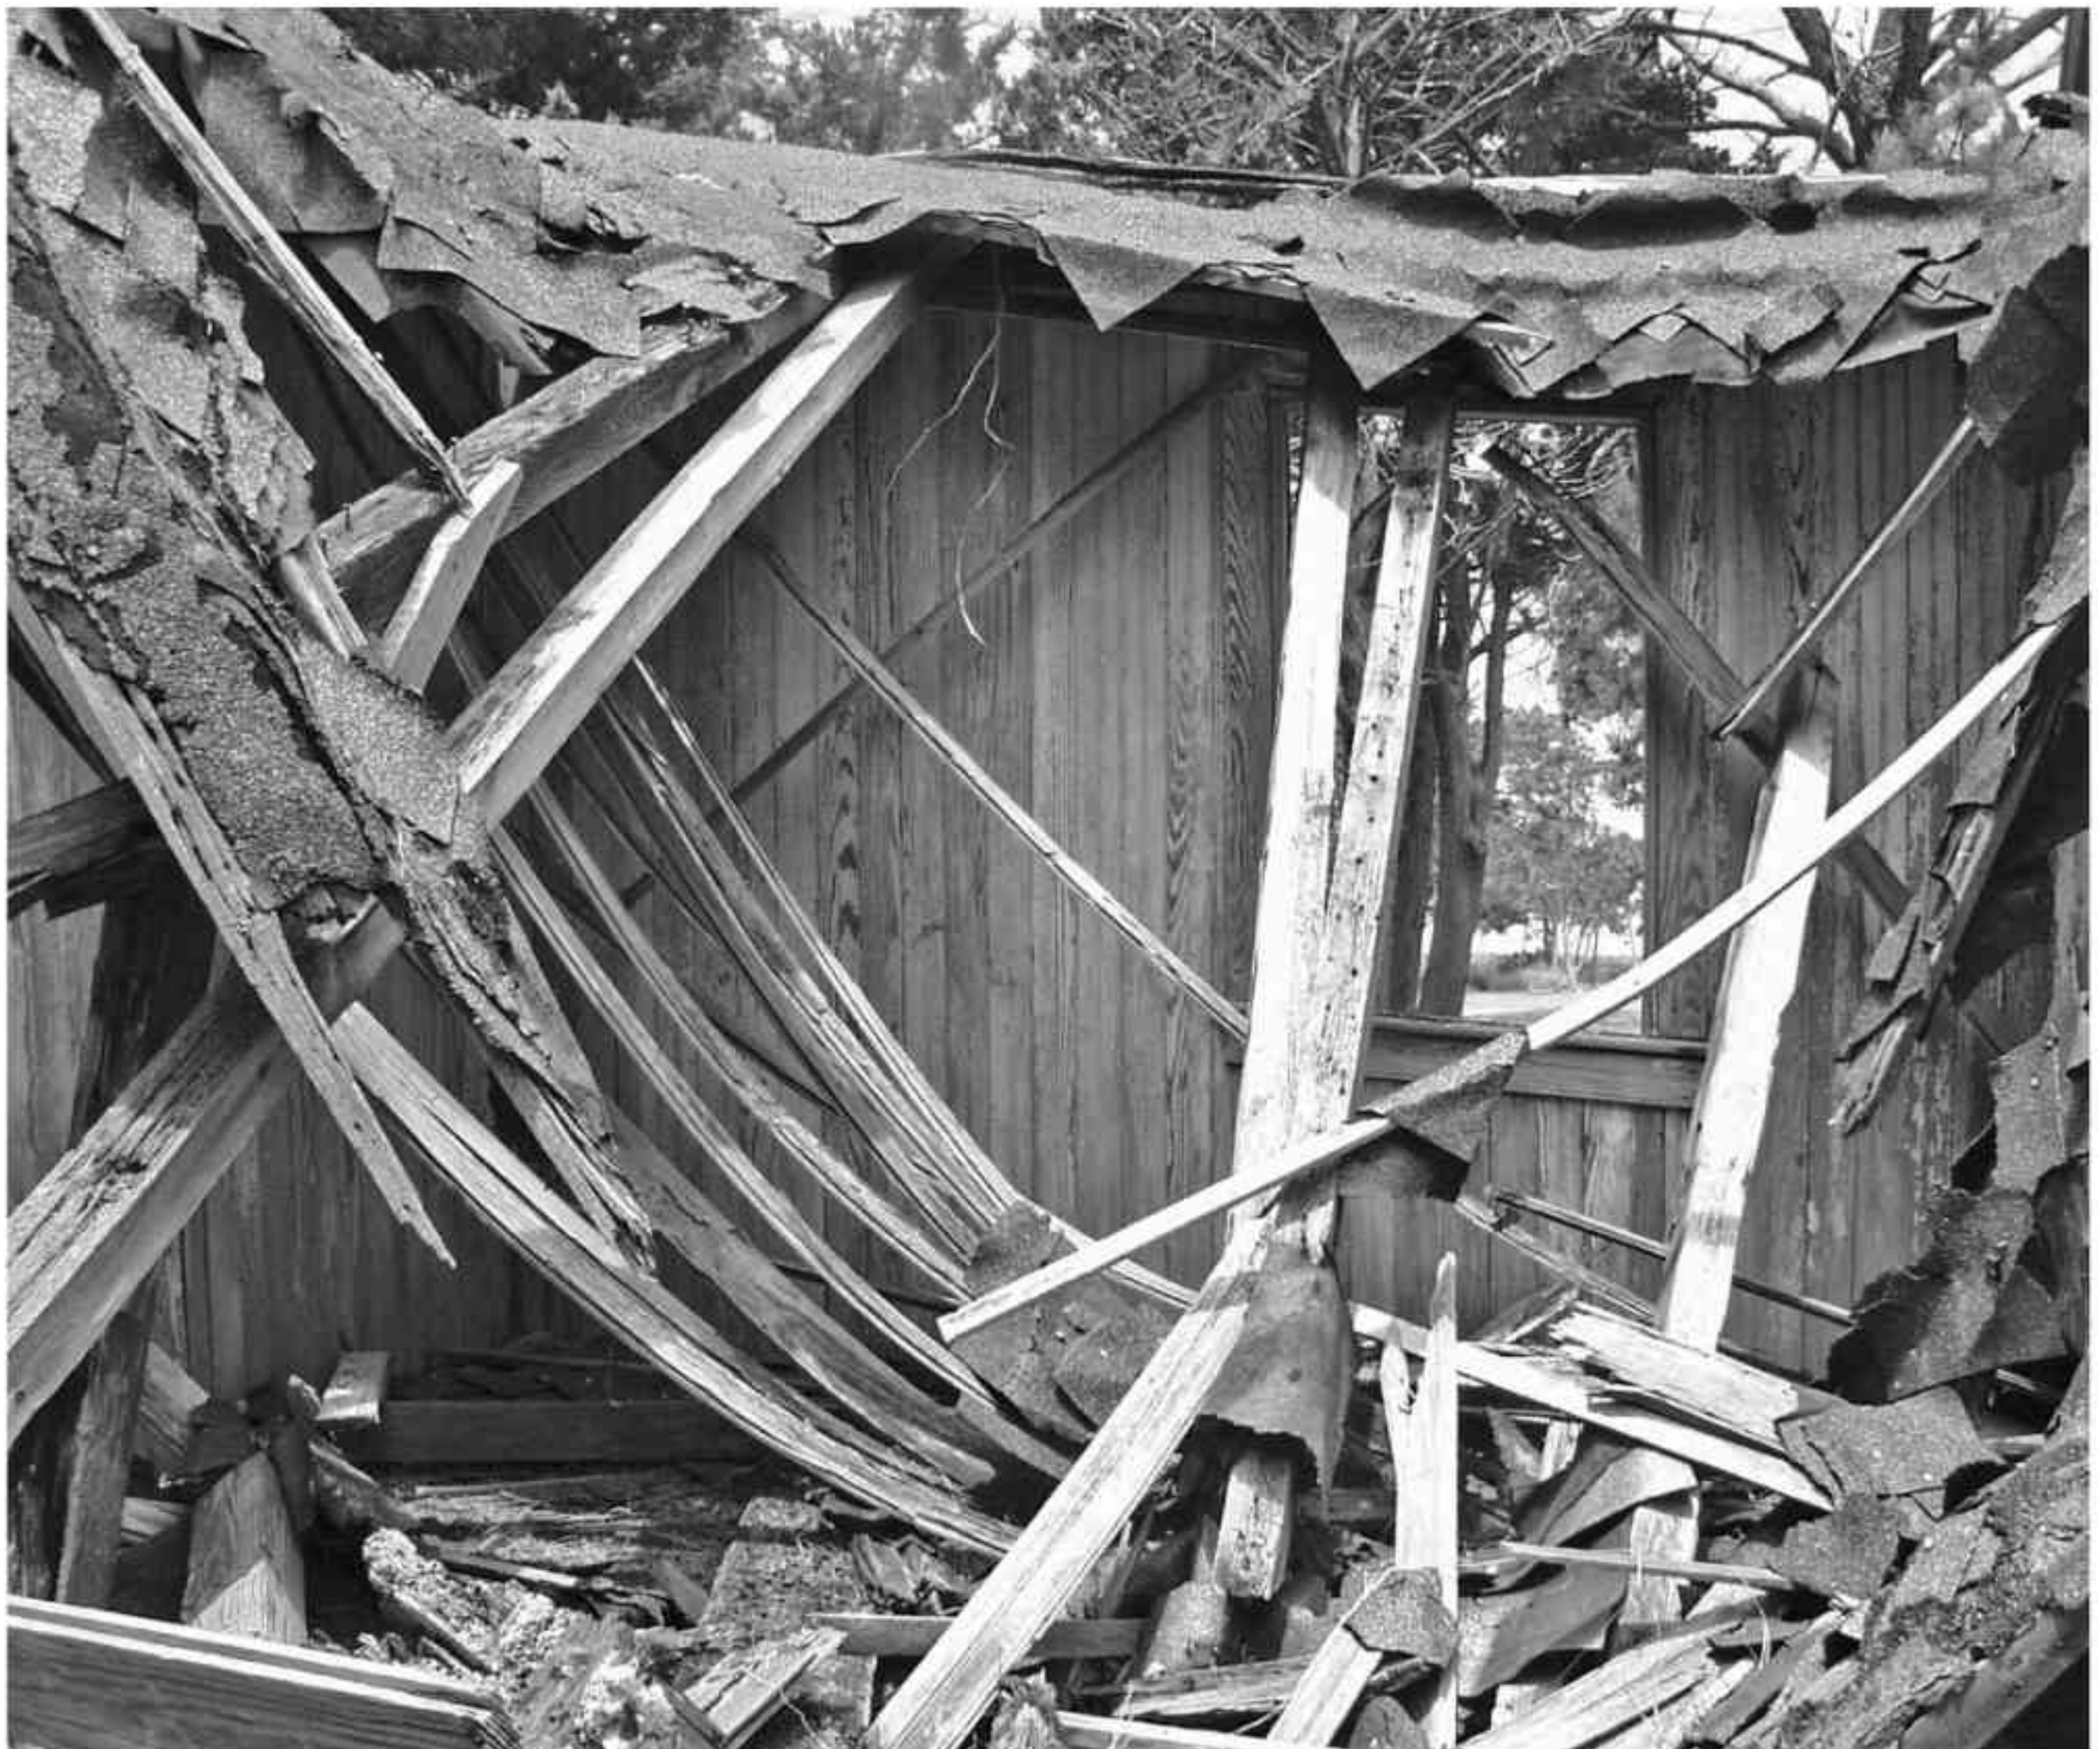
FIGURE 74. View north of Room 104. (NPS-SERO-CR, 2002) the main house, this room was clearly used as a dining room. (NPS-SERO-CR, 2002)

Thompson recorded the dimensions of this room as 13' by 14'. Although badly deteriorated, the original features and materials of the room can still be identified. Entered either from the hall (Room 105) or from a door that opened on to the front porch of

**Floors.** Flooring appears to be 3"-wide tongue-and-groove. Its condition could not be ascertained, but there is likely to be major deterioration of the material.

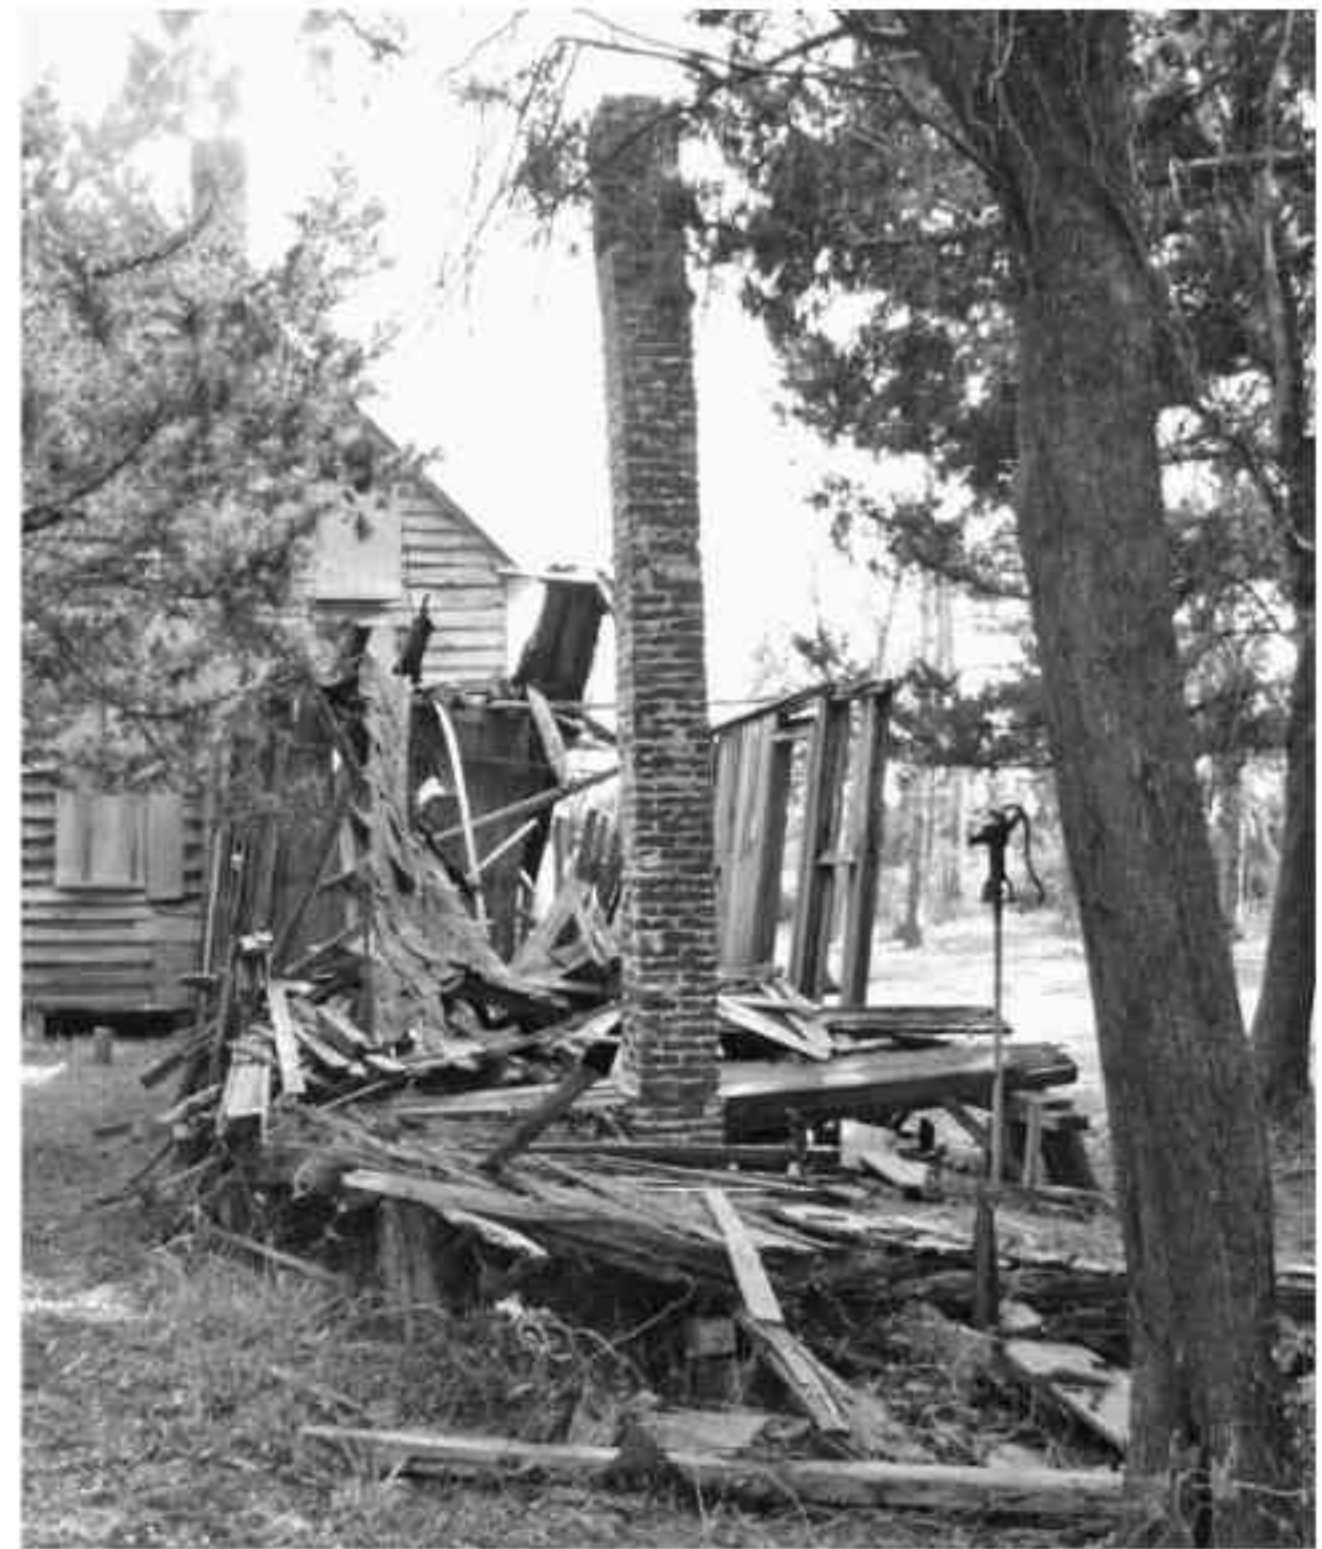
FIGURE 76. View southeast of kitchen wing. (NPS-SERO-CR, 2002)

The chimney at the west end of the kitchen wing is intact, but is tilted several degrees from the vertical. The slight tilt may be a feature of its original construction, since brick and mortar remain in reasonably good condition, in spite of the collapse of the walls of the room itself. Measuring about 14-1/2" by 14-1/2" in plan and rising approximately 16'-6" above ground, it was constructed of hard-fired, red brick and a white, Portland-cement mortar.
