4 LAZY F RANCH

Historic Structures Report

September, 2008

Grand Teton National Park
National Park Service
P.O. Box 170
Moose, Wyoming 83012

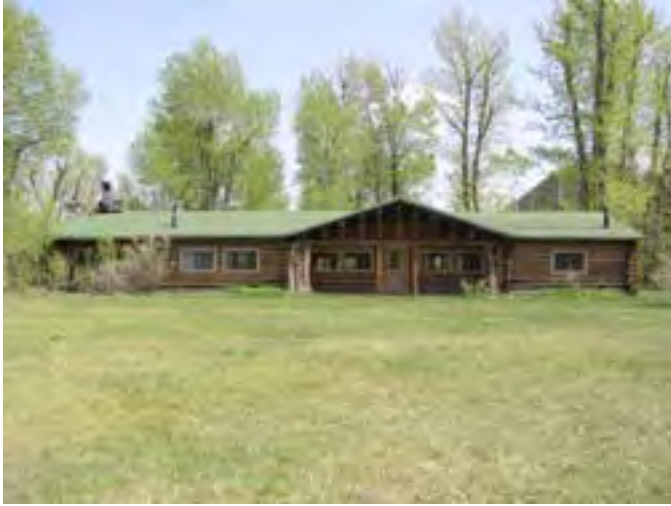
Figure 23. Looking east at the façade of the Lodge. The building is generally in good condition.

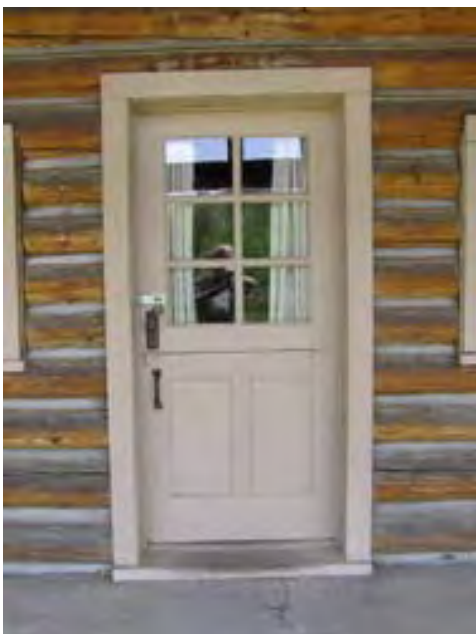
Figure 25. Looking east at the main entrance door which is in good condition.

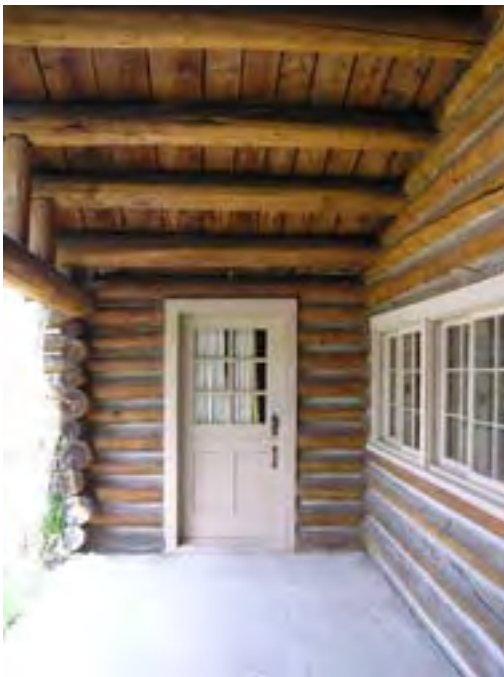
Figure 27. Looking north at a door into the living room from the front porch. Note the roof structure is in good condition.

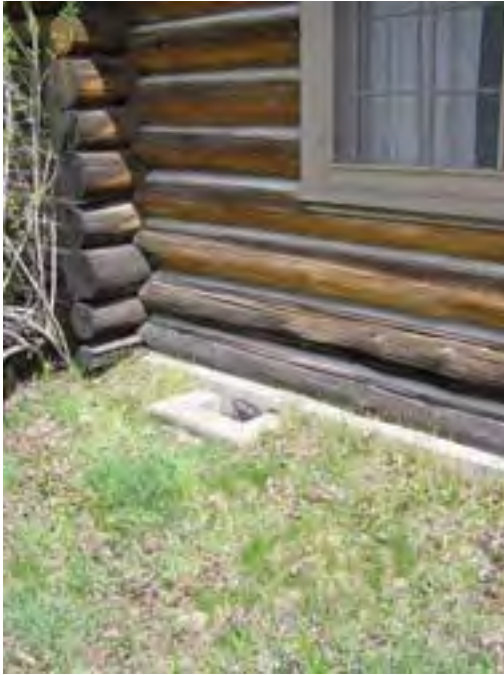
Figure 29 – Looking northeast at a typical corner of the Lodge. Note the rotted bottom logs and the soil that has accumulated against the log ends. Also note the concrete vent to the crawl space that allows air under the building.

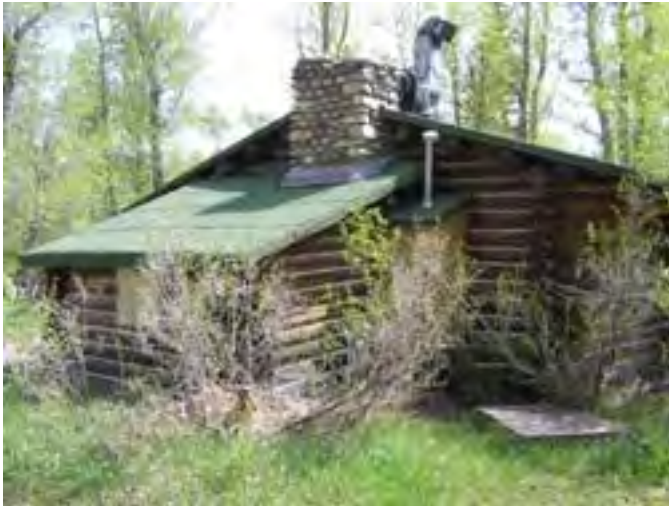
Figure 30 – Looking southeast at the Lodge with the added shed roof structure that surrounds the stone fireplace. This shed roof structure has settled because of rotted base logs and has pulled away from the Lodge wall and fireplace. Also note the water heater addition on the building which is also rotted at the base.

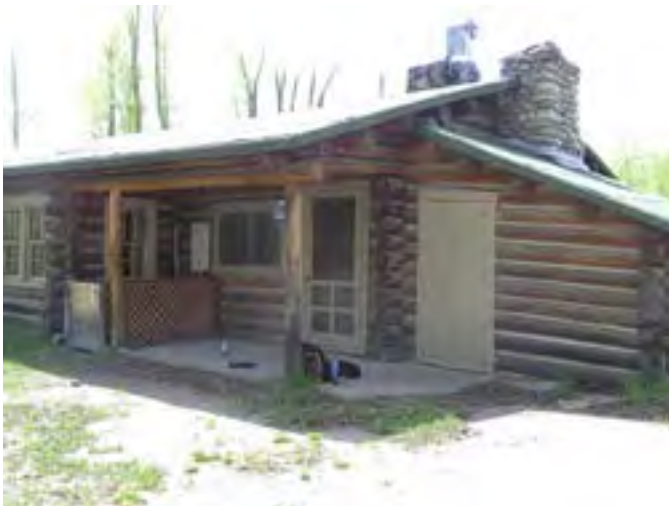
Figure 31 – Looking southwest at the back porch area. The stone chimney over the shed roof addition has some missing mortar and the flashing around the chimney is poor. The sheet asphalt roof has some damage.

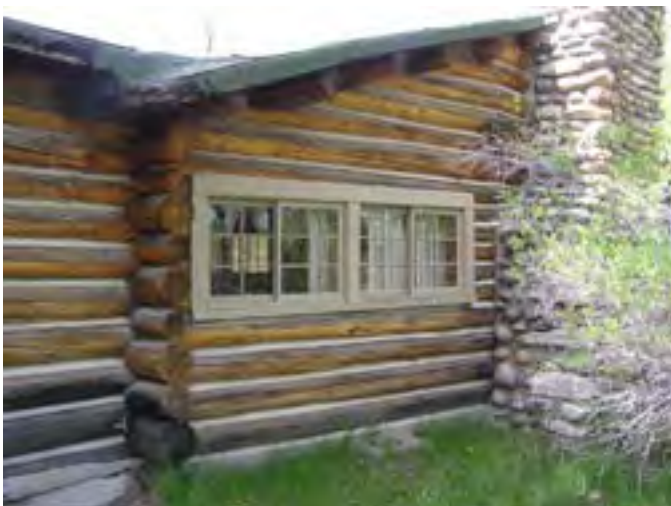
Figure 34 – Looking west at the log wall of the great room with the stone chimney. There are some rotted base logs especially at the intersection of the bedroom and the great room. The roof is damaged in this area and there is some separation of the logs and stone chimney.

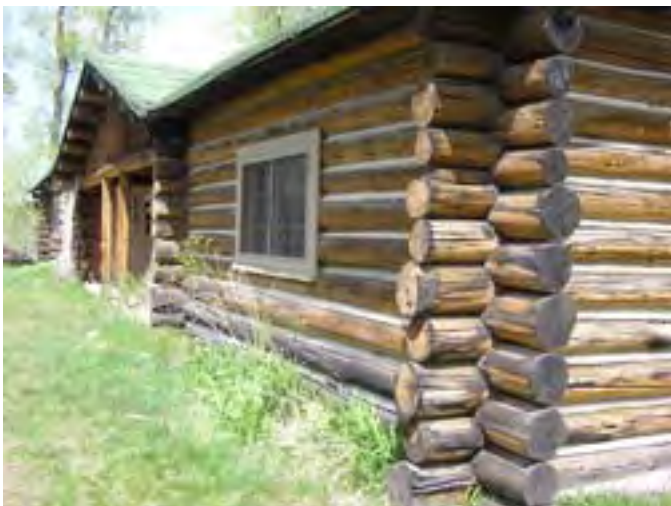
Figure 37 – Looking northeast at the Lodge building. Note the soil accumulation which has contributed to the rotted sill logs and base log at the corner.

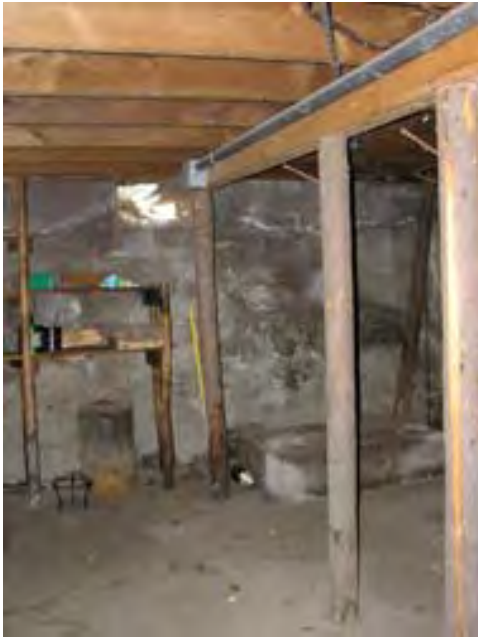
Figure 38 – Looking west at the basement under the kitchen. Note the concrete walls and floor and the added supports for the kitchen floor. There are some water stains on the concrete from some water penetration into the wall.

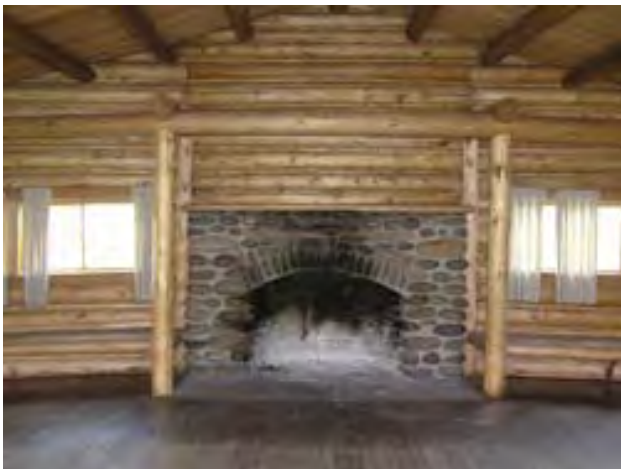
Figure 40 – Looking east at the fireplace and log work in the great room of the Lodge. Most of the woodwork and log work is in good condition. The fir floor is in good condition with the exception that there is a bulge in the center, which appears to have been caused by the outer log walls settling. This is not evident in the other rooms.

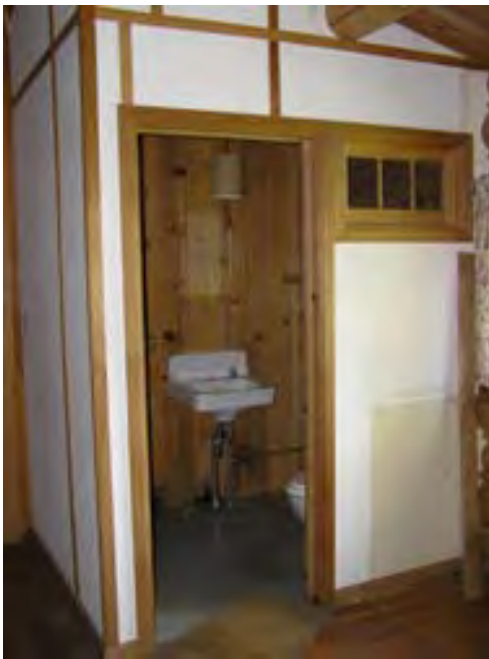
Figure 42 – Looking north at the added bathroom in the east bedroom of the Lodge. The materials are in good condition.

- Figure 41. Looking north at a typical wall and wood paneled door in the great room.
- Figure 42. Looking north at the added bathroom in the east bedroom of the Lodge. The materials are in good condition.

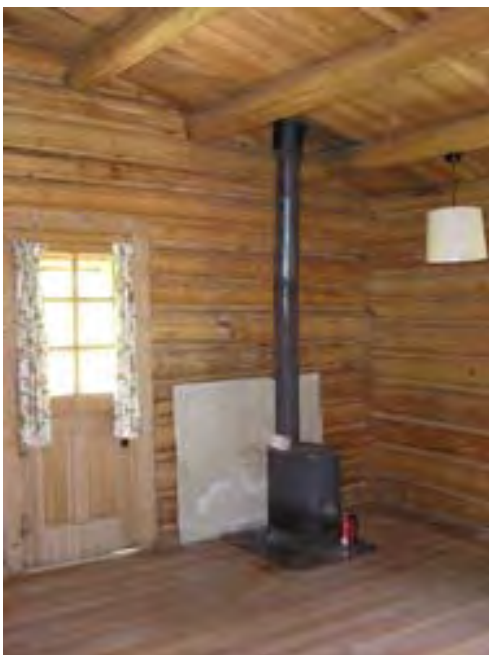
Figure 43 – Looking southwest at the west bedroom and its wood stove and chimney. The materials are in good condition.

- Figure 43. Looking southwest at the west bedroom and its wood stove and chimney. The materials are in good condition.
- Figure 44. Looking north from the dining room towards the door to the kitchen. The materials are in good condition.

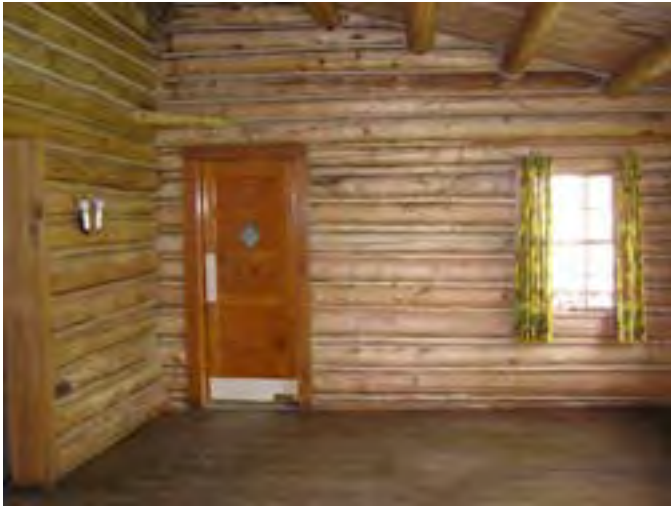
Figure 44– Looking north from the dining room towards the door to the kitchen. The materials are in good condition.

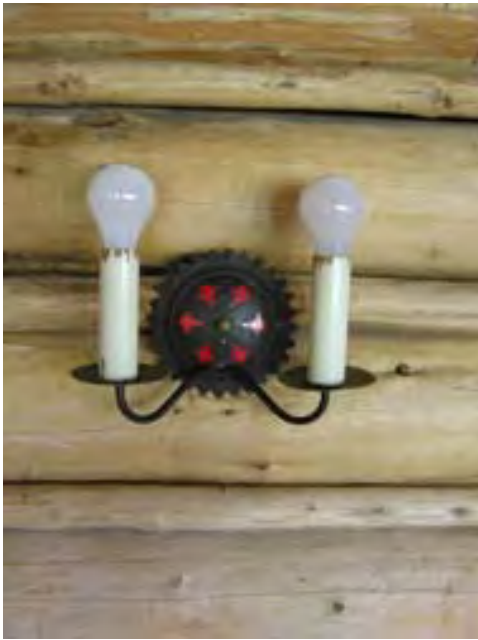
Figure 45 – Looking west at one of the walls sconces in the dining room. It appears to be original to the building.

- Figure 45. Looking west at one of the wall sconces in the dining room. It appears to be original to the building.
- Figure 46. Looking north at the cook stove in the kitchen. The walls and ceiling have been sheetrocked and there is a fire suppression system in the hood. There is a vinyl floor.

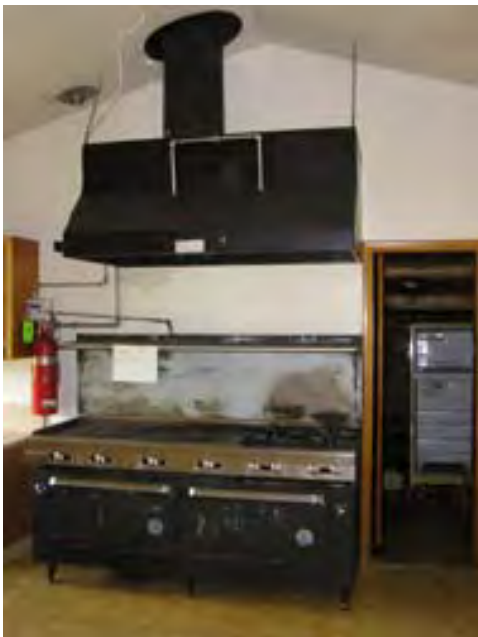
Figure 46 – Looking north at the cook stove in the kitchen. The walls and ceiling have been sheetrocked and there is a fire suppression system in the hood. There is a vinyl floor.

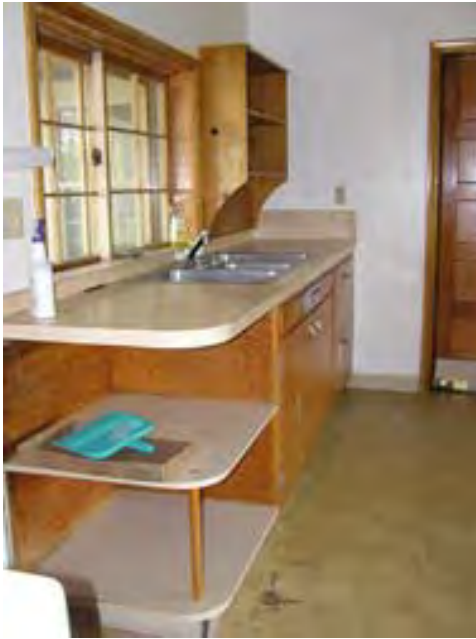
Figure 47– Looking south along some of the 1960's cabinets in the kitchen.

- Figure 47. Looking south along some of the 1960's cabinets in the kitchen.
- Figure 48. Looking north at the door to pantry and the door to the right which exits to the back porch.

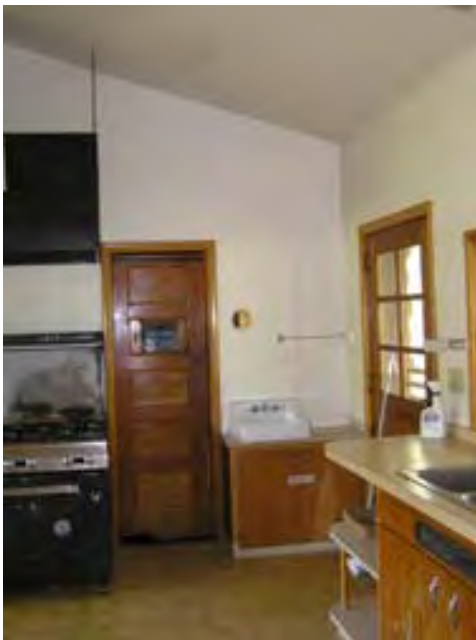
Figure 48 – Looking north at the door to pantry and the door to the right which exits to the back porch.

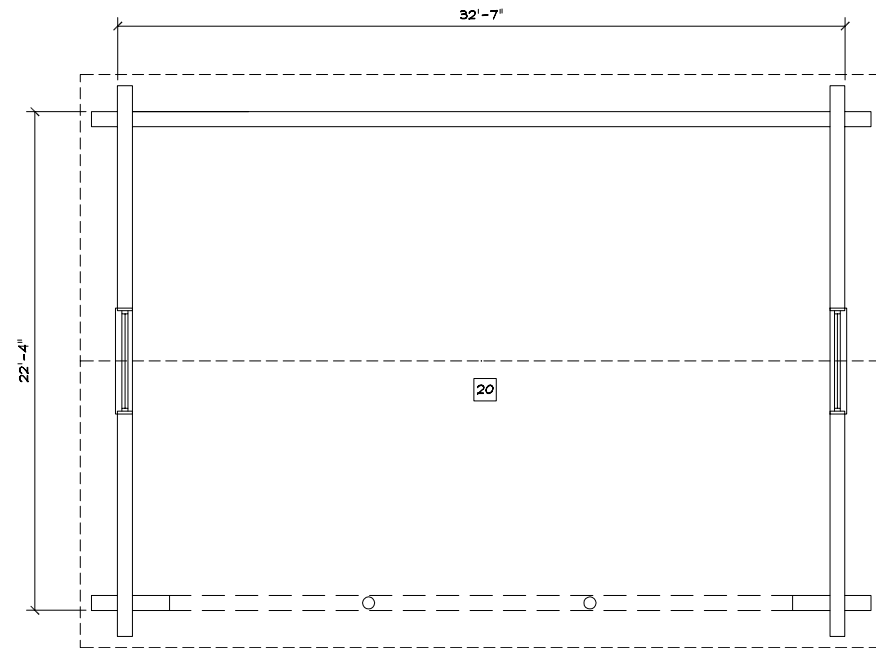
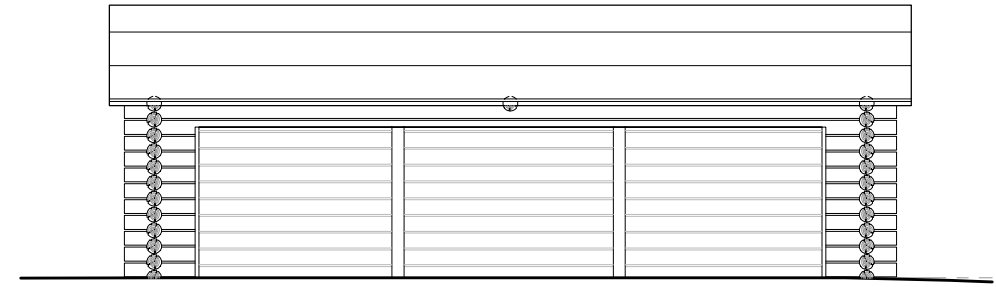
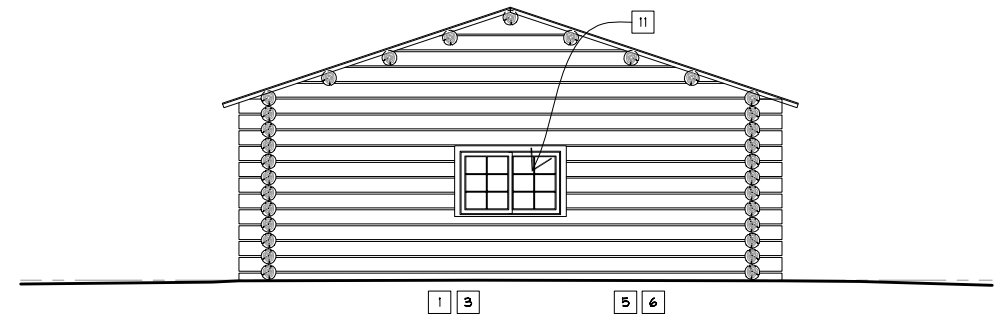
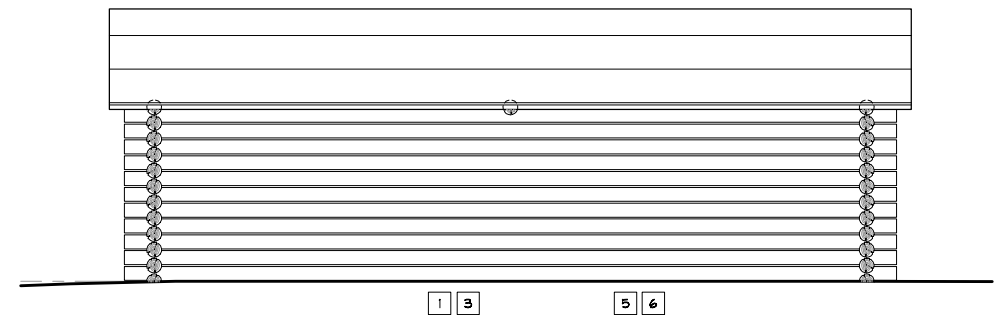
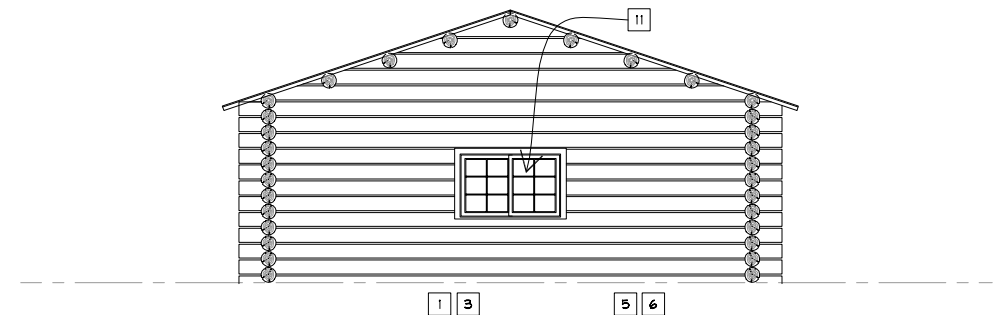
49

The Garage is in fair condition. The log walls are dry and checked. There is rot in the sill logs because of the soil that has built-up around the base of the building on all three enclosed sides. The daubing is very poor throughout all of the walls. The sheet asphalt roof is in good condition with some minor edge damage. The windows have also lost all finish and have dried out with some of the glazing in poor condition. The wood has weathered and there is some dry rot.

The thin layer of concrete that was laid down on the inside is broken up and some of it is missing. The two logs columns in the opening of the garage are not supported very well at the base, therefore the bases have some rot and are partially buried in the ground.

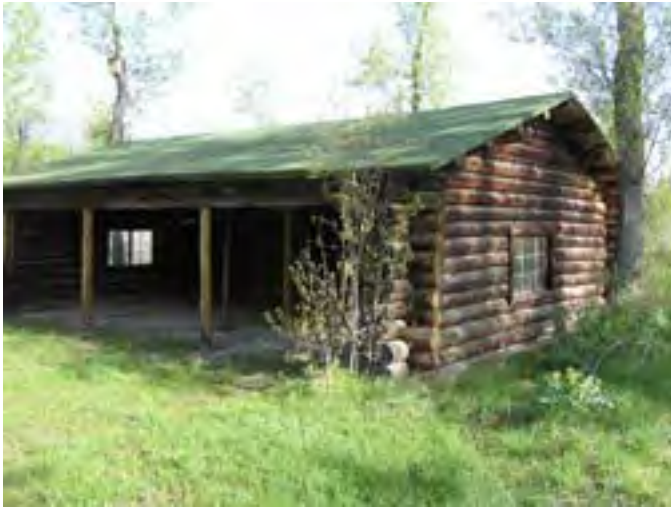
Figure 50 – Looking northwest at the front of the three-bay garage. The logs are generally in good condition but are dry and there is some rot in the base logs. The roof is in good condition.

- Figure 49. HS-403N Three-Bay Garage, floor plan and elevations.
- Figure 50. Looking northwest at the front of the 3 bay garage. The logs are generally in good condition but are dry and there is some rot in the base logs. The roof is in good condition.

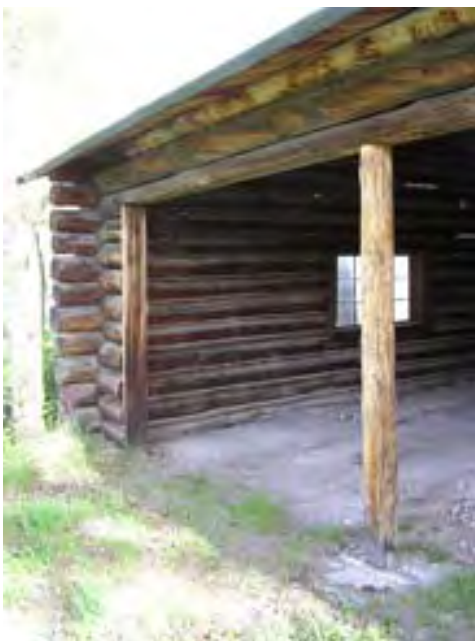
Figure 51– Looking northwest at one of the front wall columns that appears to have been replaced. The base concrete is very minimal.

- Figure 51. Looking northwest at one of the front wall supports that appears to have been replaced. The base concrete is very minimal.
- Figure 52. Looking southeast at the garage. Note the poor grade around the building which is causing some rotted sill logs.

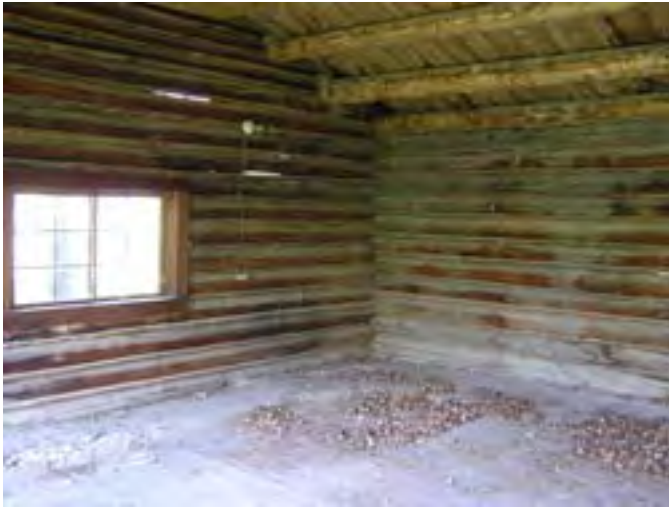
Figure 55 – Looking northwest at the interior. The logs are missing some daubing and the thin concrete floor is broken up.

- Figure 54. Looking west at the base of the east wall. Note the poor grade and the rot in the sill log. The daubing is poor.
- Figure 55. Looking northwest at the interior. The logs are missing some daubing and the thin concrete floor is broken up.

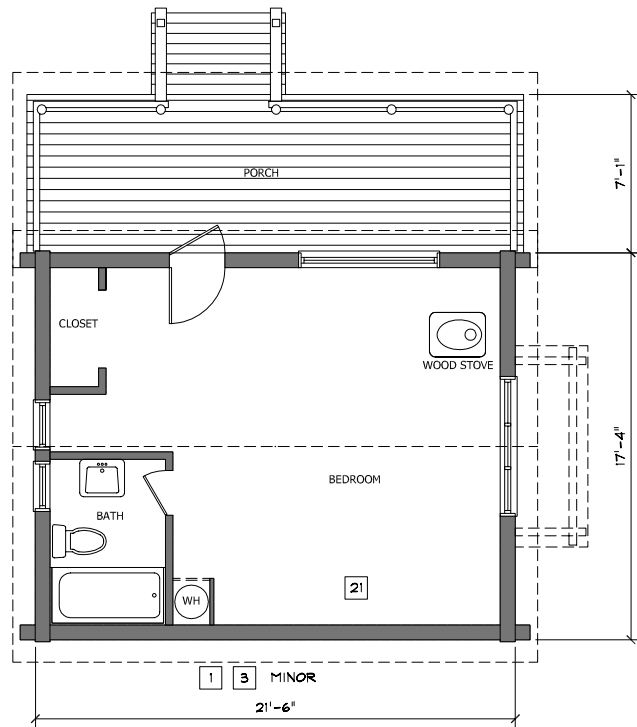
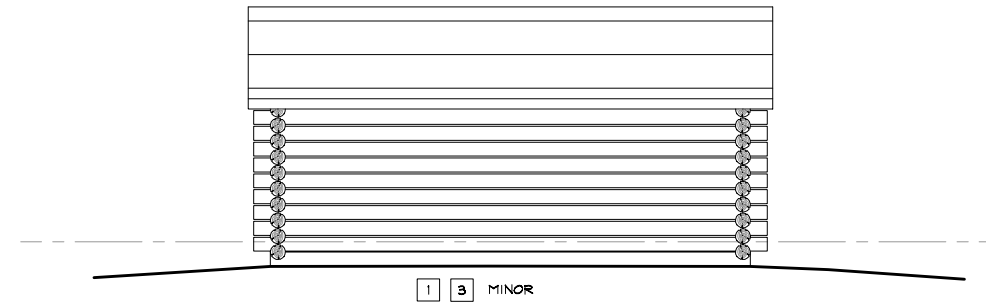
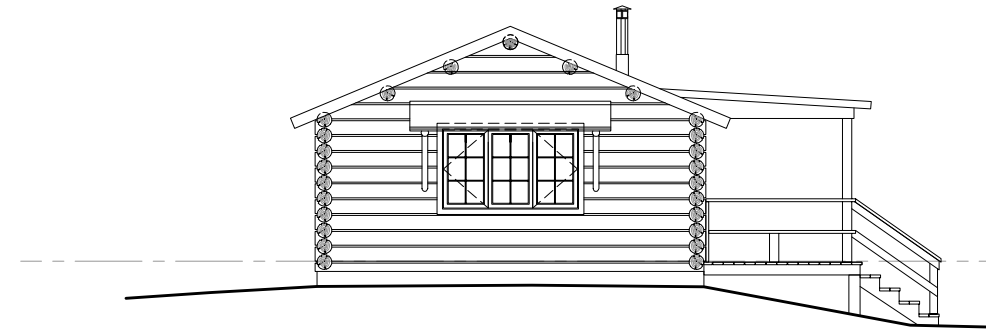
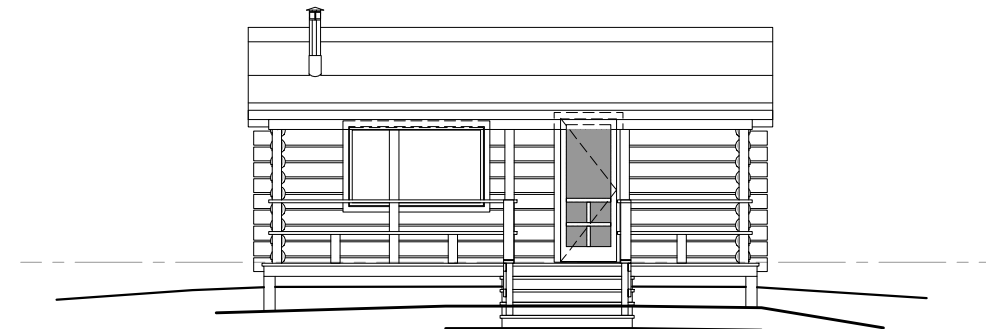
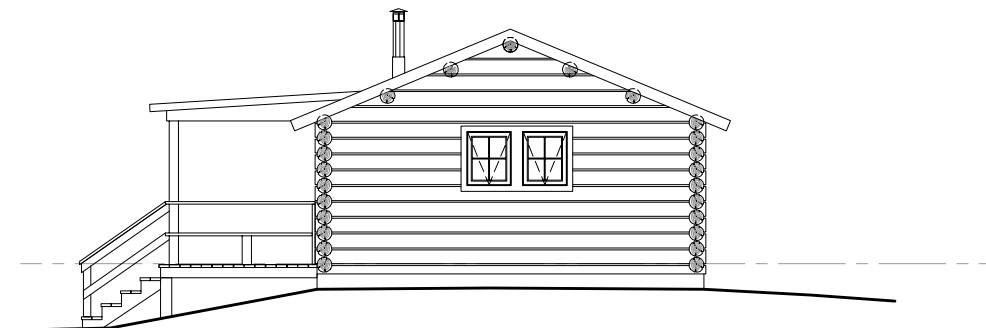
57

The River Cabin is in good condition with some minor exceptions, The building sits high on a good foundation and most of the logs are in good condition although dry with some checking. However, there appears to be some dry rot on the surface of some of the logs on the south side and a parging material has been applied to the sill log on the west side. Since the weather comes from the southwest it appears that snow has lain against the building on that side and caused some rot. Also on the interior there are water stains on the south wall in the first three logs that suggest that water has penetrated through the daubing at that point, probably from melting snow.

The roof is in good condition but the structural elements of the shed porch roof appear to be a minimum support and therefore additional supports are added to help the structure because of snow loads in the area. The windows and doors are in good condition with some minor sill deterioration and weathering.

The interior of the cabin is in good condition with the exception of the water stains on the lower portion of the south wall.

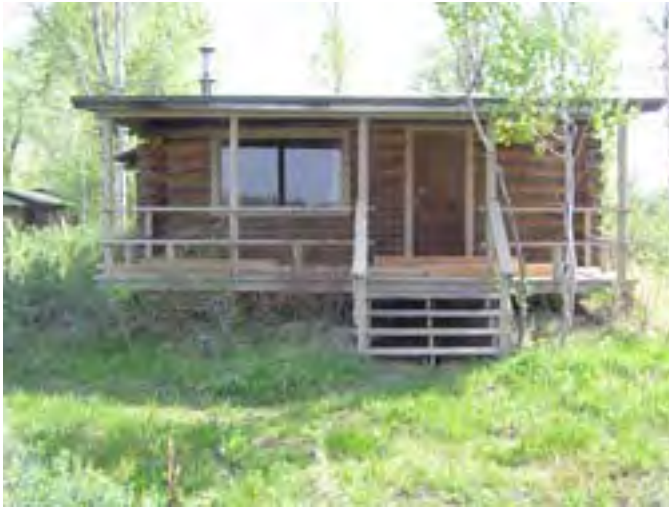
Figure 58 – Looking south at the front porch and entrance to the cabin. The cabin is in good condition and sits up on a good concrete foundation.

- Figure 58. Looking south at the front porch and entrance to the cabin. The cabin is in good condition and sits up on a good concrete foundation.
- Figure 59. Looking south at the main entrance door and screen door. They are in good condition.

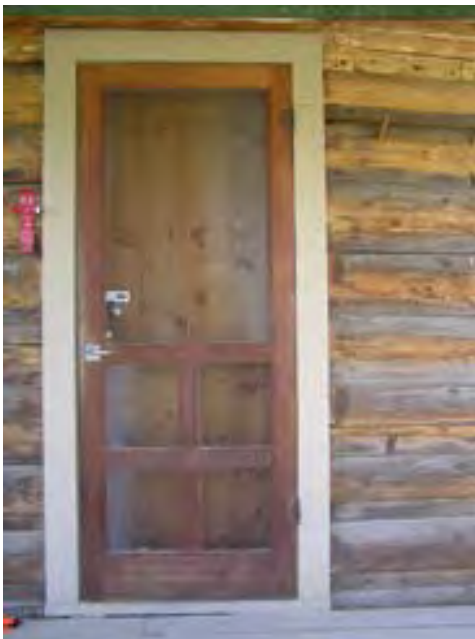
Figure 59 – Looking south at the main entrance door and screen door. They are in good condition.

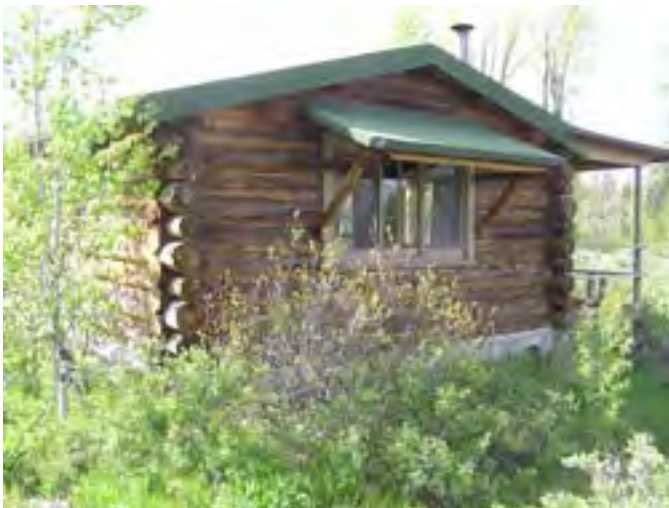
Figure 60 – Looking northwest at the cabin. Note the shed roof over the window. The window is in good condition with some minor sill rot.

- Figure 60. Looking northwest at the cabin. Note the shed roof over the window. The window is in good condition with some minor sill rot.
- Figure 61. Looking northeast at the cabin. Note some surface rot in the sill logs.

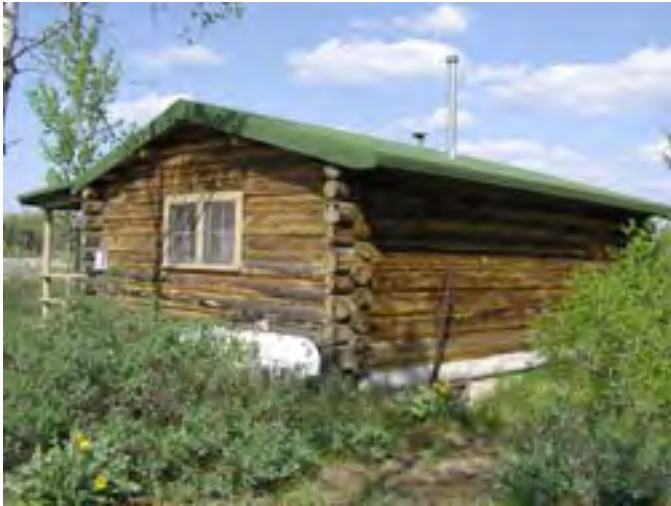
Figure 61– Looking northeast at the cabin. Note some surface rot in the sill logs.

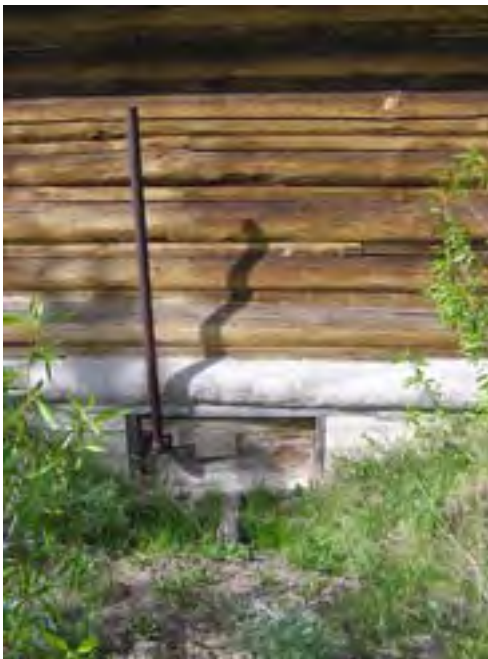
Figure 62 – Looking north at a base detail of the cabin. It appears that the sill log has been replaced with a concrete surface that is rounded like a log. Note the vent area to the crawl space.

- Figure 62. Looking north at a base detail of the cabin. It appears that the sill log has been replaced with a concrete surface that is rounded like a log. Note the vent area to the crawl space.

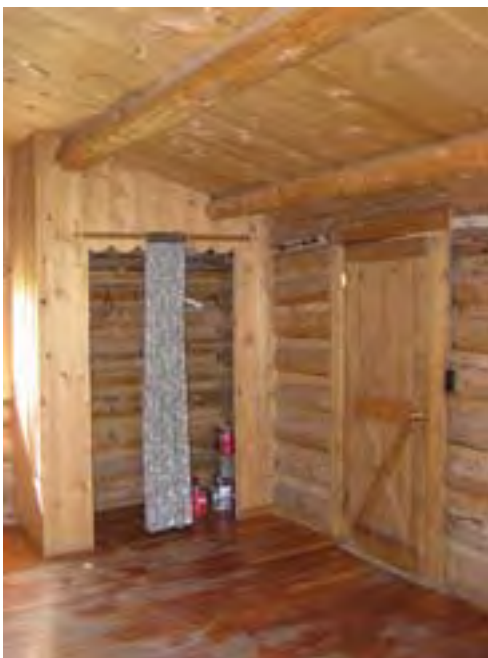
Figure 63 – Looking northwest at the front door and closet. The materials are in good condition.

- Figure 63. Looking northwest at the front door and closet. The materials are in good condition.
- Figure 64. Looking northeast the wood stove and window area.

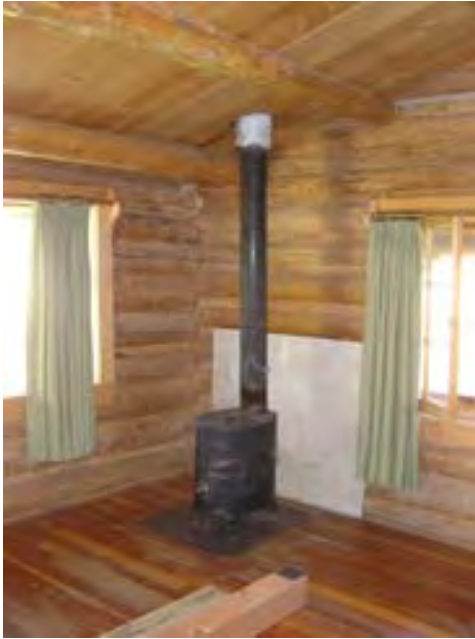
Figure 64 – Looking northeast at the wood stove and window area (possible asbestos heat shield behind wood stove).

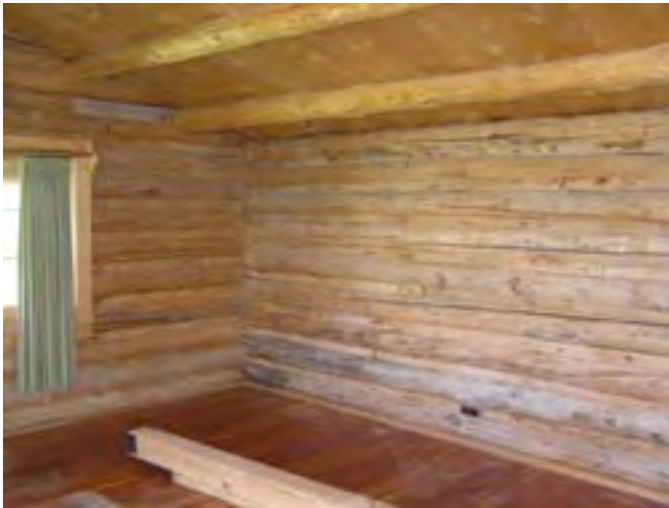
Figure 65 – Looking southeast at the back wall of the cabin. It appears that there has been some water penetration into the back wall as the base logs are stained.

- Figure 65. Looking southeast at the back wall of the cabin. It appears that there has been some water penetration into the back wall as the base logs are stained.

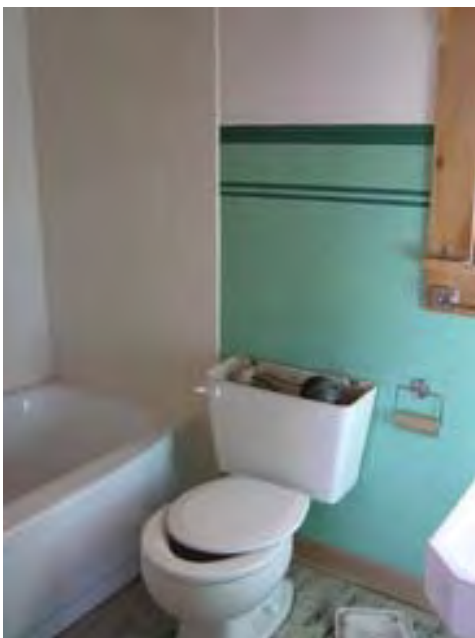
Figure 66 – Looking west at the bathroom. Note the sheetrocked walls with tile wainscot.

- Figure 66. Looking west at the bathroom. Note the sheetrocked walls with tile wainscot.
- Figure 67. HS-400A , Curing House, floor plan and elevations.

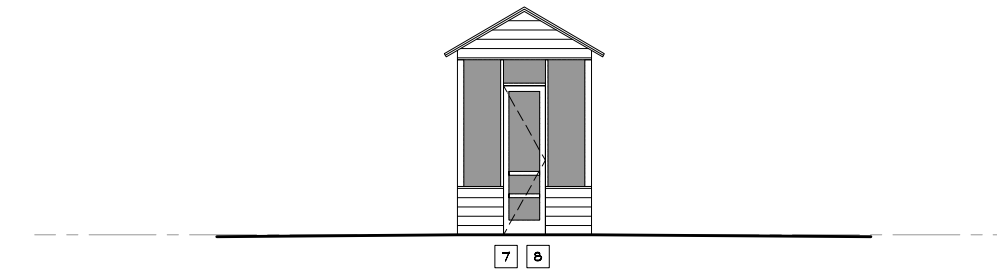
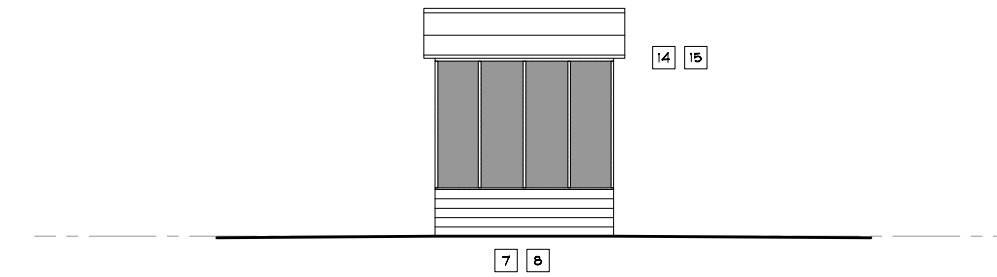
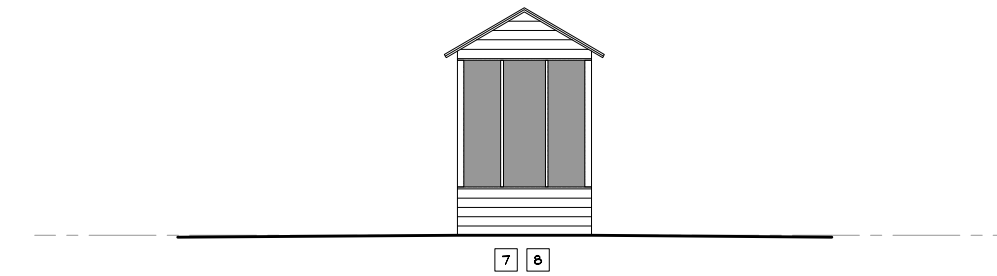
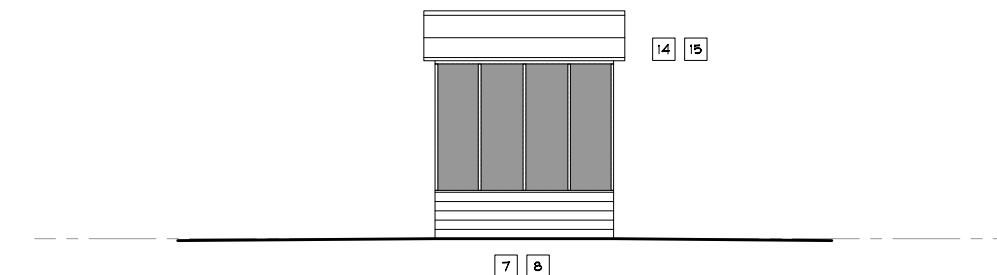
67

The Curing House is in poor condition. Most of the wood materials are weathered and rotted. The support on the base has moved out, causing some tilt to the structure. The screened areas are damaged and there is no roofing material on top. There are no electrical or mechanical systems in the building.

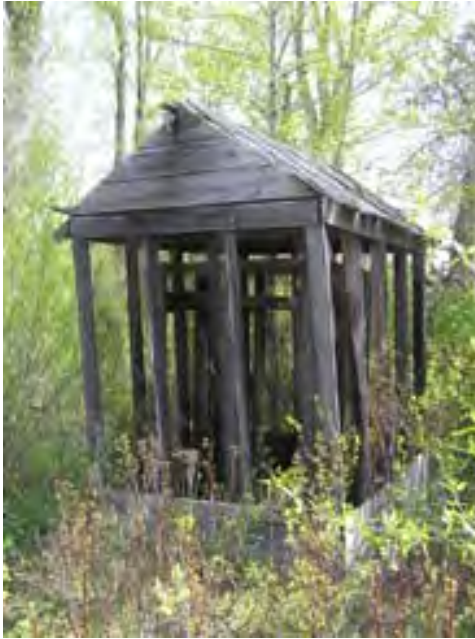
Figure 68 – Looking south at the Curing House. The screen is damaged and most of the wood is rotted. There is no roof covering on the building.

- Figure 68. Looking south at the Curing House. The screen is damaged and most of the wood is rotted. There is no roof covering on the building.
- Figure 69. HS-402-402, Nurse's Cabin, floor plan and elevations.

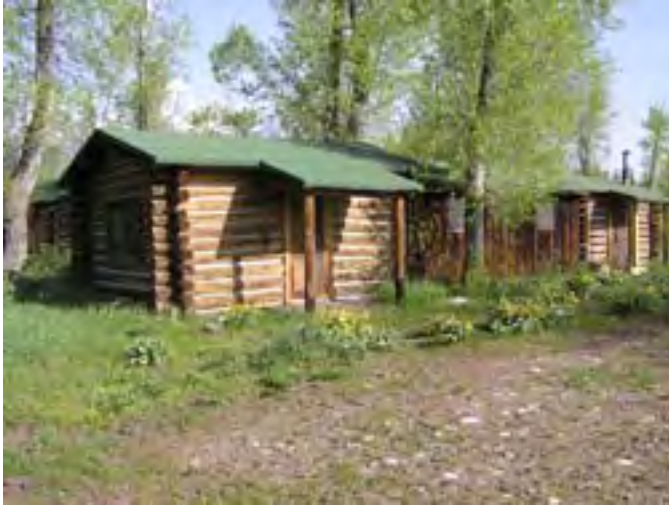
Figure 70– Looking northwest at the cabin. The building is generally in good condition with the exception of rotted sill logs and base of the frame structure. Soil has built up around all sides of the building.

- Figure 70. Looking northwest at the cabin. The building is generally in good condition with the exception of rotted sill logs and base of the frame structure. There is poor grade around the whole building.

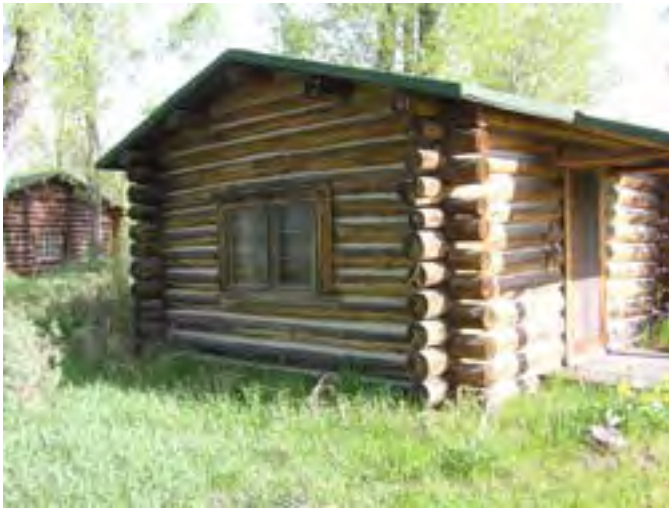
Figure 71 – Looking northwest at the log cabin on the south end of the building. Note the sag in the base due to rotted sill logs.

- Figure 71. Looking northwest at the log cabin on the south end of the building. Note the sag in the base due to rotted sill logs.
- Figure 72. Looking at a typical wood sliding window on the cabin. The glazing is poor and the wood is dry. There is some rot in the sill.

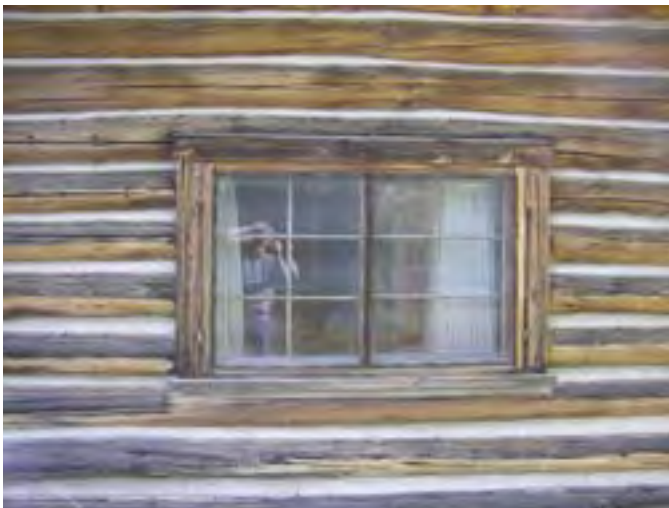
Figure 72 – Looking at a typical wood sliding window on the cabin. The glazing is poor and the wood is dry. There is some rot in the sill.

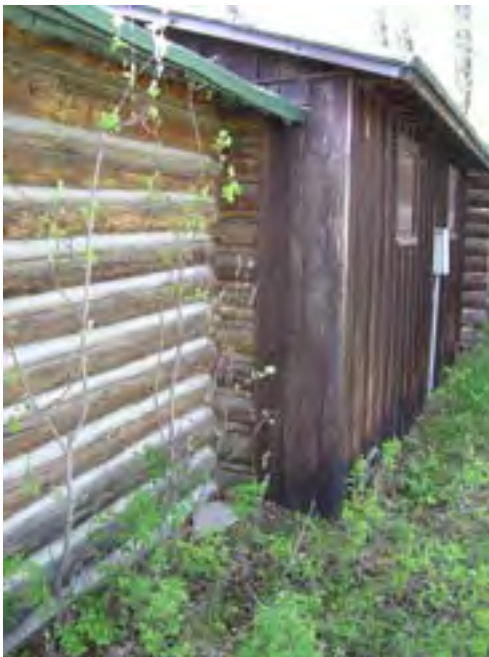
Figure 74– Looking south at the connection between the log cabin and the wood frame connecting rooms. Note the different roof planes and the water penetration into the corner.

- Figure 74. Looking south at the connection between the log cabin and the wood frame connecting rooms. Note the different roof planes and the water penetration into the corner.

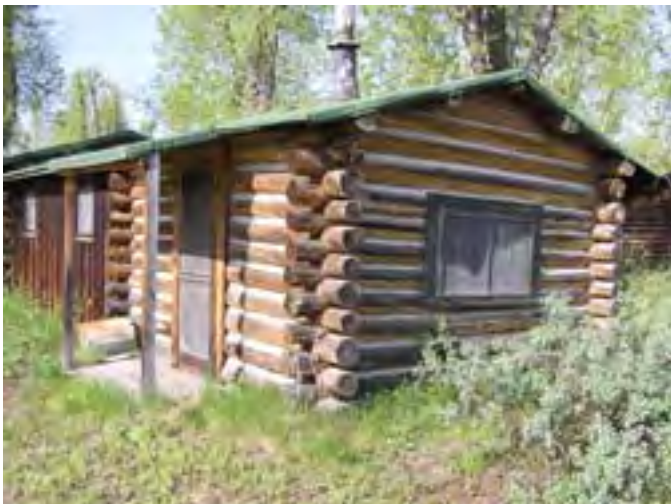
Figure 75 – Looking southwest at the log cabin on the north end of the building. It also has some sagging on the back corner because of the rotted sill logs caused by soil build-up around the base of the building.

- Figure 75. Looking southwest at the log cabin on the north end of the building. It also has some sagging on the back corner because of the rotted sill logs and poor grade.

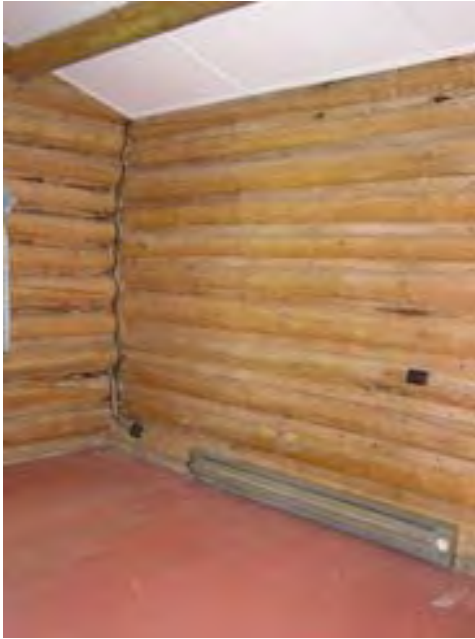
Figure 76 – Looking southwest at the log work and Celotex ceiling of the south bedroom. The interior appears dry.

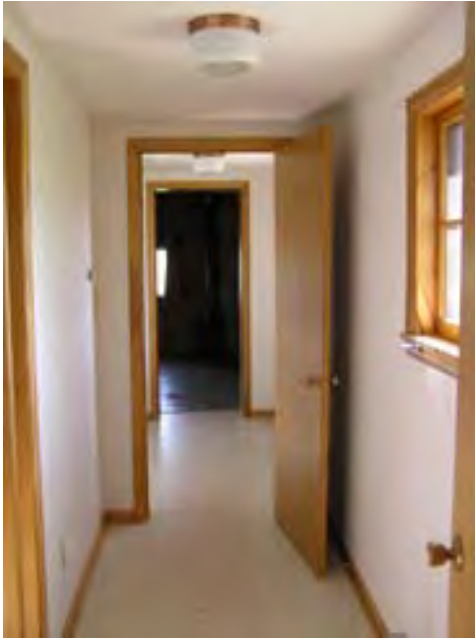
Figure 79 – Looking north at the hallway connecting the two log volumes. The sheetrock walls and ceiling and vinyl floor are in good condition.

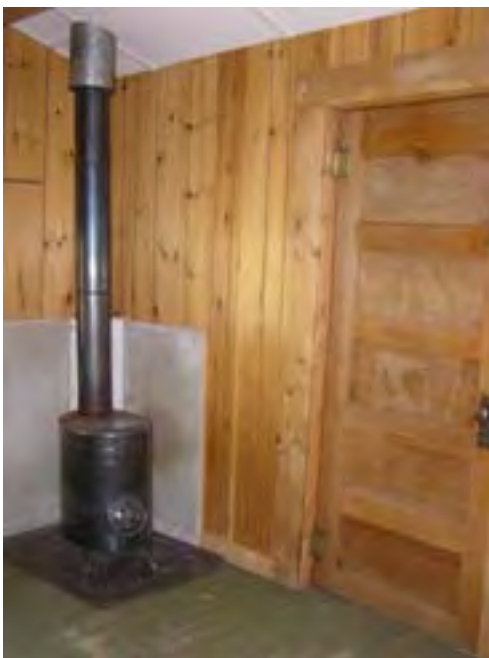
Figure 81 – Looking northeast at the wood stove and wood paneled exterior door in the north bedroom (possible asbestos heat shield behind wood stove).

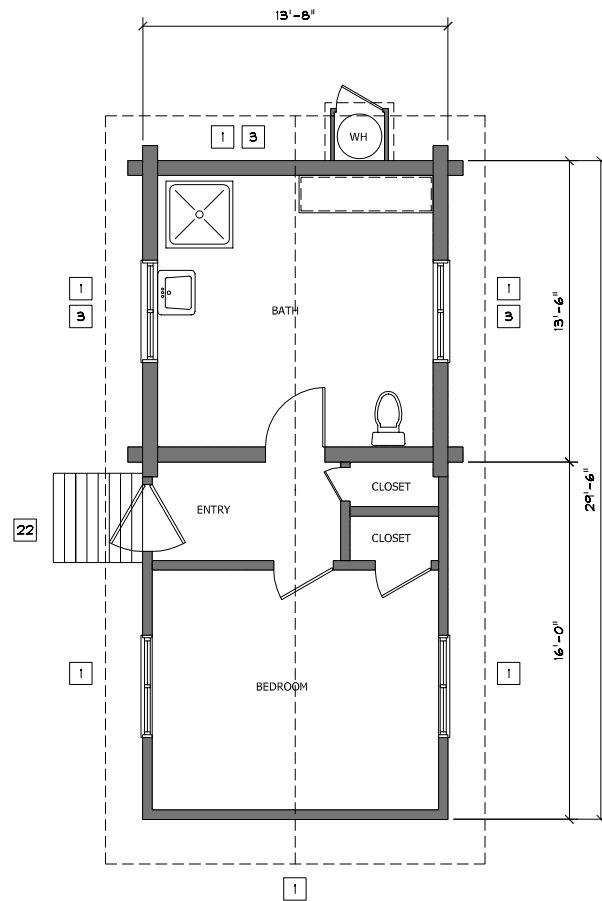
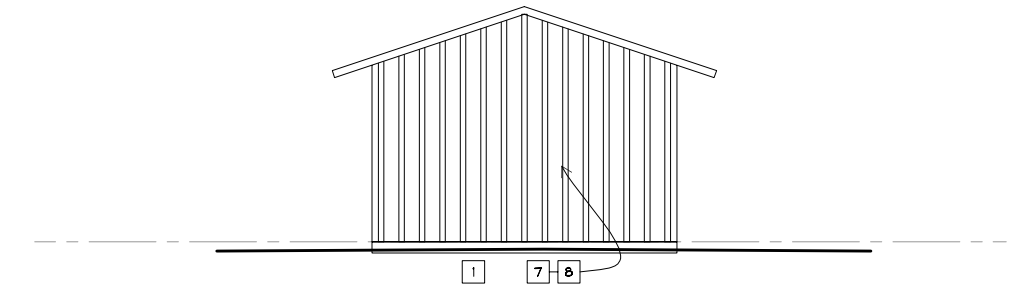
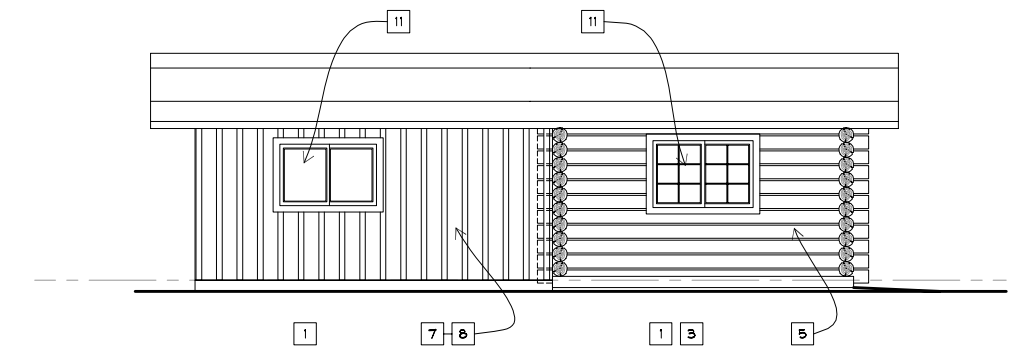
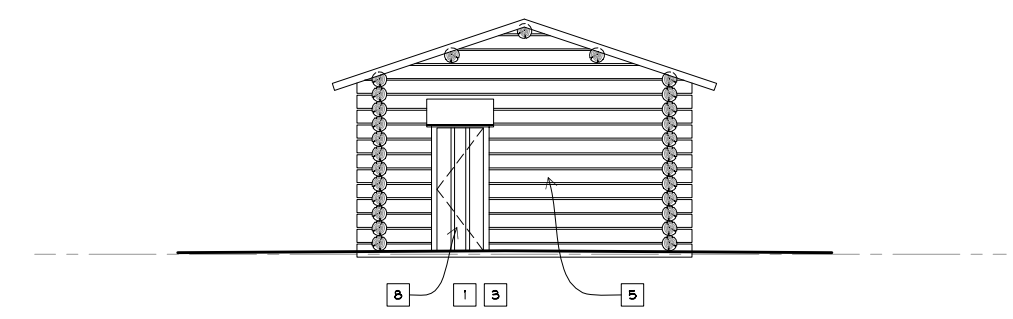
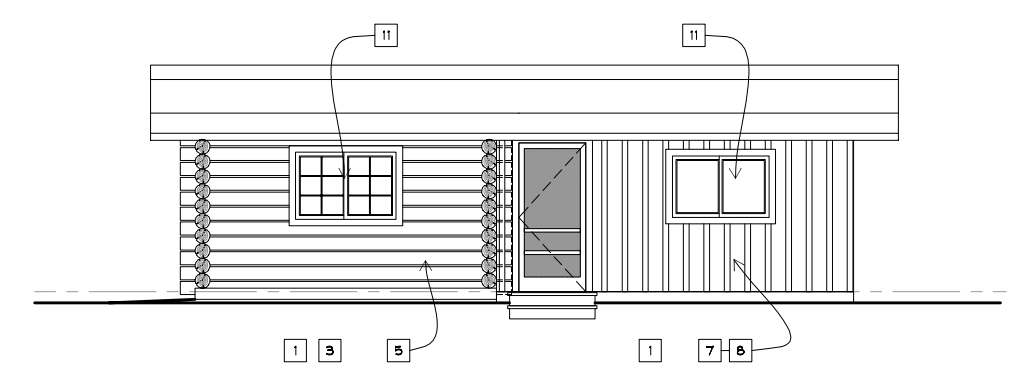
FIGURE
82

George's' cabin is in good condition generally. The log walls are dry and checked, and the sill logs in most cases are rotted because of soil build-up on the west, north and east sides of the cabin. The daubing is in good condition with some minor areas of missing daubing. The board and batten siding of the addition also has some rot in the base on the east side because of the soil that has accumulated against the base of the building. The siding is also dry and there is some dry rot. Some of the boards and battens are curling. This also occurs on the water heater addition on the north side of the cabin.

The wood windows are weathered and checked. The roof is in good condition. The minimal electrical system as well as water and sewer have been abandoned.

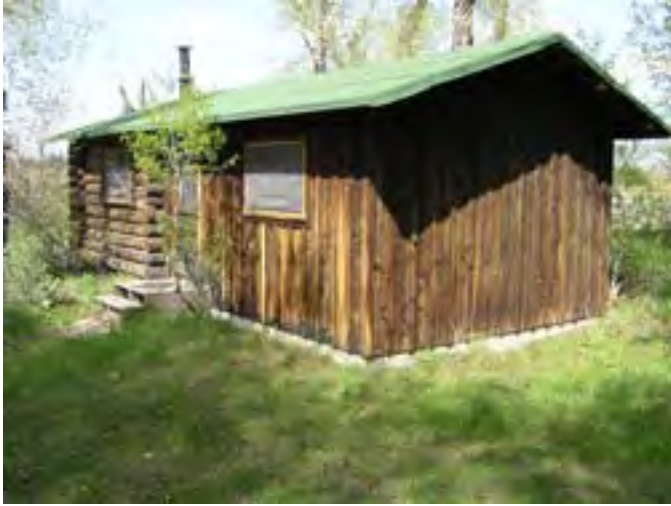
Figure 83 – Looking northeast at the cabin and at the frame addition to the log cabin on the south side. Note the dry wood on the addition. The roof appears to be in good condition.

- Figure 82. HS-404, George's Cabin, floor plan and elevations.
- Figure 83. Looking northeast at the cabin and at the frame addition to the log cabin on the south side. Note the dry wood on the addition. The roof appears to be in good condition.
