4 LAZY F RANCH

Historic Structures Report

September, 2008

Grand Teton National Park
National Park Service
P.O. Box 170
Moose, Wyoming 83012

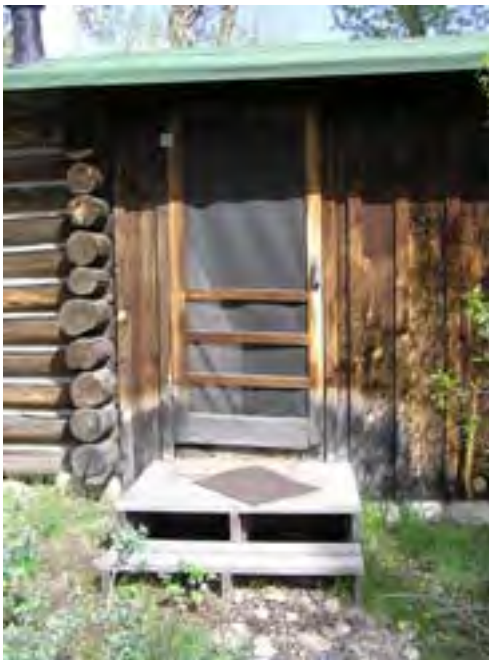
Figure 84 – Looking east at the entrance door to the wood frame addition. The porch and base of the addition and logs have some rot.

- Figure 84. Looking east at the entrance door to the wood frame addition. The porch and base of the addition and logs have some rot.
- Figure 85. Looking southwest at the log cabin portion of the building. Note the poor grade around this end of the building which is causing the sill logs to rot.

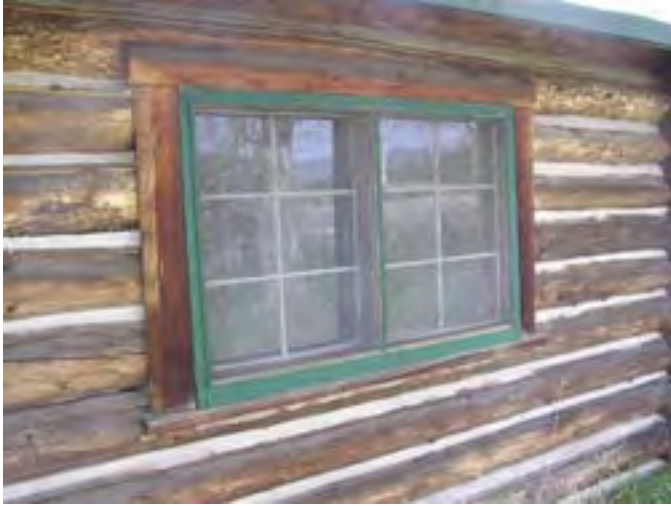
Figure 86 – Looking west at a typical window in the log cabin. Note the dry logs and dry wood around the window. The daubing is generally in good condition with some minor missing daubing.

- Figure 86. Looking west at a typical window in the log cabin. Note the dry logs and dry wood around the window. The daubing is generally in good condition with some minor missing daubing.

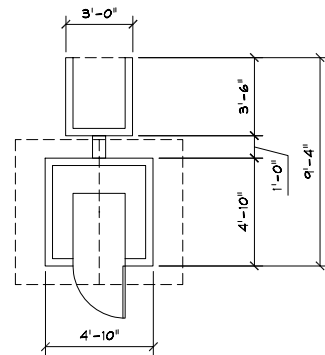
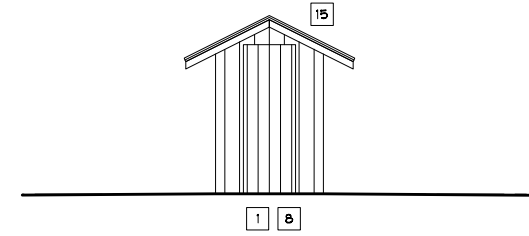
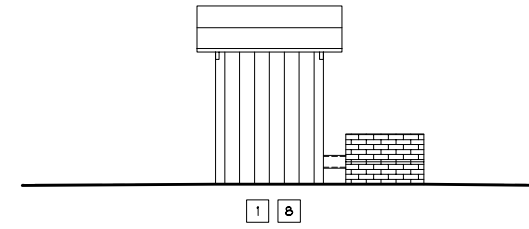
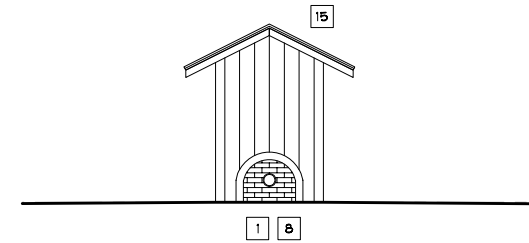
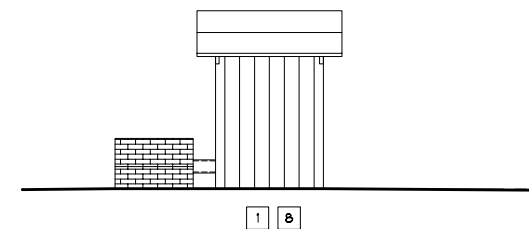
91

The smoke house is in fair condition with most of the vertical board siding weathered and cracked. There is some rot in the base because of the soil that has built-up around the base of the building. The roof is good but some of the wood edge pieces on the gable ends are splintered. The door is in poor condition. The brick firebox is starting to deteriorate on the east side where some of the bricks and mortar are coming loose. The interior is similar. There are no electrical or mechanical systems in the building.

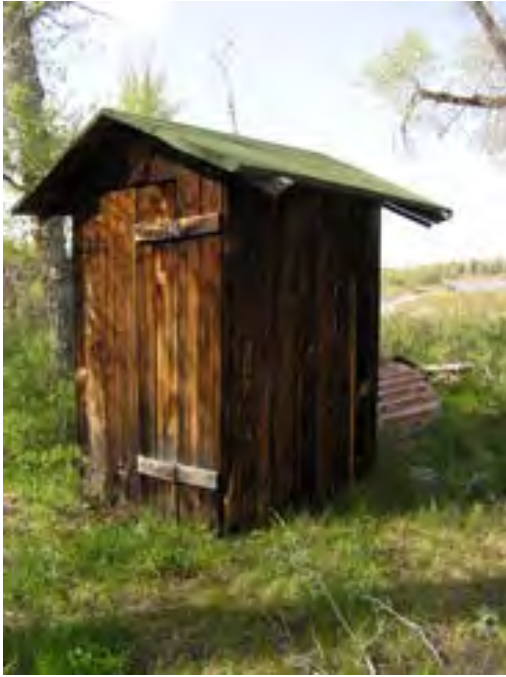
Figure 92 – Looking northwest at the smokehouse. The wood on the walls is very dry and there is some rot on the base of the building where soil has built up around the base of the structure. The door is in poor condition.

- Figure 90. Looking northwest at the bathroom on the interior of the log cabin.
- Figure 91. HS-404A, Smoke House, floor plan and elevations.
- Figure 92. Looking northwest at the smokehouse. The wood on the walls is very dry and there is some rot on the base of the building where there is poor grade. The door is in poor condition.

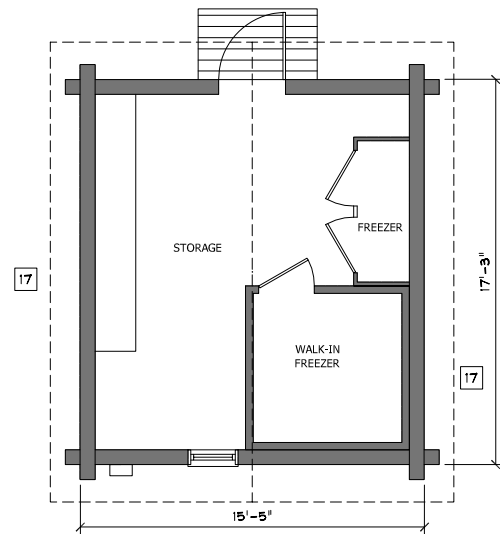
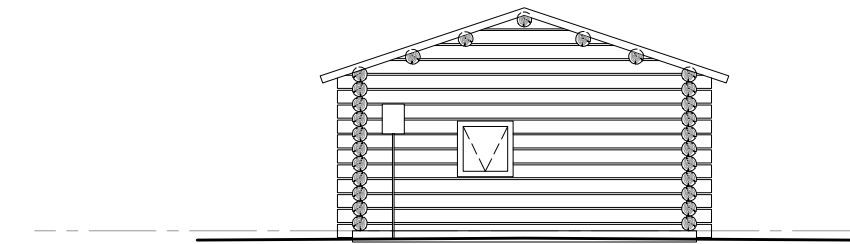
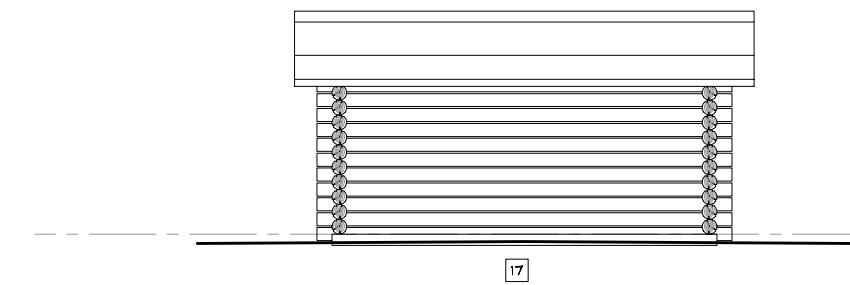
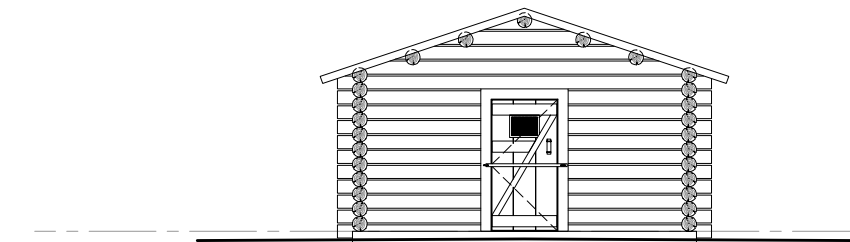
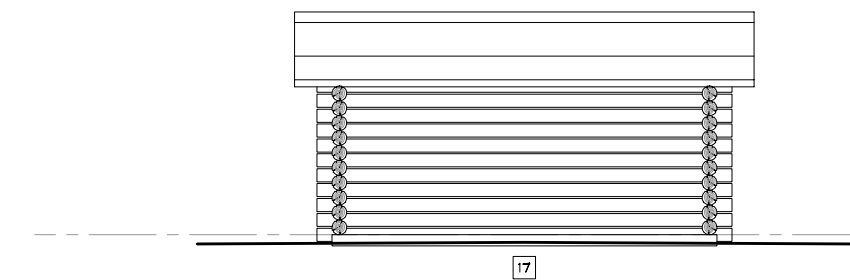
95

The Ice House is in good condition with some exceptions that appear to be minor. The building sits high on a good concrete slab foundation and most of the logs are in good condition although dry with some checking. However there appears to be some dry rot on the some of the logs on the southwest corner causing some settlement in that corner. The daubing is in good condition. The roof is in good condition with the exception of some damage on the west side where it appears that limbs from the trees have caused damage. The trees are very close to the building.

The window on the south wall has been covered over. The door is weathered and has some dry rot along the base.

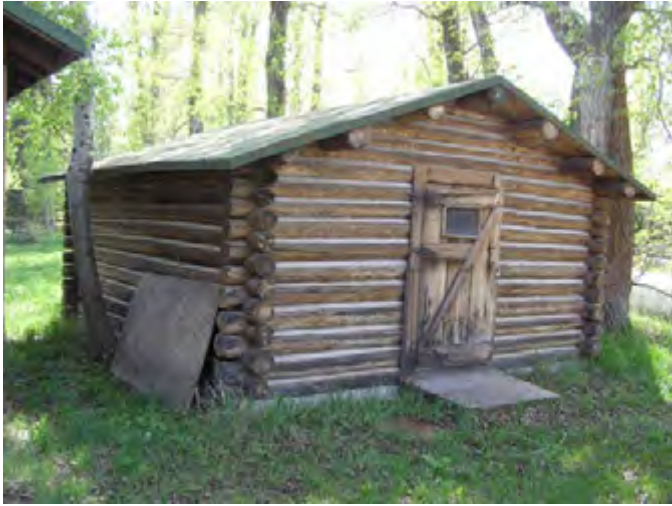
Figure 96 – Looking southwest at the log Ice House. The logs and daubing are in good condition even though the wood is dry. There is some minor surface rot at the base.

- Figure 96. Looking southwest at the log Ice House. The logs and daubing are in good condition even though the wood is dry. There is some minor surface rot at the base.

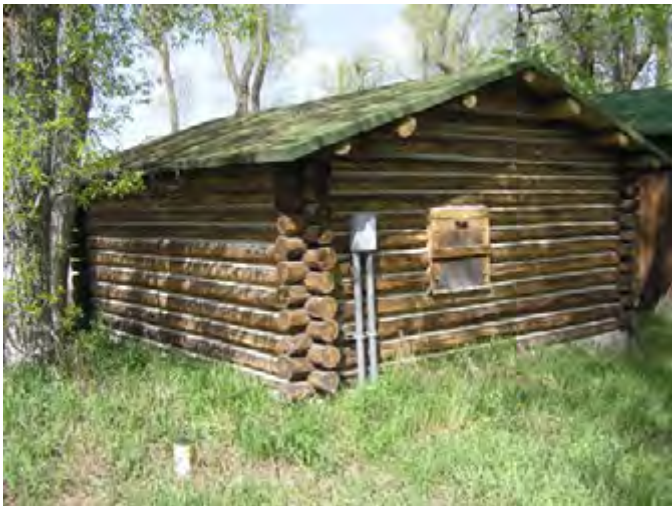
Figure 97 – Looking northeast at the Ice House. The roof is in good condition with some minor damage on the west side. The building sits up on a concrete slab and the grade around the building is good except for the southwest corner. There is some rot in the sill logs.

- Figure 97. Looking northeast at the Ice House. The roof is in good condition with some minor damage on the west side. The building sits up on a concrete slab and the grade around the building is good except for the southwest corner. There is some rot in the sill logs.

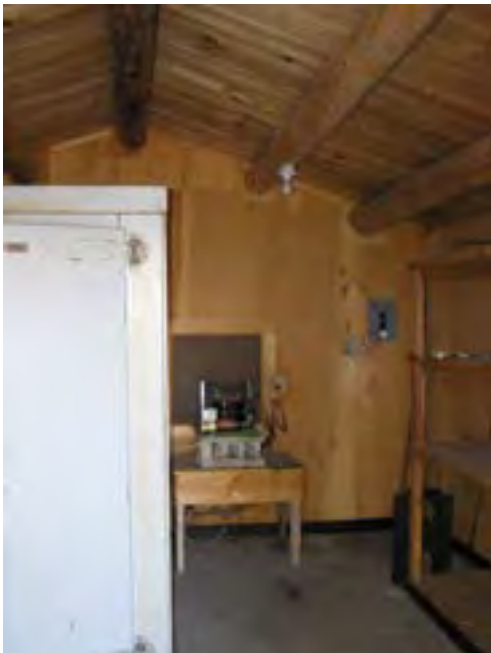
Figure 98 – Looking south at the Ice House interior. The materials are in good condition. The coolers are still in this building.

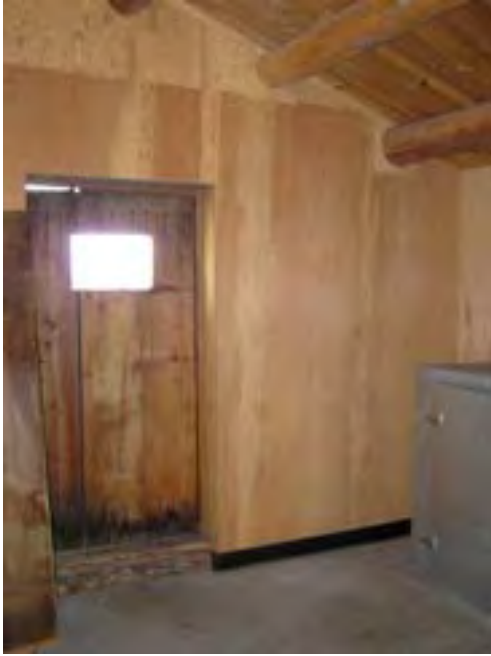
Figure 99 – Looking north at the interior and entrance door. The materials are in good condition but there is some rot on the base of the door from exterior water.

- Figure 98. Looking south at the Ice House interior. The materials are in good condition. The coolers are still in this building.
- Figure 99. Looking north at the interior and entrance door. The materials are in good condition but there is some rot on the base of the door from exterior water.

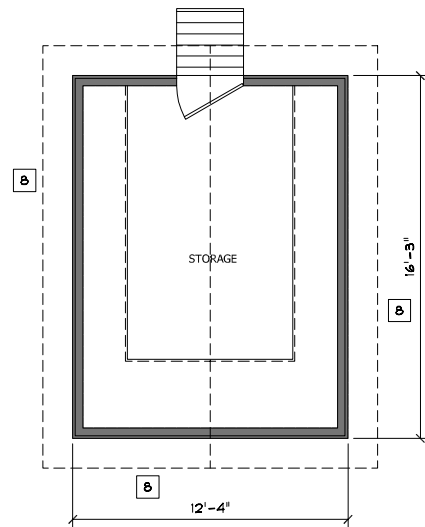
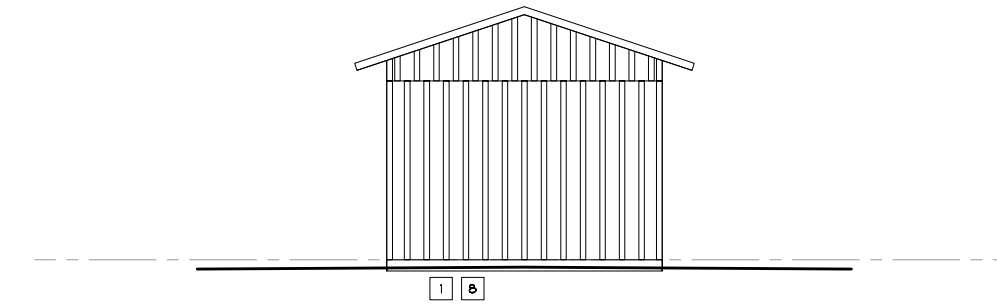
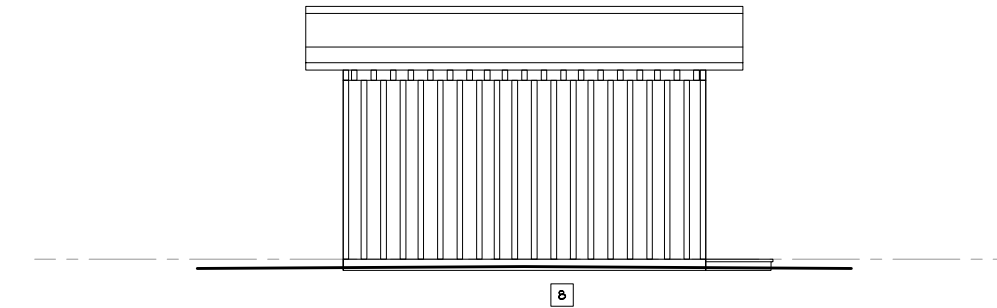
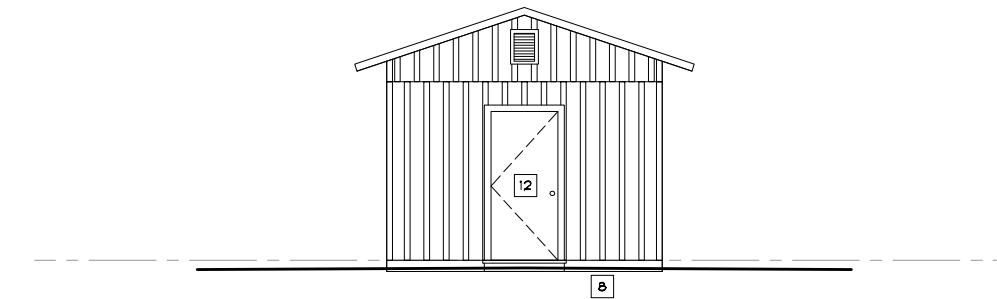
The Mouse House is in good condition with some exceptions that appear to be minor. The building sits high on a good concrete slab foundation. The board and batten siding is weathered and dry. There is some rot along the base of the siding where the grade comes up along the south side of the building. The roof is in good condition. The door is weathered and has some dry rot along the base.

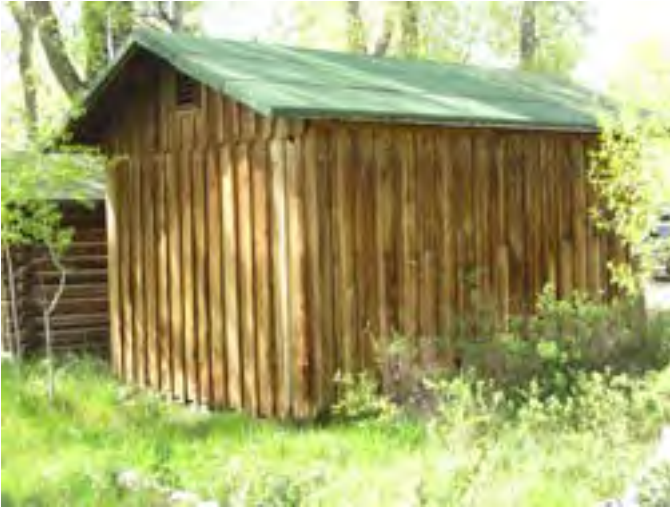
Figure 102 – Looking northwest at the building. The roof appears to be in good condition.

- Figure 102. Looking northwest at the building. The roof appears to be in good condition.
- Figure 103. Looking northeast at the base of the building. Note the concrete piers along the wall which is in good condition.

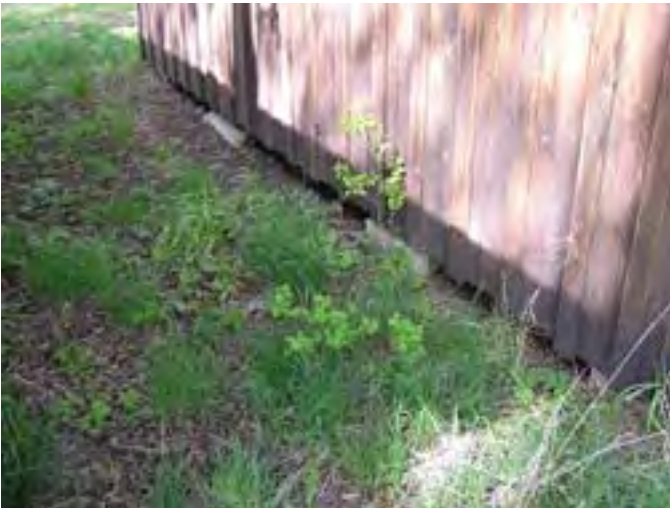
Figure 103 – Looking northeast at the base of the building. Note the concrete piers along the wall, which is in good condition.

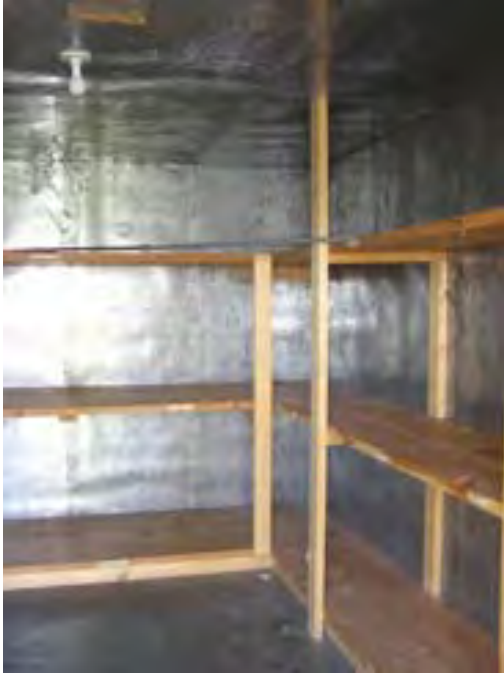
Figure 104 – Looking south at the interior of the building which has been lined with galvanized metal to keep out the mice. The materials are in good condition.

- Figure 104. Looking south at the interior of the building which has been lined to keep out the mice. The materials are in good condition.
- Figure 105. HS-407, End Cabin, floor plan and elevations.

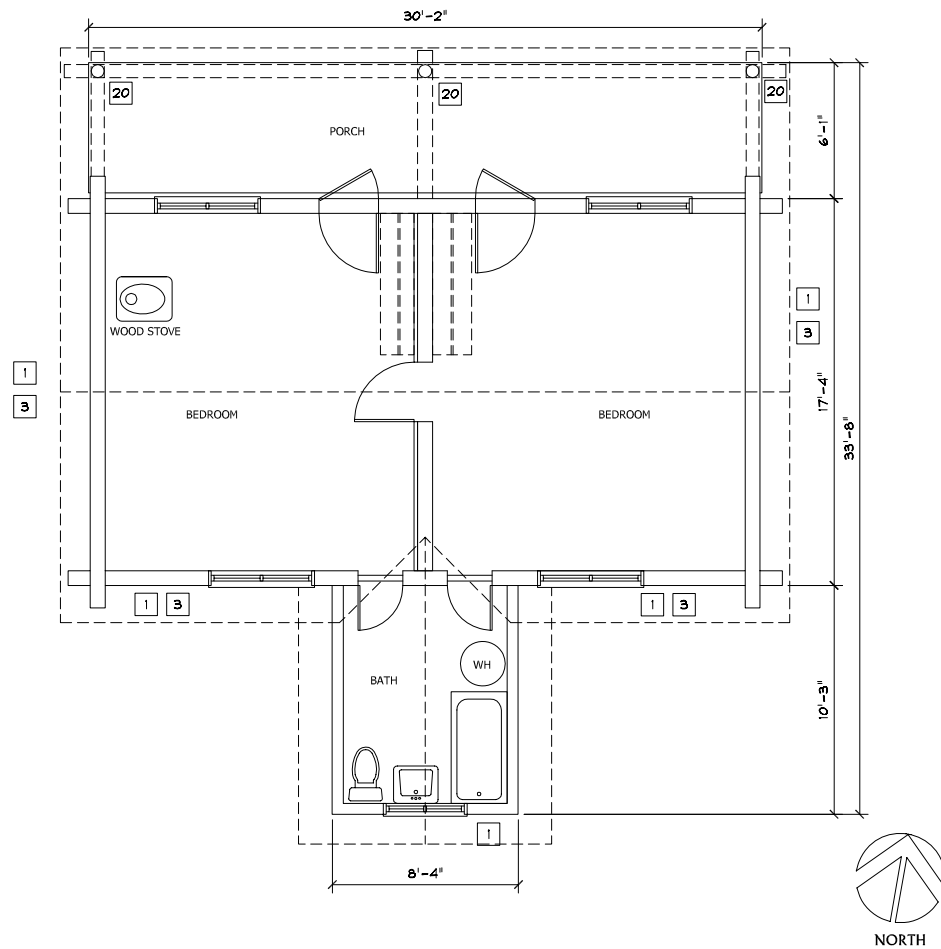
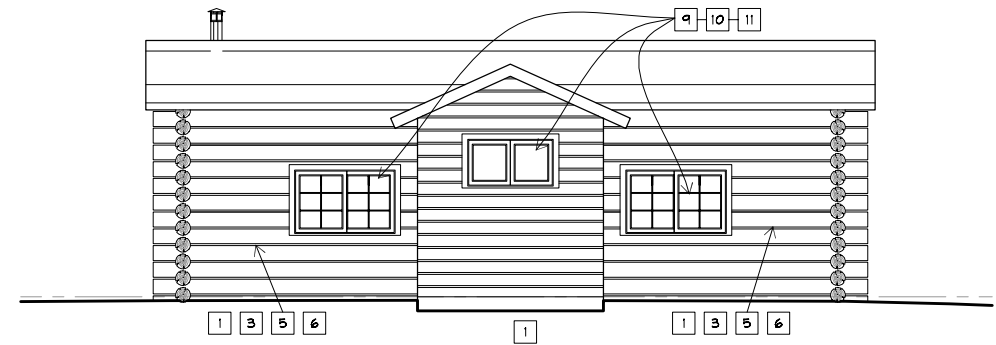
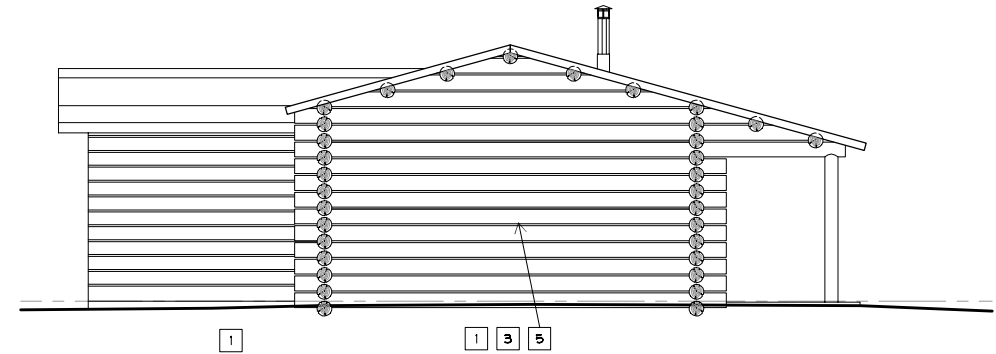
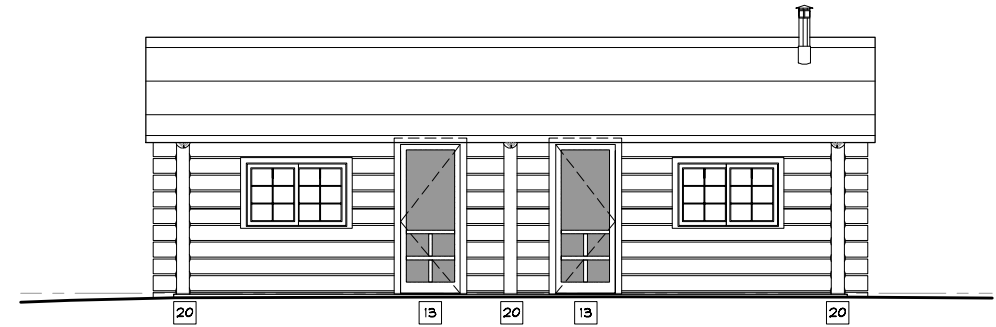
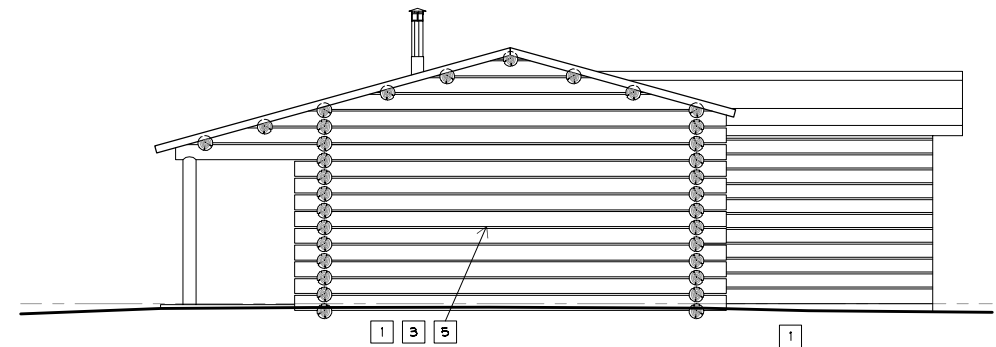
The End Cabin is in good condition with some exceptions. The building sits on a good foundation and most of the logs are in good condition although dry with some checking. However there are rotted sill logs on the east, south, west sides of the building. There is some rot in the next logs above the sills also. The daubing is in good condition but there is also some missing daubing especially on the south side. The bathroom addition sits on concrete piers. There is some undermining of the floor structure between the concrete piers.

The roof is in good condition but the log columns supporting the extended roof over the front porch have some rot in the base and the concrete slab has cracked around those supports because of snow loading.

The windows and doors are in good condition with some minor sill deterioration and weathering.

The interior of the cabin is in good condition with the exception of some water stains in the bathroom due to moisture buildup in the space.

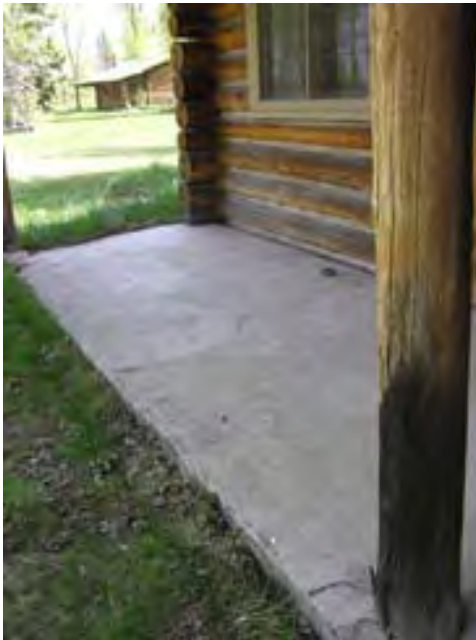
Figure 107 – Looking east at the concrete porch. There is some cracking around the column bases. Also there is a gap between the slab and the base log. Also note the surface rot on the bases of the columns.

- Figure 107. Looking east at the concrete porch. There is some cracking around the column bases. Also there is a gap between the slab and the base log. Also note the surface rot on the bases of the columns.

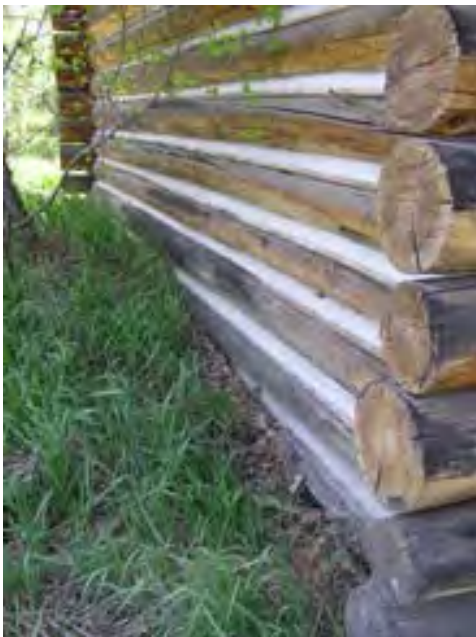
Figure 108 – Looking south along the east side of the cabin. The logs and daubing are in good condition but the wood is dry and there is some rot in the sill logs. Note the grade buildup against the logs.

- Figure 108. Looking south along the east side of the cabin. The logs and daubing are in good condition but the wood is dry and there is some rot in the sill logs. Note the grade buildup against the logs.

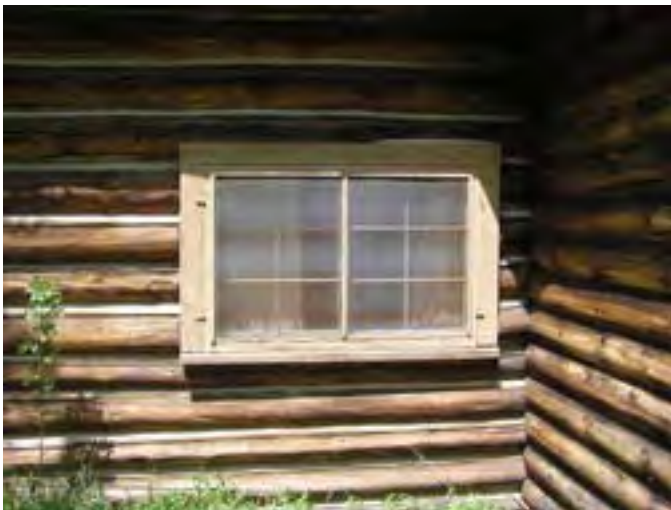
Figure 111 – Looking north at a typical wood sliding window with screen. Note the dry and weathered wood on the sill of the window. The paint is also peeling in some areas.

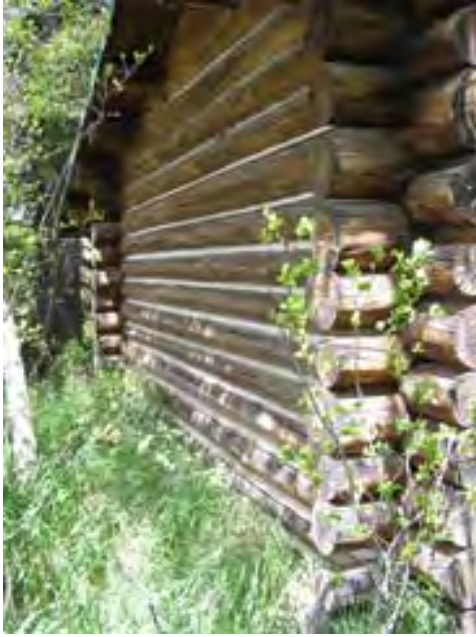
Figure 112 – Looking north along the west side of the building. The problems are typical in this area also.

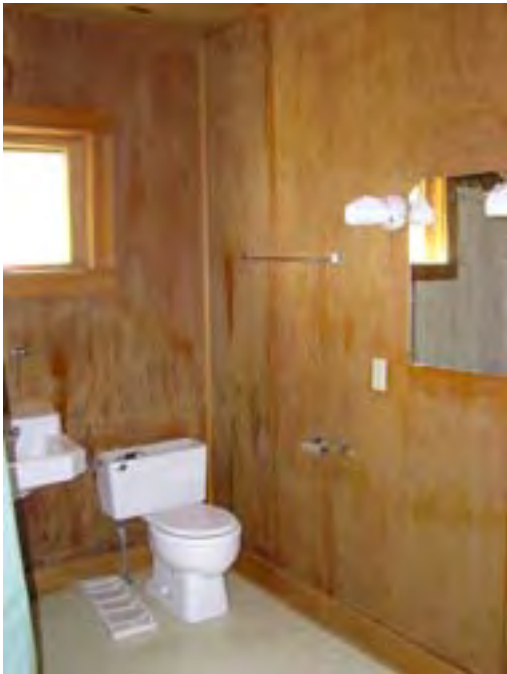
Figure 116 – Looking south at the bathroom addition to the cabin. The fixtures and materials are in good condition.

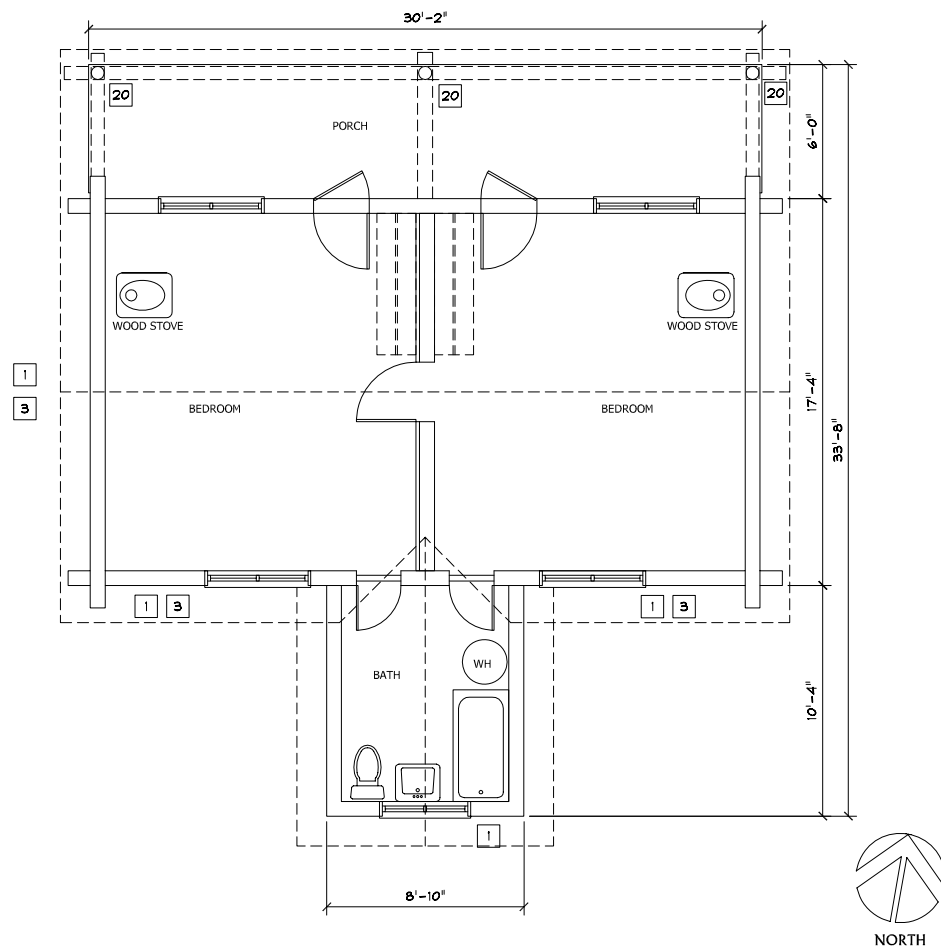
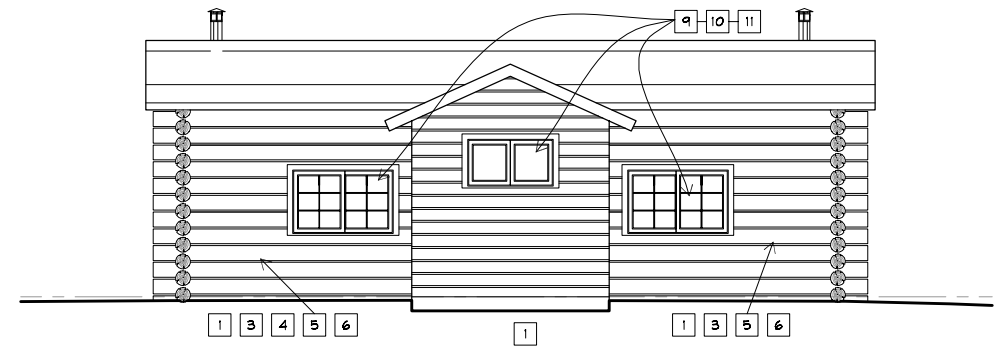
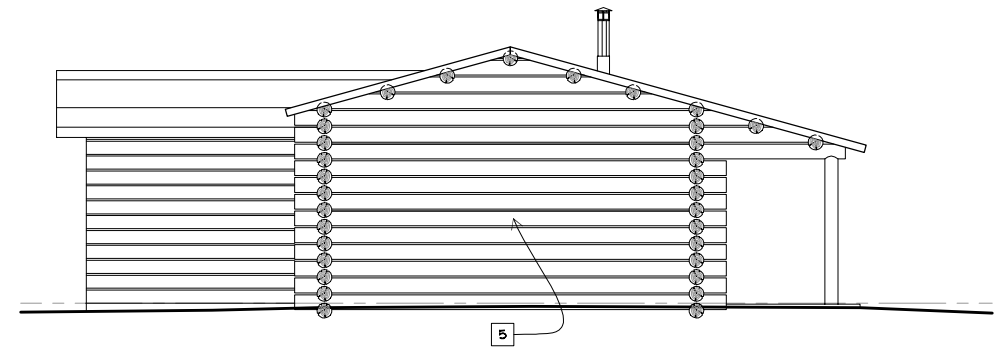
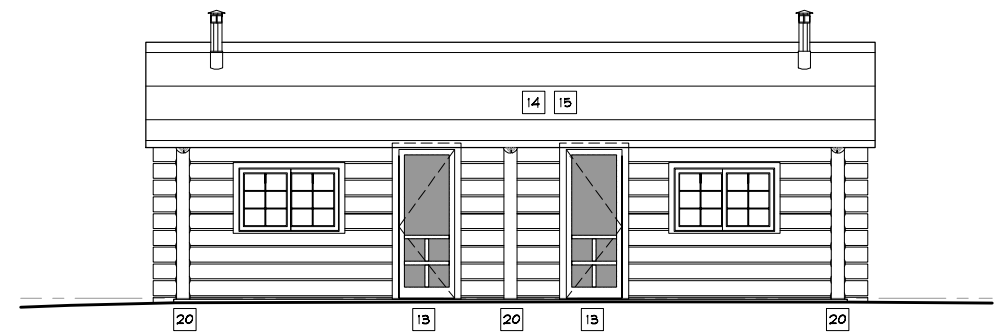
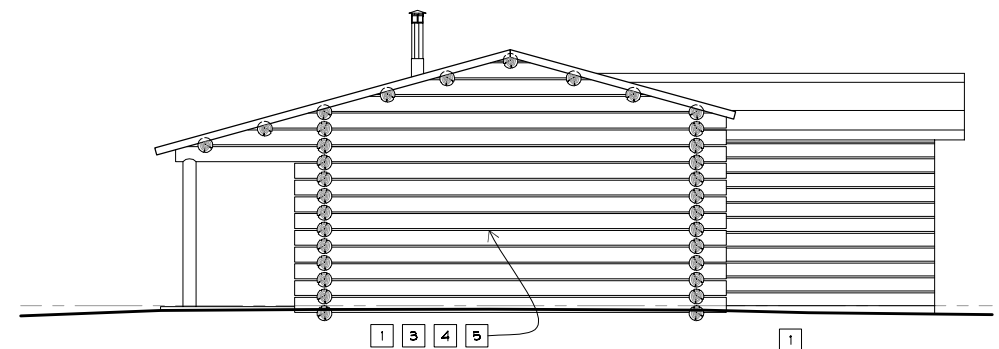
The Middle Cabin is in good condition with some exceptions. The building sits on a good foundation and most of the logs are in good condition although dry with some checking. However there are rotted sill logs on the south, west sides of the building. There is some rot in the next logs above the sills also on those sides. The daubing is in good condition but there is also some missing daubing especially on the south side. The bathroom addition sits on concrete piers. There is some undermining of the floor structure between the concrete piers.

The roof is in good condition with some asphalt roof damage on the eave of the porch. The log columns supporting the extended roof over the front porch have some rot in the base and the concrete slab has cracked around those supports because of snow loading.

The windows and doors are in good condition with some minor sill deterioration and weathering. The screen doors are weathered and dry.

The interior of the cabin is in good condition with the exception of some water stains in the bathroom due to moisture buildup in the space

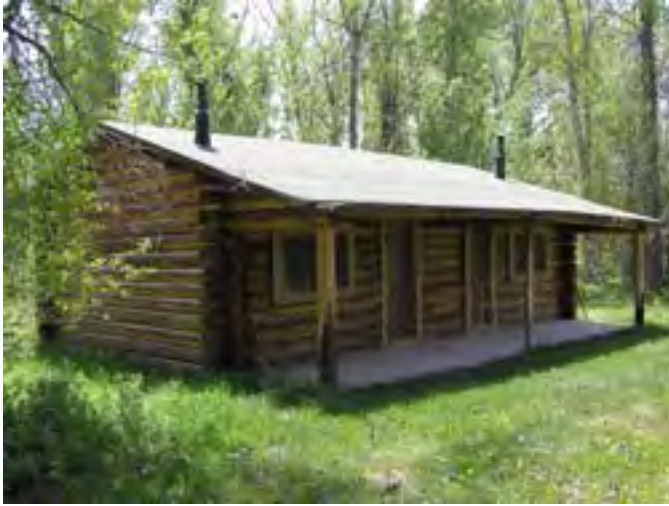
Figure 118– Looking southwest at the cabin and front porch. The roof is in good condition with some minor damage on the eave of the porch roof.

- Figure 118. Looking southwest at the cabin and front porch. The roof is in good condition with some minor damage on the eave of the porch roof.
- Figure 119. Looking south at a typical wood sliding window and wood paneled door into each of the units. They are in good condition with the exception of the screen door where the wood is dry and stained.

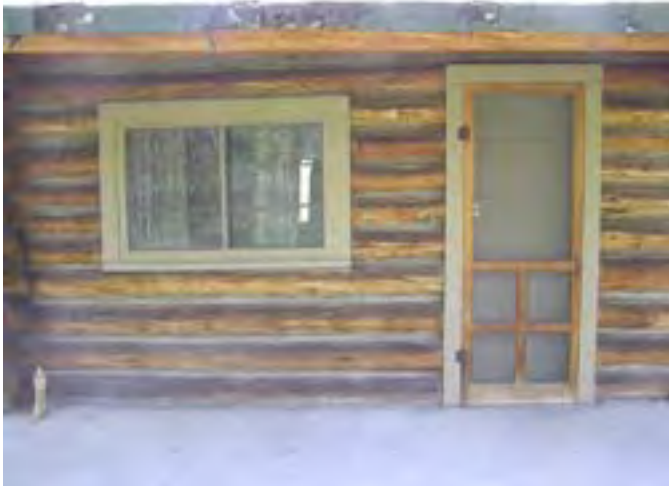
Figure 119 – Looking south at a typical wood sliding window and wood paneled door into each of the units. They are in good condition with the exception of the screen doors, which are dry and stained.

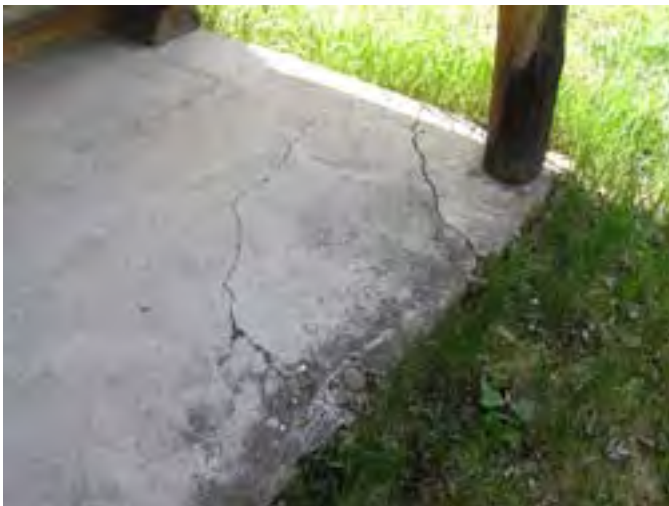
Figure 120 – Looking southwest at the concrete porch and column base. Note the cracks in the slab from the weight of the roof and column. (As the concrete appears to have been poured around the column bases, it is not possible to determine whether or not they have separate footings without destructive investigation.)

- Figure 120. Looking southwest at the concrete porch and column base. Note the cracks in the slab from the weight of the roof and column.
- Figure 121. Looking northwest at the cabin. Note the vegetation and high grade around the base which is causing rot in the sill log and base logs of the wall. The wall logs are dry but the daubing is generally good.

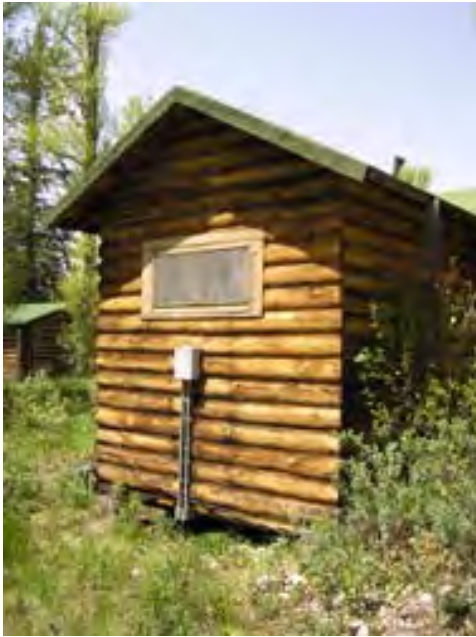
Figure 122 – Looking north at the back wall of the addition. The wood is dry and weathered, and the window needs some glazing work.

- Figure 122. Looking north at the back wall of the addition. The wood is dry and weathered, and the window needs some glazing work.
- Figure 123. Looking north at the back wall of the cabin. Note the high grade, the rotted and weathered sill and base logs. The window is weathered and needs work.

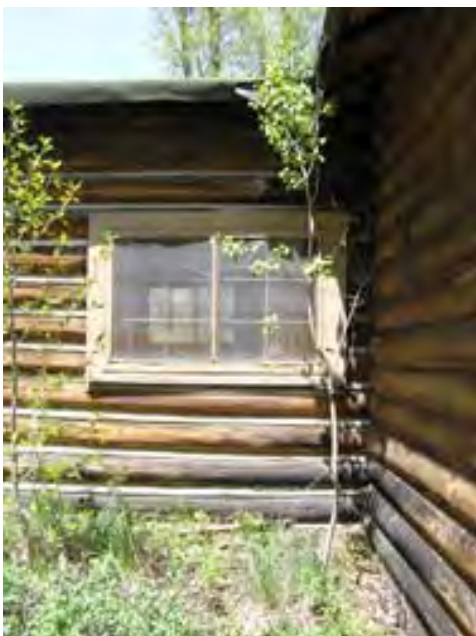
Figure 123 – Looking north at the back wall of the cabin. Note the soil build-up and the rotted and weathered sill and base logs. The window is weathered and needs repair work.

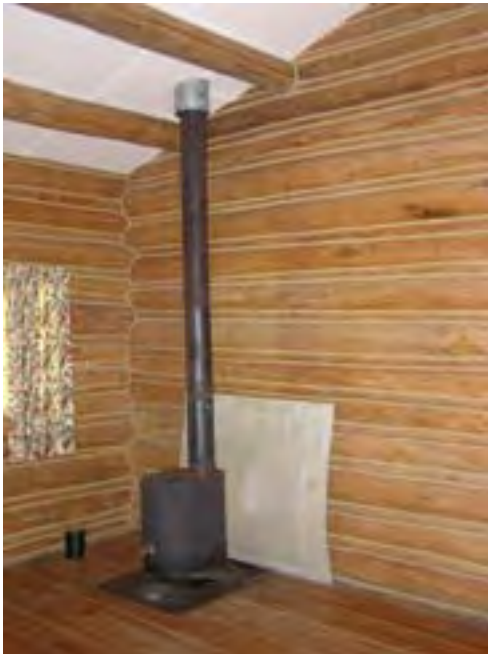
Figure 125 – Looking northeast at the interior of the east bedroom. Note the wood stove and log walls. The free-standing heat shield behind the stove may contain asbestos. The ceiling has a Celotex infill between the log purlins. The wall and ceiling materials are in good condition and the fir floor has some minor wear but is in good condition. Possible asbestos heat shield behind wood stove.

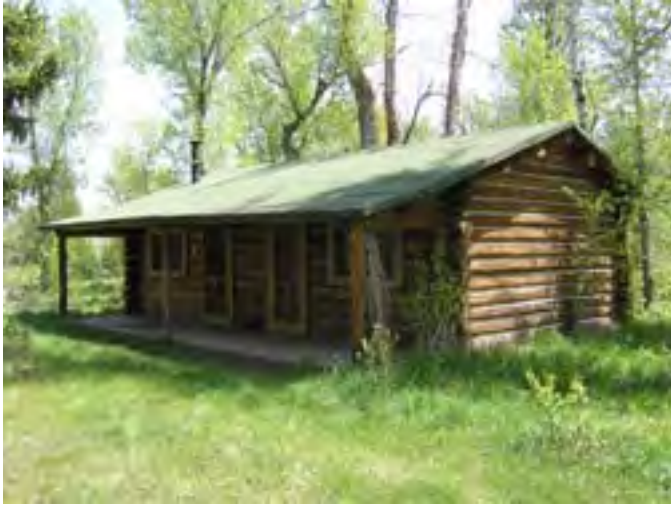
Figure 129 – Looking southeast at the cabin and front porch. The roof is good with some minor damage along the porch eave.

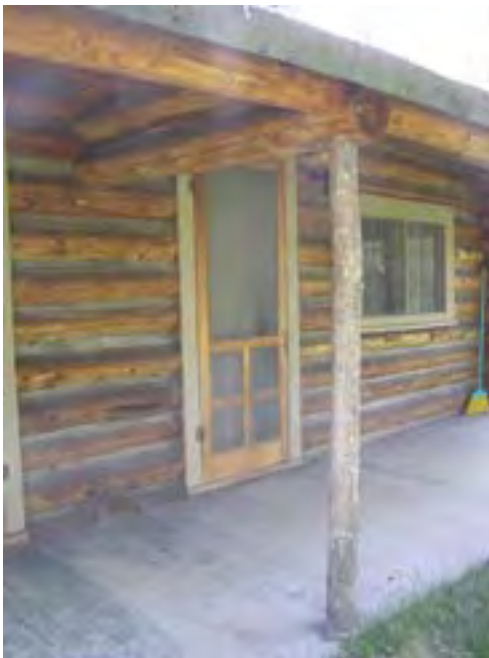
Figure 130 – Looking southwest at the front porch and typical door and window. The screen door wood is dry and stained. Note the concrete slab and wood infill where some piping evidently comes into the cabin.

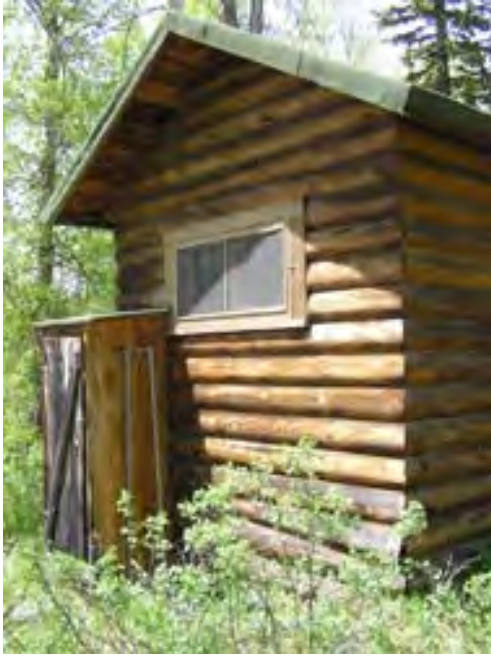
Figure 132 – Looking northwest at the back of the bathroom addition with a small structure for the water heater. The wood materials are weathered and dry and the base has some rot.

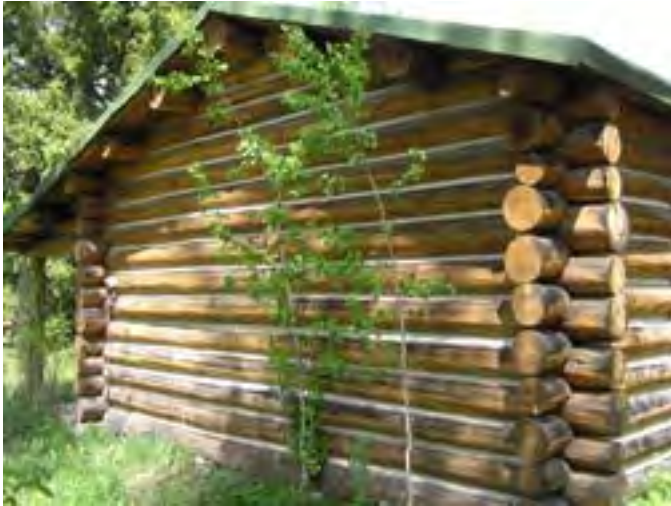
Figure 133 – Looking northeast at the wall of the cabin. Note the dry logs and some surface weathering. The daubing is good.

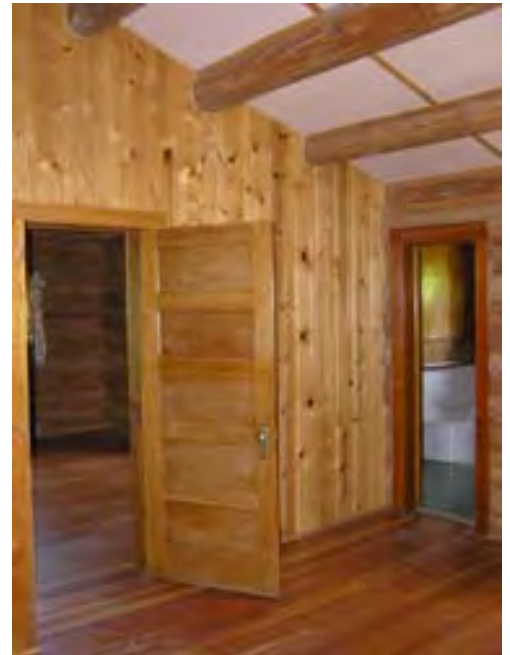
Figure 136 – Looking southeast at the connecting door and opening to the bathroom from the west bedroom. Note the good condition of the materials.

- Figure 135. Looking northwest at the wood paneled entrance door and enclosed closet area. The ceiling is celotex set between the log purlins.
- Figure 136. Looking southeast at the connecting door and opening to the bathroom from the west bedroom. Note the good condition of the materials.

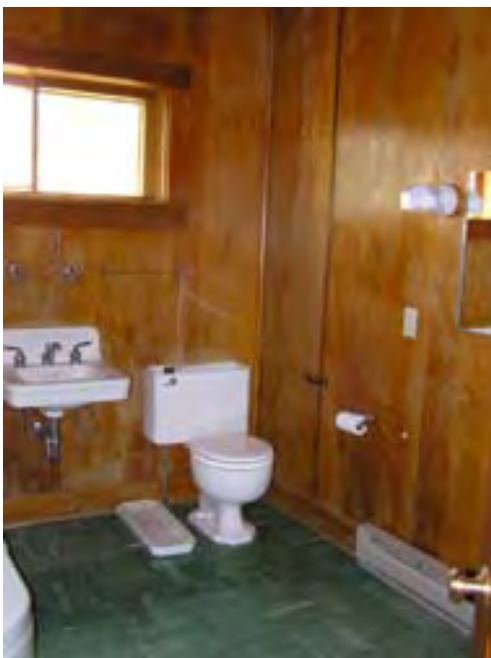
Figure 137 – Looking southwest at the bathroom. There is electric baseboard heat throughout the cabin.

- Figure 137. Looking southwest at the bathroom. There is electric baseboard heat throughout the cabin.
- Figure 138. Looking southeast at the bathtub in the bathroom. This area is dry and there does not appear to be any mould. The vinyl tile floor is in good condition.

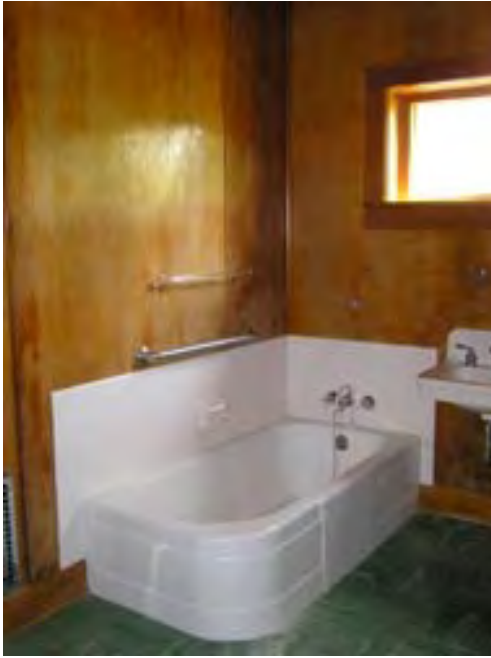
Figure 138 – Looking southeast at the bathtub in the bathroom. This area is dry and there does not appear to be any mould. The vinyl tile floor is in good condition.

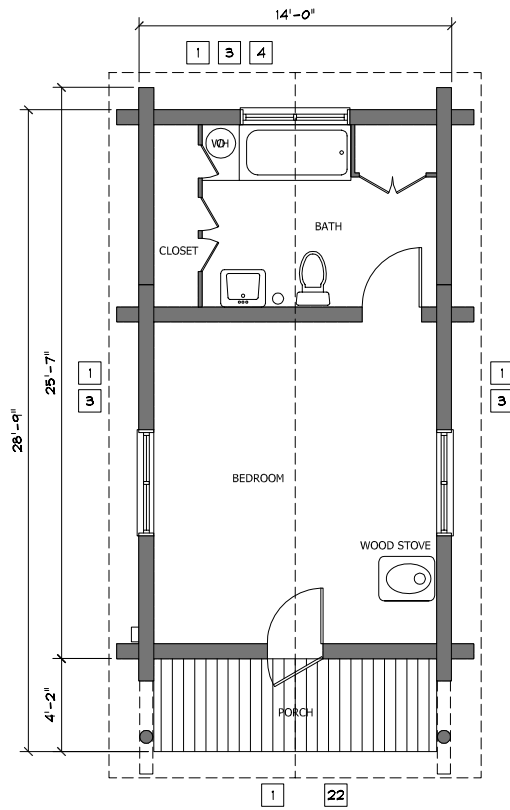
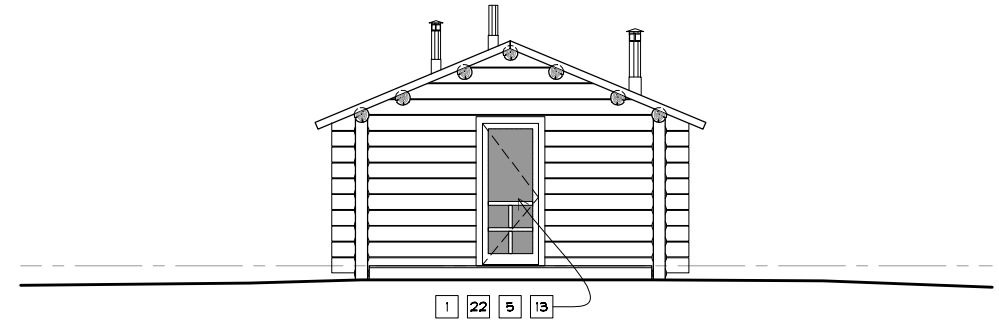
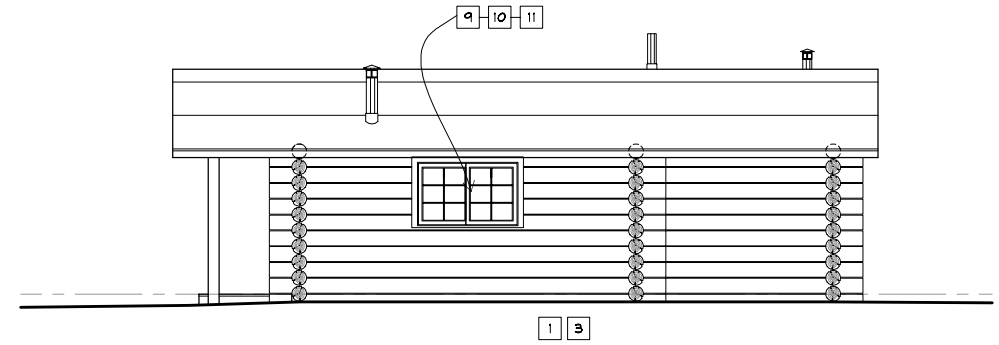
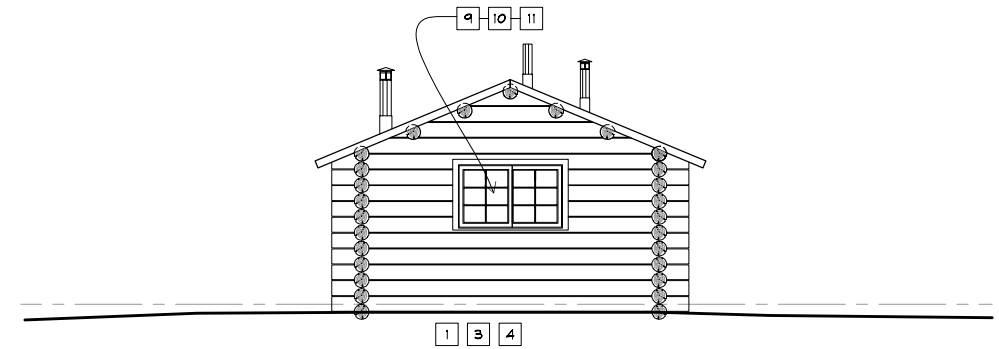
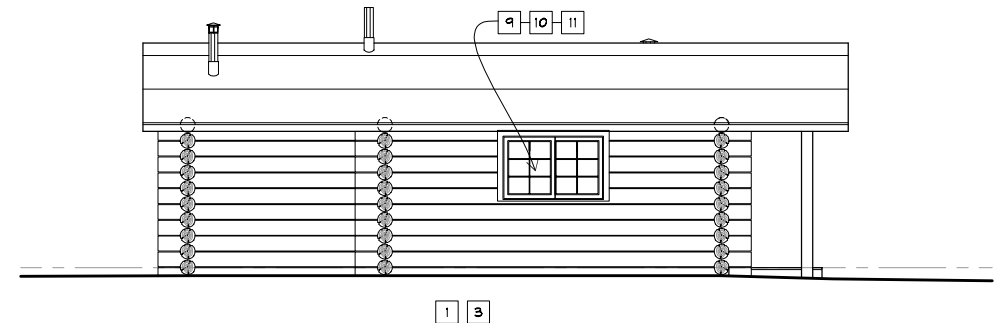
139

Harry's Cabin is generally in good condition but there are exceptions. The porch and sill logs on all sides of the cabin are rotted. The logs on the north wall from the sill up to just under the window show some areas of rot. Most of the logs are dry and checked. This cabin is on concrete piers and it appears that the cabin has settled down into the ground or the area has been drastically filled in around the cabin. The building was moved to the site and may not have been properly sited. The daubing in the original log portion to the south is in good condition and the wood chinking in the north addition appears to be in good condition.

The roof is in good condition. The windows and doors have some peeling paint and the sills are generally weathered and show some rot.

The interior of the cabin is in good condition with the exception of some water stains around vents in the ceiling. The minimal electrical system as well as water and sewer have been abandoned. The existing systems would not be adequate for potential new uses.

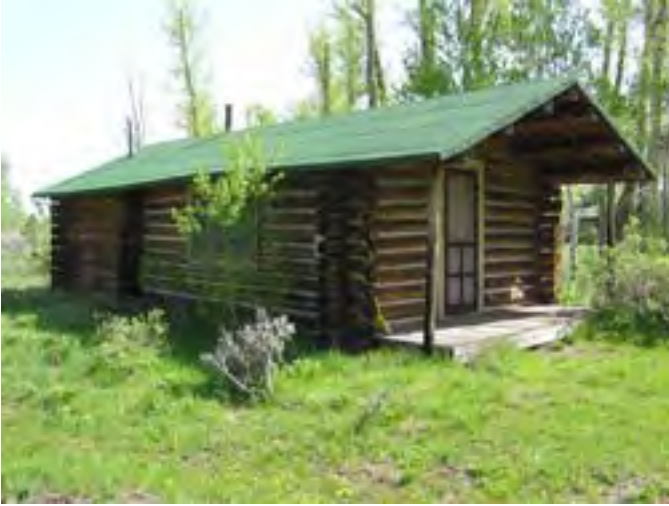
Figure 140 – Looking northeast at Harry's House. The roof is in good condition and the log walls though dry are generally in good condition. There is some rot in the sill logs.

- Figure 139. HS-410, Harry's Cabin, floor plan and elevations.
- Figure 140. Looking northeast at Harry's House. The roof is in good condition and the log walls though dry are generally in good condition. There is some rot in the sill logs.
