4 LAZY F RANCH

Historic Structures Report

September, 2008

Grand Teton National Park
National Park Service
P.O. Box 170
Moose, Wyoming 83012

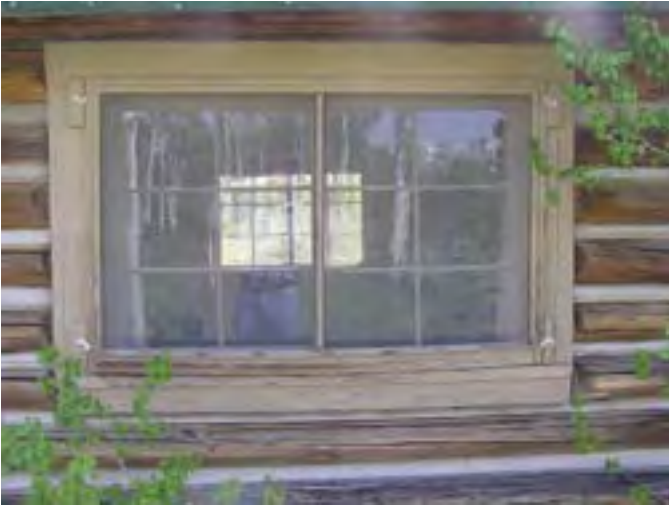
Figure 141 – Looking east at a typical wood sliding window and screen. Note the peeling paint and weathered wood on the sill of the window.

- Figure 141. Looking east at a typical wood sliding window and screen. Note the peeling paint and weathered wood on the sill of the window.
- Figure 142. Looking northeast along the main cabin and log addition to the north. The logs are dry but there is some rot in the sill logs because of the high grade. The daubing in the original building is good and wood chinking in the addition appears to be good.

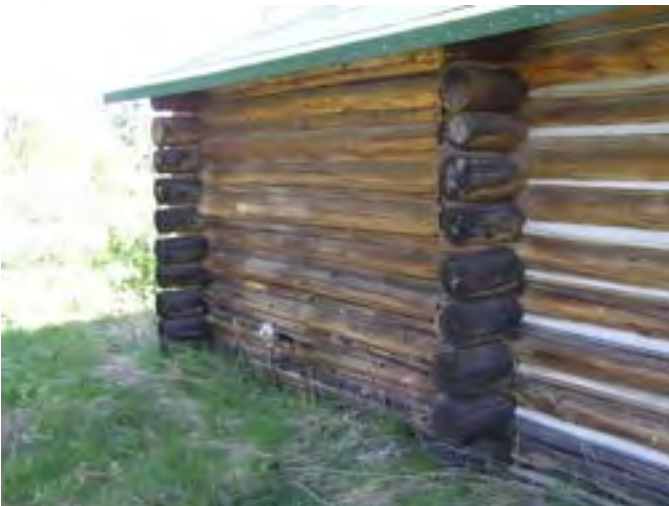
Figure 142 – Looking northeast along the Main Cabin and log addition to the north. The logs are dry but there is some rot in the sill logs because of the soil build-up. The daubing in the original building is good and wood chinking in the addition appears to be good.

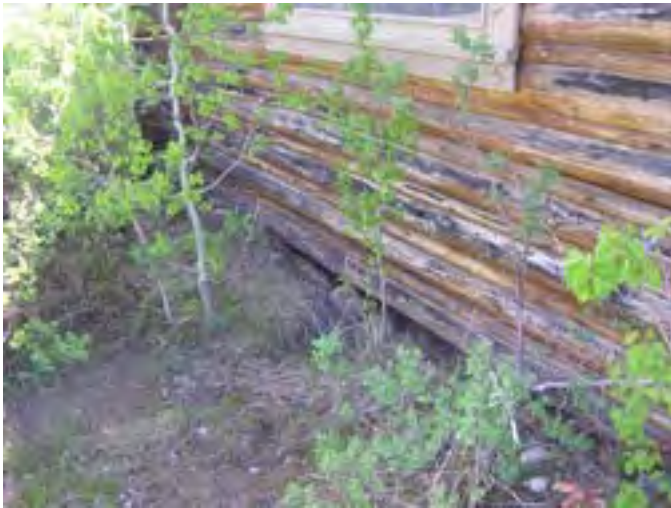
Figure 144 – Looking south at the base of the rear log wall. Note the rotted sill logs and wall logs.

- Figure 143. Looking southwest at the cabin. Note the shrubbery and high grade around the building.
- Figure 144. Looking south at the base of the rear log wall. Note the rotted sill logs and wall logs.

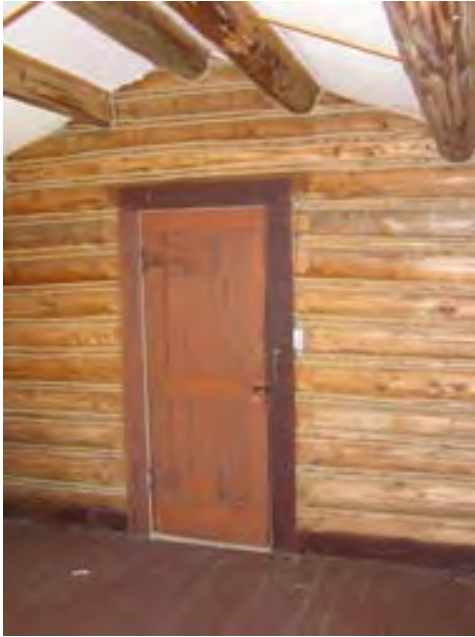
Figure 146 – Looking south at the bedroom and the main entrance door. Note the fir floor, log walls, and Celotex ceiling. These materials are in good condition with some staining around the vent pipe in the bathroom.

- Figure 146. Looking south at the bedroom and the main entrance door. Note the fir floor, log walls, and celotex ceiling. These materials are in good condition with some staining around the vent pipe in the bathroom.

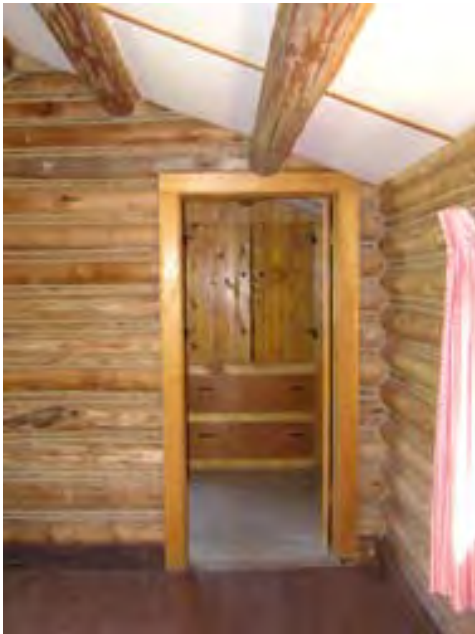
Figure 147 – Looking north from the bedroom to the doorway into the bathroom addition. The materials appear to be in good condition.

- Figure 147. Looking north from the bedroom to the doorway into the bathroom addition. The materials appear to be in good condition.
- Figure 148. Looking north at the bathroom fixtures and storage.

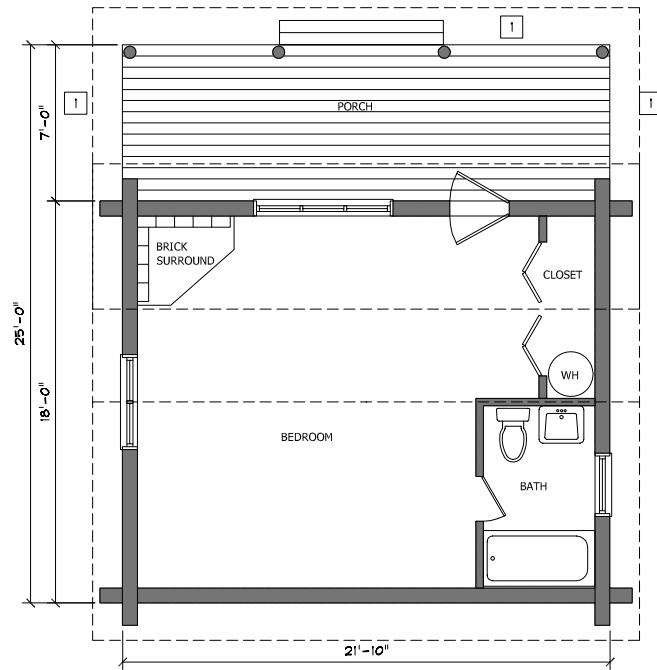
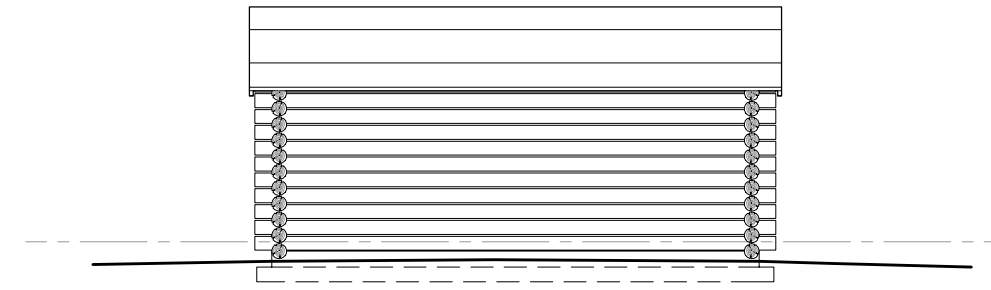
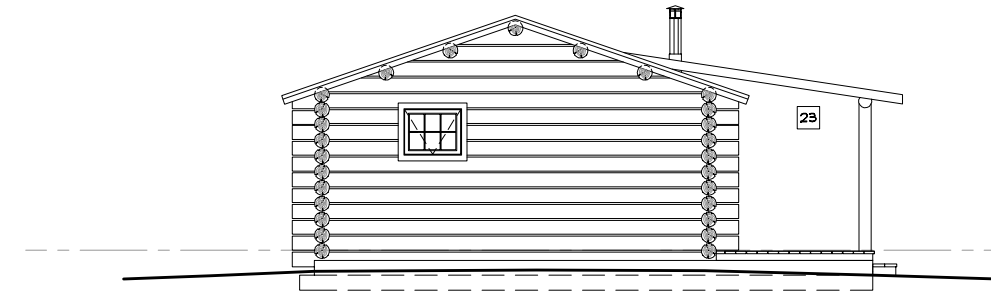
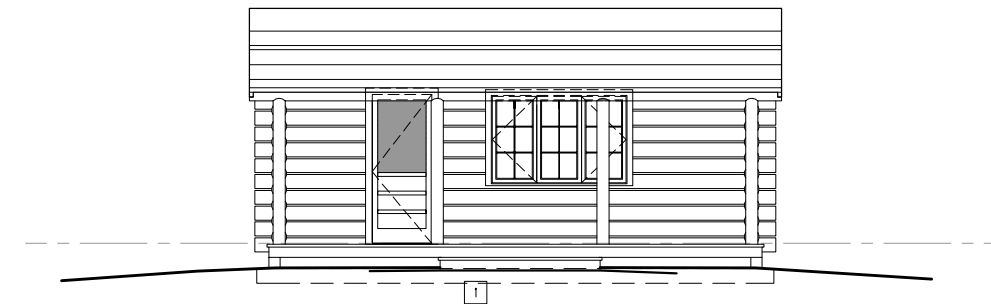
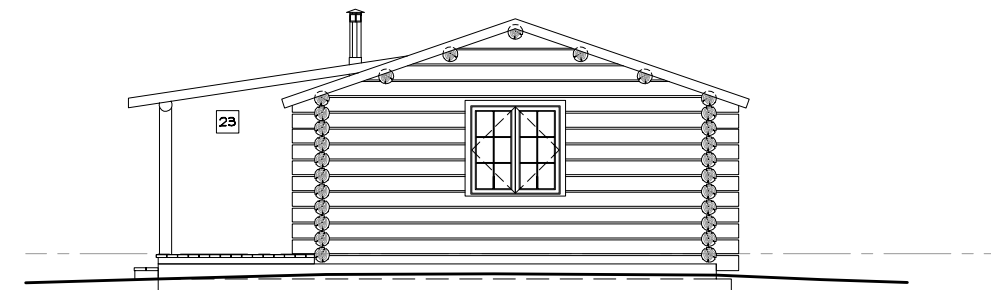
149

The New Cabin is in good condition with some exceptions that appear to be minor. The building sits high on a good foundation and most of the logs are in good condition although dry with some checking. However there appears to be some dry rot on the sill log on the west side of the cabin and some minor rot in the base of the notching on the southwest corner. The wood front porch sits on a good foundation but the soil has built up over the wood. This has potential to rot even though it does not appear to be a problem at this point. The bases of the porch columns have some dry rot.

The roof is in good condition but the structural elements of the porch roof appear to be inadequate to support the winter snow load, when additional, temporary supports are added. The windows and doors are in good condition with some minor sill deterioration and weathering of all the exposed wood.

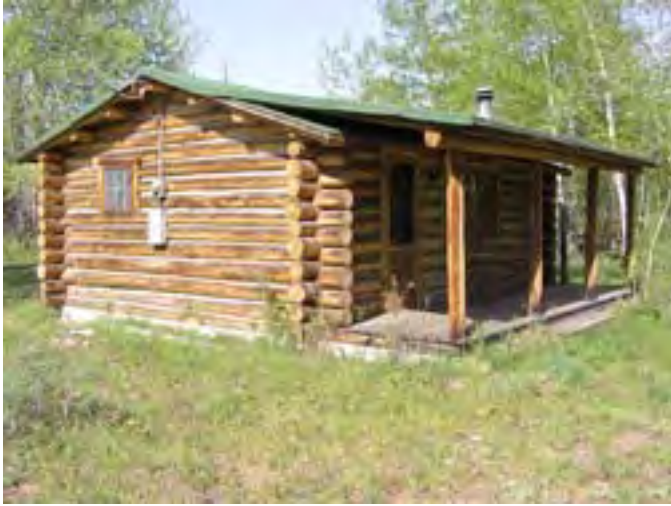
Figure 150 – Looking southwest at the cabin and front porch. The cabin sits up on a concrete foundation and generally the grade is good around the building. The roof is in good condition.

- Figure 149. HS-411, New Cabin, floor plan and elevations.
- Figure 150. Looking southwest at the cabin and front porch. The cabin sits up on a concrete foundation and generally the grade is good around the building. The roof is in good condition.

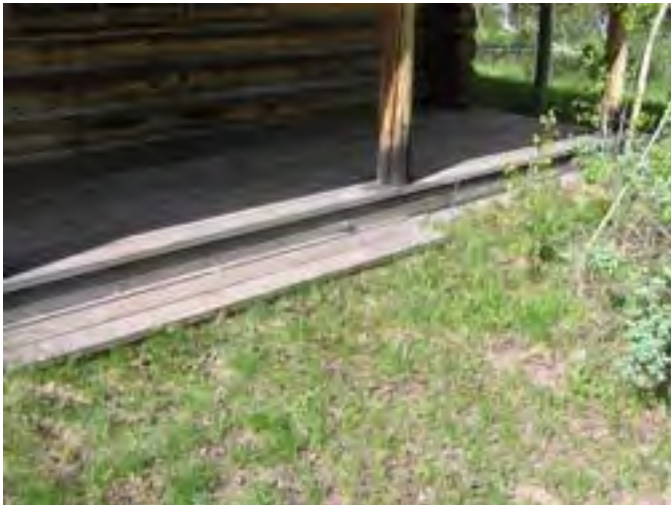
Figure 151 – Looking south at the wood porch. There is some rot in the porch and on the base of the columns.

- Figure 151. Looking south at the wood porch. There is some rot in the porch and on the base of the columns.
- Figure 152. Looking south at a typical wood casement window on the front of the cabin. The wood is just oiled but is dry.

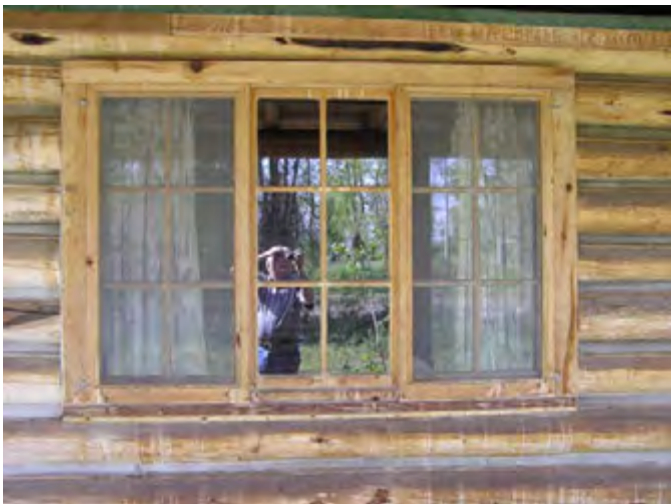
Figure 152 – Looking south at a typical wood casement window on the front of the cabin. The wood is just oiled but is dry.

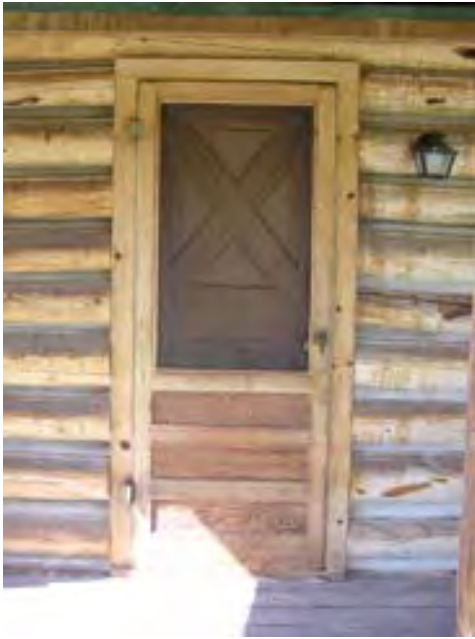
Figure 153 – Looking south at the entrance door and screen door. They are in good condition but the wood is dry.

- Figure 153. Looking south at the entrance door and screen door. They are in good condition but the wood is dry.
- Figure 154. Looking northeast at the cabin. The logs are dry and there is some rot in the sill log. The daubing appears to be in good condition.

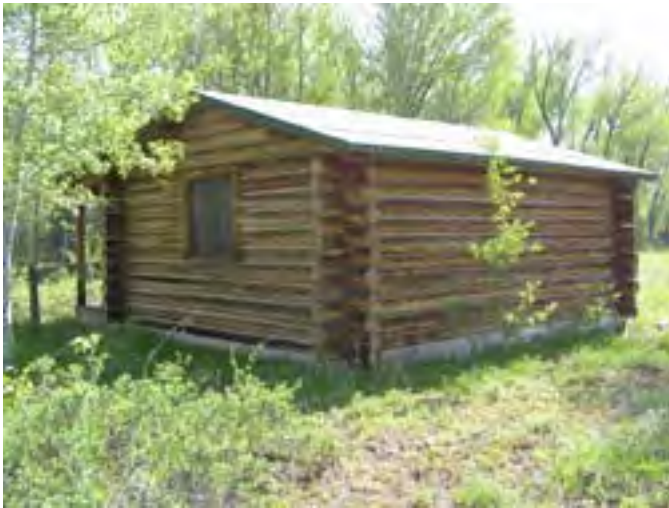
Figure 154 – Looking northeast at the cabin. The logs are dry and there is some rot in the sill log. The daubing appears to be in good condition.

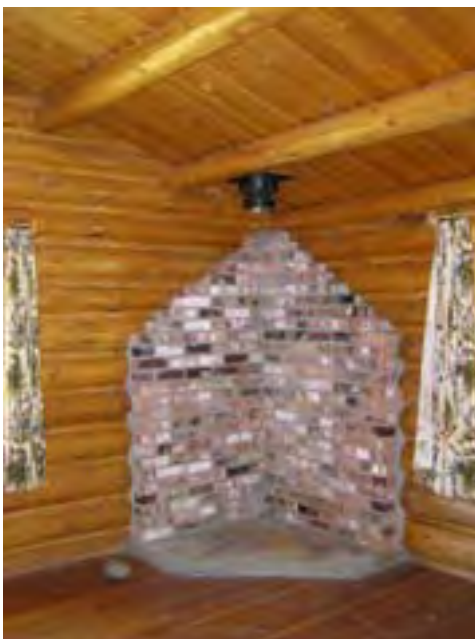
Figure 155 – Looking northwest at the corner of the bedroom with fire wall for the wood stove. The materials are in good condition.

- Figure 155. Looking northwest at the corner of the bedroom with fire wall for the wood stove. The materials are in good condition.

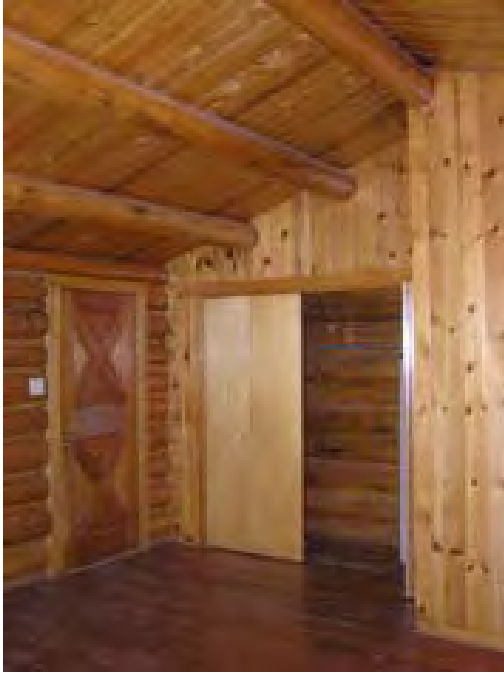
Figure 156 – Looking northeast at the wood entrance door and closet. The fir floor has some minor wear but all in all the materials are in good condition.

- Figure 156. Looking northeast at the wood entrance door and closet. The fir floor has some minor wear but all in all the materials are in good condition.

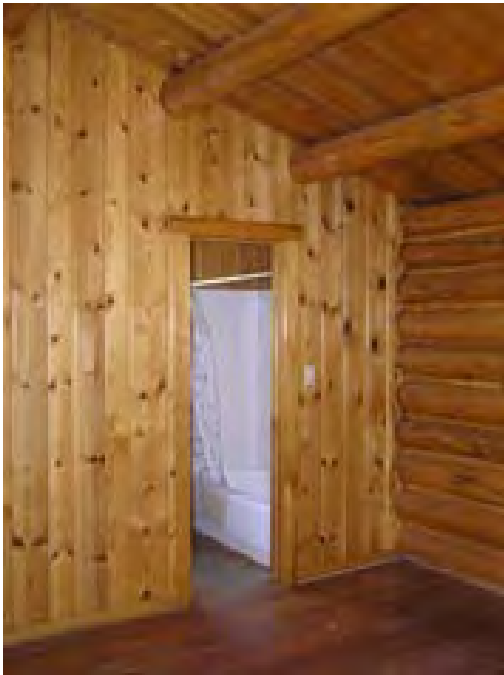
Figure 157 – Looking southeast at the bathroom and the integral fiberglass tub/shower beyond. These areas are also in good condition.

- Figure 157. Looking southeast at the bathroom and the tub/shower beyond. These areas are also in good condition.
- Figure 158. Well housing, floor plan and elevations.

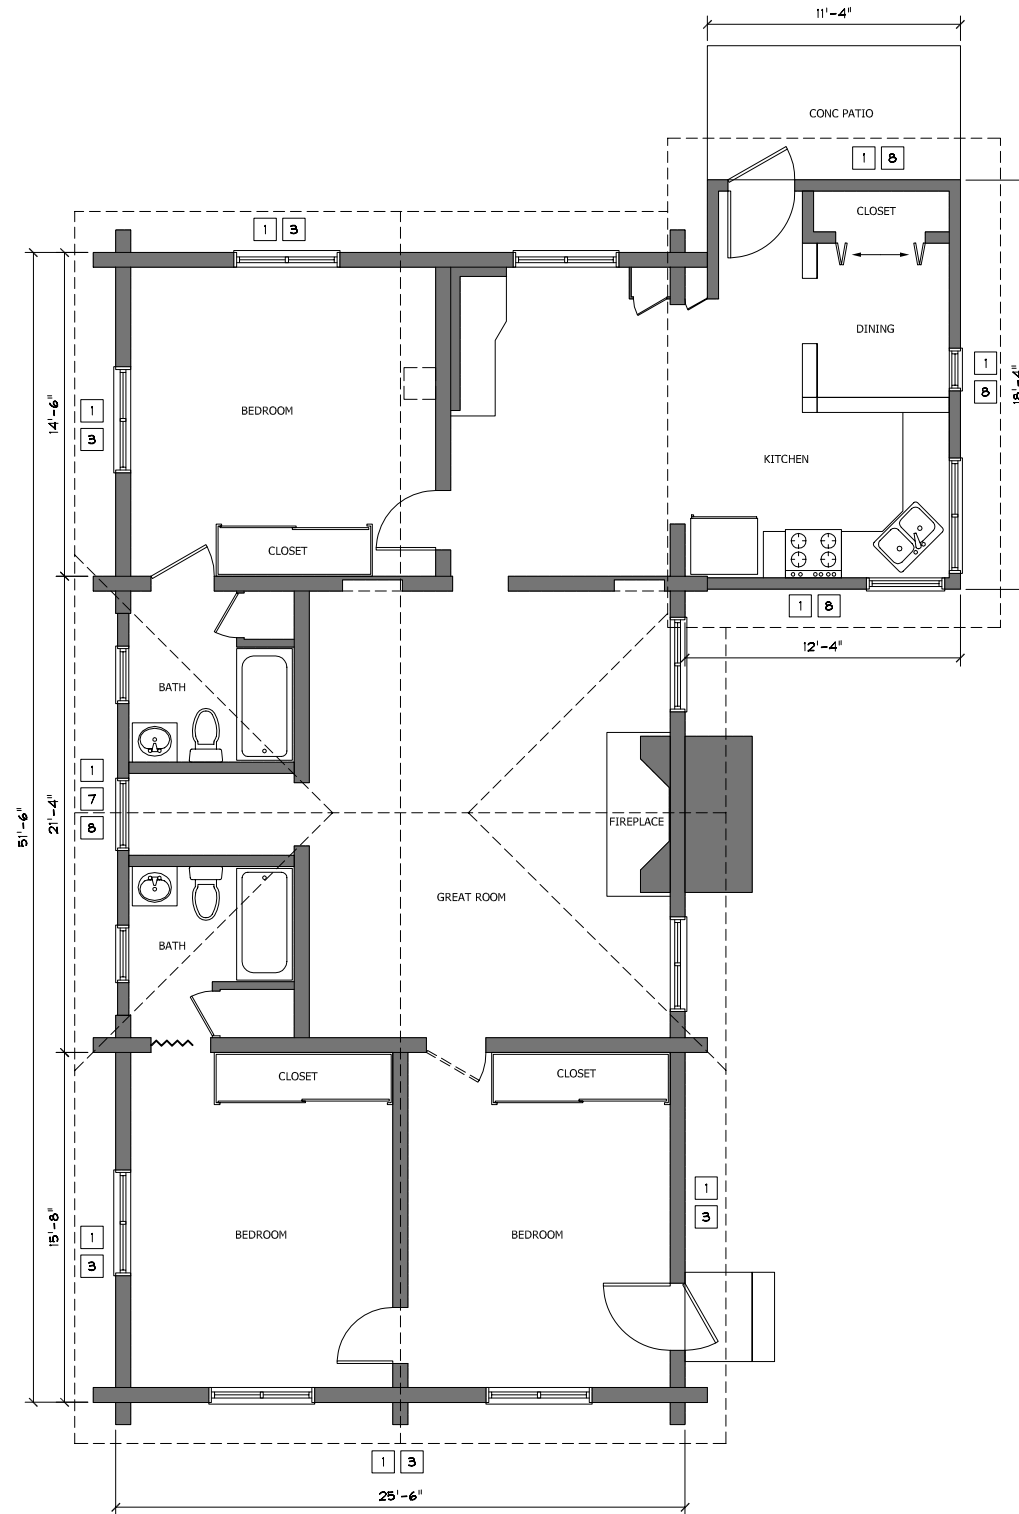
CARETAKERS HOUSE #412

With a few exceptions, the Caretaker's House is in good condition. On the exterior of the building there are rotted areas in the log sills because of soil that has built up around the building. This mostly occurs on the east side of

the building especially around the chimney and on the west side around the infill area of the original porch. A similar condition exists on the southeast corner of the House where the building has settled because of the rotted logs caused by soil buildup.

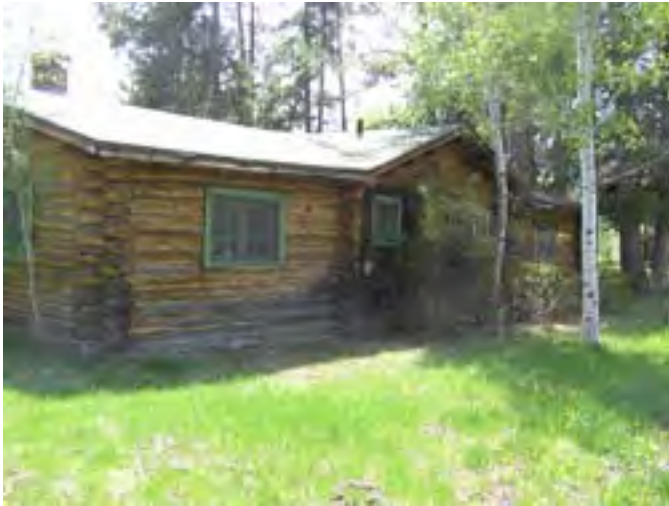
Figure 162 – Looking southeast at the Caretaker's House showing the log sections and the infill in the original recessed porch area. The roof is in good condition with some minor damage on the eaves.

- Figure 160. HS-412, Caretaker's House, floor plan.
- Figure 161. HS-412, Caretaker's House, elevations.
- Figure 162. Looking southeast at the Caretaker's House showing the log sections and the infill in the original recessed porch area. The roof is in good condition with some minor damage on the eaves.

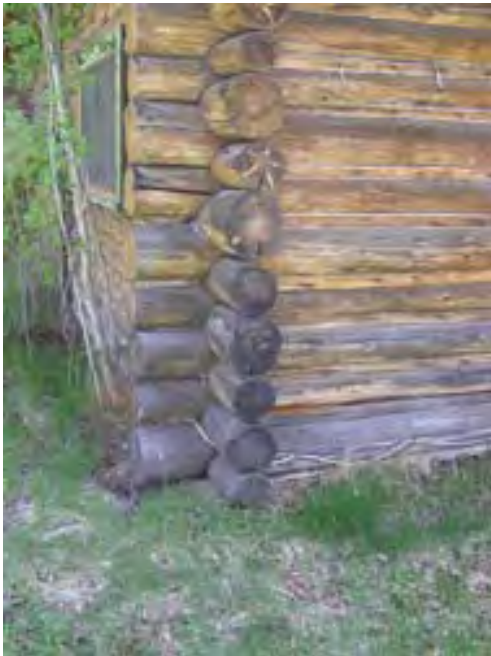
Figure 163 – Looking southeast at the log corner notches. Note the rotted sill log and surface rot on the upper logs due to the soil build-up around the base.

- Figure 163. Looking southeast at the log corner notches. Note the rotted sill log and surface rot on the upper logs due to the high grade around the building.

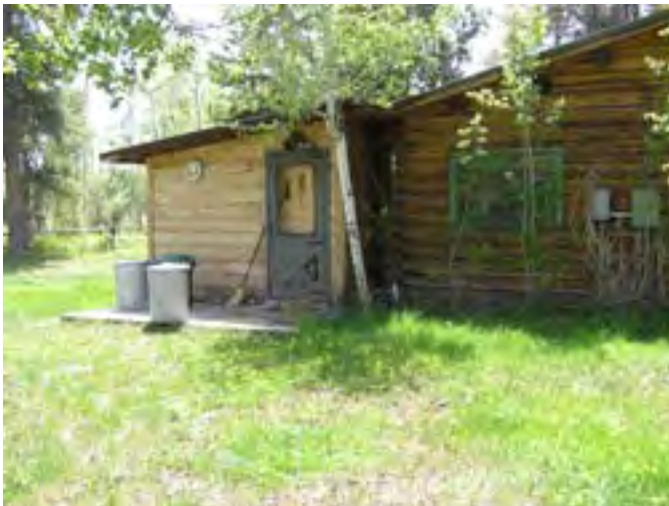
Figure 164 – Looking south at the house and kitchen wing addition. There is some rot in the sill logs and the base of the addition. The wood including the logs and wood chinking is dry but in good condition.

- Figure 164. Looking south at the house and kitchen wing addition. There is some rot in the sill logs and the base of the addition. The wood including the logs and wood chinking is dry but in good condition.

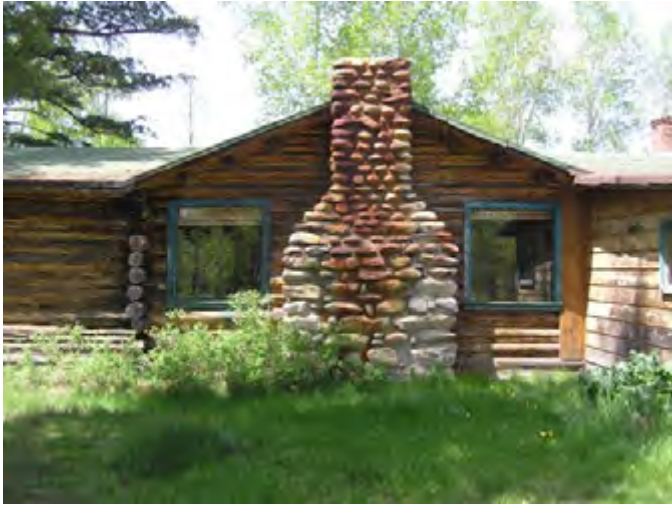
Figure 165 – Looking west at the stone chimney and log walls. The windows are in good condition with some minor weathering on the sills. A couple of the log ends of the inner walls have rotted and broken off.

- Figure 165. Looking west at the stone chimney and log walls. The windows are in good condition with some minor weathering on the sills. A couple of the log ends of the inner walls have rotted and broken off.

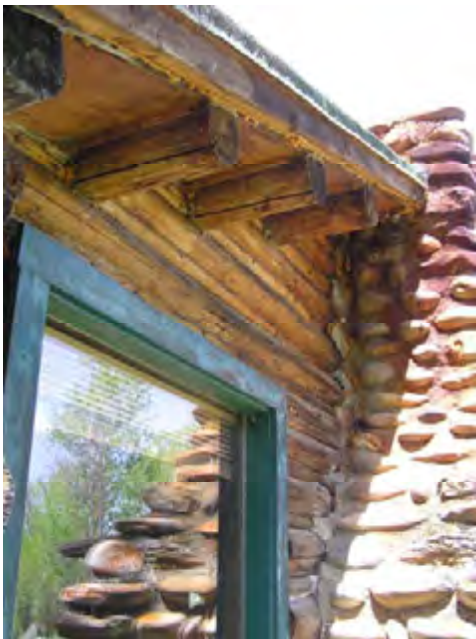
Figure 166 – Looking north up along the eave to the stone chimney. There is some staining where there have been leaks around the chimney area. There is some damage to the roofing material on the eave on this end of the building.

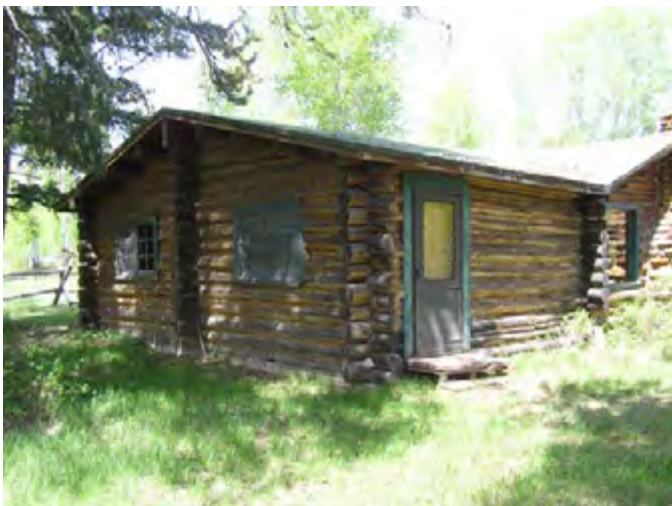
Figure 167 – Looking northwest at the south end of the Caretaker's House. Soil build-up appears to be a problem in this area causing some rot in the sill logs.

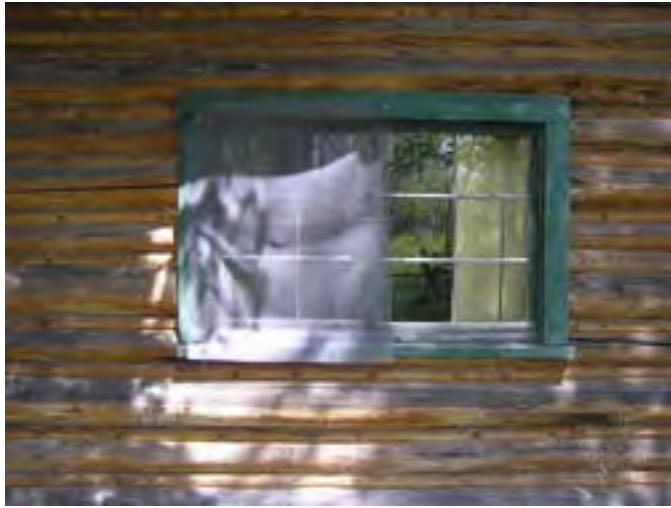
Figure 168 – Looking north at a typical wood sliding window. The window appears to be in good condition with some minor weathering on the sill.

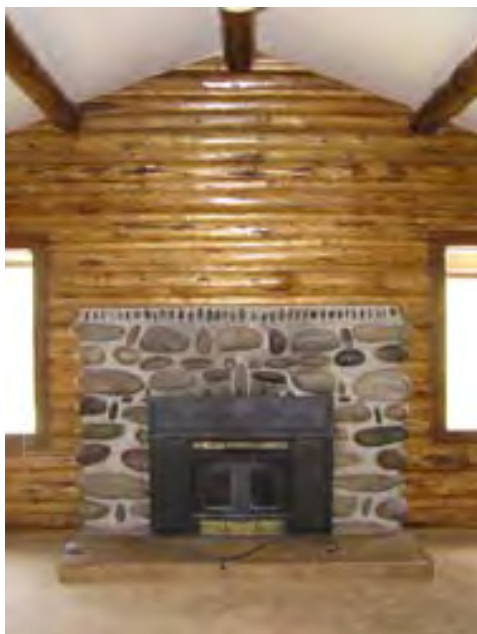
Figure 171 – Looking southeast along a detail of the fireplace. Note the river rock and patterns of the fireplace. It is in good condition.

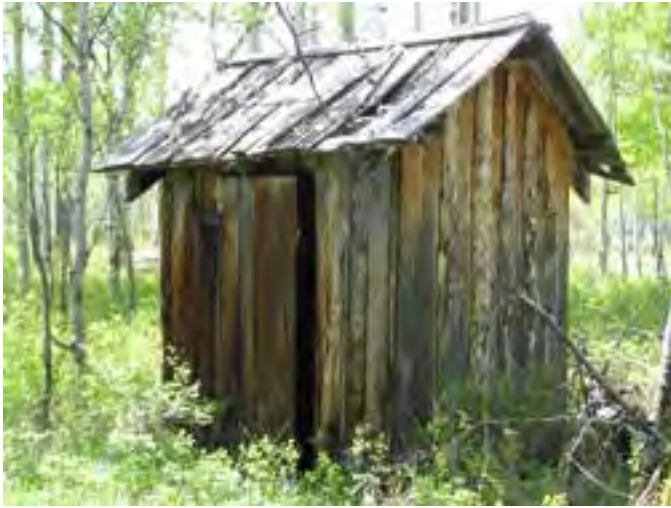
Figure 179 – Looking southwest at the outhouse. The building is in poor condition with weathered wood, a failing board and batten roof and rot along the base because of soil build-up.

- Figure 177. Looking north at the bathroom in the southwest bedroom.
- Figure 178. HS-412, Caretaker's Outhouse, floor plan and elevations.
- Figure 179. Looking southwest at the outhouse. The building is in poor condition with weathered wood, a failing board and batten roof and rot along the base due to the high grade.

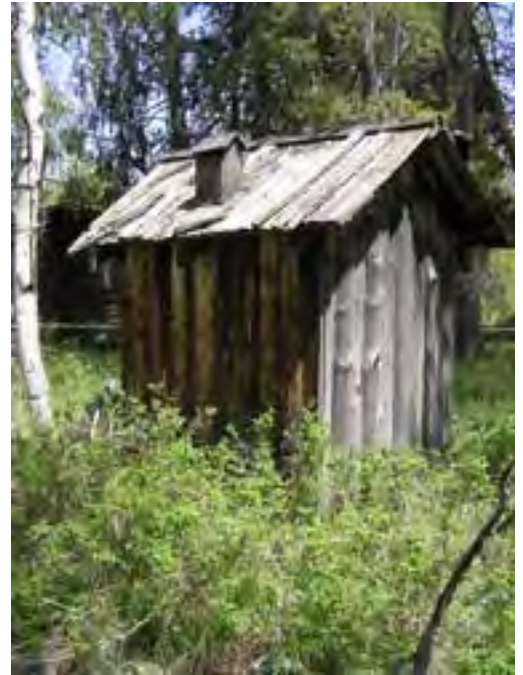
Figure 180 – Looking northeast at the outhouse. Note the accumulated soil and vegetation around the back of the building.

- Figure 180. Looking northeast at the outhouse. Note the high grade around the back of the building.
- Figure 181. Looking southwest at the interior of the outhouse. Note the filled in holes and the stained and rotted wood.

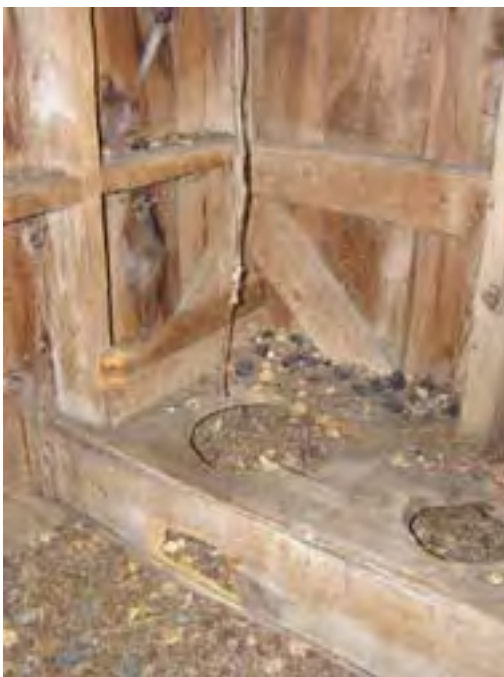
Figure 181 – Looking southwest at the interior of the outhouse. Note the filled in holes and the stained and rotted wood.

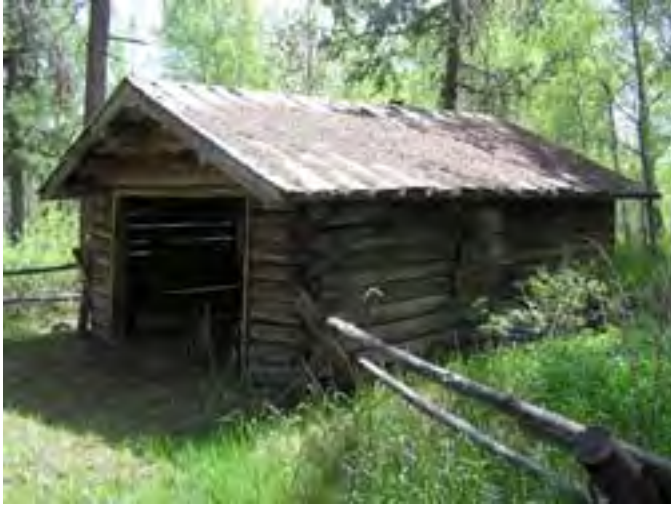
Figure 183 – Looking southeast at the garage building. The board-on-board roof is weathered and showing some leakage of water. The two side walls at the opening have moved out at the bottom.

- Figure 182. HS-412B Caretaker's Garage, floor plan and elevations.
- Figure 183. Looking southeast at the garage building. The board and batten roof is weathered and showing some leakage of water. The two side walls at the opening have moved out at the bottom.

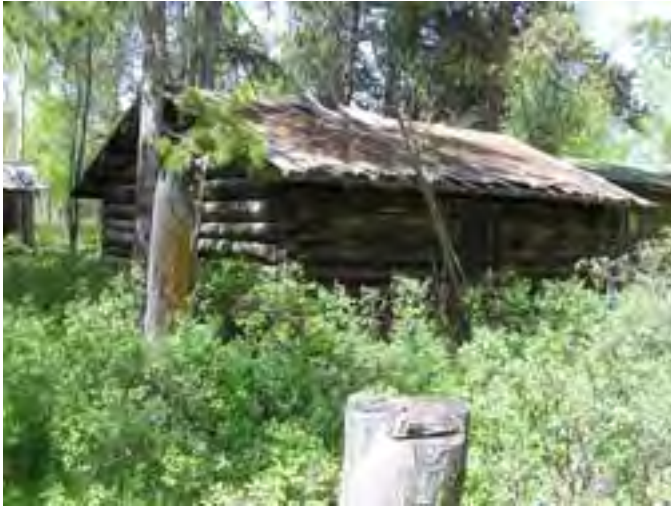
Figure 184 – Looking northwest at the Garage. The vegetation and soil build-up around the building has caused the sill logs to rot.

- Figure 184. Looking northwest at the garage. The vegetation and high grade around the building has caused the sill logs to rot.
- Figure 185. Looking east at a section of the wall and roof. Note the deteriorated log walls and the warping of the boards on the roof.

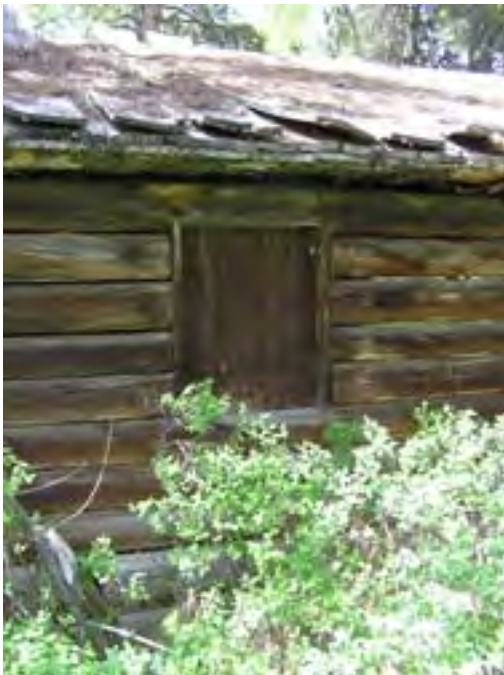
Figure 185 – Looking east at a section of the wall and roof. Note the deteriorated log walls and the warping of the boards on the roof.

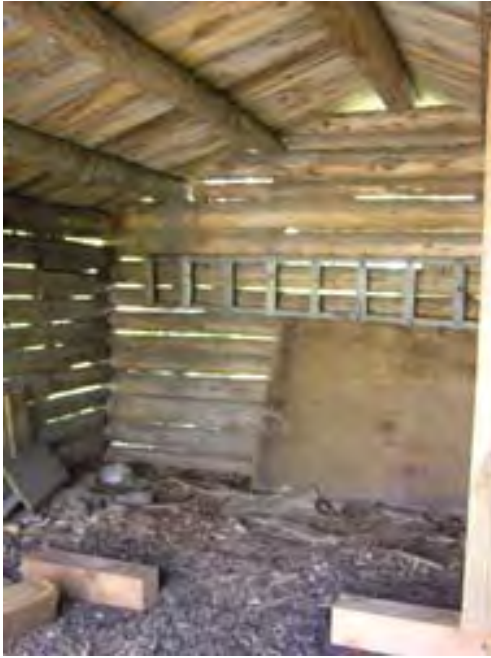
Figure 186 – Looking south at the interior of the Garage. Note the open areas between the logs and the log purlins. Water stains on the board sheathing indicate that the roof leaks.

- Figure 186. Looking south at the interior of the garage. Note the open areas between the logs and the log purlins. Water stains on the board sheathing indicate that the roof leaks.

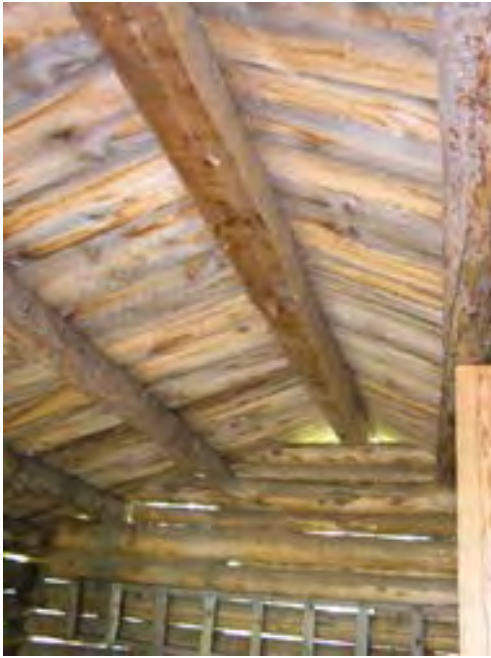
Figure 187 – Looking south at the board ceiling spanning the purlins. Note some dry rot in the wood.

- Figure 187. Looking south at the board ceiling spanning the purlins. Note some dry rot in the wood.
- Figure 188. HS-413, Barn, floor plan.
- Figure 189. HS-413, Barn, elevations.

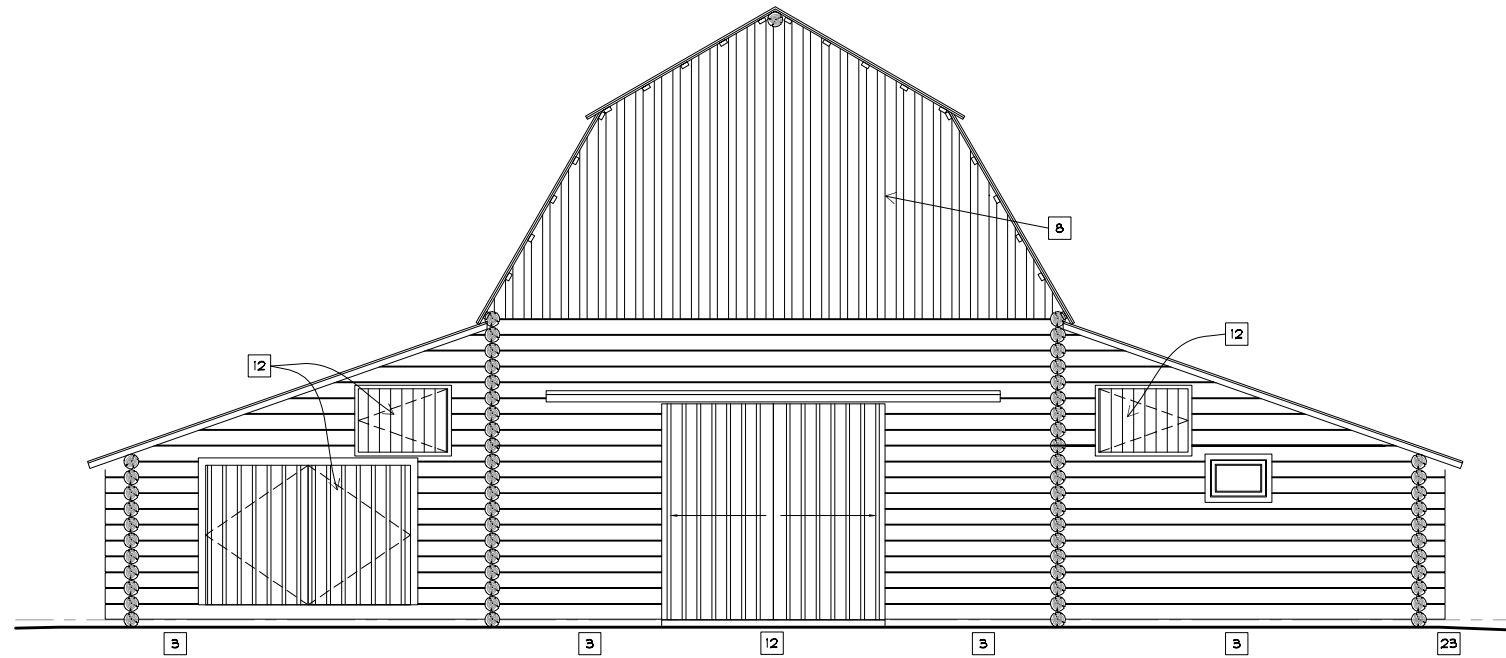
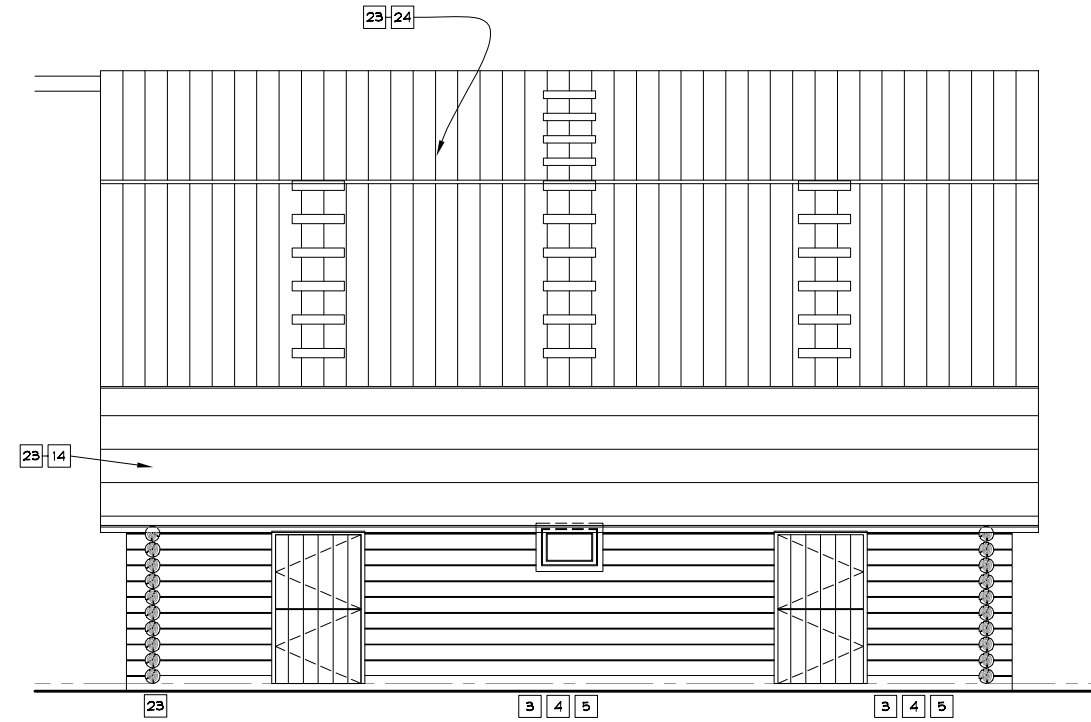
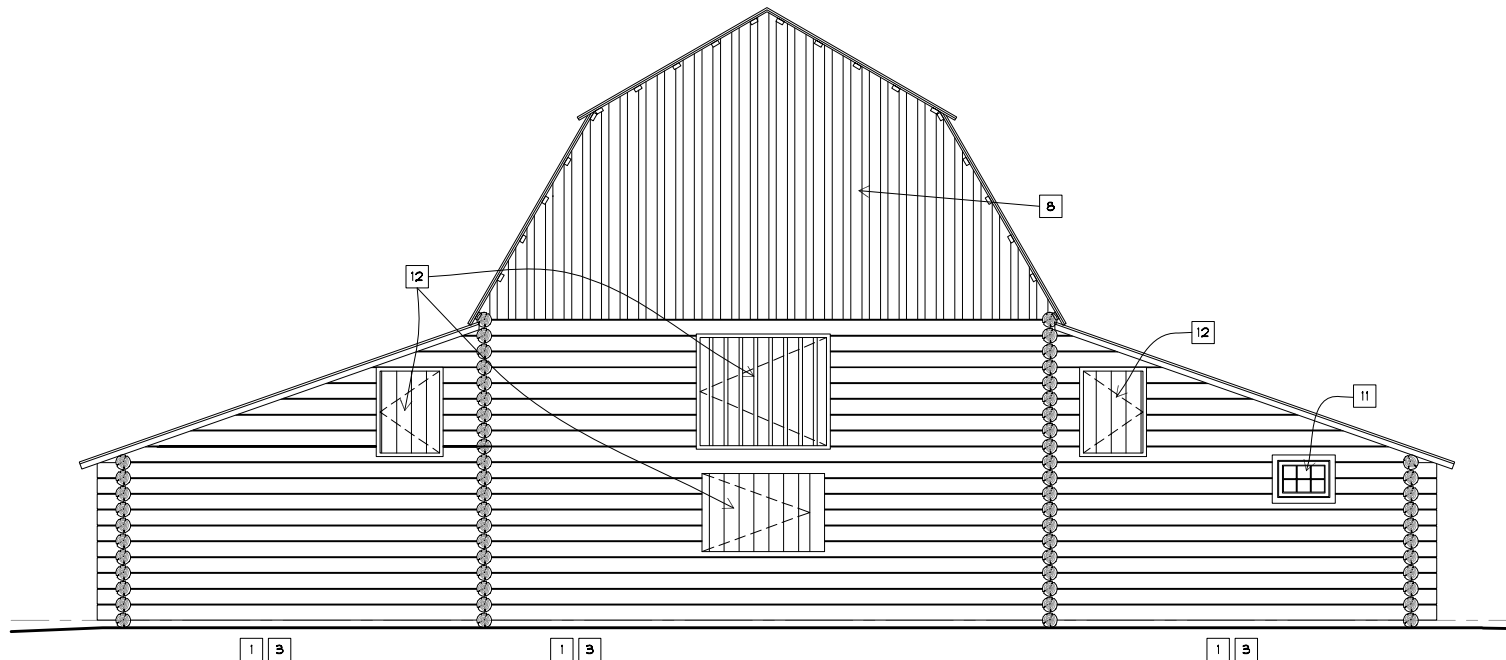
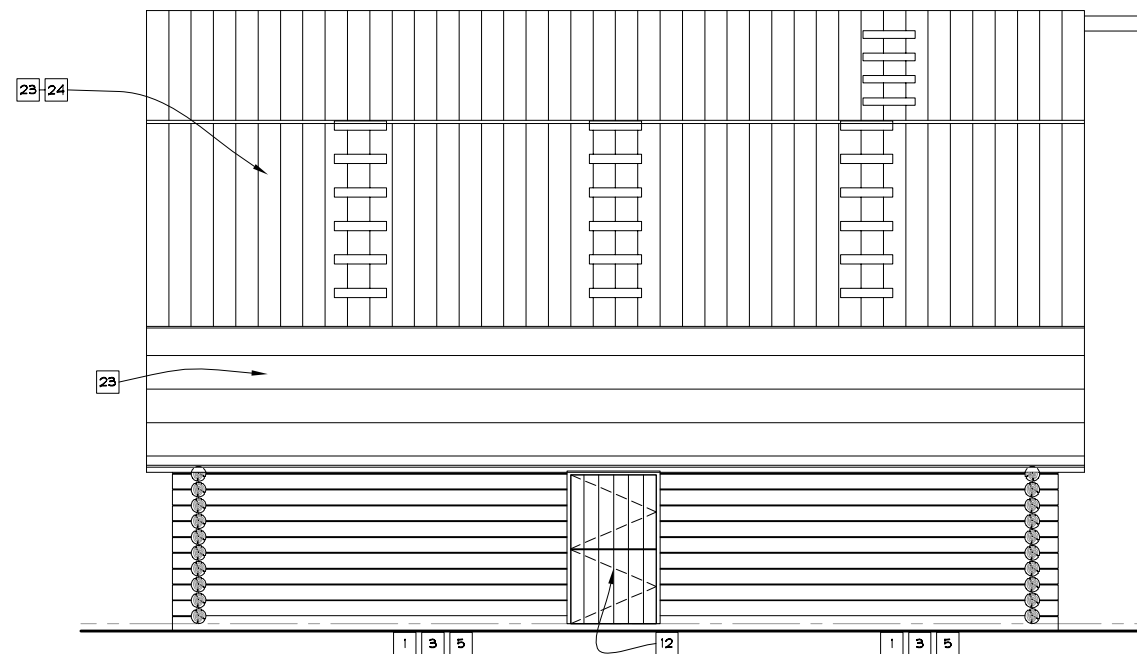
The Barn is in good condition but there are some problems with the structure that could cause the building to fail and collapse in certain areas. The concrete pier foundation under the east wing side has a lot of rot and deterioration of the sill logs as well as the concrete piers themselves. The settlement in the southeast corner of the Barn has also caused some of the shed roof structure to collapse causing a hole in the roof. Water can penetrate further into the structure and cause damage. There is some additional rot in the sill logs on the west shed roof wing because of the soil build-up around that side and part of the north side. The roof over this part of the building is in good condition. However, additional support had to be put in the interior of the west shed roof to support the structure during heavy snow loads.

The log walls are very dry and checked throughout the building and there is additional rot in the wall logs especially on the east side. The wall logs are dry and checked. The roofing over the main gambrel roof is gone and the wood sheathing and structure is exposed. The front of the central section of the building is supported by a concrete slab foundation that was put in to create a new space within the Barn structure. The slab ties into the side walls of the central structure but does not support the north wall.

The ends of the gambrel roof have weathered boards and there is some dry rot in the material. The doors are dried out and in some cases are warped. Pieces of the door are missing and they are coming apart in some cases.

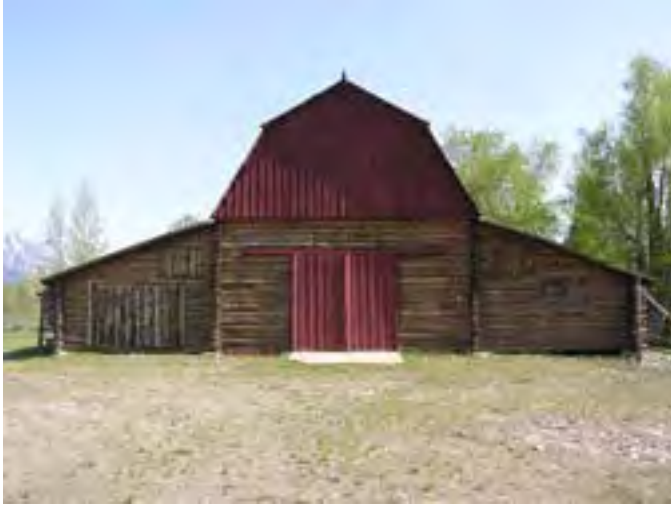
Figure 190 – Looking north at the front façade of the Barn. The log base and board and batten upper portion of the gambrel roof end are generally in good condition. There is some warping of the boards.

- Figure 190. Looking north at the front façade of the barn. The log base and board and batten upper portion of the gambrel roof end are generally in good condition. There is some warping of the boards.

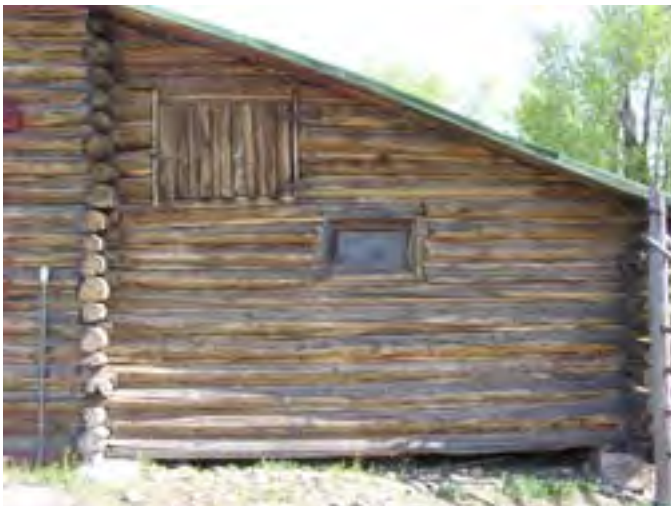
Figure 192 – Looking north at the east shed roof structure. The sill logs span the gap between the concrete piers that are showing some deterioration.

- Figure 191. Looking north at the wood sliding doors. They are warped and in fair condition.
- Figure 192. Looking north at the east shed roof structure. The bottom logs expand across to the concrete piers that are showing some deterioration.

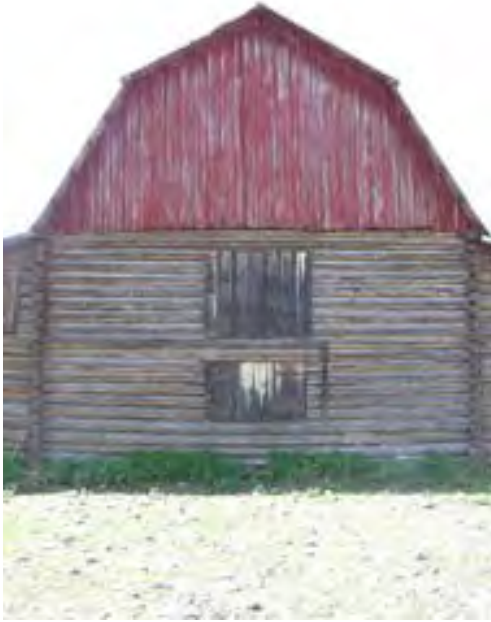
Figure 196 – Looking south at the gambrel end of the roof and log structure below. The boards and battens are warped and weathered. The doors in the lower section are in poor condition.

- Figure 196. Looking south at the gambrel end of the roof and log structure below. The board and battens are warped and weathered. The doors in the lower section are in poor condition.

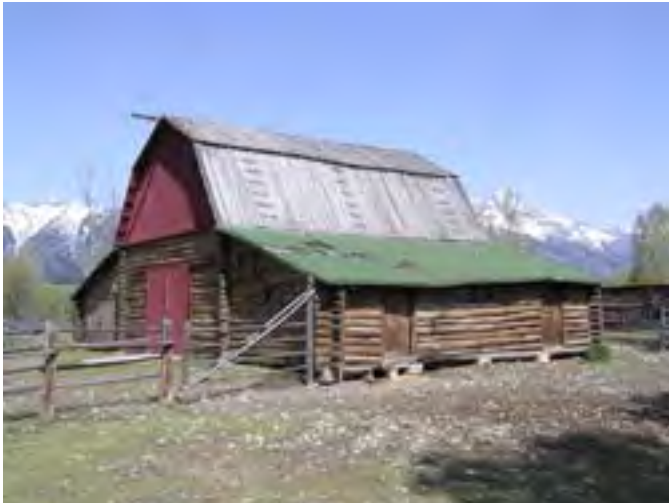
Figure 197 – Looking northwest at the Barn. The upper roof is in poor condition. The wall logs are dry.

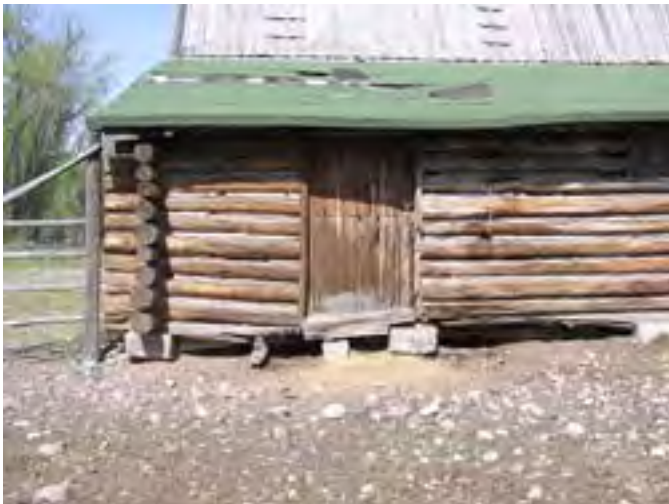
Figure 198 – Looking west at a section of the shod roof wing of the Barn. Note the damaged sheet asphalt roof where there is some damage to the structure below. Also the base logs are rotted and the logs are not properly supported at the base. The door is in poor conditional.

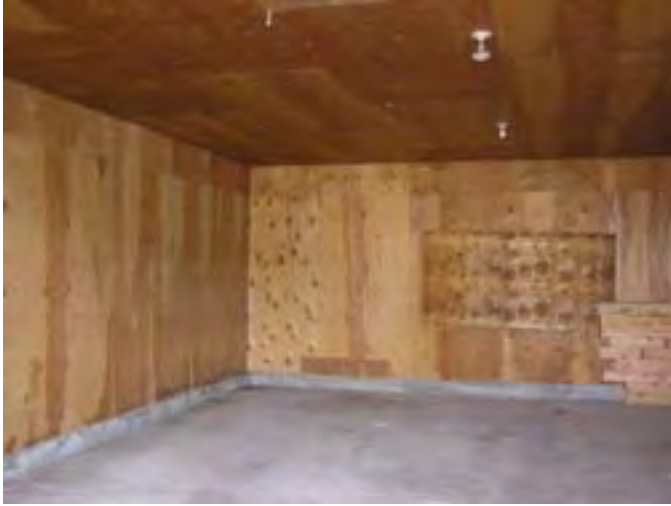
Figure 199 – Looking north at the room within the gambrel center section of the Barn. There is a new concrete floor, framed walls and plywood paneling. There is a roof with sheet asphalt on top in the loft area.

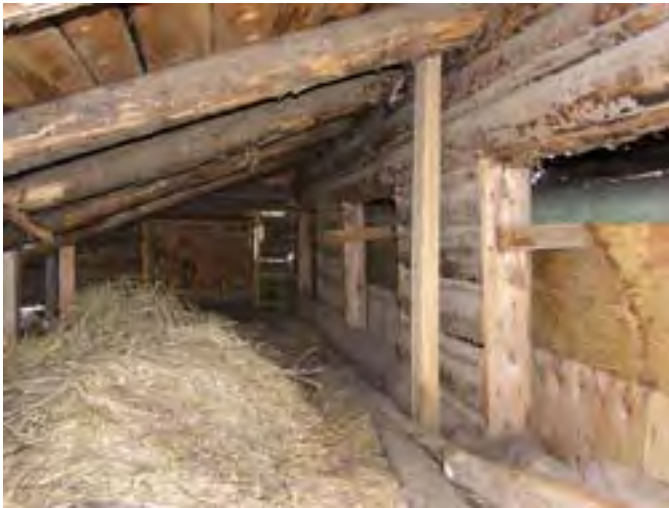
Figure 203. – Looking south at the log rafters in the east wing. There is some damaged structure on the south end allowing water to penetrate and in turn causing rot in the wood materials.
