4 LAZY F RANCH

Historic Structures Report

September, 2008

Grand Teton National Park
National Park Service
P.O. Box 170
Moose, Wyoming 83012

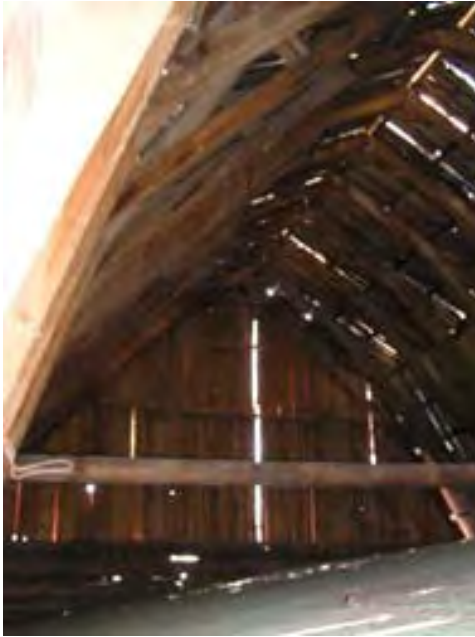
Figure 205 – Looking south at the structure of the gambrel roof and end. Note the openings in the roof and gambrel end. There is some rot in the wood structure. Note the sheet asphalt roof of the structure below.

- Figure 204. Looking west at the frame structure that was built in the center section of the barn. Note the sheet asphalt roof over the structure.
- Figure 205. Looking south at the structure of the gambrel roof and end. Note the openings in the roof and gambrel end. There is some rot in the wood structure. Note the sheet asphalt roof of the structure below.

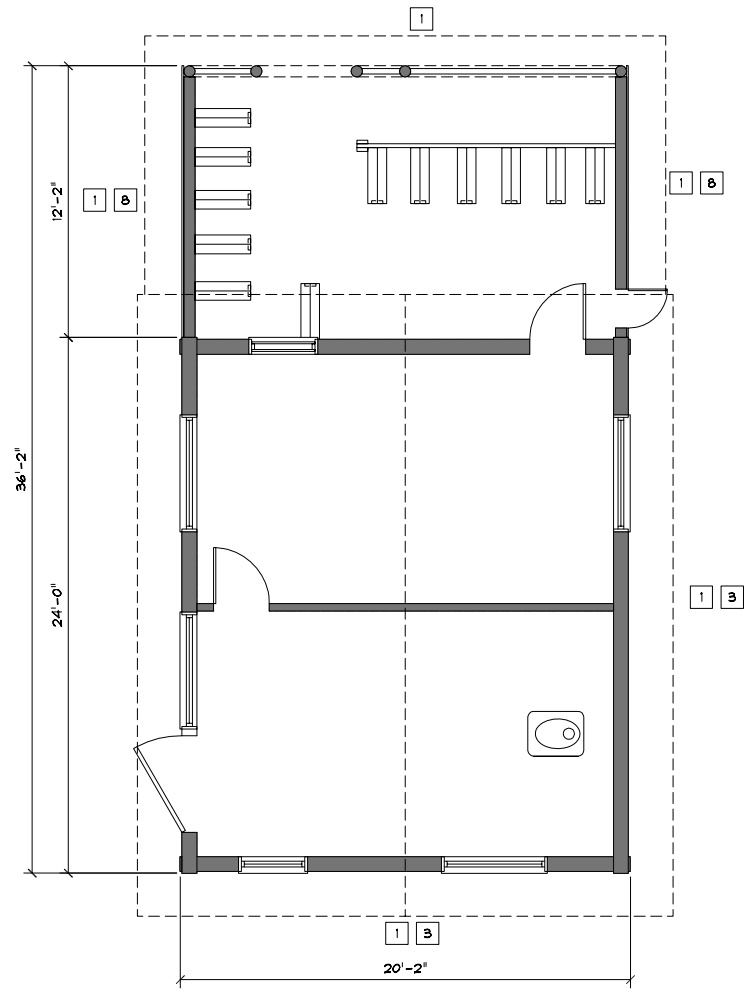
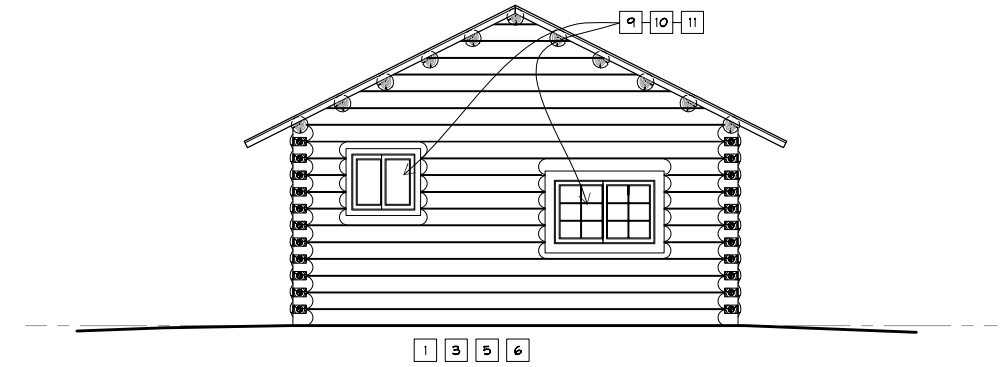
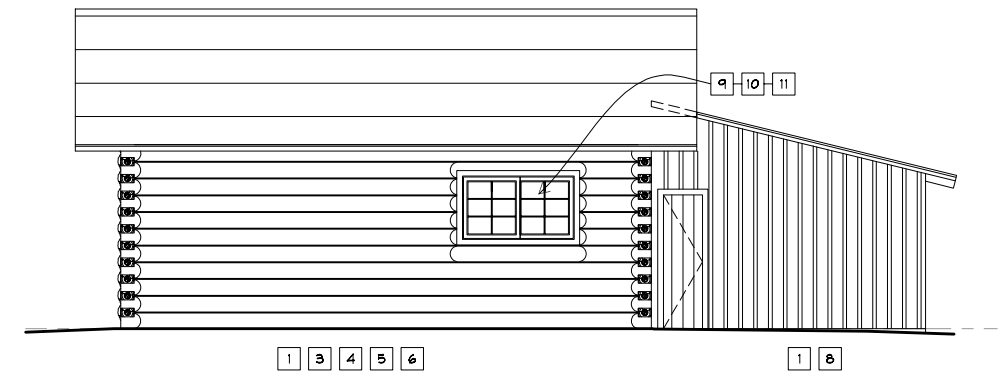
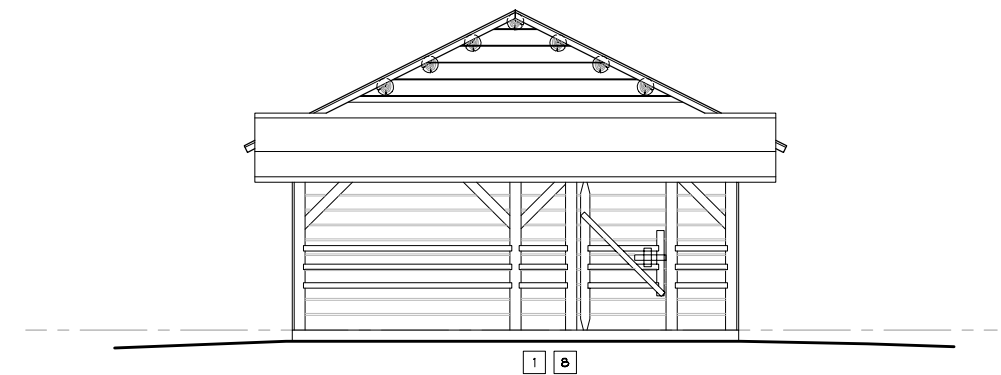
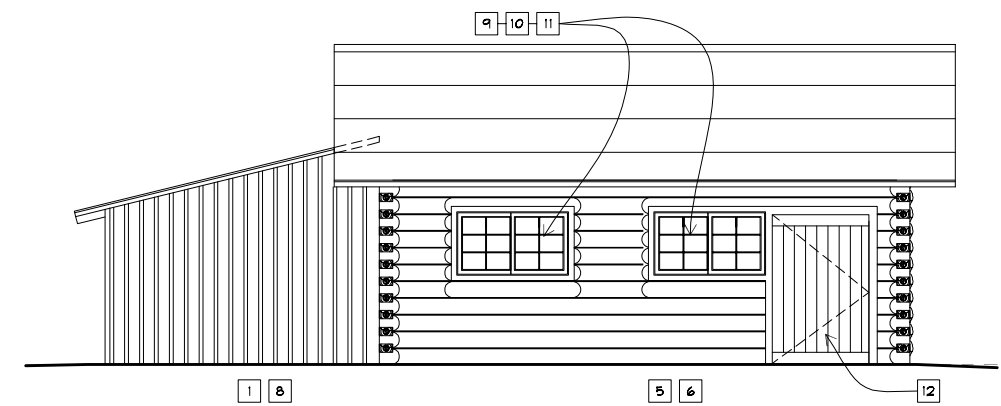
FIGURE

The Tack Shed is in good condition with some exceptions. The log walls are dry and checked and there is some rot in the sill logs and the next log in some cases on the east and south walls. This is due to soil accumulation around the base of these sections of the building. The daubing is missing in several areas of the log work especially on the east and west sides. The frame addition on the north side of the building with its board and batten siding has some rot in the base structure and the boards are weathered and show some dry rot. The roof is in good condition.

The windows are weathered and in some cases the sills are rotted. Some of the glazing is missing or deteriorating. The doors are also weathered with the exception of the main door which is worn but in better condition. The open ended area of the tack shed is worn and there is some rot in the floor.

The materials in the interior of the tack shed are worn and there is some damage because of previous water leaks. The electrical system as well as water and sewer have been abandoned. The existing systems would not be adequate for potential new uses.

- Figure 206. HS-414, Tack Room, floor plan and elevations.
- Figure 207. Looking northeast at the Tack Room. The wall logs are in good condition with the exception of some rotted sill logs on the east side. The roof is in good condition.

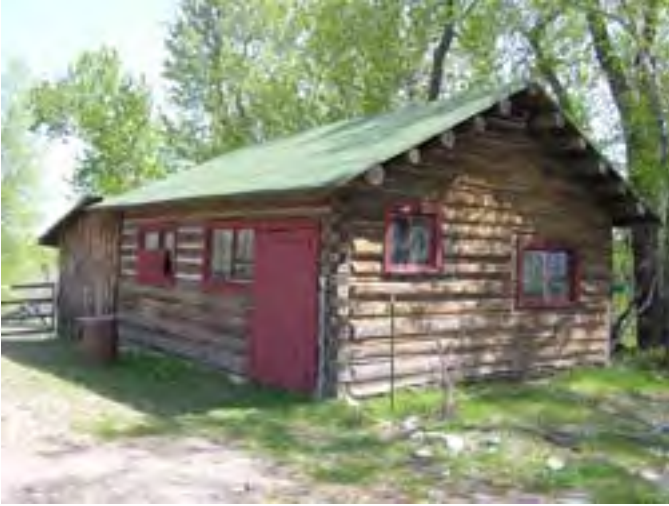
Figure 207 – Looking northeast at the Tack Room. The wall logs are in good condition with the exception of some rotted sill logs on the east side. The roof is in good condition.

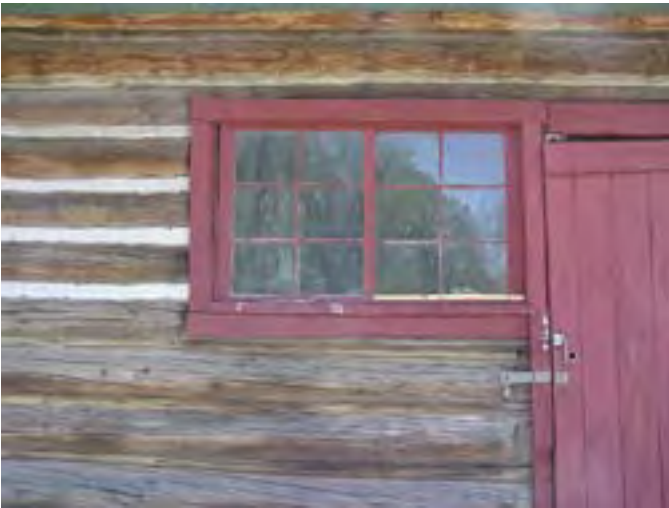
Figure 208 – Looking east at the door and window on the west side of the building. They are in good condition with some weathering of the window sill and base of the door.

- Figure 208. Looking east at the door and window on the west side of the building. They are in good condition with some weathering of the window sill and base of the door.

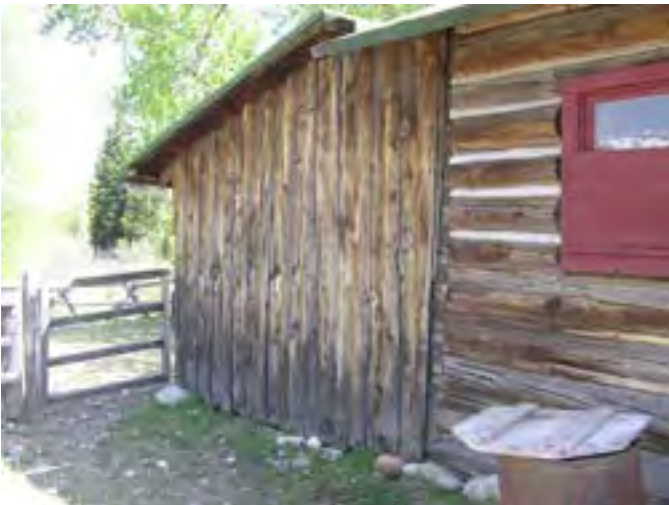
Figure 209 – Looking east at the wood frame board and batten addition on the back of the log volume. The wall is weathered and the bottom of the siding has rotted.

- Figure 209. Looking east at the wood frame board and batten addition on the back of the log volume. The wall is weathered and the bottom of the siding has rotted.

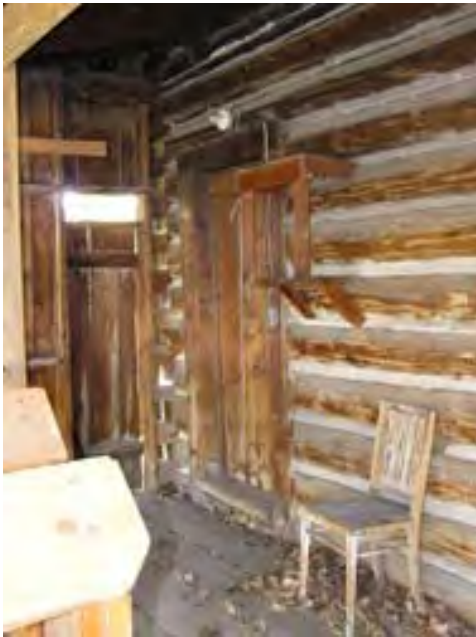
Figure 211 – Looking east along the back wall of the log Tack Room. Note the door that leads to the north room of the log volume.

- Figure 211. Looking east along the back wall of the log Tack Room. Note the door that leads to the north room of the log volume.
- Figure 212. Looking east at the tack area in the shed. Most of these materials are weathered but in good condition.

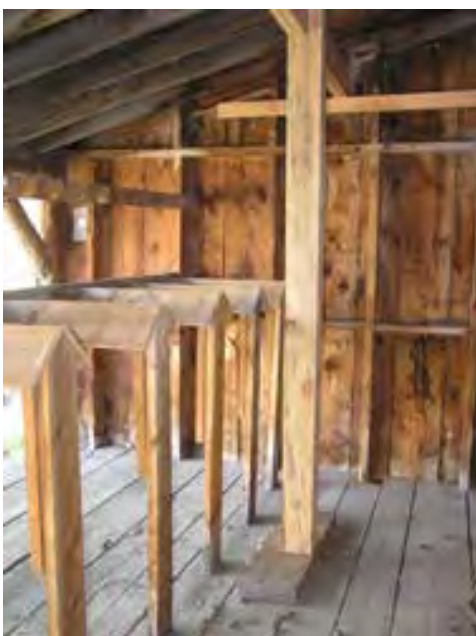
Figure 212 – Looking east at the tack area in the shed. Most of these materials are weathered but in good condition.

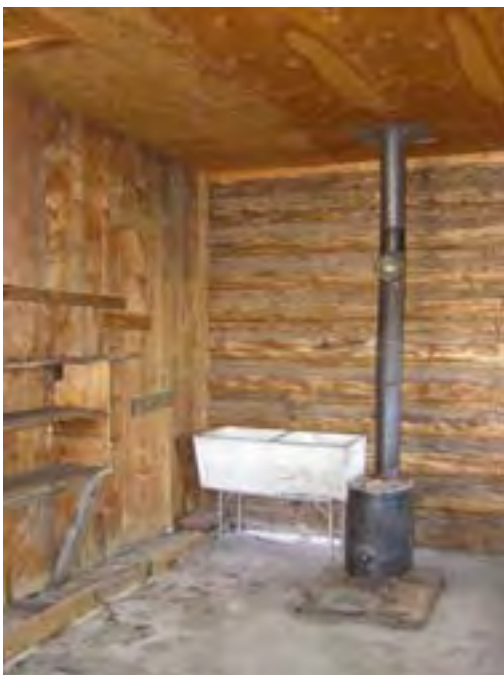
Figure 215 – Looking east at the interior of the first room in the Tack Room. Note the wood stove. Most of the materials are in good condition.

- Figure 215. Looking east at the interior of the first room in the Tack Room. Note the wood stove. Most of the materials are in good condition.
- Figure 216. Looking north at the doorway to the north room in the log volume. Note the transition from concrete floors to a wood floor. There are water stains on the base of all of the woodwork.

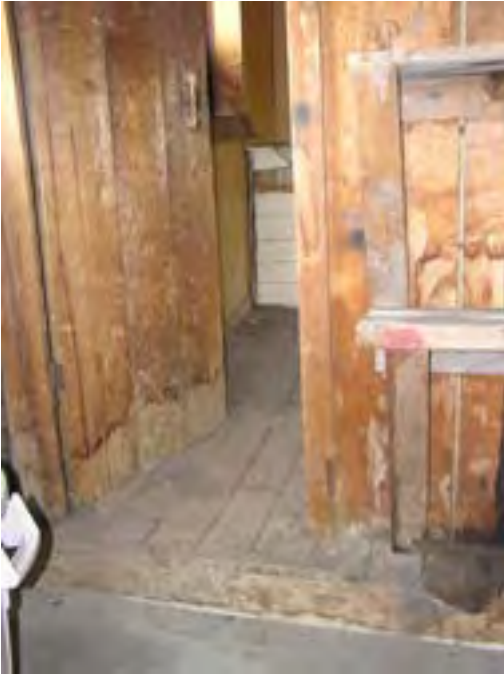
Figure 216 – Looking north at the doorway to the north room in the log volume. Note the transition from concrete floors to a wood floor. There are water stains on the base of all of the woodwork.

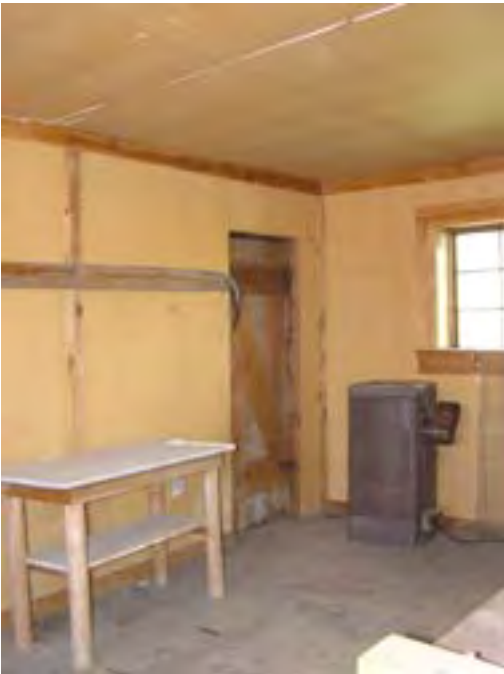
Figure 217 – Looking east at the north room in the log volume. Note the Celotex walls and ceiling.

- Figure 217. Looking east at the north room in the log volume. Note the Celotex walls and ceiling.
- Figure 218. HS-415, Chicken Coop, floor plan and elevations.

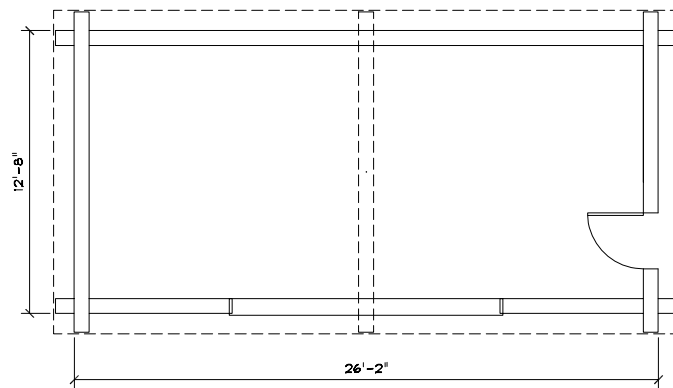
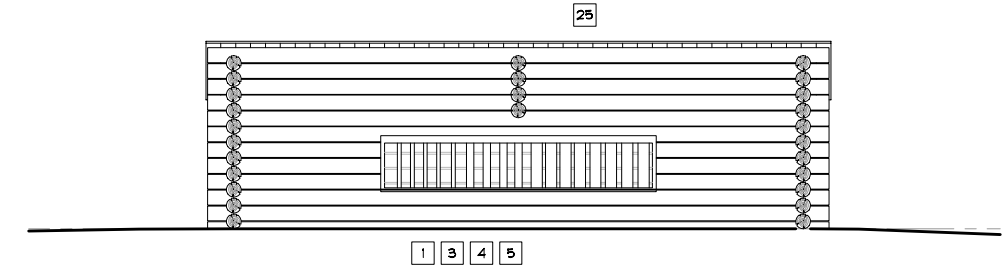
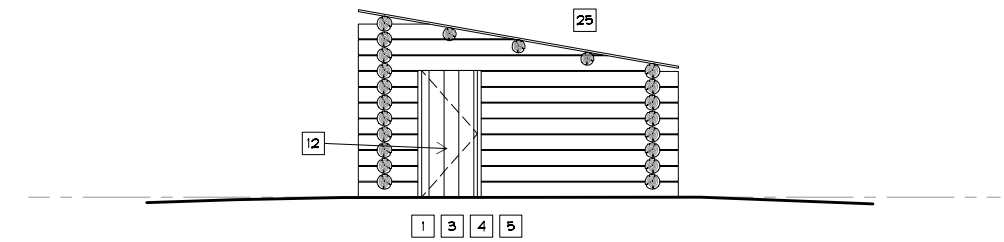
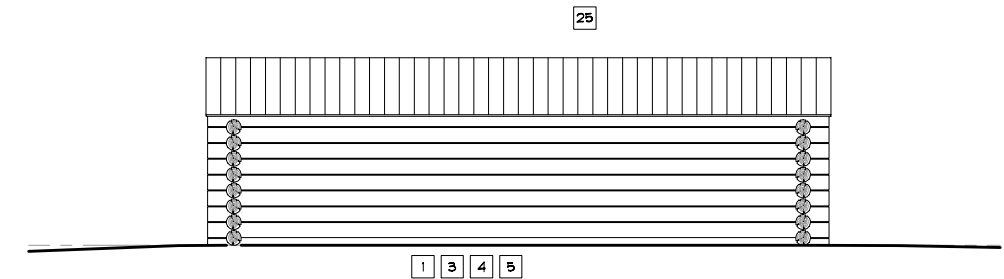
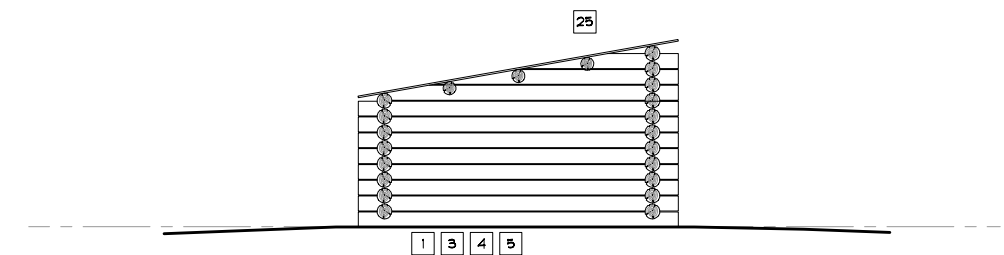
FIGURE

The Chicken Coop is in poor condition. The roof has collapsed into the interior causing the walls to also start to collapse. There is a lot of rot in the base logs on the west and north sides caused by soil accumulation along the base of the building. There is some rot in the sill logs on the east and south sides. The remaining logs are weathered and dry and there is no daubing in the building. The door has been removed from the building and there are no windows in the openings.

The poor condition suggests that the building would not be able to be saved without major reconstruction. There are no electrical or mechanical systems in the structure.

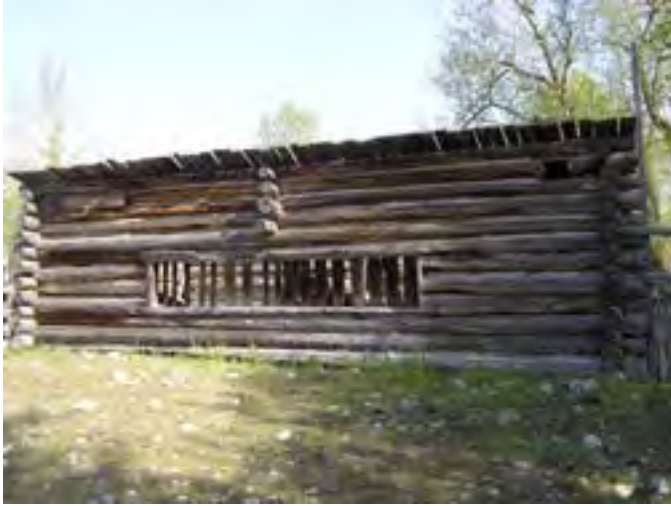
Figure 219 – Looking north at the front façade of the Chicken Coop. This log wall is in good condition although it is weathered and dry.

- Figure 219. Looking north at the front façade of the Chicken Coop. This log wall is in good condition although it is weathered and dry.
- Figure 220. Looking east at the end of the Chicken Coop. Note the collapsed roof causing the walls to fail also.

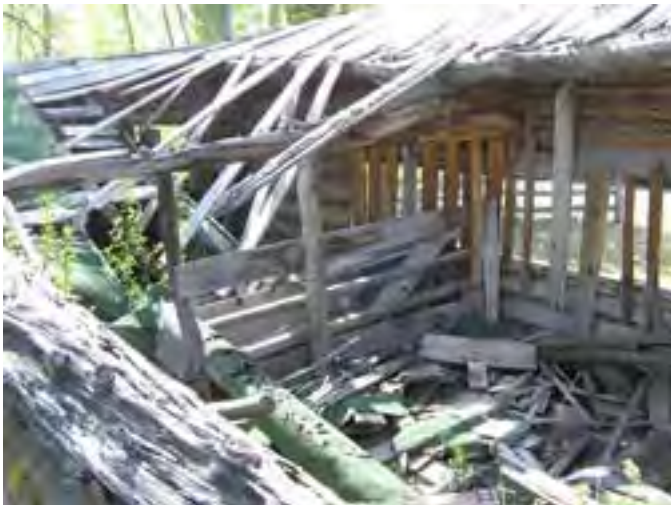
Figure 221 – Looking east at the interior of the collapsed building.

- Figure 221. Looking east at the interior of the collapsed building.
- Figure 222. Looking west at the wall of the Chicken Coop. There appears to be rot in all of the sill logs and upper parts of the walls which did support the roof.
