Snake River Land Company

Grand Teton National Park

Historic Structure Report

Prepared by
Colorado State University
Architectural Preservation Institute
Christopher Koziol, Principal Investigator

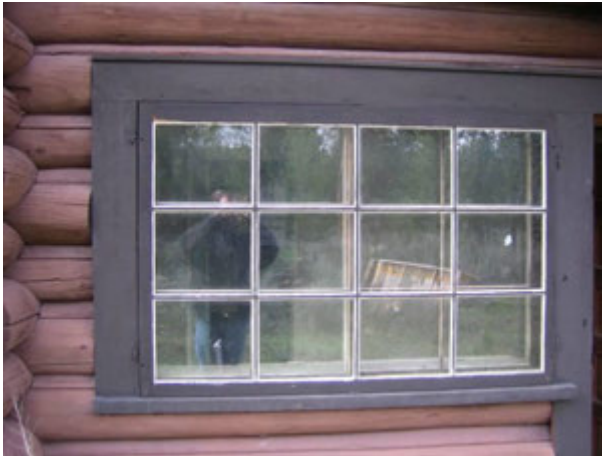
Figure 47
Window with fully intact storm window

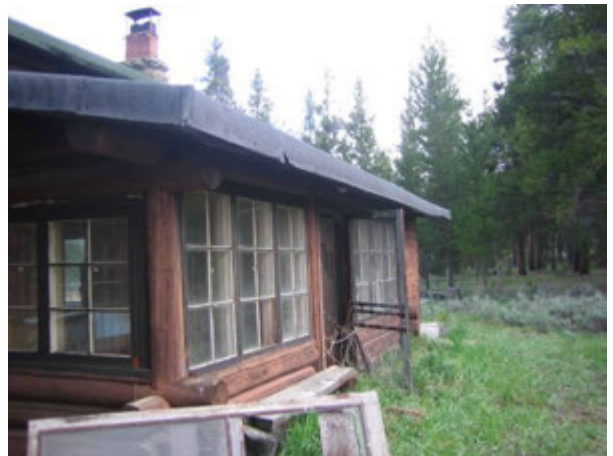
East porch enclosure with windows and door

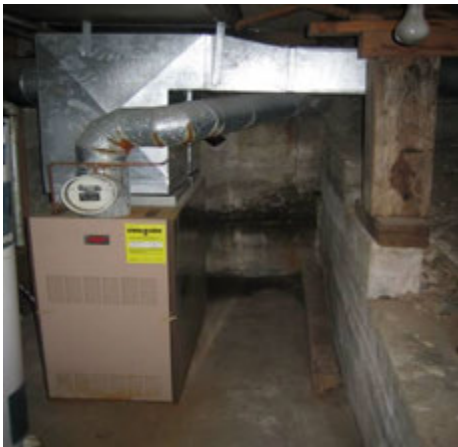
Figure 52
Oil burning furnace

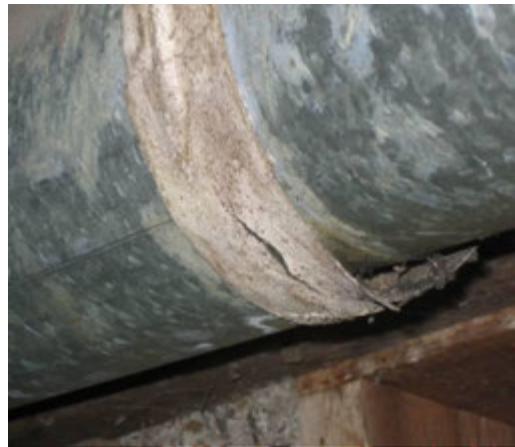
HVAC duct joint

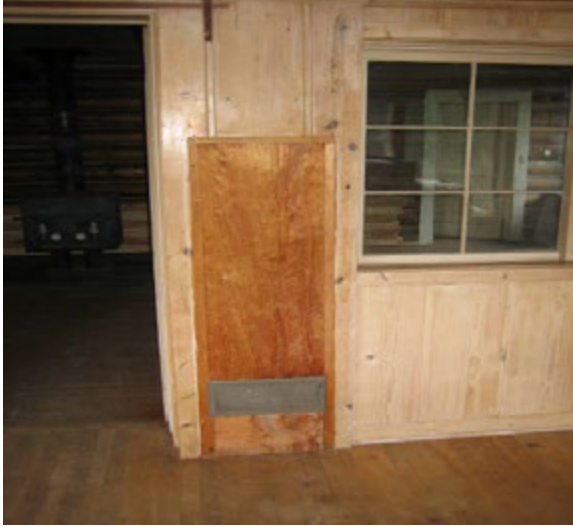
Figure 53
Wall heater in east enclosed porch

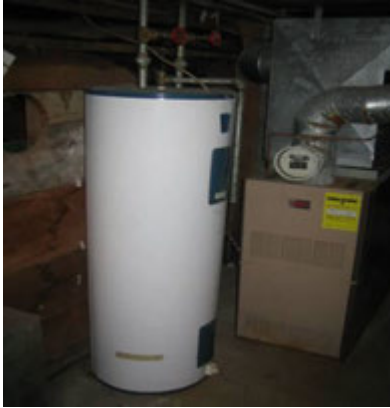
The plumbing system is in **poor** condition will need to be replaced as well. The water supply lines are of galvanized steel and are rusting at the thread joints. The waste lines are cast iron as well as some abs plastic. It is assumed as well that the cast iron has deteriorated over time and is in need of replacement as well. The bathroom has been updated and all fixtures seem to be in working order, although it is not known because the water is turned off to the building. The hot water heater is electric and is dated and it is recommended that it be replaced as well.

Figure 55
Electric water heater

- The plumbing systems should all be updated and a mechanical engineer or professional should further inspect the systems and make further recommendations.

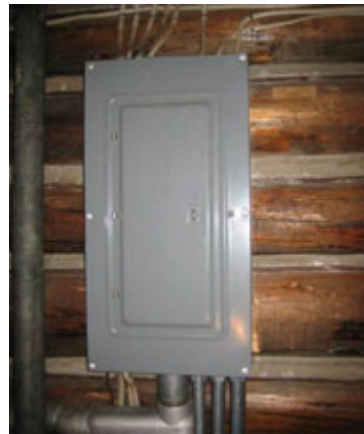
Updated electrical panel

The electrical system has been updated with copper wiring, new panel, and most outlets seem to be grounded as well. The concerns here are code issues. A good portion of the wiring inside is stapled to the logs and exposed. There is also evidence in the basement and crawl space of rodents chewing on wires with bare wires exposed.

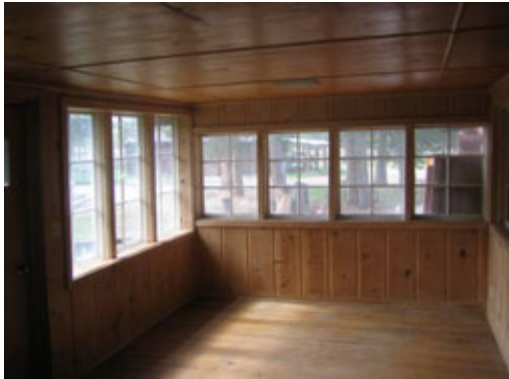
The east porch enclosure has a different wall covering than the rest of the rooms. Here, it is assumed, that when the porch was enclosed the logs were furred out and covered with sheetrock as well. At some point in the 1980's a pine tongue and groove paneling was added. The ceiling now has a 4x8 wood paneling with battens covering the seams. This area is in good condition and needs no repair.

Figure 59
East porch enclosure
