## Hilina Pali 2005

The Civilian Conservation Corps  
An Archeological Inventory Survey of the Hilina Pali  
Erosion Control Project of 1940

Pacific Island Network  
National Park Service  
U.S. Department of the Interior

Publications in Anthropology 12  
2008

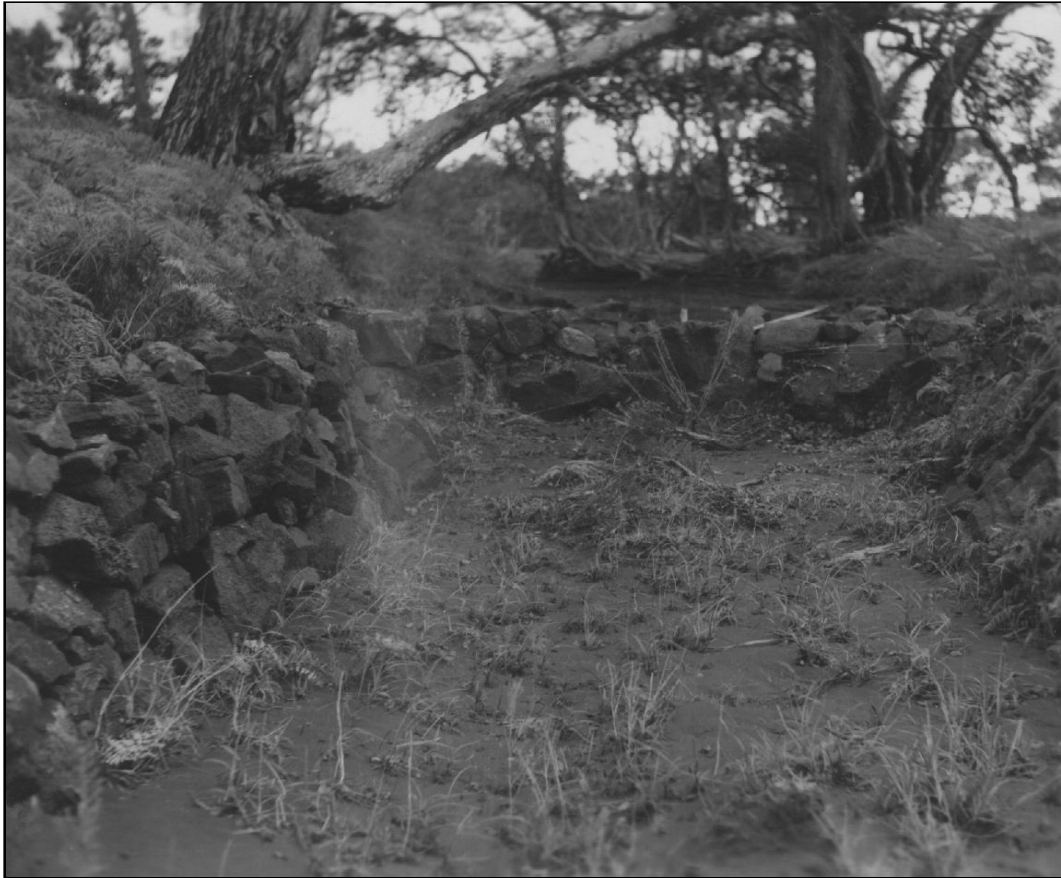
complete as it is not mentioned much more in the Superintendents Reports after this time period. On Aug 16, 1940 the Superintendent states that he did field inspections of the project and at the end of the year to monitor the success of the erosion control efforts. From the reports and pictures, and judging on how it looks today, it could safely be said that the efforts were successful and that the erosion process of the area was deterred through the construction of the walls and dams (see figure 24).

**Figure 24. “Hilina Pali erosion control project deposition and vegetation above check dam, 8 months after installation.”**

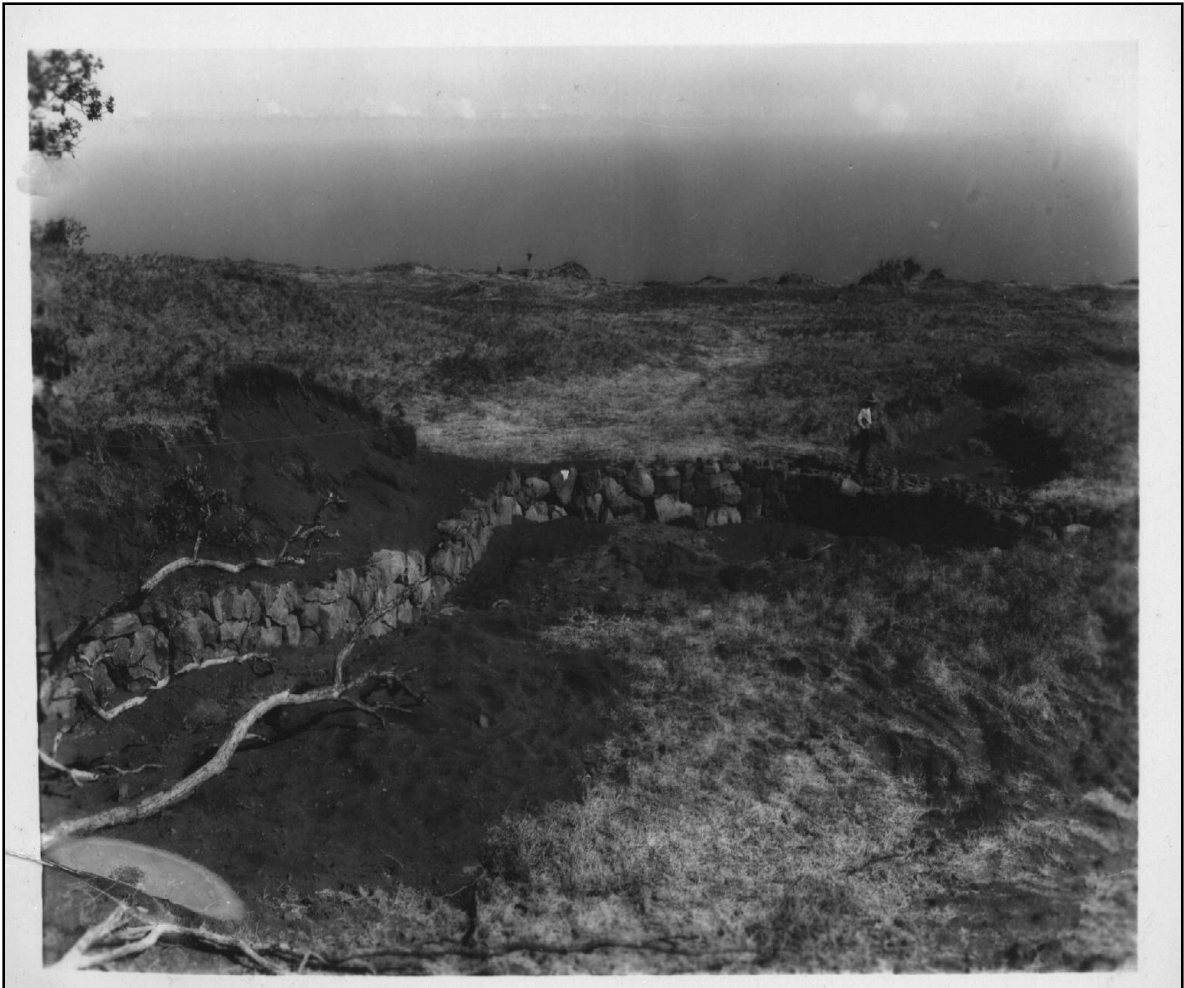
**Figure 25. CCC Job 327, wall construction**
